**Phase 2 Stream Geomorphic Assessment
Rock River Watershed
Highgate and Franklin, Franklin County, Vermont
December 2006 (Revised January 2007)**

South Mountain Research & Consulting
2852 South 116 Road
Bristol, VT 05443

Town of Highgate
2996 VT Rte 78, PO Box 67
Highgate Center, VT 05459

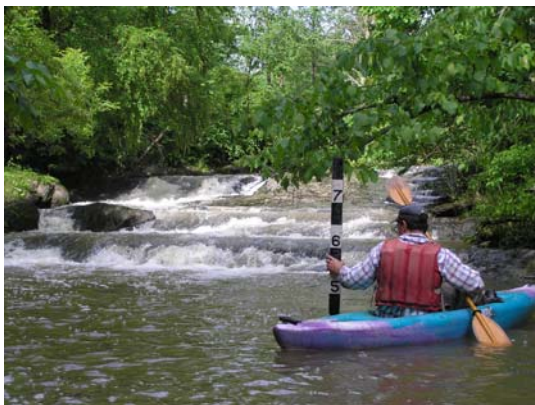
Figure 5. (M05) Bedrock falls at the site of a historic bridge crossing (now abandoned) southeast of Rollo Road in Highgate. This channel-spanning exposure of bedrock serves as a vertical grade control for the Rock River channel.

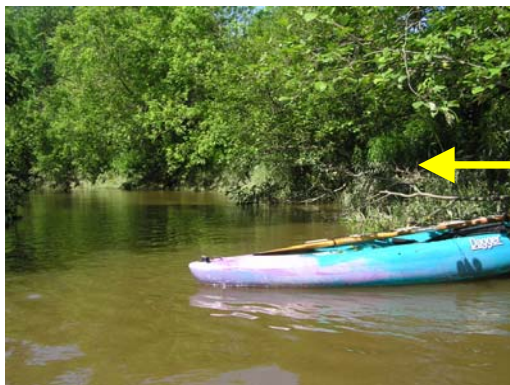
Figure 11. Sediment "halo" on vegetation (see arrow) marks the high water elevation from the 6/10 – 6/12/06 storm event on the Rock River main stem downstream of the Cassidy Road crossing.

Sediment line observed was 0.5 to 1.0 foot higher than bankfull elevation measured at two cross sections within reach M06, and approximately 2.5 to 3.0 feet higher than flow stages on 6/12 and 6/13 during assessments.

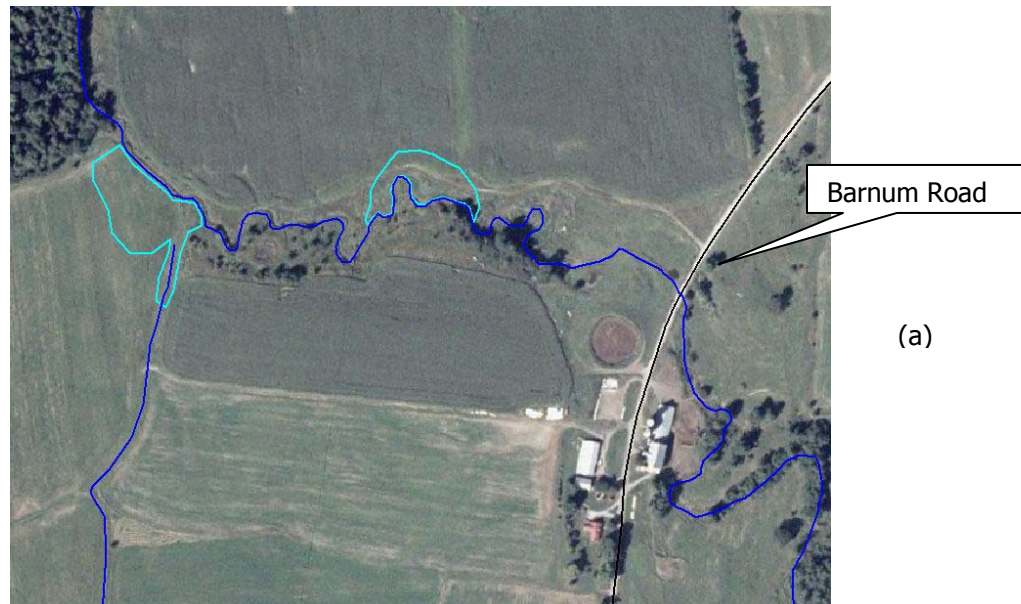
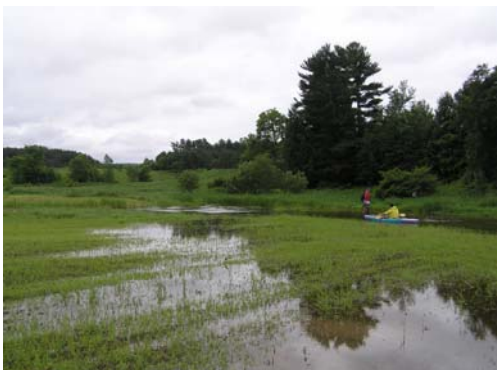
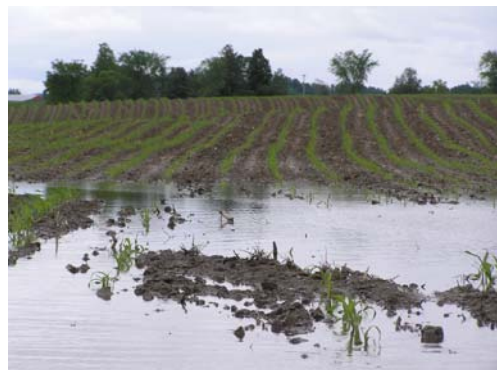
Figure 16. M07-A. Runoff contributing areas (saturation excess overflow) observed on 12 June 2006, as flood waters from a greater-than-bankfull flow were receding. (a) runoff contributing areas (RCAs) are outlined in light blue; Rock River flow is from picture right to picture left. Kayak access was possible in the downstream RCA which inundated recently emerged alfalfa (b); and in the downstream RCA which extended well into a recently planted corn field (c).

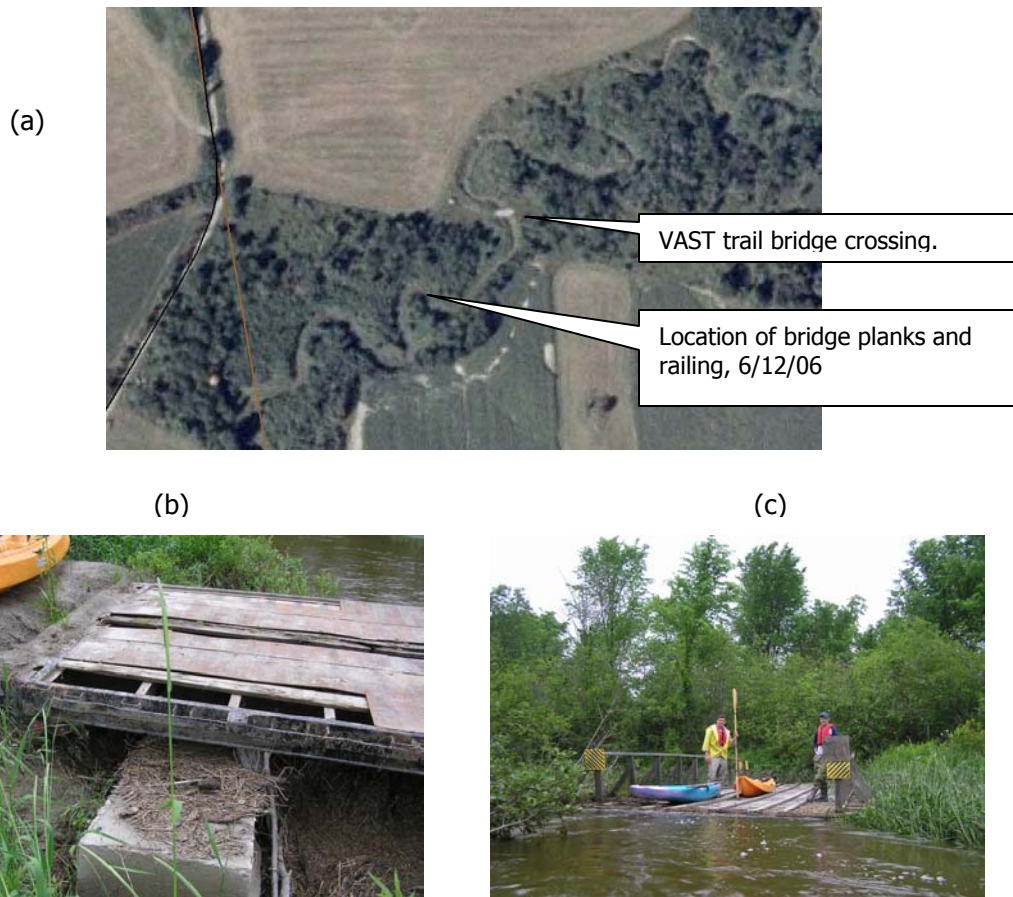
Figure 17. M06. VAST trail bridge crossing near the upper end of reach M06. The bridge decking and railing has separated from the bridge foundation and has moved approximately 320 feet downstream where it is now wedged between left and right banks. (a) map view (2003 aerial photograph), flow in Rock River is from upper right to lower left. (b) left bank bridge foundation on concrete; recent flows have scoured around the footer; (c) decking and railing floating mid channel.

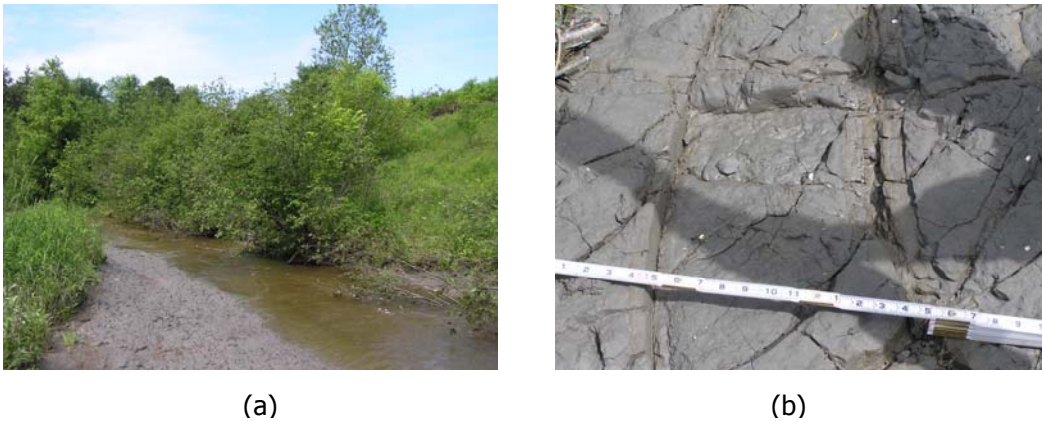
Figure 18. M06. A 120-foot channel-spanning exposure of varved clays serves as a local vertical grade control for the channel. (a) view downstream (b) closeup view of varved clays exposed above 6/13/2006 water level on the inside of the meander bend.

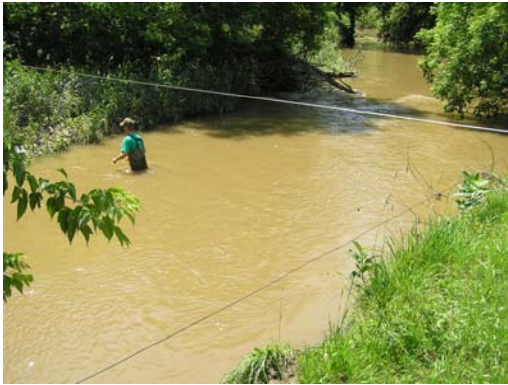
Figure 22. M04. Cross section measurement on 3 July 2006; flows are moderate to high following 30 June and 1 July greater-than-bankfull event; high suspended sediment loads result in very high turbidity.

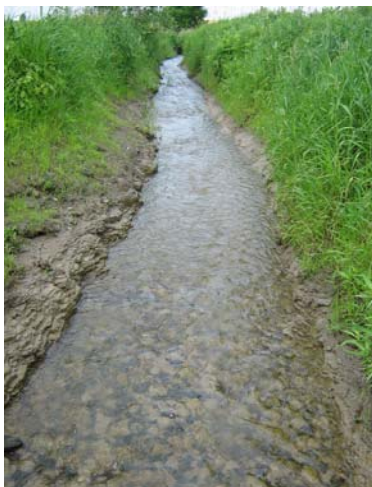
*Figure 24. M6S1.01-B.
Recent dredging was evident in this
channelized segment which flows through
dense silts and silty-clays.
View upstream, 29 June 2006.*

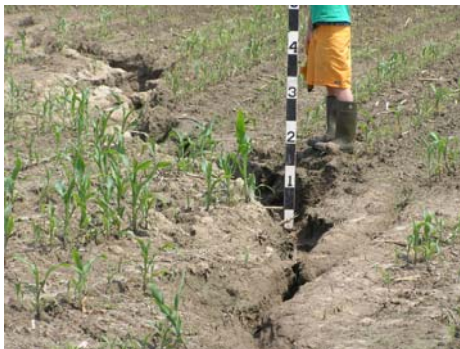
Several points of surface water runoff (rill erosion) were noted along the segment, particularly upstream of Franklin Road (Figure 26). Stormwater runoff was also noted at the downstream side of a farm road culvert crossing, mid-segment.

*Figure 26. M6S1.1S1.01-A.
Stormwater runoff eroded deep rills in
the mostly bare soils of newly planted
corn fields along the left bank and right
bank corridors.
View upstream, 3 July 2006.*

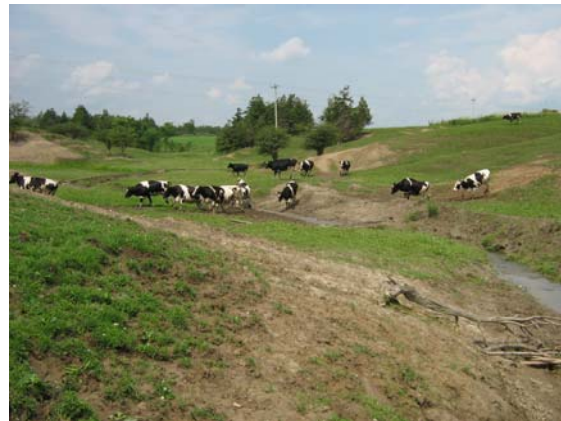
Downstream of Franklin Road, direct pasturing of livestock has resulted in trampling of stream bank soils and localized channel widening (Figure 27). Waters of this tributary are frequently turbid, even during baseflow conditions between rain events (Figure 28). A Fair score was assigned to this segment following the RHA. Conditions are compromised by the lack of morphological diversity and substrates for epifaunal colonization. Woody buffers are minimal to absent through the segment.

*Figure 27. M6S1.1S1.01-A
Direct pasturing of livestock occurs
downstream of Franklin Road.
29 July 2006.*

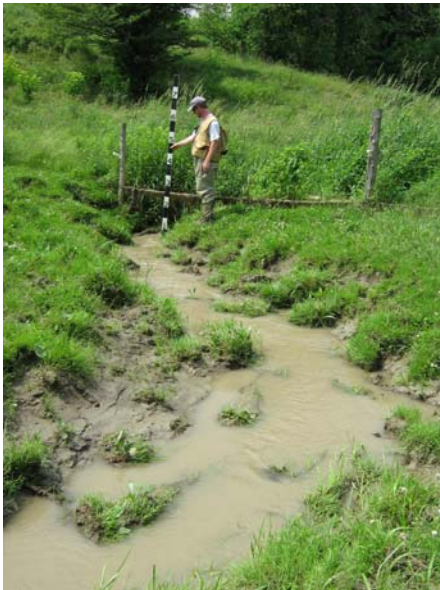
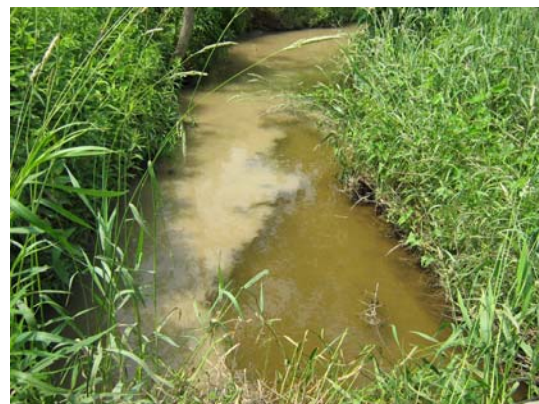
*Figure 28. M6S1.1S1.01-A; 29 July 2006.
As a result of direct pasturing, waters of this tributary are frequently turbid, even during
baseflow conditions between rain events.
(a) view upstream from confluence with M6S1.01.
(b) view downstream in M6S1.01 from confluence with M6S1.1S1.01*

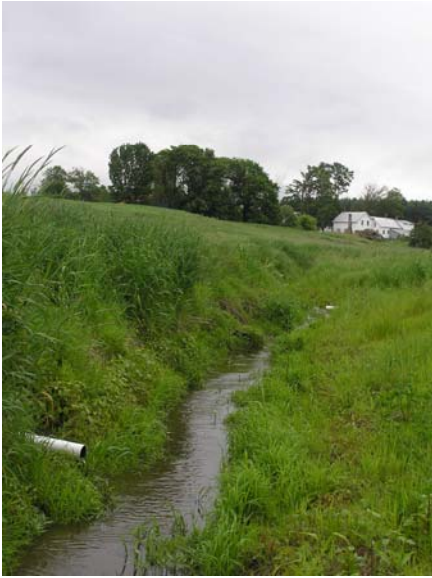
*Figure 31. M5S4.01-E.
Recent dredging was evident in this channelized segment which flows through dense silts and silty-clays. Corn fields were present on the right bank; hay fields on the left bank. Dredging spoil piles were bermed along left bank. Several tile drains were noted along left and right banks terminating at the channel. View upstream, 8 June 2006.*

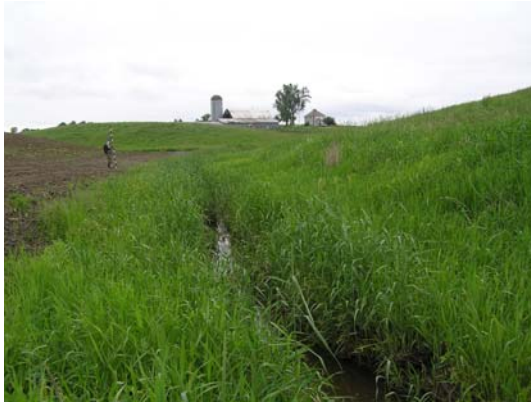
*Figure 32. M5S4.01-D.
Dredging appears less recent in this
channelized segment, which has achieved
a greater degree of floodplain access and a
minor secondary sinuosity within a narrow
linear valley than upstream Segment E.
View downstream, 8 June 2006.*

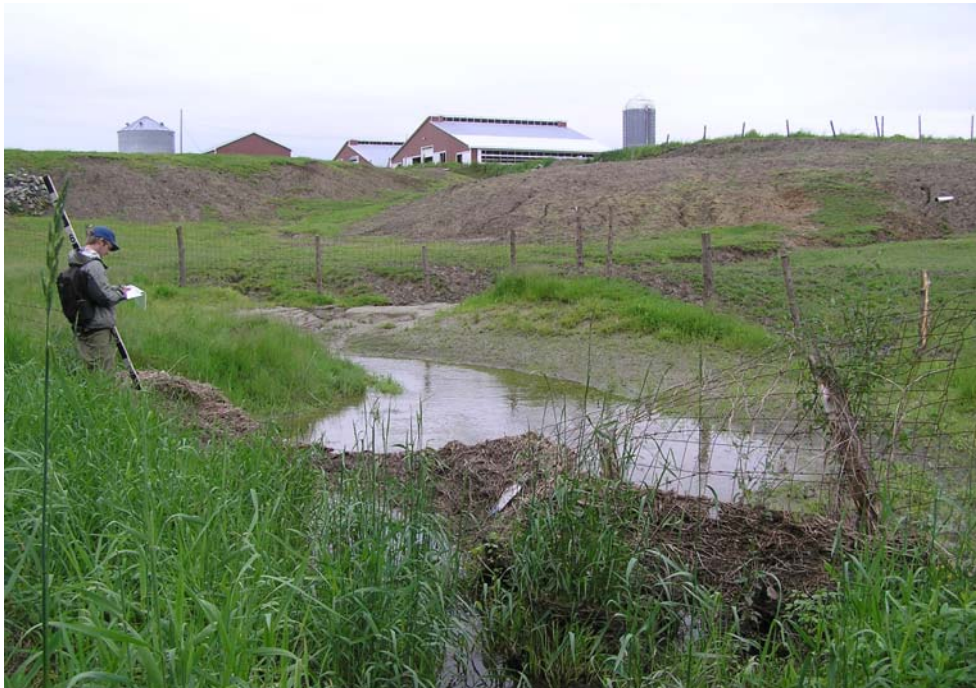
Figure 34. M5S4.01-C. View downstream, 8 June 2006. Debris is caught in a wire fence where a recent avulsion toward right bank has occurred into a high-intensity pasture. Note: Youth Conservation Corps has assisted the landowner in revegetating these slopes as of September 2006.

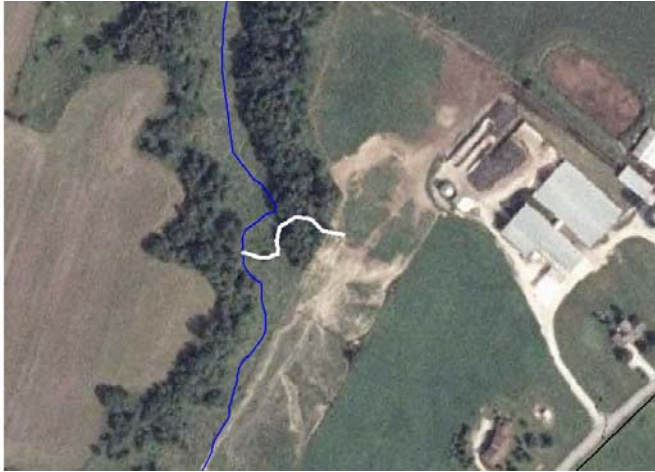
Figure 35. M5S4.01-B. The bold white line at the center of the plan view (left) marks the approximate path of a sediment flow (fine sand and silt) originating in a gully at the margins of the barnyard pasture area (picture right) and leading down the forested valley wall and out into the valley directly to the tributary channel. (Observed on 8 June 2006). Flow in the tributary (blue line) is from south (picture bottom) to north (picture top).

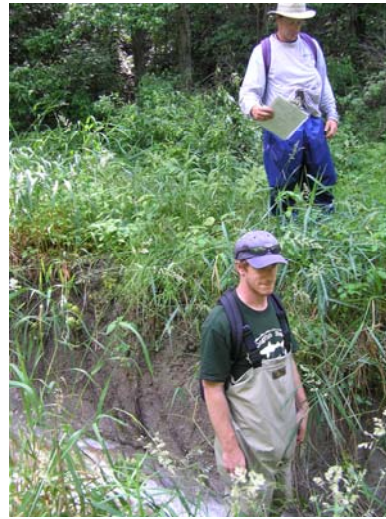
(b) incision ratio of 4.2 is measured where channel has incised to abandon the recent floodplain.

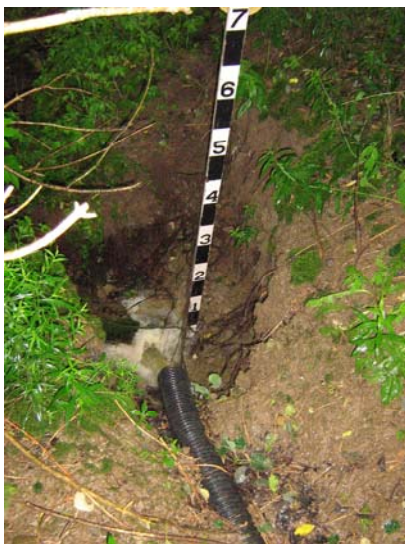
Figure 37. M5S3.01-A. 20 June 2006. Example of scour hole at a tile outlet along the edge of a hay field at the top of the right valley wall. Flows were high immediately following an afternoon thunderstorm. The scour hole leads to a gully which is approximately 15 feet wide and more than 8 feet deep, conveying stormwater and fine sediments down-slope to the tributary channel.

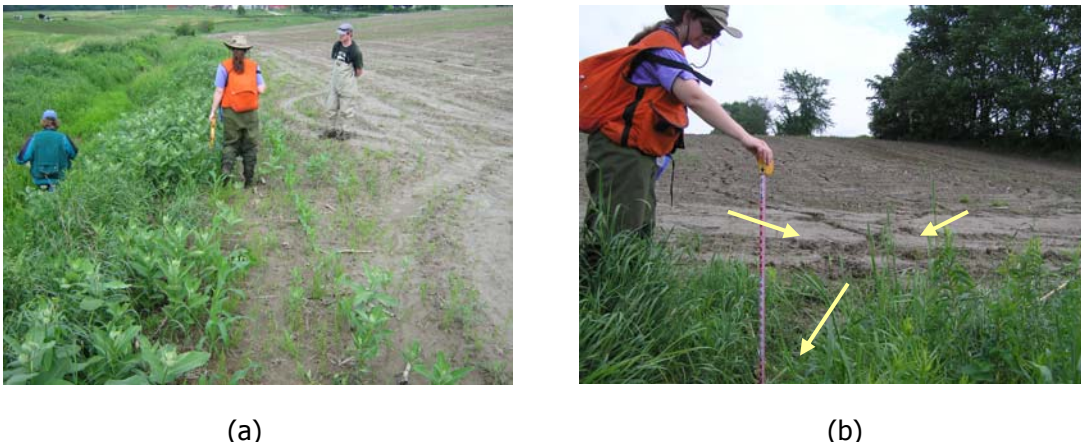
Figure 38. M5S2.01-B. (a) View downstream: channel located in ditch between recently-plowed corn field on RB and hay field on LB. (b) Rill erosion through corn field – flow is concentrated to small channels which cut through the narrow herbaceous buffer and deliver sediment and surface water directly to the tributary channel.

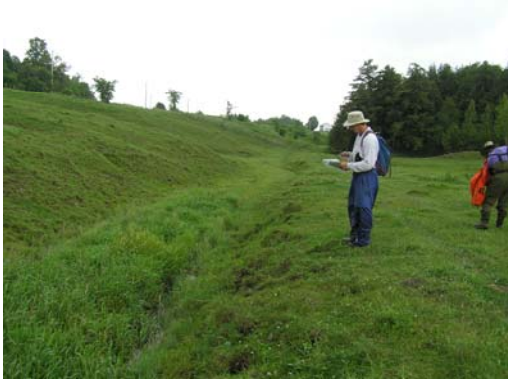
Figure 39. M5S2.01-B. View downstream. Straightened channel dredged along left valley wall through cow pasture to the tree line at picture background. Original channel visible meandering along right valley wall (beyond picture right). Straightening removed approximately 115 feet of length along a 590-foot channel, increasing local gradient.

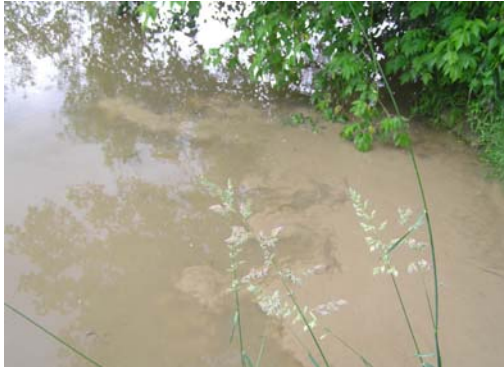
Figure 40. M5S2.01-A. View of confluence with Rock River main stem. Following a brief but heavy thunder shower on 20 June 2006, a suspended sediment plume from tributary M5S2.01 (picture right) was observed flowing into and mixing with the Rock River main stem waters of lesser turbidity (picture left).

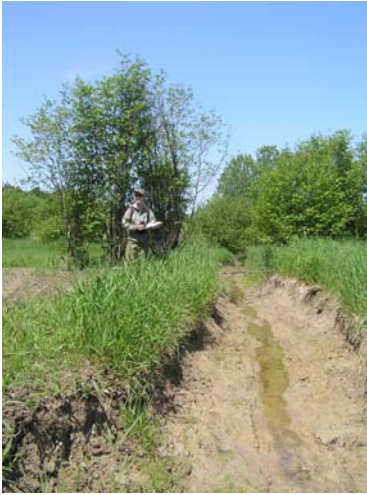
Figure 42. Tributary to M1S1.03-A. Recently, lands surrounding M1S1.03-A have been partially cleared of vegetation, and tributaries have been dredged and channelized.
