**Phase 2 Stream Geomorphic Assessment
Rock River Watershed
Highgate and Franklin, Franklin County, Vermont
December 2006 (Revised January 2007)**

Prepared by

South Mountain Research & Consulting
2852 South 116 Road
Bristol, VT 05443

Town of Highgate
2996 VT Rte 78, PO Box 67
Highgate Center, VT 05459

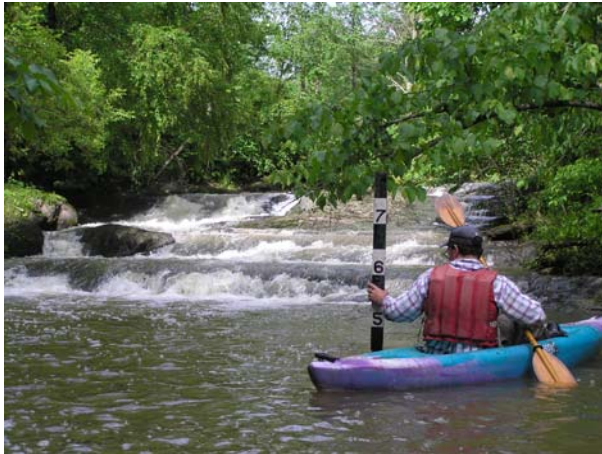
*Figure 20.
Bedrock falls encountered
near the downstream end of
reach M05.*

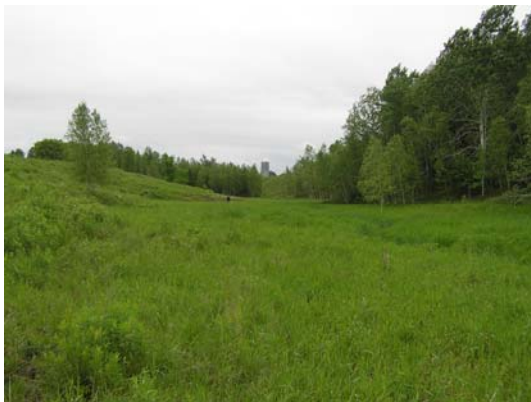
*Figure 33. M5S4.01-C.
This segment flows through a broad
valley of low-intensity pasture.
View downstream, 8 June 2006.*

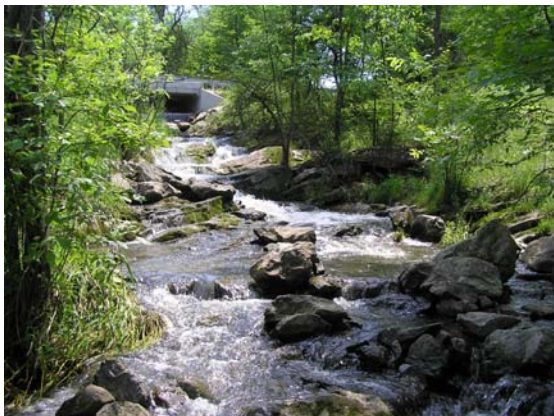
Figure 44. M1S1.02-A. Bedrock falls in the Saxe Brook downstream of the Ballard Road box culvert. Site of historic Saxe's Mills. View upstream, 6 June 2006.
