**Rock River Watershed  
Stream Geomorphic Assessment  
Phase 2 Report  
May, 2007**

**Prepared by:**

**Landslide Natural Resource Planning**  
P O Box 311  
East Middlebury, VT 05740

Windham County Natural Resources Conservation District  
28 Vernon Street  
Brattleboro, VT 05301

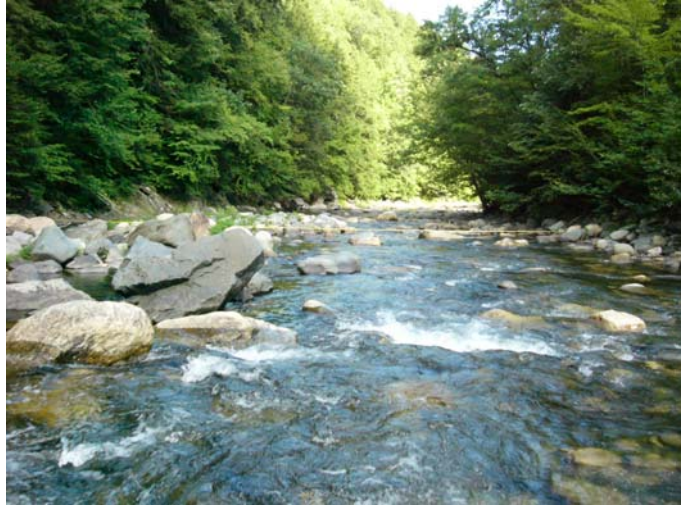
#### T2.01

This reach is located at the confluence of the Rock River and the West River in a naturally semi-confined valley. The reach is dominated by series of ledge outcrops that create deep pools with steep riffles in between them. It is both a Bc by reference and currently a Bc type channel although it is moderately entrenched and very incised. The right bank has an old road bed running along its entire length that is a public right of way that facilitates access by swimmers and is likely a recently abandoned floodplain feature. This road is found on the 1893 and 1935 USGS

topographic maps but is not shown on the 1954 edition. There are six steep riffles at the upstream end of the reach which may be related to the historic dam on T08.03. When it was removed it is likely a large amount of sediment was released, causing the previously sediment starved (and thus incised) river to now be aggrading. Reference channel width is 78' and current channel width is 115'.

This reach is in "Fair" geomorphic condition, is highly sensitive and in channel evolution stage IV-F; aggrading with historic widening and degradation. The habitat condition was rated good.

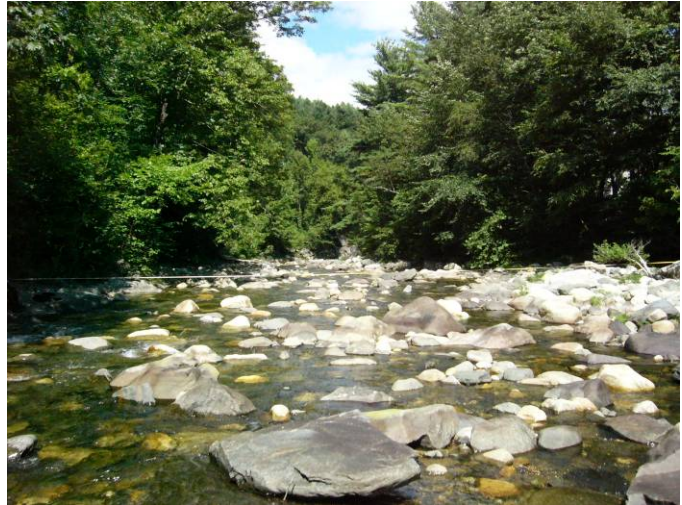
This reach is located downstream of the village of Williamsville in a semi-confined valley and it is naturally straight. There is a gravel town road along the entire right bank, which used to connect to the road in T2.01, and the left corridor is almost entirely mowed meadow though the stream bank is vegetated along both banks. There are no channel or floodplain constrictions and no grade controls that span the entire channel. However, there is ledge across the right channel in the upstream section of the reach where the stream accesses a left bank channel during high water. Reference channel width is 77' and current channel width is 96'.

T2.02 is a C plane bed stream type by reference but is currently an F plane bed channel type that is in stage IV of the F-stage channel evolution process. It is aggrading with historic degradation and widening and is in fair geomorphic condition. The habitat condition was rated good.

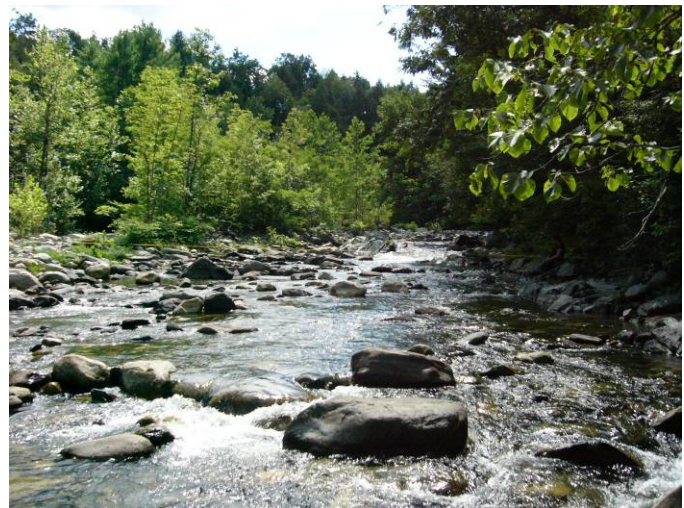
This reach is in the village of Williamsville and has a popular public swimming area in the pools created by the channel spanning grade control. It is located in a narrowly confined valley that has been altered by human land use. There is a road the entire length of the left corridor with development along most of it. The reach is dominated by ledge with an over-widened section that has two parallel flood channels. Local residents report that the main flow has been in the left channel for at least the past 30 years and the river accesses both flood channels during high flow events. All of this is down stream of channel spanning grade control that had a wooden dam on it until it was "dismantled naturally after being declared unnecessary in the 1980's" (Phase 1 SGA Report). Reference channel width for this reach is 76' and it is currently 96'.

There is one bridge in this reach that is flood prone area constriction with deposition above and below it. The left bank is dominated by the Dover Road and village development while the right bank is relatively undeveloped.

T2.03 is an F stream type in stage IV of the F-stage channel evolution process. The Phase 1 assessment identified this as a C riffle pool stream type. It is extremely sensitive and is in fair geomorphic condition. The habitat was condition was rated good.

Passive river management is recommended for this reach that will naturally narrow and re-build its floodplain as it continues to adjust to the removal of the dam. Community outreach is recommended to help residents and swimmers understand the fluvial processes at work in their part of the river.

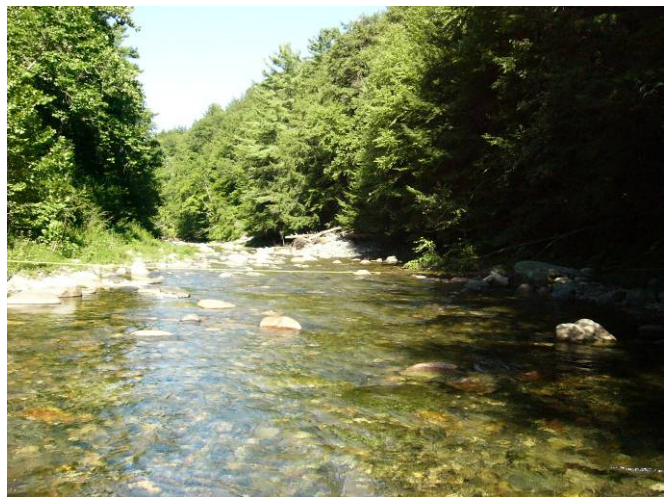
This reach is just upstream of the village of Williamsville and it is located in a broadly confined valley. During the 1990's a dredging violation occurred in the reach. Tributary rejuvenation is occurring in two gullies along the right bank of this reach and there is one mass failure on the right bank at the downstream end. There is significant erosion on the left bank in the downstream portion of the reach. There is an old channel evident on the left bank. Reference channel width is 68' and current channel width is 82'.

There is one (covered) bridge at the upstream end of the reach that is a floodplain constriction. There is dogleg shaped channel on the left bank at the downstream end of the reach that appears to be a delta bar from Baker Brook when the Rock was dammed downstream. It appears, from analysis of 1893, 1935 and 1954 U.S.G.S. topographic maps, that this reach was straightened between 1935 and 1954, most likely as part of the dam installation. (See Appendix A.)

The reach is currently an F plane bed stream type, departed from a C riffle pool by reference. The stream is currently in stage III of the F-stage channel evolution model, undergoing widening and planform adjustment. It is highly sensitive and in fair geomorphic condition. The habitat condition was good. The two gullies and one mass failure were likely triggered when the dam was removed and the water and sediment levels were lowered.

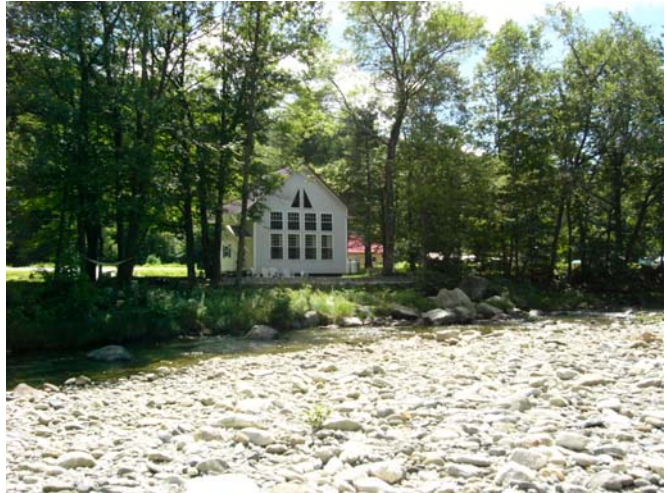
Segment A is located just upstream of the covered bridge on the Dover Road and is in a broad valley. It is a C riffle pool stream type currently and by reference. It is in good geomorphic condition and is in stage I of the F-stage channel evolution model with minor widening as the dominant adjustment process. Stream sensitivity is moderate and the habitat condition was rated good. Reference channel width is 67' and current channel width is 73'.

The upstream end of this segment has some encroachment from the road and a few houses in the corridor, but otherwise, the corridor is undeveloped and forested. There are no constrictions in this segment. It has five side bars, one mid-channel bar and one transverse riffle. It appears, from analysis of 1893, 1935 and 1954 U.S.G.S. topographic maps, that this reach was almost entirely straightened between 1935 and 1954. (See Appendix A.) The upstream end of this reach is shown to be split by the road in the 1935 topographic map but the whole channel was moved to the north by the 1954 topographic map.

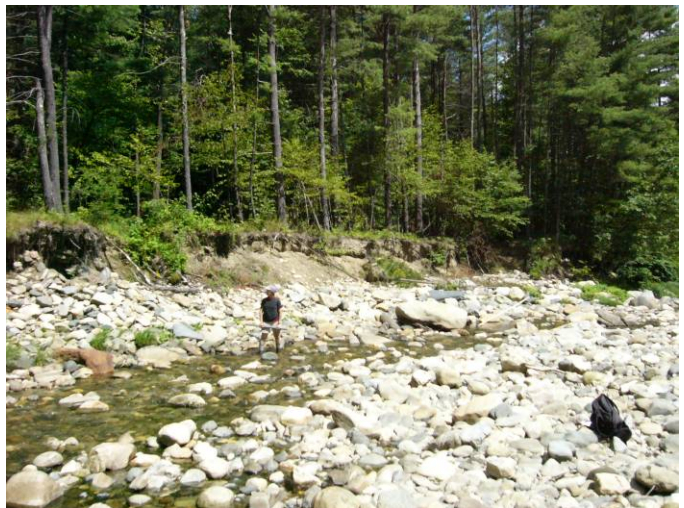
This reach was segmented due to channel dimension, substrate size, and planform and slope. It is located in a narrow valley due to human caused changes to the valley width (it is up against the road). This segment is eroding on the left bank for the entire length and has rip rap along one third of right bank where the road is closest to the channel. There was an active logging operation along the top of the left bank, a steep riffle in the down stream portion of the reach and a very large mid-channel bar dominating the mid section of the reach. There are no channel constrictions in this segment. Reference channel width is 67' and current channel width is 128'.

The stream is currently an F plane bed, though it is a C type stream by reference. It is in stage IV of the F-stage channel evolution model, currently experiencing planform adjustment. It is extremely sensitive and is in fair geomorphic condition. Habitat was rated in fair condition. The

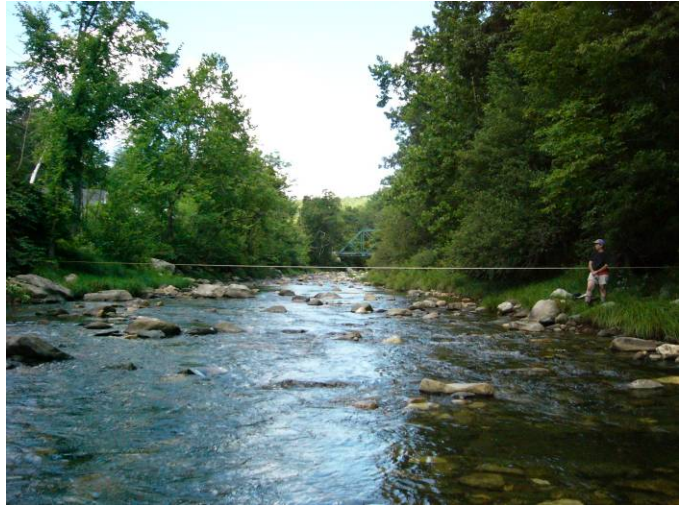
The segment is a C riffle pool stream type currently and by reference. It is in good geomorphic condition and is in stage I of the F-stage channel evolution model with minor degradation and widening as the dominant adjustment processes. Stream sensitivity is moderate and the habitat condition was rated good.

The left bank of this segment is critical as floodplain that it accesses during high flow events and it should be conserved.

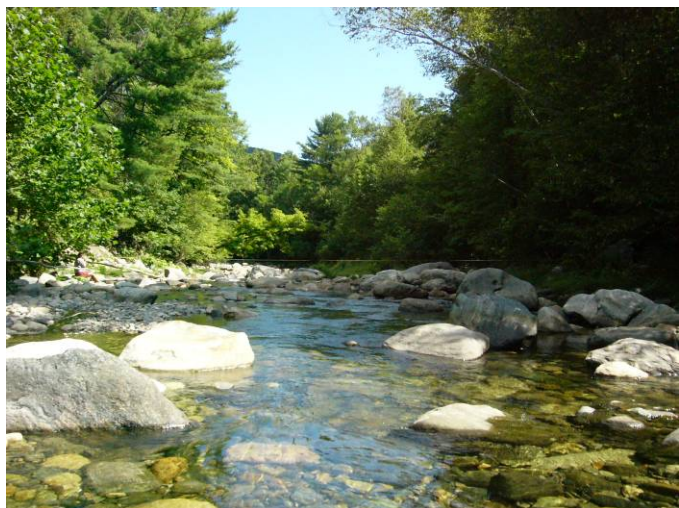
This reach was segmented due to channel dimension, substrate size and depositional features. It is located in a narrowly confined valley with no human caused changes to the valley width. It is extremely over-widened, with a reference channel width of 50' and current channel width is 84'.

There are no grade controls or constrictions on this reach. The left corridor is predominantly forested while the right corridor is dominated by residences. There are three steep riffles and one flood chute present in the reach.

It is currently an F plane bed stream type, departed from a reference C plane bed stream type. It is in channel evolution stage IV of the F-stage process. Its geomorphic condition is fair and its sensitivity is extreme. It is currently in planform adjustment and aggrading. The habitat was rated in fair condition.

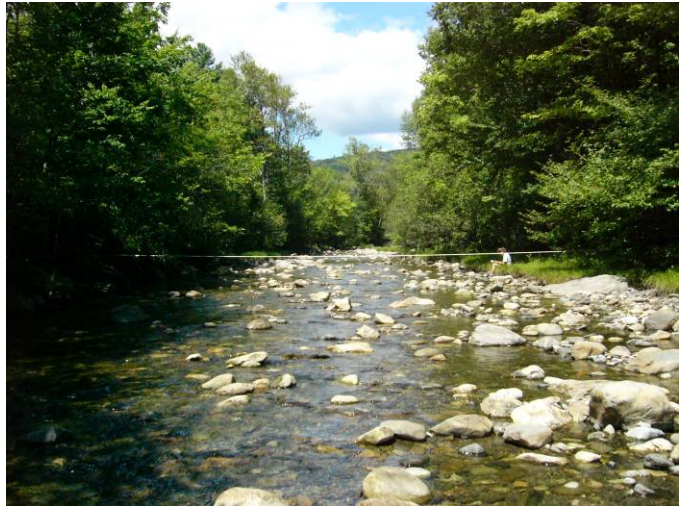
This reach was segmented due to channel dimension and substrate size. It is located in a narrowly confined valley with human caused changes to the valley width. Reference channel width is 50' and the current channel width is 65'.

There are no grade controls or channel constrictions on this reach. The left corridor is predominantly forested while the right corridor is dominated by residences. Three flood chutes were noted in the segment. There is rip-rap in both the upstream and down stream portions of the reach.

The stream is currently a B plane bed stream type, departed from a reference C stream type due to moderate entrenchment. It is moderately sensitive and in good geomorphic condition. It is in stage IV of the F-stage channel evolution process and is undergoing minor aggradation. Habitat was assessed in fair condition.

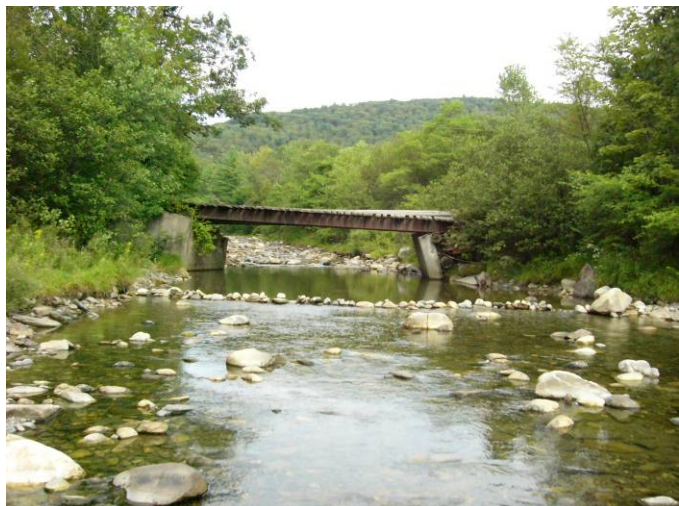
This reach runs along the Dover Road beginning at Stratton Hill Road and continuing .7 miles up stream. It is located in a broad valley and has one bridge that is not currently in use that is a channel constriction with deposition below and scour above and below. There are multiple mid, point and side bars in the channel, five flood chutes and one active stream crossing just upstream of the defunct bridge. Reference channel width is 49' and the current channel width is 58'.

C riffle-pool by reference, this stream is currently an F plane bed in fair geomorphic condition. Its stream sensitivity is very high and it is in stage IV of the F-stage channel evolution process. Habitat was assessed in fair condition as well.

Historically, this reach functioned as a sediment storage and flood attenuation asset, as do all C type streams, but it has degraded from a C to an F type stream. The multiple flood chutes indicate planform adjustment. Some time between 1935 and 1954 the road and river were moved south to their present location.

This reach is a critical attenuation asset for up and down stream reaches. If the structure were replaced (it accesses a camp that is in use) and the corridor conserved, it would narrow and re-build floodplain in the near term.

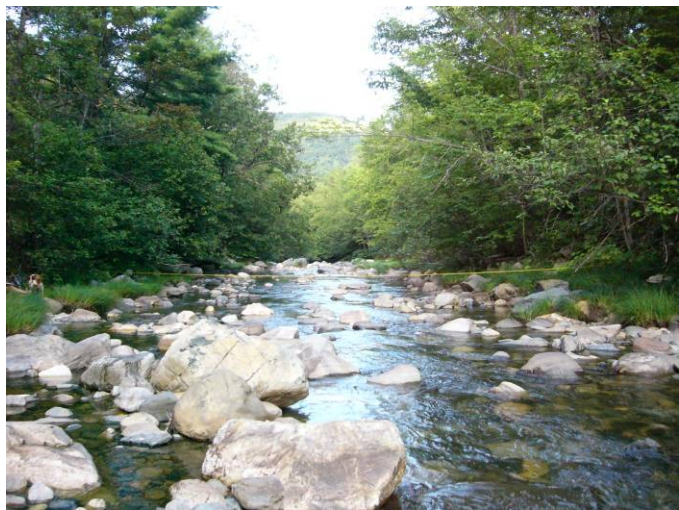
A short reach located along the north side of the Dover Road just east of Brookside in a narrowly confined valley. There are multiple bed features, one flood chute and some springs and wetlands. There is ledge at the downstream end of the reach. Reference channel width is 48' and current channel width is 51'.

The town road used to cross the downstream end of this reach to continue along the left bank of the river. At some point between 1935 and 1954 the current road was put in on the south side of the river. The river appears to be closer to its original planform after this adjustment.

This reach is a reference B step-pool but it is currently a B plane bed due to active aggradation. It is in fair geomorphic condition and highly sensitive. Habitat was rated fair as well.

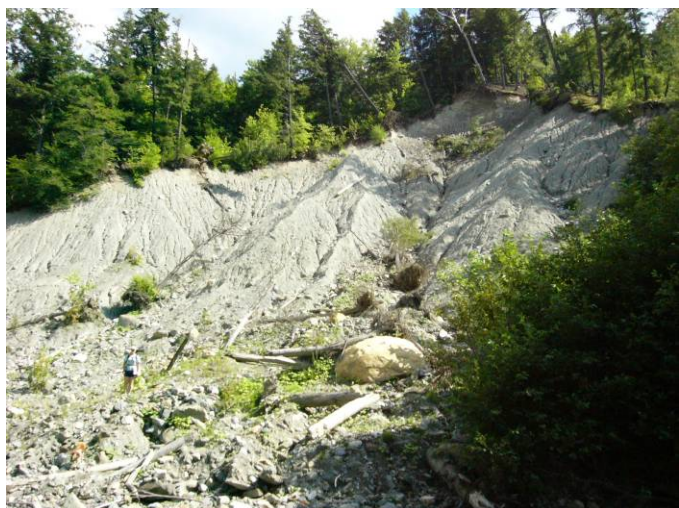
This reach is located immediately downstream of Brookside in a narrowly confined valley that is reduced in width because of the Dover Road. Twenty-seven percent of left bank is rip-rapped for the Dover Road. There are two mass failures on the right bank of the river, the upstream one being quite large. According to local resident and owner of

T2.11, Merrill Mundell, this failure (slide) started after the 1938 hurricane and it turns the river gray after big rain events. Immediately downstream of the large mass failure is a significant flood chute on the right bank. At the downstream end of this reach there is an old bridge abutment on the right bank and some historic berming also on the right bank associated with the old bridge and road location. Just upstream of this there is right bank berming that was left bank berming from an old channel. Reference channel width is 47' and current channel width is 64'.

This reach is B Plane Bed by reference as well as currently. It is aggrading with historic widening and is in fair geomorphic condition. It is in stage IV of the F-stage channel evolution model and the habitat condition is fair.

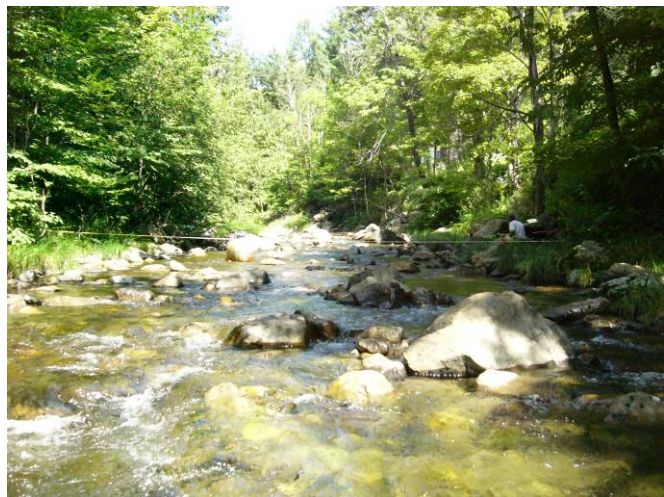
This reach starts in Brookside and ends just upstream of the Adam's Brook confluence. It is located in a narrowly confined valley and the Dover Road runs along the entire length of the left bank. The left and right banks are 25% rip-rapped and there are two mass failures on the right bank. One thousand feet of the reach are straightened and there are multiple point and side bars present in the channel. Reference channel width is 40' and current channel width is 52'.

The stream is a B step-pool by reference but is currently an F step-pool. It is in stage IV of the F- stage channel evolution model and is in fair geomorphic condition. It is undergoing planform adjustment with historic degradation. The habitat was found to be in good condition.

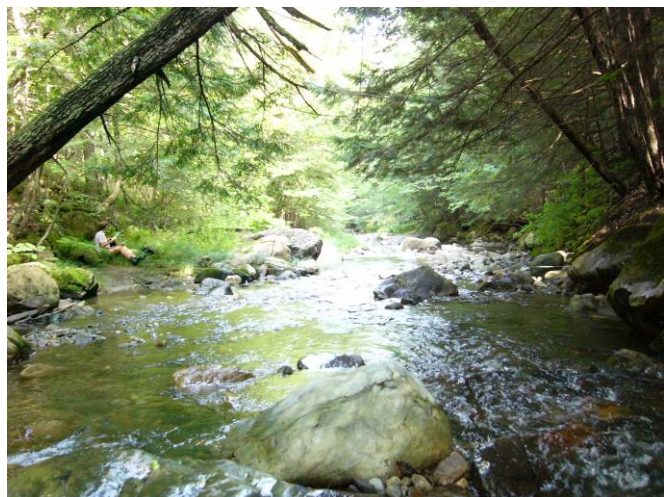
This reach runs from the confluence with Adam's Brook upstream to East Dover at the confluence with Taft Brook along the Dover Road. It is located in a narrowly confined valley and there are two gorges (one at either end of the reach) with numerous grade controls associated with the downstream gorge. The downstream gorge is a popular swimming area that is

At the downstream end of the reach there is one mass failure and one gully starting, both on the left bank. The mass failure extends all the way up to the road and has recently been treated with grading, erosion control fabric and seeding. The majority of this reach is well away from the road which makes it unique for the Rock River. There are numerous mid, point, side and diagonal bars throughout the reach and there is one human made channel constriction (a culvert) at the upstream end. The upstream gorge was the site of an old mill that is currently fenced off. There is a new box culvert that is 2' narrower than reference bankfull at the upstream end of the reach, near the confluence with Taft Brook.

The stream is a B plane bed by reference and is currently a B. It is in stage I of the F-stage channel evolution process and its geomorphic condition is good. It is highly sensitive and the habitat condition is good.

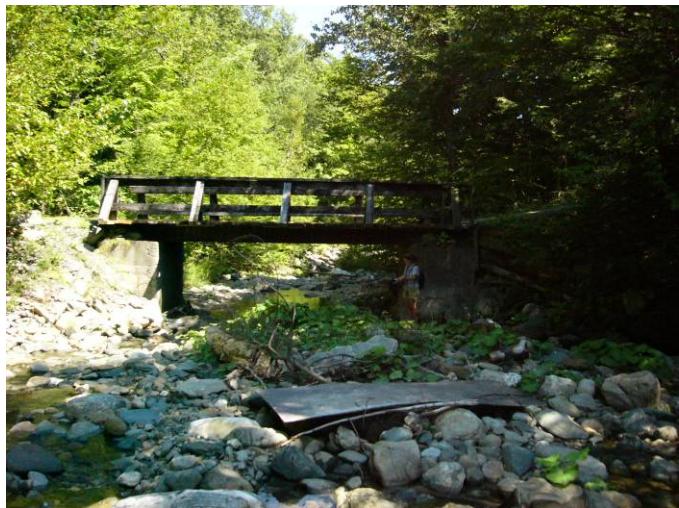
This reach runs from East Dover upstream to Goose City and is located in a naturally narrowly confined valley that also has a road in it. There are numerous mid, point, side and diagonal bars as well as two islands and seven flood chutes throughout this reach. It is 17% bermed. The road is in the river corridor for almost half of its length. There are three bridges in this reach, one of which is a minor (< 1') channel constriction, and the other two are floodplain constrictions. There are three mass failures and two steep riffles. This is the first reach on the main stem with a large amount of woody debris (19 pieces).

There are numerous seasonal camps in the corridor, one of which was being accessed by a new ford while we were surveying the stream. Reference channel width is 26' and current channel width is 31'.

This reach is a B plane bed by reference but is currently moderately entrenched and very incised, making it an F plane bed. It has undergone historic degradation and is presently in planform adjustment. The geomorphic condition is fair and it is in stage IV of the F-stage channel evolution process. The habitat condition is also fair.

This reach would benefit from the establishment of a Fluvial Erosion Hazard Zone (FEH) to prevent further encroachments into the corridor and from working with landowners and the town to implement best management practices as new camps and year round residences are built.

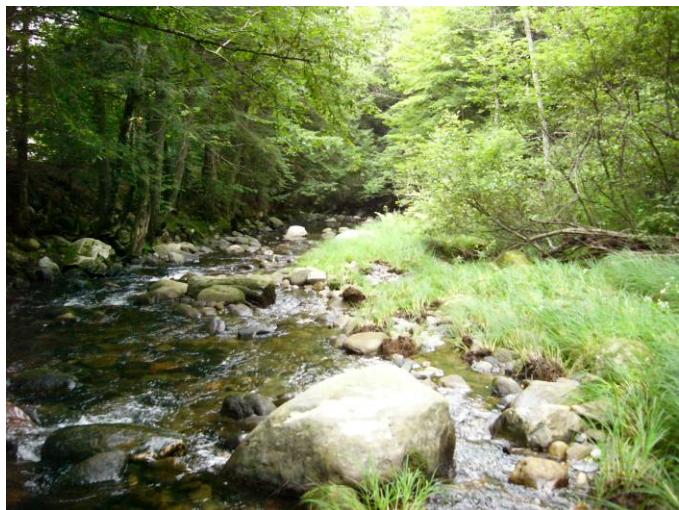
This reach is located in a semi-confined valley that is altered due to the presence of a road. There are multiple mid, point, side and diagonal bars throughout the reach and there are two channel spanning grade controls in the middle of the reach. There are two bridges in this reach, neither of them are constrictions. This reach is in the process of re-building active floodplain and there are numerous old terraces along the right bank. There is a lot of placed rock in the channel, possibly dating from the 1973 flood. It would be helpful to research whether the road bed was raised along this reach.

The stream was typed a B plane-bed in the Phase 1 Assessment. It is currently an F plane bed due to historic bed degradation and is in stage IV of the F-stage channel evolution process. The reference channel width is 39' and the current channel width is 38'. It is in fair geomorphic condition and extremely sensitive due to the stream type departure. It is currently aggrading and in planform adjustment. The habitat was rated in good condition.

This reach is a candidate for corridor conservation and would benefit from the establishment of a Fluvial Erosion Hazard Zone (FEH).

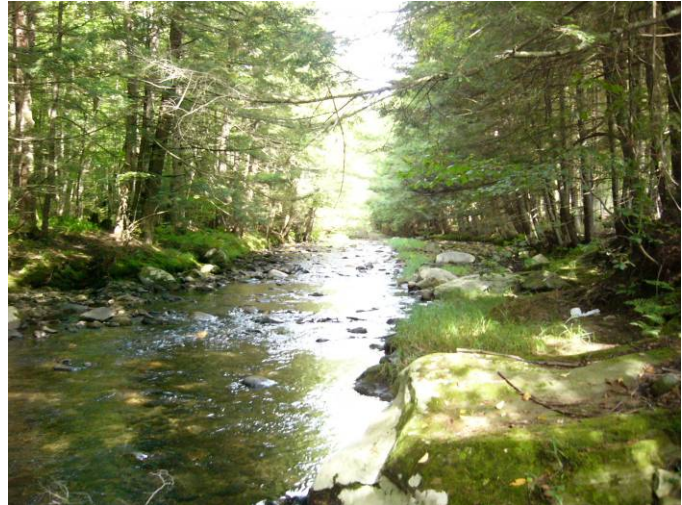
This reach is located in a narrowly confined valley that is even narrower due to the presence of a road along the entire length of the stream. There is one bridge in the reach that is a channel constriction as well as old abutments that are also channel constricting. Both structures have deposition above them. There are nine mid, one point, sixteen side and twelve diagonal bars in this segment as well as six flood chutes and eight storm water inputs. It would be helpful to research whether the road bed was raised along this reach. The reference channel width is 37' and the current channel width is 43'.

This reach is a C riffle pool by reference but is currently an F riffle pool due to historic degradation (entrenchment) and widening. It is in stage IV of the F-stage channel evolution model is extremely sensitive (due to the stream type departure) and in fair geomorphic condition. The habitat condition was good.

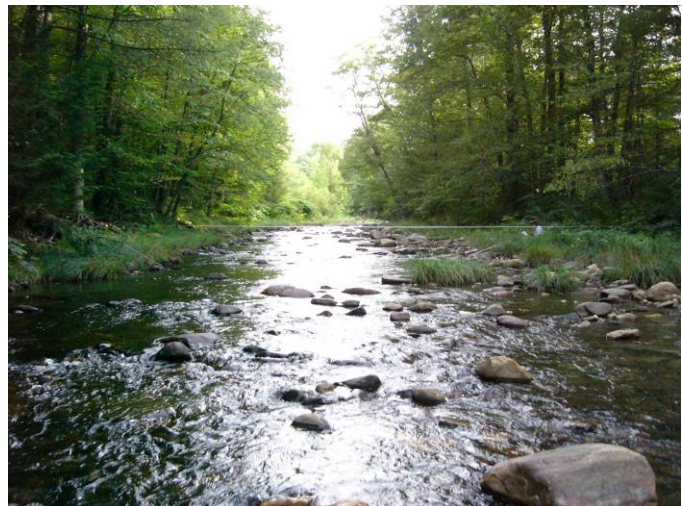
The first reach of the Marlboro Branch begins in the village of South Newfane and continues south four tenths of a mile until the stream bends sharply west. It is located in a narrowly confined valley with Augerhole Road encroaching along two thirds of the right corridor. There is one bridge at the downstream end of the reach on the Dover Road that is a floodplain constriction. There is one flood chute, one transverse riffle and multiple point and side bars in the reach. There was an old channel in the left corridor. Reference channel width is 46' and current channel width is 65'.

The left bank vegetation was dominated by knotweed and the right bank was either ledge or rip-rap associated with the road. The reference channel width is 46' and the current width is 65'. The left corridor had abundant poison ivy and invasive burning bush (*Euonymus alatus*). Burning bush "is a threat to woodland areas, fields, and coastal scrubland because it out competes native species" (The Nature Conservancy web page).

A review of the historic topographic maps (see Appendix A) reveals that some time between 1935 and 1954 the river was moved toward the right valley wall in this reach. An old channel was noted near the left valley wall during the assessment.

The reach is C riffle pool by reference and is currently a C plane bed due to aggradation. It is in stage IV of the F-stage channel evolution process with the dominant adjustment process being aggradation due to the loss of step-pool bed features. The stream is in fair geomorphic condition and highly sensitive. Habitat was rated fair.

This reach is a good candidate for management of invasive species that were otherwise rarely noted in the watershed and for corridor conservation due to the existing floodplain access along the right bank and the potential for it along the left bank.

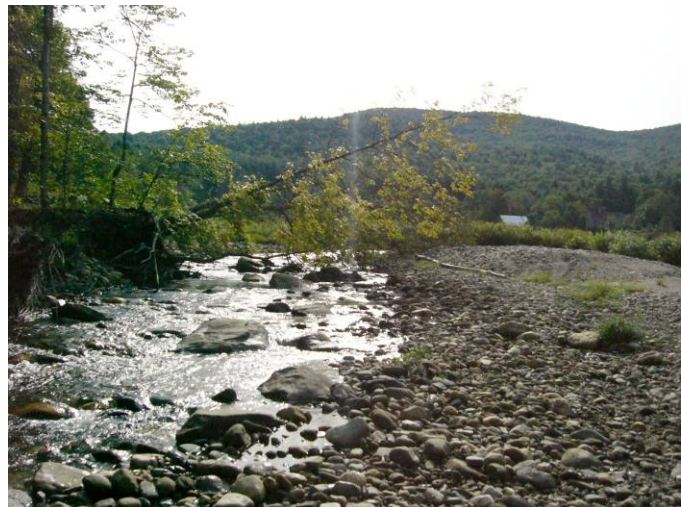
Located in the towns of Newfane and Marlboro, this reach is 1.6 miles long and is in a broad valley type. It is at the western base of the valley and there are numerous historic channels evident, many point bars and flood chutes and it has 3,288' of erosion and over 1,800' of old berms on one bank. There are multiple mass failures on the left bank and an active stream ford crosses the channel. The entire length of it has been straightened. The reference channel width is 46' and the current channel width is 70'.

A review of the historic topographic maps (see Appendix A) reveals that some time between 1935 and 1954 the river was moved toward the left valley wall in this reach. An old channel was noted near the left valley wall in some places during the assessment.

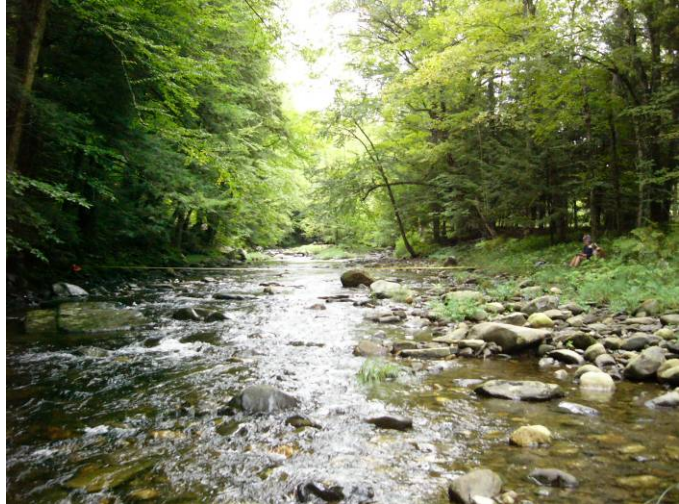
This reach begins at Gulf Brook and continues just past the junction of Augerhole Road and Lahar Road. It is located in a semi-confined valley with the left corridor being dominated by the Augerhole Road. The reach has approximately 3,800' of both left and right bank erosion and has over 800' of berming on the left or right bank. The right corridor is forested while the left corridor is dominated by the road. There are two bridges in the reach, both of which are floodplain constrictions. There are numerous mid, point, and side bars in the reach as well as five diagonal bars and five steep riffles. The reference channel width is 42' and the current channel width is 53'.

As with the two previous reaches on the Marlboro Branch, there is evidence that the river was moved and straightened between 1935 and 1954. Please see Appendix A for more information.

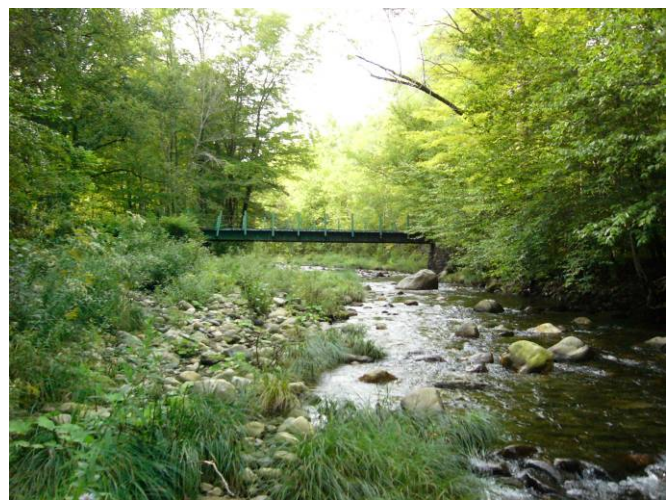
This reach is located along Augerhole Road from Lahar Road upstream to just after Adam's Brook joins the Marlboro Branch. It is a half a mile long and in a very broad valley type, though the valley narrows in the middle of the reach. There is 1,600' of berming and 780' of erosion along the reach. There is one bridge at the downstream end of the reach that is both a channel and floodplain constriction. The reference channel width is 38' and the current channel width is 56'.

The reach is C riffle pool both by reference and currently. It is in stage IV of the F-stage channel evolution process and is in good

geomorphic condition with minor planform being the dominant adjustment process. The habitat was also rated in good condition.

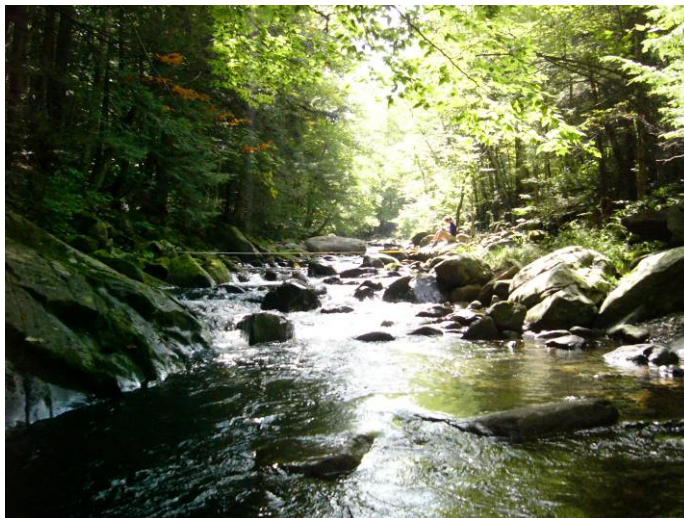
This reach begins just past the confluence with Adam's Brook, and runs 1.1 miles to just past the confluence with Worden Brook. It is located in a semi-confined valley and is dominated by ledge on the right bank and road encroachment along the left bank. There are abundant springs and seeps and some wetlands located along this reach. Eleven-hundred feet of erosion are along the left bank, numerous mid, point and side bars, four flood chutes and six steep riffles in the channel. The reference channel width is 36' and the current channel width is 36'.

The reach is a B step-pool currently and by reference. It is in stage IV of the F-stage channel evolution model and its geomorphic condition is good. It is moderately sensitive and has good habitat.

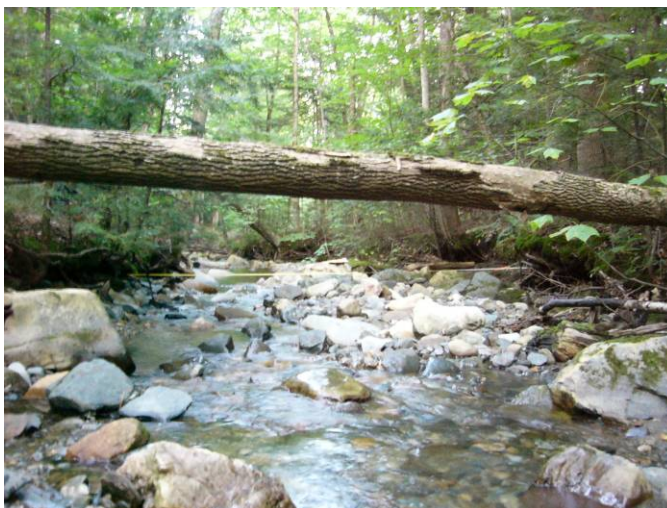
There are six structures in this reach, only one of which is not a channel constriction. They all have deposition above them and

all but one has deposition below and it has scour below. There are 12 mid channel, 22 point and 55 side bars in this reach alone and 22 pieces of large woody debris. This segment has 1,200' of erosion on both the right and left banks. There are three channel spanning natural grade controls in this segment as well. It is 21% rip-rapped along the left bank. The reference channel width is 15' and the current channel width is 18'.

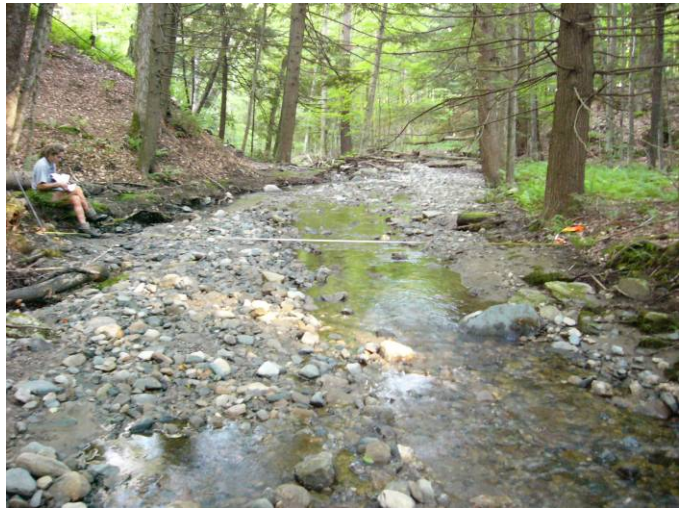
There is an active animal crossing at the same horse farm where the sandy banks are eroding. There was evidence of gravel removal at one site in this reach and there

are three mass failures. The reference channel width is 15' and the current channel width is 25'.

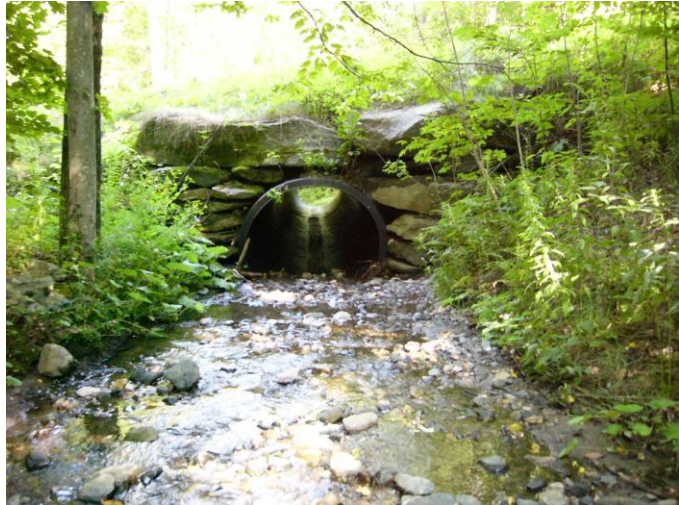
This segment is located in a narrowly confined valley that is narrower due to the presence of a road. The one bridge and two culverts in this reach are all channel constrictions. The two culverts both have deposition above and below them. The bridge did not have evidence of deposition. There are 17 mid channel, 10 point and 13 side bars in this reach alone and 22 pieces of large woody debris. This segment has multiple mass failures and two flood chutes. There is one channel spanning natural grade control in this segment as well. The reference channel width is 15' and the current channel width is 18'.

This reach was originally typed as an A step pool in the Phase 1 assessment. After this assessment the reference stream type was changed to B riffle pool. This segment is currently an F riffle pool due to historic degradation. It is in stage IV of the F-stage channel evolution process is undergoing planform adjustment and the geomorphic condition is fair. It is extremely sensitive and the habitat condition is also fair.
