TYLER BRANCH WATERSHED

PHASE 2 STREAM GEOMORPHIC ASSESSMENT

June 2, 2009

Prepared by:
Daniel Ruddell, Elisabeth McLane,
Staff Scientists, and
Ben Machin, Principal
Redstart Consulting

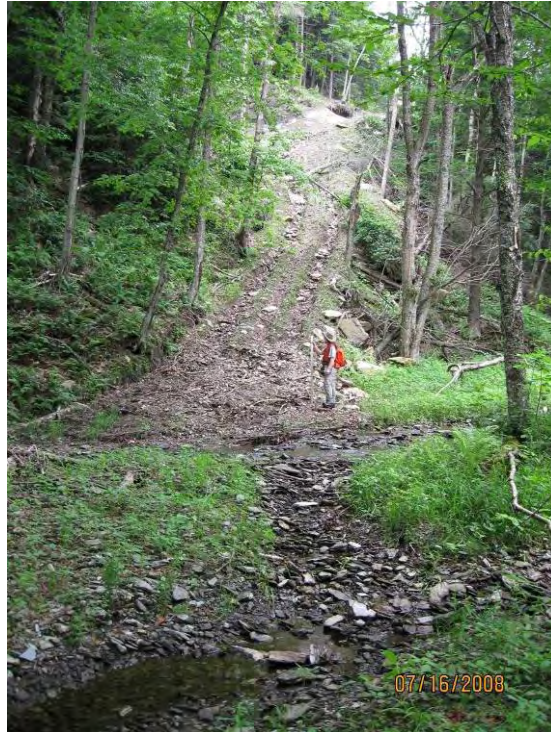
Figure 4. Dense but friable “mudstones” (primarily slates here) in reach T1.15, along with similar materials in other portions of the watershed, have contributed coarse sediments to stream beds that are relatively resistant to erosion and predispose streams to channel avulsions and lateral migration instead of bed downcutting, but will erode in major floods.

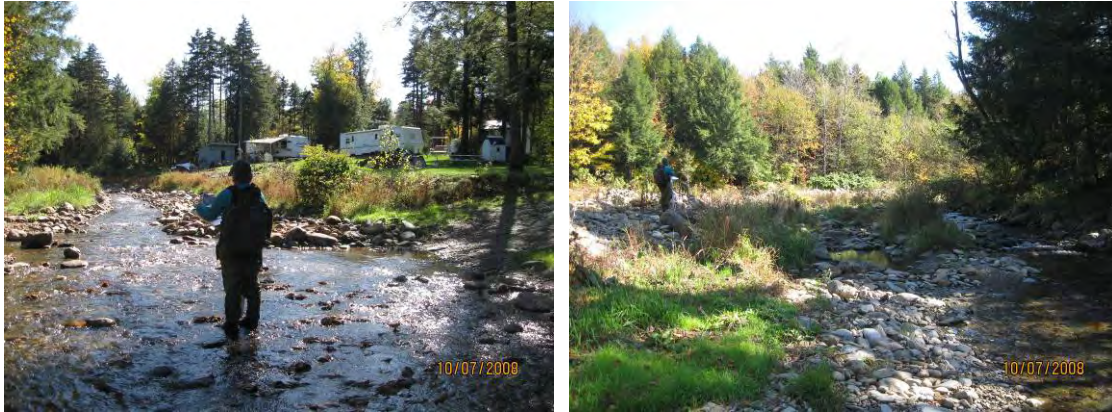
Gravel removal, windrowing and bar scalping was observed in reaches T2.03, T2.04 and T2S1.03 on Bogue Branch, M13 on Tyler Branch, and Tyler Branch tributary reaches T4.01, T3.01, T3S1.01 and T3S1.02. This practice contributes to the potential for more shallow depths due to the over-widened channel that typically results from dredging, gravel mining, and bar scalping. Removals in T2.03 and M13 appear to be ongoing, and were being stockpiled for future use (Fig. 18); removals in the other areas were primarily windrowing following flood impacts in the 1990s. Stream dynamics related to this practice are complex, but it does appear that the low velocity conditions encountered in many of these areas were contributing to further accumulation of sediments (Fig. 19). Ongoing removal of these sediments, in combination with “sediment starving” at dams on Bogue Branch and Tyler Branch, may be contributing to a progressive “fining” of sediments being transported downstream (see further discussion in Sec 5.1.2, Watershed-scale sediment regime stressors).

Figure 18. Sediment windrowing (left) and small-scale stockpiling (right) in reach M13.

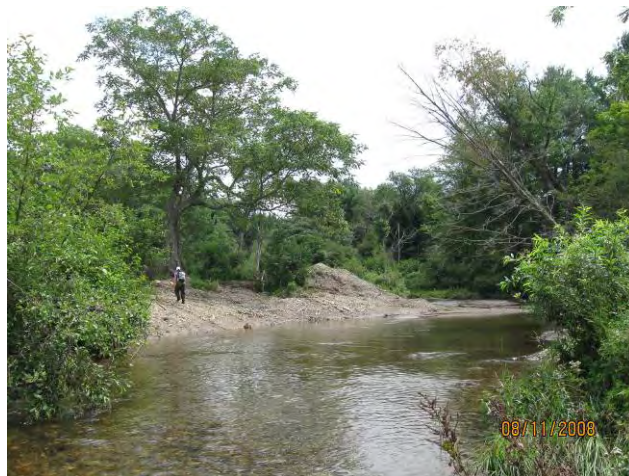
Figure 19. More sediments often drop out when low velocity conditions are encountered in widened channels near locations of gravel removal, as seen upstream (right) of this stockpile in reach T2.03.

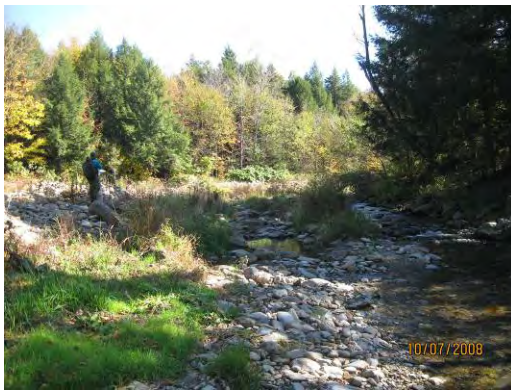
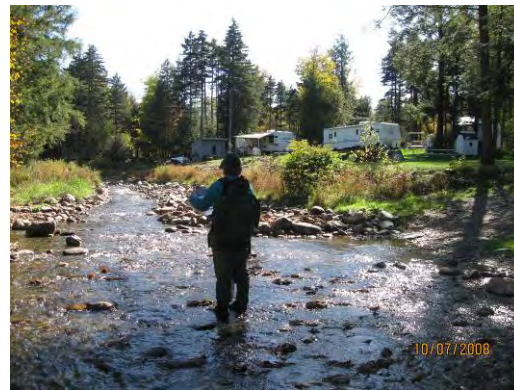
Figure 29: Reach M13, segment B shows flooding disturbance (left) and left bank development and stream manipulation (right).

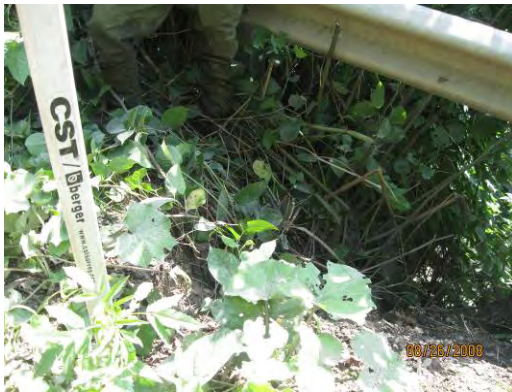
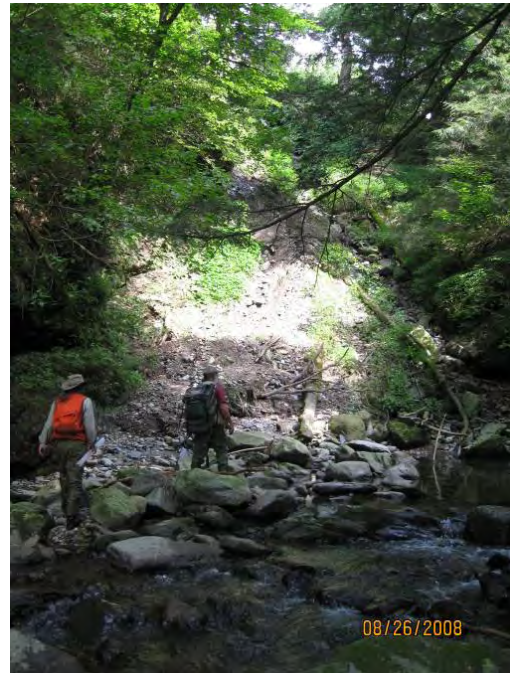
Figure 31. Bank failures triggered by stormwater inputs that carry runoff from road ditches to a perched culvert above a steep valley wall in segment M14A have repeatedly cut back the road edge (left) and triggered mass failures on the valley wall below (right). The area was heavily ripped in early 2009. Japanese knotweed in the picture at left was one of the few incidences of invasive plants evident in reaches assessed in 2008, and might be limited from further spread by a rapid response.

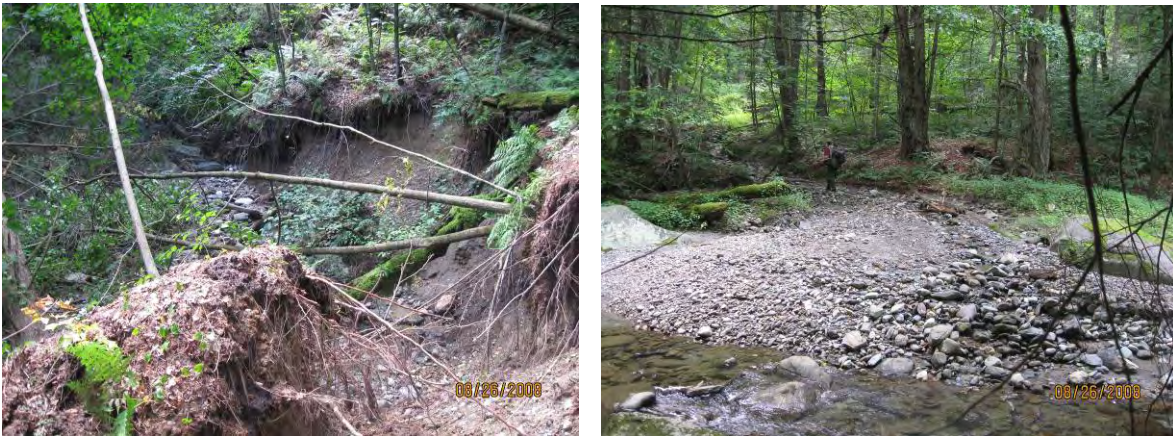
Figure 32. A classic gully opened on the left valley wall of segment M14A (left) in summer 2008 storms, resulting in a significant sediment discharge to the stream that will contribute sediments to stream dynamics for some time to come (right).

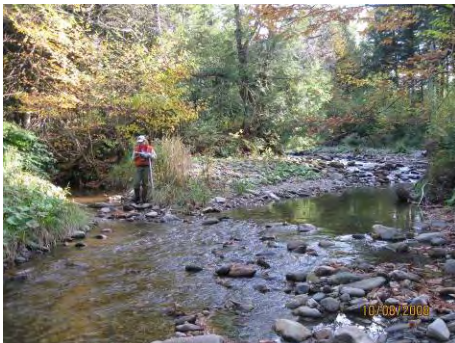
Figure 33. Dynamic nature of reach M15 is reflected in the recent change of a tributary confluence near the M16 reach break, which occurred when the mainstem avulsed (right) and the tributary captured part of the flow and used some of the avulsed channel as its own channel (left).

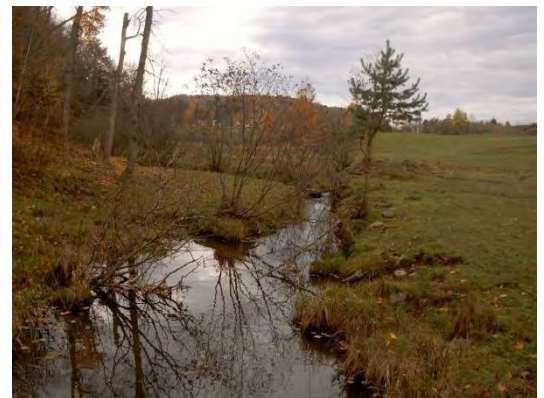
Figure 35: Reach T1.13 segment B is accessible to pastured animals, reducing buffer and causing some bank erosion.

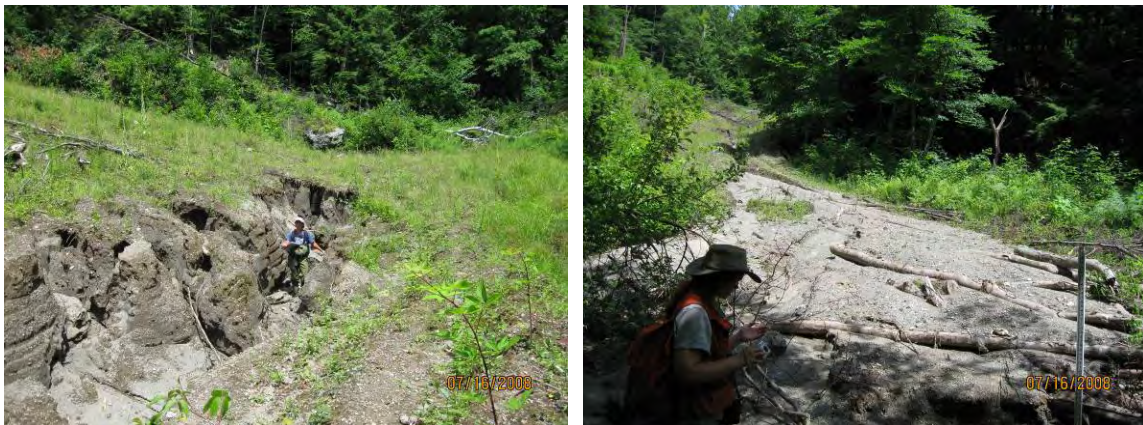
Figure 39. Gully formation (left) on logging roads in segment T1.15B resulted in significant sediment discharges to the stream (right), but large woody debris downstream and corduroy “brush bridges” still in place retained a lot of sediment and are slowing movement of these sediments. Encouragingly, the landowner and several collaborators stabilized the roads and remediated immediate impacts; follow-up visits are intended.

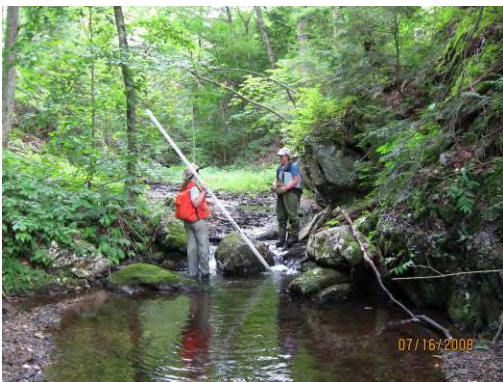
Figure 40. Sediment deposition in T1.15C includes gravel and sand from upstream beaver-impacted areas as well as cobbles from the friable slate bedrock in the area.

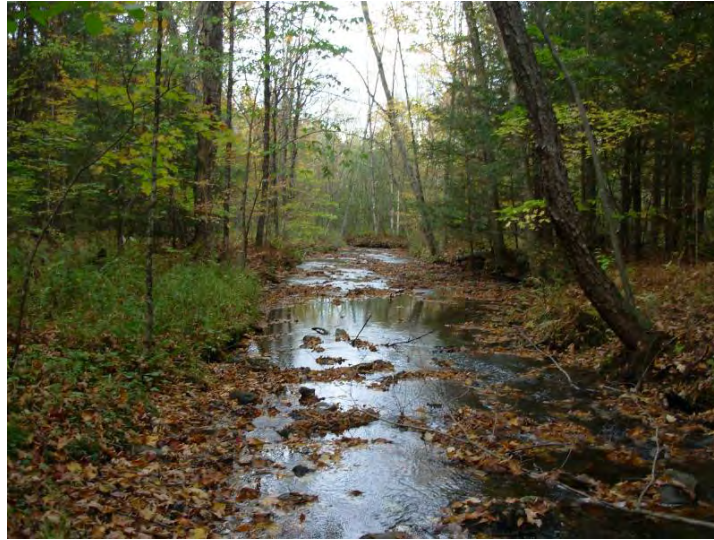
Figure 44: Beaver Meadow Brook (Bakersfield) segment T1S4.02 C shows limited incision and some aggradation.

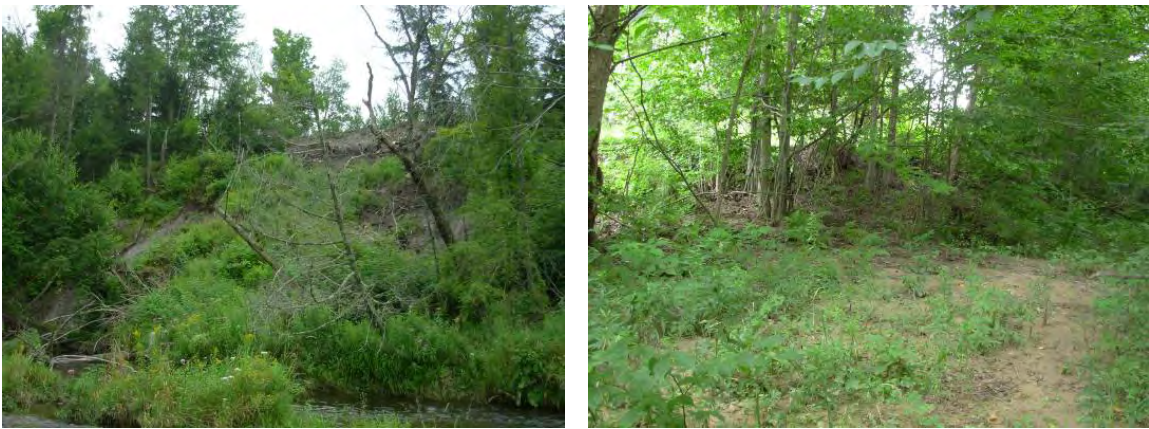
Figure 47: Bogue Branch, reach T2.01, segment C. A large mass failure is found below Bogue Rd. on the left bank valley wall in mid-segment (left). Summer downpours contributed to sediment inputs to the stream from a farm road off the right bank (right).

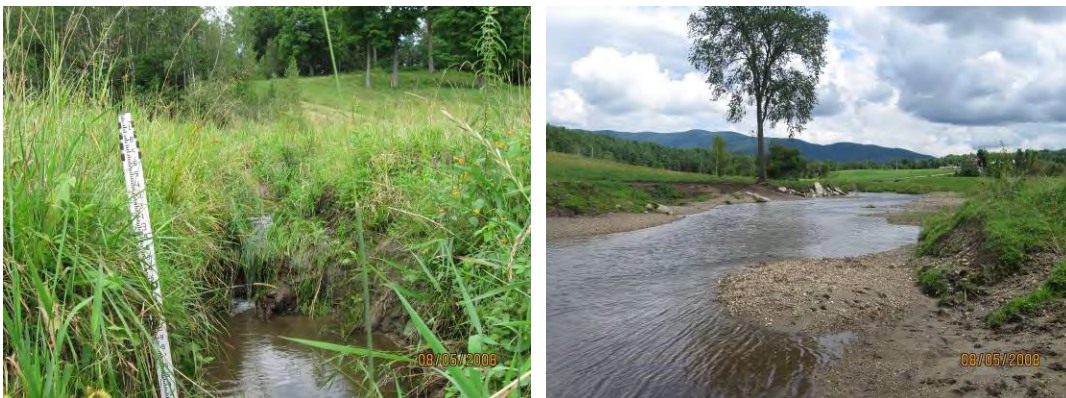
Figure 50. Nickpoint in a field ditch entering Bogue Branch T2.02C (left) may have been related to recent intense storms rather than the limited amount of stream incision noted in the segment. Gravel removal in the upstream portion of the segment (right) was part of the basis of straightening noted for the segment.

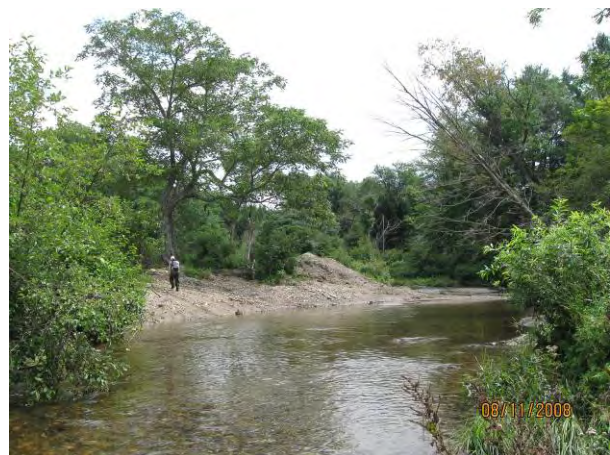
Figure 51. Gravel removed from Bogue Branch segment T2.03A was stockpiled along the banks in a few areas.

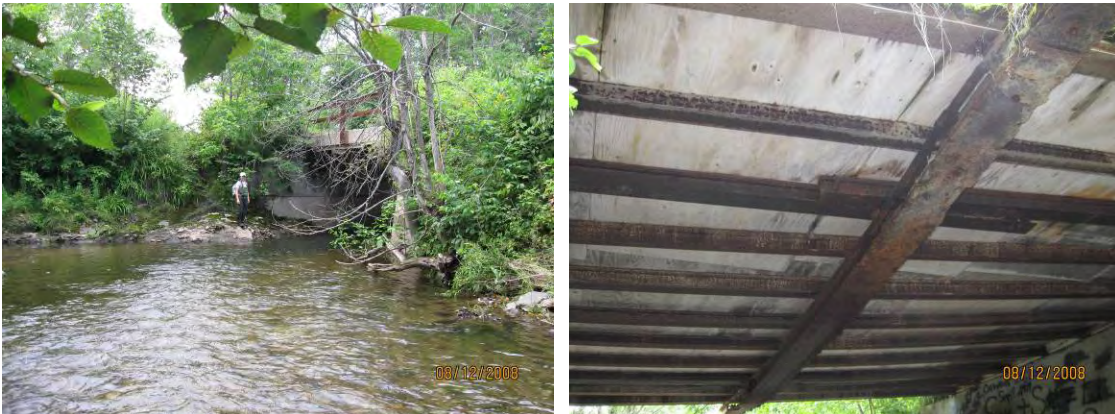
Figure 58. Bridge at Witchcat Rd. in segment T2.04B is reduced to 40% of bankfull channel width by the angle of alignment to the stream (left), appears to have possible signs of structural fatigue (right), and is recommended for further assessment regarding possible replacement.

- Further bridge assessment at Witchcat Rd., west of the Joyal Rd. intersection, regarding possible replacement (in reach T2.04 of the Bogue Branch): potential safety issue regarding structural fatigue, with possibilities for addressing significant constriction and alignment issues if this bridge needs to be replaced

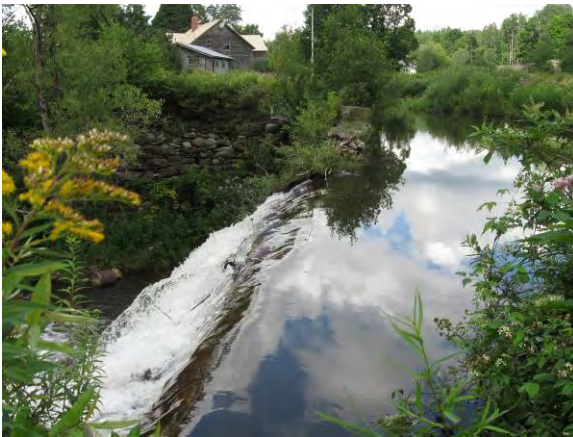
Figure 59. The old Johnson Mill dam at reach break T2.05 is relatively intact, but the old mill buildings have burned leaving only the foundations.

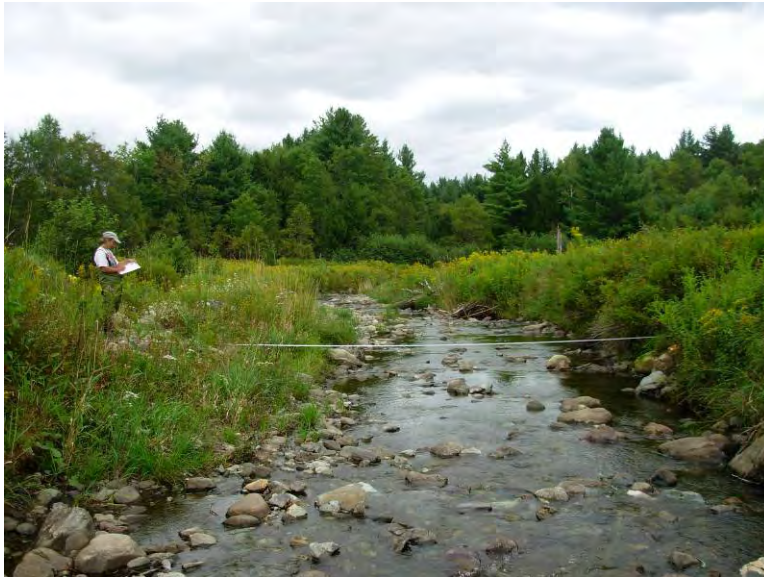
Figure 68: Bogue Branch reach T2S1.03 segment C shows signs of channel straightening and windrowing following beaver damming.

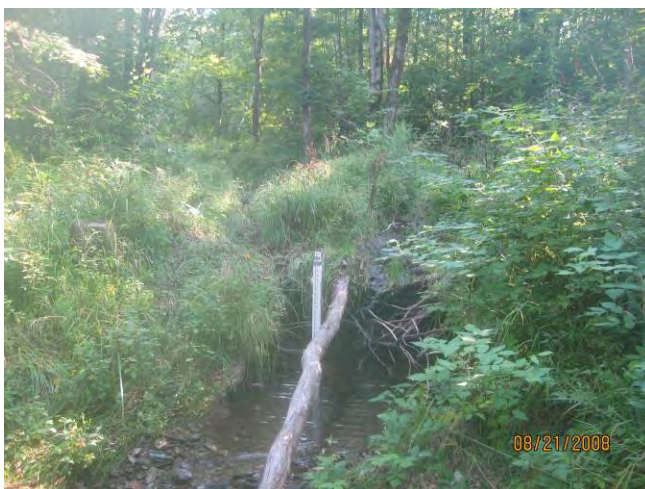
Figure 76. This headcut is moving up a road in the Branon sugarbush on segment T2S1.04D. Several headcuts like these are impacting the roads as well as posing the potential for extending the stream network, increasing flows in the stream while eliminating access to valuable floodplains.

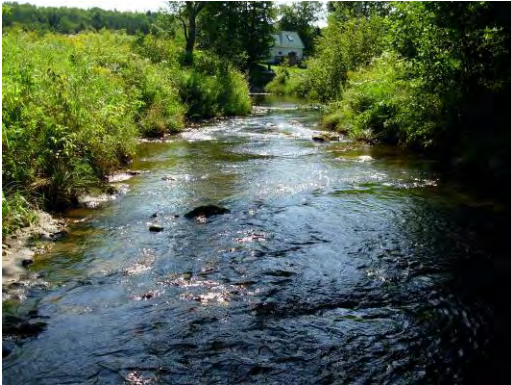
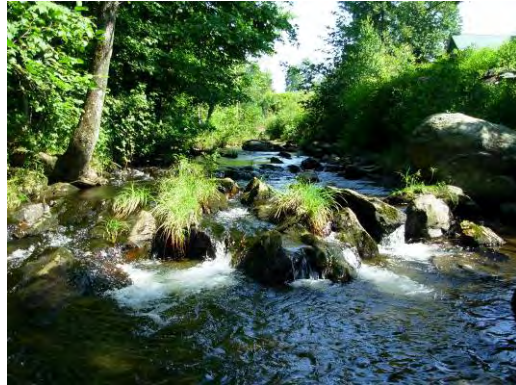
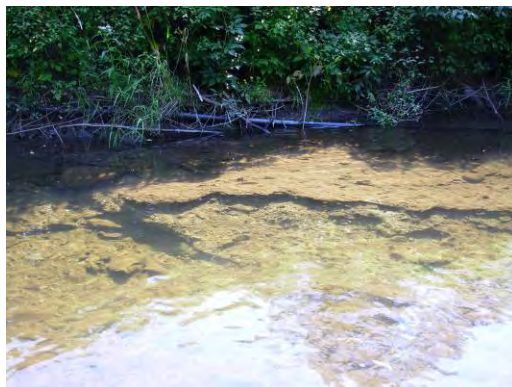
Figure 79: Beaver Meadow Brook (East Enosburgh), reach T3.01 segment B has significant left bank encroachment (upper left), bedrock grade controls (upper right). Lower segment has pond embankment that is being eroded by stream channel (bottom).

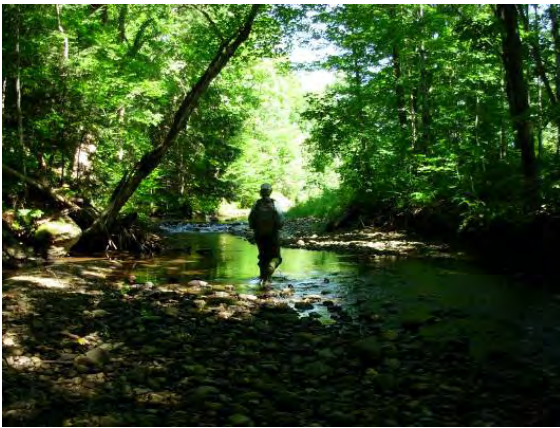
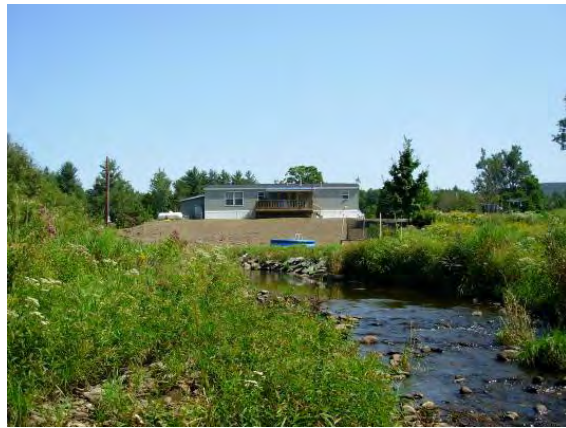
Figure 80: Beaver Meadow (East Enosburgh), reach T3.01 segment C. Aggradation is occurring after historic incision and widening (left). New development on left bank in upper portion of segment has altered the stream planform (right).

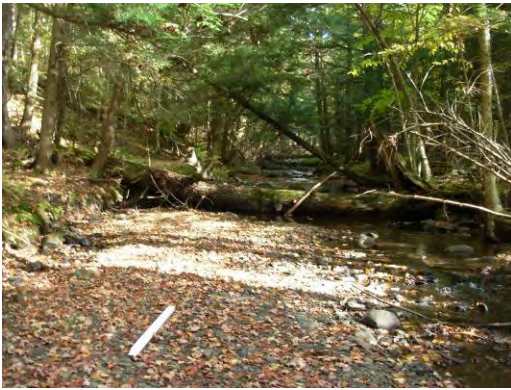
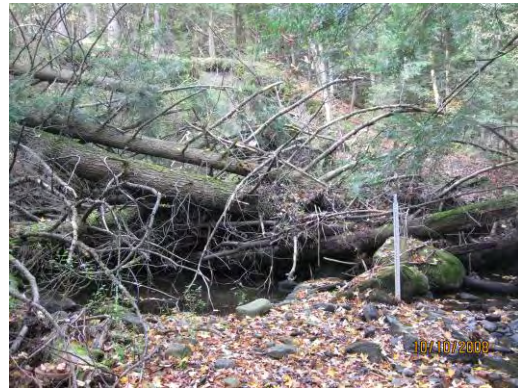
Figure 85: Reach T3S1.02, segment A shows significant aggradation (left). Mass failures and bank erosion in a forested setting has led to a significant number of debris jams (right).

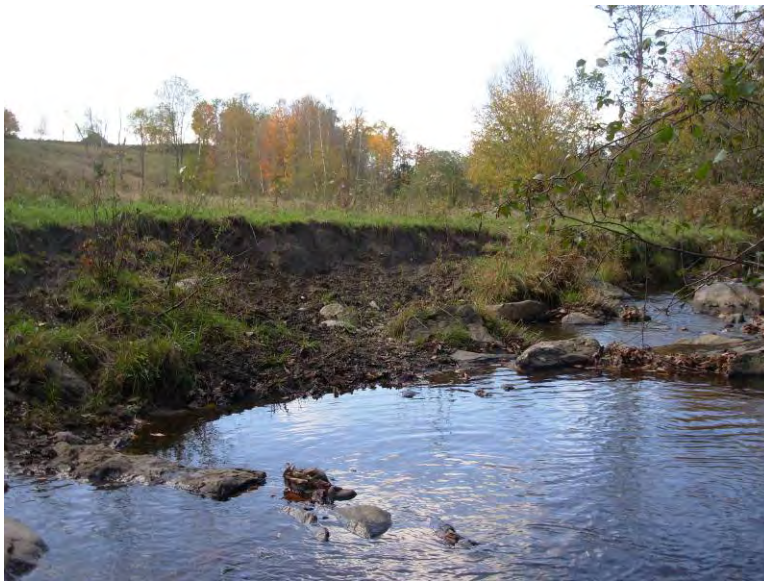
Figure 86: Un-named tributary to Beaver Meadow Brook (East Enosburgh), reach T3S1.02 segment C. Agricultural pasture use has reduced buffers and caused some bank erosion in this segment.

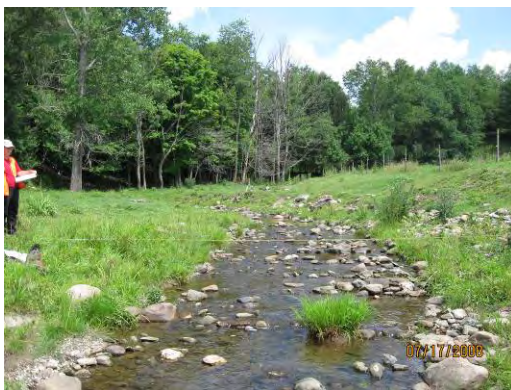
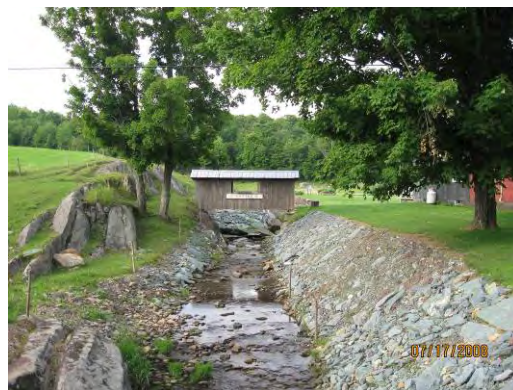
Figure 88: Reach T4.01, segment A has been straightened most of its length. The upper portion of the segment has created new floodplain (left), while the downstream end has been completely armored to prohibit lateral movement.

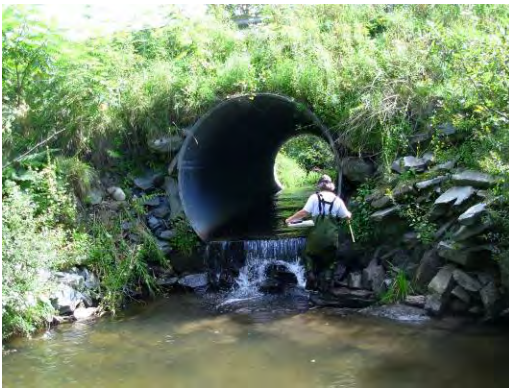
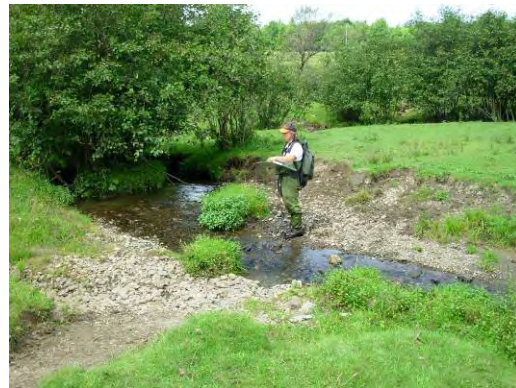
Figure 91: Reach T4.02. Two culverts in the lower part of the reach are significant channel constrictions (left). Extensive agricultural pasture use has caused reduced buffer and bank erosion (right).
