# **Phase 2 Stream Geomorphic Assessment**

**Tyler Branch Watershed  
Towns of Sheldon, Enosburg, and Bakersfield  
Franklin County, Vermont**

**March 2006**

Re: Phase 2 Stream Geomorphic Assessment  
Tyler Branch Watershed  
Franklin County, Vermont  
JCO Project No. 3-1313-1

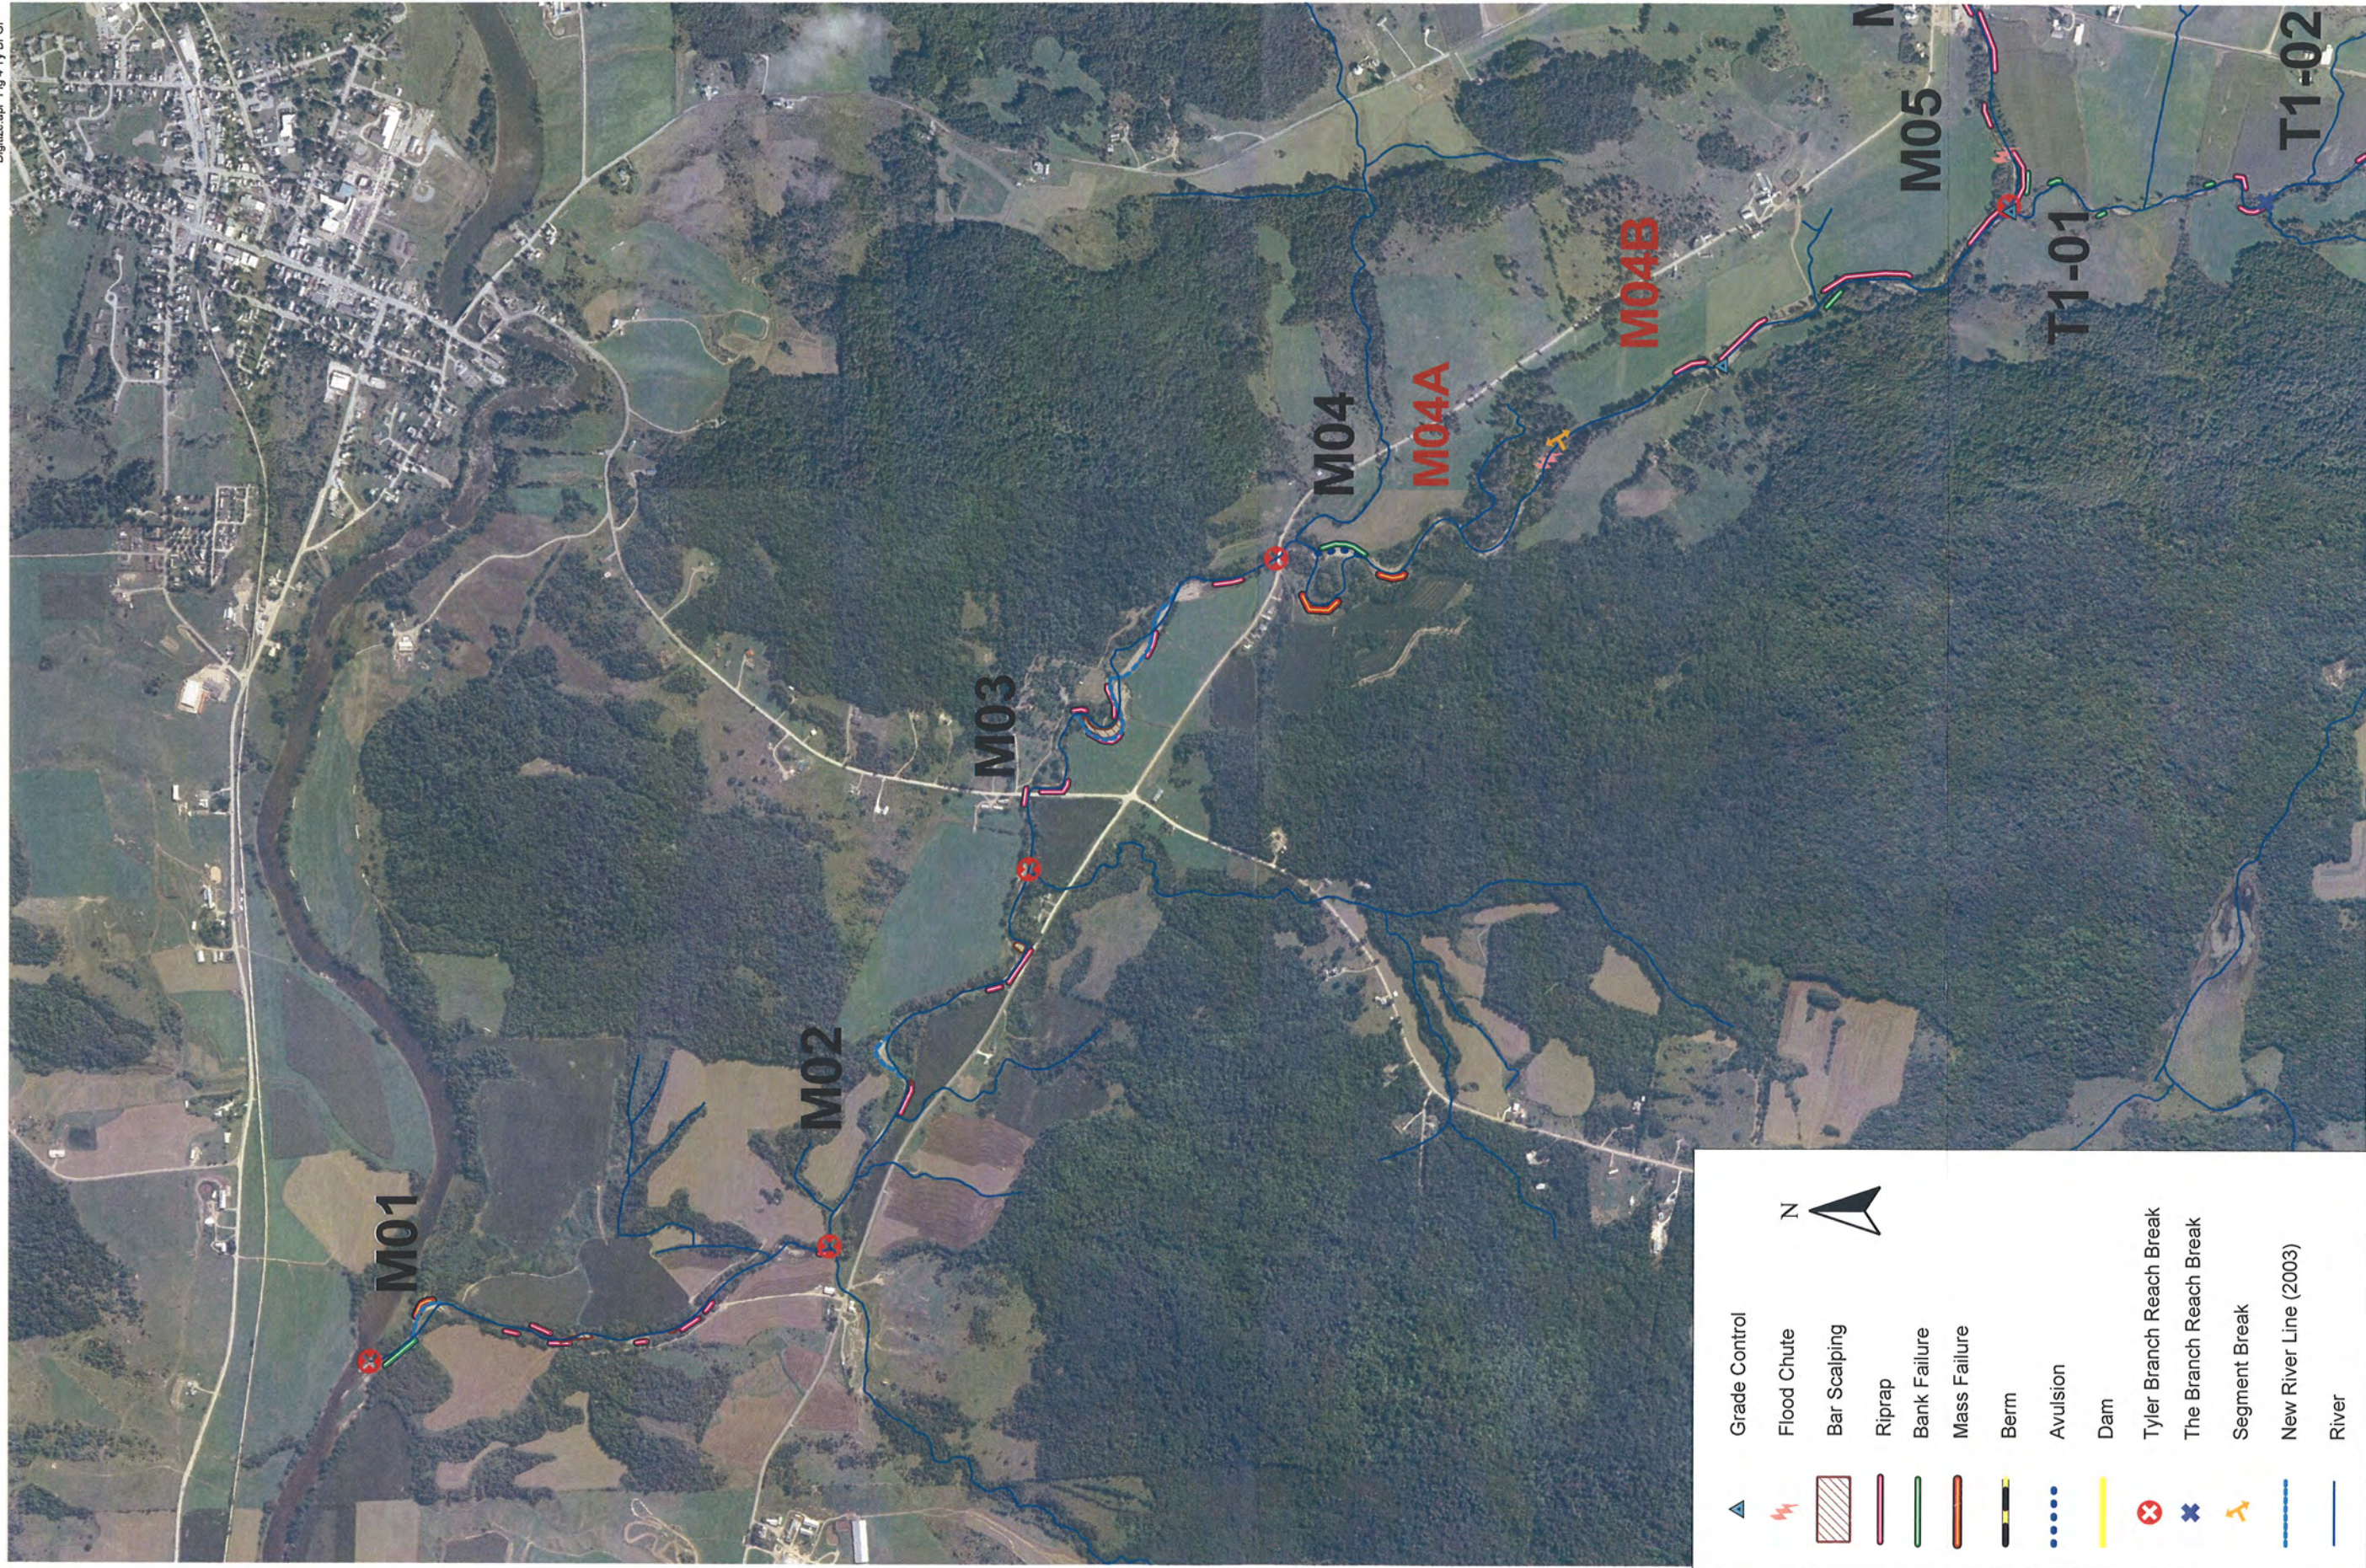
**Figure 4. Geomorphic Features- Tyler Branch  
Reach M01-M04  
Phase 2 Geomorphic Assessment  
Enosburg-Bakersfield, Vermont**

Several large mass failures were observed in reaches M01, M04, M12, T1-02, and T1-08 and are shown on Figures 4 through 7. These mass failures, combined with the many other smaller bank erosion sites are major contributing factors to the overall sediment regime of the watershed.

Figures 4 through 7 show the locations of bank armoring and active erosion. Significant portions of some of the assessed reaches have been armored, with rip-rap being the most common method. The most significant armoring was noted in reaches M01 through M10. While the rip-rap has helped to limit the amount of bank erosion, it has also prevented the stream from completing its natural evolution process where a degraded stream, such as the Tyler Branch and The Branch, widens to create new floodplain. Areas of extensive rip-rap also tend to transfer energy downstream and erode the nearest unprotected bank as is evident in reach M07 where a long section of the left bank was recently rip-rapped to protect an adjacent hayfield. The rip-rap area ended at the property line and now the unarmored bank just downstream of the rip-rap has begun to erode.

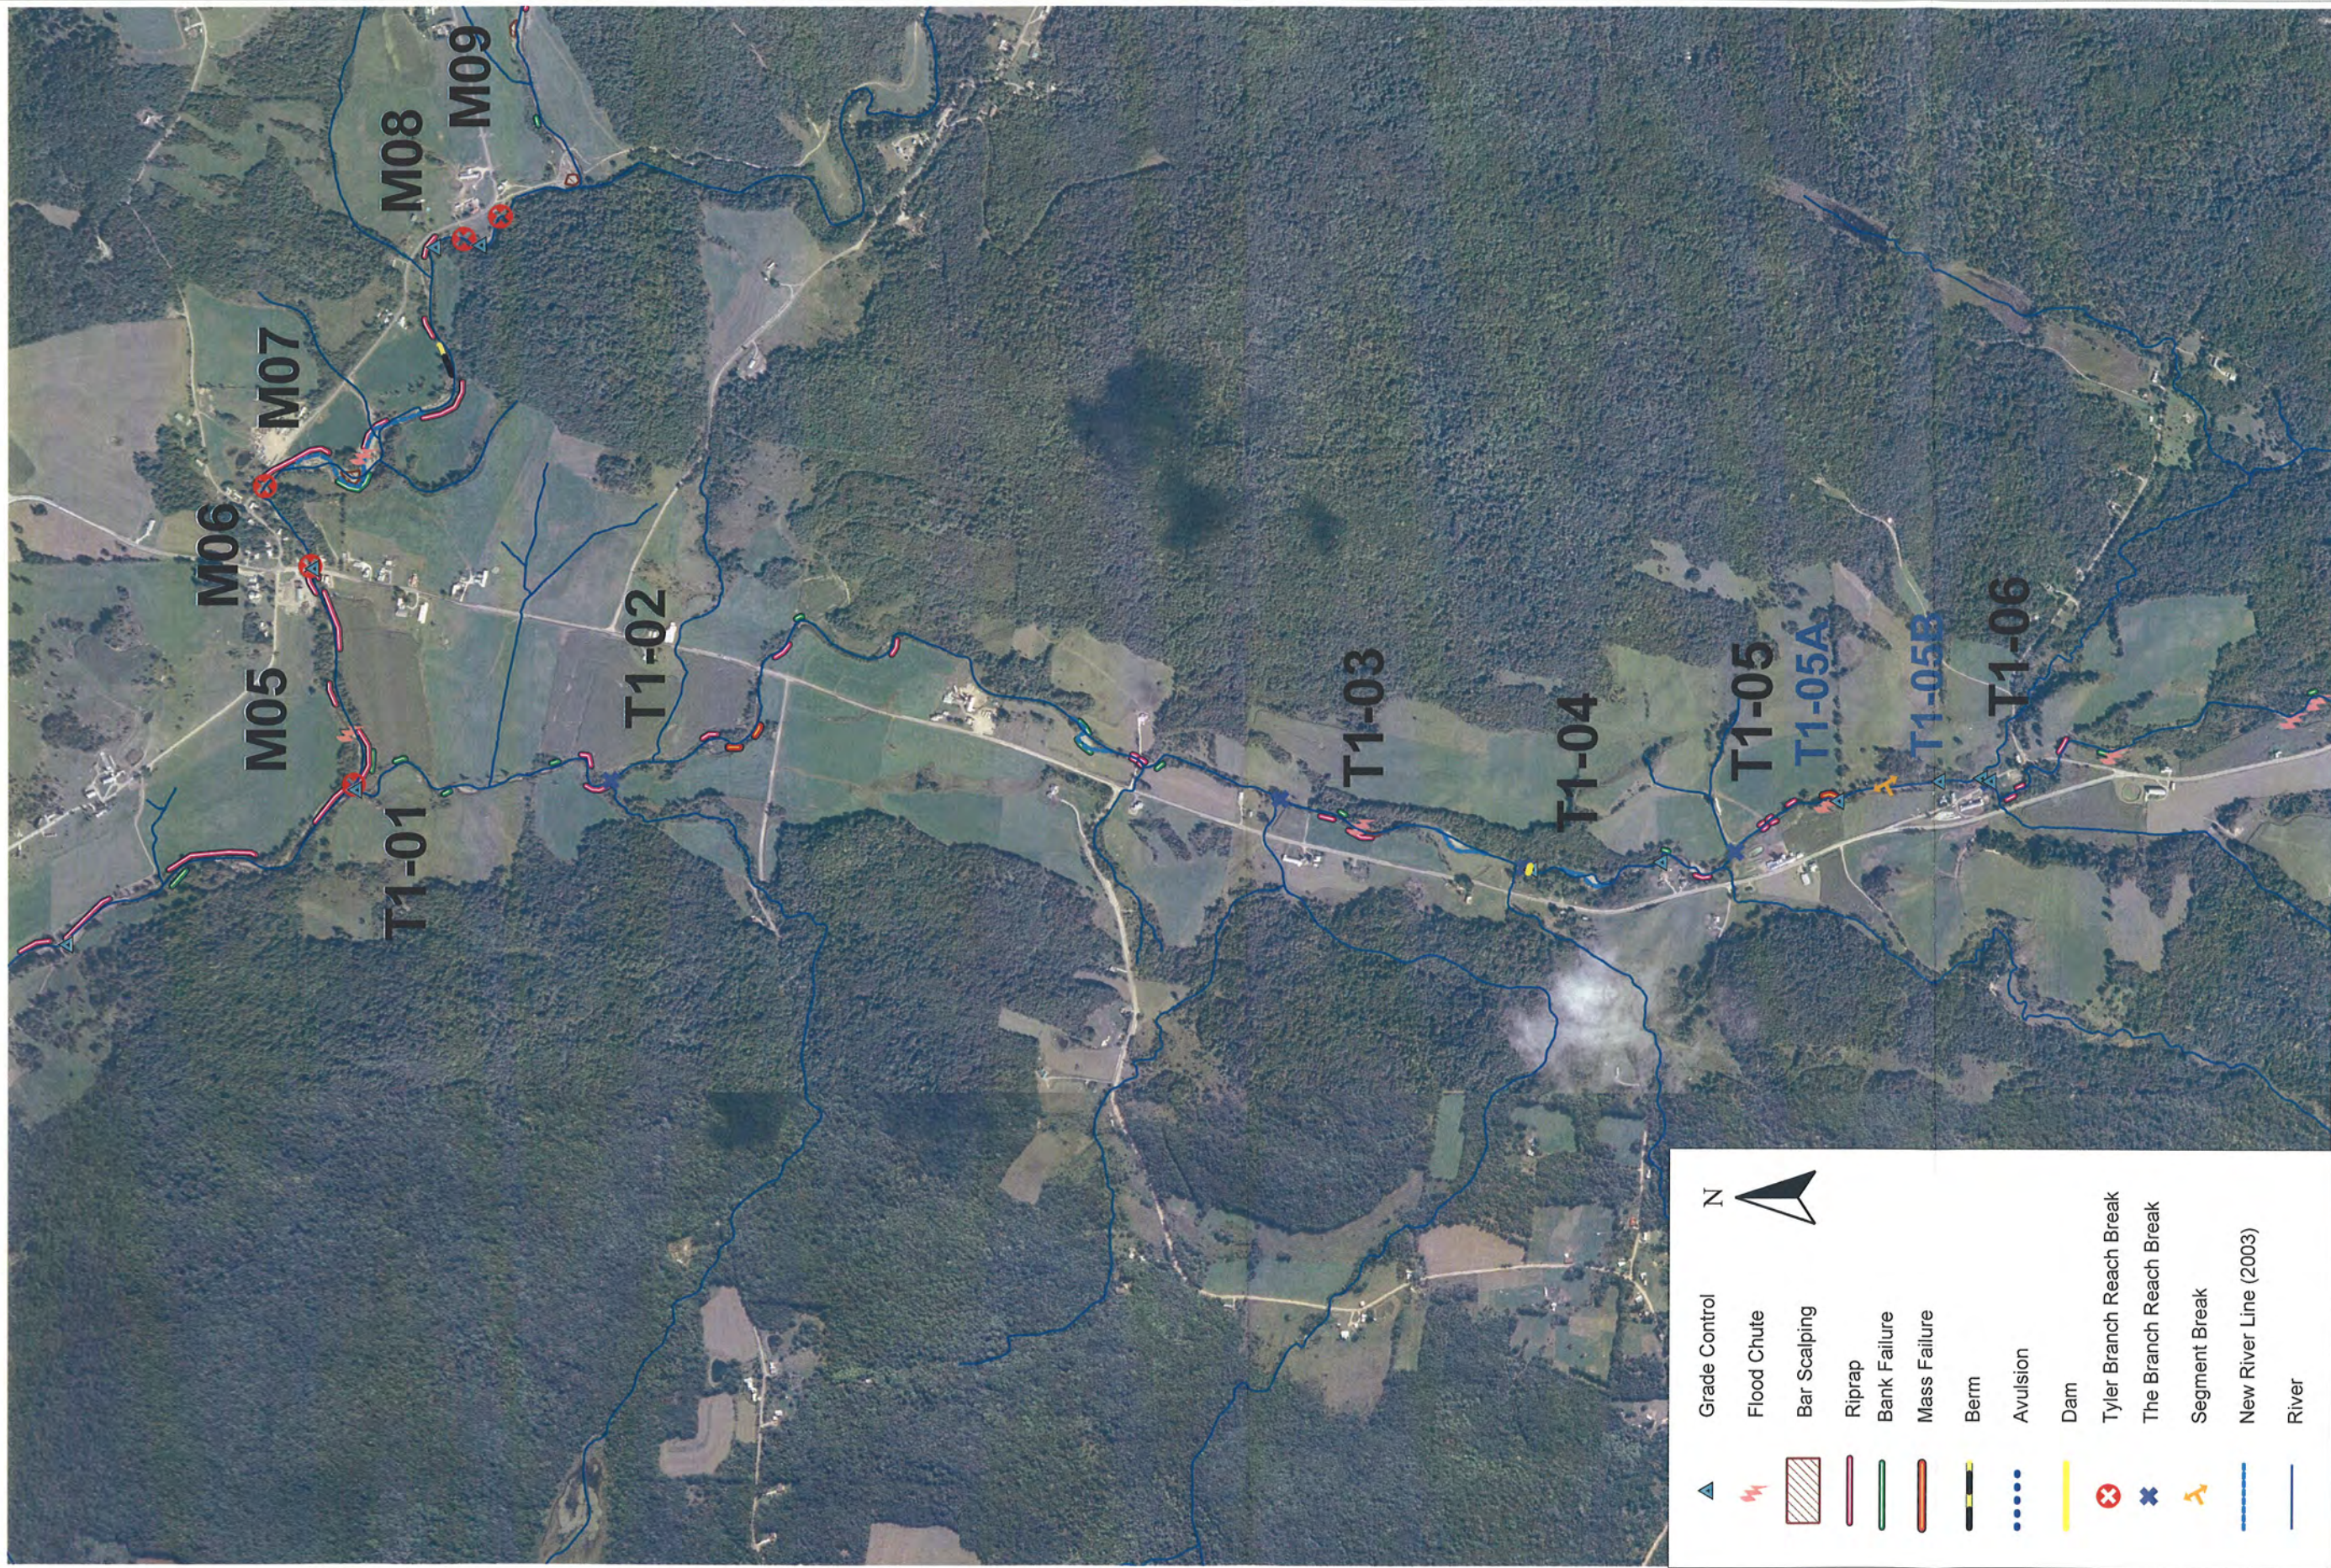
**Figure 6. Geomorphic Features- The Branch  
Reach T1-01-T1-05  
Phase 2 Geomorphic Assessment  
Enosburg-Bakersfield, Vermont**

There are two dams located in the study area, one in T1-04, and one at the upstream end of T1-08 (Figures 5 and 6). Both dams were previously used for mill operations and/or power generation; however neither has been in use for at least the past 20 years. Both of the dams are constructed within naturally occurring bedrock gorges in areas which would have naturally acted as constrictions. A large amount of sediment, seen as enlarged bars, was observed immediately upstream of the dam located in T1-04, but these effects were limited to T1-04 and did not extend upstream to other reaches. The impounded reach upstream of the dam at the end of T1-08 was

There are two dams located in the study area, one in T1-04, and one at the upstream end of T1-08 (Figures 5 and 6). Both of these dams were constructed in naturally occurring bedrock gorges. A large amount of sediment, seen as enlarged bars, was observed immediately upstream of the dam located in T1-04, but these effects were limited to T1-04 and did not extend upstream to other reaches. The impounded reach upstream of the dam at the end of T1-08 was not assessed as part of this project.

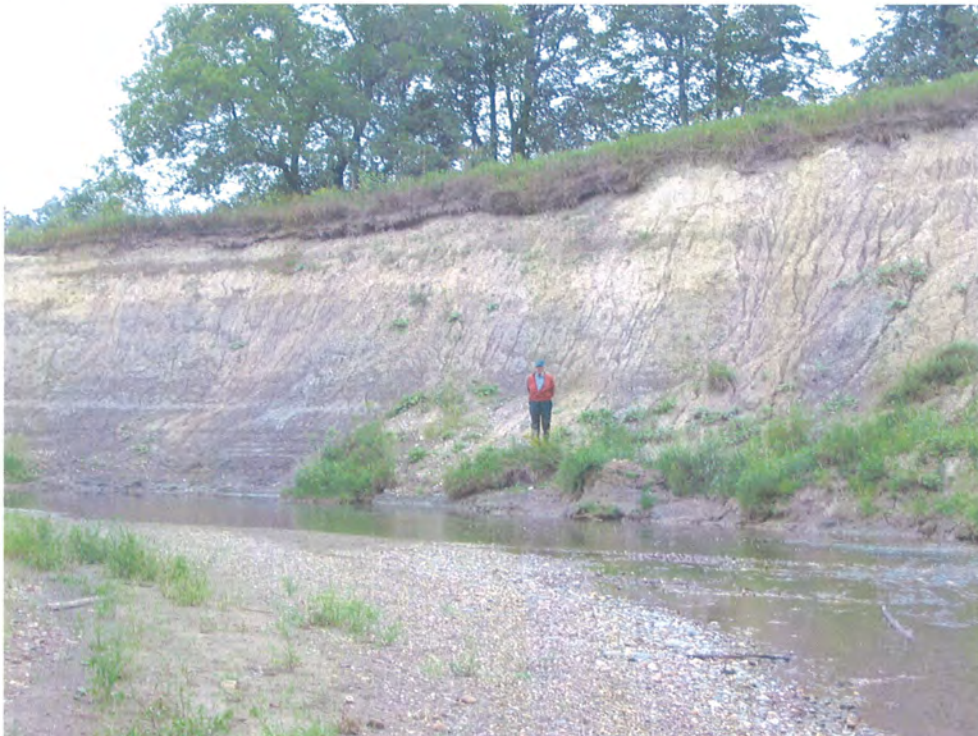
Photo Point 2: Reach M01.

- **Tyler Branch M01** (Photo Point 2 and 3) – Two problem areas were noted in M01, a very large mass failure near the confluence with the Missisquoi, and an eroding bank near the upstream end of the reach. Given the rather remote access and size of the mass failure, it would be a very expensive and labor intensive process to stabilize the entire bank. The lower portion of the bank is primarily clay, which is somewhat resistant to erosion, and some lower portions of the bank are beginning to re-vegetate. To maximize the use of limited resources, it may be best to focus restoration efforts on smaller scale projects which could achieve better results with less effort. The eroding bank near the upstream end of M01 is a good example. Currently, the land owner is attempting to stabilize the bank by placing fill along the stream bank. While this may provide some protection in the short term, the fill will also wash away over time and provide unnecessary sediment and nutrients to the system. It may be possible to work with the landowner to provide a more permanent bank stabilization solution, such as those described for T1-02.

M01 extends from the confluence with the Missisquoi River to the first tributary near Tyler Branch Road. The Reach was found to be in regime with the Phase 1 reference stream type (C, gravel, riffle-pool stream). The dominant adjustment process was aggradation, as evident by the multiple steep riffles and large point and side bars. The stream was found to be in Stage IV of evolution as the stream has aggraded and begun to develop a new floodplain at a lower elevation, though it still has access to its historic floodplain as well. The habitat and geomorphic assessment scores were 0.63 and 0.68 respectively, both in the "good" range. Bar scalping and gravel mining were evident throughout the reach. According to the landowner, a permit has been granted by the Rivers Management Program allowing the gravel removal. Hay and cornfields on the right and a mix of hay fields and forestland on the left dominated the riparian corridor. Most of the reach did contain a narrow buffer of mixed trees ranging in width from 5 to 50 feet. One large mass failure was noted near the confluence with the Missisquoi. The

failure was approximately 200 feet long by 30 feet high. Another smaller bank failure (300 feet long by 6 feet high) was noted on the left bank just downstream of the mass failure. One other problem area noted in the reach was an eroding bank located near the upstream end of the reach. An attempt was being made by the landowner to stabilize the bank by dumping gravel and fill along the erosion; however it is unclear if this will stop the erosion or simply wash more sediment into the system and delay the erosion of the bank.

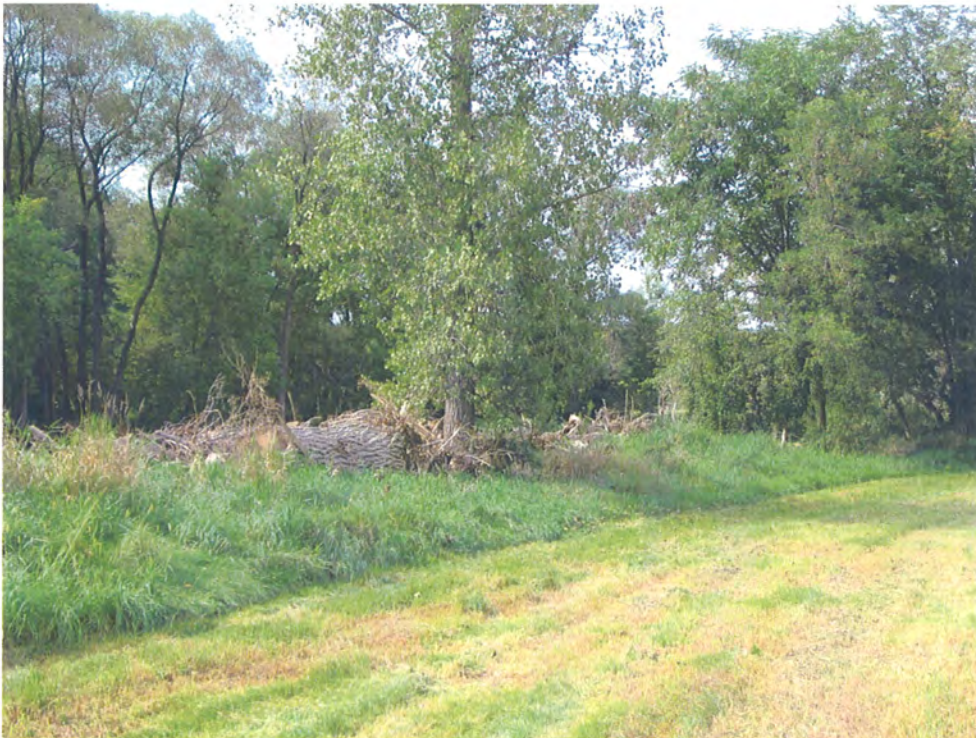
M07 extends from near the intersection of Grange Hall Road to a large bedrock gorge located approximately  $\frac{3}{4}$  of a mile upstream. The stream was found to be in regime with its Phase 1 reference stream type (C, gravel, riffle-pool). The major adjustment processes were major historic degradation (incision of 1.6), and active aggradation and widening (evolution stage III). Multiple large point and mid channel bars, along with multiple steep riffles, were observed throughout the reach. The habitat and geomorphic assessment scores were 0.61, both in the “fair” range. Hayfields are present along both banks with a buffer ranging from 5 to 50 feet. The Vermont River Management Division has issued a permit allowing for gravel mining and bar scalping, which was evident near the downstream end of the reach. Significant portions of the right bank (1,800 feet) and left bank (400 feet) have been rip-rapped limiting erosion to one area on the left approximately 6 feet high and 300 feet long. A new house has been constructed a few hundred feet from this eroding bank, and may become threatened if the stream continues to migrate and no erosion abatement measures are taken. The Missisquoi River Basin Association recently completed a tree-planting project along a portion of the left bank. Use of berming was observed along a portion of the right bank.

Photo Point 6: M07 – berm.

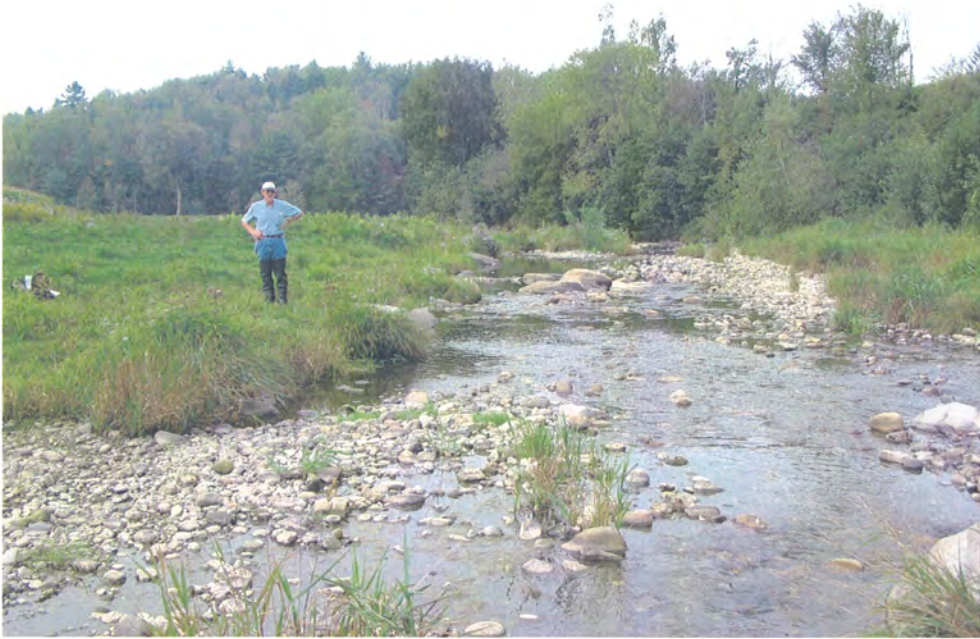
Photo Point 7: M09.

- **Tyler Branch M09** (Photo Point 7) – Two major problems were noted in M09, virtually no riparian buffer, and cattle access to the streambed throughout the reach. The entire right riparian corridor, including the stream channel is utilized for pasture, and a travel corridor for cattle to access upstream grazing areas. It may be possible to work with the landowner to reestablish an adequate buffer, and limit the cows' access to the stream channel to reduce nutrient inputs.
- **Tyler Branch M11** – Like M09, M11 suffers from a lack of riparian buffer along the downstream end of the reach. While there is no major active erosion currently taking place, establishment of woody vegetation would stabilize the stream bank and help prevent erosion in the future.

M09 is located from the end of M08 to the next upstream tributary that enters near the intersection of Tyler Branch Road and Ovitt Road. The stream was found to be in regime with its Phase 1 reference stream type (C, gravel, riffle-pool). The major adjustment processes were historic degradation, and minor aggradation and widening placing the channel in Stage III of evolution. Based on field observations and the current meander width ratio (~3) it appears the channel may have been historically straightened. The habitat and geomorphic scores were 0.53 (fair) and 0.74 (good) respectively. The landowner has a permit from VT ANR allowing for gravel mining from the reach, which was observed on a large point bar at the downstream end of the reach. A single steep riffle and multiple large point and side bars were observed throughout the reach. The riparian corridor was dominated by pasture and a single cornfield with no buffer for most of the reach. Cows were observed in the stream channel throughout the entire reach, which is utilized as a corridor for the cows to access pastures further upstream. Also, the large point bar which has been scalped serves as a feeding area for the cows. Despite the lack of riparian buffer, there was only one small area of erosion noted within the reach (50 feet long by 5 feet high mid-reach). No other problem areas were noted.
