Poultney River Geomorphic Assessment and Stream Corridor Plan

**Prepared by the Poultney-Mettowee
Natural Resources Conservation District**

December 2006

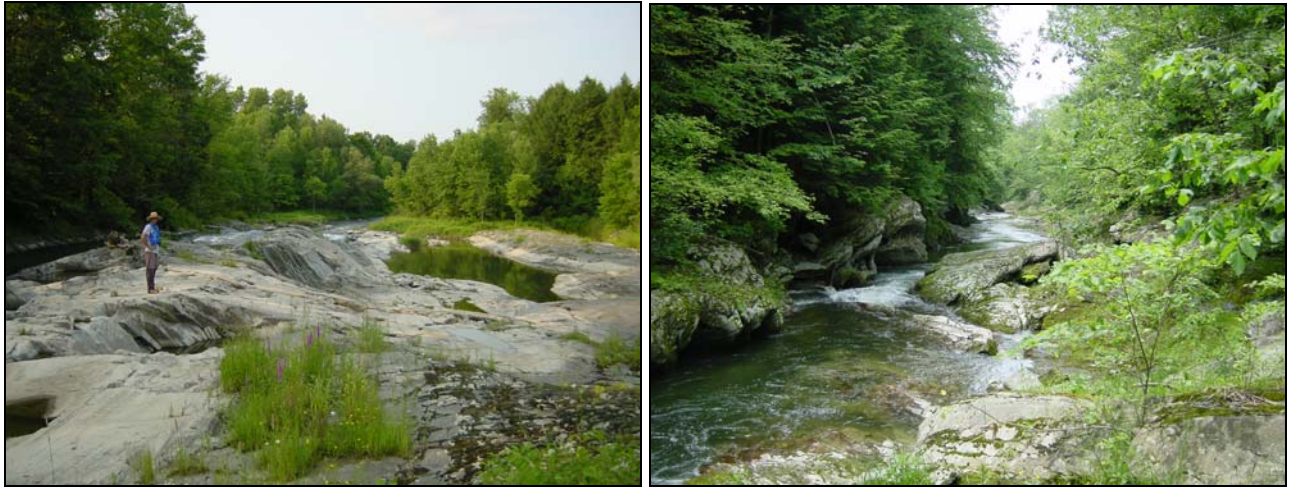
Figure 2. Bedrock ledges in reach M06 and M11B.

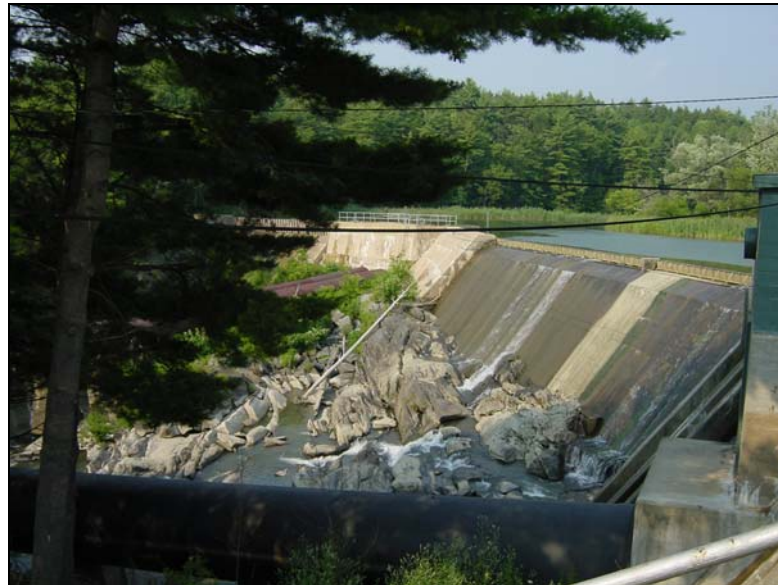
Reach M04 appeared in “Poor” condition, resulting from severe channel incision attributed to dam operations and reduction in sediment load downstream of the dam (Figure 4). Reach M07 also appeared in “Poor” condition. Factors affecting M07 were channel straightening for highway construction resulting in extreme channel planform adjustments, bank erosion, and pending neck cutoffs.

Figure 4. Carver Falls Dam between Reaches M04 and M05.

The dam at the M04/M05 reach break (Carver Falls Dam) also altered stream geomorphology. The downstream area of M05 has become a pond, where sediment deposits. As the water flows over the dam to reach M04, it increases in velocity, but lacks an appropriate sediment load, termed “hungry water.” This hunger for sediment is satiated by eroding the bed and banks of the downstream area (M04). Reach M04 has experienced channel incision and now minor widening, resulting in a stream type departure from a B to an F type and appears in “Poor” condition.

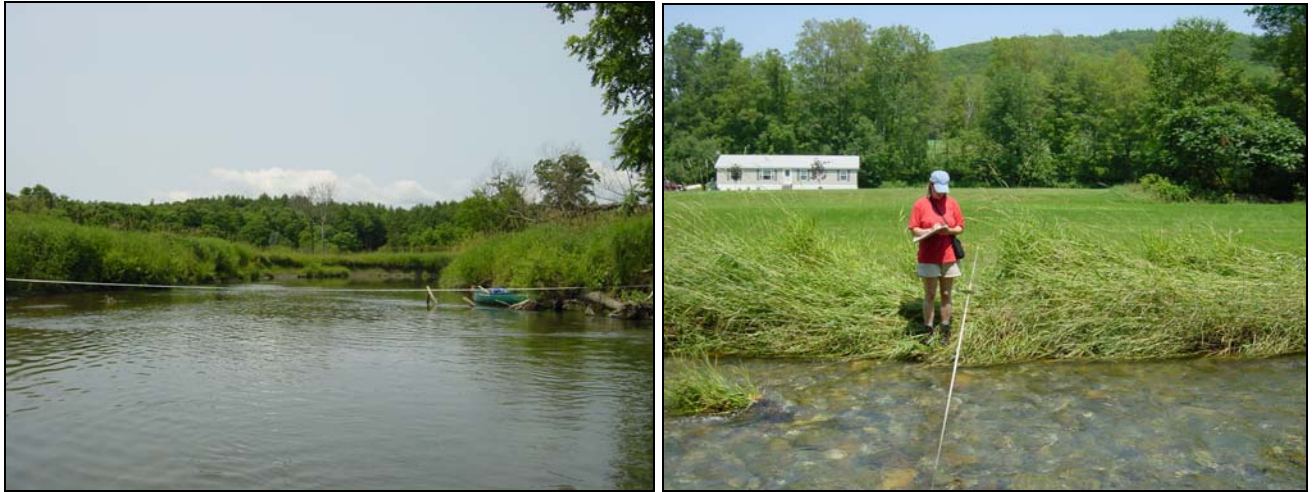
Figure 5. Lack of woody riparian vegetation along M07 and M14A.

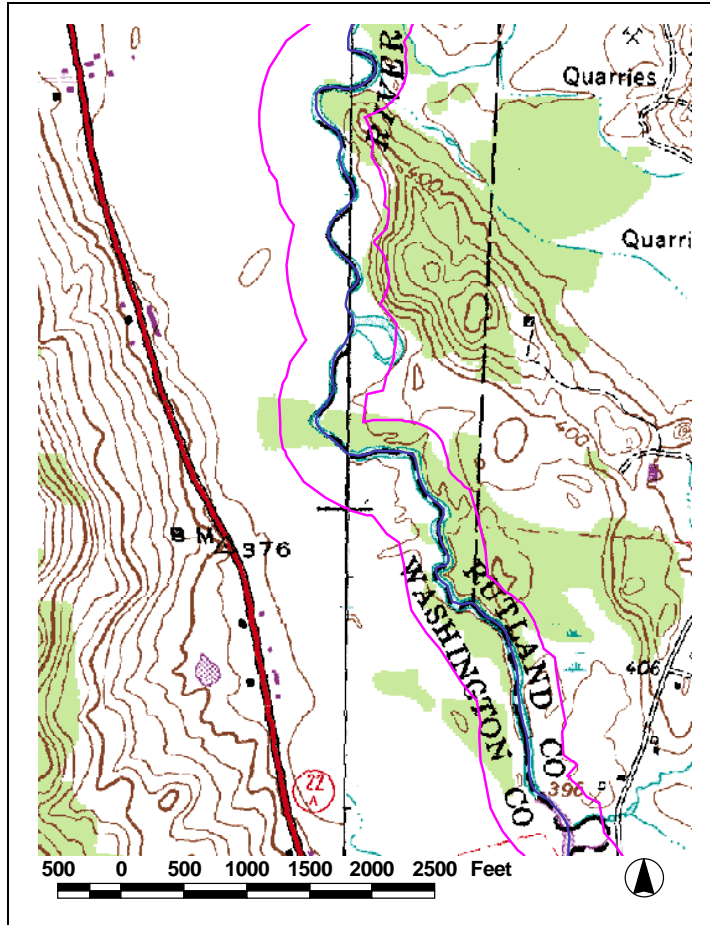
Reach M08 had been and continues to be straightened. This reach would have a very wide valley, but appeared to have been straightened and pushed over to the right valley wall (Figure 6). Under unmanaged conditions, the river would have meandered across the valley, depositing nutrient rich sediment, perfect for agriculture.

Figure 6. Topographic map showing a portion of reach M08 up against the right valley wall with a wide, flat valley on the left.

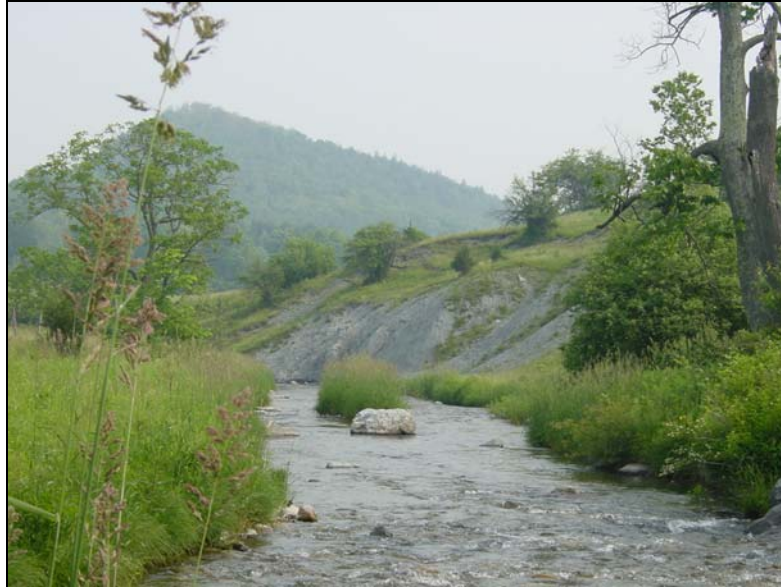
Segments M14A and M14 C also had been straightened. Higher velocities in M14A were working against a gravel hill (Figure 7), which was eroding and contributing a significant amount of sediment to the system. Large bars were present downstream of the erosion site (Figure 8).

Figure 7. Gravel hill eroding and contributing sediment.

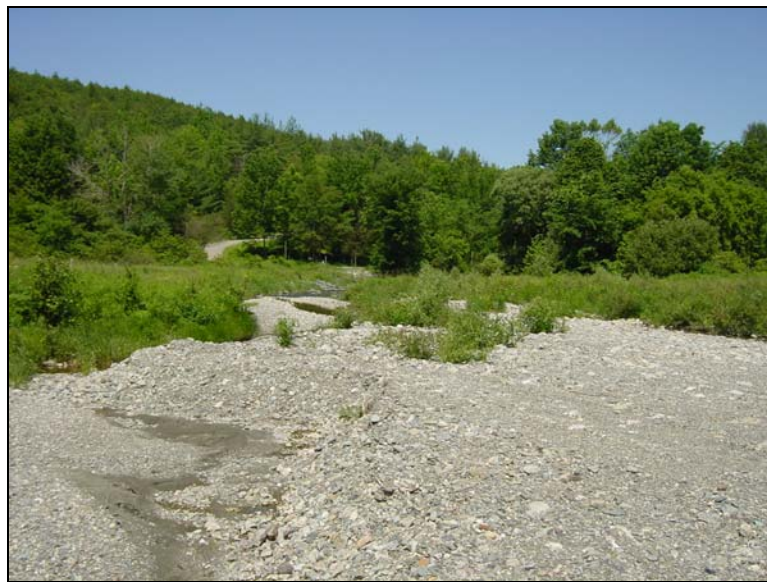
Figure 8. Large sediment deposits downstream of the gravel hill.

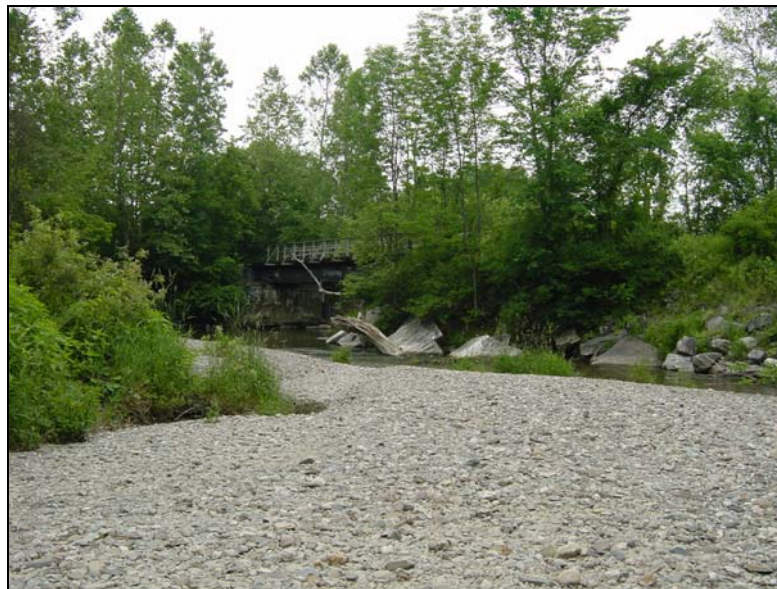
Undersized bridges and culverts act as channel or floodplain constrictions. These structures block the free passage of water, sediment and organic debris, and can result in flooding of land, severe aggradation of the channel and floodplain, and severe degradation downstream. Channel obstructions and constrictions along the Poultney River interfered with natural geomorphic functions. Examples of undersized bridges and culverts along the Poultney River include the Rail Trail Bridge in reach M10, the M13/14A site at the road bend, and a bar upstream of the bridge in segment M14A. (Figures 9 and 10)

Figure 9. Bridge at the Rail Trail with heavy sediment deposits upstream.

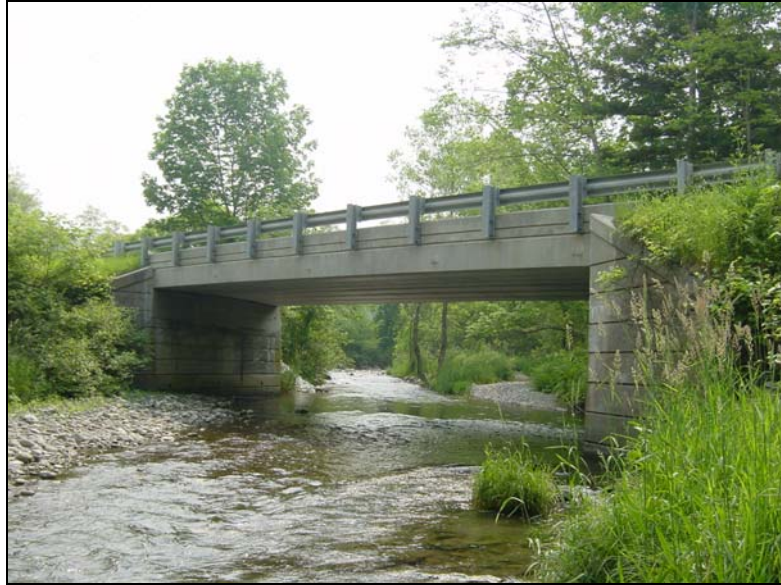
Figure 10. Sediment deposited upstream of this bridge on M14A. Photo view is looking upstream through the bridge.

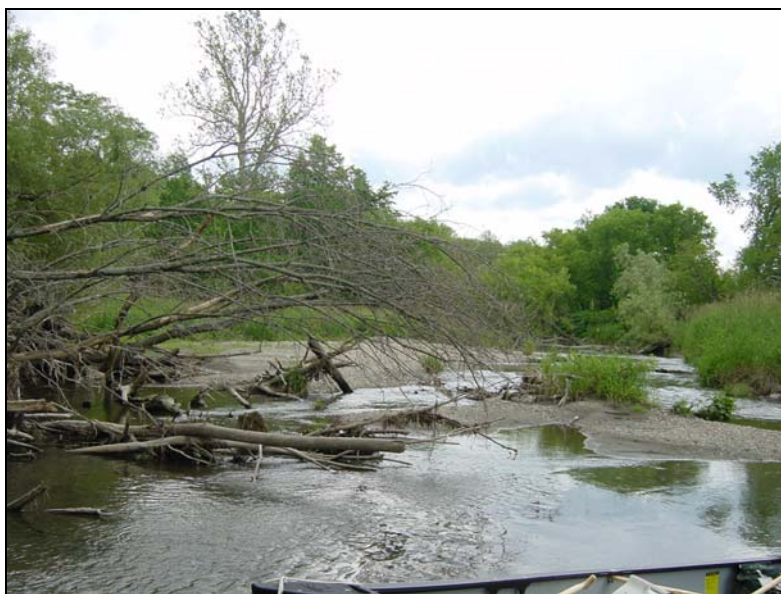
Figure 11. Aggradation upstream of debris in M08.

Aggradation was seen in segments where the channel had been straightened and was progressing through channel adjustments to regain equilibrium. Figures 11 and 12 show examples of aggradation in such straightened segments. The channel will soon begin to meander if allowed to continue along the evolution process.

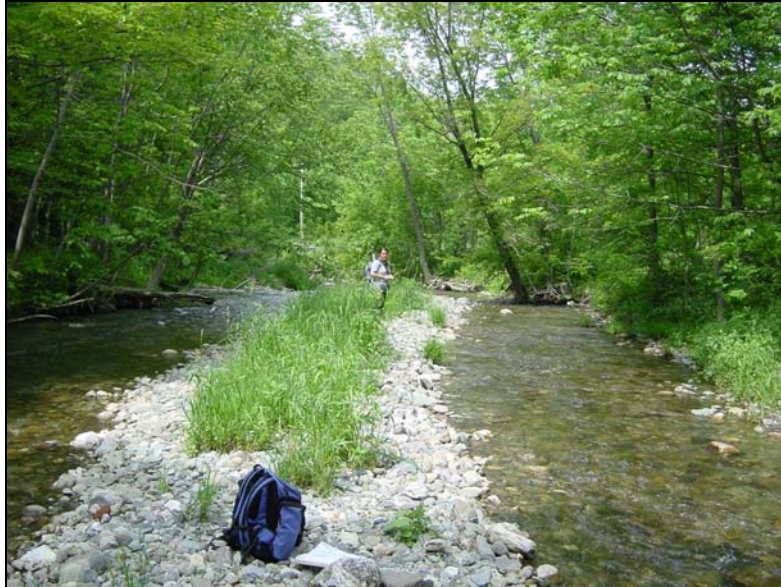
Figure 12. Sediment deposition upstream of a bridge channel constriction on M14A.

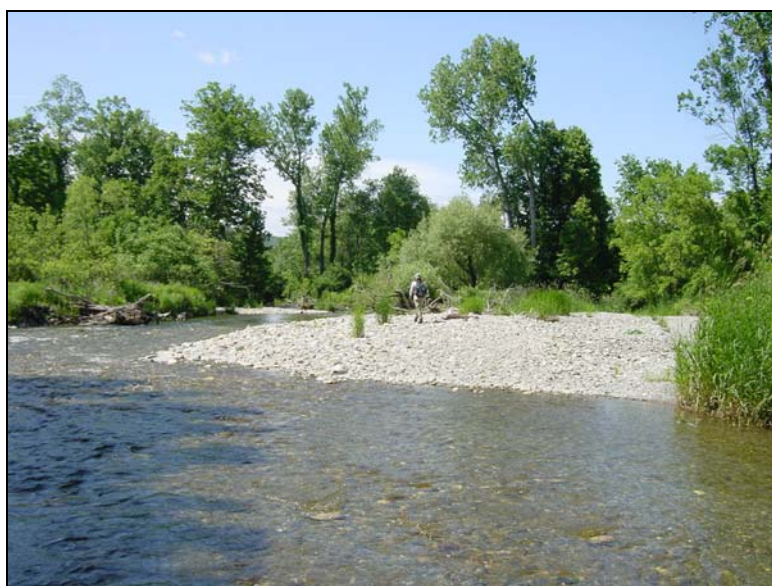
Figure 13. Aggradation and braiding in a sediment attenuation zone in M13.

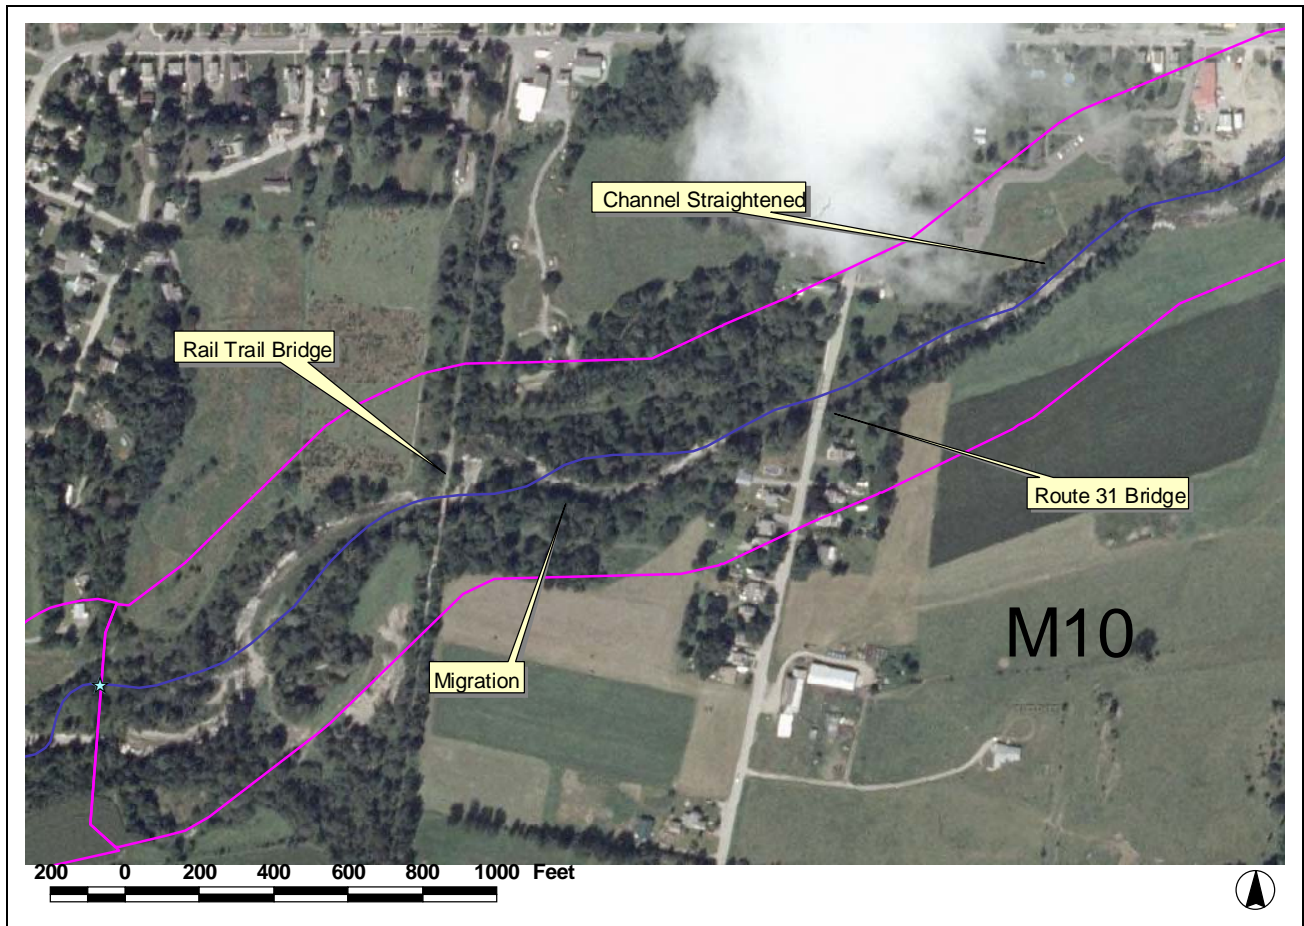
Figure 14. Aggradation and resulting migration in reach M10 is seen in this photo. This area would be a natural attenuation zone, being in an unconfined valley setting downstream of confined areas in segments M11B and M12B. The sedimentation is exacerbated by channel straightening upstream and an undersized structure for the Rail Trail.

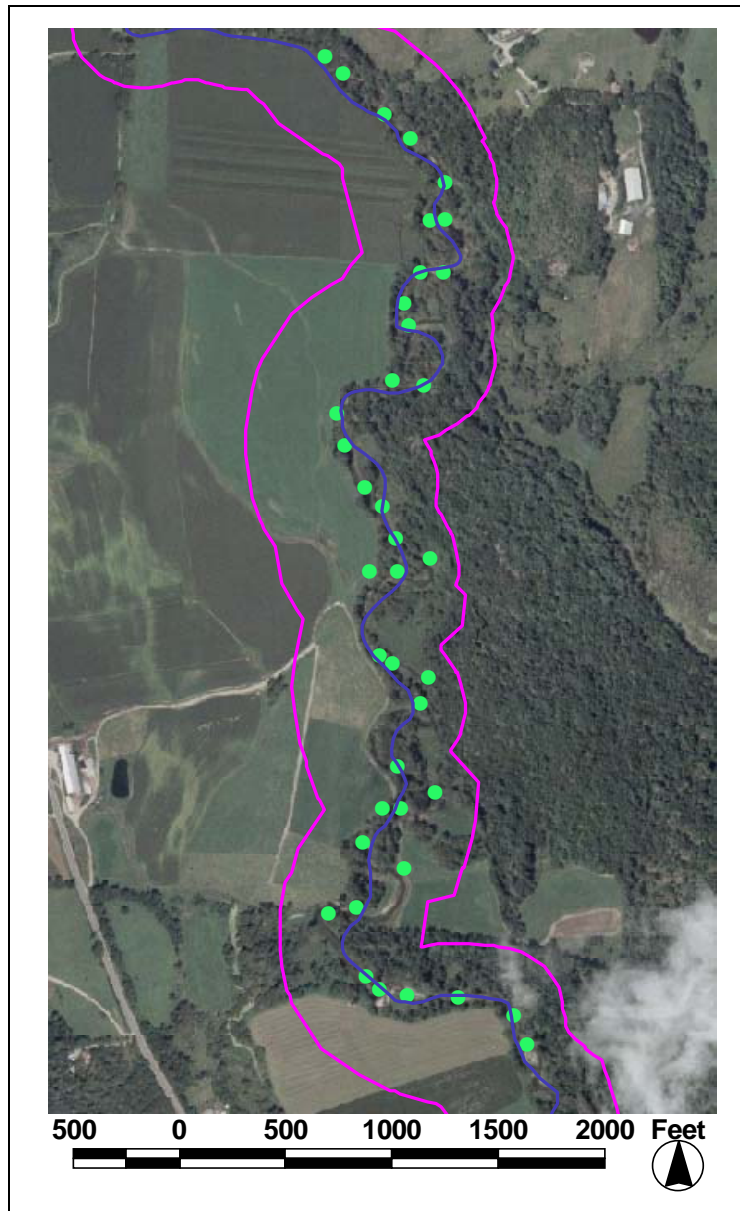
M08 appeared to be in stage IV with planform adjustments dominant. The channel was attempting to migrate (Figure 16), however continued straightening and bank armoring of this reach has inhibited the ability of the channel to regain equilibrium. Similarly, Reaches M07, M10, and segments M14A and C have experienced recent straightening and continue to attempt planform adjustments. Allowing these reaches to complete the current adjustment processes will increase overall stream stability and benefit upstream and downstream reaches by attenuating flow and sediment and improving water quality for downstream reaches, as well as reducing pressures.

Figure 16. Reach M08, straightened and moved over to the right valley wall, was attempting to regain an equilibrium meander geometry, however continued bank armoring was limiting migration. The blue line shows a past channel pattern (stream layer) while the green GPS points show current channel pattern as traveled during the assessment.

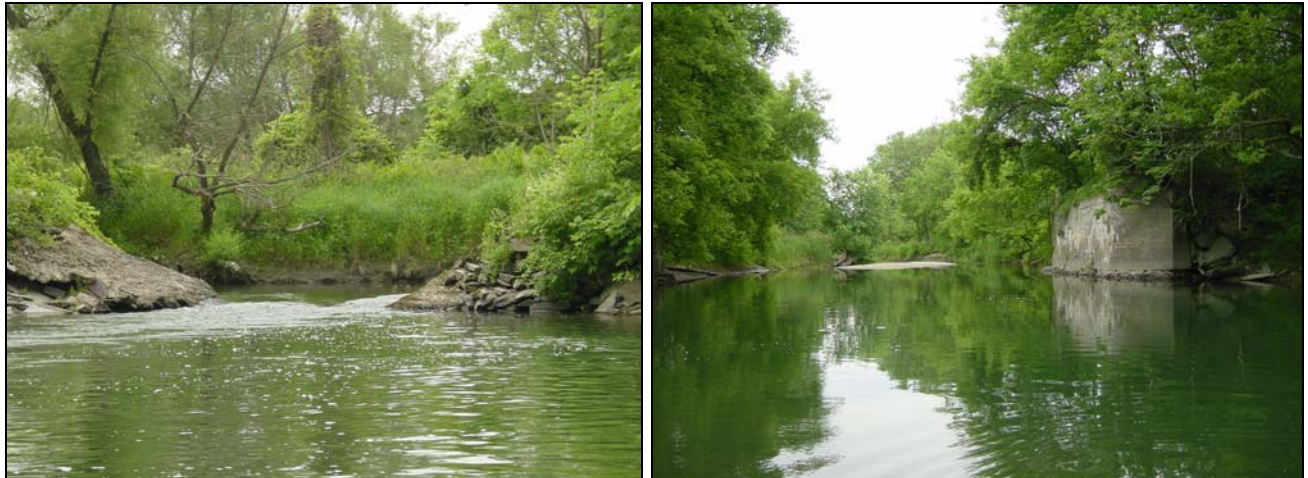
Reach M07 was “Extremely” sensitive to disturbance. This reach was a highly meandering segment of stream with sand/silt/clay banks. Old abutments (Figures 18) constrict the channel and have been outlined as potential removal/replacement projects in Table 3: River Corridor Restoration and Protection Project Table. One abutment is just downstream of an actively migrating channel (Figure 19), some of which might be resulting from the channel being constricted at this point.

Figure 18. Old abutments constricting the channel in reach M07.

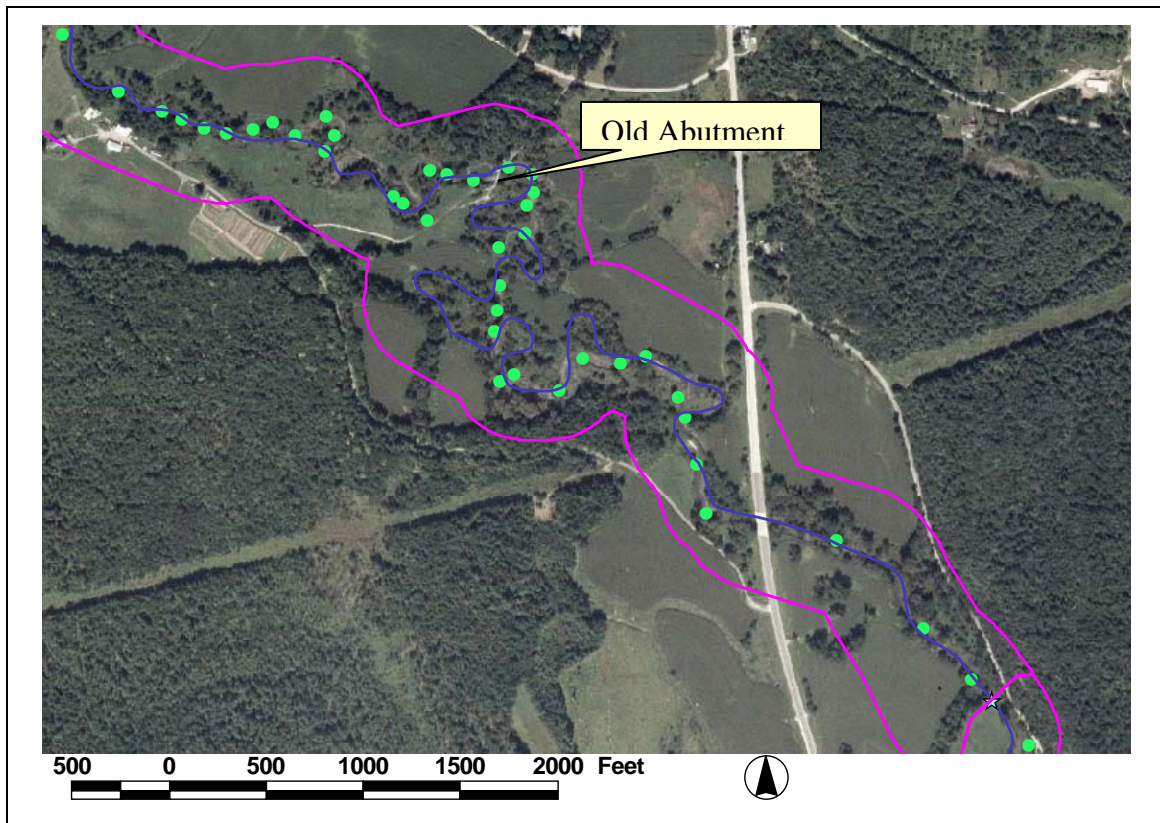
Figure 19. Aerial view of channel migration upstream of old abutment in M07 with less migration downstream of the abutment. GPS points showing actual travel along the current stream channel are in green. Stream corridor is in pink.

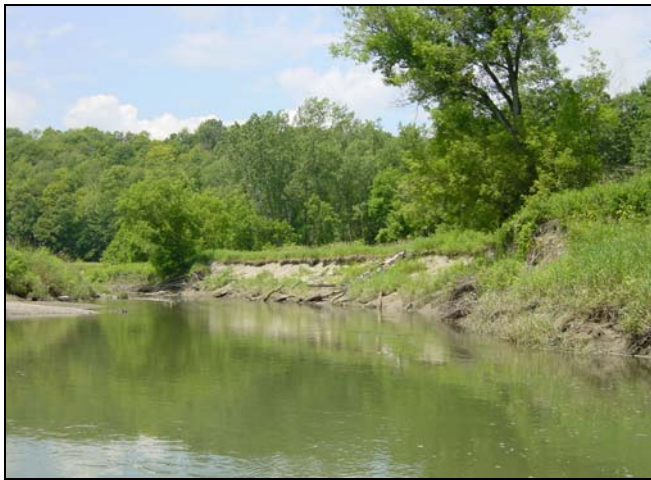
M03

Figure 21. Examples of bank instability along the Poultney River.

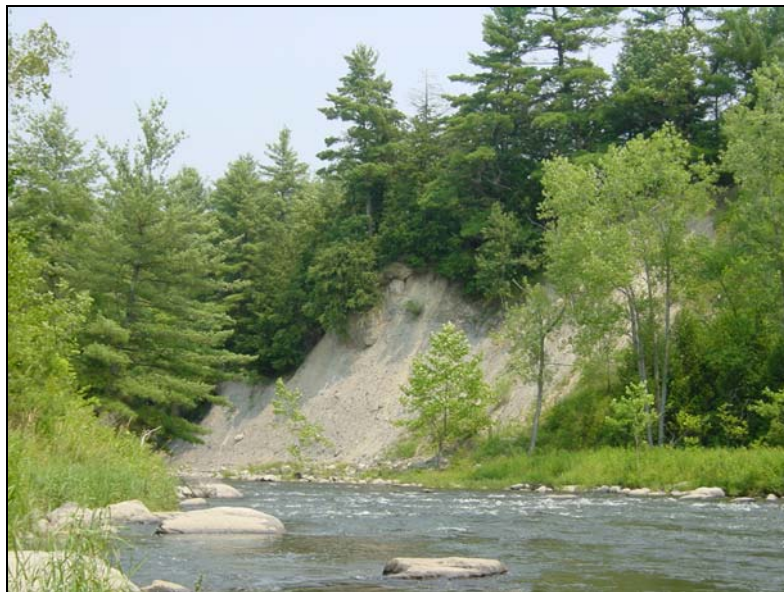
Reach M05 had “Fair” bank stability due to several mass failures (Figure 23) and “Fair” embeddedness and epifaunal substrate and cover.

Figure 23. One of several mass failures in reach M05 resulting in reduced habitat and geomorphic condition.

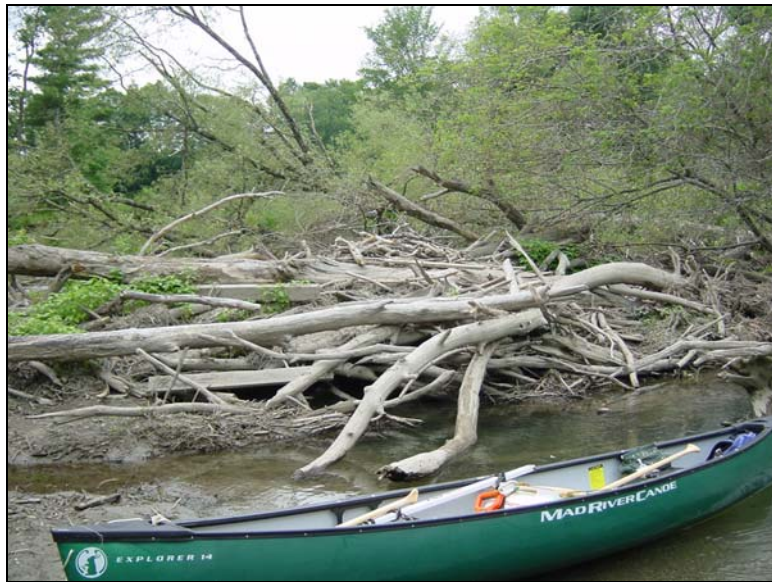
Figure 24. While not good for boating, LWD and debris jams contribute to quality habitat by providing food, cover, and protection from high flows.

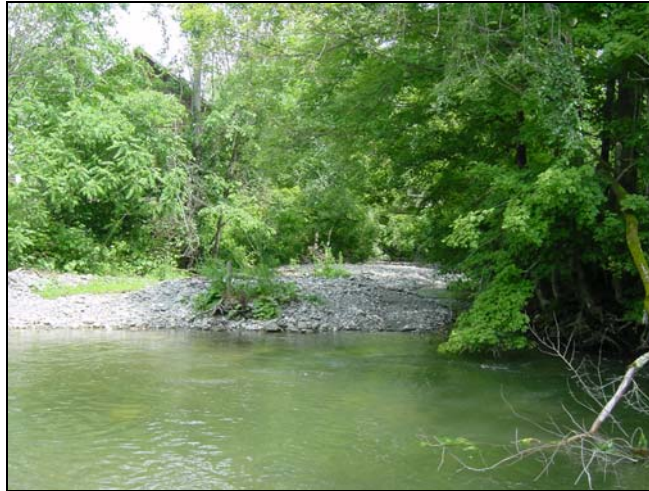
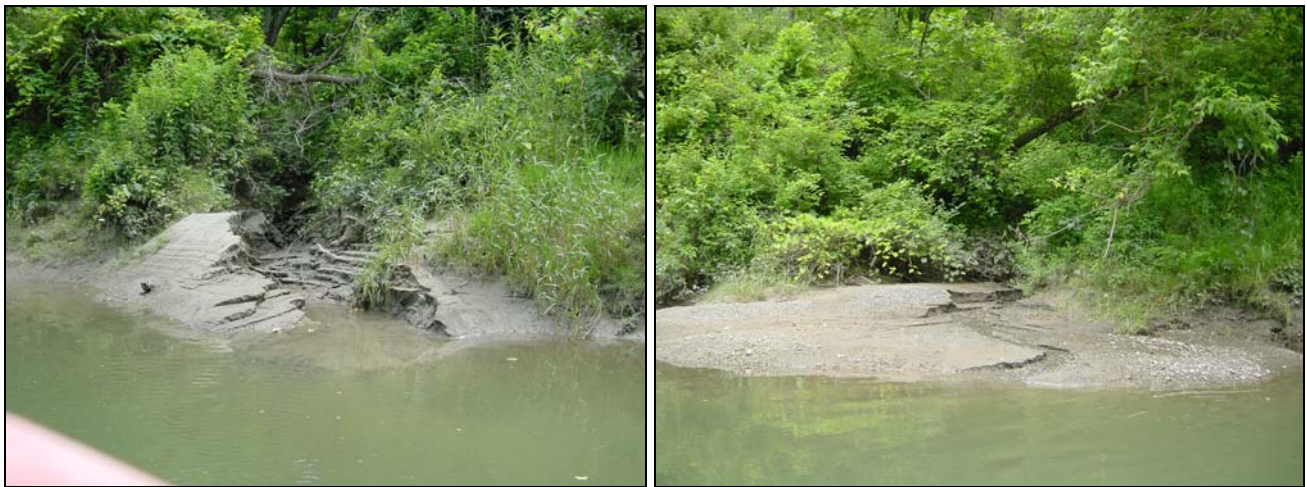
Reach M04 had “Poor” ratings for embeddedness, morphological diversity, and bank stability with several mass failures also present in this reach. Rejuvenating tributaries (Figure 25) also contributed to increased sediment in this reach as well as M02, M03, M05, and M06.

Figure 25. Rejuvenating tributaries in reaches M11 from Finel Hollow Brook (top), M03 (left), and M04 (right) with delta bars.

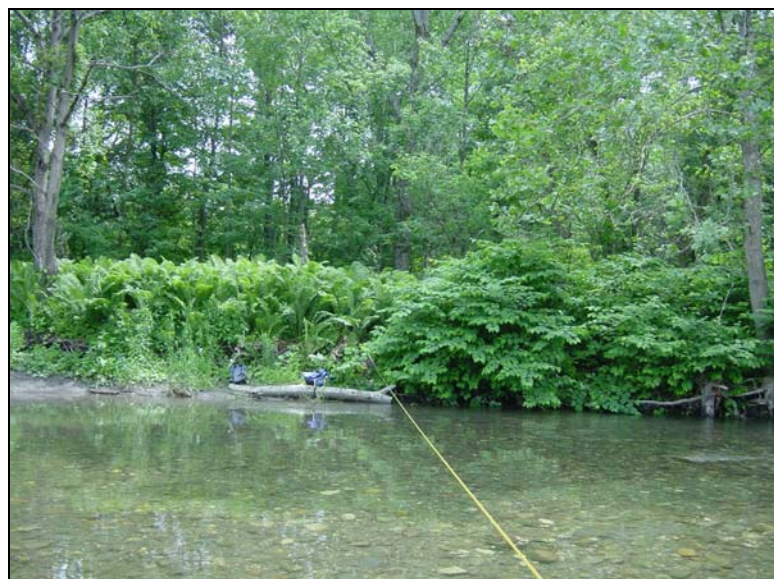
Figure 27. Ferns and Knotweed in segment M11A at the cross section location.

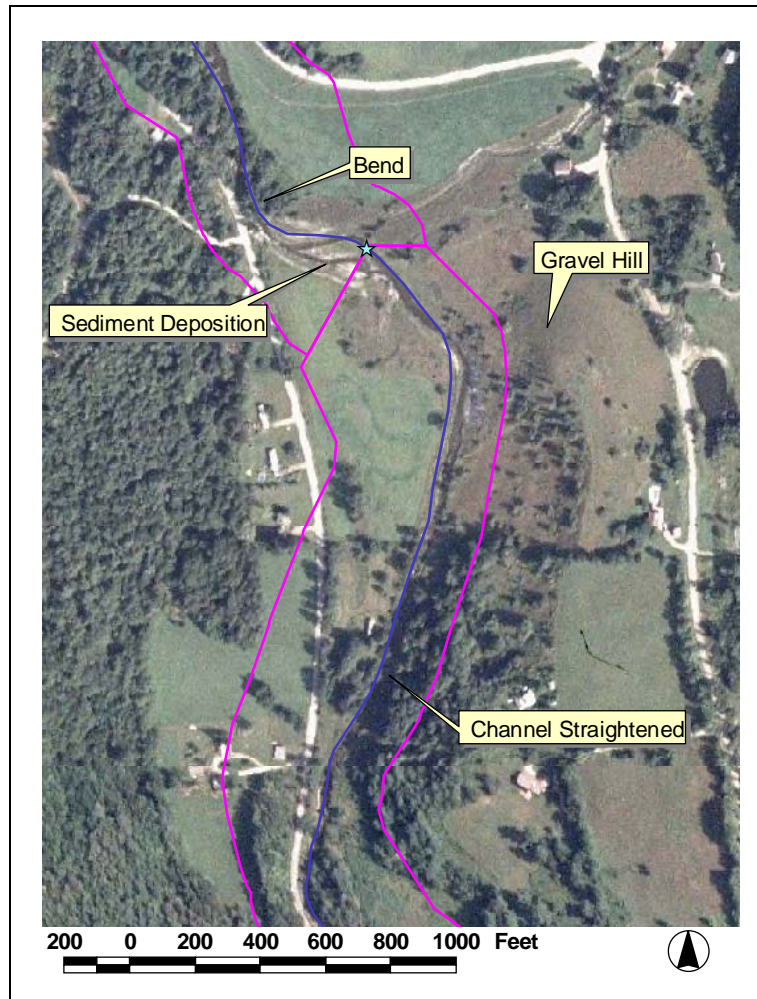
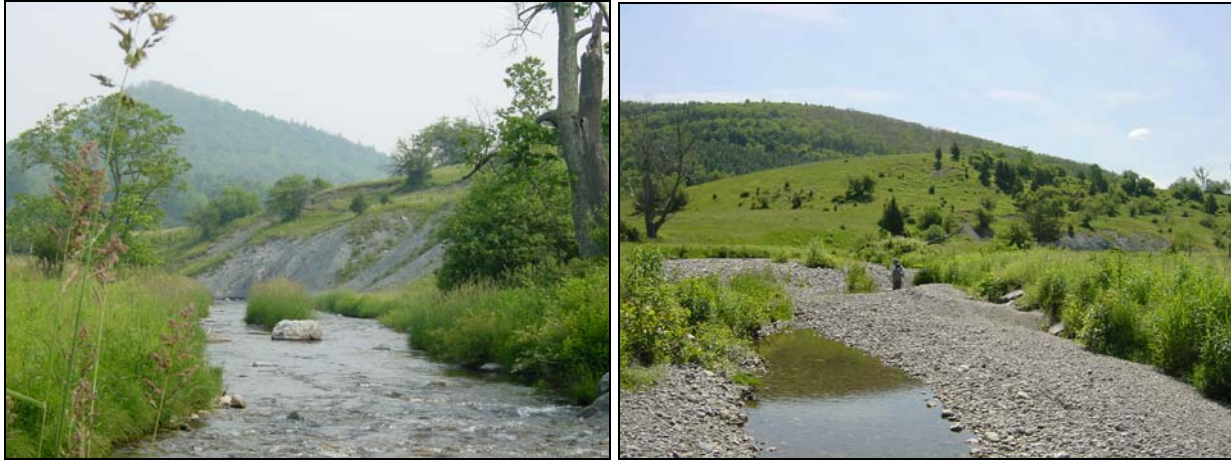
Background: On the right bank, a large gravel hill was deposited by glacial activity. Now, the river is up against this non-resistant hill, eroding the gravel and carrying it downstream. Large sediment deposits have built up in the channel and migration is evident. Just downstream of this area, the channel runs up against the road on the left bank (rip-rapped) and must make a sharp turn to the right. Stabilizing the bank of the gravel hill could help by reducing sediment inputs from this source. Protecting the corridor here would help by allowing the channel to migrate and continue to deposit the sediment just downstream of the hill. Placing investments in this area would not be good. A more intensive project would be to recreate meanders upstream to reduce the pressures on the gravel hill. This could either be in an “active” way, or with placed wood to “aim” flow at opposite banks to induce meanders. One trailer on the left bank is a potential constraint. This meandering with wood placement could be carried out upstream of this site as well where the stream has been straightened for the road and what appears to be previous agricultural use. Active agriculture does not appear to be a factor, although some new houses have been built on the right bank and would need to be protected from excessive migration.

- Replace Structure – Resize bridge as it is up for replacement to improve sediment continuity.

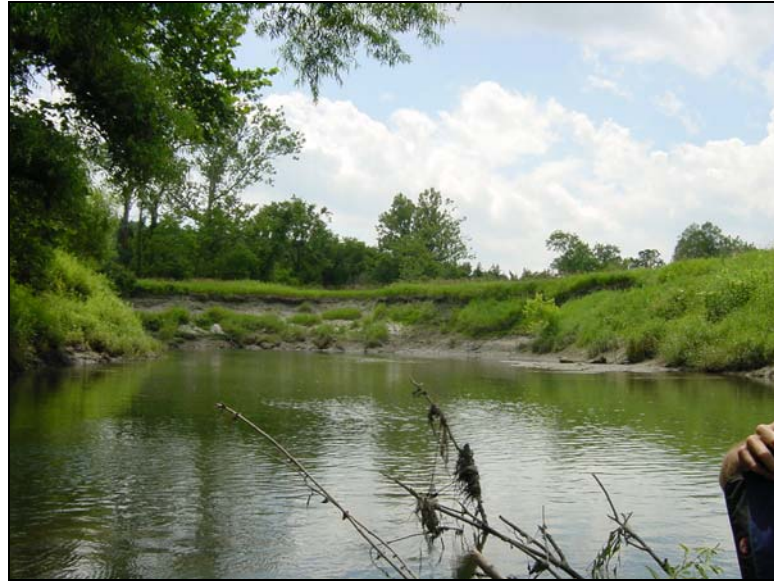
Reach #: M16C

Background: This section appeared to be undergoing planform adjustments and had large sediment deposits. The segment had alternating large point bars and erosion of outside banks and multiple flood chutes. This appeared to be an important sediment attenuation zone and should be protected from development so it can continue this function and help relieve watershed pressures on downstream reaches. Planting would not be necessary here.

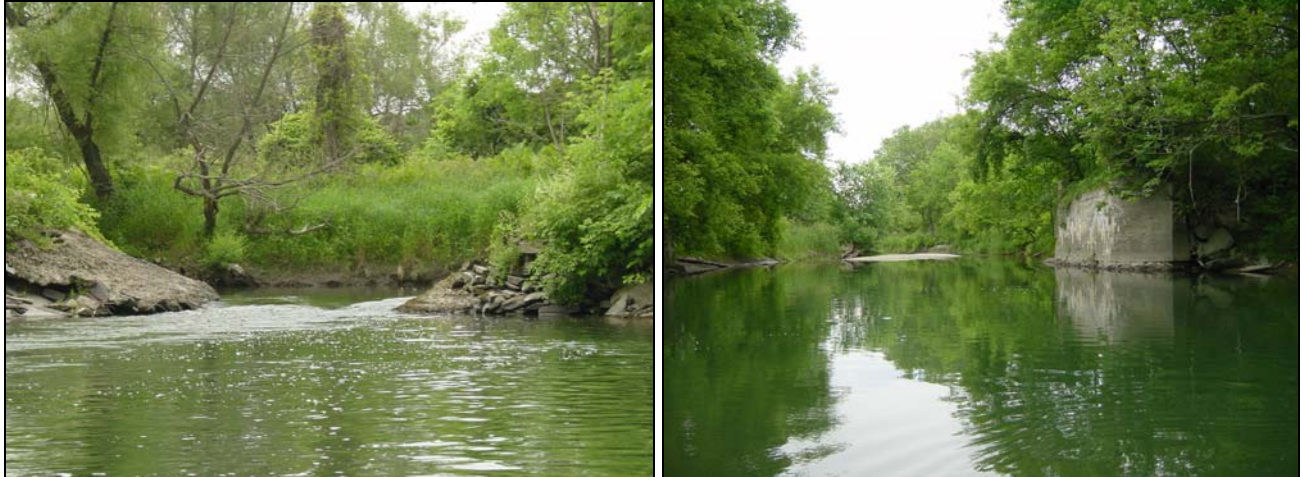
Left photo is abutment highlighted in Figure 16. Right photo is upstream of Route 22A.

Protect the corridor to allow the stream to complete channel adjustments (currently planform) and regain equilibrium. Plant stream buffers in areas away from actively migrating banks.
