Browns River Phase 2 Stream Geomorphic Assessment Summary Underhill, Jericho, and Westford Reaches

March 30, 2010

Fitzgerald Environmental Associates, LLC.
316 River Road
Colchester, VT 05446

Chittenden County Regional Planning Commission
110 West Canal Street, Suite 202
Winooski, VT 05404

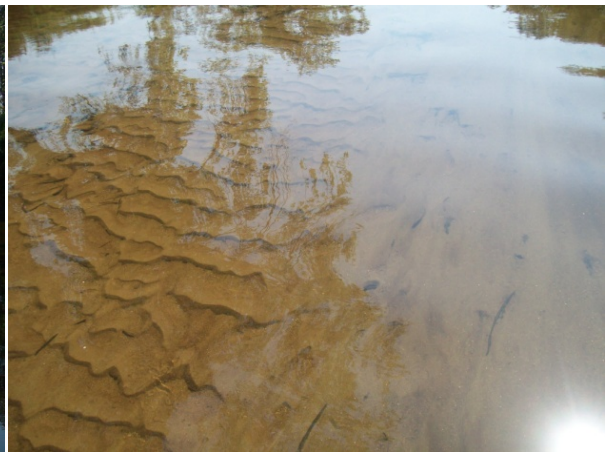
Figure 4.4. Sand-dominated bed substrate

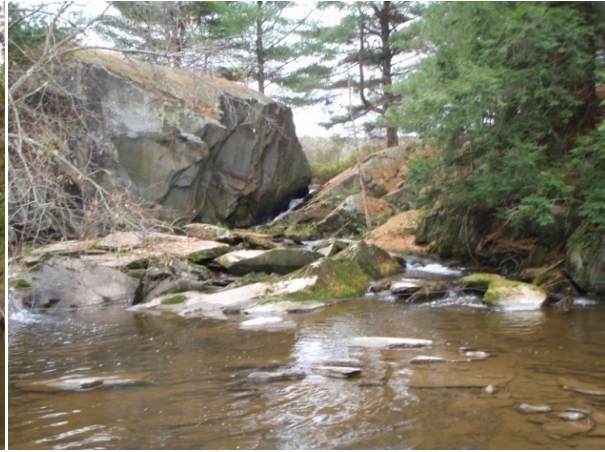
Figure 4.16 Grade control located upstream of the main stem

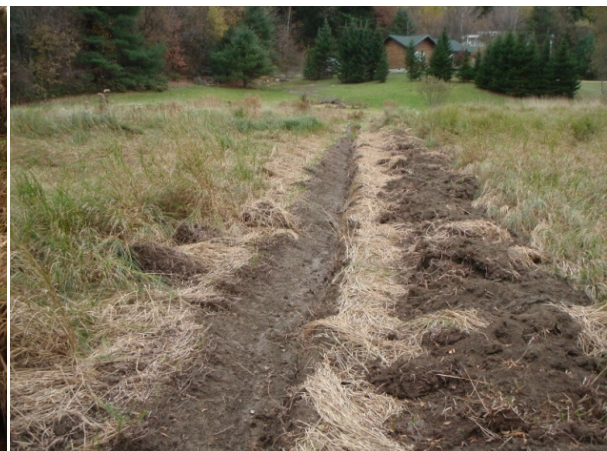
Figure 4.20 Floodplain in lower reach that has been ditched

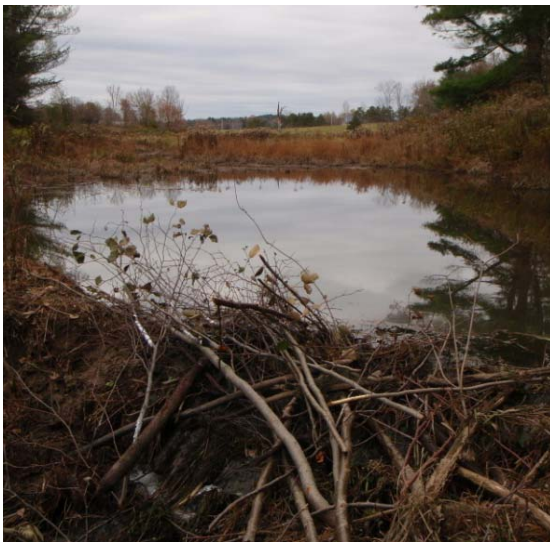
Segment T1.02-C was not fully assessed because of impoundment associated with several beaver dams (Figure 4.23). Aerial imagery also indicates that this segment was recently completely inundated with water (Figure 4.24). This probably was the result of a larger debris jam on the downstream channel constriction. T1.02-C begins upstream of the channel constriction and ends 0.4 miles upstream at the change in flow status about 600 feet downstream of Old Number 11 Road. The majority of this segment is currently being used to graze cattle, which are free to come in contact with the stream. This has led to an increased sediment load. This area has potential for restoration and could qualify for CREP (Conservation Reserve Enhancement Program) funding. Professional judgment was used to identify the stream type, bedform, and substrate (E-type; Dune-Ripple; Sand). Administrative judgment was also used to determine the RGA condition (RGA score = “Fair”).

Figure 4.23 One of the 3 beaver dams observed in the segment

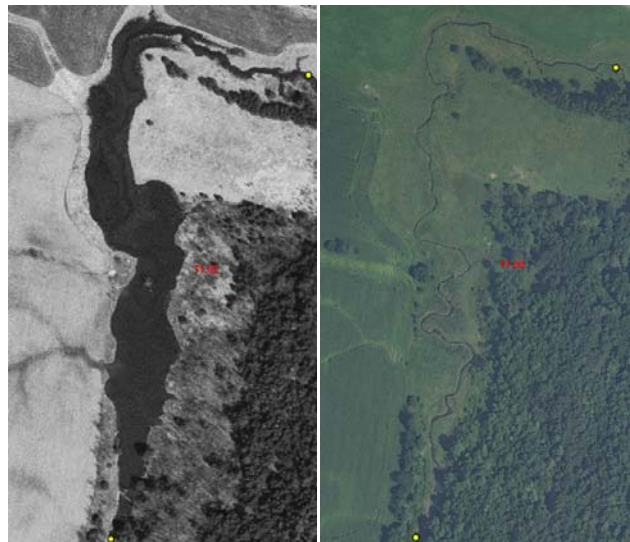
Figure 4.24 T1.02-C inundated by water in 1999 and clear in 2008

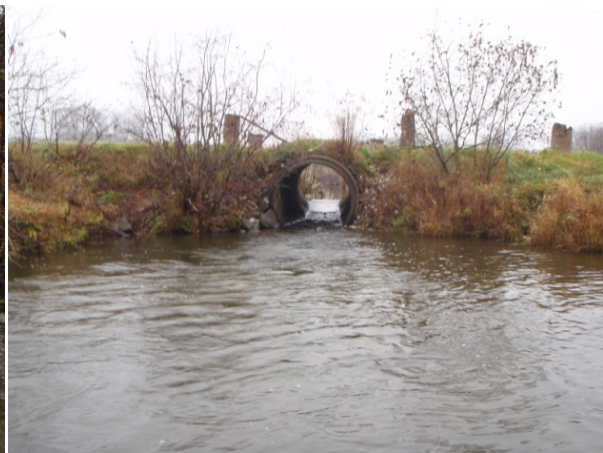
Figure 4.26 Culvert causing a large plunge pool downstream

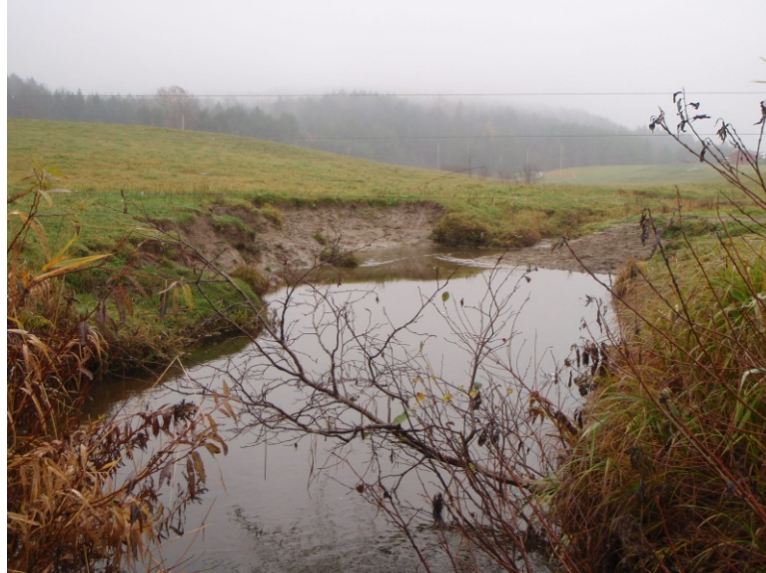
Segment E was not fully assessed because of lack of property access. T1.02-E begins just upstream of the driveway crossing off Old Number 11 Road and extends upstream 0.2 miles, ending 2,000 feet due east of the Old Number 11 and Cambridge Rd intersection where the fence line is found. Cattle and horses were observed grazing throughout the segment impacting the stability of the banks. The entire segment has been straightened and no buffer exists on either side of the channel (Figure 4.27). Professional judgment was used to identify the stream type, bedform, and substrate (C-type; Plane bed; Sand). Administrative judgment was also used to determine the RGA condition (RGA score = “Poor”).

Figure 4.27 Looking downstream into the segment; no buffers and some bank erosion

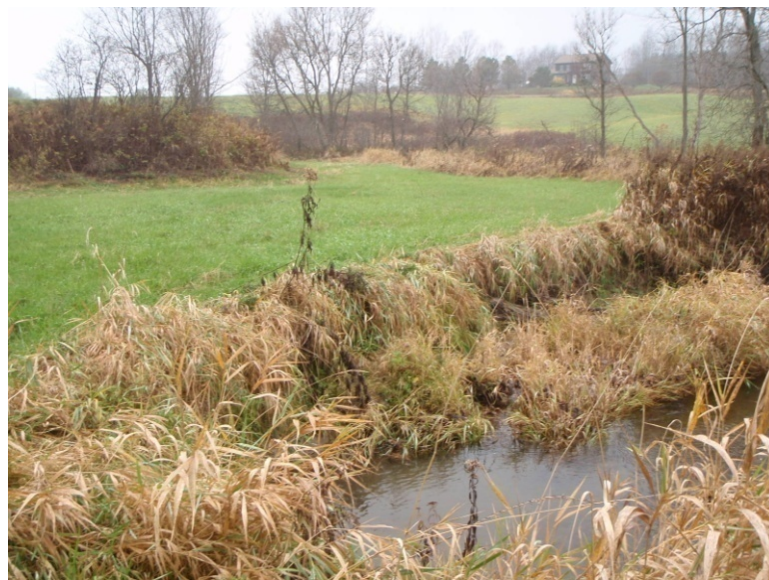
The last segment in reach T1.02, segment F begins at the fence line where property access was granted and extends upstream to the reach break just upstream of a significant tributary which enters from the east. The segment is 0.9 miles in length in a broad valley setting with no human-caused change in valley width. The channel exhibits E-type morphology with dune-ripple bedform. The width-to-depth and entrenchment ratios are 6.3 and 9.1, respectively. A moderate degree of incision observed in this segment; the degradation resulting from historical channel straightening and areas of limited buffer width ($IR = 1.4$). The bed substrate is predominately sand (58%) and sinuosity is moderate. Several areas in the middle and upper segment that have reduced buffer width and straightening are experiencing shifts in planform and bank erosion (Figure 4.28).

Figure 4.28 Bank slumping and buffer width < 25 feet on the left bank

Habitat in this segment has been impacted by the corridor agricultural land use and limited buffer widths (RHA score = “Fair”). Woody debris and pool density were 63 (LWD/Mile) and 27 (Pools/Mile), respectively. One crossing was observed in this segment at Covey Road North. This structure appears to be sized adequately with minor scour below (Figure 4.29). The geomorphic condition, much like the habitat, has been impacted by the land use and channel alterations (RGA score = “Fair”). Changes in planform and minor widening have occurred following the incision and the channel is in stage III of the CEM.

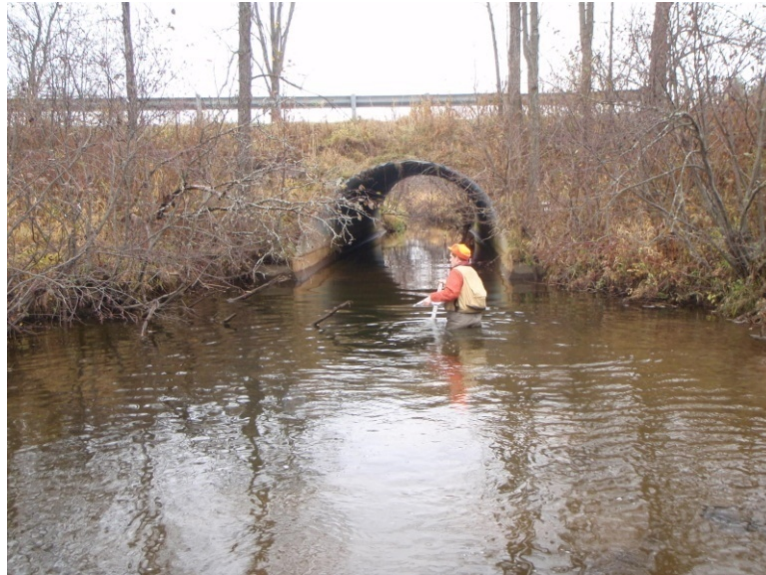
Figure 4.29 Covey Road North culvert looking upstream, some bank erosion downstream

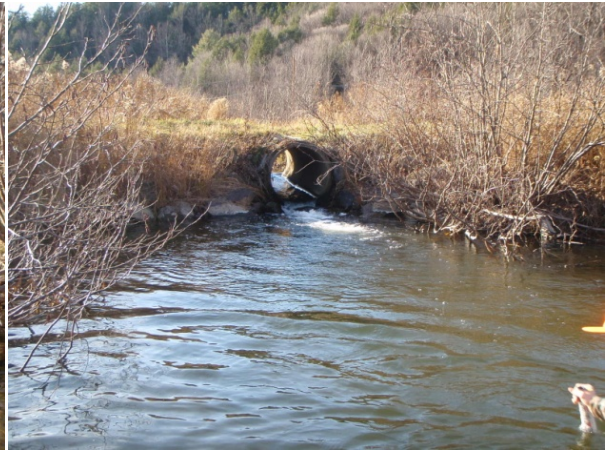
Figure 4.33 Scour-pool downstream of constricted culvert

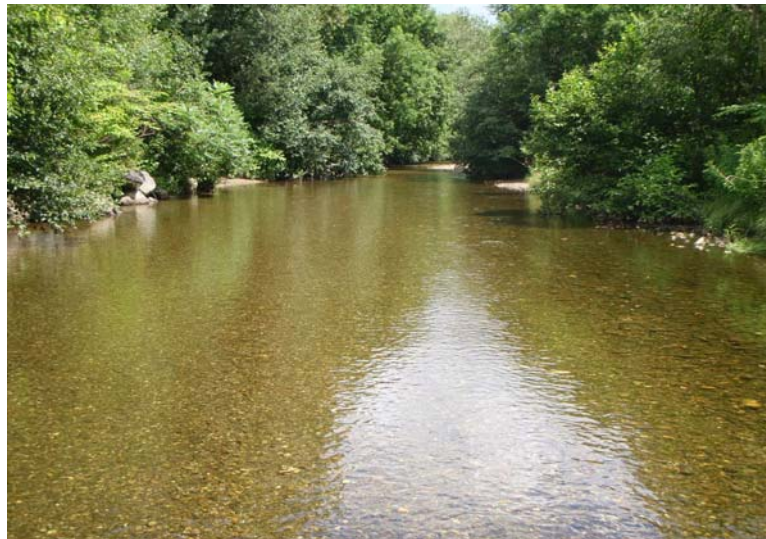
M16-A is 0.9 miles in length with a slope of 0.4%. The segment begins at the confluence with T5.01 and ends 400 feet upstream of the covered bridge at the Mill Riverside Park. This segment's natural geomorphic state and habitat have been severely impacted by anthropogenic activities both past and present. The channel geometry is indicative of a B-type channel with a subclass slope of c. Entrenchment (ER = 2.0) and incision (IR = 2.0) ratios suggest departure from its reference condition of a C-type to a B-type channel. Some widening has occurred (WDR = 17.8), but it has been limited by the extensive rip-rap armoring. Virtually all sinuosity has been removed by straightening and the channelizing effects of rip-rap. This has led to a system dominated by sediment transport processes and the bed morphology is plane bed (Figure 4.41). The substrate is gravel, with 39% and 16% coarse and fine gravel, respectively.

Figure 4.41 Plane bed channel with gravel substrate
