**STEVENS RIVER WATERSHED**  
**STREAM GEOMORPHIC ASSESSMENT**  
**and RIVER CORRIDOR PLAN**  
**2010-2011**

August 12, 2011

Prepared by:  
Daniel Ruddell, Courtney Haynes,  
and Elisabeth McLane,  
Staff Scientists, and  
Ben Machin, Principal  
Redstart Consulting

Prepared for:  
Caledonia County Natural Resources Conservation District and  
Vermont Agency of Natural Resources/  
Department of Environmental Conservation  
River Management Program

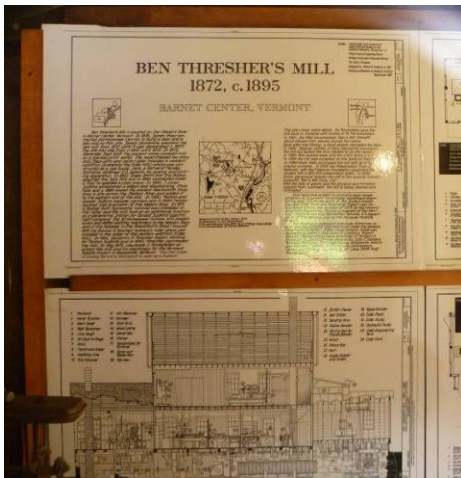
**Figure 3. At the location of one of at least 13 historical dams in the watershed, Ben's Mill on the Stevens River mainstem in Barnet Center is being restored as a working power museum. According to the historical documentation on the wall at the Mill, the dam (remains visible at left in photo of mill) was damaged in a flood in 1990; stream adjustment processes are clearly visible both upstream and downstream of the site.**

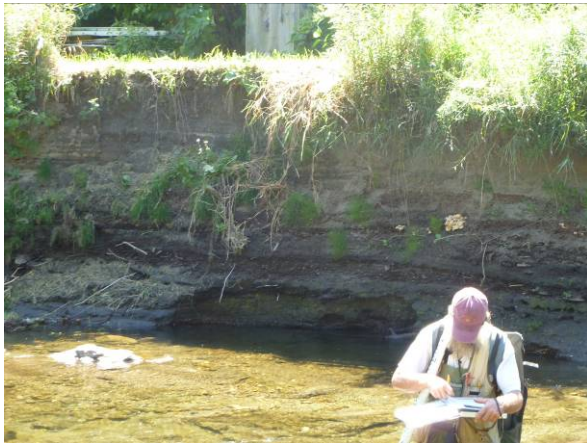
Documentation at Ben Threshers Mill in reach M1.07 indicates that the old dam at that site was damaged by a flood in 1990 (the dam was breached and has now been replaced by a penstock to supply power to the mill; millfixer1 2009). It is not clear if this may have been the same 10-year event that was recorded in March 1989 at the Passumpsic River gage (Fig. 12). Eroded banks just upstream of the old dam indicate rapid loss of legacy sediments (deposited above the dam while it was in place) when the dam was breached (Fig. 13) , and a stream channel neck cut-off and large stretches of sediment deposits appear to have occurred downstream at this time (see Sec 6.1.7).

**Figure 13. Legacy sediments behind the old dam at Ben’s Mill show a distinct pattern of banding indicating cyclic deposition over the years the dam was in place; a heavy sediment discharge and subsequent erosion have occurred since the dam breached (around 1990).**

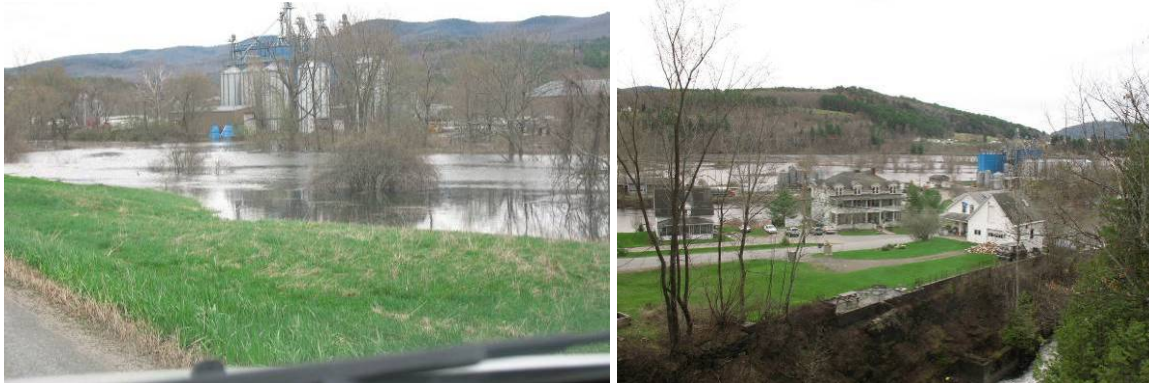
**Figure 14. While flash flooding is more common in the Stevens River basin, inundation flooding on the Connecticut River combined with high flows on the Stevens to surround Morrison Feeds during late April 2011 (Connecticut in background in picture at right, Stevens in foreground in both).**

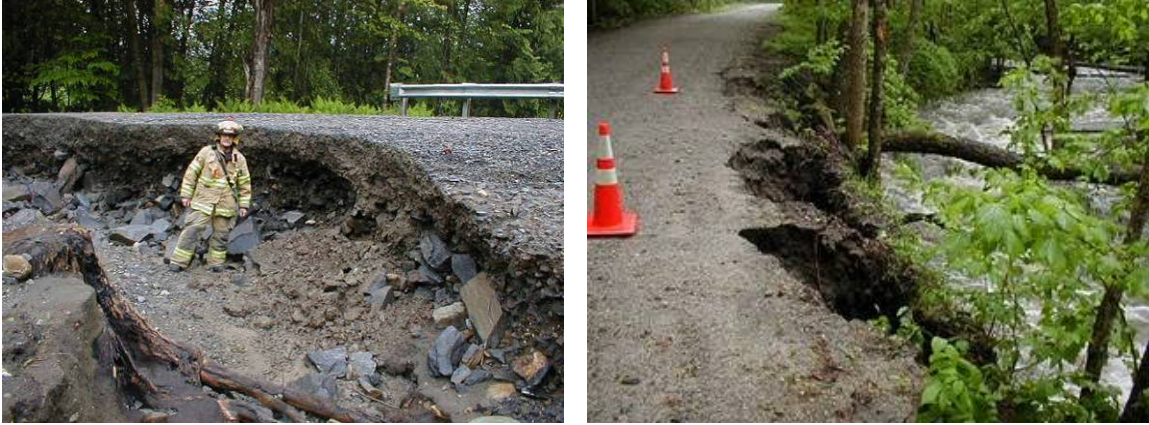
**Figure 15. Sediment from portions of Gov. Mattocks Rd. taken out by South Peacham Brook suddenly became a significant contribution to stream dynamics after an intense storm in May 2011 (photos from Town of Peacham).**

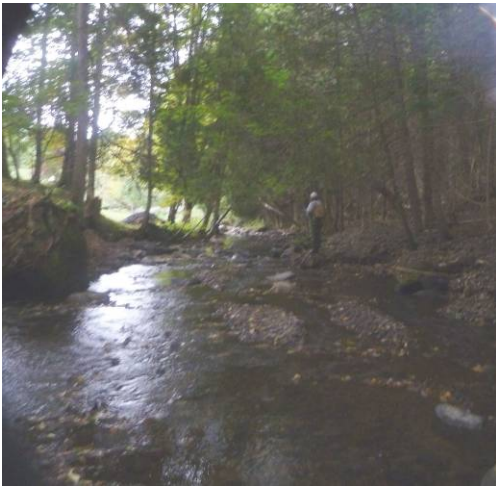
**Figure 20. Small-scale gravel removals in reach T1.05 (gravel stockpiled in background) are quickly followed by further gravel aggradation when stream power is reduced as it flows through the widened channel in this section, dropping sediments as it loses power. Areas downstream may lack coarse sediments to rebuild stable stream features until the water and sediment loads come back into balance.**

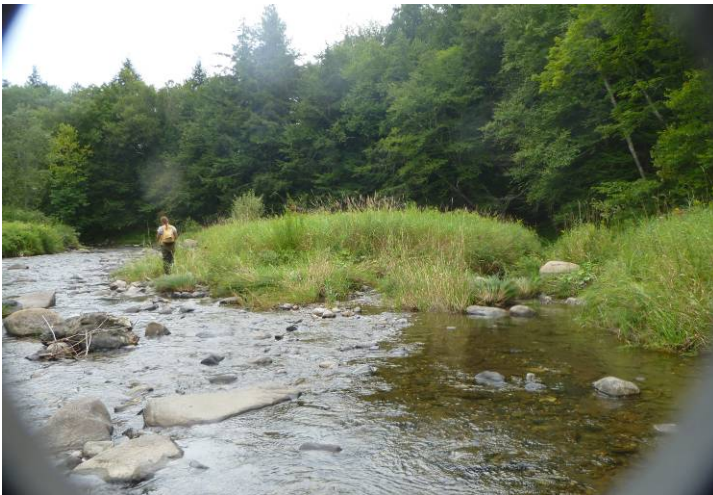
**Figure 27. A sediment “slug” in reach M1.06B downstream of the breached former dam at Ben’s Mill currently splits flows in this widened section of the Stevens River mainstem. With this bar revegetating, this feature will likely become part of a new planform as the stream evolves.**

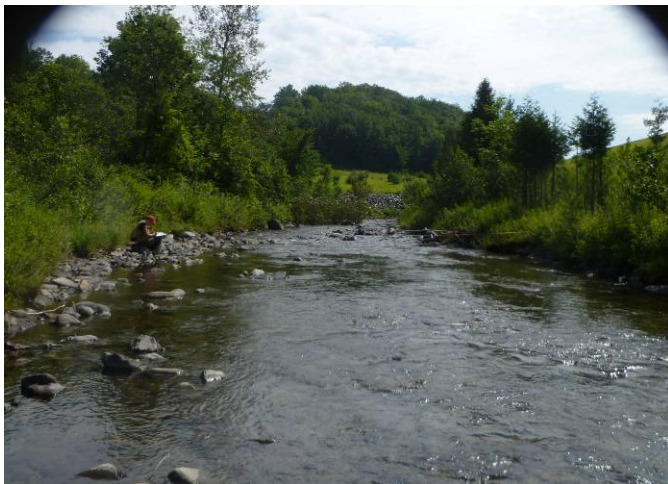
**Figure 32. High embankments of I-91 off the right bank of T1.03B combine with a small left bank berm, windrowing and extensive riprap on both banks to restrict floodplain access; removal of the berm in the trees at left in this photo might restore some of that access.**

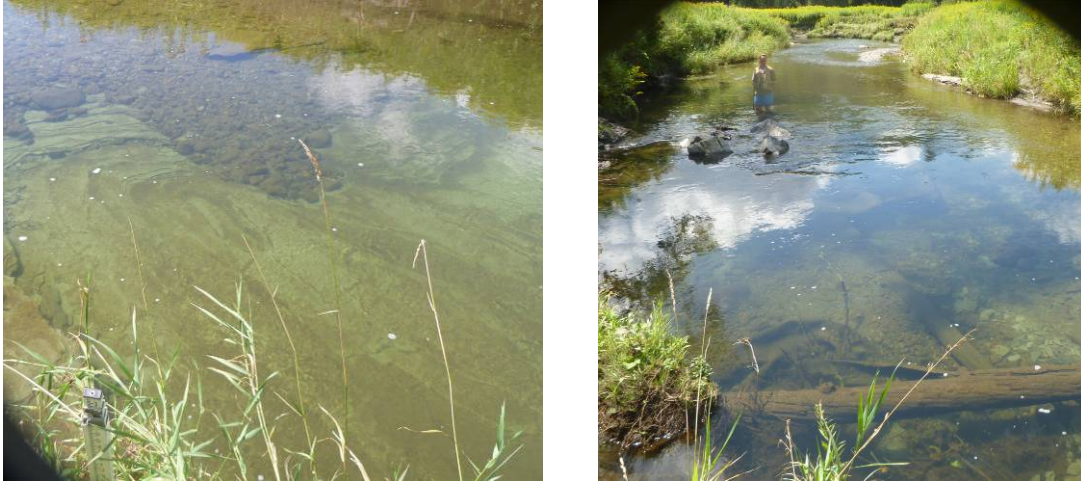
**Figure 35. Exposed clay lenses in the stream bed of reach M1.05 are located close to a series of timbers that appear to have been structural at some point, leading to questions about possible clay excavation.**

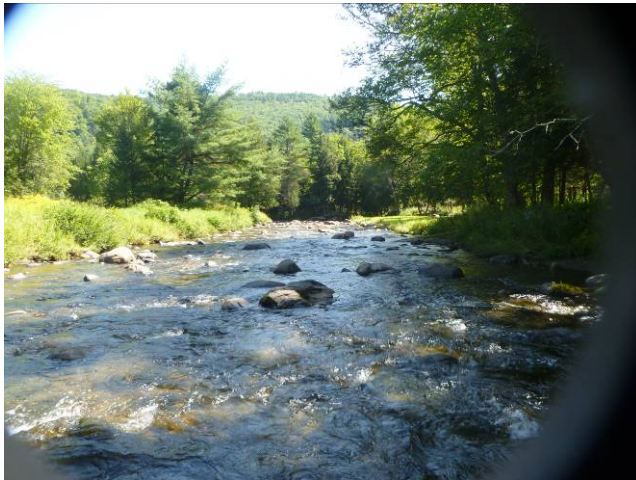
**Figure 37. Large side and mid-channel bars have significantly re-vegetated in segment M1.06B during the 20-30 years since the breach of the Ben’s Mill dam. Side bar deposited at left of this photo contributed to forcing the stream through a neck cut-off at center of photo.**

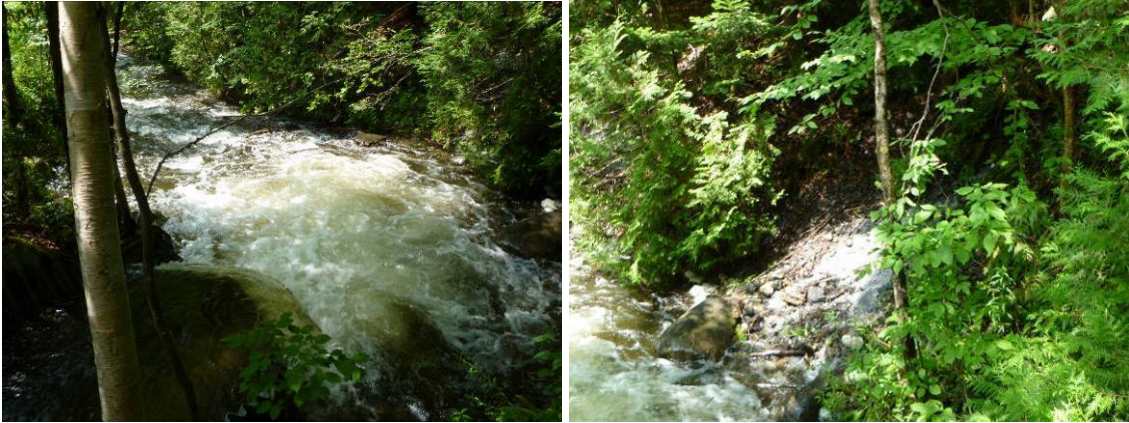
**Figure 45. Exposed blue clay on the right bank downstream (right) of a perched culvert (left) on the East Peacham Rd., upstream portion of reach T1.05, may indicate scour that could trigger bank instability beneath a pond perched at the top of the slope above.**

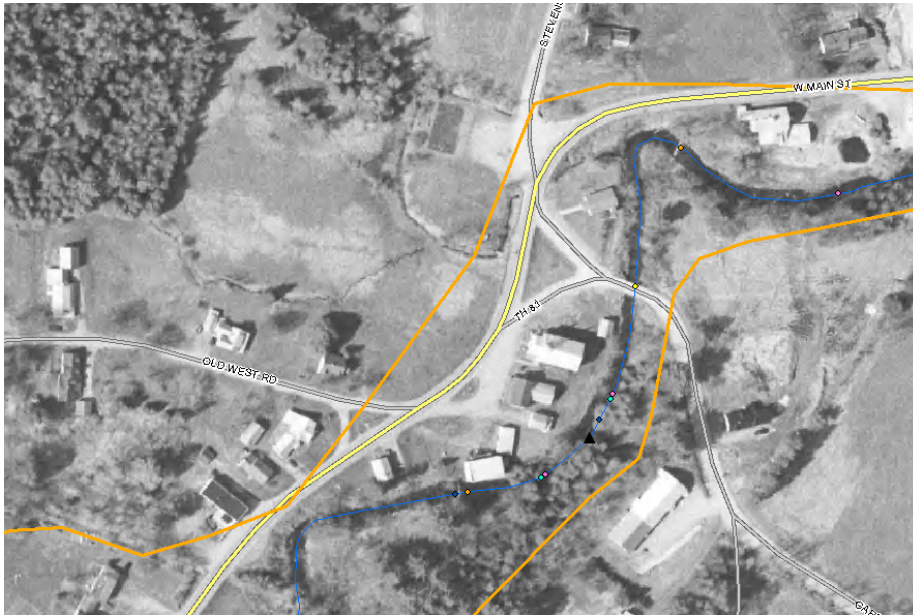
T2.02B

- Near XS location of ph.2 verified valley shapefile (xs is black triangle above), I measure the valley as ~360' wide in GIS, but step 1.5 and xs spreadsheet suggest 270' wide. Which is correct? The field measurements should be pretty accurate; adjusted the valley wall to be congruent with those, which was mostly a matter of adding vertices on the LVW and tightening the distance from the stream on the RVW.
