# **Upper West Branch Little River Corridor Plan**

**Stowe, Vermont  
October 12, 2010**

Prepared by:  
Bear Creek Environmental, LLC  
297 East Bear Swamp Road  
Middlesex, Vermont 05602

Prepared for:  
The Lamoille County Planning Commission  
632 LaPorte Road  
Morrisville, VT 05661

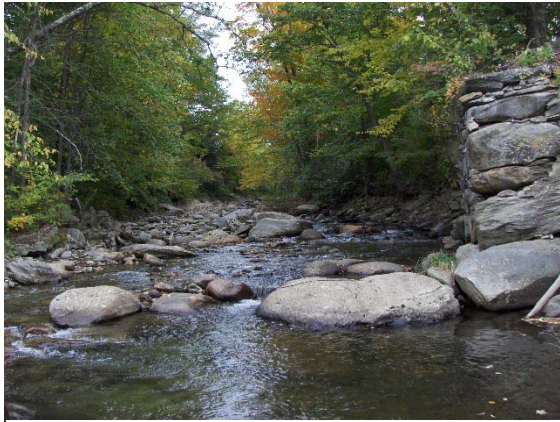
abutment is causing a channel and floodprone constriction resulting in deposition upstream and scour downstream (Figure 7.1). This structure could be removed to improve geomorphic stability. Rip-rap armoring is common along the eastern bank where Notchbrook Road is close to the channel. The majority of the eastern side of the corridor has a buffer less than 25 feet with residential its dominant land use due to development on Notchbrook Road (Figure 7.2). Due to the close proximity of the road, a planting project is not recommended for this reach. The western corridor is well forested with a wide riparian buffer.

**Figure 7.1. Straightened channel and old abutment in Segment M07-A**

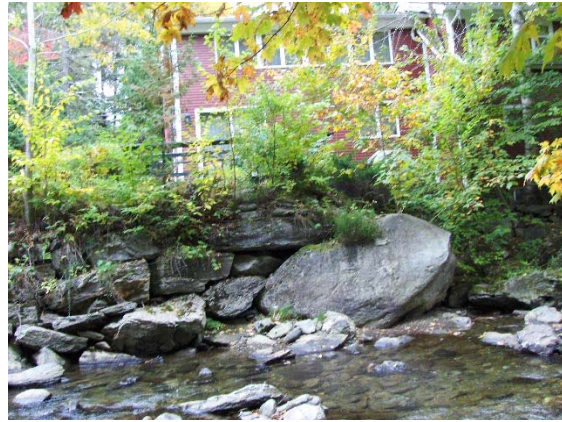
**Figure 7.2. Development and armoring along Segment M07-A**

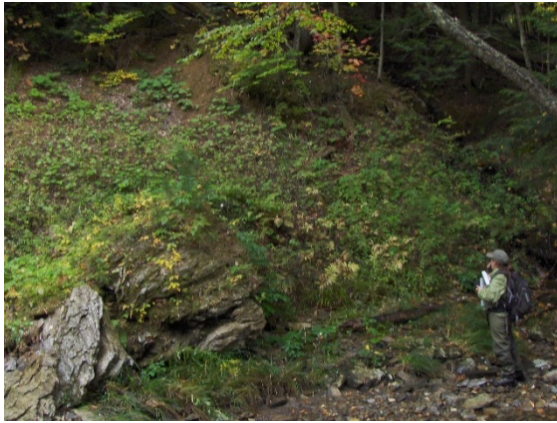
**Figure 7.6. Mass failure in segment M07-D**

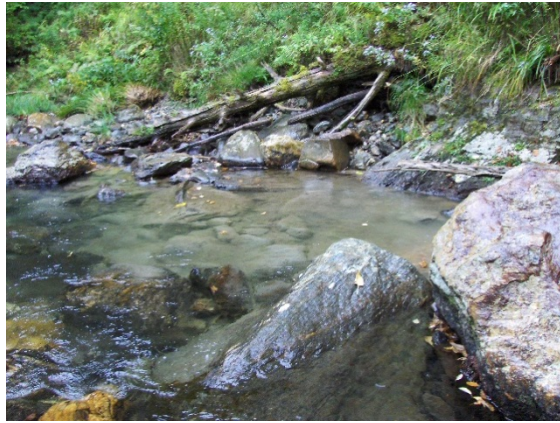
**Figure 7.7. Turbid water downstream of mass failures in M07-D**

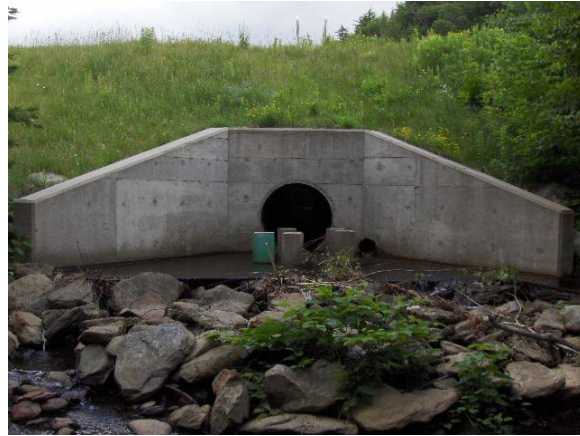
**Figure 7.11. Stormwater outlet from former snowmaking pond in M08-B**

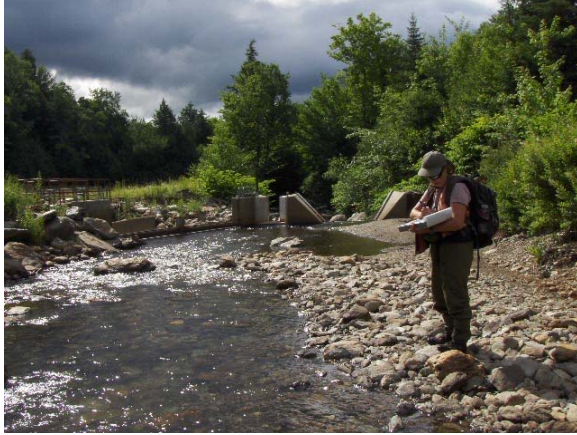
There is a weir grade control in segment M08-C where flow is diverted into a snowmaking pond during the winter. The weir is causing a channel constriction that is resulting in sediment deposition above and below the structure (Figure 7.12). There is a 2.2 foot drop on the downstream end of the weir, which may be impeding the passage of fish (Figure 7.13). A significantly undersized arch at Mountain Road is causing deposition and scour above and below the structure. There is sediment throughout the structure, and fish passage does not appear to be an issue. This structure has been given a high priority for replacement given the sediment transport issues.

**Figure 7.12. Upstream view of weir and sediment deposition in M08-C**

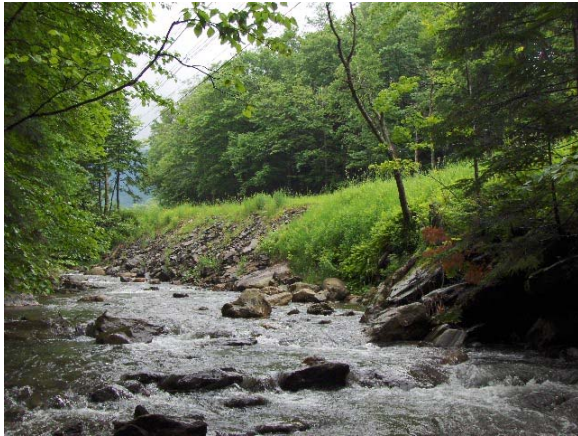
**Figure 7.14. Straightening and armoring of M09-A along Route 108 causing lack of riparian buffer and decreased floodplain access**

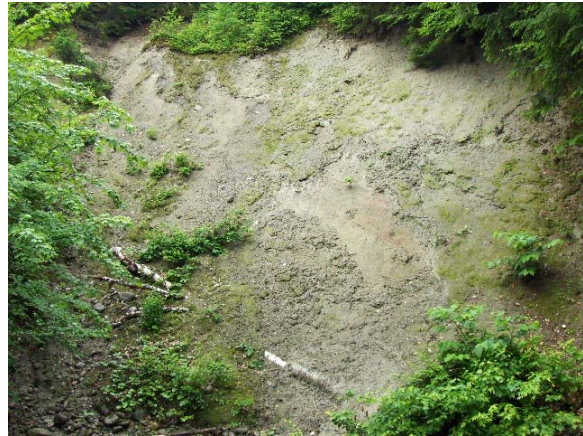
**Figure 7.15. Mass failure 25 feet wide by 65 feet high along M09-A**

mass failure has become more active. A project to redirect the streamflow away from this bank and improve stability of the mass failure is recommended.

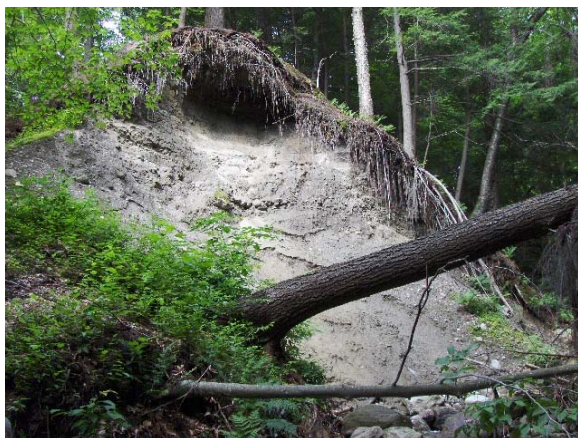
**Figure 7.18. Mass failure in segment M07.T5.01.S1.01-A**

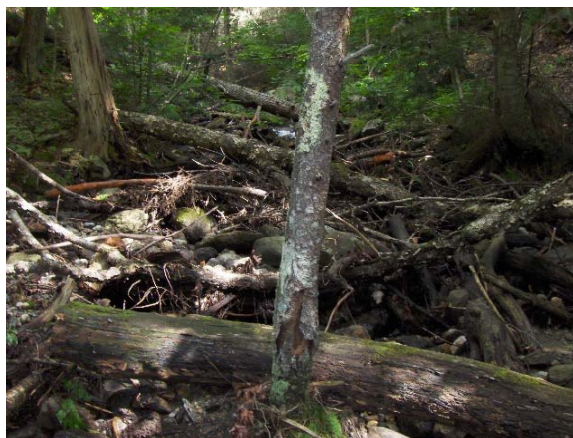
There is a significant amount of trash (e.g. glass, plastic bottles, and scrap metal) in segment M07.T5.01.S1.01-A. Therefore, a clean-up project would help to improve the aesthetics and possibly the habitat conditions. There is a mass failure 65 feet long and 40 feet high on the western bank (Figure 7.18). The mass failure and erosion of the banks has led to abundant debris in the channel causing four debris jams (Figure 7.19).

**Figure 7.19. Abundant debris in channel of segment M07.T5.01.S1.01-A**

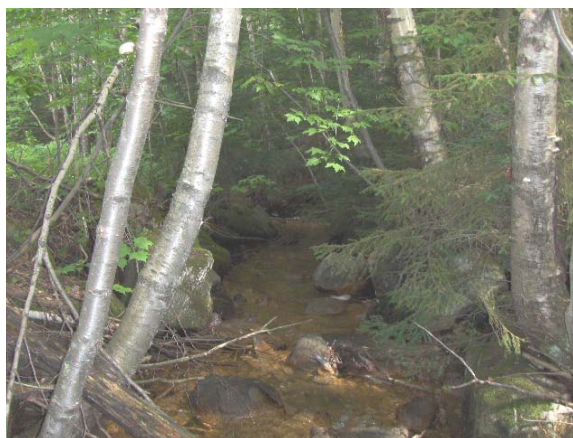
**Figure 7.21. Iron staining covering substrate in M07.T5.01.S1.01-B**

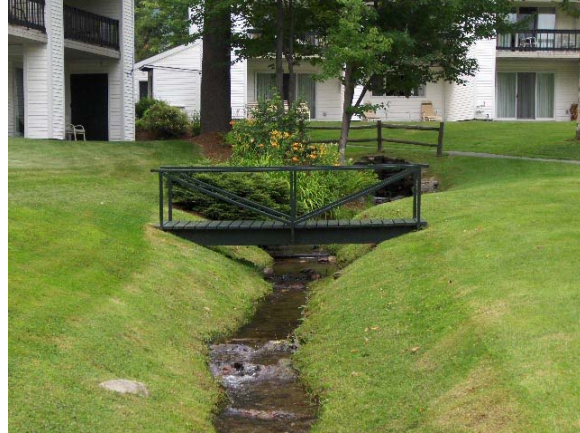
**Figure 7.25. Lack of buffer at The Lodge in M07.T5.01.S1.01-C**

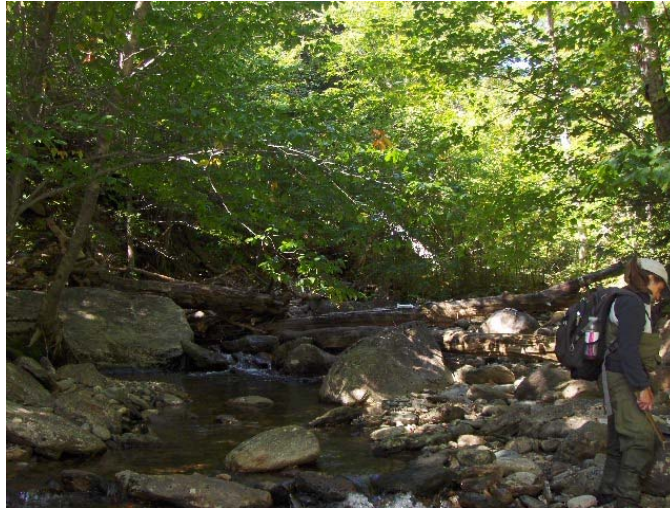
in M07T6.01-A is well forested on both sides with wide buffers. Segment M07.T6.01-A is not incised, but the drop in slope and widening of the valley has caused major aggradation and planform adjustment (Figure 7.26).

**Figure 7.26. Deposition within segment M07.T6.01-A of Pinnacle Brook**

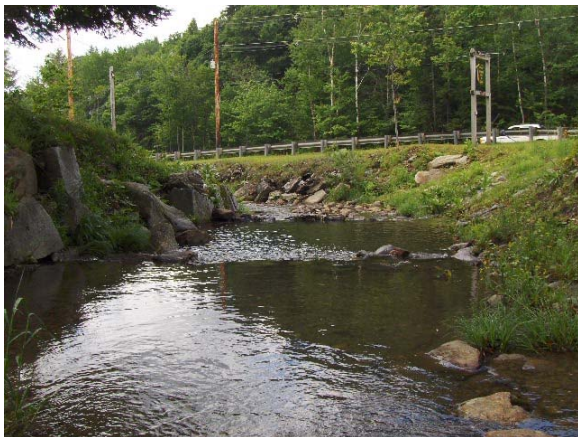
**Figure 7.27. Channel alteration and armoring along Route 108 in M08.SI.01-A**

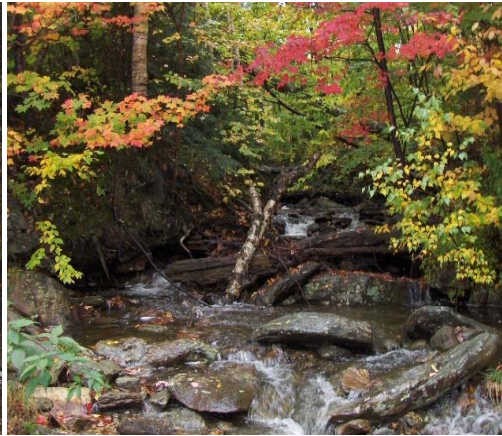
**Figure 7.34. Active head cut and bank erosion in segment M08.S1.03 of Big Spruce Brook**
