**Phase 2 Stream Geomorphic Assessment  
West Branch Little River Watershed  
Town of Stowe  
Lamoille County, Vermont**

November 7, 2005

Lamoille County Planning Commission

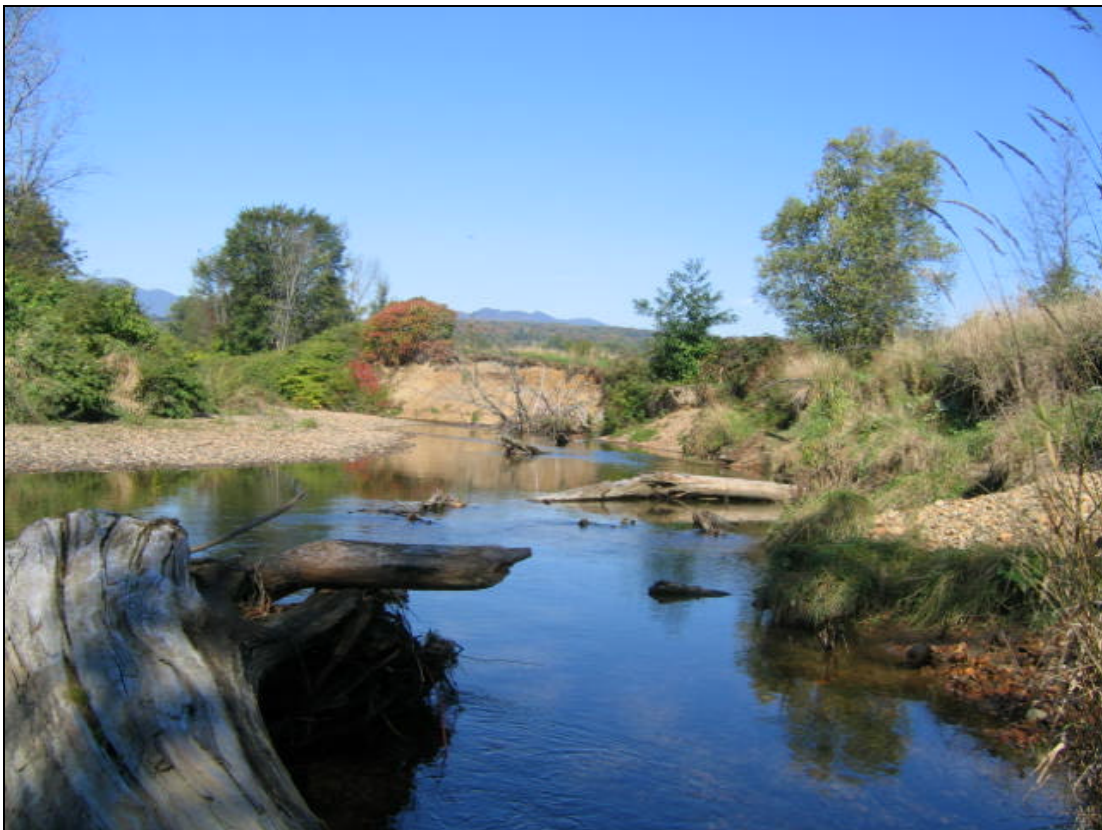
Reach M3.01 has undergone a stream type departure from a C channel to a B channel due to historic incision. The current incision ratio was calculated to be 2.3, suggesting the incision process has reduced the flood prone area of this reach creating a channel that has lost access to most of its historic floodplain. This reach is exhibiting signs of active channel adjustment as it is now working to recreate a lower floodplain area through planform adjustment, widening and aggradation.

**Figure 3. M3.01 has lost access to its floodplain. It is currently exhibiting active planform adjustment and widening as it works to create a new lower floodplain bench.**

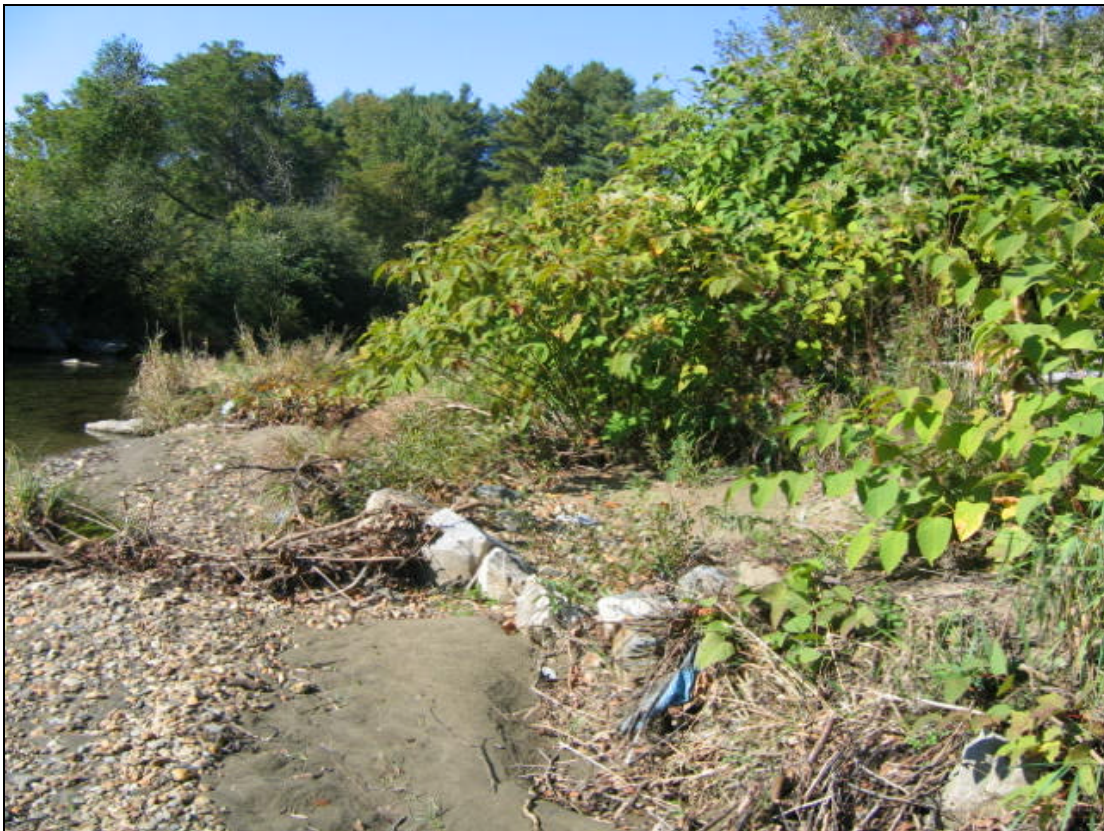
Active adjustment was evident through erosion which was prevalent in this section. Approximately 50 percent of the left and right banks had moderate to severe bank erosion (Figure 3). Where active erosion was absent, riprap often covered the banks. In one area, riprap was found crossing the middle of the channel, thereby marking the historic location of the river and creating evidence of lateral migration (Figure 4). Hay fields were noted to be the dominant land use within the riparian corridor of reach M3.01. The buffer was narrow on both sides (<25 feet in width) with lots of invasive Japanese knotweed. Herbaceous vegetation was the dominant vegetation type.

**Figure 4. Planform adjustment is evident in this photograph of M3.01 where an attempt to riprap this actively moving channel had failed leaving the riprap cutting from a bar across the channel to the far bank.**

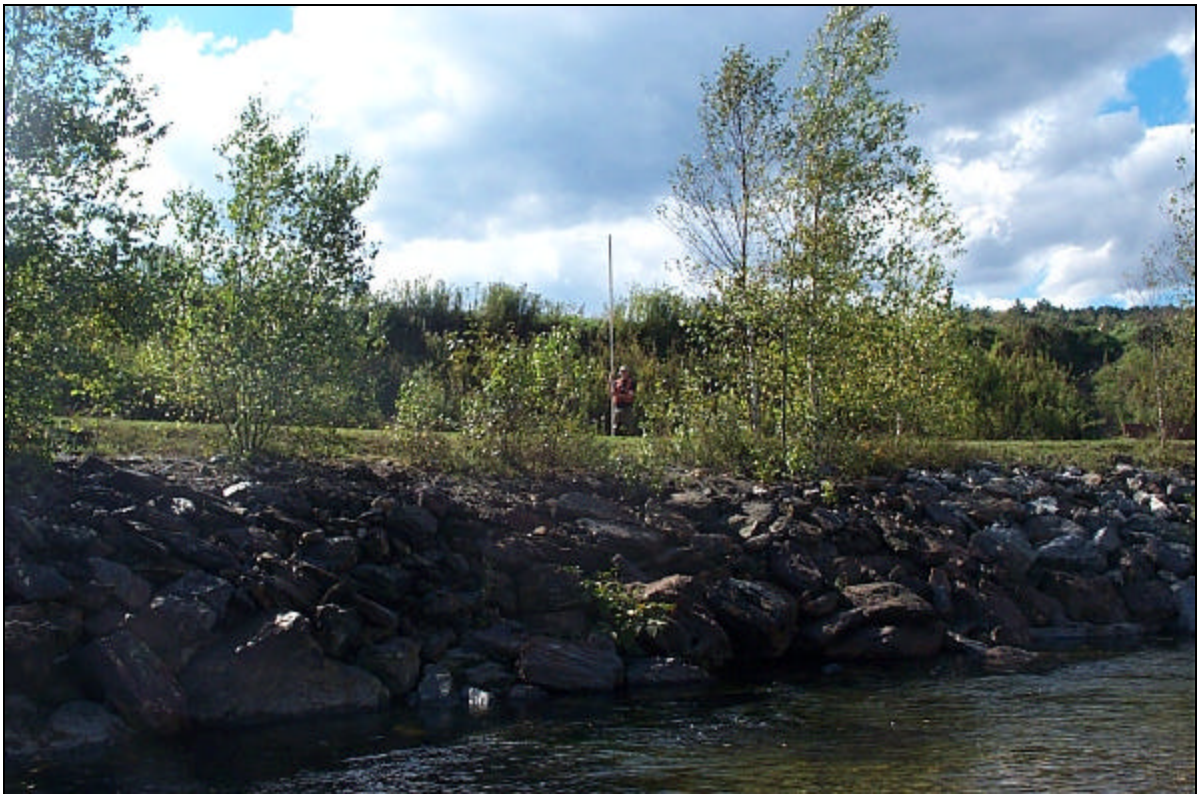
West Branch River. This reach, however, has also undergone historic incision (Figure 5). Information recorded at one typical cross section rated the incision ratio to currently be 1.92. The reach is actively working to recreate a new floodplain at a lower elevation and is doing so by migrating laterally and scouring its banks.

**Figure 5. High abandoned terraces along reach M3.02 help show the historic incision that has occurred on this reach. The second terrace (behind and above the field scientist) is a flat agricultural field that was at one time the floodplain of the West Branch.**

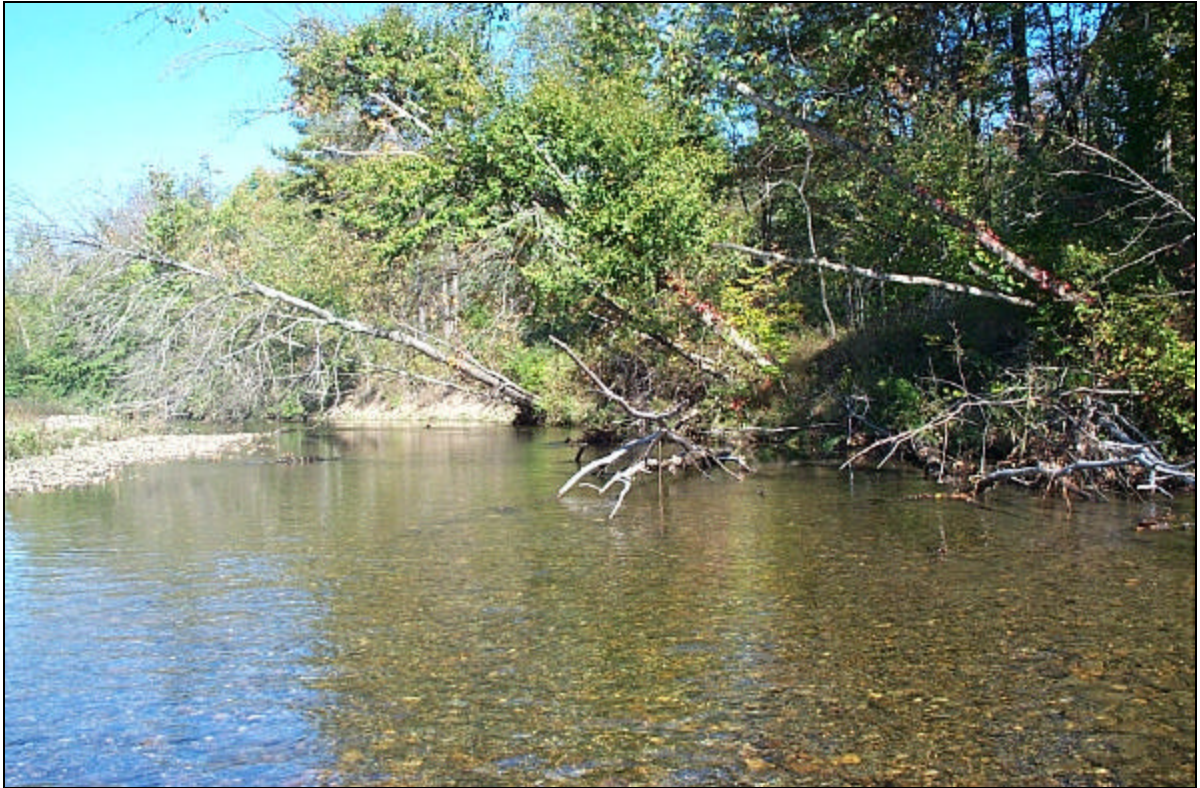
Extensive lateral bank erosion was observed in reach M3.02 on most outside bends, as shown in Figure 6. Based on the high lateral bank erosion and the historic and active flood chutes, reach M3.02 appears to be undergoing major planform adjustment and widening.

**Figure 6. Reach M3.02 is actively undergoing planform adjustment. As illustrated in this photograph, the river is migrating into its left bank causing trees to fall into the river.**

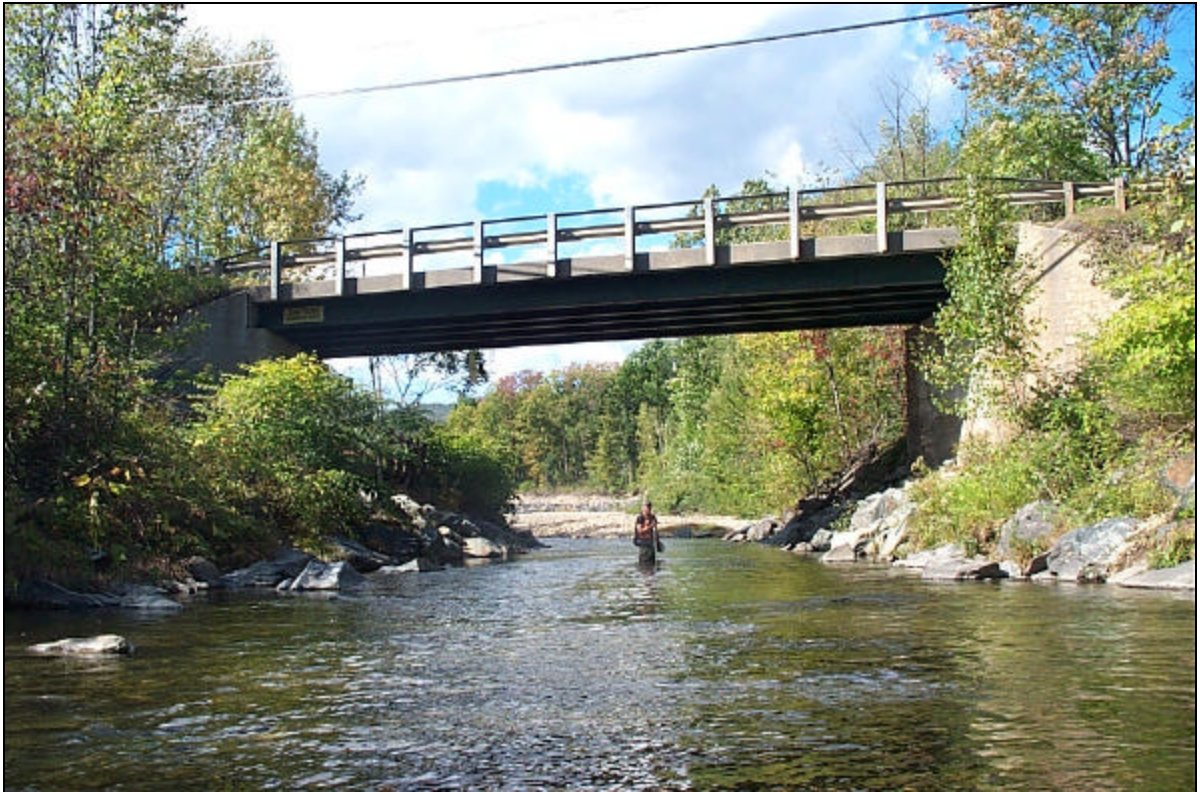
Among two channel bridges that constrict the channel of reach M3.02, Luce Hill Bridge is perhaps most noteworthy for its affect on sediment transport on the West Branch. As seen in Figure 7, Luce Hill Bridge is only 30 feet wide at its base, thereby causing major upstream deposition of sediment and scour in the area downstream of the bridge.

**Figure 7. Luce Hill Road Bridge, a channel constriction that locally disrupts the sediment transport of the West Branch within Reach M3.02.**

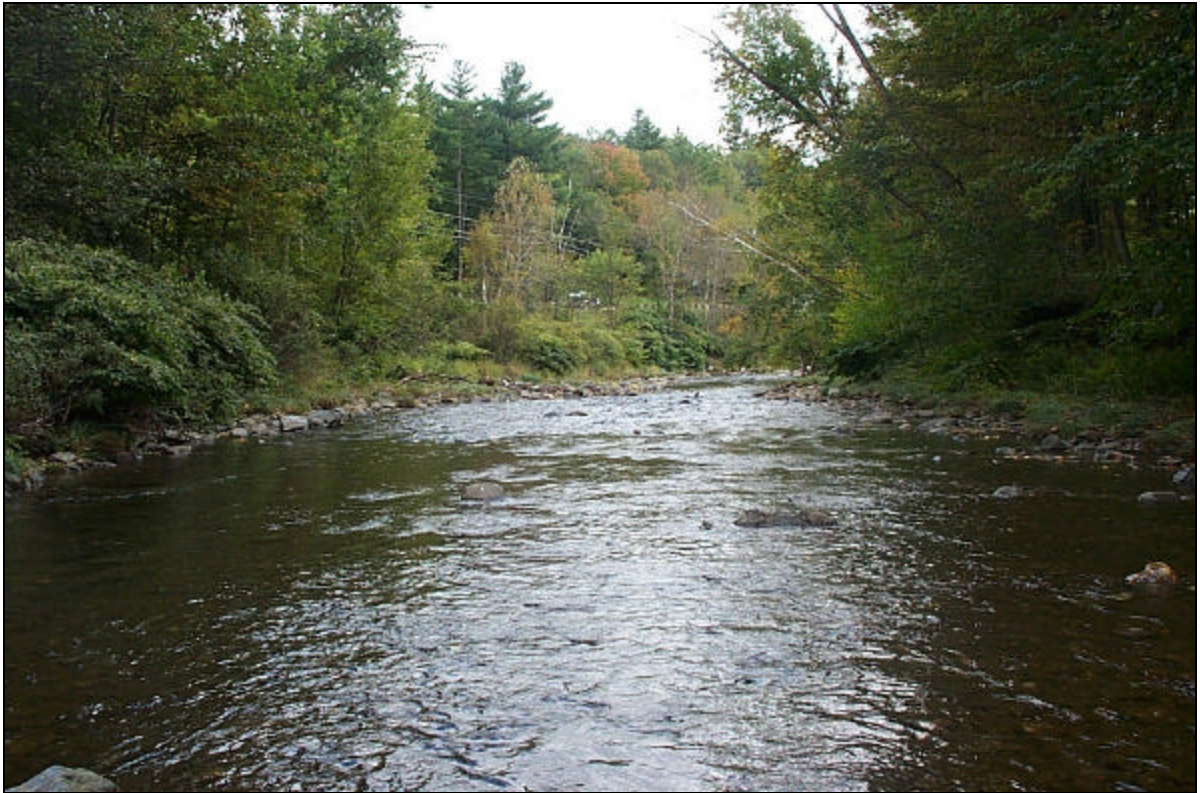
Encroachments from Route 108 and past channel management activities have caused this segment to become incised, overwide and featureless as shown in Figure 8. BCE and ANR scientists recorded the incision ratio to be 2.47. The river lacks access to an adequate floodplain through this reach and has therefore become an “F” type stream channel with a plane bed form. There is very little sediment storage within this segment. Bank erosion would likely be more severe if the left bank had not been riprapped along most of the segment.

**Figure 8. Floodplain encroachment from Route 108 along with historic incision has created an “F” channel along segment M3.03-A. Note the plane bed bedform and high width to depth ratio.**

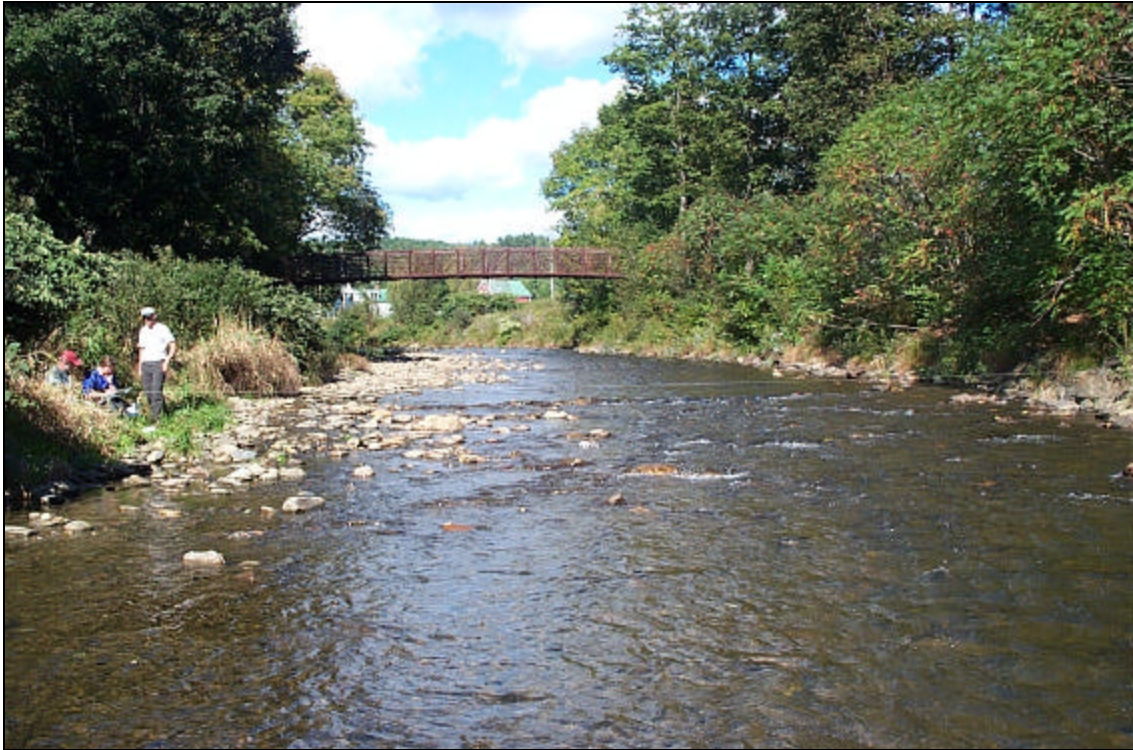
Reach M3.03-B, like many on the West Branch, has been impacted by channel incision and floodplain encroachment. The river is further along in channel evolution than its downstream segment M3.03-A, having reestablished a small floodplain bench and begun to develop point bars (see Figure 9). It remains relatively wide and shallow, however, and is a moderately entrenched “B” type channel that is dominated by plane bed features.

**Figure 9. This photograph shows a typical cross-section along segment M3.03-B. The stream has worked to create a small bench on the right bank and is now only moderately entrenched.**

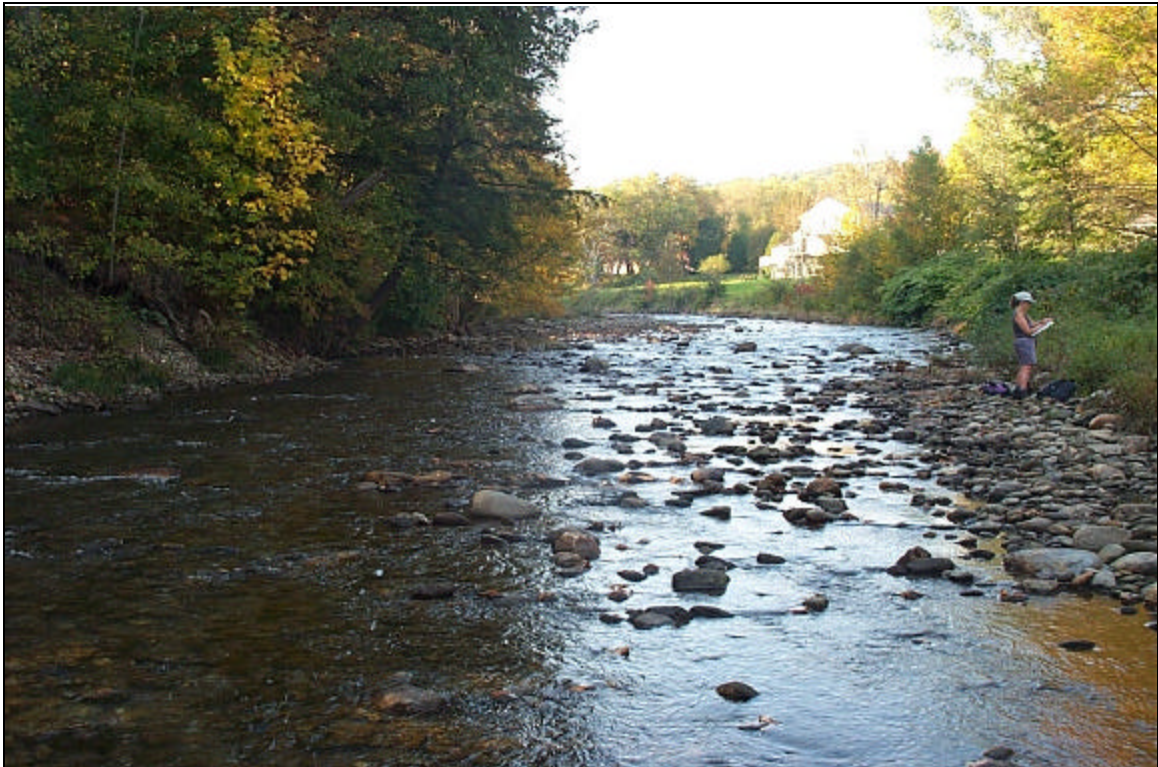
Segment M3.04-A, also has been impacted by channel incision and floodplain encroachment. The river is far along in the channel evolution model (stage IV), having reestablished a small floodplain bench and begun to develop bars. However, it remains wide and shallow (see Figure 10), and is a moderately entrenched “B” type channel that is dominated by plane bed features. The current incision ratio was measured to be 2.86.

**Figure 10. Reach M3.04-A is typically wide and shallow. The stream has only a small floodplain along most of the reach and is actively undergoing planform adjustment to try and reestablish a floodplain bench.**

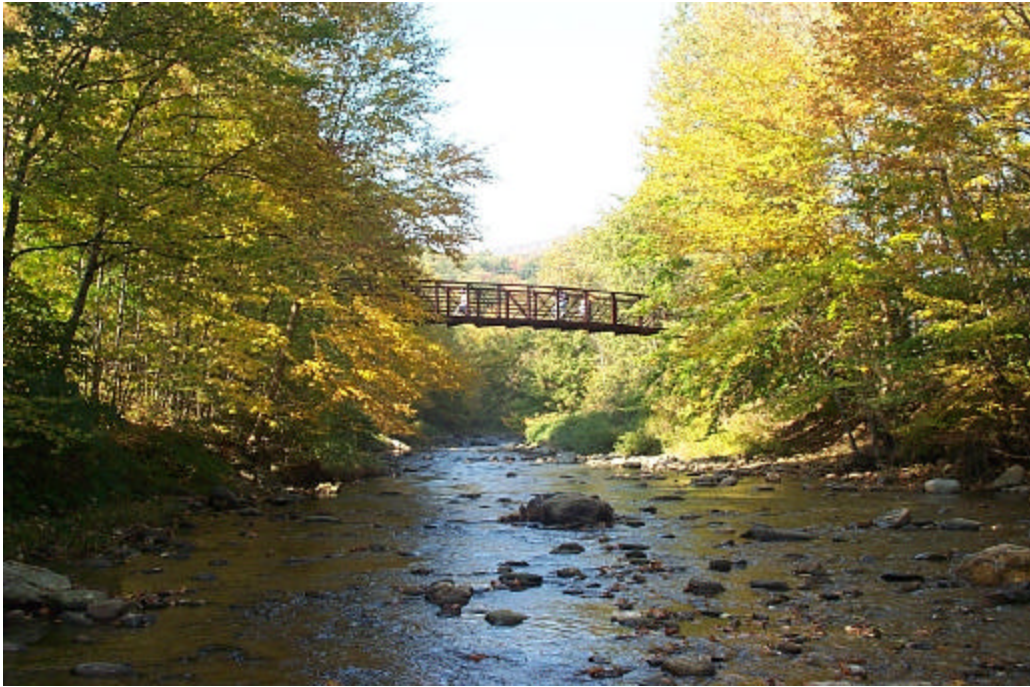
**Figure 11. Segment M3.03-B has incised. It is an “F” channel with plane bed characteristics.**

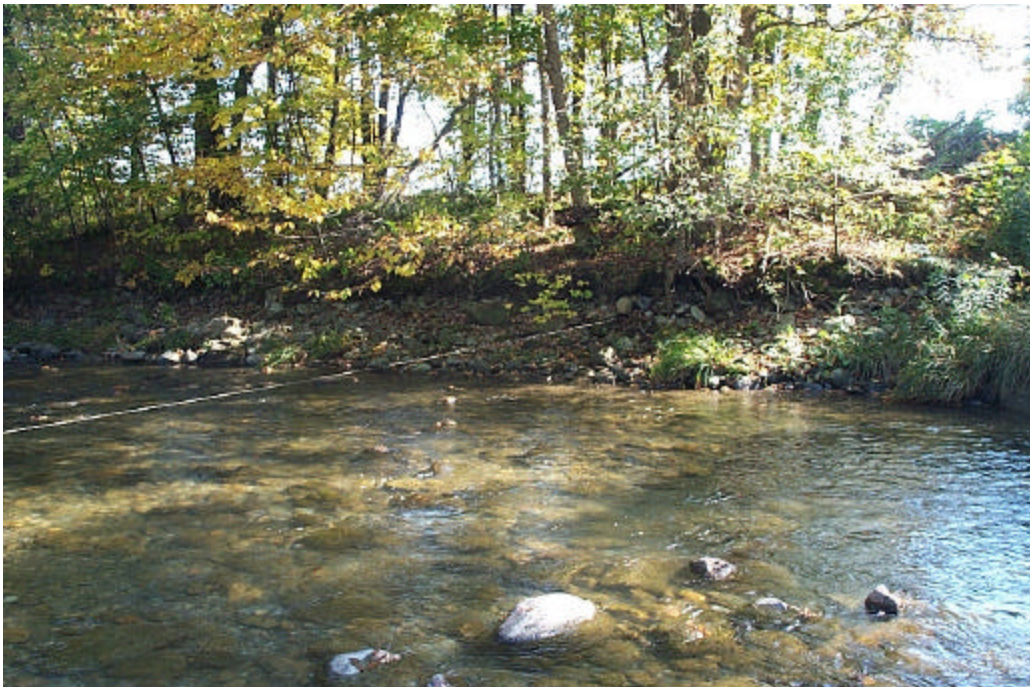
Segment M3.04-B is a highly entrenched. The incision ratio through this reach was calculated to be 3.6. After the channel incised it widened to its current condition, an "F" type channel that has lost its riffle-pool bedform (Figure 11). There is high bank erosion, 50%, on the left bank, however there is still very little sediment storage occurring along this reach. As shown in Figure 12, the riparian corridor is dominated by a fairly healthy forested buffer along most of the reach. This healthy mix of trees has probably slowed planform adjustment and widening along this reach, which would help

**Figure 12. Photograph depicting level of incision at segment M3.04-B**

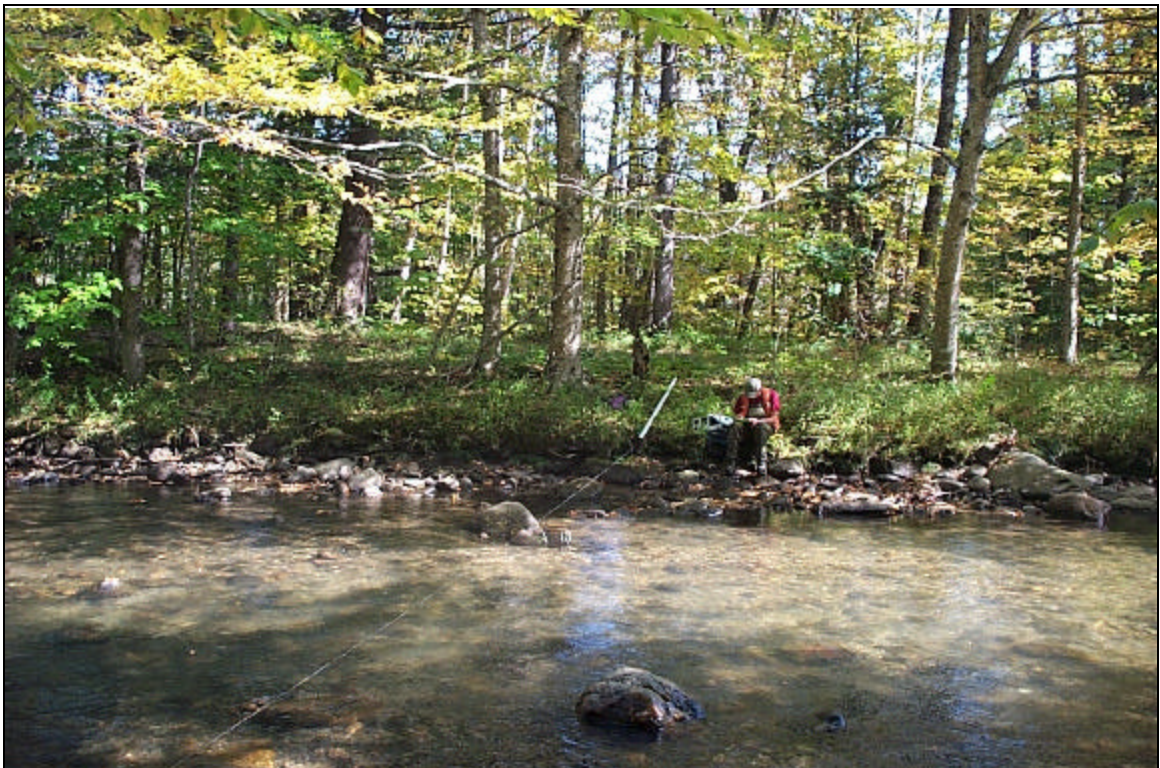
Segment M3.04-C was not as incised as many of the other reaches surveyed in this study. With a recorded incision ratio of 1.52, segment M3.04-C was moderately incised, however, had not lost access to all of its floodplain (see Figure 13). Although moderately entrenched, the river in this segment is still a “C” channel with weak riffle-pool features. BCE recorded major historic degradation and active planform changes as the major adjustment processes affecting this reach. Signs of bed aggradation and sediment storage were evident in the mid, point, and side bars found within this reach. There was one active flood chute suggesting some potential planform change.

**Figure 13. Here at M3.04-C, the stream is less incised and therefore has low entrenchment as a C channel.**

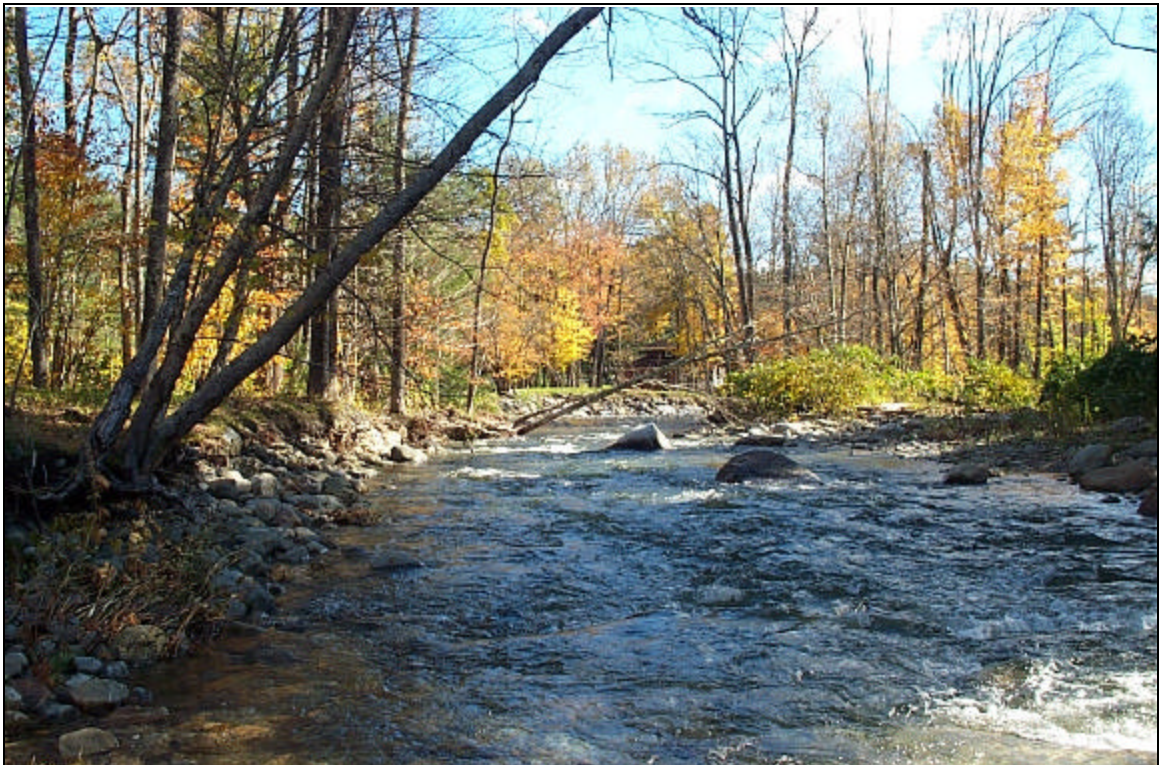
Reach M3.05 was a highly active reach in terms of planform adjustment (see Figure 14). There were numerous active flood chutes (one about to form a permanent island) that the river had been accessing during high flow events. This reach was also very responsive to sediment and has been storing it in the form of large point and side bars.

**Figure 14. Reach M3.05 is undergoing active planform adjustment. A flood chute cuts across the inside of this meander (right bank) as the river migrates left causing trees to fall into the river.**

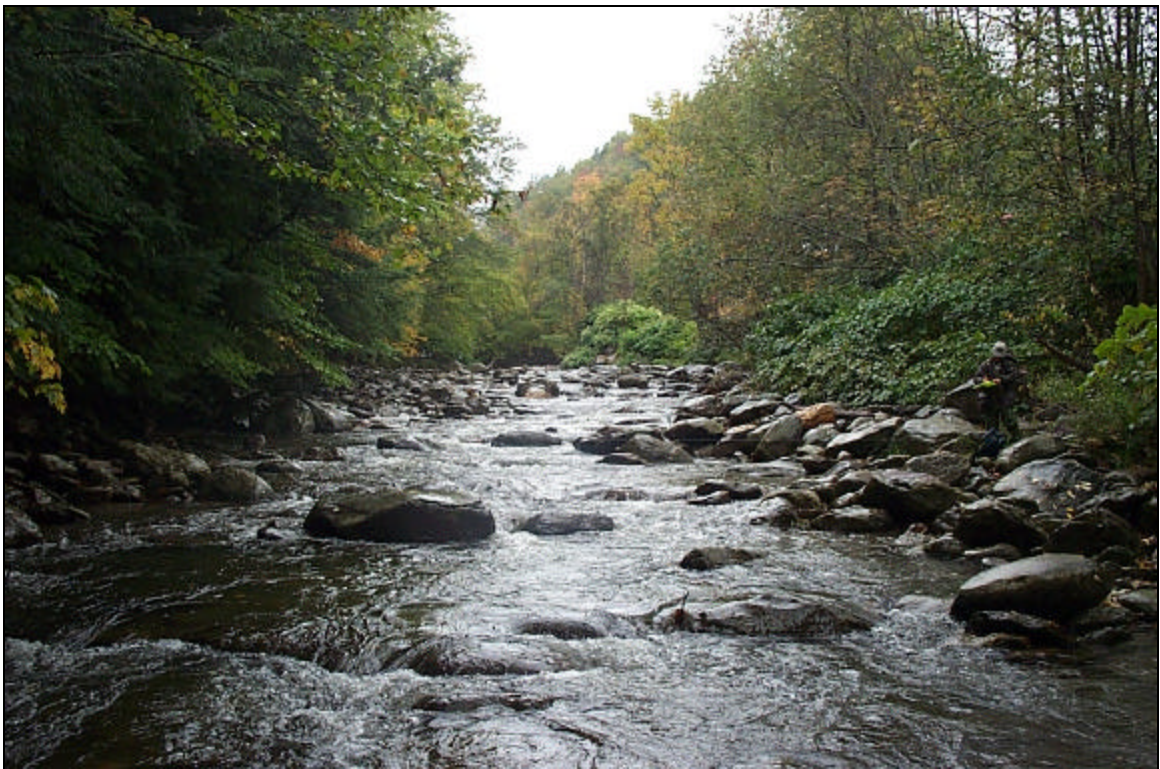
The uppermost reach of this study, M3.06 is draining a watershed area of 14.71 square miles. Evaluated in the phase 1 study to be a “C” type channel, this reach was found to be a moderately entrenched “F” type channel. As shown in Figure 15, historic degradation, floodplain encroachment, and channel straightening have affected this reach greatly. It was found to be a plane bed channel that had very little sediment storage capacity.

**Figure 15. Reach M3.06 has seen historic straightening and floodplain encroachment and is now an entrenched “F” stream type with plane bed morphology.**
