Mill Brook Watershed Report: Phase 1 and 2 Stream Geomorphic Assessment Summary

July 5, 2007

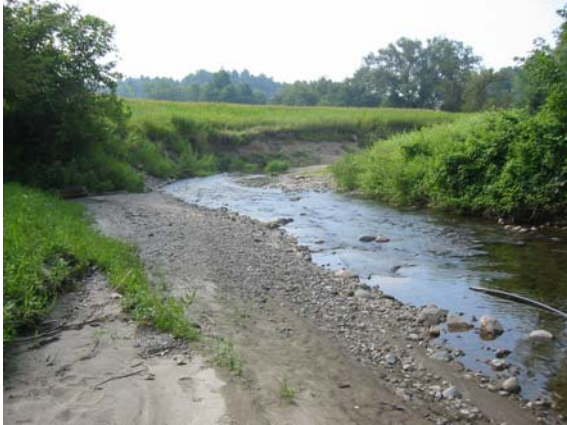
Reach M01 is found from the outlet at the Winooski River up approximately 2,200 feet to a change in valley confinement as the channel nears Barber Farm Road. This reach has C-type geometry (Rosgen, 1994) with cobble substrate, riffle-pool bedform (Montgomery and Buffington, 1997) and a channel slope of 1.3 %. Today's channel conditions have resulted from an evolution of channel planform and slope and are now in the latter stages of adjustment and stabilization (stage IV of channel evolution). Significant bank erosion was observed in the lower part of the reach near the outlet (Figure 1) where the channel has cut through the historically aggraded floodplain of the Winooski River. One small waterfall acts as a grade control in the upper part of the reach approximately 150 feet below the reach break.

Figure 1. M01 bank erosion near outlet

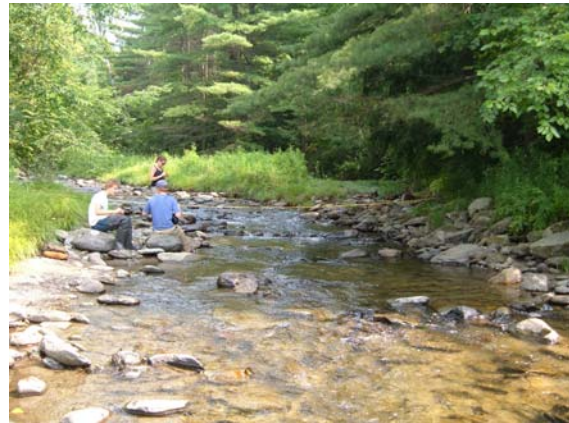
Reach M02 is found along Barber Farm Road up to the confluence with a large tributary entering from the northeast. This reach has B-type geometry with plane bed morphology and cobble substrate (Figure 2). This reach has been studied by Alex Hackman and the UVM RAN research team, and represents a good reference reach for other coarse bottomed channels in Chittenden County. Two large waterfalls are found within the reach which act as grade controls. Good geomorphic stability and habitat conditions were observed and the reach is in stage I of channel evolution.

Figure 2. M02 cross section

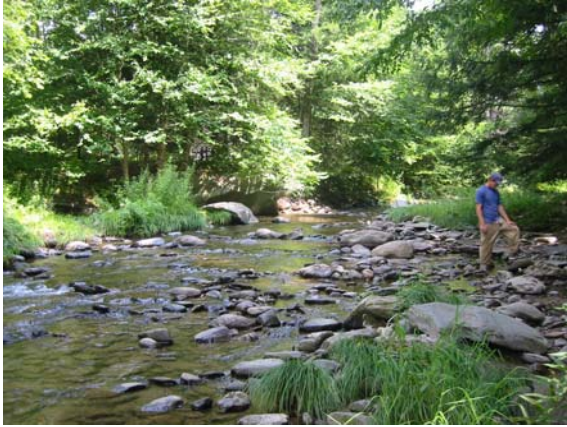
Reach M03 has an overall channel slope of 1.8% which supports a stable plane bed system with cobble substrate (Figure 3). Four natural grade controls were noted within this reach. Reach M04 has an overall channel slope of 3.3% which supports a step-pool system with cobble substrate. Four grade controls were also observed in M04, including a large waterfall located midway up the reach (Figure 4). Because of the reference conditions observed in these reaches, no project identification summary has been included.

Figure 3. M03 cross section

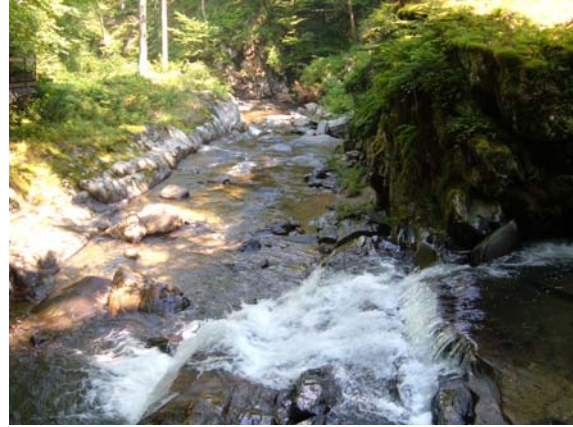
Figure 4. Grade control mid-reach in M04

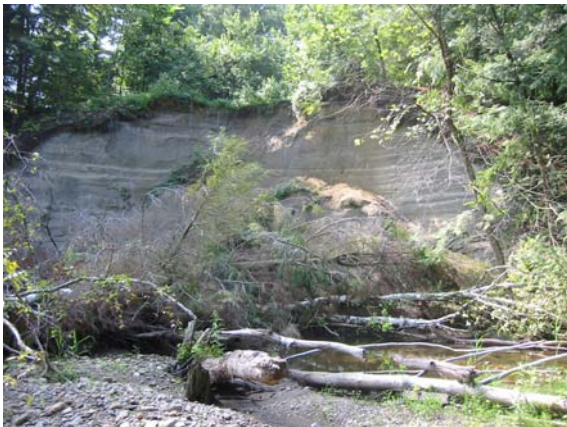
Figure 5. Large mass failure in M05-A

Reach M05 begins at the break in slope east of Tarbox Road and continues up approximately 1.4 stream miles to the Browns Trace Road crossing at the reach break with M06. The reach was divided into three segments based on changes in depositional features and distinct stages of channel evolution. Segment M05-A has gravel bed substrate and less incised geometry

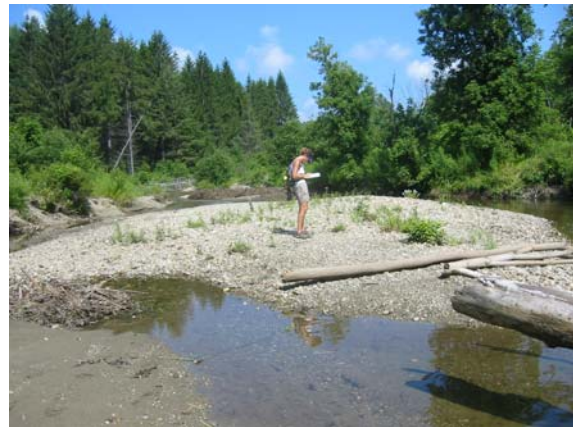
Figure 6. Aggradation of gravel substrate in M05-A

than upstream segments. Fair habitat and geomorphic stability conditions were observed as the segment continues to aggrade coarse material (Figure 6) and regain equilibrium conditions through floodplain redevelopment (stage IV of channel evolution). No corridor encroachments were noted for this segment, but the shrub-sapling vegetation along the banks and buffers indicate that the adjacent floodplain was likely used for agricultural purposes within the last ~50 years. Segment M05-B has a slightly steeper slope than Segment A with cobble substrate, and is currently moving through stage III of channel evolution. Some incision was noted within the segment (see cross section in Appendix 2) and fair geomorphic stability was recorded. The geomorphic conditions of segment M05-C are heavily influenced by two crossings: 1) mid-segment crossing of Fitzsimonds Road; 2) upstream crossing of Browns Trace Road. Downstream of these floodprone-constricting crossings are some degradational features (e.g., incision and bank erosion) which are likely contributing to the transport of gravel substrate to downstream segments A and B.

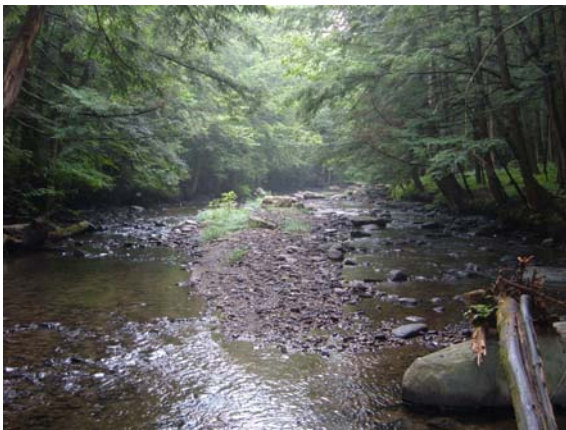
Reach M06 is found from the crossing at Browns Trace Road up to approximately 600 feet above the crossing of Fields Road. The channel slope in this reach is 1.7%, and much of the reach exhibits plane bed morphology with some areas of riffle-pool bedform. The channel evolution stage has been assessed as stage I, however there are some isolated areas in the lower reach where aggradation and widening is occurring (Figure 7). One large grade control (waterfall) was noted just below the Fields Road crossing where a diversion and mill once existed. Good geomorphic stability and habitat conditions were noted throughout and many sensitive macroinvertebrates were noted the substrate sampling.

Figure 7. Aggradation and Widening in lower M06

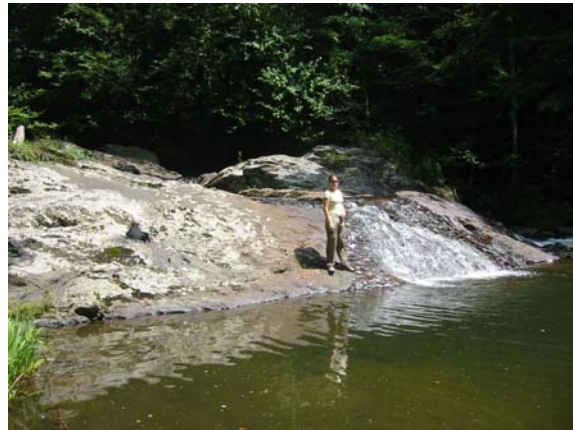
Figure 8. Grade Control in Upper M07

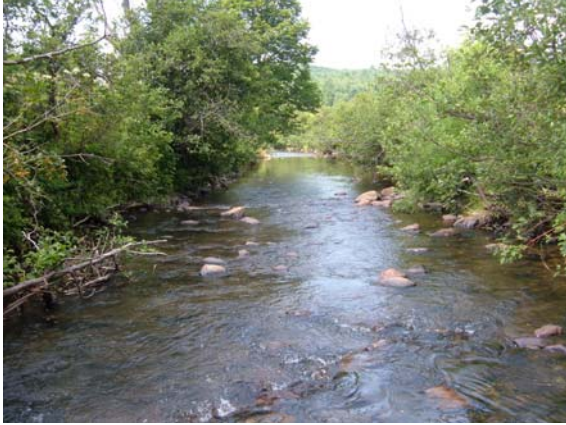
Reach M08 is found from the lower end of the West Bolton valley up to the crossing at Snipe Island Road and has a channel length of 2190 feet. The channel slope for this reach is 0.9%, and the surrounding soils are alluvial resulting in a coarse bed channel. Although the upper section of this reach may have been a plane bed system in reference conditions, the lower section of the reach is assumed to have been a riffle-pool system with a floodplain accessing the wide valley. Historic straightening and bank armoring has led to incision and entrenchment of the channel, and a departure from C-type geometry to F-type geometry (Figure 9). One small beaver dam was noted in the lower section of the reach which affected 100 feet of the channel. Fair geomorphic stability and habitat conditions were noted, and the channel evolution was assessed at stage II. The lower section of this reach is considered to be an “extremely” sensitive reach due to its departure from reference conditions. As the channel seeks new equilibrium conditions in the future, significant bank erosion and widening followed by a redevelopment of sinuosity will likely occur.

Figure 9. Plane bed morphology in reach M08

Two areas of this watershed zone should be considered in future efforts to identify equilibrium restoration sites. Reach M08, which has maintained an incised channel geometry following straightening, continues to be a sediment transport reach in a depositional zone of the watershed. The adjacent land use appears to be primarily for hay, which may present an opportunity for floodplain restoration given limited infrastructure encroachments. Similarly, the depositional zone of segment M12-B which has been converted to a transport zone will be of particular interest in future restoration efforts. There are properties within the corridor of this segment which could be in danger of erosion hazards should the channel continue to adjust its planform during a large event. If corridor property owners in the lower part of the segment were willing to cooperate in a floodplain restoration project, removal of the large amount of bank armoring found there would further induce the recover of a meandering planform and equilibrium conditions.

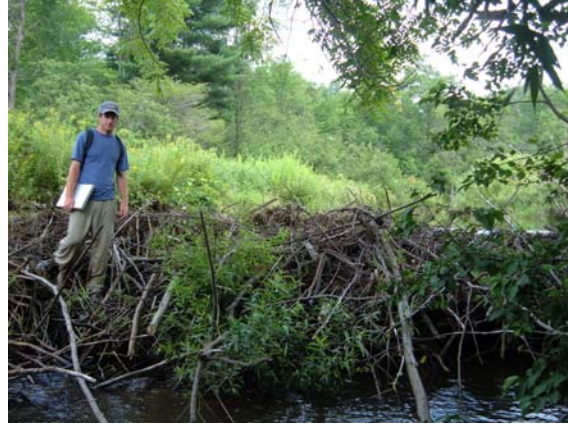
Reach M09 is a short reach found from the Snipe Island Road crossing up to a confluence with a large tributary entering from the north. The channel length is 970 feet with a slope of 0.5%. This reach has a mixture of sand and fine gravel substrate and E-type geometry. It is impacted in the lower section by berming associated with the adjacent road, and has been assessed at stage II of channel evolution due to the incision resulting from these impacts. Approximately 600 feet of the reach is affected by a large beaver dam found immediately upstream of the Nashville Road crossing (Figure 10). Fair geomorphic stability and habitat conditions were observed in this reach.

Figure 10. Large beaver dam in M09

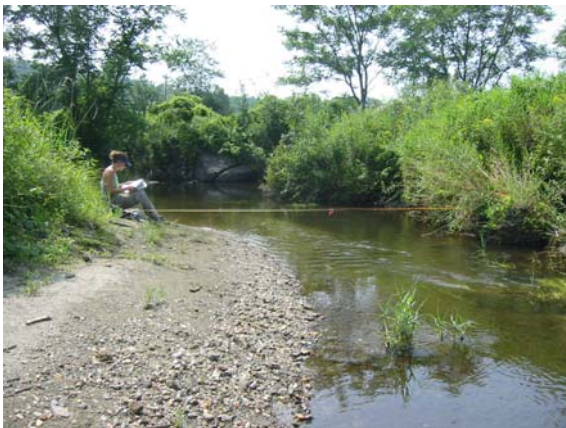
Reach M10 is found to the north of Nashville Road from approximately 700 feet upstream of the road crossing up to the confluence with a large tributary entering from the north. The channel length is 3534 feet and has a slope of 0.4%. The channel is highly sinuous (sinuosity = 1.3) and has likely recovered from a period of historic straightening (not indexed with FIT) which is evident upon review of historic imagery. The current planform supports a channel with C-type geometry and a mixture of sand and gravel substrate (Figure 11). Four beaver dams were observed in the reach which affect approximately 700 feet of the channel. Good geomorphic stability and habitat conditions were observed in the reach, and the channel evolution was assessed at stage V due to the recovery of a meandering planform following historic channel straightening.

Figure 11. Riffle pool morphology in reach M10

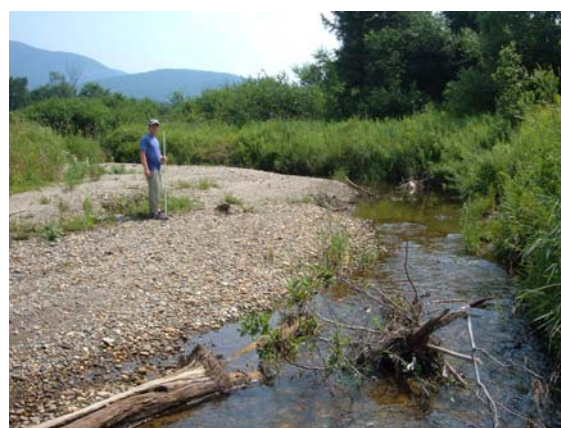
Figure 12. Aggradation in segment M12-A

Segment M12-A is gravel-bed reach that has still maintained its riffle-pool morphology, but is experiencing significant aggradation of coarse material (Figure 12). This material is being transported from upstream segment M12-B as a result of the severe straightening in that segment. Multiple beaver dams were noted in the extreme lower section of the segment where the channel slope lessens. Geomorphic stability and physical habitat conditions were assessed as fair. Due to the extreme aggradation and subsequent changes in planform observed in this reach, the channel evolution stage has been assessed at stage IIb.

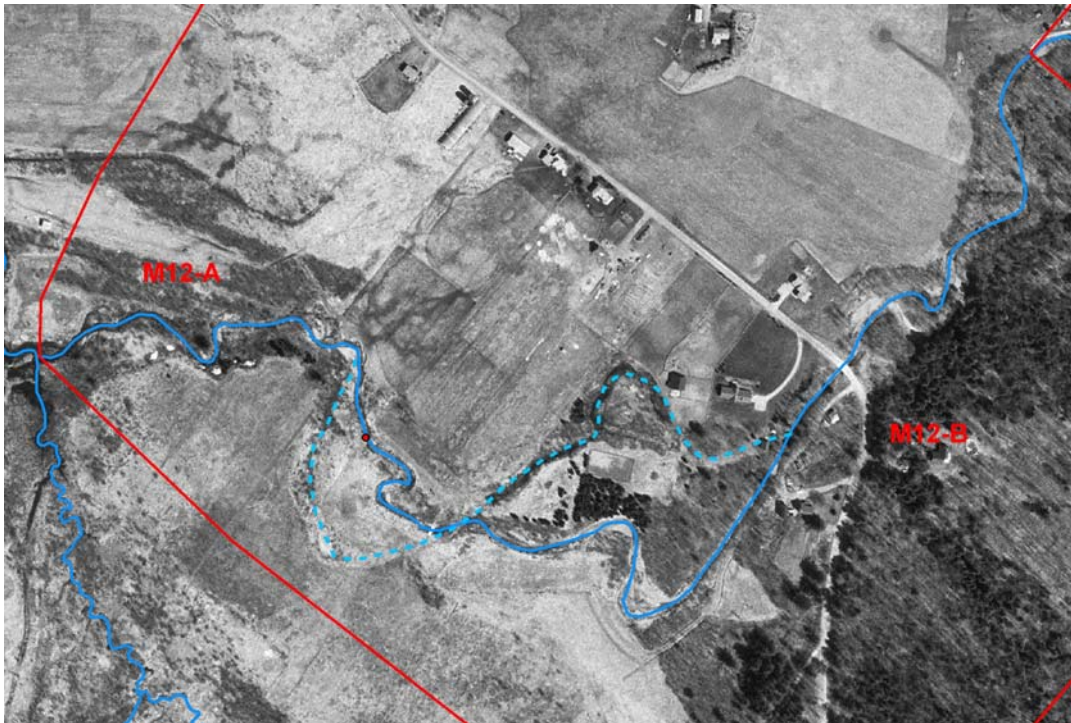
Segment M12-B has had significant alterations to the planform, and the channel is beginning to aggrade material and redevelop limited sinuosity following years of straightening and armoring. Figure 13 depicts the extent of the straightening to maximize surrounding farmland. These alterations have severely reduced the channel stability and quality of the physical habitat throughout this reach. While some areas of the reach continue to incise where armoring has recently been added, much of the reach is beginning to widen and aggrade material, indicating stage III of channel evolution.

Figure 13. Current channel location (solid blue) and pre-straightened channel location (dashed blue) in reach M12.

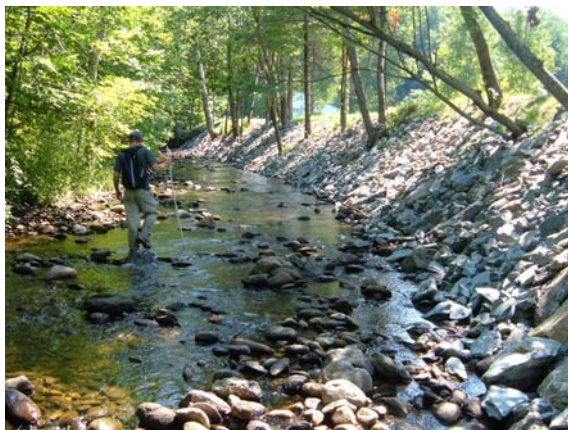
Figure 14. Armoring along reach M13-A

There is one area of corridor encroachment in the lower section of M13-A which should be monitored carefully in the future. Just upstream of the M12/M13 reach break there is a sharp bend that is armored on the right bank to protect the property within the corridor. As noted above, an unnatural degree of aggradation of coarse substrate was observed in this segment due to the encroachment-induced transport conditions found immediately upslope. While the armoring may currently be stable, there is potential for the channel to become dynamic during a large flood event. Future corridor planning effort should consider the hazard these structures pose considering their location in a transitional zone from sediment transport to deposition.

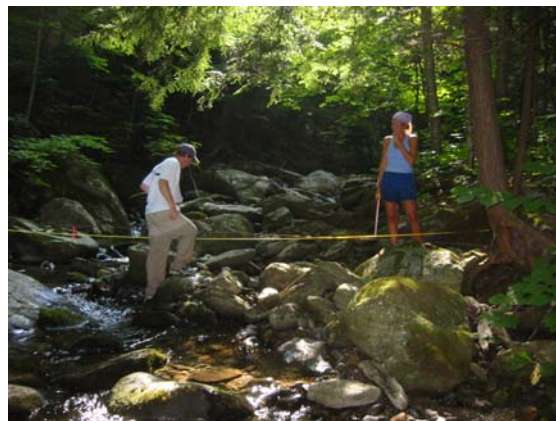
Figure 16. Cross section in M15

Reach M15 is an extremely steep headwaters channel with a slope of 15% and cascading bedform throughout. It is found from the confluence with a large tributary entering from the south up to the source of Mill Brook just west of Bolton Mountain. A-type geometry and reference conditions were observed in the absence of significant human impacts.
