Mill Brook Geomorphic Assessment

Southern Windsor County
Regional Planning Commission
2002-2003

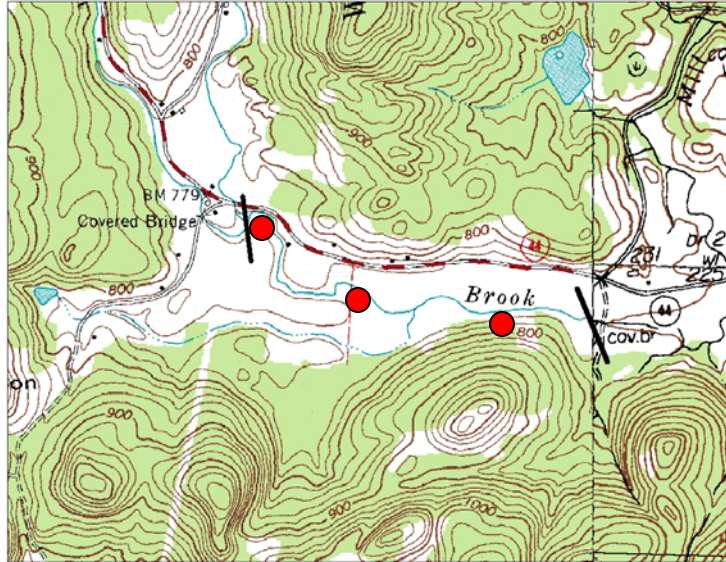
Figure 1: West Windsor Flats

The two problem reaches that were identified pre-assessment are the West Windsor Flats in West Windsor and the Narrows in Windsor. The West Windsor Flats are located just West of Brownsville on VT 44 (see Figure 1). The area has historically been used as a farm fields and pastures with little or no protective buffer of the stream. Currently, the fields are still hayed during the summer months although a few houses have been built taking up some acreage. There have also been efforts to grow a considerable buffer in riparian zones.

- Sediment Deposition – **Poor**; heavy deposits of fine material, increased bar development; more than 80% of the bottom changing frequently; pools almost absent due to substantial sediment deposition. (5)

- Bank Stability (Right Bank) – **Fair**; moderately unstable; 60% of bank segment has areas of erosion; high erosion potential from crumbling, unvegetated banks during flood events. (6)
 (Left Bank) – **Fair**, moderately unstable; 30% of bank segment has areas of erosion; high erosion potential from crumbling, unvegetated banks during flood events. (10) Overall (8)

Degree of Channel Degradation (Incision) – **Fair**; Moderate incision and/or impending incision; higher terraces adjacent to low bank; nick points or steep riffles may be present; undermining of infrastructure; future incision likely (6)

Degree of Channel Aggradation – **Fair**; Moderate deposition of new gravel, sand or fine sediment on old and new bars; 40% of the bottom affected; Larger sediments are 60% embedded; moderate filling of pools; bars with similar sized materials on both up and downstream ends; point bars are different sizes and heights relative to water surface; some steep bar faces; fine sediment feels soft underfoot. (7)

Over-Widened Channel – **Fair**; trees are overhanging; scour, where occurring, happens on both sides; channelization seems to compound this problem; mid channel bars. (6)

Change in Planform – **Fair**; Evidence of incipient or recent flood chutes, and channel avulsions; mid channel bars are present; thalweg not lines up with planform. (12)

Dominant Channel Adjustment Process: III Widening

Total Score: 0.35

Condition: Poor

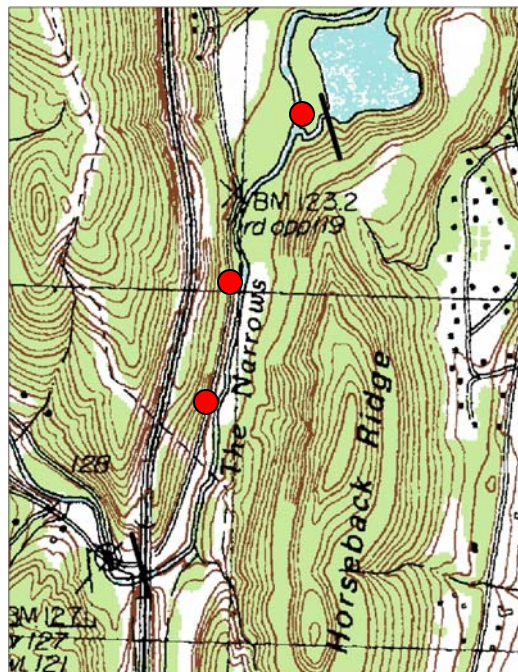
Figure 2: The Narrows

The Narrows begin at the intersection of the Mill Brook and Interstate 91 and extend downstream until the confluence with Mill Pond. This area has been heavily disturbed in the past due to the narrow valley constraints and the presence of VT 44 (see Figure 2). In order to allow passage of the road and reduce flooding of the road the Brook has been altered and armored in many places. Fortunately, the current land owner south of the Brook is letting much the property grow in and allowing the stream to meander as needed. Although this is promising for the future, the current state of the Brook is quite unstable.

On the Narrows there is much more encroachment. As mentioned before, VT 44 has altered the location of the Brook throughout most of the Narrows. Road fill and armor prevent the Brook from accessing a large portion of the already narrow valley. Again, the landowner on the south side of the Brook has been letting the Brook meander as necessary although this is not guaranteed in perpetuity.

- Pool Substrate Characterization – **Fair**; mostly sand/silt bottoms and little to no vegetation present. (7)
- Pool Variability – **Fair**; throughout the whole section only 3 large pools; shallow pools are much more prevalent. (8)

- Sediment Deposition – **Fair**; moderate deposition of new gravel, sand and fine sediment on old and new bars; 50-80% of the bottom affected; sediment deposits at obstructions, constrictions, and bends; moderate deposition of pools prevalent. (10)

- Bank Stability (Right Bank) – **Fair**; moderately unstable; 60% of bank segment has areas of erosion; high erosion potential from crumbling, unvegetated banks during flood events. (6)
 (Left Bank) – **Fair**, moderately unstable; 30% of bank segment has areas of erosion; high erosion potential from crumbling, unvegetated banks during flood events. (10) Overall (8)

Dominant Channel Adjustment Process: III Widening
Total Score: 0.6
Condition: Fair
