**LaPlatte River Phase 2 Stream Geomorphic Assessment:
Hinesburg Reaches**

**Prepared by the LaPlatte Watershed Partnership
February, 2006**

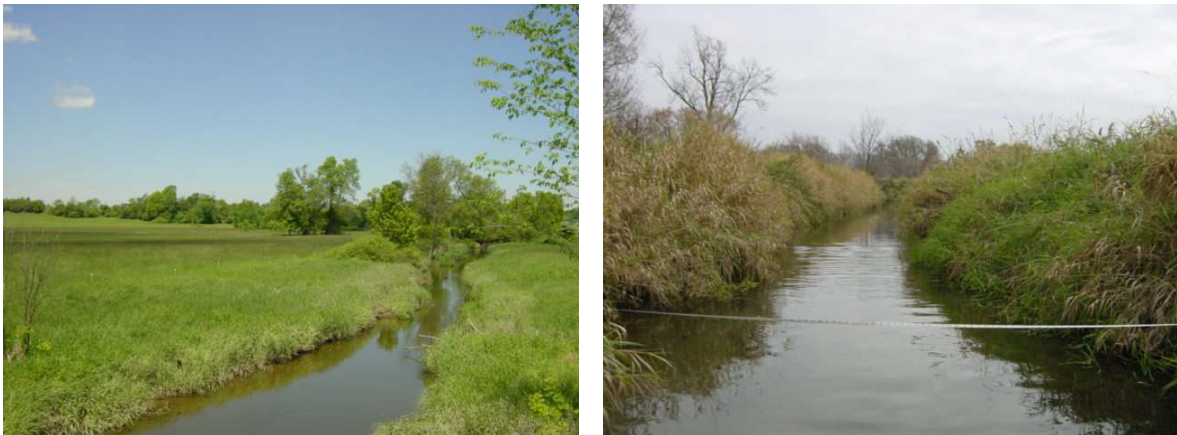
Historical channel alteration appeared to have affected many of the reaches in Hinesburg. Straightening of streams in the valleys and ditching and draining wetlands allowed for increased tillable land for agriculture. Along with this came reduction or elimination of woody riparian vegetation (Figure 3). These activities reduced geomorphic and habitat conditions in many of the valley reaches, and in some cases have led to extreme adjustment or stream type departure (M17, T5.01D). Elsewhere in the valley (M12, M13, M14, and M15a) the channel does not appear to have been straightened, although riparian vegetation is still lacking.

Figure 3. Straightening and lack of woody riparian vegetation affected RGA and RHA condition in Hinesburg.

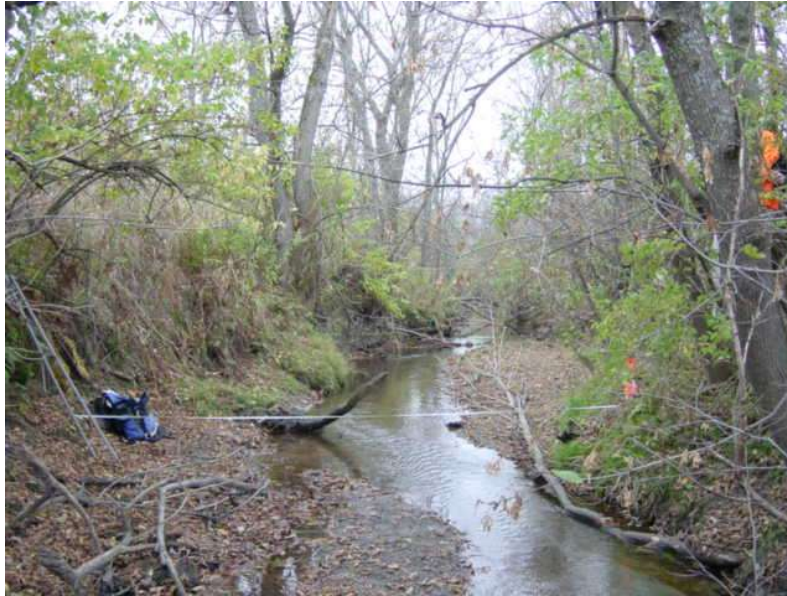
Straightening combined with berming on M17 and T5.01D resulted in severe channel departure from reference. Reach M17 experienced a stream type departure (C to B) and currently appeared to be widening and aggrading, attempting to gain some floodplain and sinuosity in its incised and entrenched position (Figure 4).

Figure 4. Reach M17, entrenched and now widening and aggrading.

Reach M17 had degraded and lost floodplain access (stage II of the F process), likely from straightening and berming activities. Now, the reach appeared to be in stage III of the F-stage process, widening and aggrading and attempting to regain some sinuosity (Figure 4).

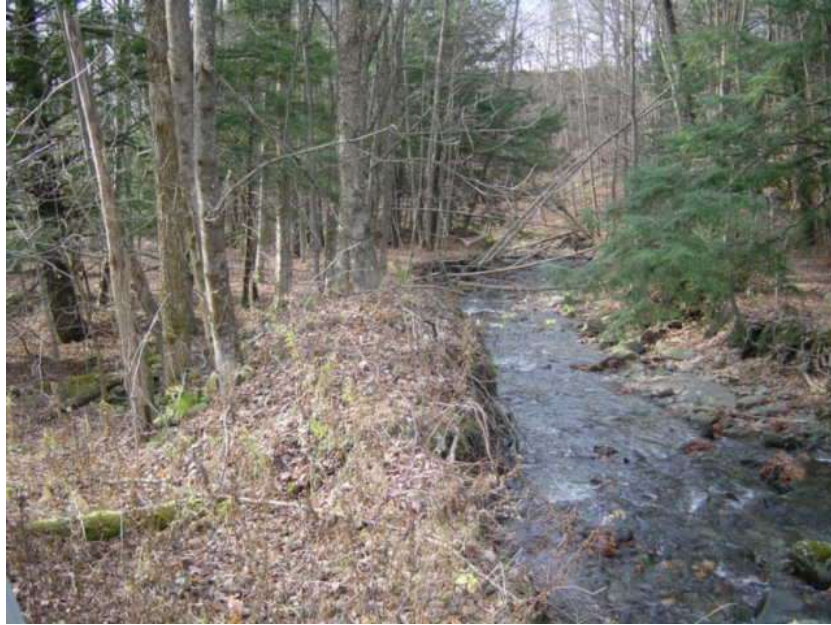
Segment T5.01D had been straightened, moved, and bermed historically, likely in conjunction with construction of North Road. Following the channel alteration, the stream had no access to floodplain and appears to have severely widened and incised. Continued incision and widening (channel enlargement) were evident in headcuts and scoured banks (Figure 5), leaving property at risk. This segment had ledge grade controls at both the upstream and downstream ends, helping confine these adjustments to this area.

Figure 5a. Signs of an old channel were evident to the left of the photo. The channel appeared to have been moved to its current location and held in place by a berm, seen in the center of the photo.

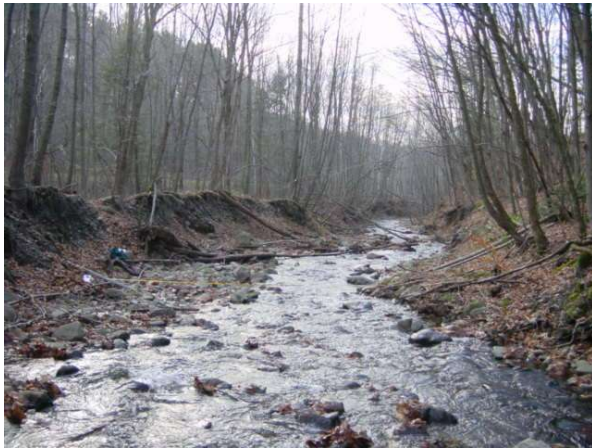
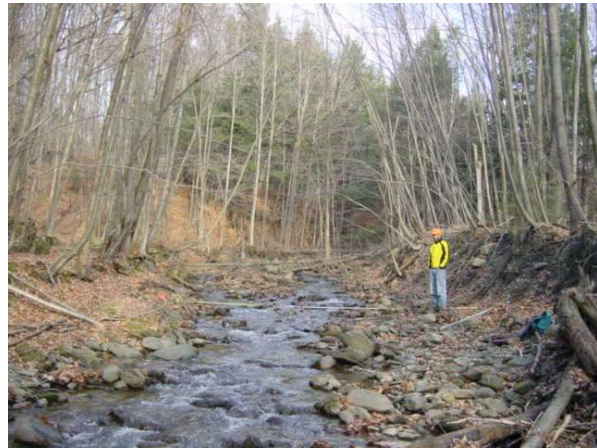
Figure 5b. Significant channel enlargement following straightening and berming.

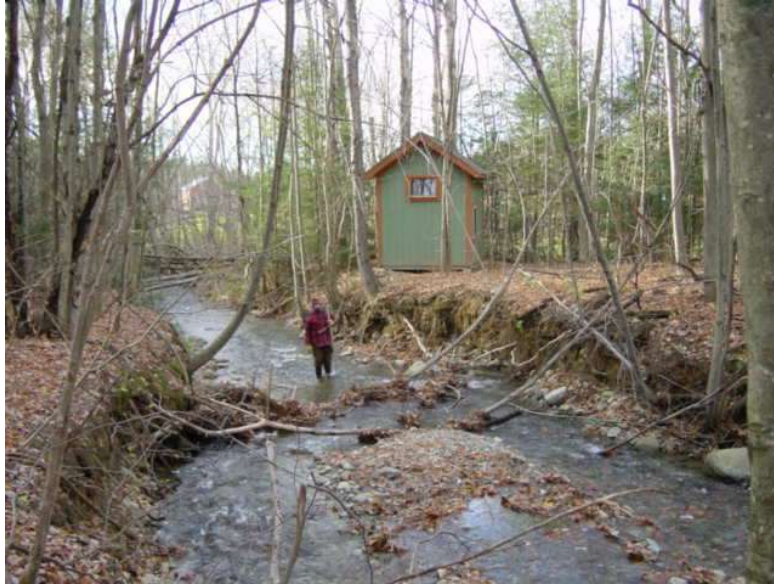
Figure 5c. Channel enlargement leaving investments in danger.

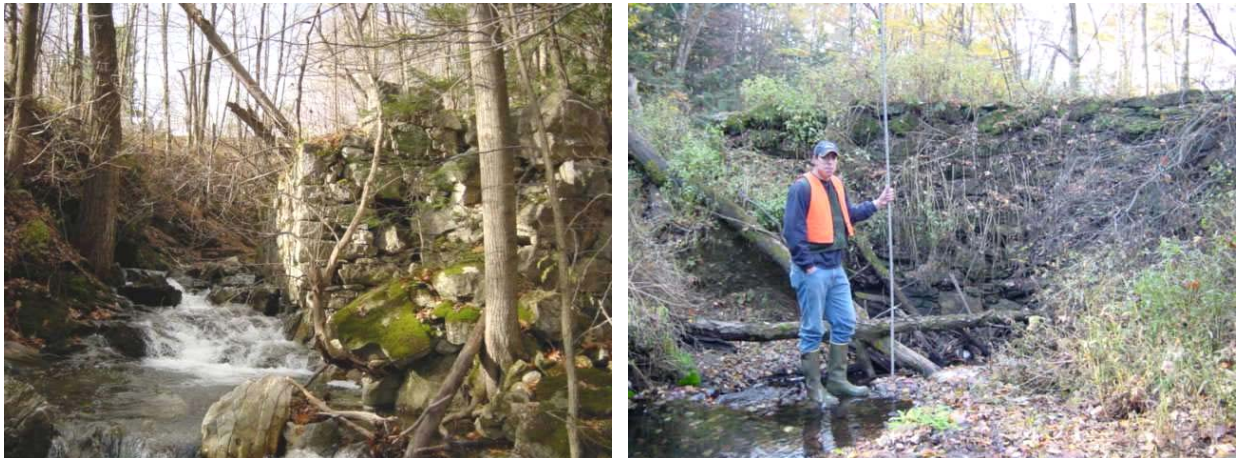
Other factors affecting geomorphic and habitat condition in Hinesburg were structures obstructing or constricting of the channel. Historical structures included milldams and footings on the steeper reaches of Patrick Brook and Beecher Hill Brook. Many of these structures were in part still existing (Figure 6).

Figure 6. Mill footing on Beecher Hill Brook T5.01C (left) and mill dam on Patrick Brook T4.04 (right).

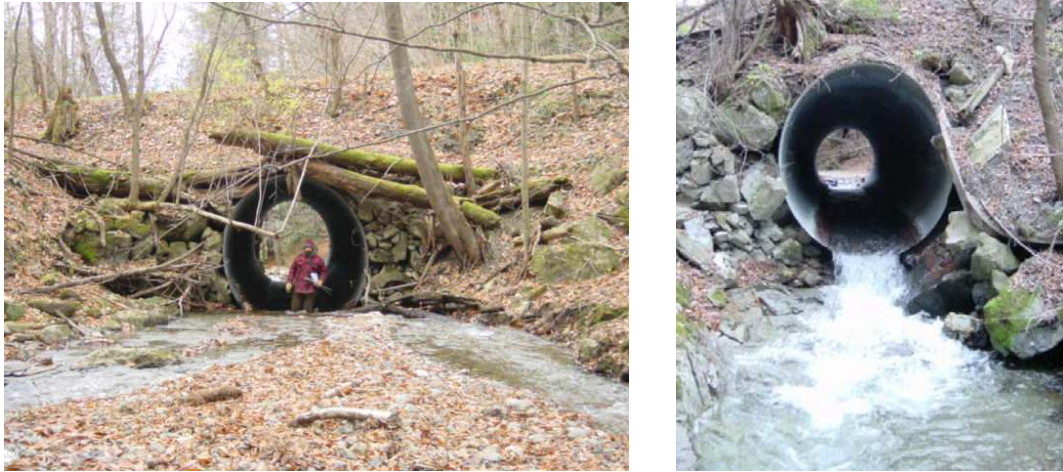
severe aggradation of the channel and floodplain, and severe degradation downstream. Two examples are the culvert on Beecher Hill Road in segment T5.01B (Figure 7) and the culvert crossing Route 116 in segment M18B (Figure 8).

Figure 7. Beecher Hill Brook (T5.01B) culvert. Note aggradation forming bars and splitting flow upstream. Some erosion was noted downstream, although the downstream end falls onto ledge and boulders.

Undersized bridges and culverts, and those poorly aligned with stream channels, have resulted in erosion, aggradation, outflanking, loss or damage of infrastructure and personal property, reduced wildlife passage, backup of flood waters, reduction of floodplain function, and debris jam catchers. As bridges and culverts require replacement, sizing new structures according to bankfull and floodprone widths and placing them in proper alignment with stream channels could alleviate these problems.

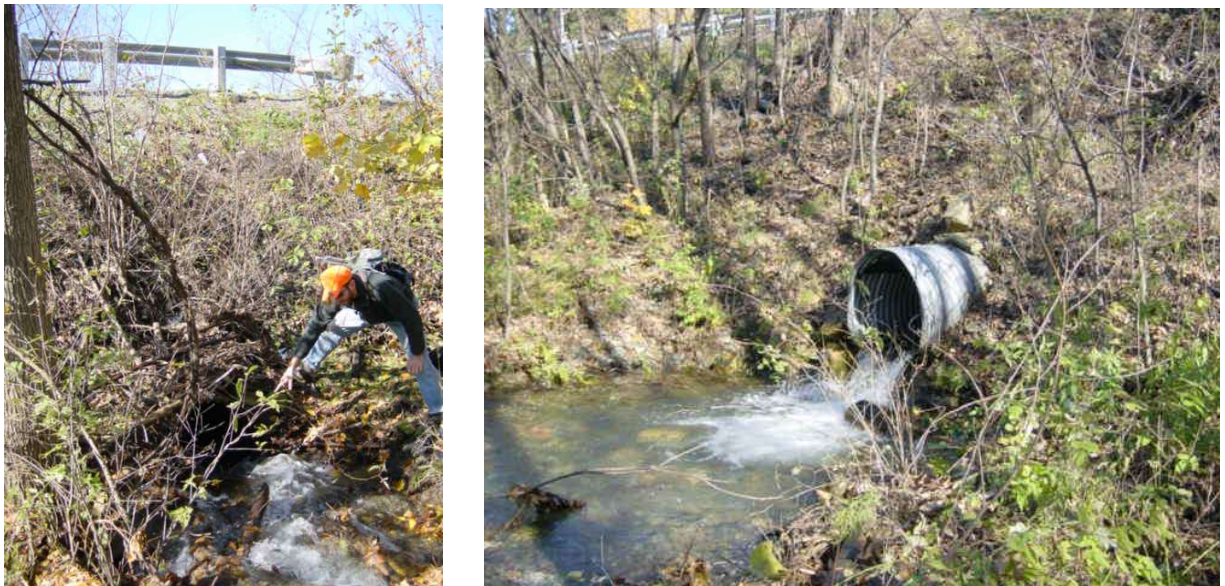
Figure 8a. Culvert on segment M18B. The upstream end of the culvert was blocked by sediment and debris and was hardly visible (left). Extreme scour was apparent at the downstream end and beyond (right).

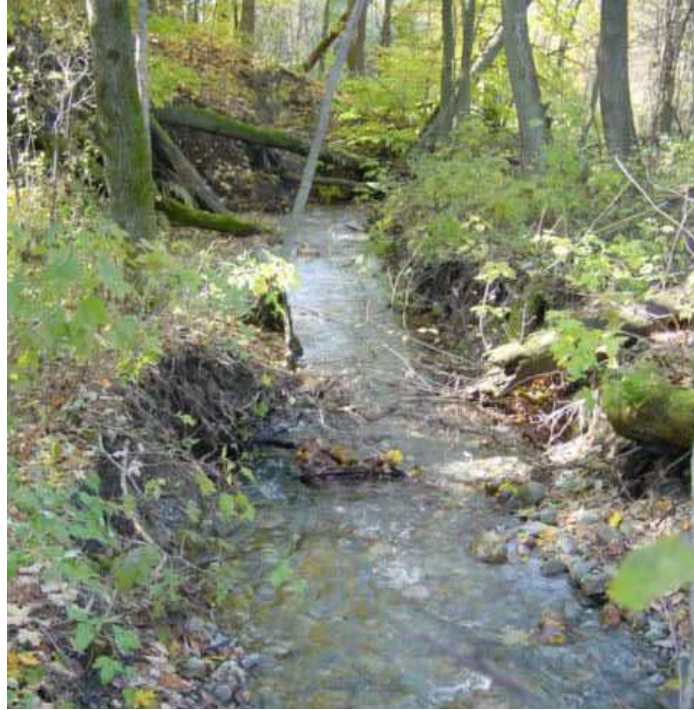
Figure 8b. Extreme effects of constricting the channel and blocking flow of sediment has led to property damage with aggradation upstream and erosion downstream.

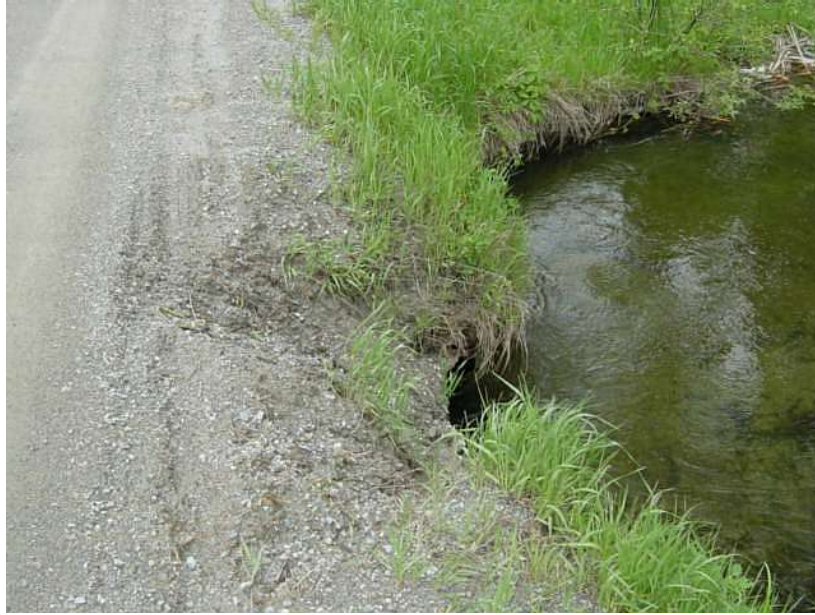
Runoff from roads and road washouts during storms also appeared to be a source of increased sediment in the streams (Figure 9). Driveways and roads had essentially dammed floodplains and channeled runoff directly to streams, which was especially evident in hill reaches. Exposed soil from incremental development in the watershed was another source of sediment to stream channels.

Figure 9. Sand and gravel from roads washing into the channel.

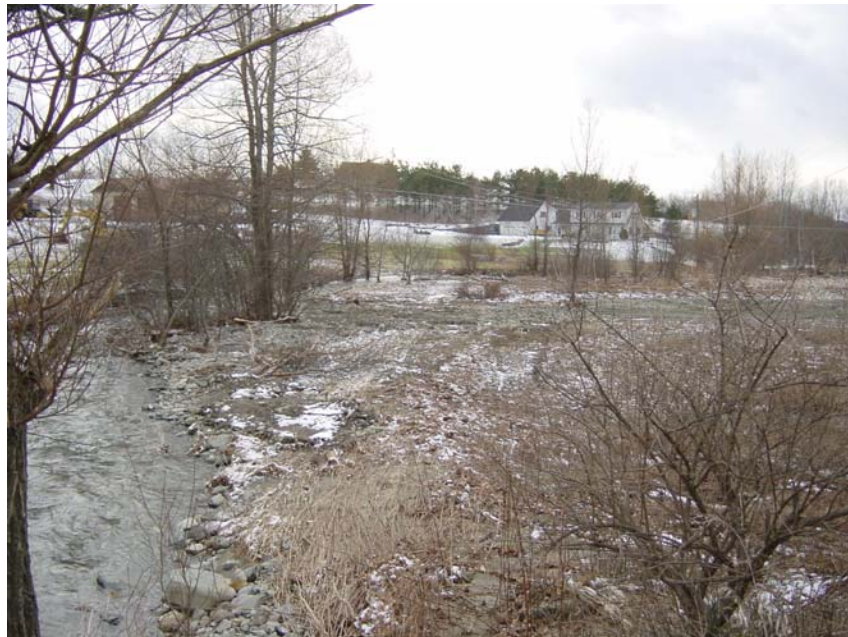
Some vital flow and sediment attenuation zones were being filled and bermed as on T5.01D (Figure 10) and M17.

Figure 10. Floodplain fill replaced after January 18, 2006 storm flows, reducing sediment and flow attenuation in this area, which was between 2 degrading areas.
