**Phase II Geomorphic Assessment of the LaPlatte River:  
Hinesburg Reaches**

**Vermont Watershed Grant 2004**

**Prepared by the LaPlatte Watershed Partnership**

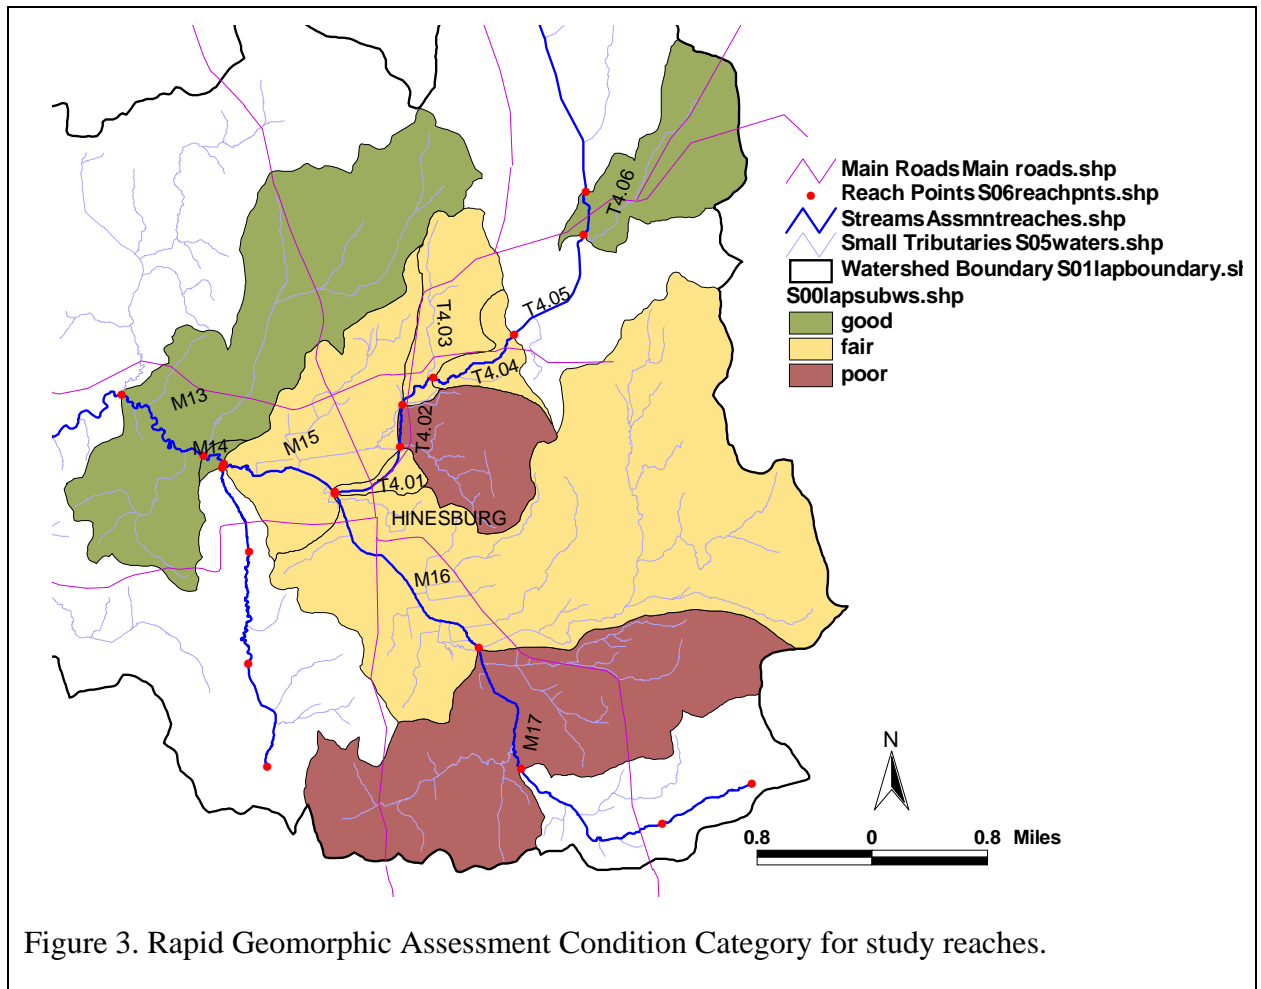
Figure 3. Rapid Geomorphic Assessment Condition Category for study reaches.

RGA conditions of the valley reaches vary. M13 and M14 appear in good condition and in regime for their stream type, that is, they do not appear to be undergoing adjustment due to disturbance. Reaches M15 and M16 appear in fair condition and undergoing stage IIc of the D-stage channel evolution process. They are undergoing planform, widening, and aggradation adjustments. Reach M17 is in poor condition, it is incised and entrenched and now widening and migrating laterally. These reaches are moderately to highly sensitive to future disturbance.
