LaPlatte Watershed Partnership

Phase 2 Stream Geomorphic Assessments  
Lower LaPlatte River & McCabe's Brook  
Shelburne and Charlotte, Vermont  
June 2007

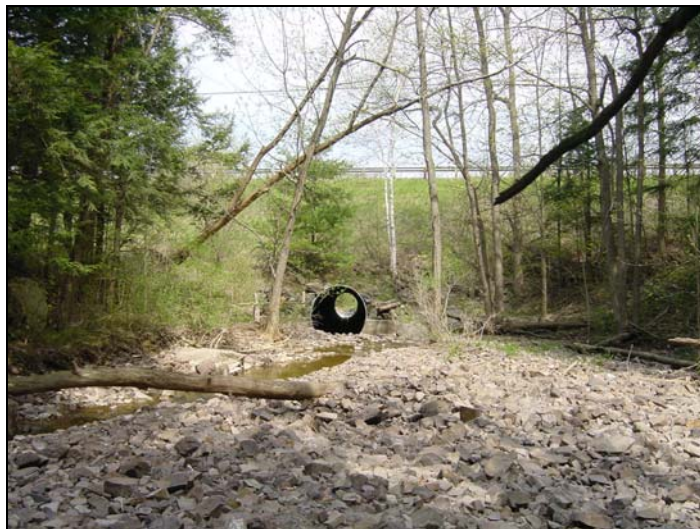
Both structures in segment T1.05A constrict the channel and block the floodplain. The Bostwick Road culvert has significant sediment deposits and channel widening upstream, with bed degradation downstream. This signals a break in sediment continuity where the culvert traps sediment upstream and resulting "hungry water" scours the bed and banks downstream. The floodplain is entirely blocked by the elevated and filled roadbed. Erosion and floodwater buildup could undermine the structure eventually, however more importantly from a geomorphology perspective this scenario has led to significant channel adjustments downstream including bed incision and bank erosion.

Bostwick Rd crossing in T1.05A with large sediment deposits and channel widening upstream.

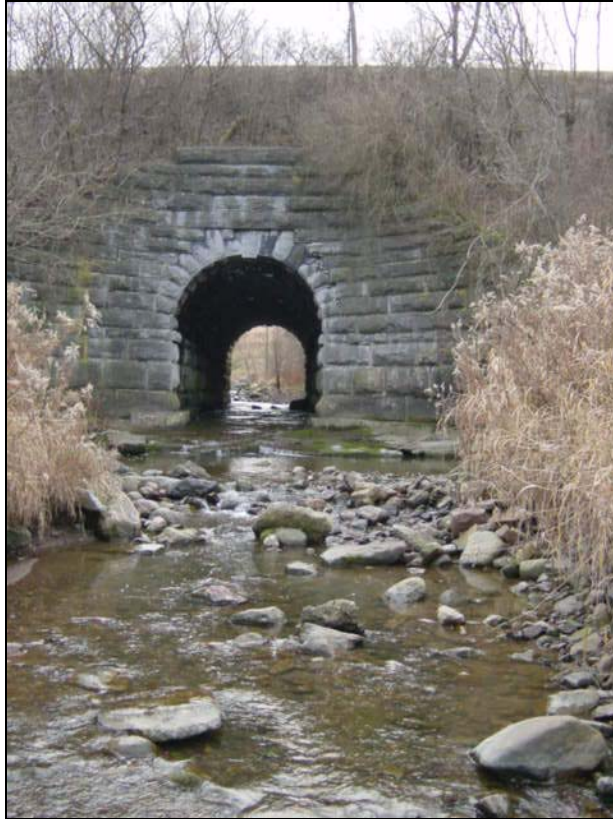
Along the stream, this structure is followed closely by a railroad bridge with similar effects. Again, the floodplain is entirely filled by the rail bed and the structure constricts the channel. Extreme bed degradation including headcuts was observed downstream. Bed degradation continued into segment T1.04B. Replacement of these structures with appropriately sized structures is important to help the stream regain equilibrium. The size and age of the railroad structure, an old stone structure, complicates replacement.

Railroad crossing on T1.05A from downstream looking upstream.

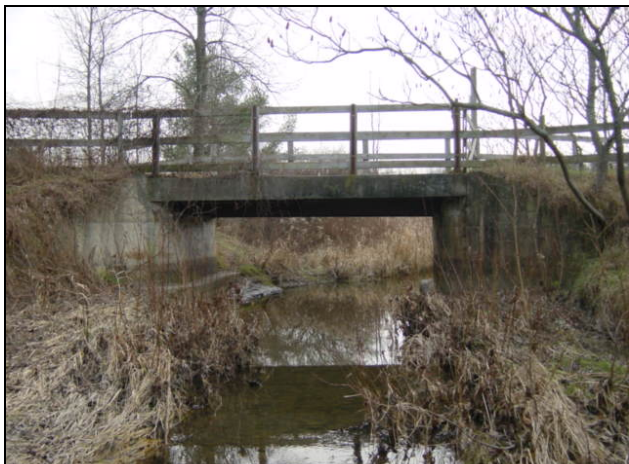
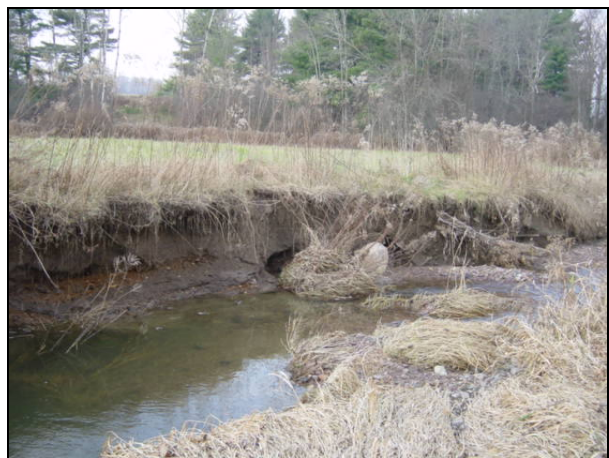
The bridge in segment T1.04B also appeared to be affecting channel geomorphology. This structure constricted the channel and the road approaches completely filled the floodplain. Sediment was deposited upstream with severe bank erosion and channel migration observed downstream. Widening this structure and lowering to approaches to allow for passage of flood flows and sediment could help alleviate these problems.

Bridge in T1.04B (L) and erosion downstream (R).

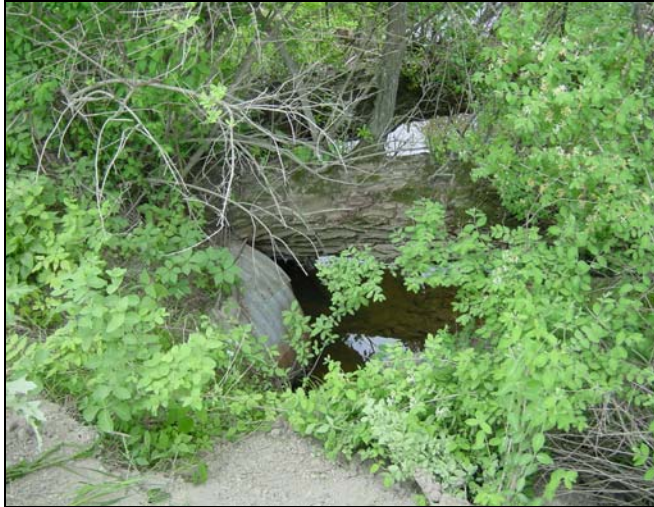
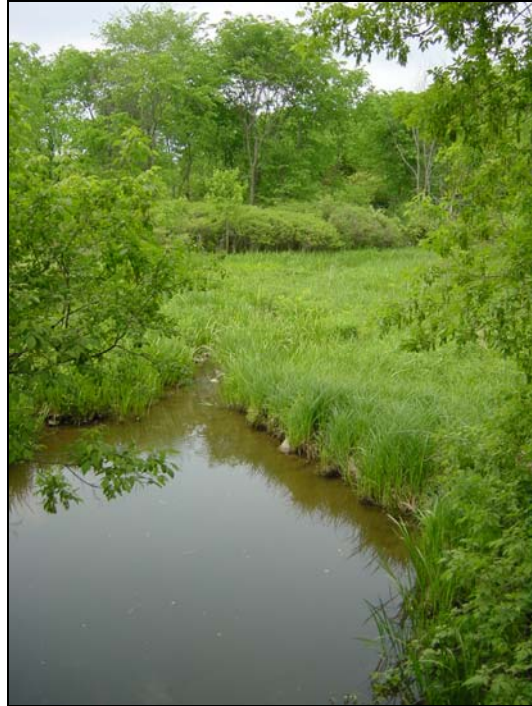
The structure on Lime Kiln Road in T1.06 was significantly smaller (20%) than the channel width (as estimated in Phase 1 SGA). This structure was also obstructed at the upstream end by a

fallen tree. Downstream, the high velocities produced by the culvert had scoured a large pool. This structure appears at risk of failure by washing out due to being undersized and blocked by a large tree upstream. Furthermore, sediment from the dirt road appeared to wash into the channel at this point. Resizing the culvert and removing the debris is recommended.

Lime Kiln Rd culvert with upstream obstructions (L) and scour pool downstream (R).

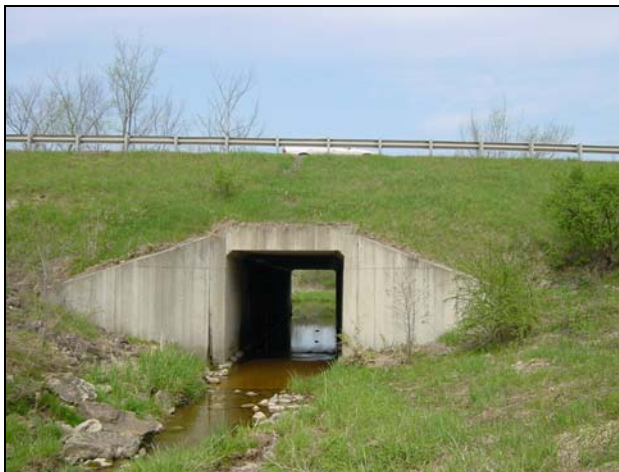
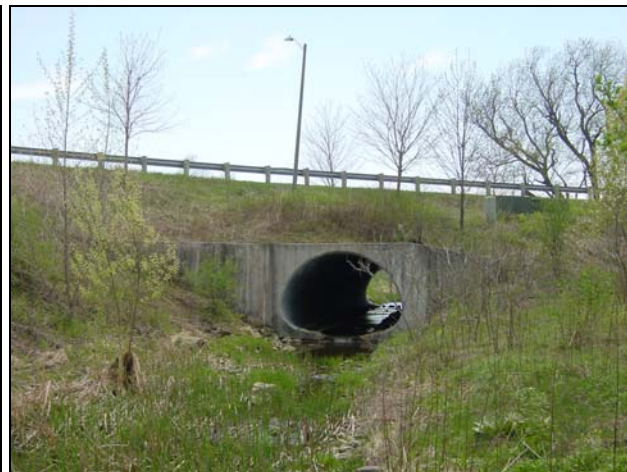
Two structures, closely spaced, in segment T1.05B constricted channel width. Both had scour pools at the downstream end, the one at the Route 7 bridge was particularly large. Again, entirely filled floodplains cause all flow to pass through these narrow structures, increasing velocities and scouring the bed and banks downstream. While the structures themselves appeared well built and not likely to fail in the near term, they interrupted geomorphic functions and contribute to channel adjustments.

Structures in T1.05B: Route 7 crossing (L) and VT Teddy Bear drive (R).

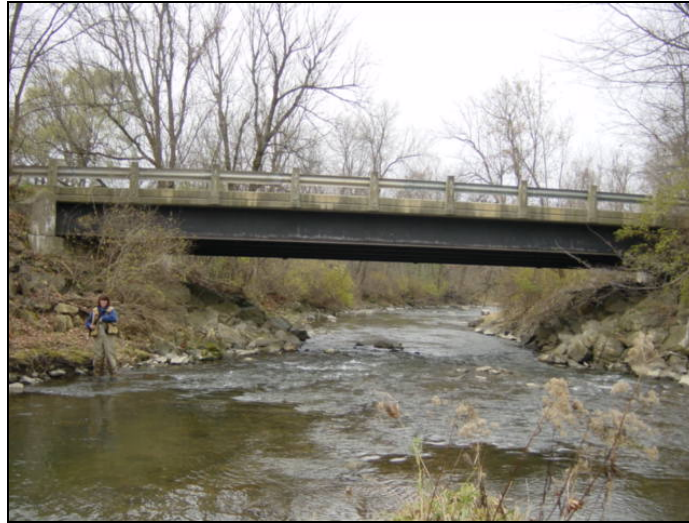
The Spear Street Bridge in segment M09A did slightly constrict the channel width (88%) and had sediment deposition upstream and bank erosion present. Again, the floodplain was entirely filled by the road approaches, forcing all flood flows through this structure. Bank armoring was present as well, but resizing this structure could alleviate bank pressure and reduce erosion.

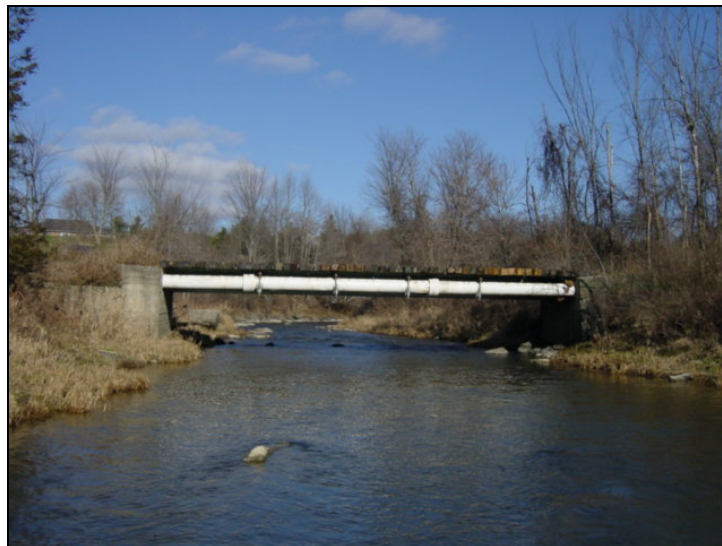
In reach M06, a farm access bridge constricts the channel width. Minor scouring of the channel bed was present downstream of the structure. Reach M06 did appear to be incised, so additional pressure would be placed on the banks in higher than bankfull flows that are not high enough to reach the floodplain. This structure could be at risk of failure from erosion due to it constricting the channel, however, the floodplain did not appear to have been filled for the roadway or the approaches to the structure. Therefore flood flows that reach the floodplain could pass over the road and around the structure.

Farm access bridge in M06.

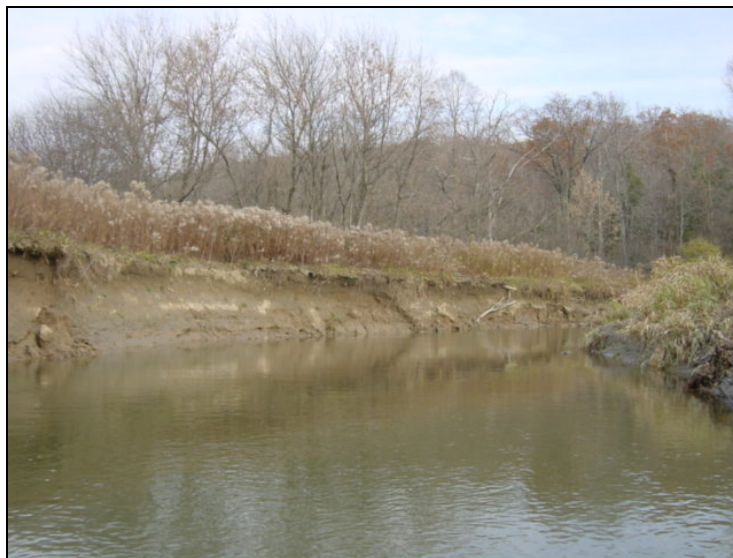
Bank erosion signaling planform adjustments and contributing sediment.

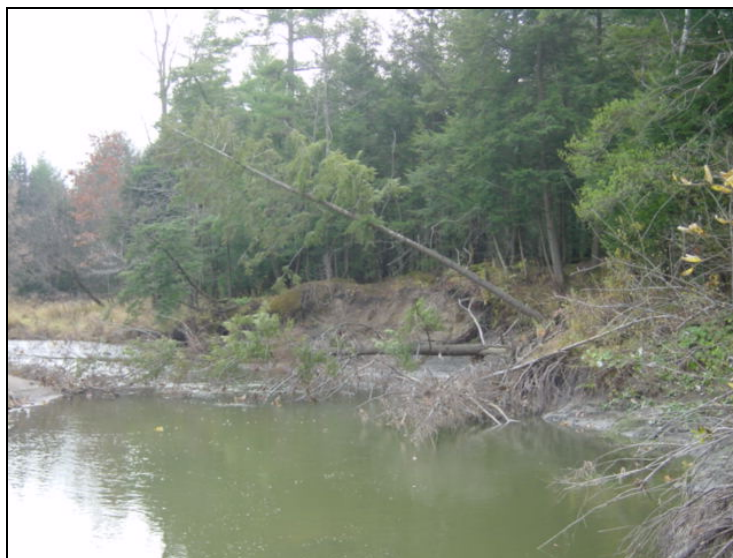
Mass Failure on an outside bend with trees falling into the channel to become LWD.

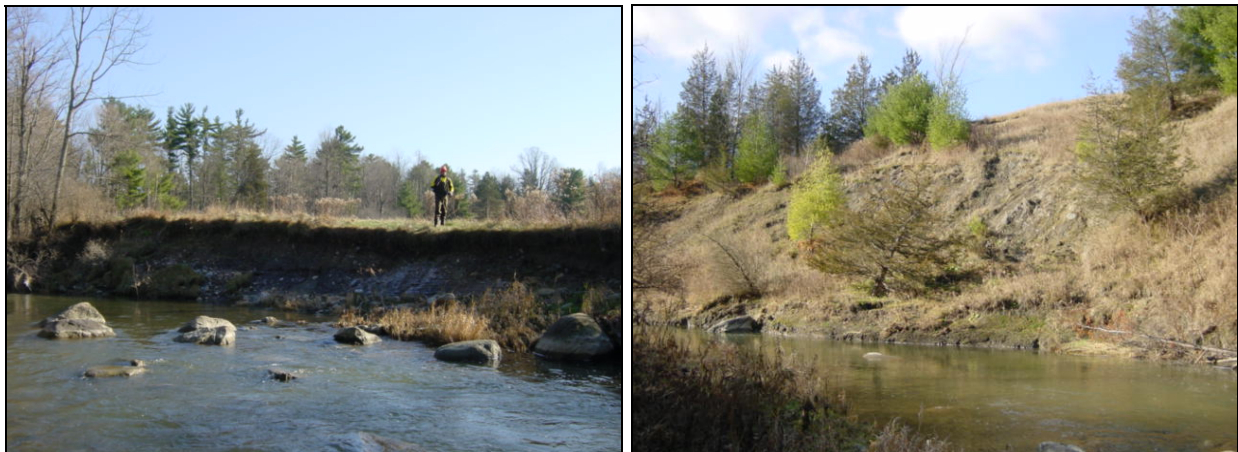
Bank erosion on an outside bend, contributing sediment (L) and one of many mass failures in M06 (R).

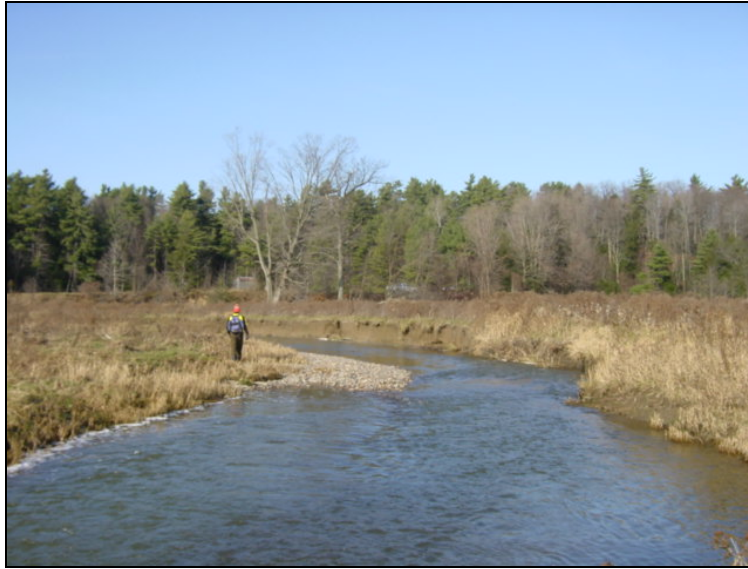
Right bank erosion and diagonal bar.

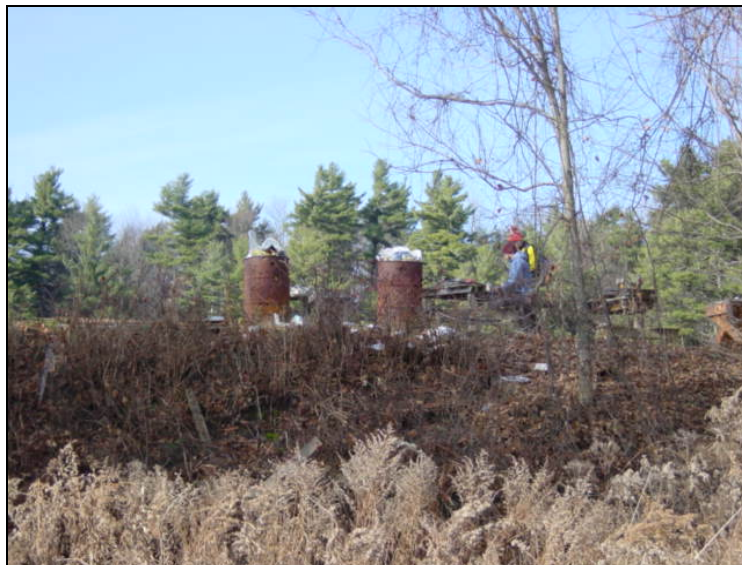
Trash close to the channel at the shooting range. Photo taken from the top of the left bank.

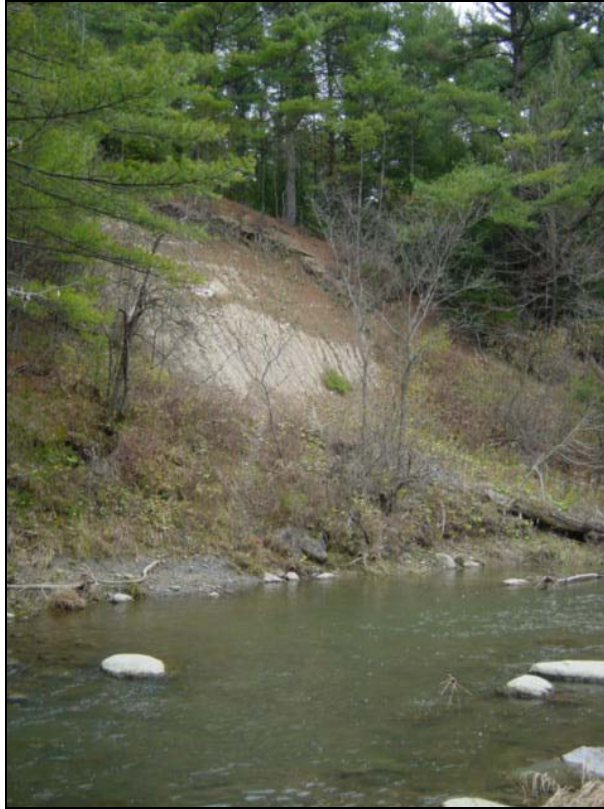
Mass Failure in M09A.

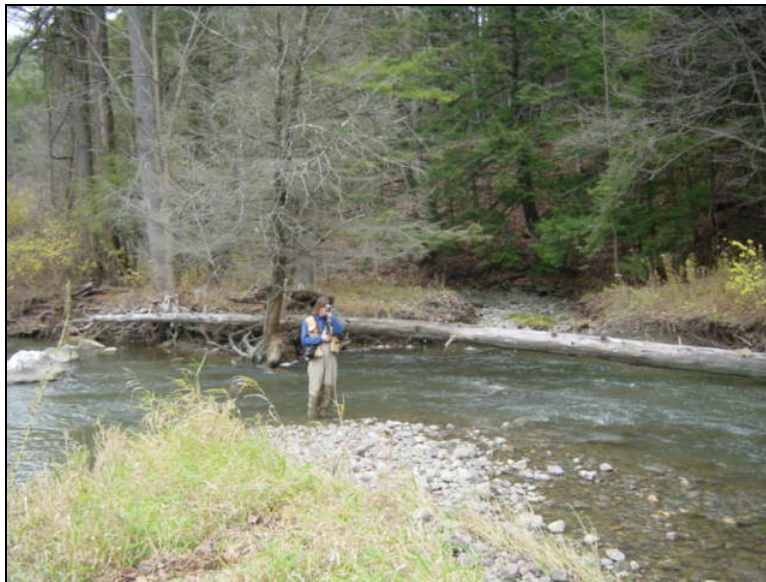
Several flood chutes were seen in M09A, signaling planform adjustment.

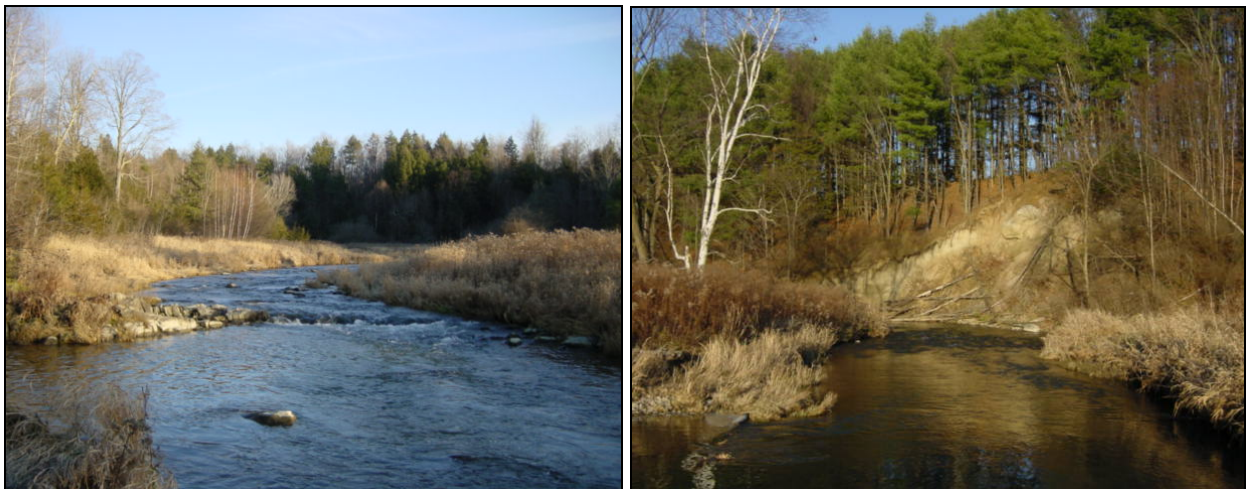
Ledge grade control and herbaceous bank vegetation (L), and one of several mass failures in the reach (R).

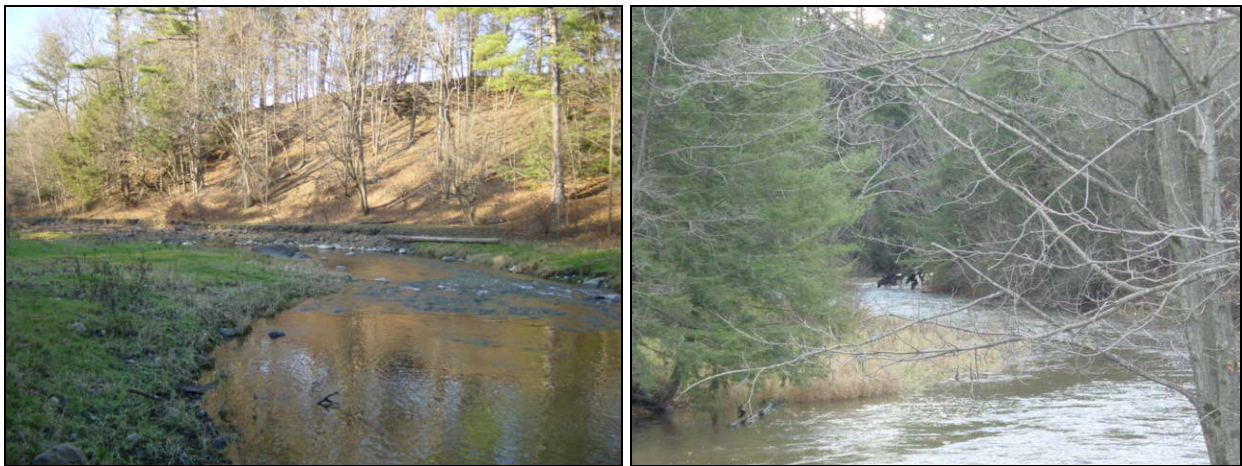
Animal access to channel and bank trampling (L) and cows with full access to the channel (R).

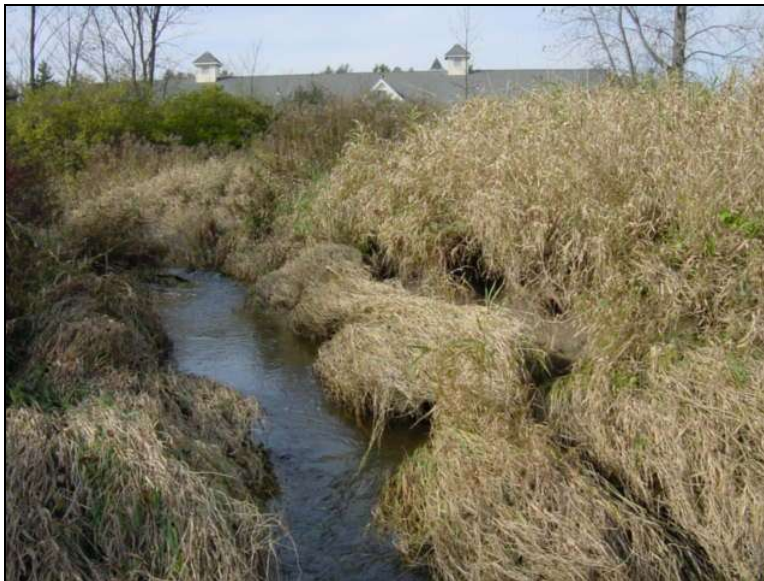
Bank slumping in T1.03.

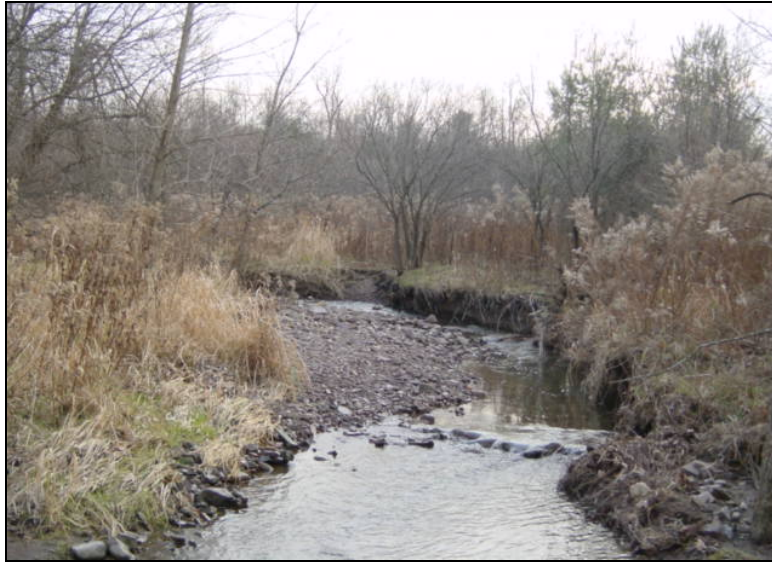
Bank erosion and point bar in T1.04B

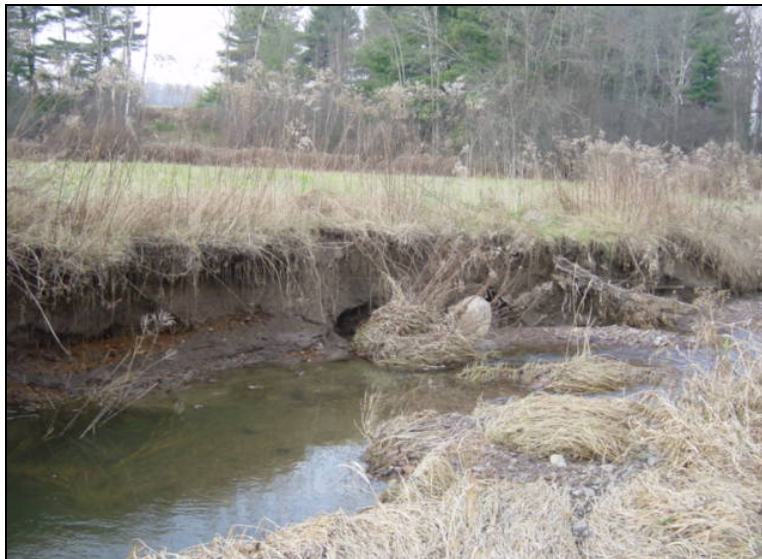
Left bank erosion with closely cropped herbaceous bank vegetation offering little bank protection.

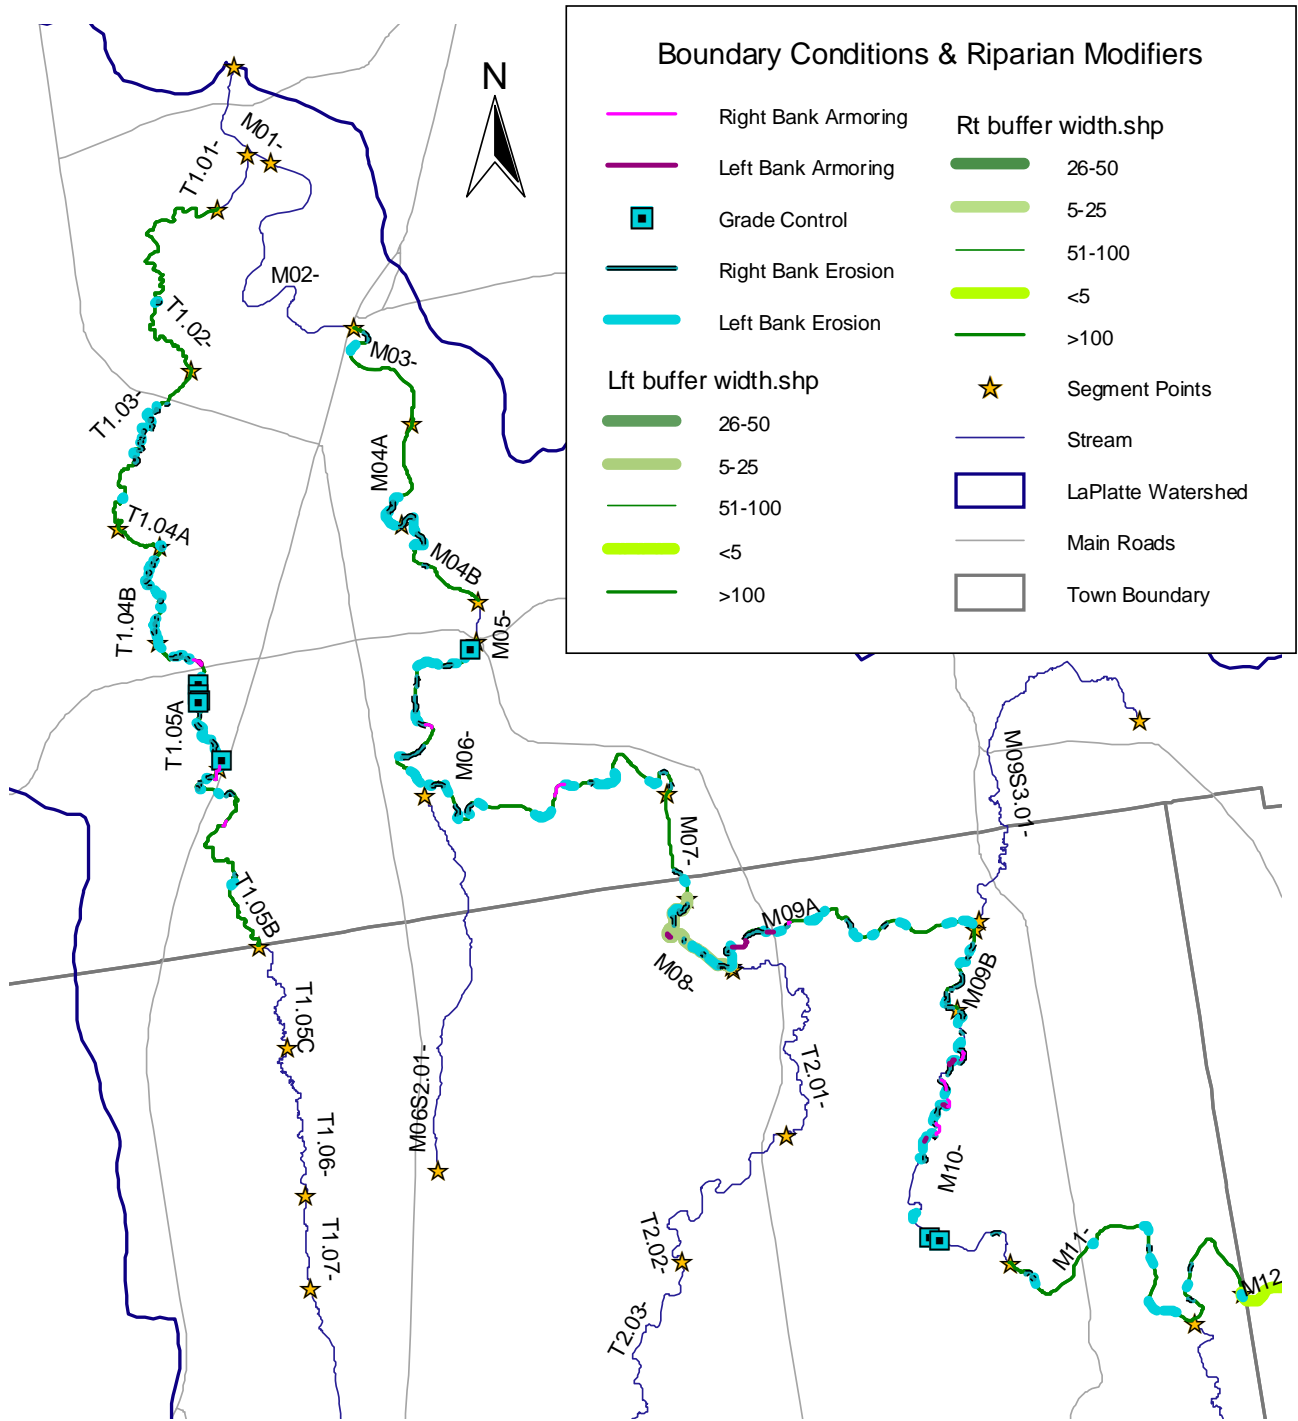
Blue lines highlight many areas of erosion. Reach M08 had buffer width of only 5-25 feet. Grade controls, present in M05, M10, and T1.05A limit further bed incision in those areas. Relatively little bank armoring was observed and was typically in areas of road crossings. Bank armoring in M10 consisted of log revetments. Stressors in blue and green tones signify those that act to reduce channel resistance to stream power while those in red tones signify stressors increasing resistance.
