## **Sucker Brook Watershed Report: Phase 1 and 2 Stream Geomorphic Assessment Summary**

**October 11, 2007**

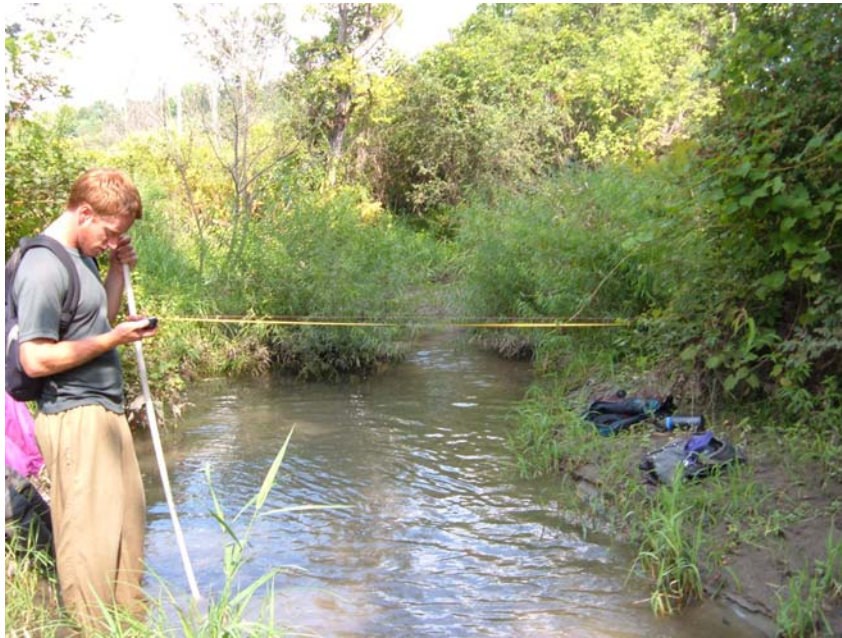
Reach M02 is found from the confluence with a minor tributary entering from the south up to a change in valley slope and confinement approximately 500 feet upstream from the South Brownell Road crossing. This reach has E-type geometry (Rosgen, 1994; Figure 1) with sand

substrate, dune-ripple bedform (Montgomery and Buffington, 1997) and a channel slope of 0.2 %. Some ponding was noted in the lower section of the reach due to a large beaver dam in downstream reach M01. The current channel conditions of this reach are relatively stable, with limited evidence of incision from the historic straightening (stage I of channel evolution). Rapid Geomorphic Assessment (RGA) and Rapid Habitat Assessment (RHA) scores were in the good range for this reach. The culvert beneath South Brownell Road (18 feet diameter) represents only a minor constriction of the channel (width of 21 feet), with no aggradation or scour noted in the vicinity of the structure. Due to the limited impacts and channel adjustments observed in this watershed zone, no project identification summaries have been included.

Figure 1. Cross-section for Reach M02

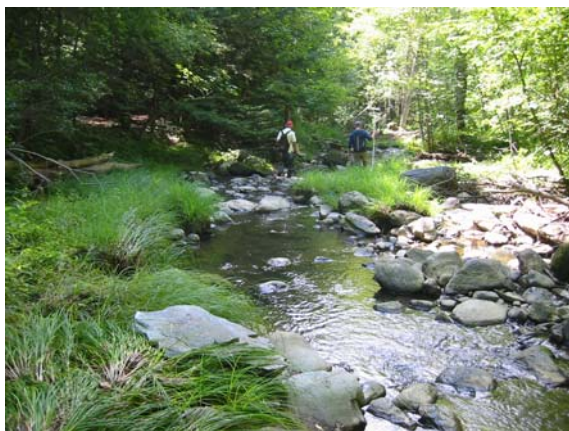
Figure 2. Stable plane bed features in Reach M03

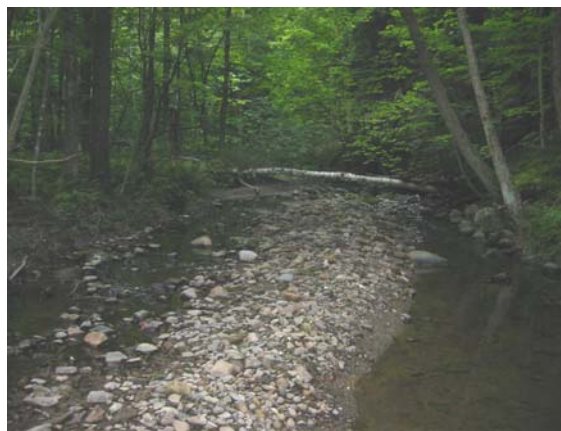
slope of 1.3% which supports a stable riffle-pool and planebed system with cobble and gravel substrate (Figure 3). Significant aggradation was noted in the lower section of the reach where a large mid-channel bar has formed prior to a 90 degree bend in the channel. This feature is causing minor widening and bank erosion in this area, but it is isolated to a 200 foot section of the channel. Upstream of this feature, stable riffle-pool and planebed features were observed. Rapid Geomorphic Assessment (RGA) and Rapid Habitat Assessment (RHA) scores were in the good range for this reach, and channel evolution stage was assessed at stage III due to the minor aggradation and widening observed in the lower reach. Due to the limited impacts and channel adjustments observed for this reach, no project identification summaries have been included.

Figure 3. Mid-channel bar in lower Reach M03

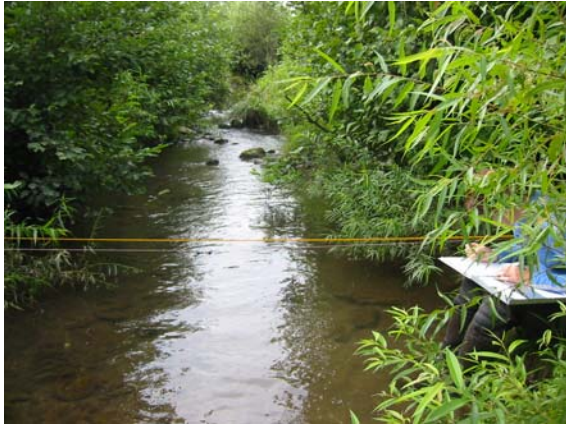
Figure 4. Riffle-pool bed features in Segment M04-A

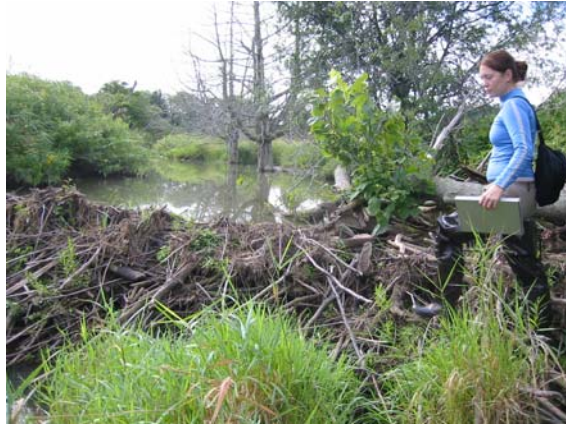
processes have been assessed at stage III. Upper segment M04-B has E-type geometry with sand substrate. Ponding due to a large beaver dam was occurring in segment B at the time of the field assessments in 2005 (Figure 5). Some redevelopment of sinuosity was noted throughout this reach, and the channel evolution processes have been assessed at stage IV. Rapid Geomorphic Assessment (RGA) and Rapid Habitat Assessment (RHA) scores were in the good range for both segments.

Figure 5. Large beaver dam in Segment M04-B

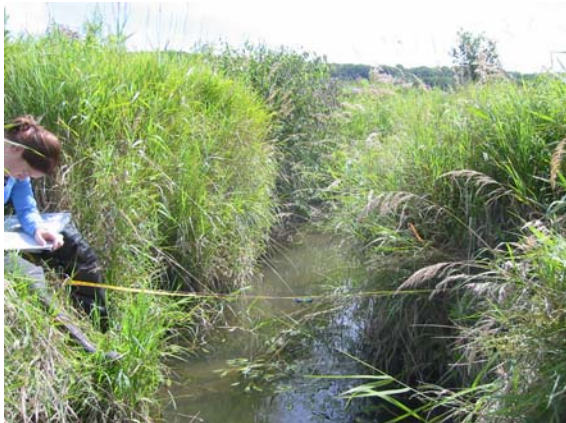
Figure 6. Cross section in M05

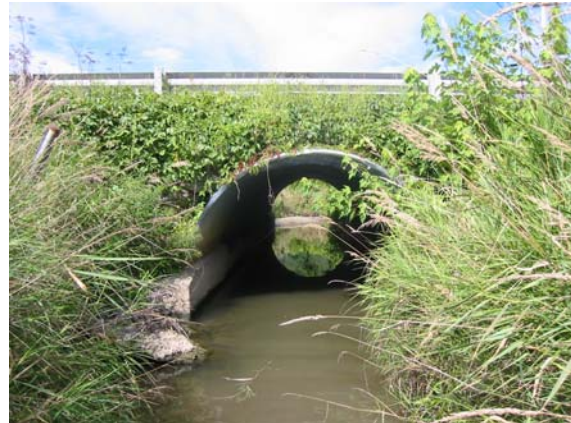
Reach M05 is found from approximately 1000 feet downstream of the mainstem crossing of Route 2A up to where a minor tributary enters from the north. This reach has E-type geometry (Figure 6) with sand substrate, dune-ripple bedform and a channel slope of 0.3%. Some ponding was noted in the lower section of the reach due to a large beaver dam in downstream segment M04-B. The current channel conditions of this reach are relatively stable, with limited evidence of incision from the historic straightening. These conditions have resulted from an evolution of channel planform and slope, and much of the lower reach is now stable (stage V of channel evolution). Rapid Geomorphic Assessment (RGA) and Rapid Habitat Assessment (RHA) scores for this reach were good and fair, respectively. The culvert beneath South Brownell Road (7 feet diameter) represents only a minor constriction of the channel (width of 8 feet), with only limited scour noted in the vicinity of the structure.

Figure 7. Culvert beneath Route 2A

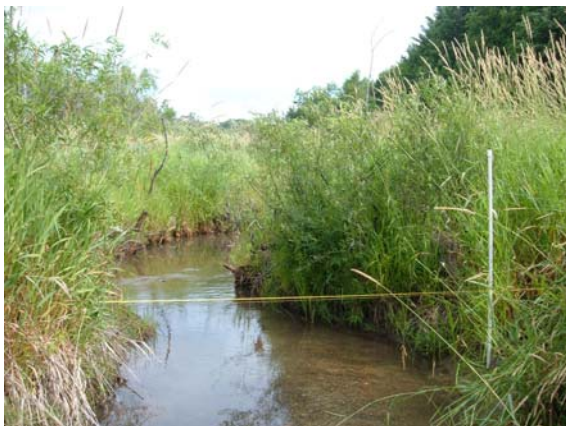
Figure 8. Cross section in lower T1.01

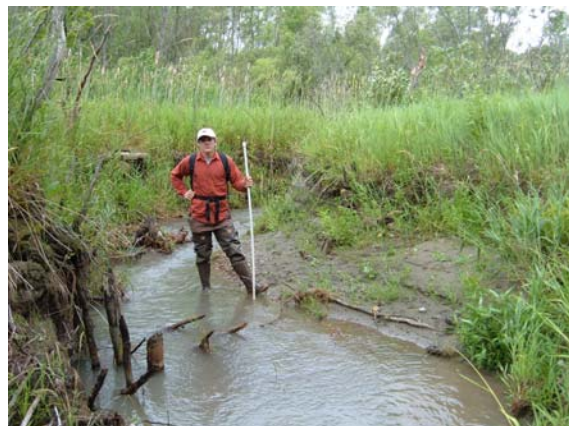
Reach T1.01, the first reach on the north branch tributary, is found from the north branch confluence with the mainstem up to a driveway approximately 1300 ft north of Ridge Rd. This reach has E-type geometry with gravel substrate, riffle-pool bedform and a channel slope of 0.7% (Figure 8). Significant incision was observed in two areas in the reach: 1) in the lower section below the Route 2A crossing; 2) approximately 500 feet upstream of the Ridge Road crossing. The incision (incision ratio > 1.5) below Route 2A is resulting from an undersized culvert (8.5 feet diameter; channel width = 13 feet) which is restricting the transport of fine gravel through the structure. Upstream of Ridge Rd the channel is downcutting through previously aggraded material (Figure 9) delivered from the avulsion in upstream segment T1.02-B. In between these two areas of incision the channel is in fair to good condition with limited adjustments, but the overall reach geomorphic stability and habitat conditions have been assessed as fair (channel evolution stage is II).

Figure 9. Channel incision in upper T1.01

The severe aggradation of coarse material in reach T1.01 has been problematic for the Town of Williston and the landowners whose driveways and roads cross the channel. Due to the exorbitant volume of sediment observed working its way through the reach, it is likely that vertical (aggradation followed by incision) and lateral (planform change) adjustments will continue to occur over the next 10 to 20 years, even as the stability of the upstream reach is restored. The 3 culverts found in this reach are all inadequately sized, especially the upper 2 culverts with widths of 5.5 and 4.5 feet for Ridge Road and the driveway crossing at the reach break, respectively. The channel width through this area ranges between 13 and 15 feet, and the undersized culverts are restricting the downstream passage of coarse sediment. Replacement of the upper 2 culverts should be considered as a potential action to alleviate the periodic upstream flooding around these structures, and to allow the passage of the sediment through the reach. This effort would likely minimize the need for dredging upstream of the culverts, and would allow for greater connectivity of the sediment transport processes along the channel, thereby encouraging a more rapid recovery of channel stability in this reach.

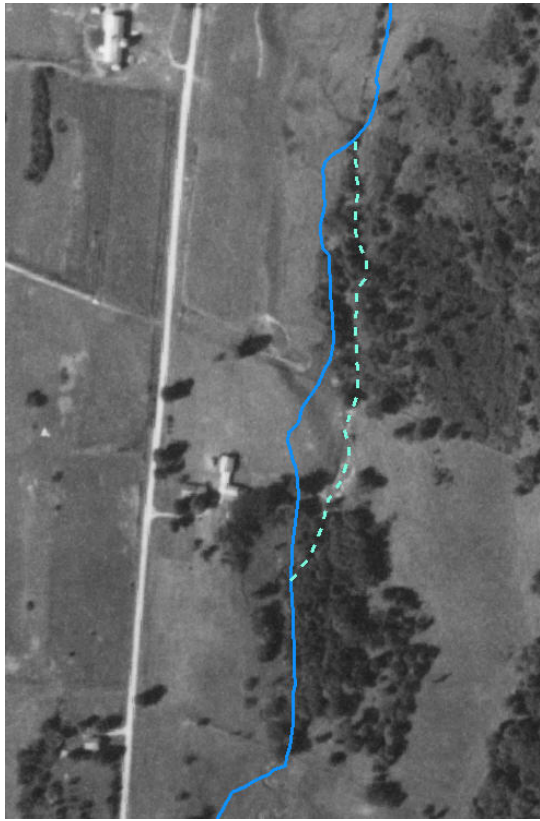
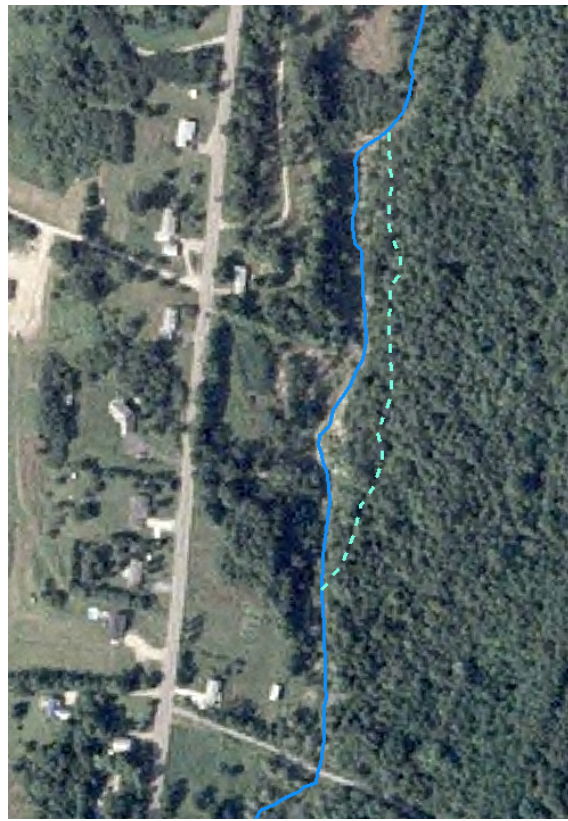
Reach T1.02 was delineated during the Phase 1 analysis to encompass the site of the channel avulsion and subsequent restoration effort. This reach is found from a driveway crossing at the reach break with T1.01 up to approximately 250 feet above LaClair Road. This channel position has shifted to the west by 150 feet in some locations, as seen in Figures 10 and 11. Under reference conditions, this reach had a channel slope of 4.4%, which likely supported a B-type channel with step-pool morphology and cobble substrate. In the 1980's an extreme flood event moved the channel into a new location through an old gravel pit underlain with sands and clays. Since the avulsion, the channel has deepened to form a 40 foot gully, delivering approximately 72,000 cubic yards of material to the downstream reaches. VTANR considers this one of the worst channel avulsions known to Vermont (Dubois and King, 2007). Today, the gully is the site of an extensive restoration effort to stabilize the channel through the installation of rock weirs and large substrate to control the vertical adjustments.

Figure 10 & 11. Aerial photographs of the channel avulsion site from 1937 (left) and 2003 (right). The current channel location is shown in solid blue, and the 1937 channel location in dashed blue.

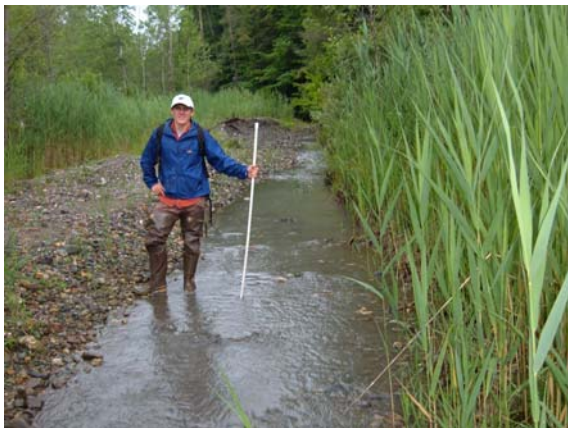
Figure 12. Above 48 inch culvert in lower Reach T1.02

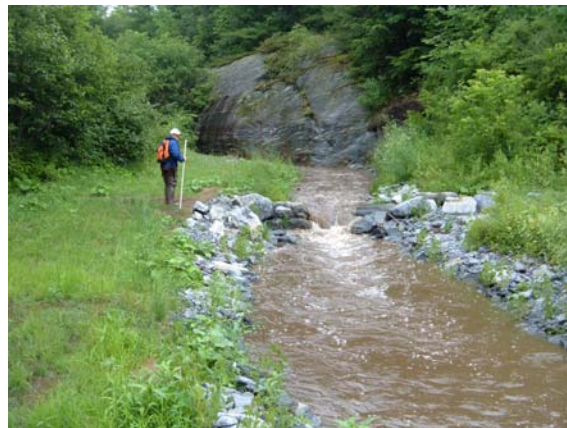
During the Phase 2 assessment of this reach in 2007 by FEA, only the area downstream of the restoration site was accessible for evaluation. The reach was segmented to capture the current bedform conditions below the restoration site, which have undergone a change from step pool morphology to plane bedform due to the aggradation of sediment from above and the redevelopment of a narrow floodplain within the confined valley setting. Segment A is located from the downstream reach break at the driveway crossing up 675 feet to the site of the historic waterfall. This segment is characterized by a B-type stream with plane bedform and cobble substrate. RGA and RHA scores indicate a reach in fair conditions, with the channel evolution processes reflecting the aggradation and redevelopment of sinuosity (stage IV). Large amounts of coarse material are periodically removed from the channel at the downstream area to avoid flooding at a 48 inch culvert beneath a driveway (Figure 12). Within the channel restoration site, numerous rock weirs are being installed to return the channel to its stable dimensions with B-type geometry and step-pool bedform (Figure 13).

Figure 13. Channel restoration site in upper T1.02

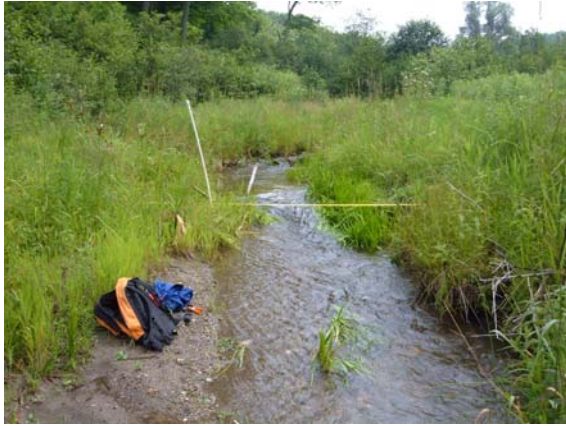
Figure 14. Cross section in Reach T1.03

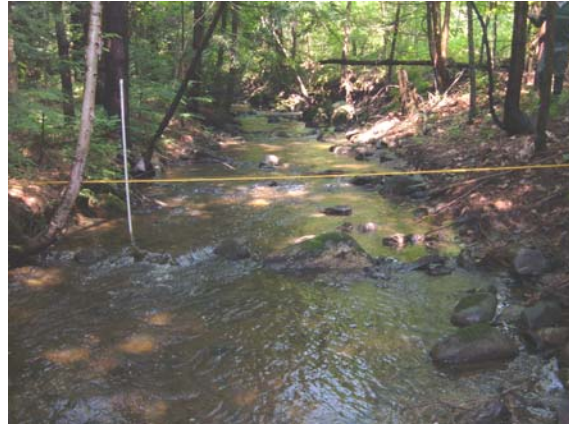
Figure 15. Cross section in lower Segment T1.04-A

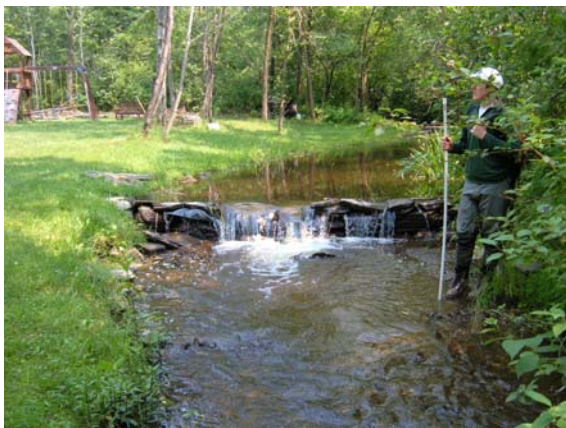
Figure 16. Rock weir in lower Segment T1.04-B

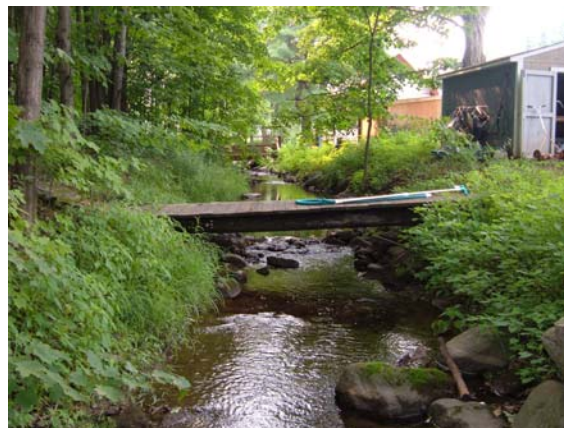
Figure 17. Corridor encroachment in T1.05-A

The two segments in between the Old Creamery Road crossings have been highly impacted by historic straightening, residential encroachment on the corridor and unnatural structures placed in the channel. Both have undergone a departure from reference bedform (see Appendix 3), due mainly to a loss of sinuosity. The channel and watershed characteristics in this upper zone are such that little future lateral channel migration is expected; channel straightening combined with bank armoring will hold the channel in place indefinitely. The in-stream structures (e.g., weirs) in reaches T1.04-B and T1.05-A are permanent enough to remain in place during moderate flow events (below bankfull) when fine sediment is being transported through the channel. As discussed above, this is resulting in aggradation upstream of the structures that is degrading the habitat. It is recommended that these structures be removed to reduce further habitat impacts. Additional projects in this densely residential zone would include the revegetation of the buffers with native woody vegetation. Future efforts to identify specific projects in this watershed zone would involve extensive public outreach, given the large number of residential properties found along the channel, especially in segment T1.05-A.

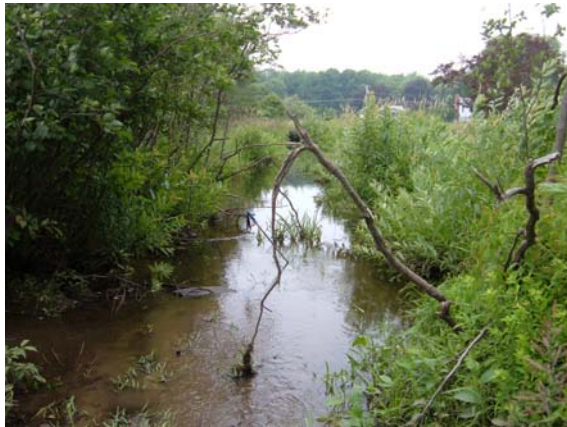
Figure 18. E-type channel in Segment T1.05-B

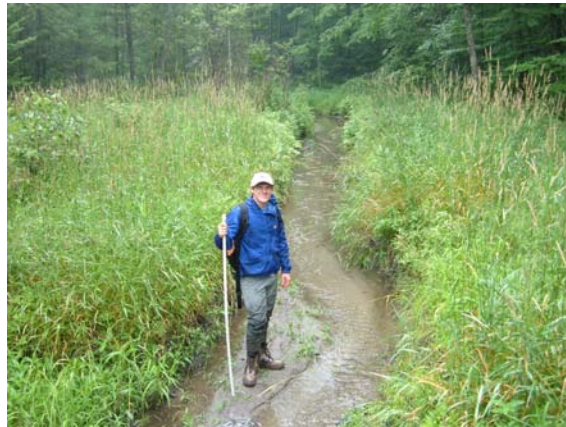
Figure 19. E-type channel in Segment T1.05-C
