Phase 1 Geomorphic Assessment of the White Creek/Mill Brook Watershed in Southwestern Vermont

Conducted in 2005 by

Bennington County Conservation District
PO Box 505, 310 Main St.
Bennington, VT 05201
802 442-2275 bccd@sover.net

Report dated November 17, 2006

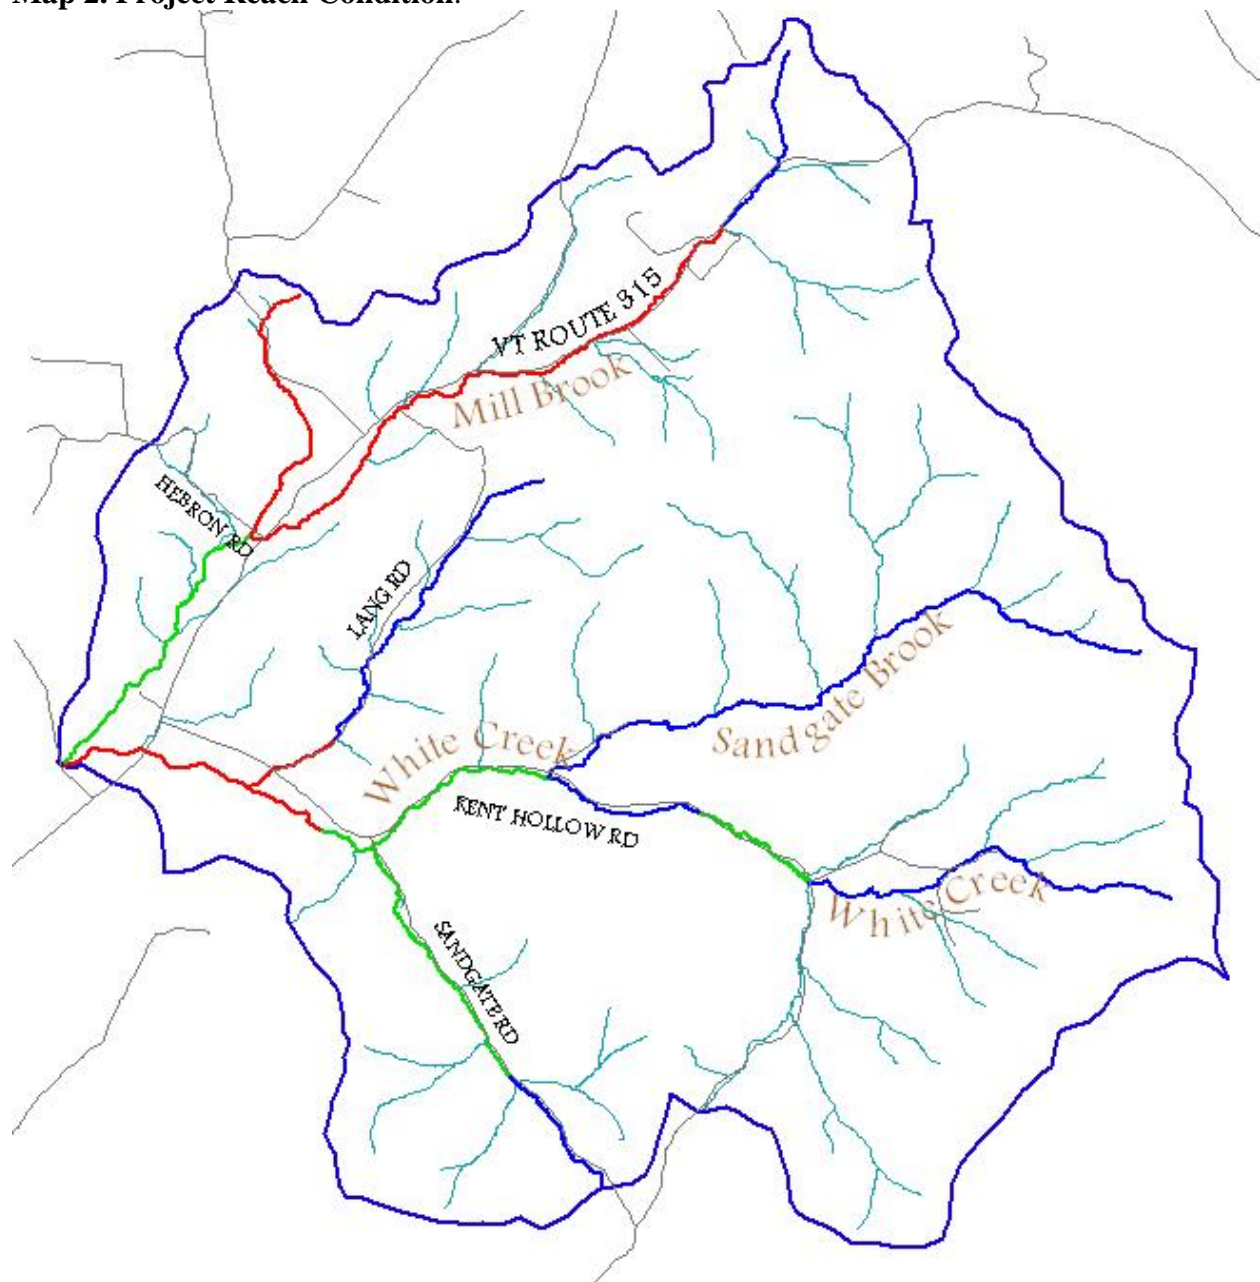
Map 2. Project Reach Condition.

Table 9 displays these DMS-generated findings for reaches with total impact scores equal to or greater than “9.” (It’s near this point in the descending-order impact list that project reach conditions become “good” or “reference.” No reaches rated in “poor” project reach condition are omitted from the table.) “D” signifies degradation; “A,” aggradation; “W,” widening; and “P,” planform change.

| Reach #/Stream Name | Highest adjustment processes | Total Impact Score | Project Reach Condition | Statewide Reach Condition |
|---|---|---|---|---|
| M01/White Creek | A 10; D&P 9 | 17 | Poor | Fair |
| M02/White Creek | D 8; P 8 | 15 | Poor | Fair |
| M01T1.02/Mill Brook | A 9; D&W 7 | 17 | Poor | Fair |
| M01T1.03/Mill Brook | P 9; D&A 7 | 17 | Poor | Good |
| M01T1.04/Mill Brook | D 9; A 8 | 14 | Poor | Fair |
| M01T1.S1.01/Mill Brook trib | D9; A&P 7 | 14 | Poor | Good |
| M01T2.01/downstream White Creek trib | D 9; A 8 | 13 | Poor | Fair |

system highly altered by human activities and one, in many locations, still adjusting to the impacts of those activities. Future field studies focusing particularly on “high” total impact, “poor” project reach condition reaches can help area residents and municipal officials craft short-term and long-term management plans.
