White Creek and Mill Brook Stream Geomorphic Assessment Phase 2 Report

December 2008

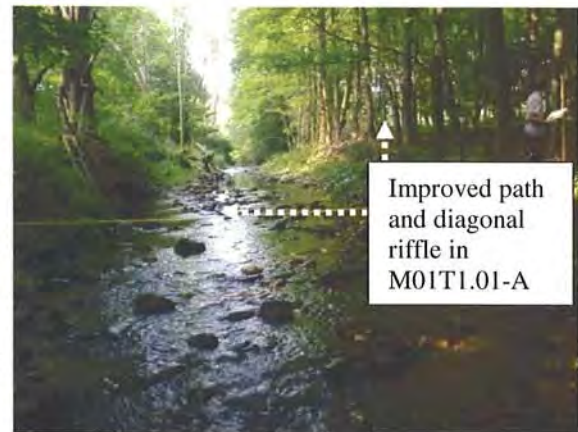
This segment is a C3 stream type with a riffle-pool bedform and a bankfull width of 29.5 feet. Just upstream of the confluence of White Creek, M01T1.01-A has a forested riparian buffer, three bedrock ledge grade controls, and no corridor encroachments. However, the upper two thirds of the reach is heavily influenced by the improved path on the left bank which is preventing floodplain access. The improved path is also a channel stressor as it is protected with riprap in sections. The improved path is a lateral constraint resulting in about 50 percent of the segment being straightened. The improved path (see photograph) and the pasture in the right corridor, in the upper section of the segment, have resulted in a less than 25 foot buffer in some areas.

The geomorphic repercussions of these stressors resulted in a "fair" RHA and RGA scoring and "high" stream sensitivity. This segment is in stage IV of the channel evolution model and with historic incision (IR=1.8) and current aggradation (4 steep riffles, 1 diagonal riffle (see photograph) and planform adjustments as the dominant channel processes. The incision and improved path has significantly reduced access to the floodplain.

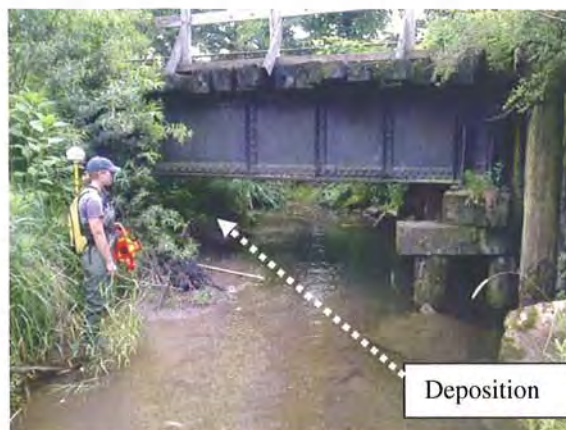
This segment is an E4 stream type and is much more narrow (bankfull width = 14.9 feet) compared to M01T1.01-A. Segment M01T.101-B meanders through agricultural pastures/fields and a natural meadow in a broad valley setting. The substrate in M01T1.01-B is finer, with sand and silt representing 40 percent of the bed composition. This segment of Mill Brook crosses under the improved path via two iron bridges. Both bridges are floodplain constrictors. Upstream of the first bridge crossing, there is over 500-600 feet of straightening due to the improved path, which is a river corridor encroachment in the right corridor. The first bridge (moving upstream from the start of the segment) is located at a sharp bend in the stream with hard bank armoring on the left bank and deposition greater than bankfull height under and upstream of the bridge (see photograph looking upstream at the bridge). The second bridge is at mild bend with hard bank armoring and deposition under the structure. The upper half of this segment does not have any corridor or channel constraints as it is much more sinuous in the open valley floor. There is good floodplain access in this segment, especially above the second bridge where there are no impacts from the improved path.

This relatively stable segment is in channel evolution stage I with some evidence of erosion on the outside of bends but is otherwise relatively stable. Both the RHA and RGA scored “good” with a stream sensitivity of “high”. The segment ends where it becomes braided and there is no longer a defined channel in what becomes a wetland feature.

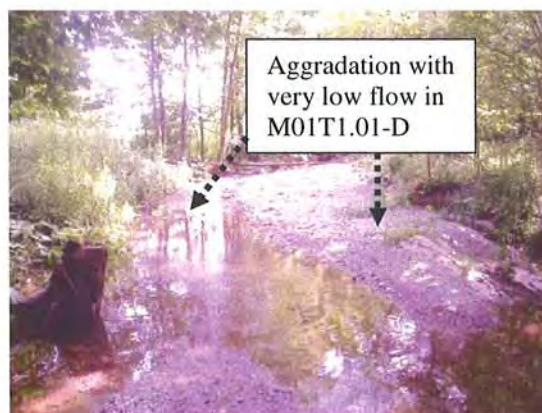
Upstream of the wetland, the stream channel is more defined on the right side of the valley as the segment is forested. The downstream section of M01T1.01-D was dry on July 14th, 2008, but upstream there was very low flow. The segment returned to a C stream-type and its substrate is dominated by gravel (course and fine), which comprised 76 percent of the bed substrate. In this short segment there is very little erosion (only 18 total linear feet), and no corridor encroachments. The upstream portion of this segment becomes sandwiched between two agricultural fields and there are small sections of straightening and buffers less than 25 feet.

This low gradient segment is dominated by un-vegetated depositional features including point, side and mid-bars (see photograph). The active adjustment process in this segment is aggradation and this is evident in the riffles which are sedimented (1 diagonal and 3 steep riffles). The high width-to-depth ratio (25.52) indicates that widening has already occurred, and M01T1.01-D is in channel evolution stage IV. The RHA scored "fair" and the RGA scored "good" with a "high" for stream sensitivity.

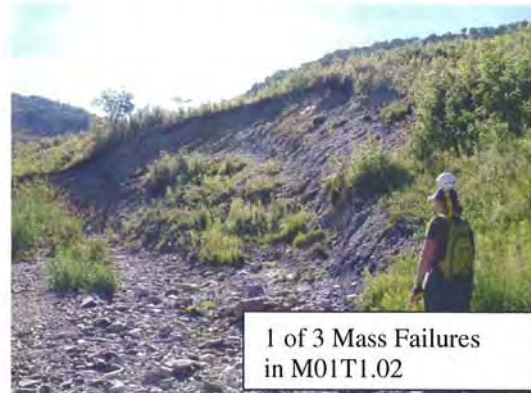
This reach begins by crossing under the improved path and VT Route 153, near Hebron Road, and continues 5,912 feet upstream through residential development in the town in Rupert terminating just upstream of the Youlin Road crossing. The lower section of M01T1.02 had very low flow (on July 15th 2008), no riparian canopy cover, a river corridor encroachment from VT Route 153 on the right bank, and is affected by three mass failures, all on the left bank (see photograph). The middle section of the reach is bounded by a small forested riparian corridor (although the buffer is less than 25 feet at several points), as it is sandwiched between agricultural fields. The flow disappeared in the middle section of this reach (when it was assessed on July 15th 2008) and is dominated by un-vegetated depositional features including all three types of bars. Flow returned to the channel (when assessed on July 15th 2008) as this reach continues upstream through the backyards of several residential developments. The upper section of the reach has evidence of historical incision (possibly due to 1 stormwater input and/or channel constraints [riprap] from residential development), and the stream lacked access to the abandoned floodplain in the agricultural fields on river left.

There are four bridges in this reach. The most geomorphically problematic structure is the VT Route 153 crossing. This bridge has a narrow bankfull span, a very small clearance, and deposition was observed upstream, downstream and in the structure. The bridge is located at a sharp bend in the stream and is armored with 53 feet of hard bank wall on the left bank, upstream of the structure. M01T.102 is a C4 stream type in channel evolution stage IV. Channel adjustment processes include historical incision with active aggradation and planform changes (evident from erosion and mass failures). The RGA and RHA both scored "fair", with a stream sensitivity of "very high".

- Replace the VT Route 153 Bridge, which has a very low clearance, is skewed and necessitates hard bank armoring on the left bank.
- Work with private landowner to prevent farm animal access to the brook/stream banks and establish a vegetated riparian buffer.

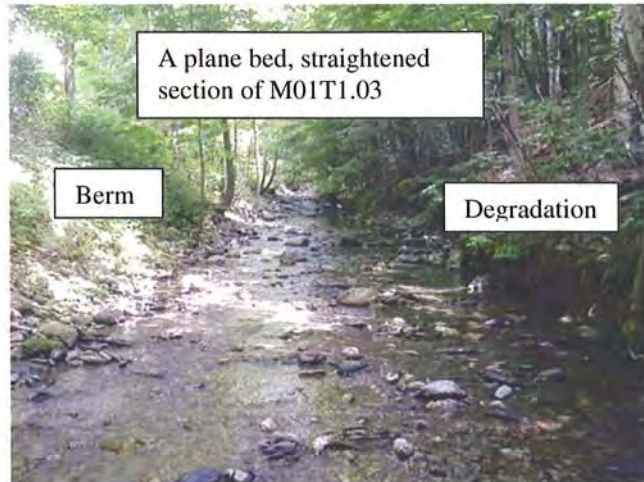
Reach M01T1.03 is a C4b stream type. The reach is encroached upon by a berm to protect a residence on the right bank (see photograph below). The upstream half of the reach is impacted by VT Route 315 which (in sections) acts as a corridor encroachment, causes the riparian buffer to be less than 25 feet, prevents floodplain access, and straightens sections of this reach with bank armoring. VT Route 315 causes changes in valley width and channel confinement. The upper portion of this reach is, at times, sandwiched between VT Route 315 and agricultural fields, which also reduces the buffer on the left

bank to less than 25 feet. These impacts have resulted in active degradation (CEM stage II) with two headcuts observed, and an incision ratio of 1.66 (see photograph). There is moderate to heavy erosion in the lower section of this reach and two mass failures on the left bank.

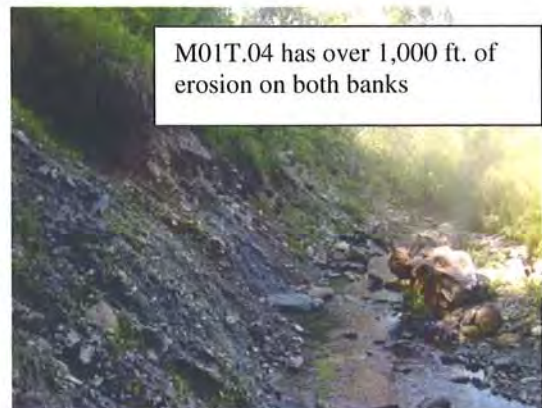
M01T1.04 is a B4 step-pool stream type. This reach is more entrenched and has a narrower valley confinement than the downstream reaches on Mill Brook. This long reach (almost 7,000 feet) is heavily impacted by VT Route 315, which represents a significant human-caused change in valley confinement and prevents complete floodplain access. Over 75 percent of this reach is encroached upon by VT Route 315, as the highway runs parallel to the creek. Channel confinement in the form of bank armoring has resulted in about 60 percent of the reach being straightened. These lateral constraints have resulted in active degradation and downstream planform adjustments. Tributary rejuvenation and multiple head cuts cause us to classify this reach as in stage II of the CEM. There are over 1,000 feet of erosion on both the right and left banks (see photograph) and two mass failures. More than 2,695 ft on the left bank and 1,421 ft of the reach on the right bank have a riparian buffer of less than 25 feet

Four structures cross this reach, including two new structures under VT Route 315. Although the new structures are bankfull constrictions, they incorporate natural substrate bottoms to increase stream bed roughness. M01T1.04 ends just upstream of an

undersized culvert at Watrous Road. Both the RGA and RHA scored "fair" with "high" stream sensitivity.

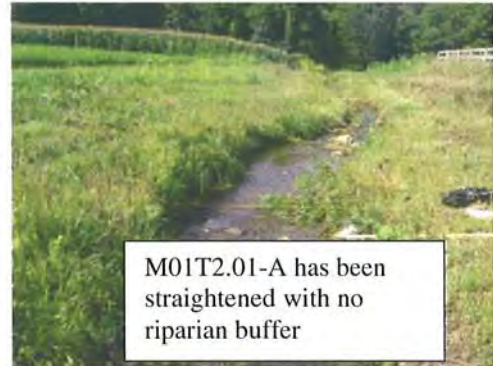
M01T2.01-A

This is the most impacted segment in the watershed. Stressors have caused a stream type departure from its reference type stream, into an E3b riffle-pool stream type with a low width-to-depth ratio. This departure is due to historic straightening through an agricultural field that is currently cut to the stream bank with no riparian buffer (see photograph). These stressors have resulted in active degradation (incision ratio = 2.54) and a stage II of the CEM. There were only two pieces of large woody debris documented in this segment. A decrease in bank and in-stream roughness has increased stream velocity contributing to streambed degradation. There is an adequately sized culvert for the Kent Hollow Road crossing that is not a bankfull or floodplain constrictor but does have a 1.4 foot free fall outlet drop representing a barrier to aquatic organism passage. Above the box culvert the segment ends as the stream banks become forested. The RHA and RGA scored “fair” with a stream sensitivity of “high”.

- Restore the stream to its natural stream type. Plant a vegetated buffer, install large woody debris structures to increase sinuosity/habitat, restore access to a floodplain, and install cross-vane step pools. These measures would prevent further stream degradation and would likely return this segment to its equilibrium. This restoration would require preliminary extensive surveys (SGA Phase 3) and a design plan before construction.

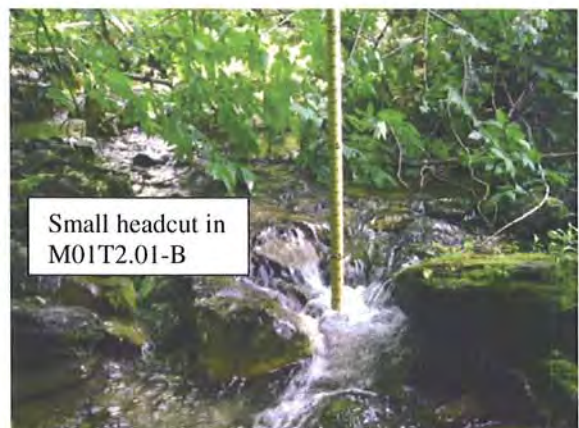
This 1,760 foot segment has maintained its reference B stream-type, but is heavily influenced by Lang Road running parallel to M01T2.01-B on the left bank, which is a corridor encroachment for 85 percent of the reach. Lang Road represents a human-caused change in valley width and has resulted in 456 ft of stream bank with a buffer less than 25 feet. Lang Road has reduced the size and accessibility of the floodplain on the left bank and has resulted in 50 percent of the reach straightened. The right hillside is very steep and is always within one bankfull width of the stream bank with very little floodplain access. These stressors have caused active degradation with an incision ratio of 1.64 and three small headcuts observed in this segment (see photograph). This segment is in stage II of the CEM. There are two bedrock ledges providing grade control to this system. At the upstream end of this segment there is a

small water diversion for a private trout pond. There are no stream crossing structures within this segment. The RGA and RHA scored "good" with "moderate" stream sensitivity.

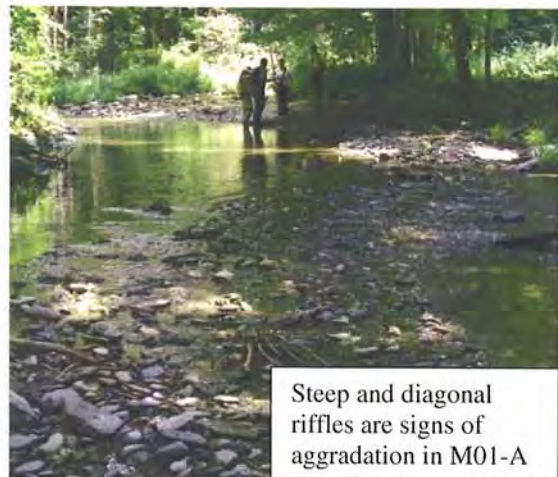
M01-A is the most downstream segment in a large watershed and therefore exhibits the effects from upstream impacts. This segment is also low gradient resulting in depositional features (see photograph) and active aggradation. There are indicators of active planform adjustments (i.e., moderate bank erosion) resulting in a classification of stage IV of the CEM. A recently abandoned floodplain on the left corridor and an incision ratio of 1.92 are signs of historic incision. Major impacts within the segment, partially responsible for the aforementioned adjustments, included a 400 ft berm

resulting in straightening and an inaccessible floodplain. There are two structures in the segment. The first bridge for the improved path is bankfull and floodplain constriction located at a sharp bend in White Creek, resulting in riprap bank armoring on the left bank and deposition under the structure. M01-A ends at the VT Route 153 structure crossing, which is adequately sized and causes no geomorphic issues.

M01-A is a C4, riffle-pool stream type with a very broad valley confinement. This segment is almost entirely forested with a small section having a buffer less than 25 ft due to residential development and the VT Route 153 bridge. The RGA and RHA both scored "good" with "high" stream sensitivity.

- Remove berm at the downstream end of the reach on the left bank and restore floodplain access in the agricultural field.
- Replace rail-trail bridge over White Creek just upstream of the White Creek/Mill Brook confluence. The bridge span is undersized and is skewed, causing scour and deposition and necessitating the need for riprap bank revetments upstream.

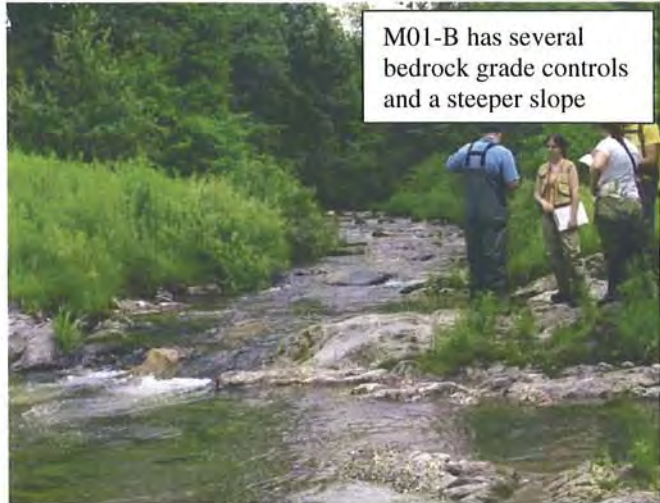
M01-B is a more open system, with less forested cover due to a natural meadow and adjacent agricultural fields. M01-B extends from the VT Route 153 crossing of White Creek to the confluence with Tributary A. As one progresses upstream the steep valley wall becomes adjacent to the left bank, and floodplain access becomes limited to the right corridor. However, historic degradation has reduced access to a floodplain on the right bank. Personal correspondence with a land owner confirmed that yearly or bi-yearly bankfull flows do not saturate the adjacent field. Incision and increased entrenchment has resulted in stream type departure from a C stream type to a F3 riffle-pool stream type. There are no encroachments, lateral constraints, or constrictors, within

the segment and the historic and current adjustments are due to upstream impacts (straightening, hard bank armoring, degradation etc.). There are three bedrock ledges in the middle of the segment providing grade control to the segment (see photograph). The current high width-to-depth ratio (37.0), historic degradation, and little signs of planform/aggradation adjustments resulted in stage II classification of the CEM. The high incision ratio (2.0) resulted in a low RGA scoring of "fair" and poor epifaunal substrate and available cover caused a "fair" scoring for the RHA. The "fair" RGA scoring resulted in "very high" stream sensitivity.

M01-B has several bedrock grade controls and a steeper slope

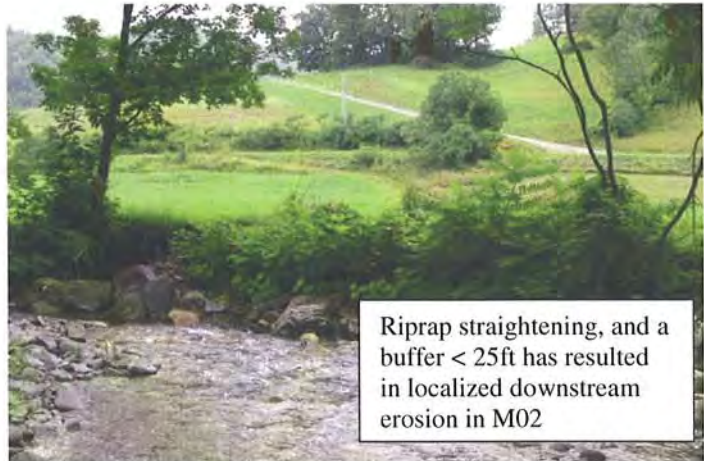
M02 also has very little in-reach human impacts but several indicators of geomorphic adjustments. M02 is a short, forested reach beginning at the confluence of Tributary A and extending to just downstream of a residential development and a bedrock grade control. The corridor of M02 has pasture fields on the right and a very steep valley wall on the river left that is always within 40 ft of the stream bank. A riparian buffer on the right bank is generally greater than 25 feet. There is moderate erosion both banks and a mass failure (located at bottom of the reach on the left bank) that is 73 ft high. In addition to planform adjustments there are steep and diagonal riffles indicating aggradation. Historic degradation (incision ratio = 2.25) has limited access to the floodplain on the right bank. These adjustments have resulted in a stream type departure from a reference C stream type to a more entrenched B4c stream type. The CEM stage for this reach is transitioning from stage III to stage IV. A lateral constraint from hard bank armoring in conjunction with a buffer less than 25 feet on the outside of a meander bend has resulted in localized downstream erosion (see photograph). The high incision ratio caused a "fair" scoring for the RGA while the RHA scored "good" with "high" stream sensitivity.

Riprap straightening, and a buffer < 25ft has resulted in localized downstream erosion in M02

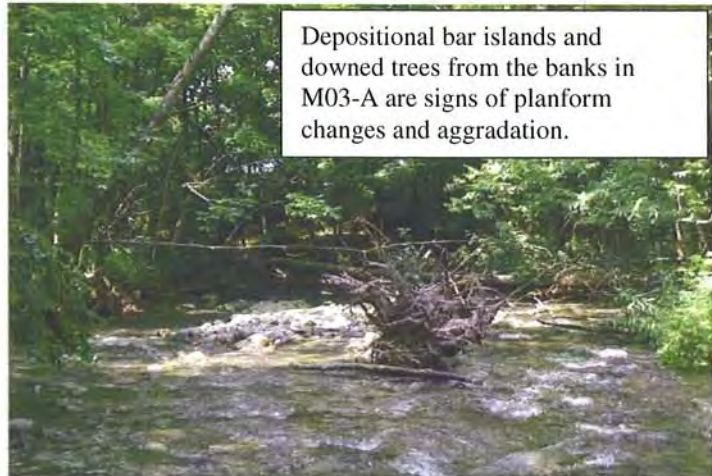
This segment is very short (1,596 feet), beginning just downstream of bedrock ledge grade control and terminating at the confluence of Sandgate Brook. There is minimal erosion but evidence of active planform adjustments and aggradation. There is a flood chute avulsion on the right bank and channel widening is evident from several leaning/fallen trees into the stream (LWD count= 11) (see photograph). Diagonal and steep riffles and a mid-channel bar island are signs of active aggradation.

Historic degradation is also apparent from a 1.9 incision ratio. These historic and current adjustments classified the segment in stage IV of the CEM. The left valley wall is not adjacent to this reach; however, streambed degradation prevented access to the pasture/floodplain in the left stream corridor. However, there is access to a large floodplain that has been partially encroached upon by residential development in the right stream corridor (floodprone width= 164 feet). Besides two small sections of buffer less than 25 ft, there are no in-stream human impacts or structures in this segment. Kent Hollow Road represents a river corridor encroachment in the middle section of the segment. M03-A is a C4 stream type with "very high" stream sensitivity due to a "fair" scoring in the RGA. The RHA scored "good" for this segment.

Depositional bar islands and downed trees from the banks in M03-A are signs of planform changes and aggradation.

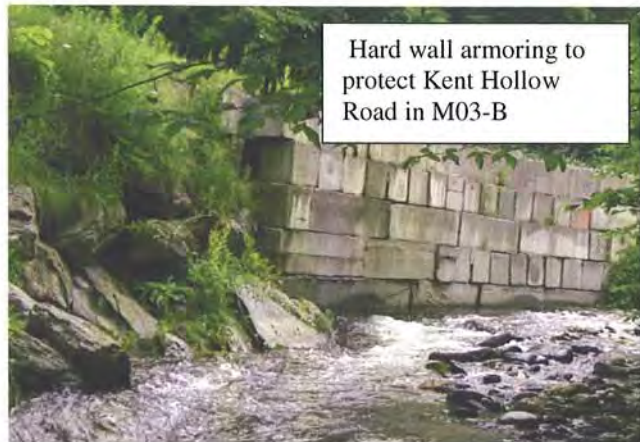
M03-B is narrower, steeper segment with more cobbles dominate substrate than M03-A. M03-B is a stable system – with few indications of major channel adjustments. The long reach (5,707 feet) begins at the confluence with Sandgate Brook and extends upstream to the confluence with Tributary B. This C3b, plane bed, stream type has long sections that are featureless. There are few signs of erosion or deposition. There is localized aggradation above a mass

Hard wall armoring to protect Kent Hollow Road in M03-B

failure on the river left that is created by a large woody debris jam, which is currently blown out. The most noticeable in-stream impacts are five bridges and rip-rapped banks to protect their abutments. All five bridges represented bankfull and floodplain constrictions but only one bridge has upstream scour and another has an alignment issue. There is over 680 ft of bank armoring on the right bank and over 20 percent of the reach is straightened, including a section of a 9 ft high wall hard armoring (see photograph). This armoring protects Kent Hollow Road which paralleled M03-B for its entirety – constituting a river corridor encroachment and a human-caused change in valley width. Although Kent Hollow Road represents a channel and valley lateral constraint, the confinement for M03-B is “broad”. In addition to Kent Hollow Road on the right bank, residential development and pastureland reduce buffers over 1,300 ft of streambank to less than 25 ft on the left bank. Historic incision was documented in this segment but there are no current major adjustments. M03-B is therefore classified as being relatively stabilized in stage V of the CEM. The RHA scored “good” with low scores for diversity of velocity/depth patterns and channel alteration parameters. The RGA scored “good” with a stream sensitivity rating of “moderate”.

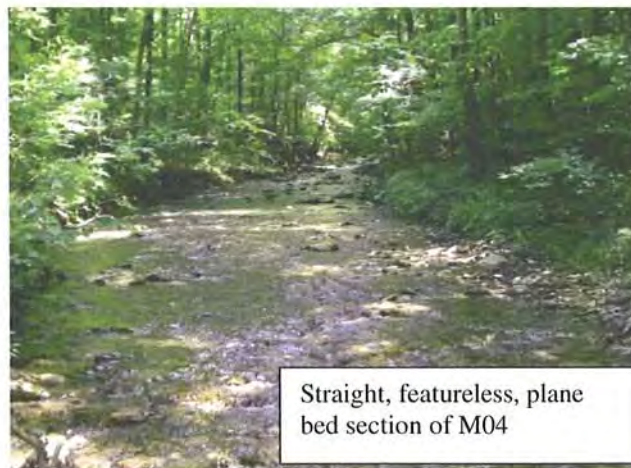
M04 began at the confluence of Tributary B and extended 4,524 feet upstream. Similarly to M03-B, this reach is also a plane bed system. Historic incision in M04 has resulted in a stream type departure. A reference C system has degraded into an entrenched B4 stream type. There are lateral constraints to protect Kent Hollow Road where the stream abuts the road in M04. There is riprap protecting a residential development on the right bank at the upstream end of the reach. Suppressing the sinuosity of M04 with hard bank armoring resulted in 889 feet of riprap and 1,029 ft of a buffer less than 25 feet on the right bank. Otherwise, the riparian corridor is primarily forested. Kent Hollow Road represents a river corridor encroachment at the upstream and downstream ends of the reach where the road is within approximately four channel widths of the meander centerline of M04. The aforementioned stressors have resulted in stream bed degradation which is evident from high incision ratios from two cross-sections and one instance of tributary rejuvenation. This historic incision has prevented access to the historic floodplain on the right corridor (current pastureland) as the left valley wall is adjacent to the left bank. There is erosion observed on the outside of meander bends and on both banks at a riffle indicating active widening. Therefore, M04 is in stage III of the CEM. The RHA scored a “fair” due to low values for frequency of riffles/steps, diversity of velocity/depth patterns and channel alteration. The RGA also scored “fair” (due to low values for both degradation and widening) and a stream sensitivity of “high”.

Straight, featureless, plane bed section of M04

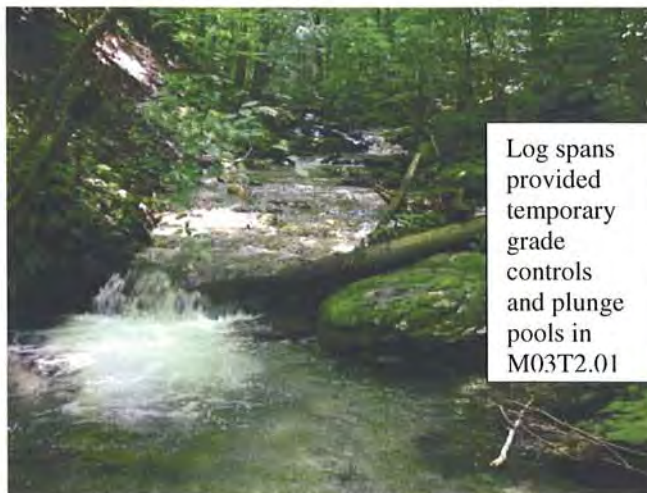
This is a very long reach (9,024 ft) beginning at the confluence of White Creek and extending upstream to the third major tributary on the right bank. The bottom one third of the reach is impacted by residential development and Hidden Valley Road in the right river corridor. There is over 300 feet of rip rap protecting the road which is directly

on the right stream bank, which also caused 839 feet of streambank buffer to be less than 25 feet on the right bank. The effect of lateral constraints is apparent downstream; there are four mass failures on the left bank. Straightening and floodplain encroachment from Hidden Valley Road caused historic incision at the very bottom of the reach. However, some of the mass failures seemed to be initiated from large woody debris jams, which are currently blown out. Progressing upstream, Hidden Valley Road

Log spans provided temporary grade controls and plunge pools in M03T2.01

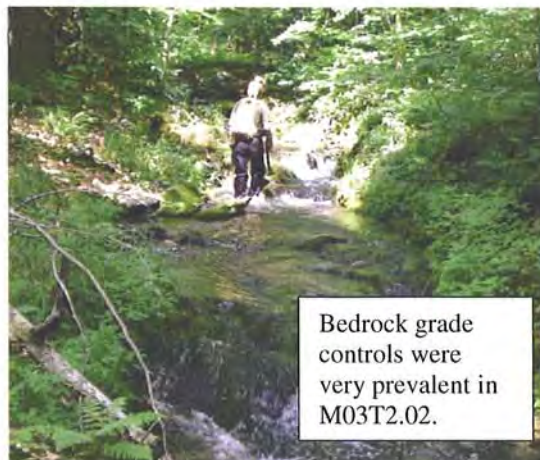
This was the longest reach (10,620 feet) in the watershed, and extended from the end of M03T2.01 to the headwaters of Tributary B at an elevation of 2,300 feet. This extremely steep reach has no human in-stream impacts and a completely forested watershed (with limited managed logging in Merck Forest and Farmland Center land). There are no river corridor encroachments, straightening or stream bank buffers less than 25 feet. However, there was moderate natural erosion on the left and right banks

Bedrock grade controls were very prevalent in M03T2.02.

and a logging road stream ford. There is 706 feet of erosion on the right bank, which is almost twice as much feet of erosion as on the left bank. M03T2.02 is a high gradient, entrenched, A3 step-pool stream type. This reach contained eight bedrock grade control features (see photograph) and approximately 16 log spans providing temporary grade control. There are 126 pieces of large woody debris in M03T2.02. The RGA and RHA scored “reference” with a stage I CEM and a “high” stream sensitivity.

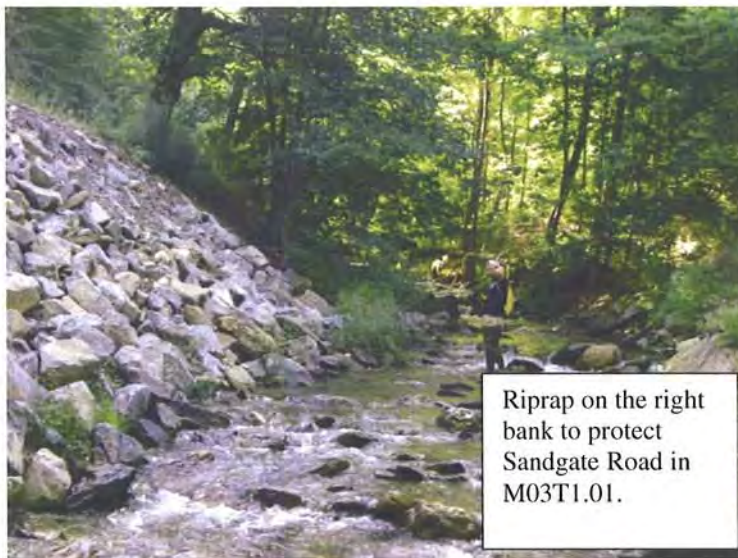
Riprap on the right bank to protect Sandgate Road in M03T1.01.

There are 154 feet of hard bank armoring on the right bank (see photograph) to protect Sandgate Road, which caused a right buffer to be less than 25 feet for 528 feet. Lateral constraints on the right bank contributed to 566 feet of erosion on the left bank, which is twice as much erosion as documented on the right bank. In the middle of the reach there is one large by-pass for a residential pond. M03T1.01 contains three structure crossings of Sandgate Brook for residential access on the south side of the brook. Two bridges represent bankfull and floodplain constrictions, and a culvert is not aligned properly and is undersized, resulting in upstream deposition. Sandgate Road is set back from Sandgate Brook for the upstream half of this reach.

Overall, M03T1.01 is a relatively stable reach with erosion due to the effects of in-stream straightening. The lateral constraints have not caused streambed degradation as there is a small accessible floodplain at most points in the reach. Thus, the reach is classified in stage I of the CEM. M03T1.01 is a B4, step-pool system with a “good” RGA and RHA scoring and “moderate” stream sensitivity.

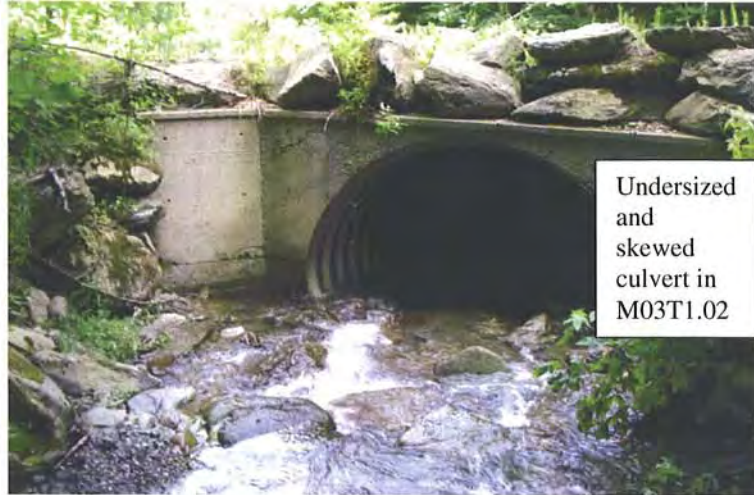
Sandgate Road represented a river corridor encroachment for the entire length of M03T1.02, which is crossed by Sandgate Road twice as it extends upstream 4,467 feet

from the upstream end of M03T1.02. This reach is steeper and its streambed substrate is dominated by cobbles (as opposed to gravel in M03T1.01), classifying M03T1.02 as a B3a, step-pool, stream type. There is one waterfall bedrock grade control in this reach. There are six different instances of bank revetments totaling 586 ft of rip rap just on the right bank. In total there is over

2,800 feet of straightening, 979 feet of stream buffer on the right bank and 231 feet of stream buffer on the left bank less than 25 feet due to the impacts of Sandgate Road. The hard bank armoring on the right bank resulted in increased erosion on the left bank, including one mass failure on the left bank that is 18 feet high and directly downstream from riprap on the right bank. Much of the original small floodplain on the right bank is encroached by Sandgate Road. However, there is some accessible floodplain on the left bank in sections. Both of the culverts for the Sandgate Road crossing are undersized and have alignment issues resulting in either the need for upstream riprap or scour (see photograph). M03T1.02 scored “good” for the RGA and RHA with “moderate” stream sensitivity as it is classified in stage I of the CEM.

- Replace the second culvert under Sandgate Road. It is undersized and skewed, causing deposition and scour.
