Phase 2 Stream Geomorphic Assessment

**East Creek Watershed
Towns of Rutland, East Pittsford, and Chittenden
Rutland County, Vermont**

March 2007

Re: Phase 2 Stream Geomorphic Assessment
East Creek Watershed
Rutland County, Vermont
JCO Project No. 1-1872-5

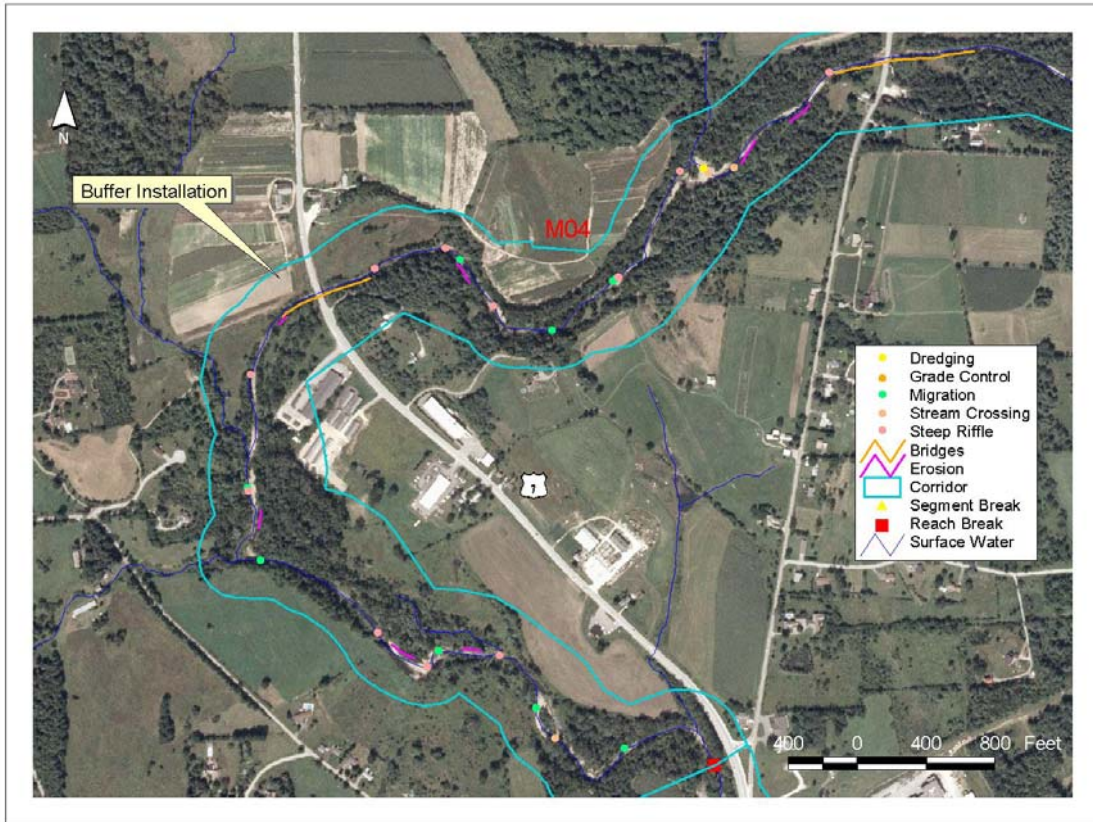
Figure 3 Proposed buffer installations on the right side of Reach M04

The reach is well buffered by trees on both sides with buffer widths ranging from 51 feet to more than 100 feet. The geomorphic assessment rating was “good”, 0.7, and the habitat assessment rating was also “good”, 0.7. This is a high gradient stream showing evidence of aggradation by the number of mid, point, and side bars and steep riffles. Some scalping of gravel from a point bar was noted. Effects of the Glen Dam can be observed at the upstream end of the reach.

Two bridges were located in this reach which showed deposition above and below and evidence of scour. While not forming channel constrictions, these bridges were flood prone constrictions.

While this reach is generally well buffered, inadequate buffer widths were noted adjacent to fields in agricultural use. Buffer installation on these fields is recommended.

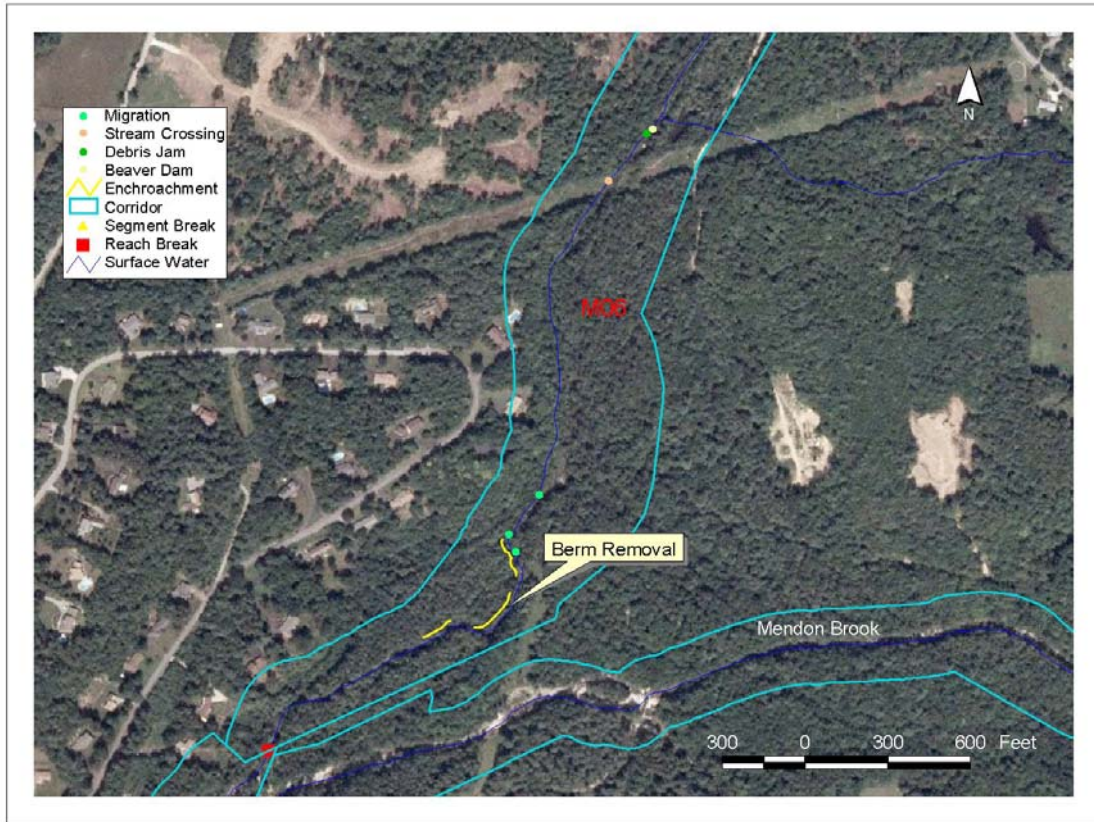
Figure 4 Potential for a berm removal project in Reach M06

M06 extends from approximately 400 feet upstream from the confluence of the Mendon Brook with the East Creek to approximately 700 feet upstream from the bridge at East Pittsford. This reach was in regime with its reference stream type C. The stream is slightly incised, incision ratio 1.2, but not entrenched (entrenchment ratio 11.8), so it still has floodplain access at high flows. It was found to be in Stage II of evolution with a very high sensitivity rating, which indicates that the stream is currently incised. Active channel migration was evidenced by flood chutes. A ledge provided bedrock grade control within the reach. Berms were noted on both sides of the downstream portion of the reach, limiting the floodplain access.

The reach was well buffered by trees on both sides, with buffers generally in excess of 100 feet wide. This is a high gradient stream and a large amount of woody debris was noted in this reach. The geomorphic assessment rating was “fair” but the habitat rating was “good”. Two beaver dams and one debris jam were located on the lower to mid-portion of the reach acting as grade control and channel constriction. One bridge was located in this reach which acted as a channel constriction.

Removal of the berms which are corridor encroachments in this reach is recommended. Also, this reach is relatively undeveloped and contains some riparian wetlands, so a Corridor Protection Plan is also recommended.

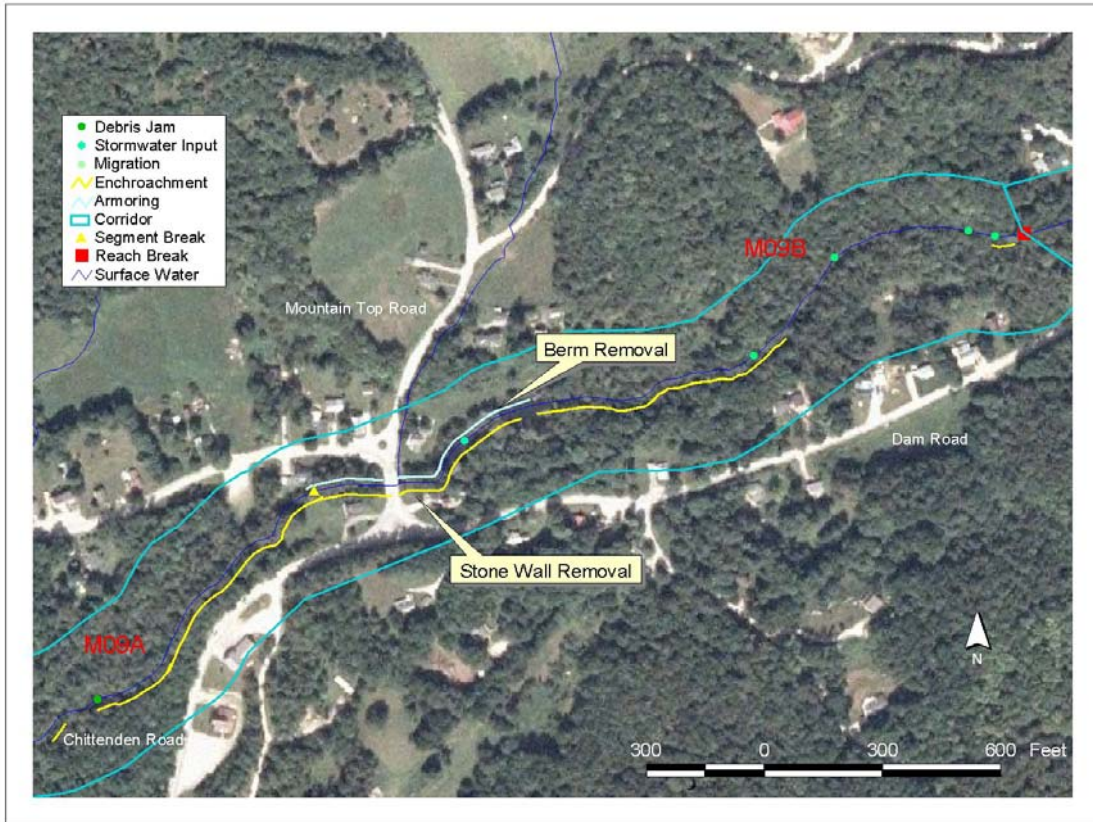
Figure 5 Segmentation of Reach M09 and potential sites for berm and stone wall removal

M09B extends from approximately 100 feet downstream from the Holden Road bridge to approximately 400 feet downstream from the culvert at the Fox Creek Inn. This segment had departed from its reference stream type C to a type B. The stream is highly incised (incision ratio 3.5 and entrenchment ratio 2.3) and was found to be in channel evolution Stage II, with a very high sensitivity rating. Active channel migration was evidenced by flood chutes. One debris jam acted as channel constriction. The stream has lost access to its historic floodplain and is now confined by a terrace on the left side and a berm on the right side that is continuous along almost all of the right side of the segment. The distance from the top of the terrace to the valley wall is less than 50 feet and the distance from the top of the berm to the valley wall are approximately 100 feet. Both the geomorphic and habitat assessment ratings for this segment were “fair.” The bridge at Holden Road in Chittenden Village was undersized and showed evidence of scour both above and below.

The areas of erosion noted were limited, but the reach was armored with rip-rap and stone walls. One channel avulsion was noted near on the upstream end of M09B. Historic evidence of straightening was found. The right side of this reach was not well buffered.

Since M09B is constricted by a significant berm on the right side, removal of part or all of this berm is recommended. Further study of the site is necessary to assess potential for negative impacts on adjacent property from berm removal. The removal of the stone wall that acts as a revetment is also recommended.
