**VAIL BROOK STREAM GEOMORPHIC ASSESSMENT**  
**HILARY SOLOMON**  
**POULTNEY METTOWEE WATERSHED PARTNERSHIP**  
**NOVEMBER 10, 2007**

**INTRODUCTION**

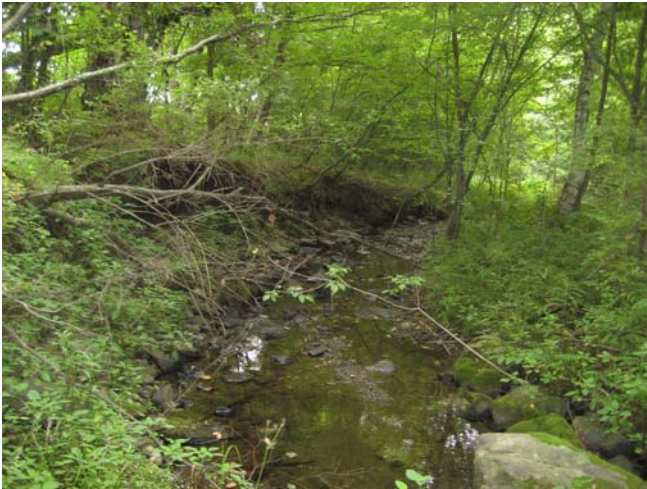
The geomorphic score was (a marginal) “good” and the habitat score was “fair”. The main stressor was deposition including islands, some braiding, and a long section of dry creek bed. This section of brook also had a relatively high level of erosion and was degrading slightly. The sediment deposition resulted from the bed and banks in this reach as well as upstream reaches S1.01C, S1.02A, and S1.02B, which are all degrading and widening.

Photo 1: Erosion and leaning trees along an outside bend in the upstream section of this reach.

Potential Projects: Notify landowners along this section of the assessment results and allow them to monitor the continued adjustment of the brook.

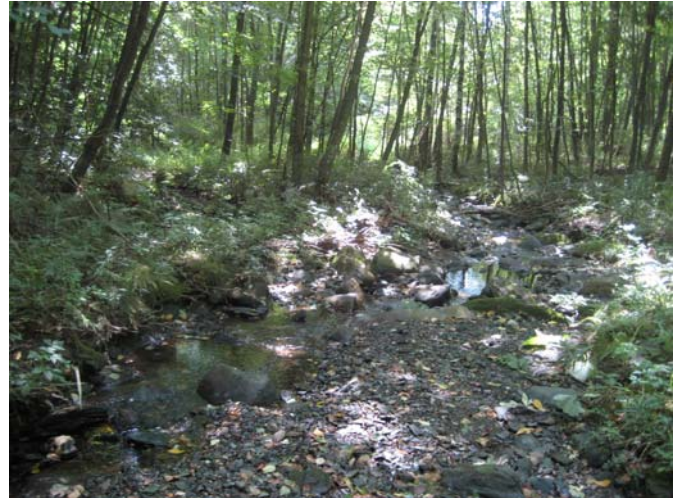
Photo 2: Island with stream actively flowing on both sides and some gravel deposition in foreground.

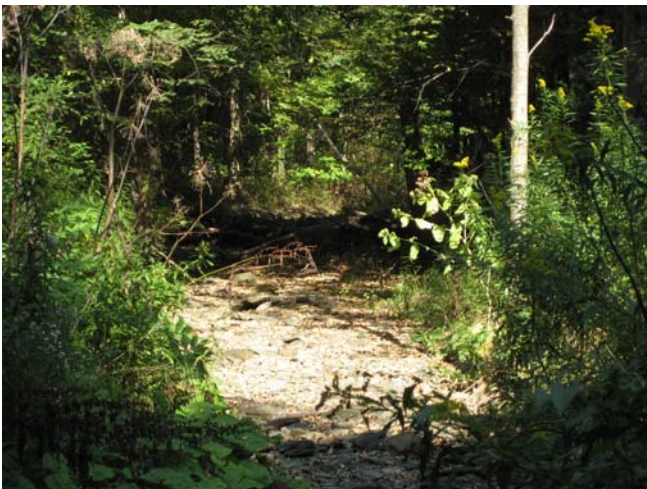
Photo 3: Dry channel in middle section of segment. This section was largely plane bed, though up- and downstream sections had more riffle/pool development.

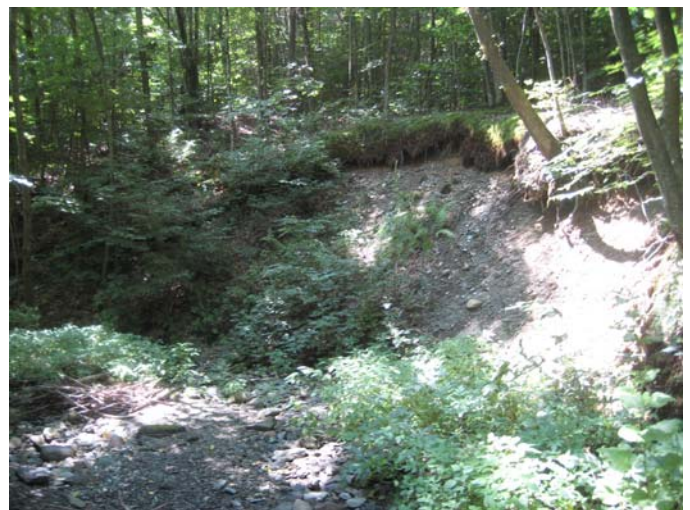
Photo 4: Dry section and erosion on sharp, outside bend upstream of a culvert. Again, note deposition upstream of bend.

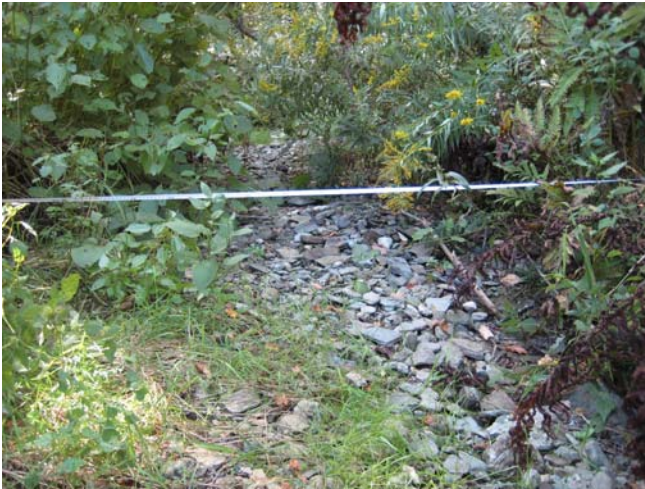
Both the geomorphic and habitat scores were “fair” for this segment due to poor channel flow (no water in the channel), lack of epifaunal cover, high sediment deposition, low bank stability, lack of trees in the riparian area, some degradation (one nickpoint), and poor channel development.

Photo 1: Gravel bottom and herbaceous banks along this segment. Note dry channel bed.

Potential Projects: Notify landowner of the assessment results and continue to monitor the migration and adjustment of this section. This section is located in a fallow field and should be allowed to adjust naturally until it achieves a stable planform.

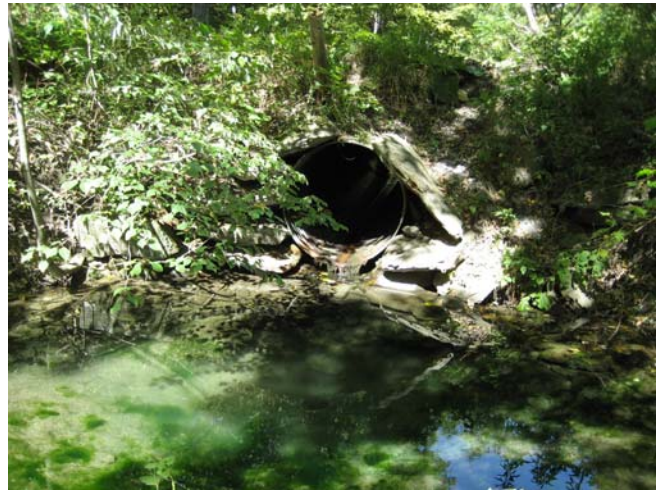
Photo 2: Downstream end of culvert under Norton Road. Deep pool sheltered many trout. Water actively flowing downstream of the culvert.

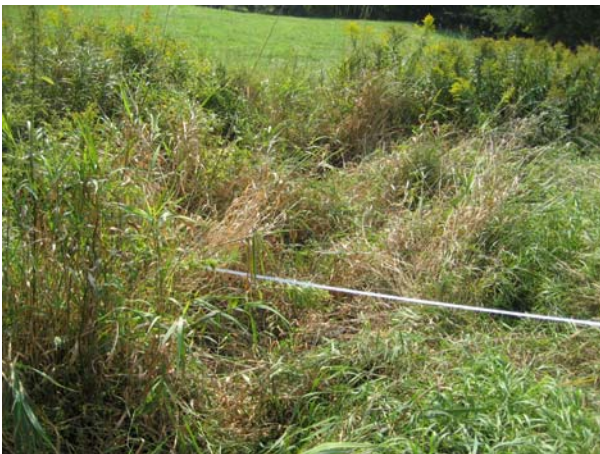
The geomorphic score for this section was “fair” due to signs of degradation, aggradation and widening. Pressures from the new dam and degradation upstream seem to be destabilizing this section of stream and planform changes were beginning to accelerate. The farmer who hays the field remarked that both this section and the upstream section were becoming deeper and more unstable in the last few years (personnal communication, Eric Tarbell, 8/30/2007). The habitat score for this segment was poor due to lack of cover, high embeddedness, poor channel flow (no water), lack of depth/velocity variety, lack of developed riffles or steps.

Photo 1: Grassy channel with hay field in background. Channel is beginning to erode and regain some (limited) sinuosity. Tape measure is set at bankfull-note narrow channel with wide benches on each side.

Potential Projects: Notify landowner of assessment results and apparent degradation. Continue to monitor this section of stream as it adjusts. Once it reaches a stable planform, plant the riparian buffer area with native trees and shrubs.

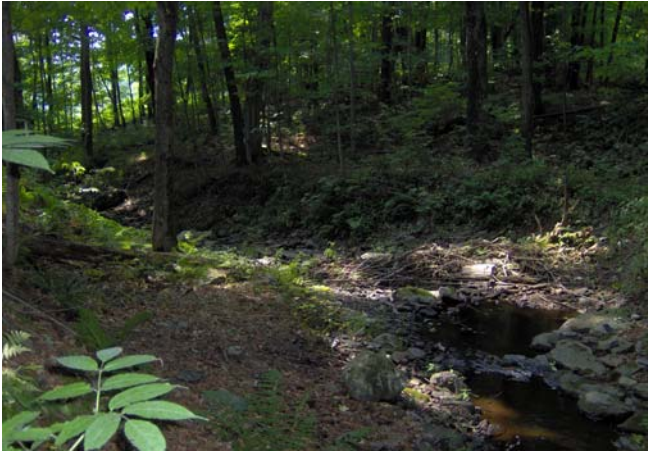
Photo 1: End of bedrock control. Note some floodplain access at upstream end (bottom of photo), but degradation past debris jam.

Potential Projects: Notify landowners of assessment results and apparent degradation. Potential to create grade controls to arrest degradation.

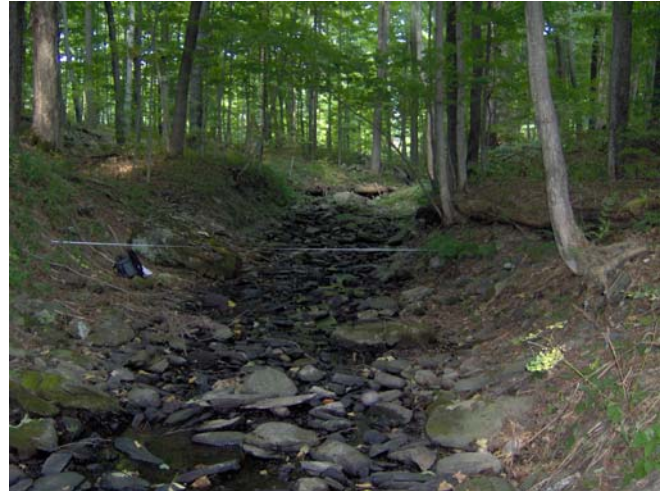
The geomorphic and habitat scores for this section were moderated by the upper step-pool section of this segment. The geomorphic score for this section is “fair”, due to degradation and widening. The habitat score was (a high) “fair” with lack of cover, velocity/depth variety, lack of developed riffles/steps and active channel alterations.

Photo 2: Degraded section. Notice tree roots protruding on left side of photo indicating recent degradation. Also note plane bed features in foreground.

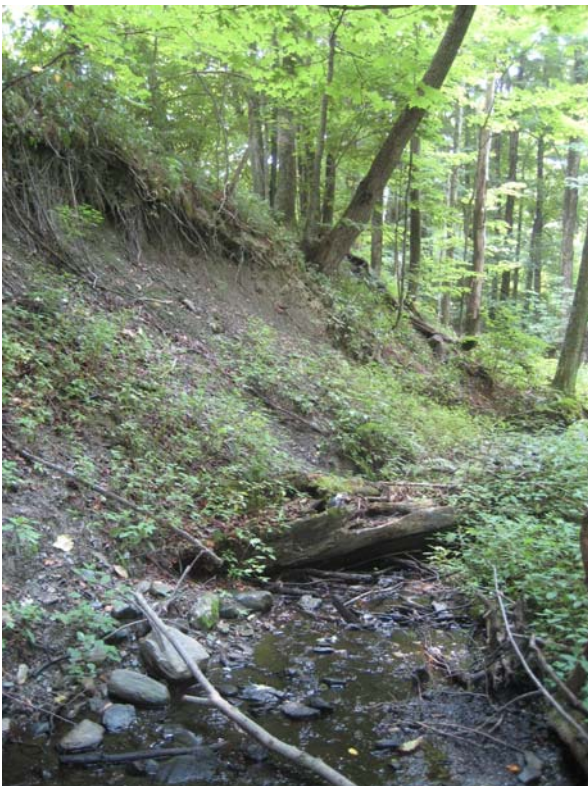
Photo 1: Erosion along valley wall. This section had lots of large woody debris.

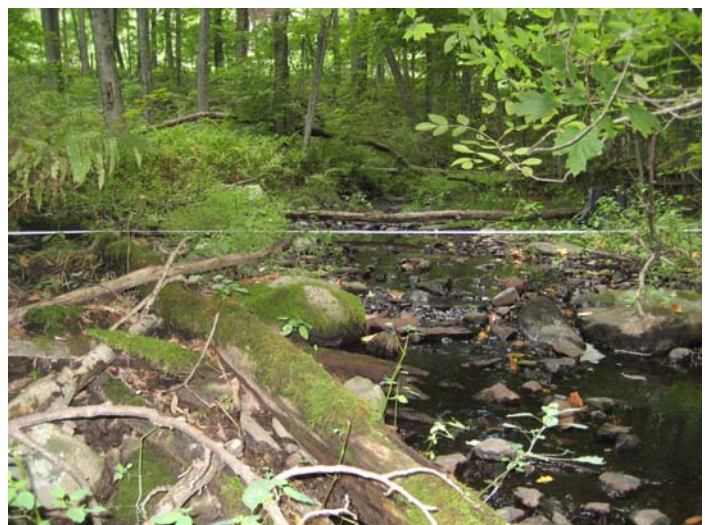
Photo 2: Flat cross section and adjacent (wet) stream valley.

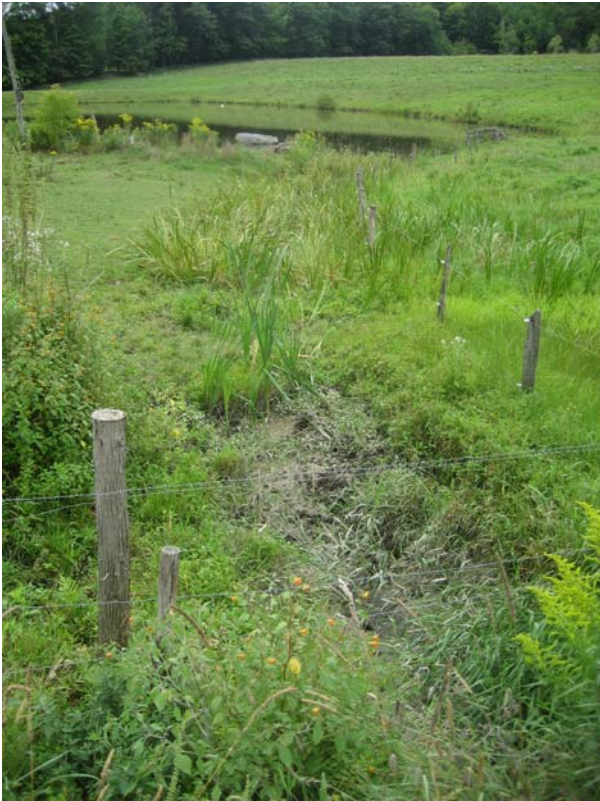
Photo 1: Stock pond at downstream end of this reach

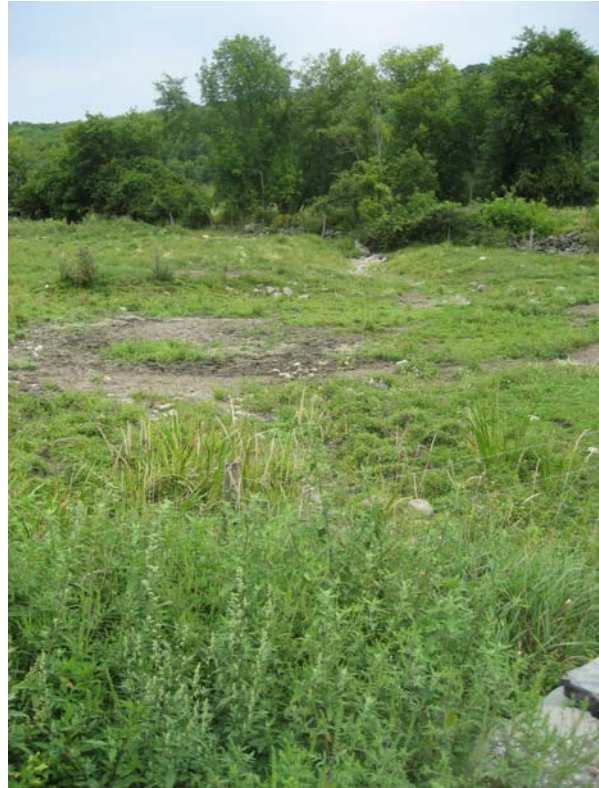
Photo 2: Filled in area upstream of stock pond where farmer digs settling ponds for road settlement.

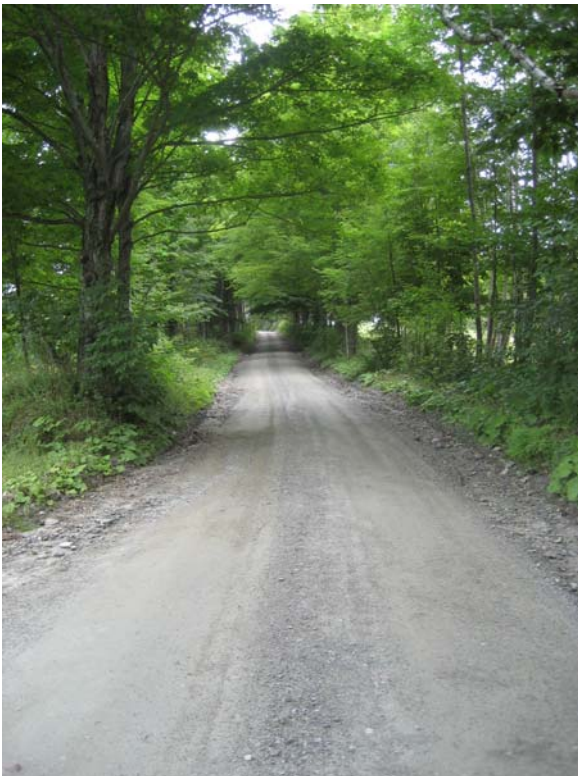
This reach was not assessed due to lack of access, however, during an interview the landowner expressed some concerns about sediment from road runoff entering this section of stream. The farmer generally digs a small pond, just upstream of the existing stock pond that helps to settle sediment from the road and protect his pond from infilling. A long stretch of Spruce Knob Road, without well-developed ditches, drains to this reach. This reach flows through a cow pasture. It is ephemeral and the channel is not well-developed. It lacks riparian buffers and is accessed by the cattle.

Photo 3: Erosion on both sides of Spruce Knob Road drains to Vail Brook.

Potential Projects: Notify Town of Middletown Springs about the potential for Better Backroads Projects along this section of Spruce Knob Road. Contact the landowner about the potential for cattle exclusion fencing through the pastures and riparian plantings.

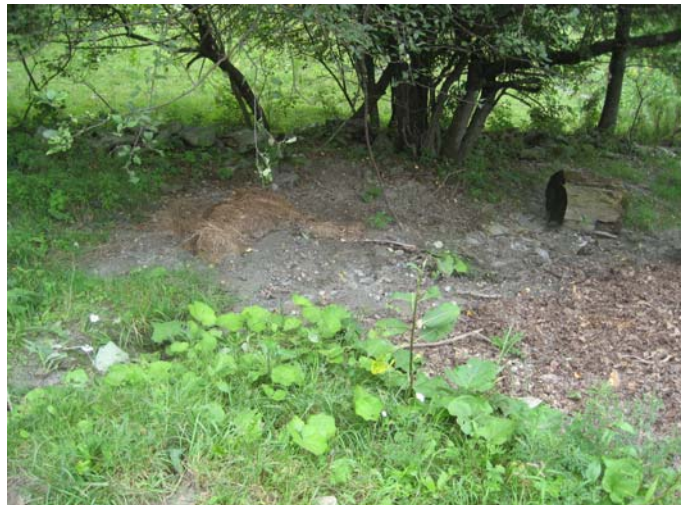
Photo 4: Sediment draining to Vail Brook.
