Lewis Brook & Finel Hollow Brook

Phase 2 Stream Geomorphic Assessment Report

Rutland Regional Planning Commission
August 20, 2006

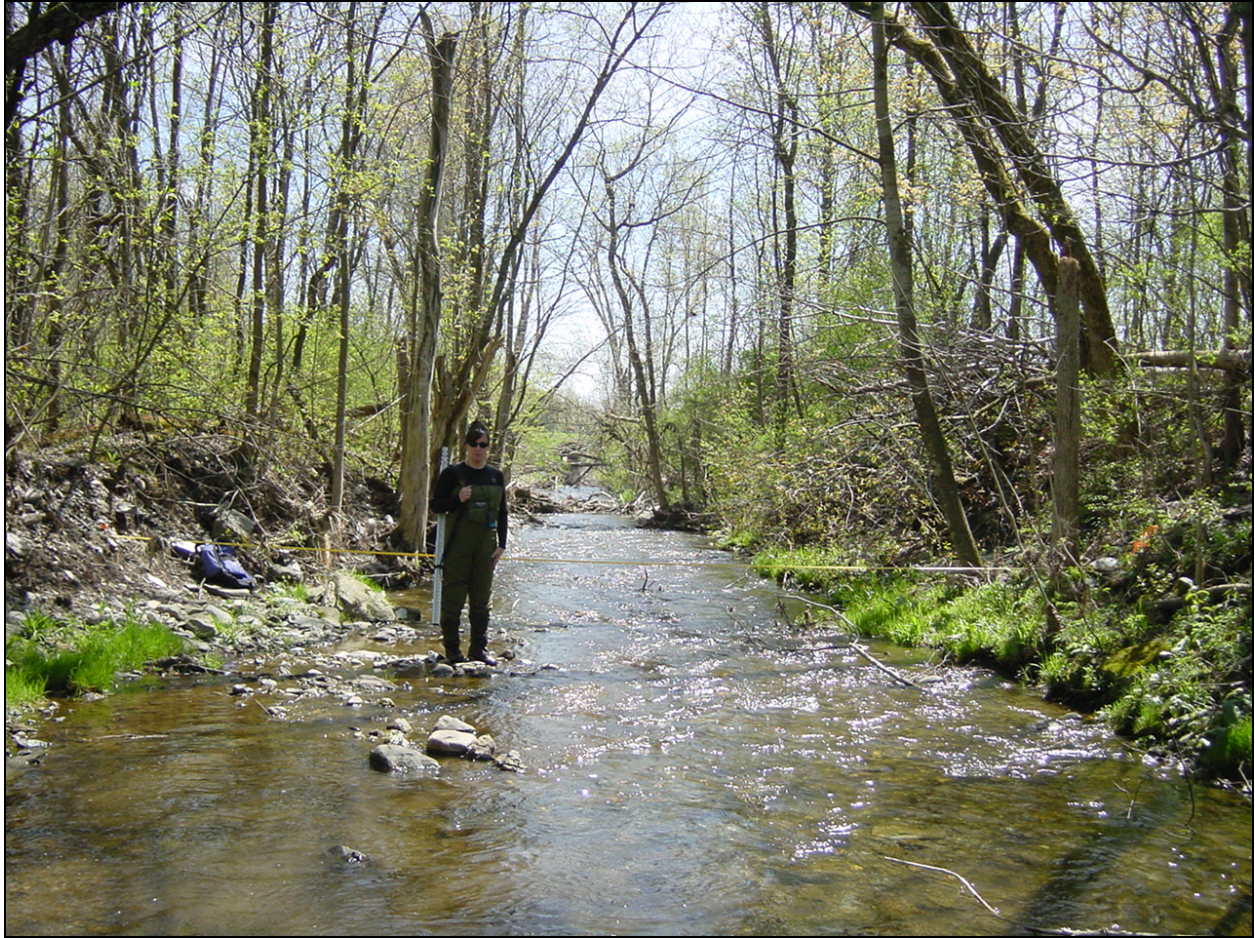
Figure 4. Berms on both banks in Segment M08S1.02B.

Segments M08S1.02B, M08S1.04D, and reach M08S1.05 appeared to be in stage II of the F-stage channel evolution process. M08S1.02B was confined by berms on both banks and appeared straightened and incised due to the presence of the berms. Reach M08S1.05 was in a narrow valley and was further confined by a road and likely straightened as well.

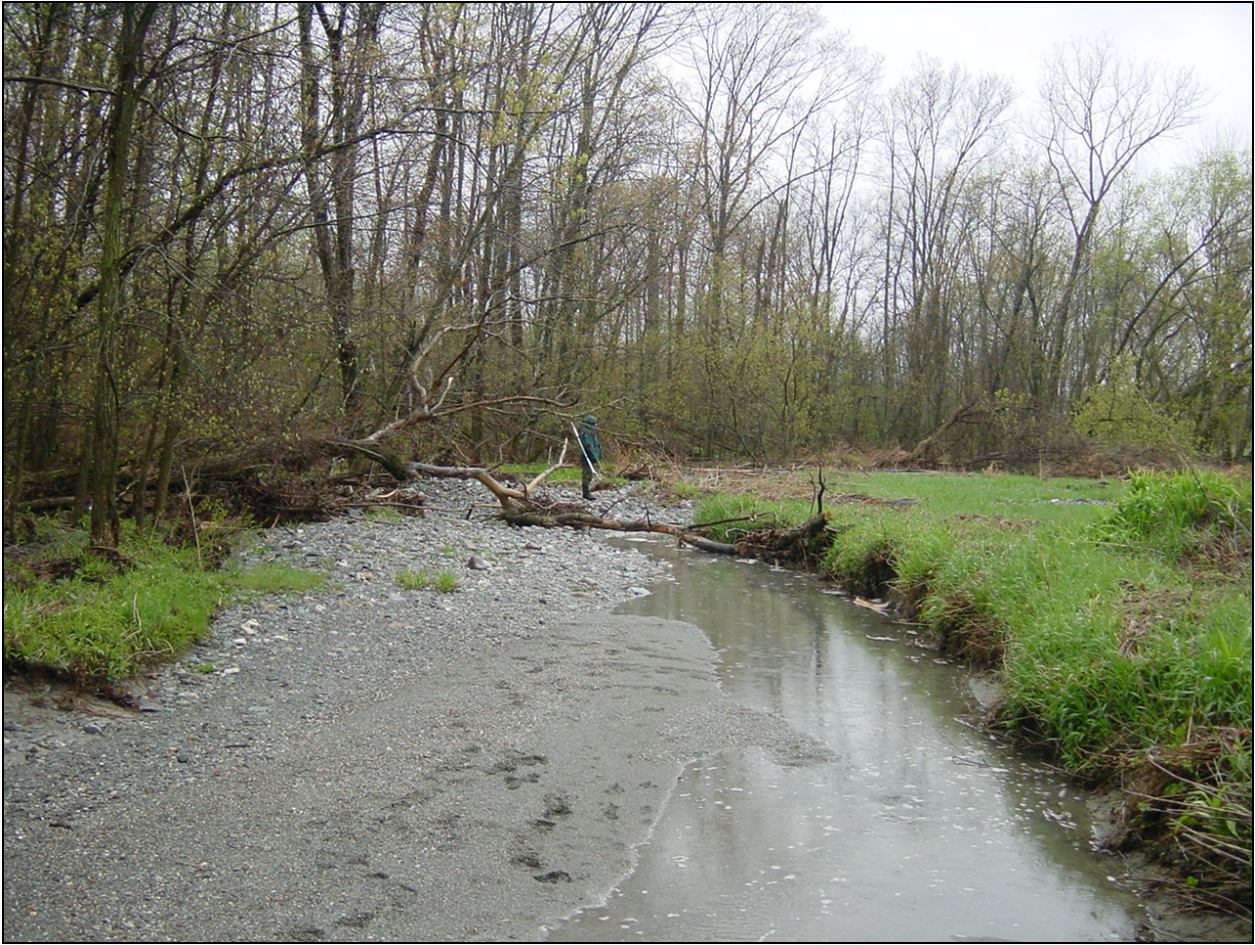
Figure 5. Extreme aggradation in Lewis Brook, resulting in subterranean stream flow.

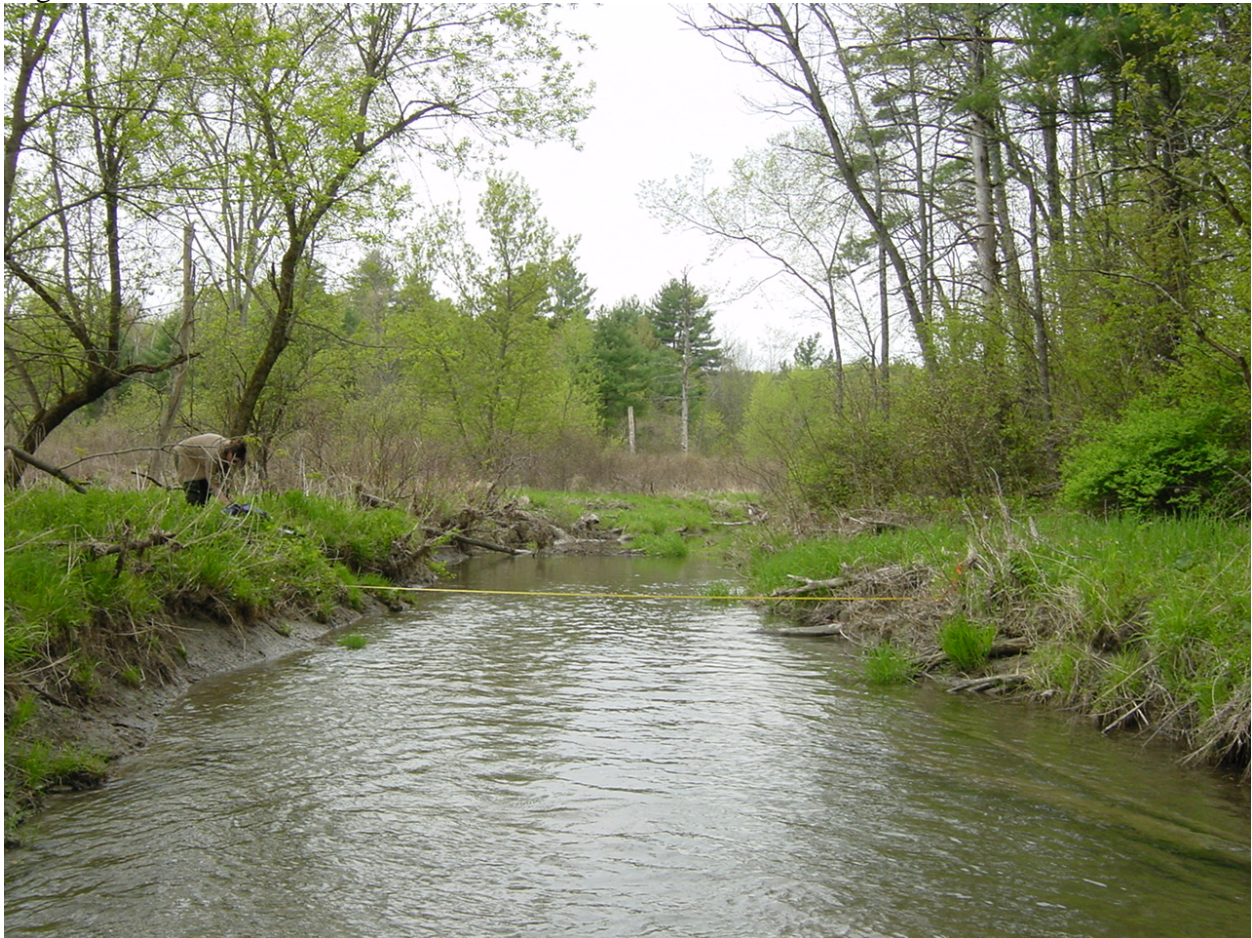
Segment A

Active flood chutes, signs of old meander bends, old avulsions, and neck cutoffs were seen in this segment. Meander migration appears recent and one bend in particular appears to have moved about 90 feet. Beaver activity and many debris jams were observed in this segment. An old abutment (20 ft wide) constricts the channel at the upstream end of the segment. Much riparian vegetation had been removed. Planting could be a good project here, although the meander migration and beaver activity could prove detrimental to plantings. A small berm could be removed to reduce potential sediment inputs to the Poultney River. Habitat appeared to be in “Fair” condition, affected by channel alteration, sediment deposition and bank instability. The SGA indicated the stream was in “Fair” condition and in stage IV of the F-stage evolution process. Aggradation was the main adjustment process with some widening and planform adjustments as well.

M08S1.01A – This is a good candidate for corridor protection and bank planting, although the meander migration and beaver activity could prove detrimental to plantings. Planting away from the banks is recommended to reduce losses from channel migration. A small berm on the left bank could be removed to reduce potential sediment inputs to the Poultney River.

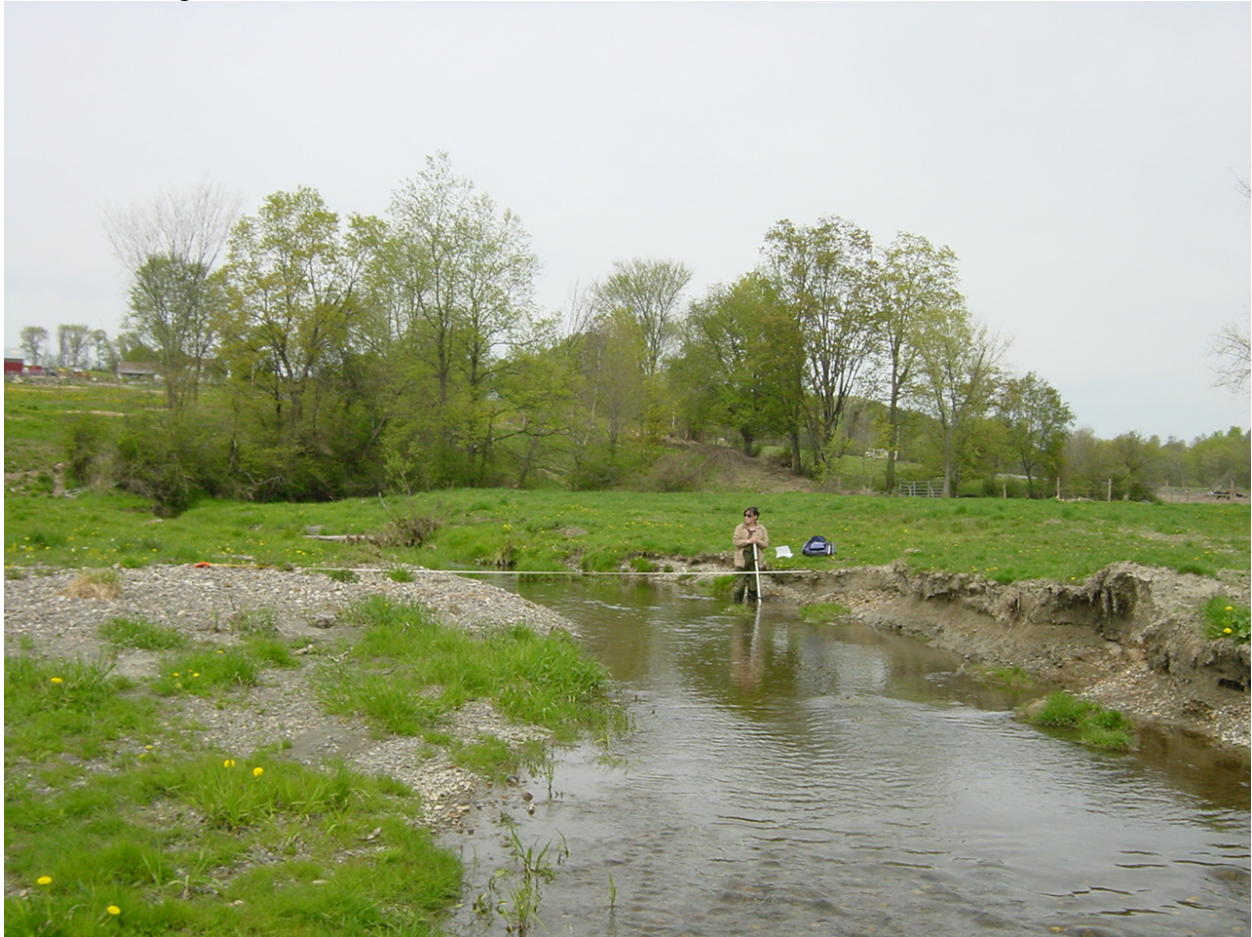
M08S1.01 Segment B

Major aggradation was evident through many depositional bars and sediment deposits on banks. The landowner reports he has seen the channel migrating to the edge of his field and undercutting the fence. Cows were allowed full access to channel here when they are in this pasture. The landowner was working with a grant program to fence along the channel. That may prove difficult to maintain due to the major planform adjustments occurring in this segment. The downstream end of the segment runs through a slate quarry with ponds. Some signs of gravel removal were observed. This segment appeared to need room to migrate and deposit its high sediment load. The segment appeared to have been straightened to improve fields at some point, now the landowner is wrestling with the stream as it attempts adjustment. Habitat condition appeared “Fair” with bank instability, lack of riparian buffer, sediment deposition, and little mix of substrate types as the main factors. Geomorphic condition appeared “Fair” and the main adjustment processes were aggradation and planform (Stage IV).

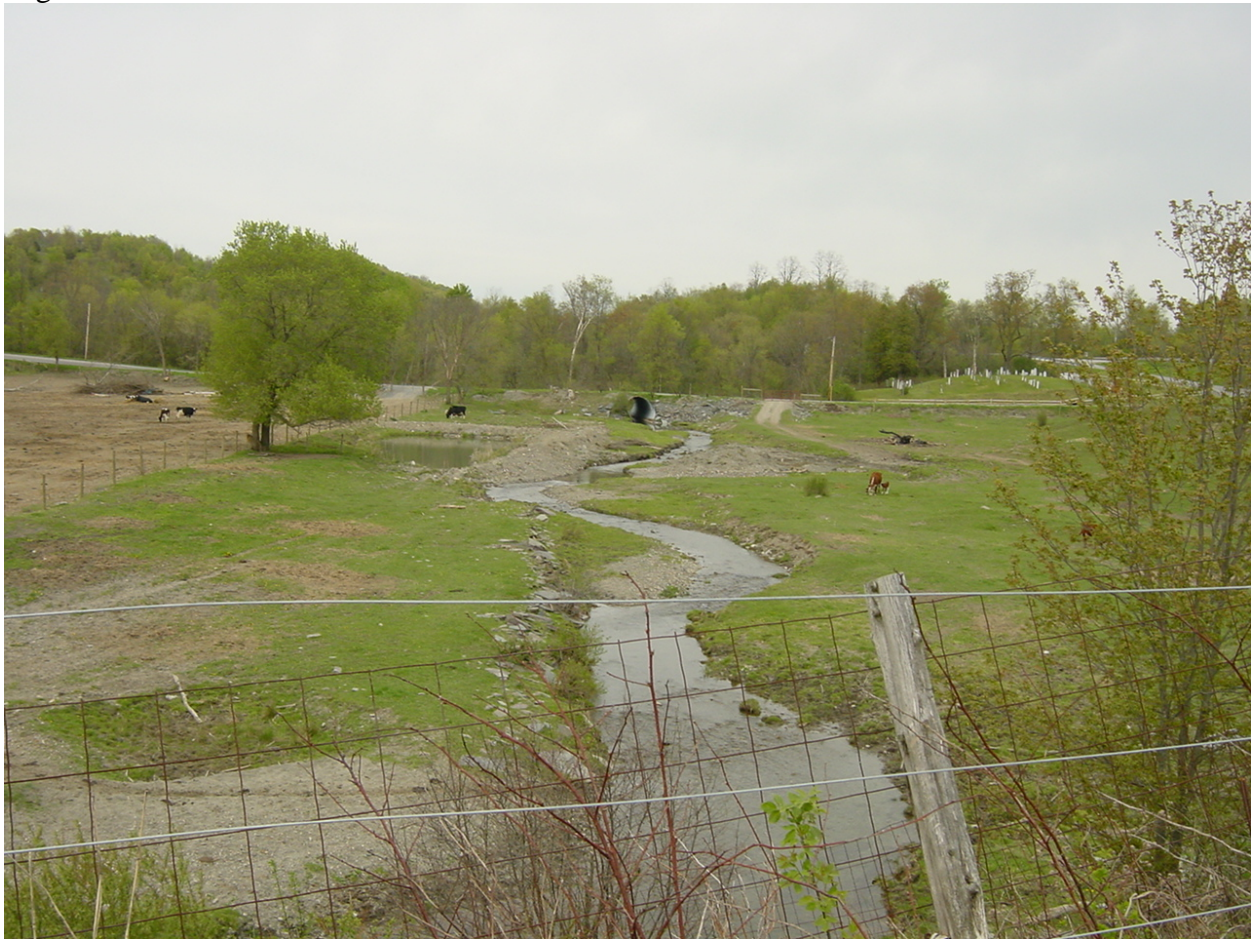
Segment A

This segment encompassed a cow pasture. The landowner was digging out channel downstream of the culvert where sediment had deposited. The landowner was enrolled in program to fence cows out of the channel in 4 years. Bulls were in the pasture at the time of assessment, so the segment was observed from the road, adjacent fields, and downstream. The cross section from segment M08S1.01B was used for this segment as well. Cows were allowed full access to channel here when they are in this pasture. Riparian and bank vegetation is absent or minimal in many areas. The landowner was working with a grant program to fence along the channel. That may prove difficult to maintain due to the major planform adjustments occurring in this segment. This segment appeared to need room to migrate and deposit its high sediment load, much of which deposits just downstream of the culvert and the landowner removes it. The segment appeared to have been straightened to improve fields at some point, now the landowner is wrestling with the stream as it attempts adjustment. Habitat condition appeared “Fair” with bank instability, lack of riparian buffer, sediment deposition, and little mix of substrate types as the main factors. Geomorphic condition appeared “Fair” and the main adjustment processes were aggradation and planform (Stage IV).

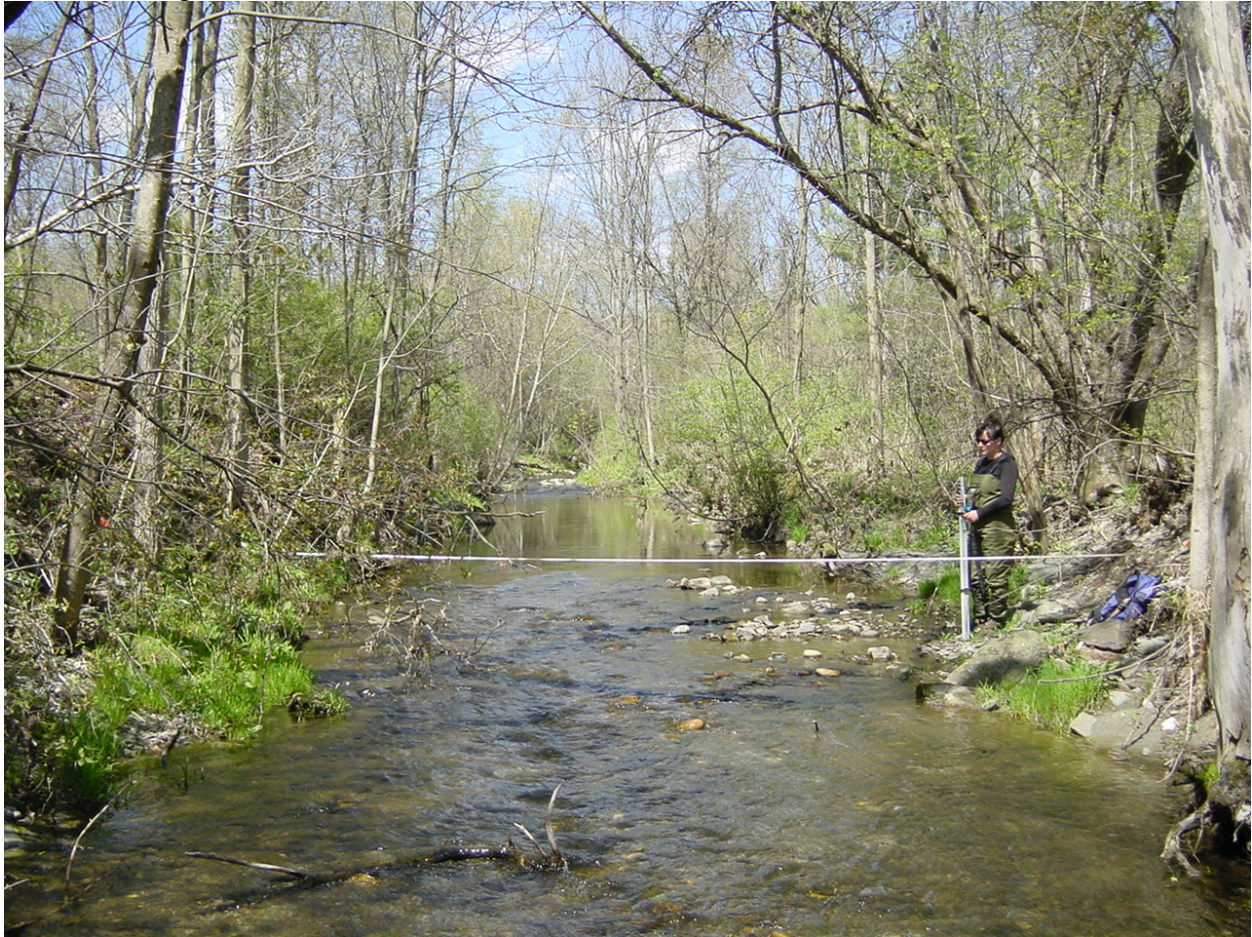
M08S1.02 Segment B

Berms were observed on one or both banks of the channel. Apparently this was an old apple orchard, so the berms were likely constructed to protect the orchard. The orchard was grown over and did not appear to be maintained. The berms appeared to be acting as a sediment supply. A potential project could be to remove the berms or move them back away from the channel to provide floodplain access. This section was segmented due to berms, larger channel substrate and steeper slope. Riffles appeared eroded. No clay was noted. The cross section shows incision, but it was attributed to the berms. The bed and banks appeared fairly stable. One culvert and one bridge constricted the channel. Buffer width was greater than 100 feet on both banks which could provide stability if berms were moved. Overall, the segment appeared to be in “good” condition and in stage II of the F-stage evolution process, due to the berms. The segment appeared fairly stable but it was bermed without floodplain access and therefore transporting all sediment. Berm removal or movement could increase sediment storage in the segment.

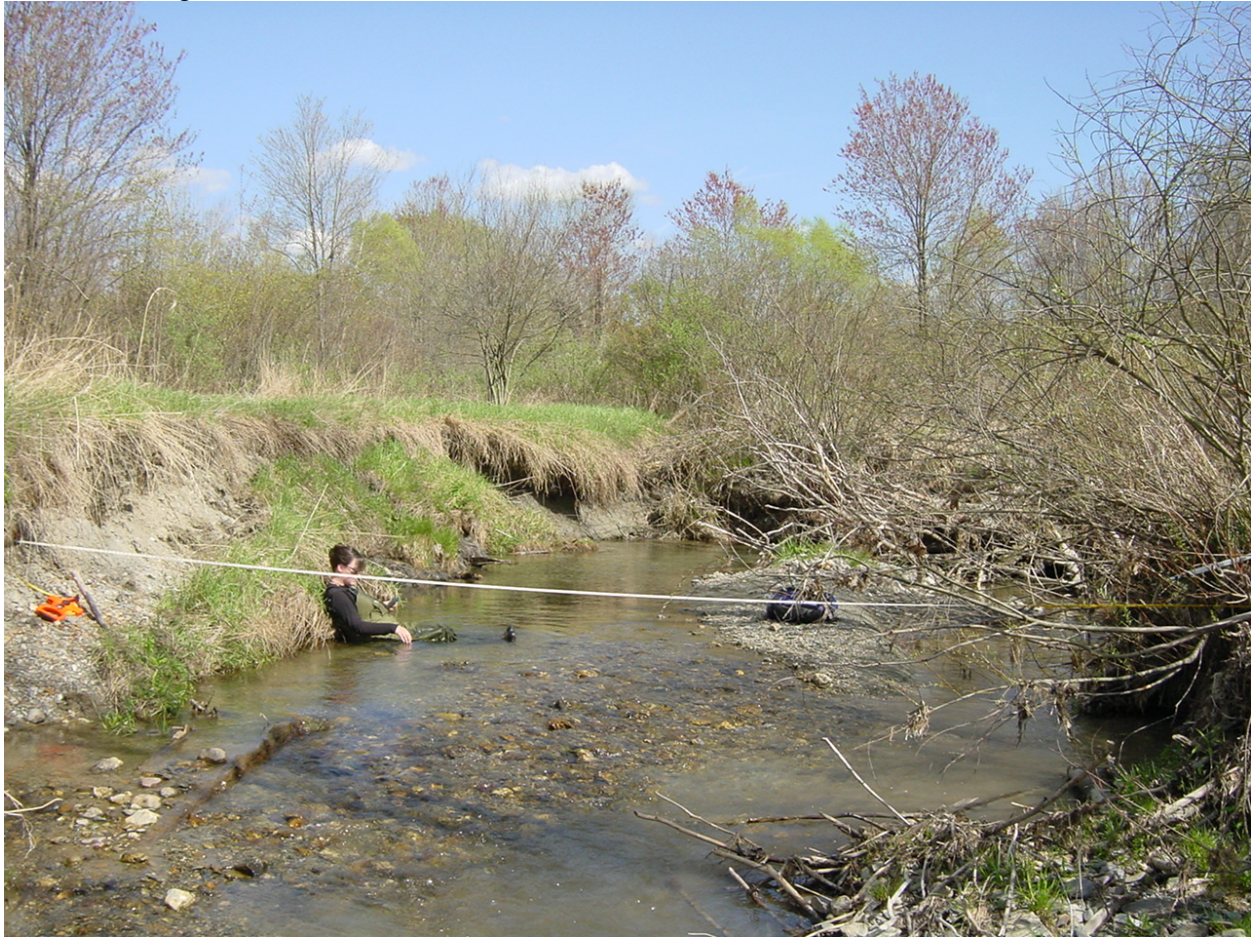
M08S1.02 Segment C

This segment encompassed a section of stream with a shallower slope. The segment appeared to be experiencing planform adjustments, and had beaver activity and a large pond. The upstream portion of the segment was aggrading and migrating laterally, fairly highly sinuous, and had floodplain access. The central portion has a large beaver dam and pond. Downstream of the dam appeared to be moderately incised and may have had past beaver dams. The channel appeared to have incised slightly (possibly due to sediment being trapped in a pond and “hungry water” scouring the channel) and was now aggrading and migrating laterally. These sections were included as one segment as the beaver activity could (and likely has) occur anywhere along the segment. Riffles appeared sedimented and a large increase in fine sediments was noted. Riparian buffer width was good, however it was comprised of herbaceous species with some shrubs-saplings. Planting along this segment could be a potential project, if planform adjustments and beaver activity were considered. Overall, this segment appeared in “Fair” condition and in stage IV of the F-stage channel evolution process. Adjustment processes were major planform adjustments with minor aggradation and widening. Stream sensitivity was “Very High.”

M08S1.02C - This is a good candidate for corridor protection and buffer planting. Planting away from the banks is recommended to reduce losses from channel migration.

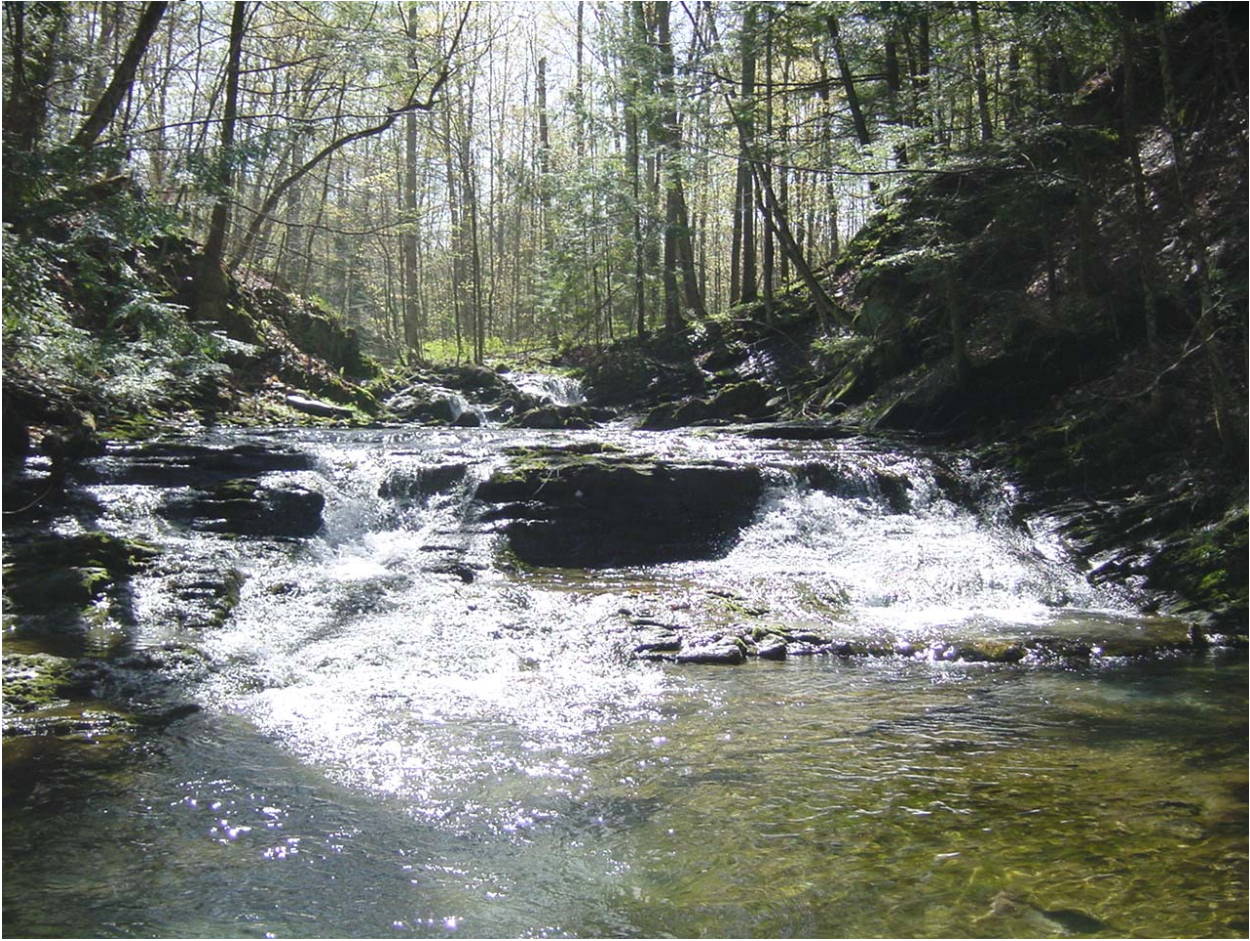
M08S1.02 Segment D

Segment D and M08S1.03A were considered in a gorge, with multiple bedrock ledges providing grade control. A large slate abutment was in the center of the channel. An old dam was also present, although now lower than its original height. Buffer width was 26-50 ft comprised of deciduous and mixed trees. The riparian corridor was forest with a road on the left and a field on the right. Adjacent valley side slopes were steep.

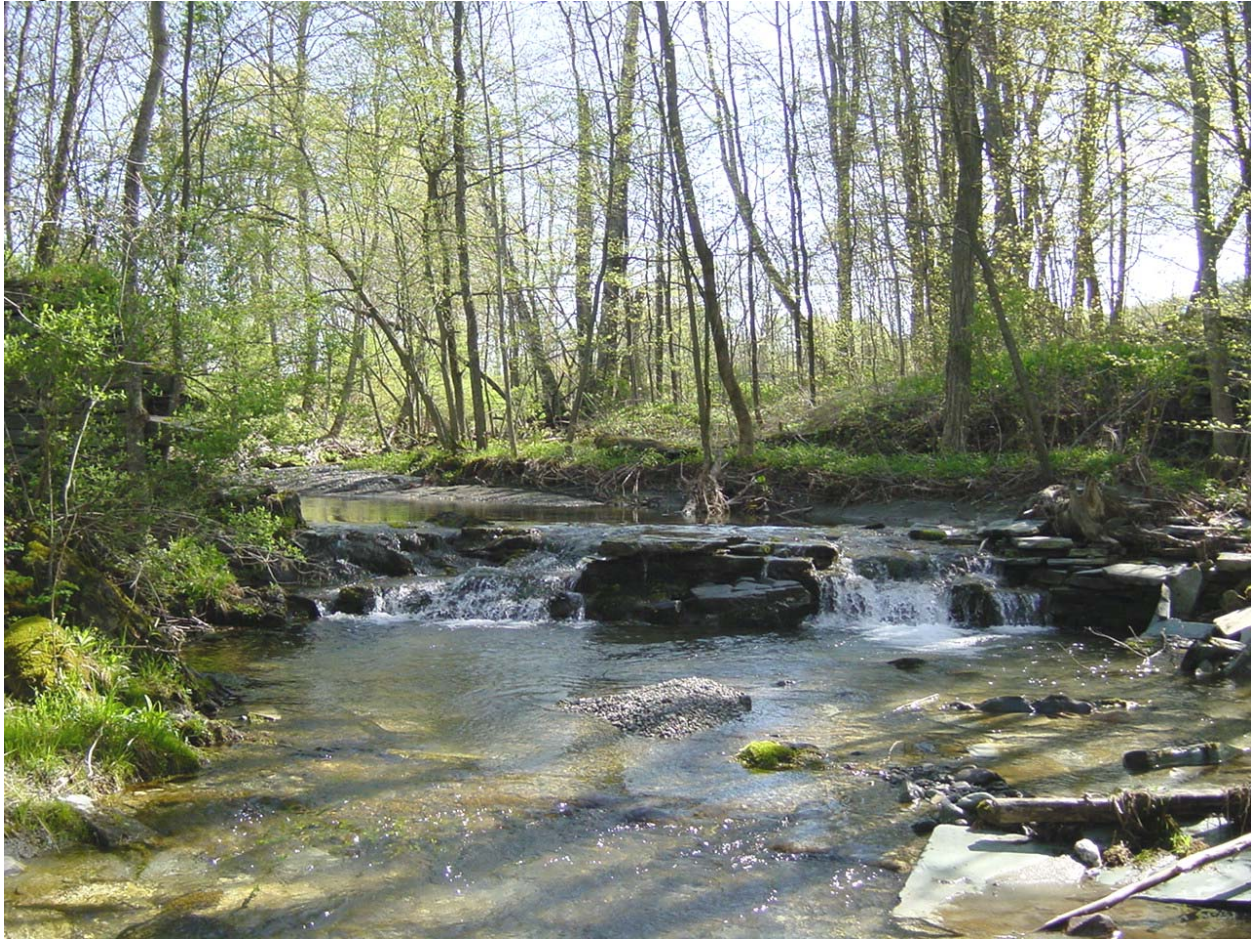
Segment A and M08S1.02D were considered in a gorge, with multiple bedrock ledges providing grade control. A large slate abutment was in the center of the channel. An old dam was also present, although now lower than its original height. Buffer width was 26-50 ft comprised of deciduous and mixed trees. The riparian corridor was forest with a road on the left and a field on the right. Adjacent valley side slopes were steep.

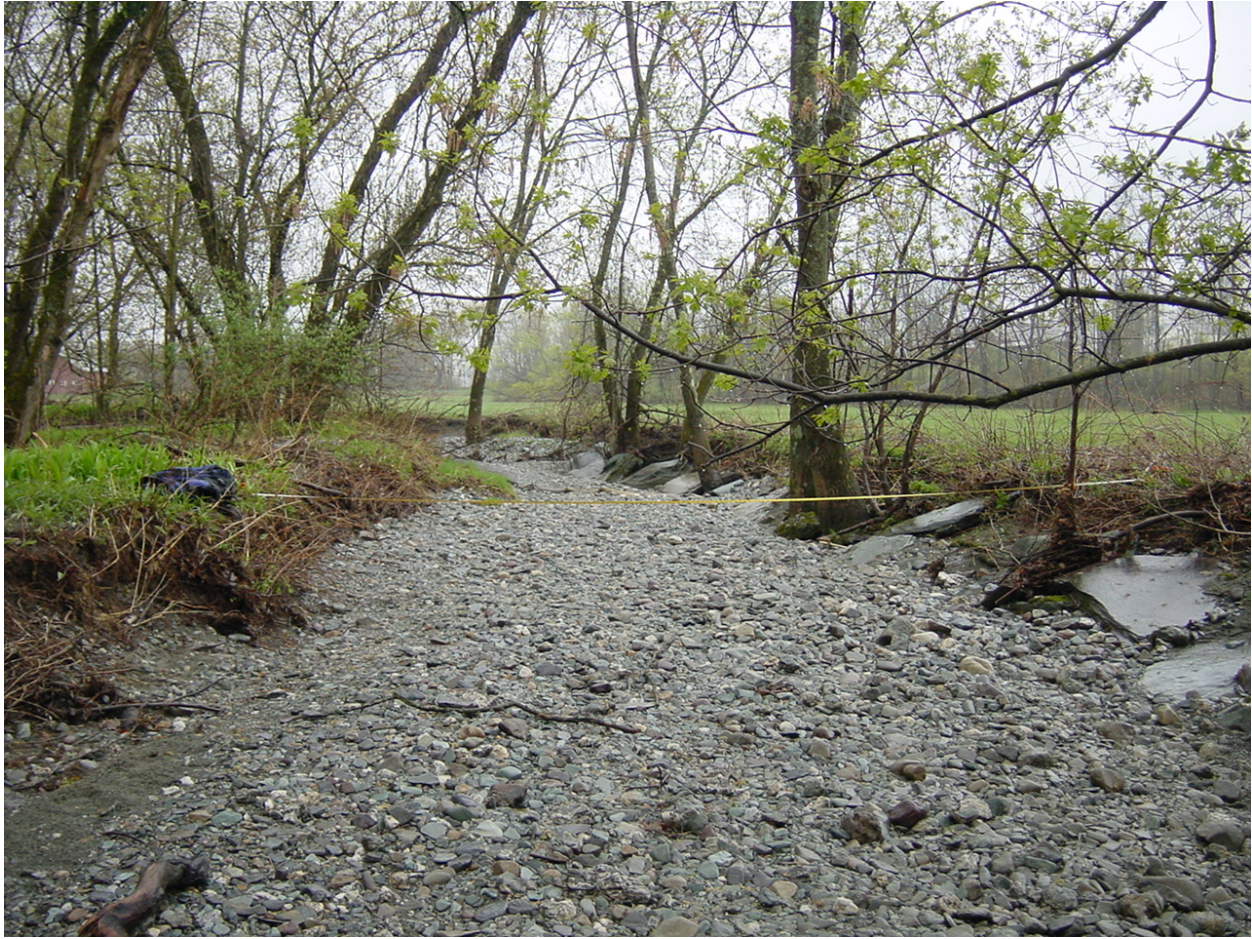
M08S1.03 Segment B

Extreme aggradation was evident in this segment through multiple point, side, and diagonal bars with channel avulsions and flood chutes. Fine gravel and sand sediments had filled the channel and spilled onto an adjacent field. Trees were buried in sediment. The landowner expressed concern, however we have not yet discussed this segment in detail. Riffles appeared sedimented, with pool present only where flow has scoured around trees and logs. This channel had been dry in the days before the assessment but this segment had some flow in areas and pools during the assessment due to recent rain. The cross section location was dry. Flow was likely subterranean due to heavy buildup of sediment. The heavy supply of sediment was likely from upstream of the assessment reaches, in an area of clearing in the upper watershed. RGA and RHA conditions were “fair” with aggradation and planform the dominant adjustment processes and minor widening. The segment appeared to be toward the end of stage III of the F-stage model. Segmentation was due to floodplain access and adjustment process.

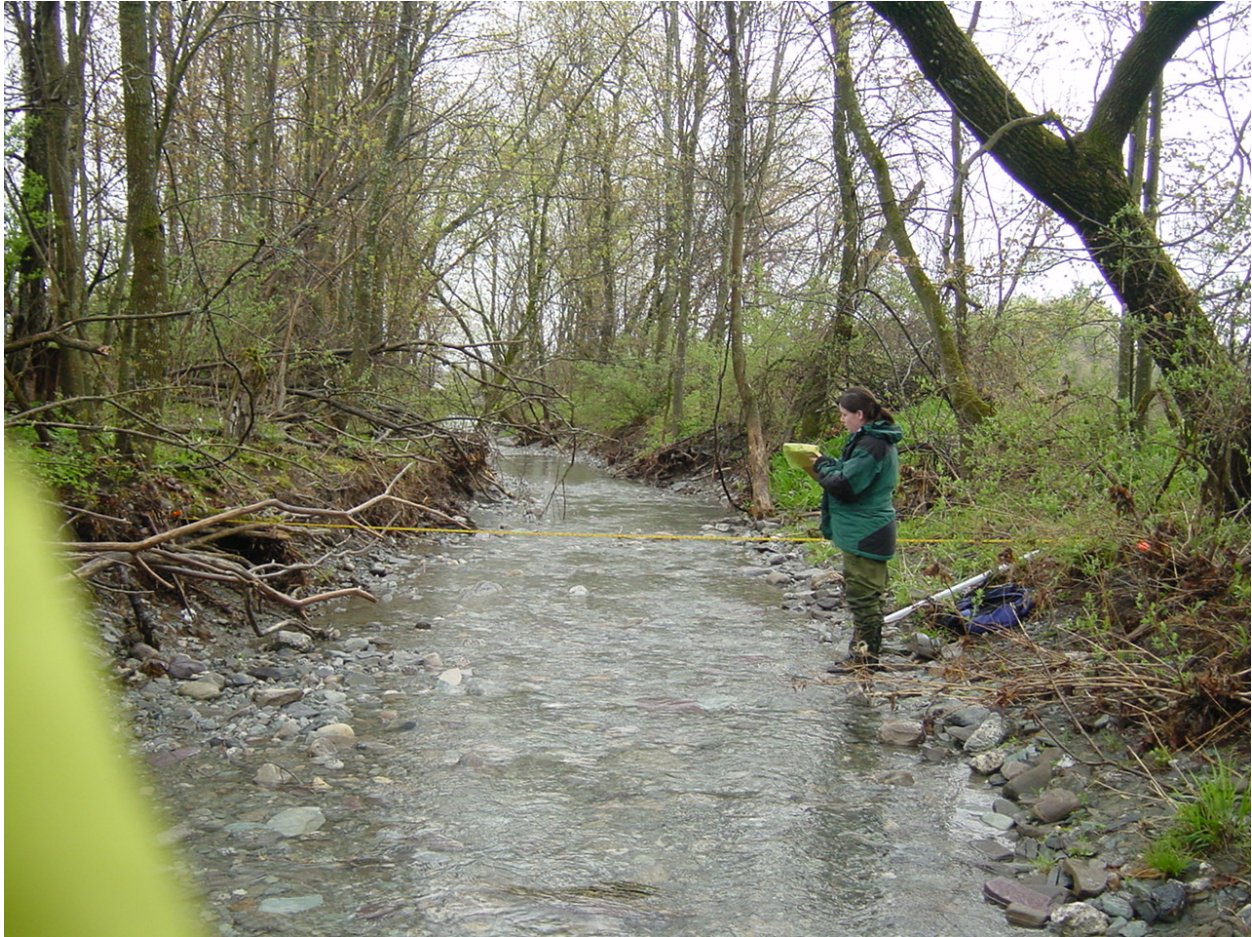
M08S1.03 Segment C

This segment appeared to have been straightened and had berms on both banks. Erosion was observed on both banks as well, signaling widening. The channel had incised yet retained access to floodplain. Riffles were sedimented and mostly replaced by plane bed features. Increased fine sediments and bar formation were noted. Riparian buffer was limited (5-25 ft) with adjacent land use hay and some crop rotation. The channel had been dry in the days before the assessment but due to rains had some flow. Habitat condition was rated “poor” due to channel alteration, lack of bed diversity, heavy deposits of sediment, bank instability, and limited riparian vegetative zone width. RGA channel adjustment processes were incision (may or may not be “historic”), aggradation, and beginning to widen. Overall RGA condition was assessed in “fair” condition and in the beginning of stage III of the F-stage channel evolution model.

An area of an avulsion and heavy sediment buildup at the upstream end of Segment C was similar to what was observed in Segment B.

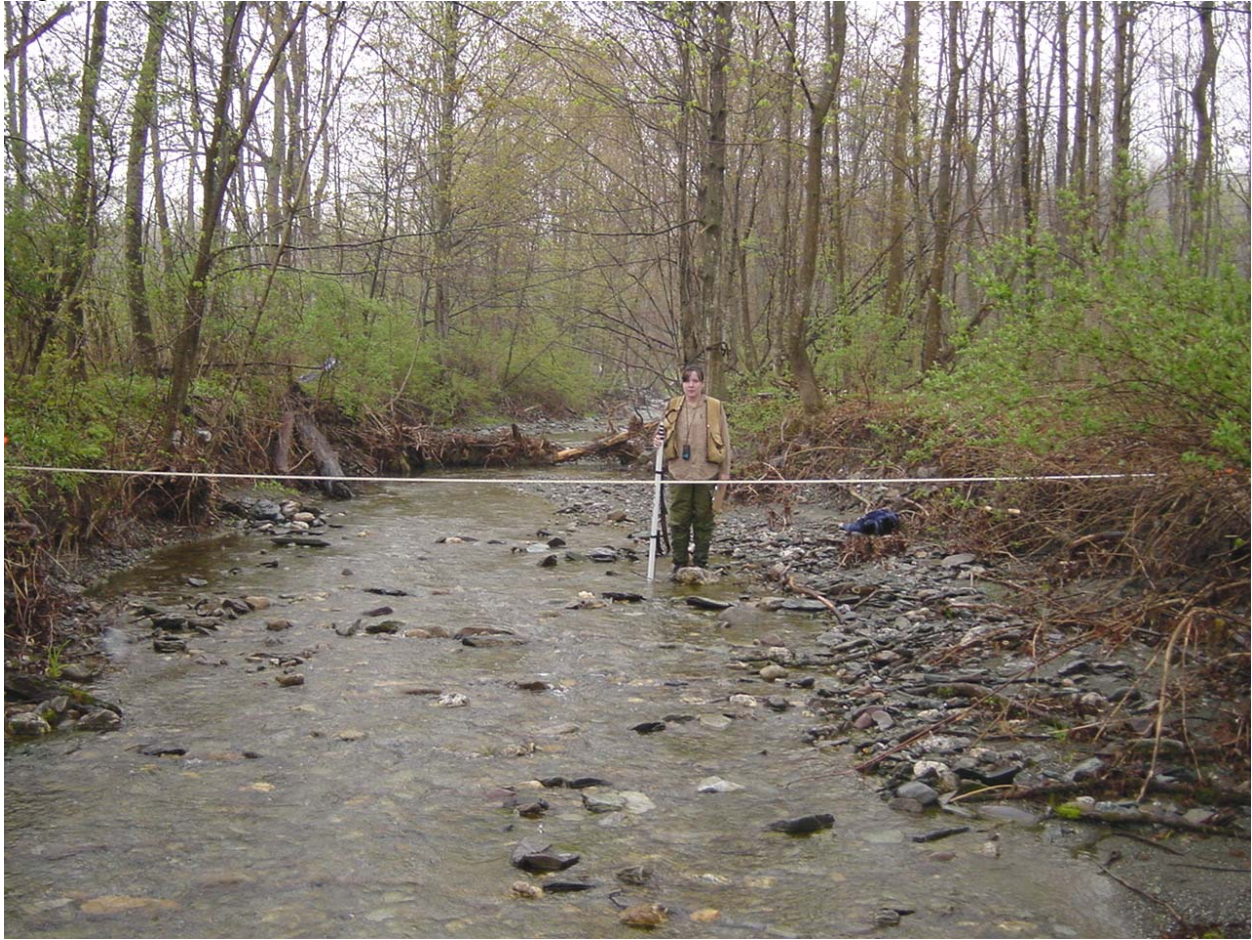
Segment A encompassed the area from the downstream reach break to just upstream of the bridge on Gorhamtown Road where the bedrock grade controls begin. Erosion noted along right and left banks. Berms on right and left banks stretch from the bridge downstream about 150 feet. Side and diagonal bars signal aggradation. Scour on the right and left banks near the bridge was attributed to the berms.

Segments A and C were similar, separated by an area of bedrock grade controls including ledges and falls. Segments A and C were therefore assessed together and share cross section and field notes data. Dominant channel adjustment processes appeared to be aggradation with some planform adjustment. Overall the segments appeared in “fair” condition and in stage III of the F-stage channel evolution model.

These segments appear to have been straightened at some time in the past. The segments were not incised and had floodplain access. Riparian buffer was limited (5-25 ft). These segments would be good candidates for corridor protection or buffer enhancement if landowners were interested in pursuing funding.

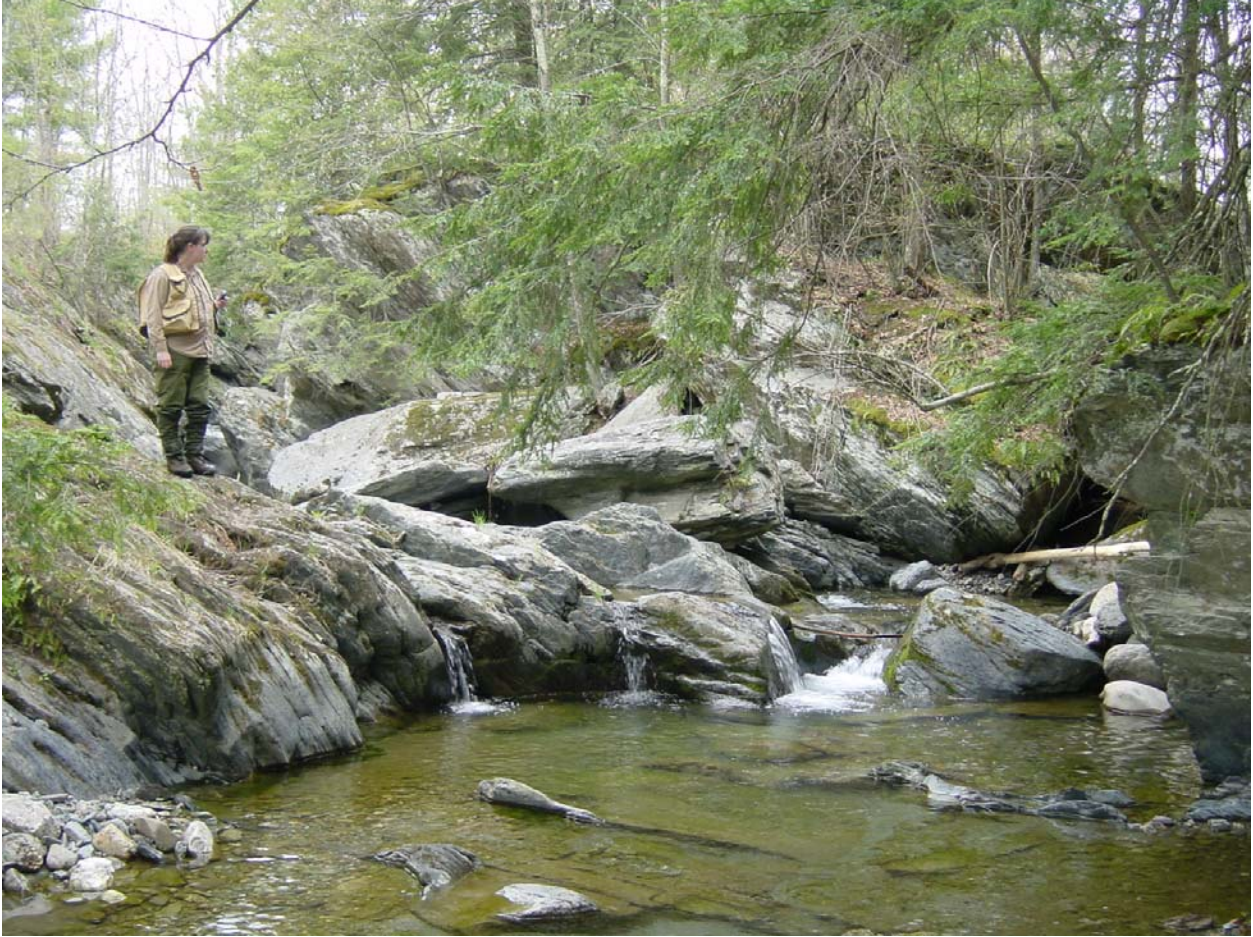
M08S1.04 Segment B

This segment encompassed a gorge with several bedrock ledges and falls providing grade control and was considered a sub-reach. Buffer widths were 51-100 feet, consisting of mixed trees. Riparian corridor land use was forest.

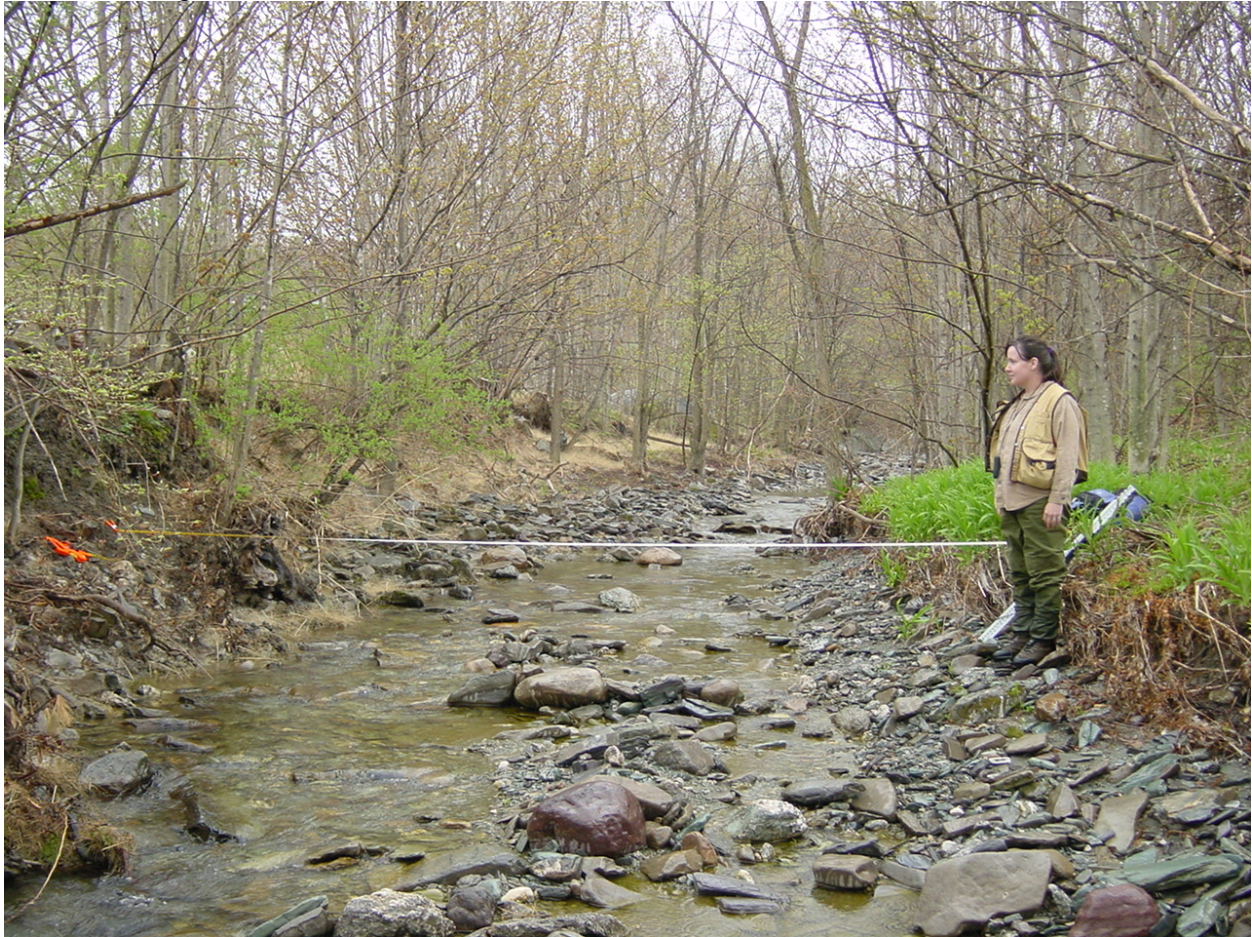
M08S1.04 Segment D

The segment began toward the upstream end of the hayfield and continues to the reach break. Segmentation in this section of stream was due to elevated terraces on both banks, the channel being entrenched and lacking floodplain access. This was a transitional area between the upstream reach (M08S1.05), which was in a confined valley setting with steeper slope and the downstream (M08S1.04C) section with floodplain access and shallower slope. Entrenchment here may be related to the channel cutting through glacial outwash in a post-glaciation alluvial fan. In other words, this may not be a human-induced or recent condition. Two steep riffles were noted in this segment and aggradation was evident. Riparian buffer was limited in this segment as well. Dominant adjustment process was aggradation with historical degradation noted. Overall the RGA condition was “fair” and appeared to be in stage II of the F-stage evolution model.

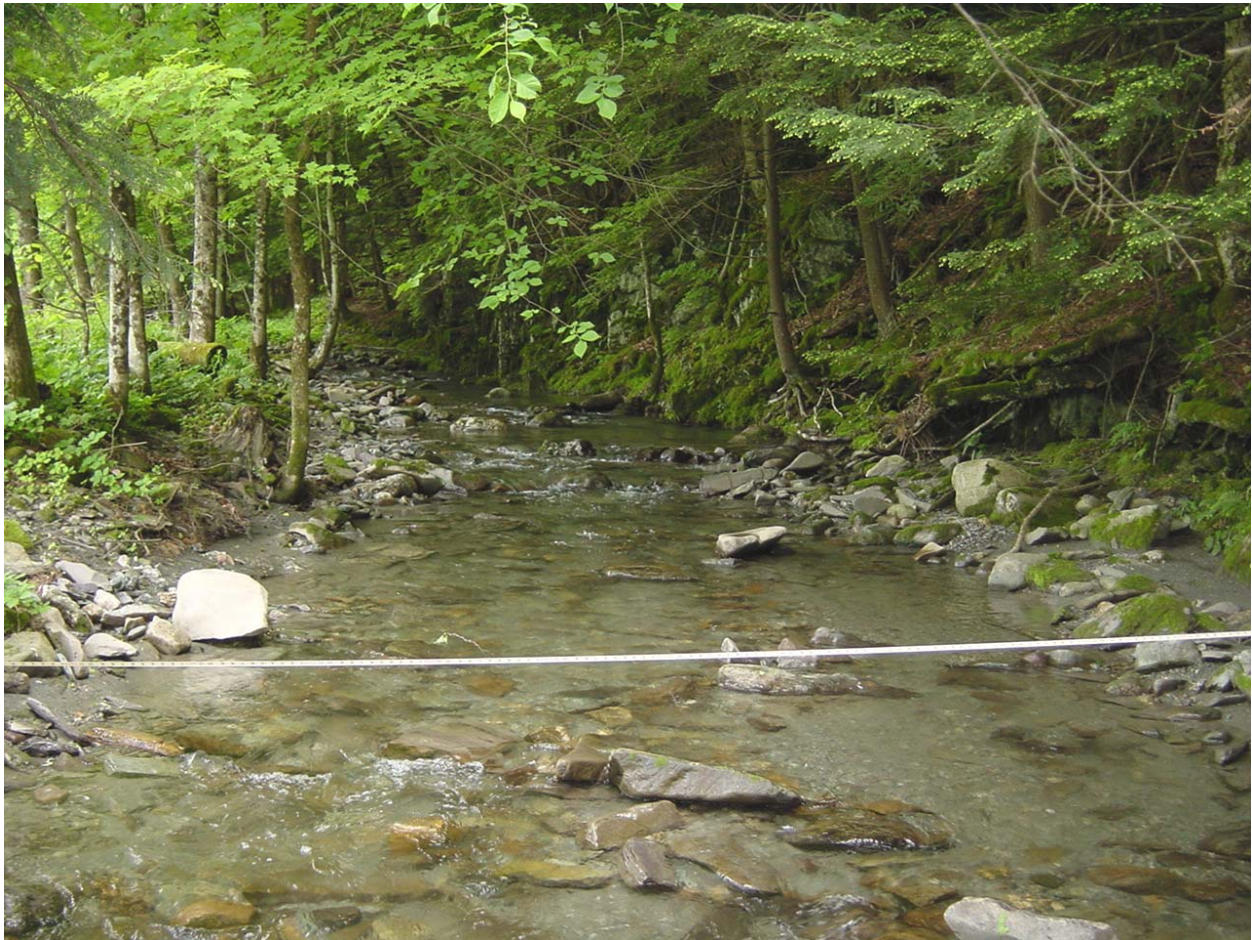
M08S1.05

This reach did not have grade controls, but bedrock was observed along the banks in some areas. One steep riffle was noted upstream of a constriction created by riprap and a tree stump. Riprap was present on the right bank along the road and this area appeared to have been straightened. Minor incision and aggradation of fine material observed. The channel could have been moved over to increase the size of the field, and then incised. However, it was difficult to determine if the reach had been straightened adjacent to the field. The channel now appeared fairly stable due to bedrock and coarse boundary conditions. The dominant adjustment processes appeared to be minor incision with aggradation of fine sediment. The reach appeared to be in “Good” condition, in stage II of the F-stage channel evolution model, with “Moderate” sensitivity to disturbance.

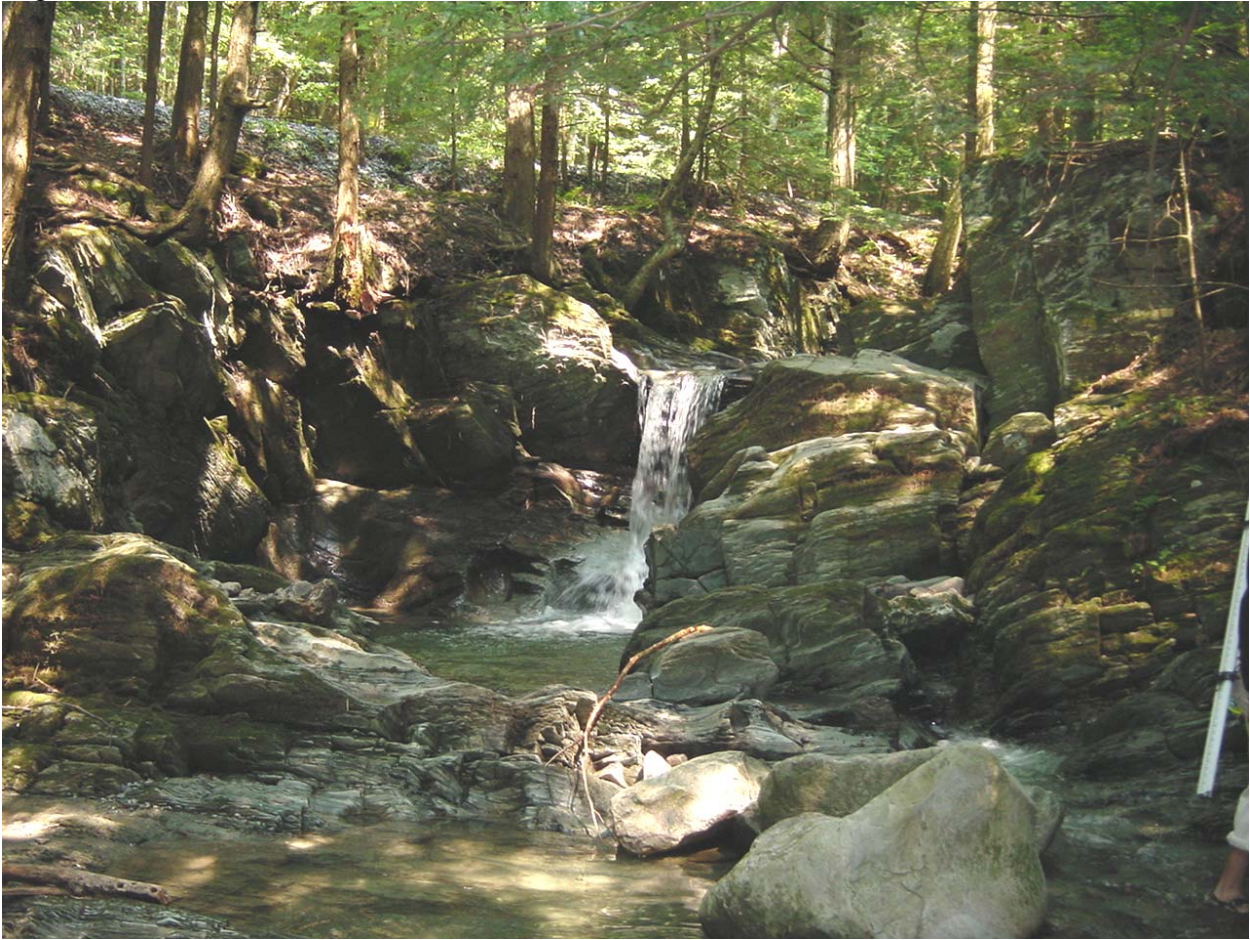
Segment A

This segment had many steep ledges and falls providing grade control. This segment was considered a sub-reach of the entire reach. Riparian buffer was greater than 100 feet, comprised of coniferous forest. A road on the right bank encroached in the buffer toward the upstream end of the segment.
