Lewis Brook & Finel Hollow Brook

Phase 2 Stream Geomorphic Assessment Report

Rutland Regional Planning Commission
August 20, 2006

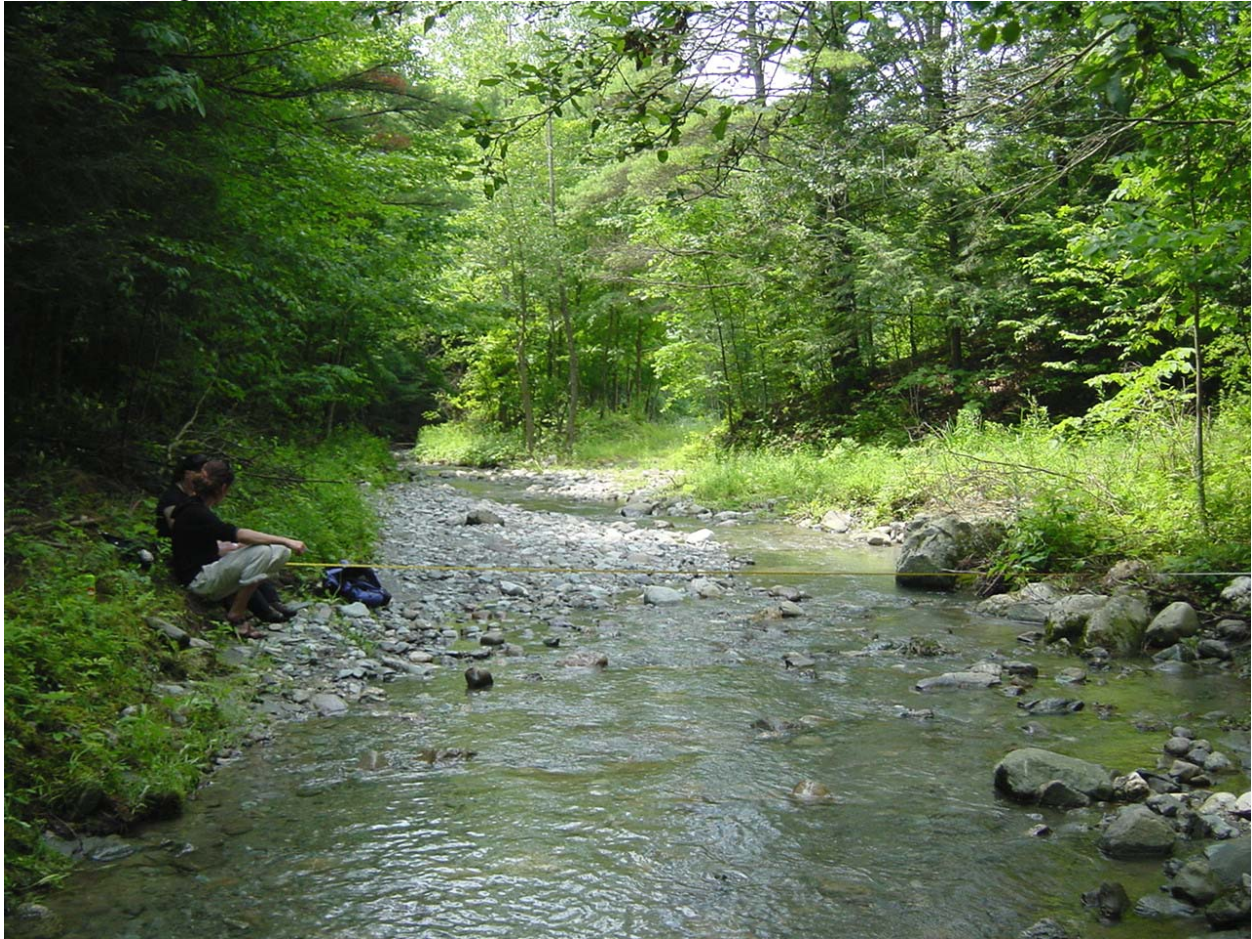
M08S1.06 Segment B

Many ledges providing grade control were present in this segment. Sediment was entering upstream end and M08S1.07, likely from clearing in the upper watershed. Berms were observed along the segment and appeared to be from dredging and straightening of the channel. Much of the slope change in this segment is from ledges and falls, leaving the remainder of the segment with a lower slope. Therefore the reference stream type here would likely be a "C." The segment would have some floodplain access in the absence of the berms. In this case, the stream type departure from C to B resulted from the construction of the berms rather than incision of the channel itself. Therefore the geomorphic condition was rated as "Fair" rather than "Poor." Some tributary rejuvenation was observed in a localized area of incision downstream of a grade control. Multiple point and side bars were noted. Buffer width was greater than 100 feet, except for a pasture area with a 5-25 foot buffer on the right bank. Riparian corridor land use was forest with some pasture on the right bank. One culvert constricted the channel at the segment break between A and B. Deposition was present above the culvert. Aggradation appeared to be the dominant adjustment process. Overall the segment appeared to be in "Fair" condition and in stage IV of the F-Stage evolution process.

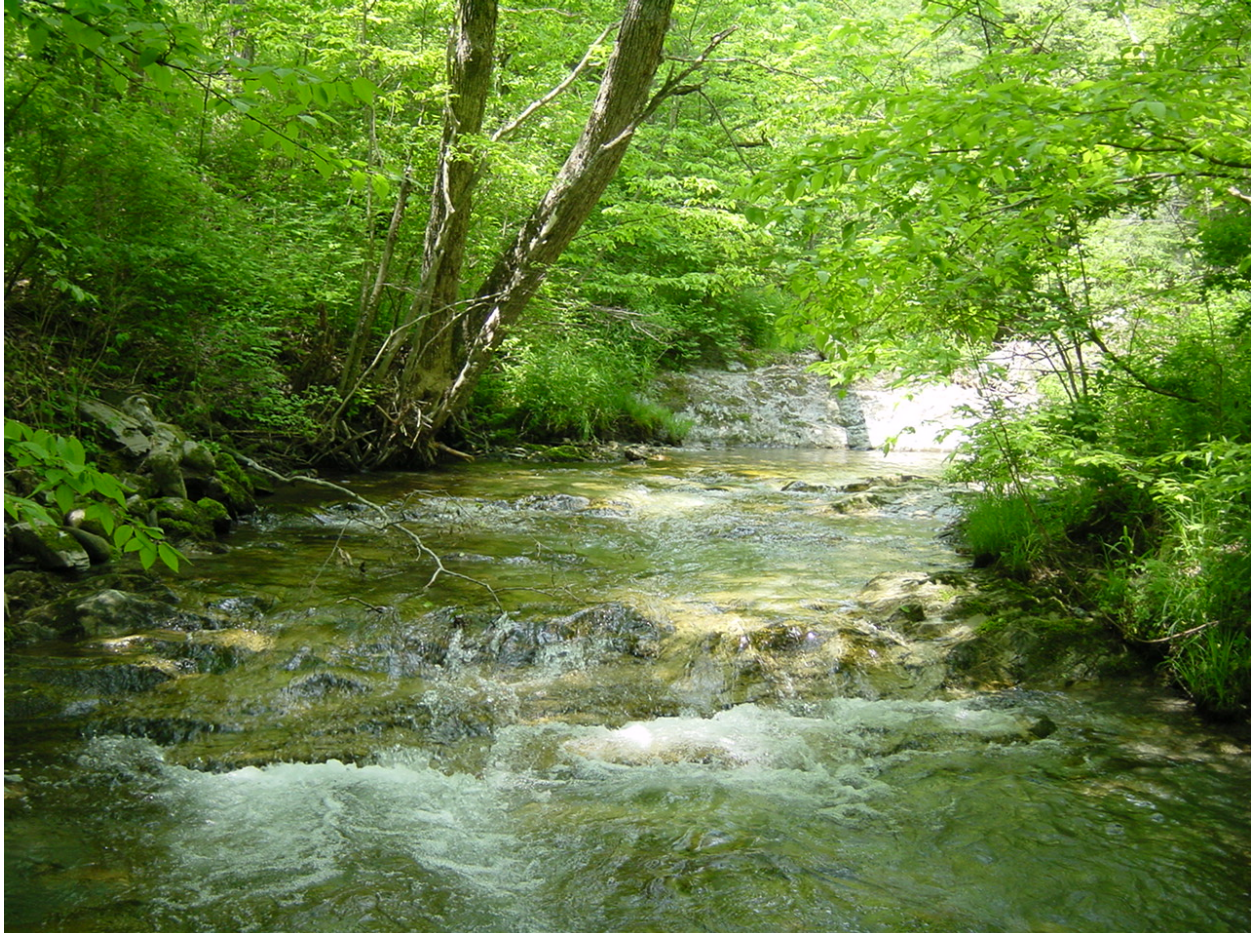
M11S1.01

This reach had many grade controls. This reach was not incised (cross section showed some incision, but that was due to a local rise in the floodplain at the site). Some areas were bedrock confined and some areas had small floodplain areas. Some sediment was deposited upstream of constrictions. Pools appeared filled with sediment except just below ledges. Minor aggradation and planform adjustments were noted, but overall the reach appeared to be in regime and in “Good” condition. Riparian buffer appeared to be good and vegetated. This reach appeared to be a Bc by reference. Any C-type conditions (connection to upper terrace) appeared quite long ago, so describing this reach as having experienced a stream type departure from C to B may not be fair.

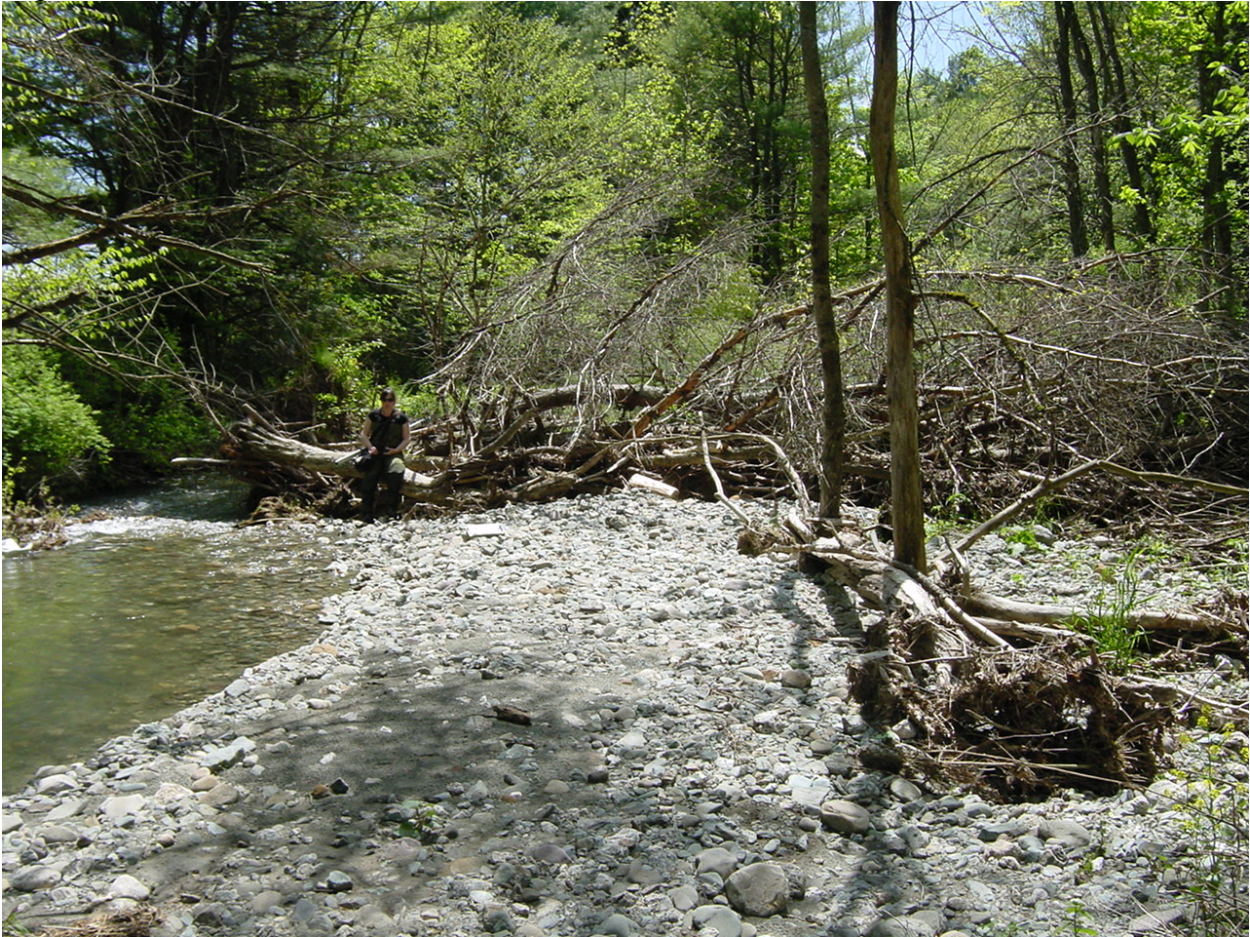
Segment A

The landowner reported that about 8 years ago, the stream was narrow, but then high water “took all the soil” and left the stream wide with gravel deposits. One field now has a large meander bend where it had been straight (likely straightened). Typical buffer width was 26-50 feet. This could be a good segment to allow some adjustment to occur. Some tree planting could help stabilize the banks. Cows were in pastures encompassing the channel in 2 places, so access in those areas was limited. Channel adjustment processes appeared to be aggradation and planform. Overall the segment appeared to be in “Fair” condition and in stage III of the F-stage evolution process.

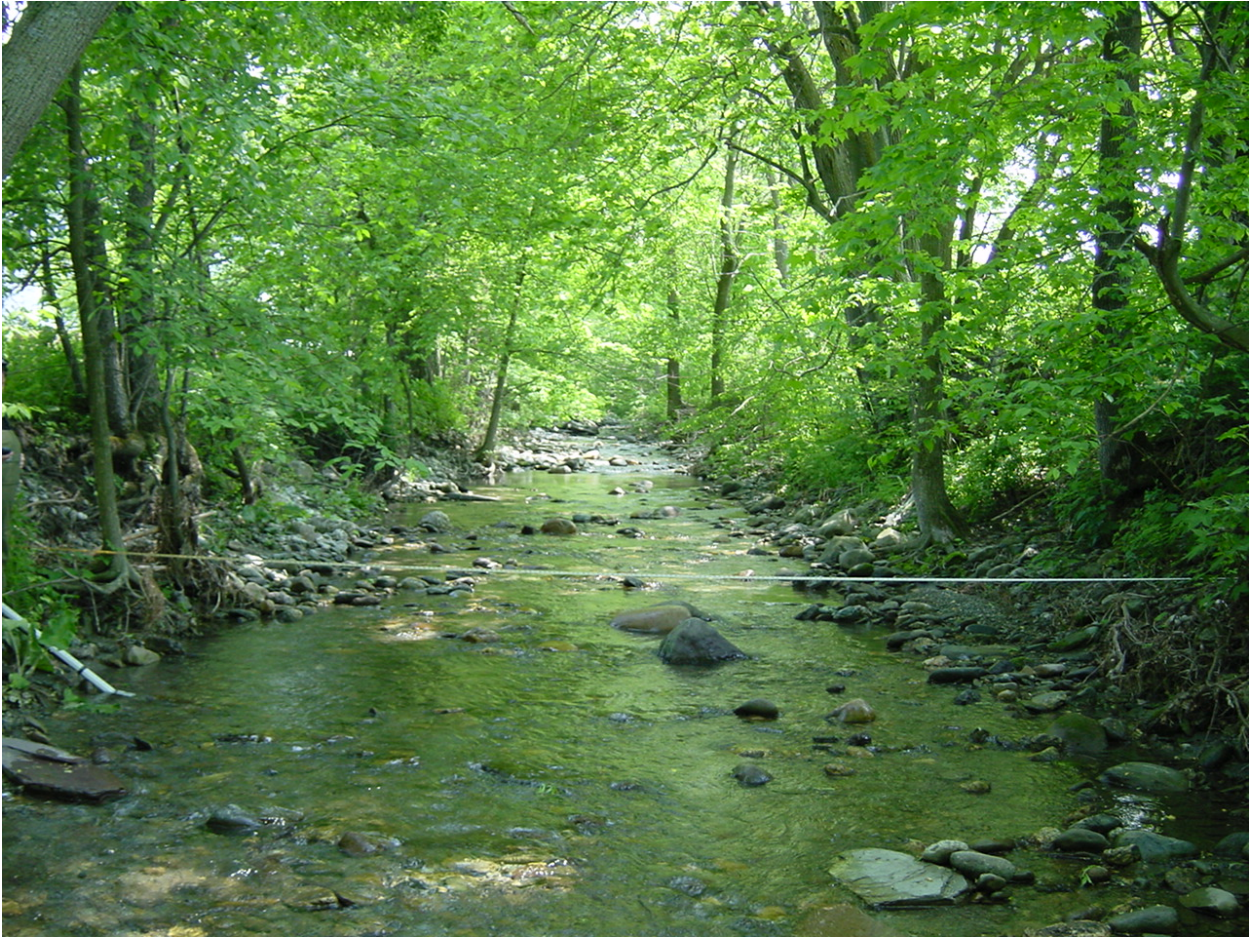
M11S1.02 Segment B

This segment appeared to have been straightened to improve adjacent farmland. This segment had berms on both banks and some rip-rap was present. Adjacent land use was crop and pasture. Buffer widths were 5-25 feet with some areas less than 5 feet. Several stream fords/animal crossings were evident. The segment appeared to have incised and was now aggrading with planform adjustments. Geomorphic condition appeared "Fair" with the segment in stage III of the F-stage evolution process.

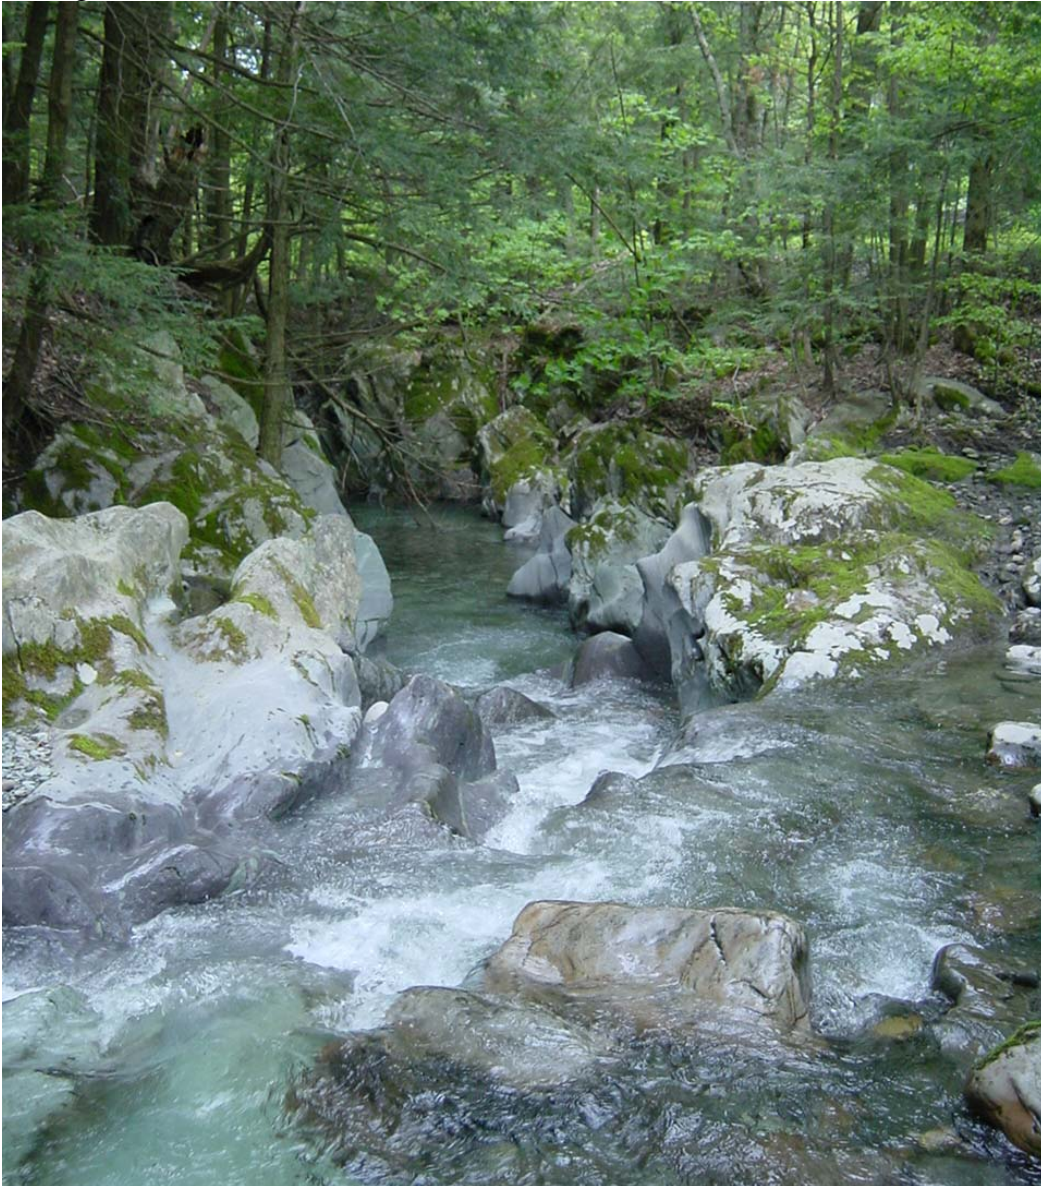
M11S1.02 Segment C

Segment C was in a gorge. Only Steps 1, 3, and 5 were completed. The channel appeared to have a good buffer (>100 ft) of coniferous trees. The right bank buffer was less at 50-100 feet before the road and some residential development. Some aggradation was observed as a side bar and a mid-channel bar. Bedrock was controlling the grade in this segment.

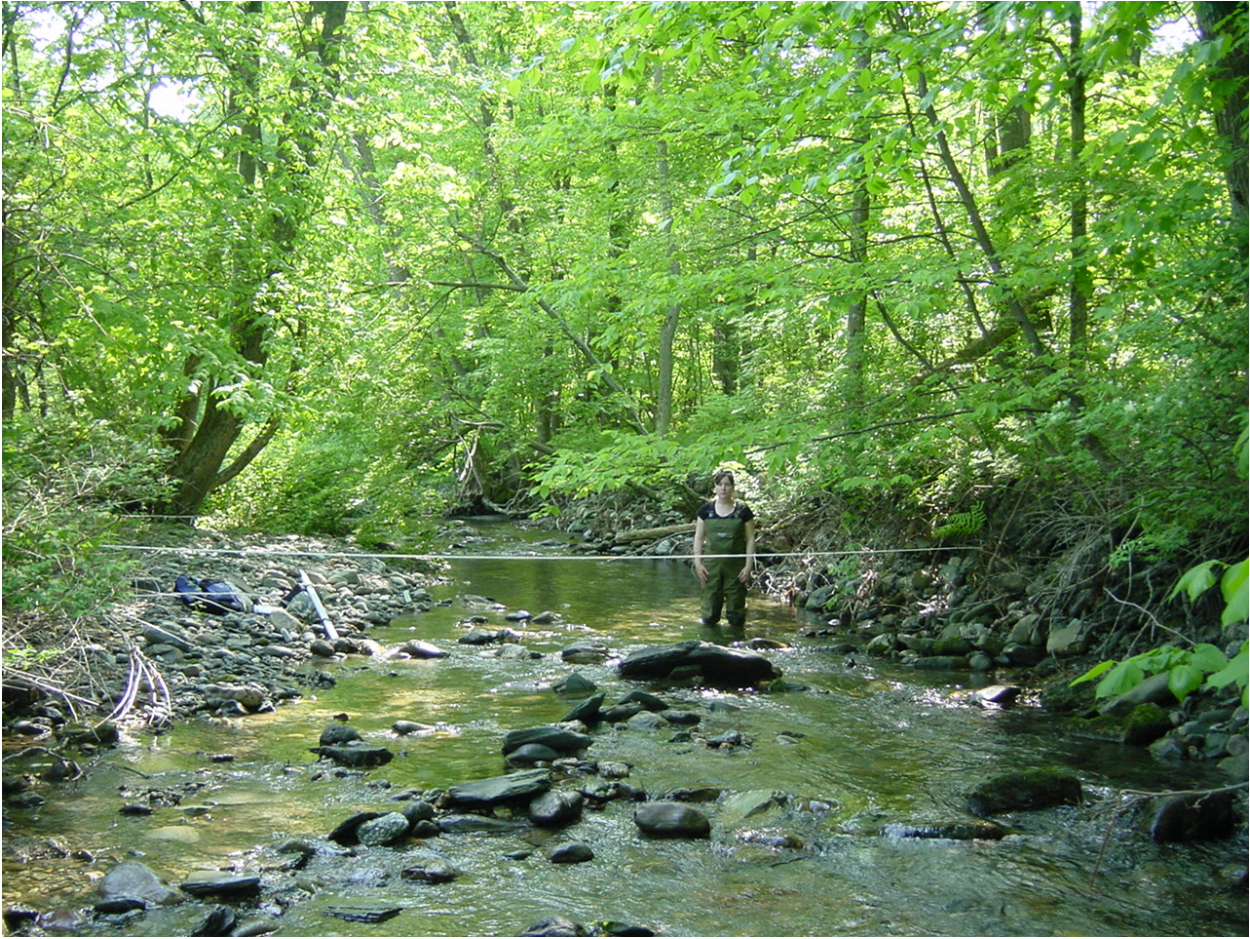
M11S1.02 Segment D

This segment appeared incised, but with access to floodplain at flood stage. Bed materials were mostly cobble. The segment was likely straightened at some point. Bed elevation was bedrock controlled at the upstream and downstream ends by gorges. The segment appeared to be a transporter of sediment, yet some bars and aggradation were observed upstream of debris jams and could signal a high sediment load in this stream. Buffer width was 51-100 feet on the left bank and 5-25 feet on the right bank. The channel appeared to be widening with some aggradation and in “Fair” condition. The segment was in stage III of the F-stage evolution process.
