**New Haven Tributaries  
Stream Geomorphic Assessment  
Phase 2 Report  
June, 2007**

**Landslide Natural Resource Planning**  
P O Box 311  
East Middlebury, VT 05740

Addison County Regional Planning Commission  
79 Court Street  
Middlebury, VT 05753

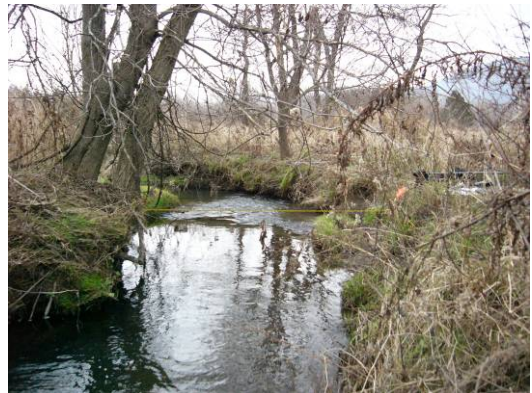
**M10-S1.01** – This reach is located at the north end of West Brook, at the confluence with the New Haven, north and south of the Cove Road in Bristol. It is in a very broad valley and was divided into four segments due to beaver activity on segments A and C. It is an E stream type by reference and currently and is at the high end of fair geomorphic condition. The dominant adjustment processes are widening and planform. Crop land use is rated extreme and depositional features are greater than 5/mile throughout the reach. Urban development within the watershed is between 5 and 10% but less than 5% in the stream corridor. None of this reach was found to be straightened and there are no corridor encroachments. Greater than 20% of both the right and left riparian areas have no vegetation. It is rated very highly sensitive, making it vulnerable to rapid geomorphic change. The habitat condition was found to be good. It is currently in Fine Source and Transport sediment regime, though very close to Coarse Equilibrium/Fine deposition. Between 5 and 20% of segment B and greater than 20% of segment D have eroding banks.

Establishment of riparian buffer area where it is absent would reduce the sediment load entering the stream due to agricultural land use in the watershed.

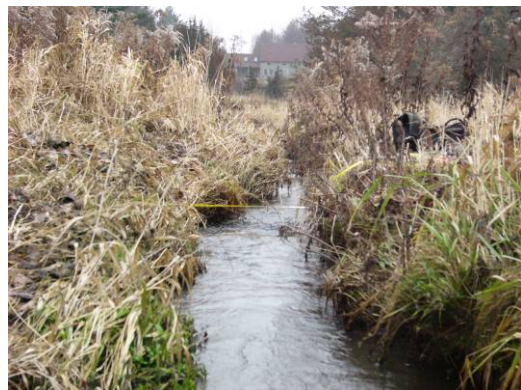
**M10-S1.02** – This reach is located up against the left valley wall and is in a very broad valley. It is an E stream type by reference and currently, and was segmented due to riparian buffers and channel width. The channel width changes dramatically between segments due to soil type. Segments A and C are quite narrow due to clay soils and segment B being much wider due to sandy loam soils. The riparian buffer is also significantly different between the

segments, with A and C being primarily pasture and B being woody vegetation and crop land. Segments B and C are greater than 20% straightened, with C being 48% straightened. This reach was very likely moved out of the valley and put up against the left valley wall to increase agricultural land. Segment C runs through a cow pasture with cows accessing the stream throughout the segment. In some places the banks are severely eroding.

Segment A is periodically pastured to keep it open, according to a neighbor. Segment C has no riparian vegetation and would benefit from the cows being fenced out of the stream.

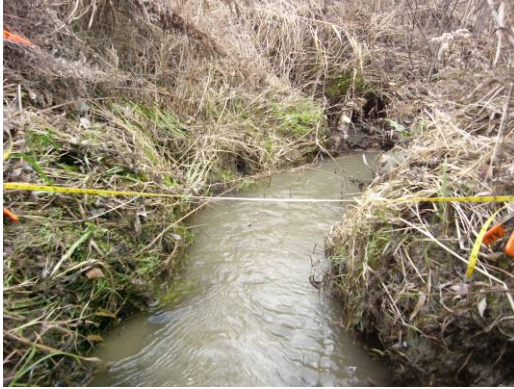
Segment A

There are 18 flood chutes and 1 avulsion and crop land use is high throughout the reach. Depositional features are greater than 5/mile and urban development and corridor development are both low. There are no encroachments or straightening but there are three channel constricting culverts, one on each of segments A-C. Segment C has a tarmac filled reservoir adjacent to it that has an overflow pipe into the stream. There is a mass failure at the site of the pipe. Riparian condition is greater than 100' throughout most of the reach, though the left bank of segment C has 51-100' and the right bank of segment D has 26-50' of buffer. Segments A-C are in Fine Source and Transport sediment regimes and D is in reference as a Transport type stream.

Structure replacement is recommended for culverts in segments A and C. The segment B culvert is a long, new structure that goes under route 116 and does not have deposition above or scour below it.

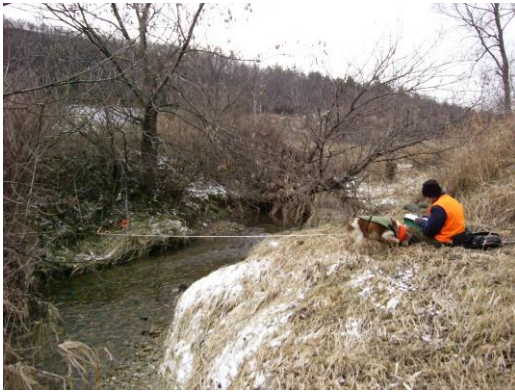
Segment A

**M11-S1.01** – This reach is located at the confluence with the New Haven River in a very broad valley and it was segmented due to a headcut propagating at the downstream end. The entire reach is a C stream type by reference but segment A has degraded to an F stream type making it an Unconfined Source and Transport sediment regime type currently. Segment B is a reference stream type C as well as reference sediment regime of Course Equilibrium/Fine Deposition. The

The dominant adjustment process for segment A is incision and widening and planform for segment B. Crop land use in the sub-watershed is extreme and depositional features are between 2 and 5/mile. Urban development in the watershed is low and not significant within the corridor. Greater than 20% of the reach has been straightened and encroachments are insignificant, however, development within the floodplain at the down stream end is increasing. There are three storm water inputs and segment A has more than 5 depositional features/mile. The riparian buffer is 5-25' along both banks.

The head cut in segment A should be monitored and possibly arrested to avoid it propagating upstream. Woody vegetation should be allowed to grow into the riparian area.

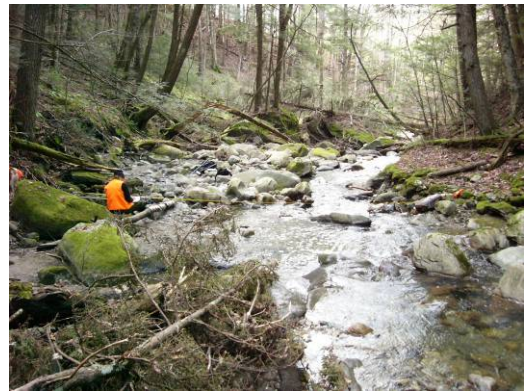
**M17-S1.01** – This reach is located at the confluence with the New Haven River. It was segmented based on stream types. Segment A is located in a semi-confined valley and is a reference stream type A and segment B is in a narrowly confined valley and is a reference stream type B. Segment A is a Transport type stream both currently and in reference. Segment B is also a Transport stream type by reference but is currently a Confined Source and Transport type. Sensitivity is high and the dominant channel adjustment is aggradation and widening for both segments, though it is minor on segment A. Crop land use is high in the sub-watershed, though the riparian buffer is greater than 100' on both banks. There are multiple flood chutes and braiding throughout the reach. Development within the corridor is low and less than 5% in the watershed. There are two channel spanning ledges – one in each segment and there are no storm water inputs. None of the segment was straightened and there are only minor road encroachments. Segment A has two channel constricting bridges with deposition above them.

Structure replacement with corridor conservation is recommended for this reach.

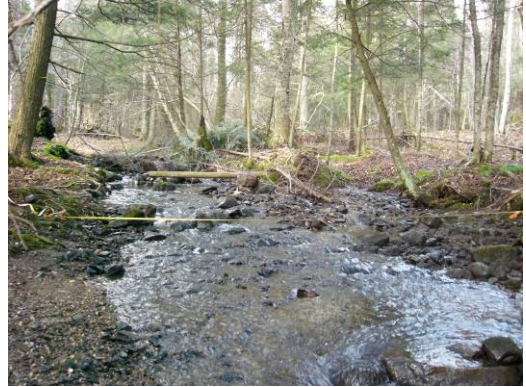
Segment A

**M17-S1-t1.01** – This reach was segmented due to slope, channel width and soil type. Segments A and C are C stream types by reference but are currently entrenched and incised making them F type channels. Segment B is an E stream type currently and by reference. All three segments are located in a very broad valley, are very sensitive and widening is the dominant adjustment process, though it is minor on segment B. The entire reach is Coarse Equilibrium/Fine Deposition by reference and

segment B is currently. Segments A and C are Fine Source and Transport. Crop land use in the watershed is high and depositional features are greater than 5/mile on segments A and C. There are also a number of flood chutes, avulsions and significant erosion on segments A and C. There are a number of grade controls near the confluence with Isham Brook. There are no encroachments and riparian buffers are greater than 100' on both banks. There is significant erosion on segments A and C.

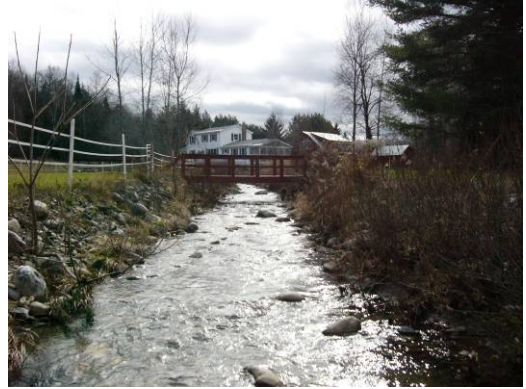
**T5.01** – This reach is at the confluence with the New Haven River on the River Street in Lincoln. It was segmented four times due to planform and slope. Segments A, B and D are all C stream types by reference. Segment C is a B by reference as well as currently. Segment A was moved, channelized, and hard armored (rip-rap) after the 1998 flood making it currently a G stream type. Segments B and D are currently C stream types in good geomorphic condition. Segment C is currently a B stream type in

Segment A is entirely straightened and though no alluvial fan was identified either during the Phase 1 or in the field, it is likely that segments A and B had historic alluvial fans that have been concealed by human alterations to the landscape. Depositional features are greater than 5/mile in segments B-D. There is no riparian buffer on segment A, but the remainder of the reach has greater than 100' on both banks, except for the left bank of segment B, which is 26-50'.

Segments B, C and D are good candidates for corridor conservation. Segment A could be restored by working with the current landowners who are not using the horse ring. Otherwise, that segment would benefit from riparian plantings.

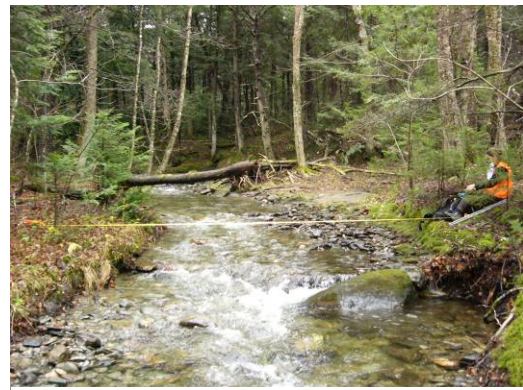
is not a channel constriction. Depositional features are greater than five/mile on both segments. Segment A has one flood chute but segment B has 8 flood chutes. The left bank of segment A has greater than 20% erosion but the remainder of the banks are all between 5 and 20% eroding. There are three mass failures in Segment B. Corridor development is rated high in T5-S4.01, immediately upstream of Segment B and one of the sub-watersheds and corridors at the edge of the watershed has almost 8% urban development and the corridor development impact is rated low. On T5-S2.01, also upstream of Segment B, both banks have greater than 20% with no riparian buffer. These factors may account for the sediment and planform adjustment occurring on Segment B.

This reach is a good candidate for corridor conservation, particularly given the new camps that are being built within the corridor. However, upstream impacts should be explored further and with remediation pursued where necessary.

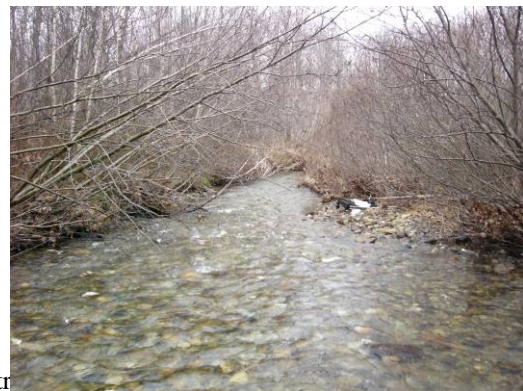
**T6.01** – This is short reach located in a very broad valley type. It is a C stream type by reference as well as currently. It is in good geomorphic condition and its sensitivity is high. It is Coarse Equilibrium/Fine Deposition sediment regime type by reference but it is currently Fine Source and Transport/Coarse Deposition. Sensitivity is rated high for this reach. There is one house in the corridor but no roads or channel constrictions. Right bank erosion is greater than 20% and

depositional features are greater than 5 per mile. Corridor and sub-watershed development are not significant on this reach and the left buffer is greater than 100' but the right buffer is 5-25'

Further encroachments into this reach should be prevented through corridor conservation due to its strategic location at the confluence with the New Haven and the significant development impacts upstream.

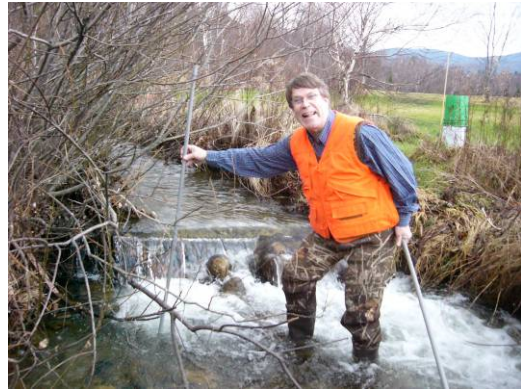
**T6.02** – This reach is located in a very broad valley type and is a C stream type by reference. It was segmented five times due to riparian buffer, sediment size and planform and slope. Three of the five segments are C stream types currently and Segment C is a G stream type due to incision and entrenchment resulting from channelization, windrowing and berming just upstream of an undersized bridge. The entire reach was extensively straightened, with all but Segment A being 100% straightened. It was likely moved east

toward the valley wall to make way for agricultural use of the land. The entire reach is Coarse Equilibrium/Fine Deposition sediment regime by reference with Segments A and D being currently in reference regime. Segments B,C and E are all currently Unconfined Source and Transport. Sensitivity is high for all segments except for C, which is extreme. Segments A, C, D and E all have channel constrictions. There is significant development in Segment A, but it is limited within

With the replacement of undersized structures throughout the reach, segments A, B, D and E would re-gain equilibrium. Segment C could be restored to equilibrium.

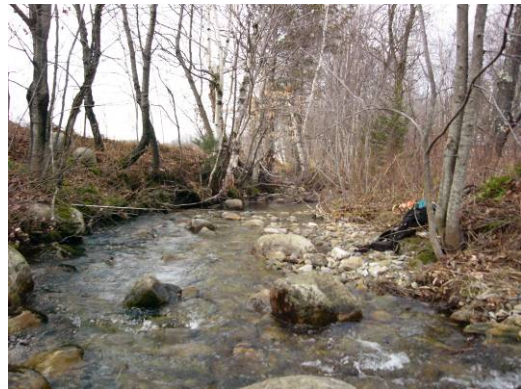
the corridor upstream. There are seven flood chutes spread throughout the reach and Segment B has three steep riffles. The entire reach has greater than 5 depositional features/mile. Corridor development impact is low for the entire reach. The right riparian buffer is greater than 100' for the entire reach. The left buffer is 26-50' for Segments A and D, 5-25 for Segment B and greater than 100 for Segments C and E.
