# **Cold River**

## **Phase 2 Stream Geomorphic Assessment**

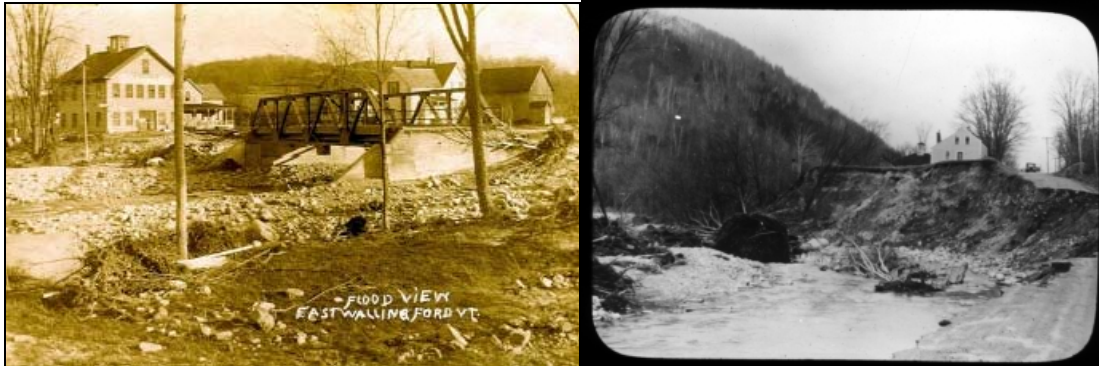
**Figure 3: These images of the nearby Mill River show damage from the 1927 flood. Left image is looking towards the intersection of Route 104 and Route 155 in East Wallingford. Right image is of route 103 washout in Cuttingsville. (Similar damage was likely inflicted on land around the Cold River).**

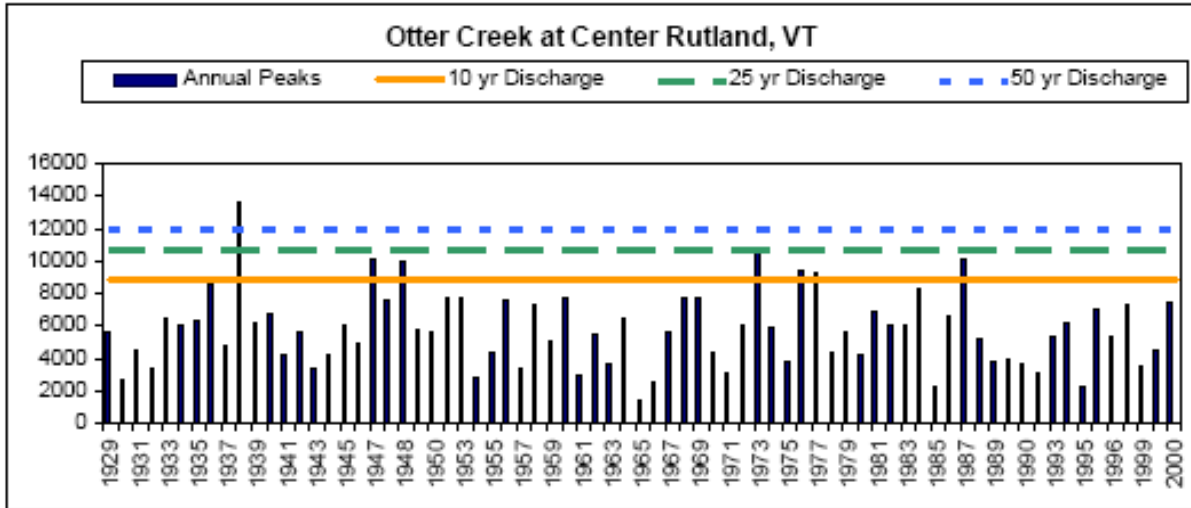
Figure 4: Flood frequency analysis for Otter Creek, Rutland, VT.

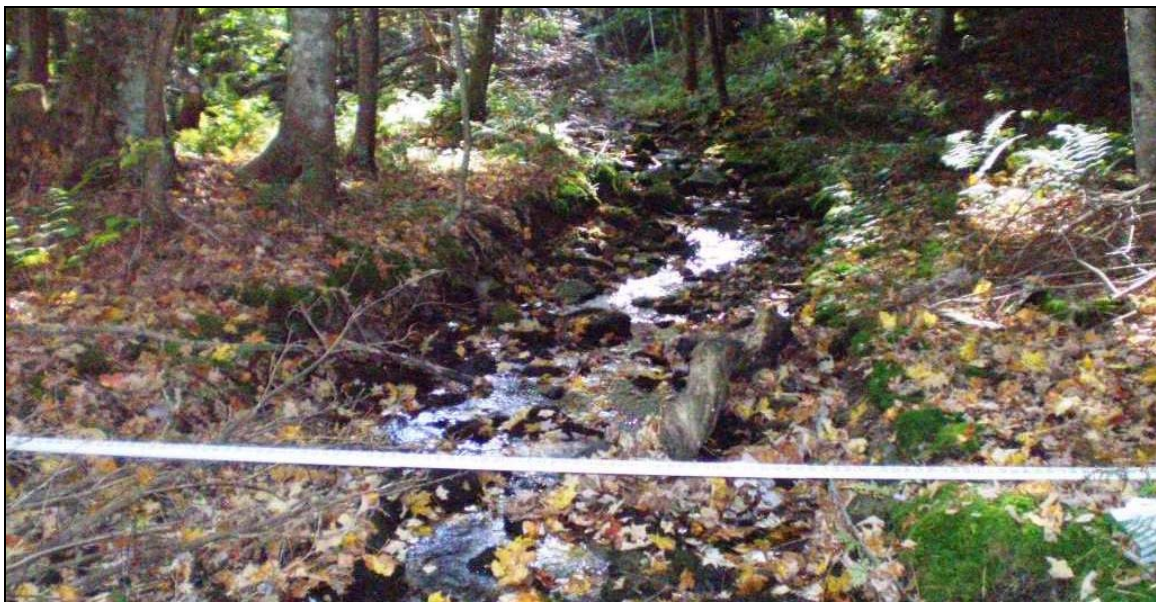
**Figure 7. Segment M10-F is a stable channel in a well forested watershed.**

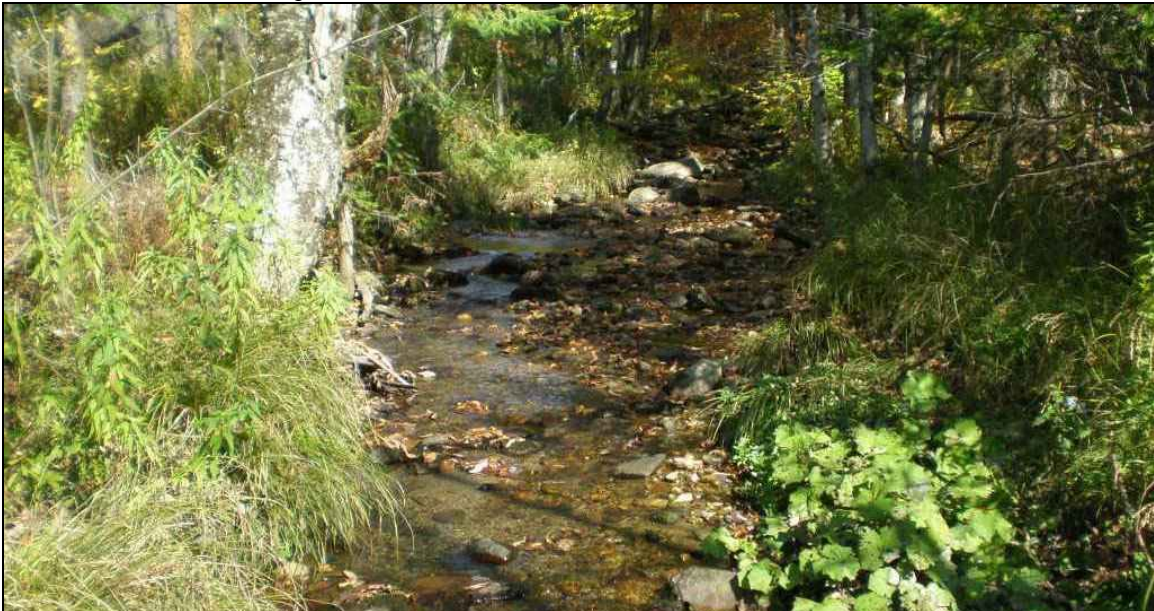
**Figure 10. Cold River segment M10-C is in stable condition with adequate floodplain access and a forested buffer.**

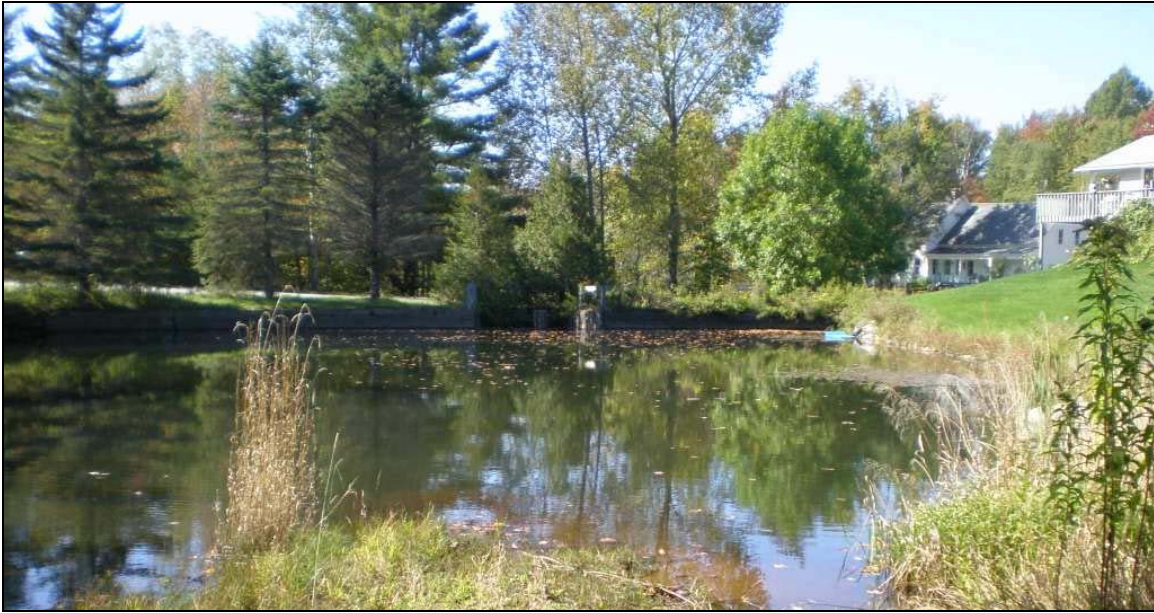
**Figure 11. Segment M10-B is an on-stream pond controlled by a small concrete dam.**

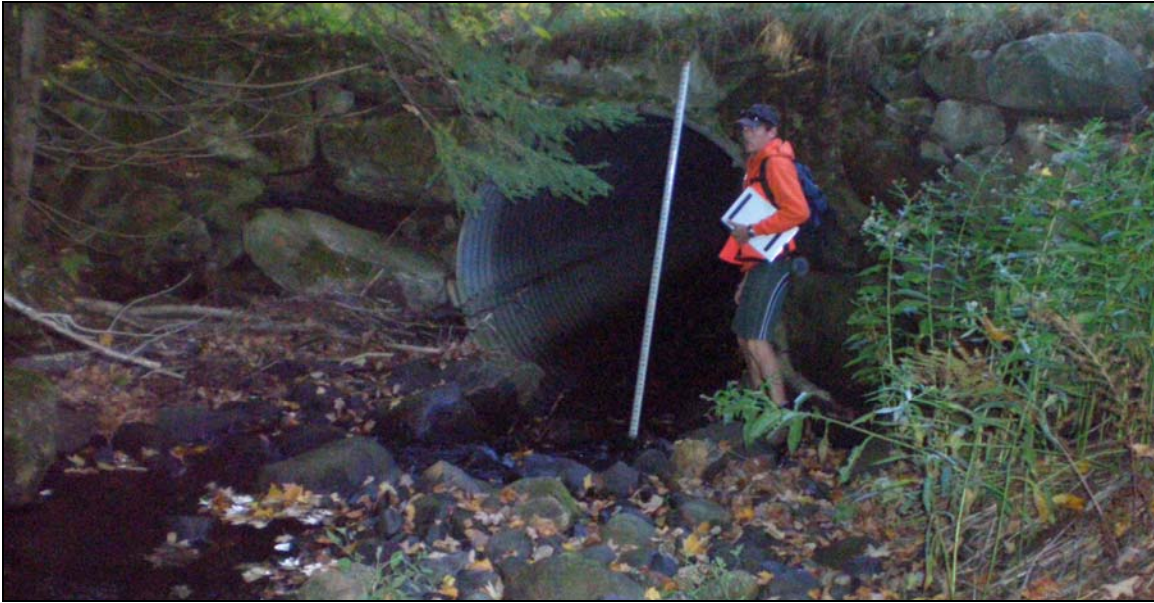
**Figure 12. Segment M10-A has incised and has several floodplain constrictions such as this culvert under Northam road.**

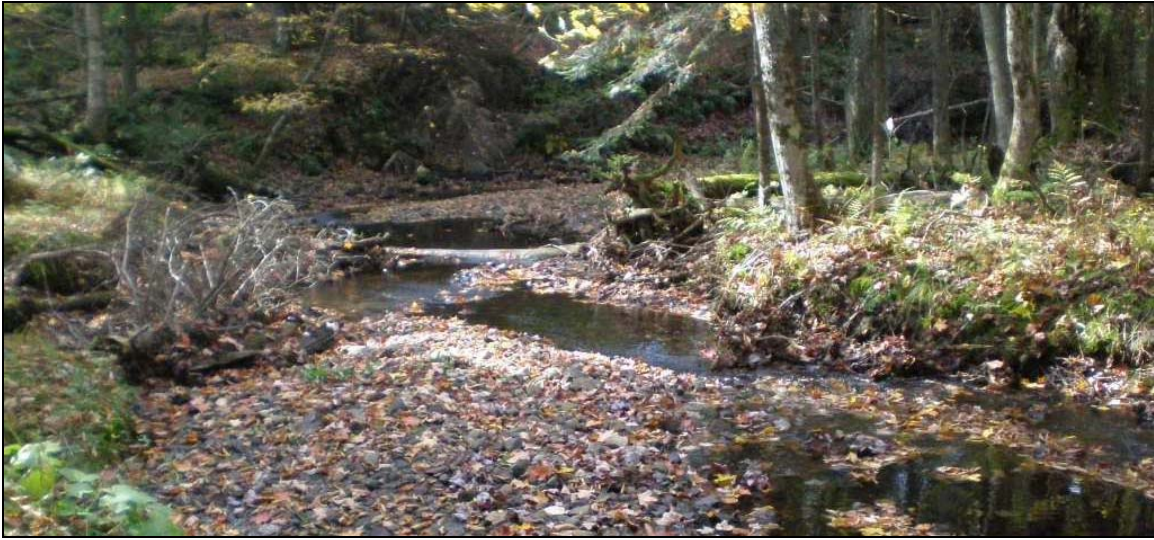
**Figure 13. M09-B flows through a predominately forested corridor and has minor channel widening and planform adjustments as a result of major aggradation.**

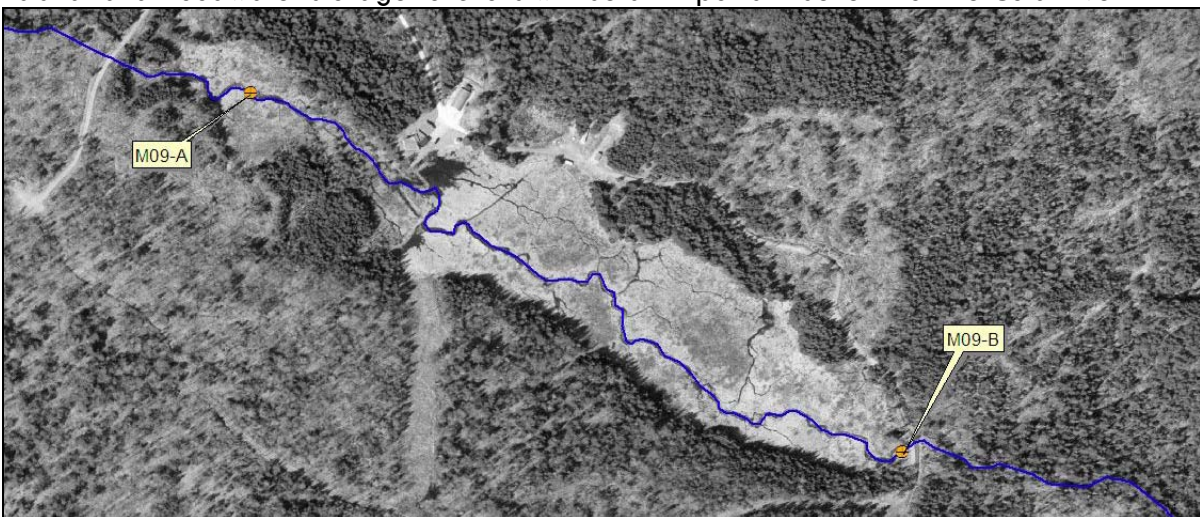
**Figure 14. M09-A consists of a large wetland complex as seen in this aerial photograph.**

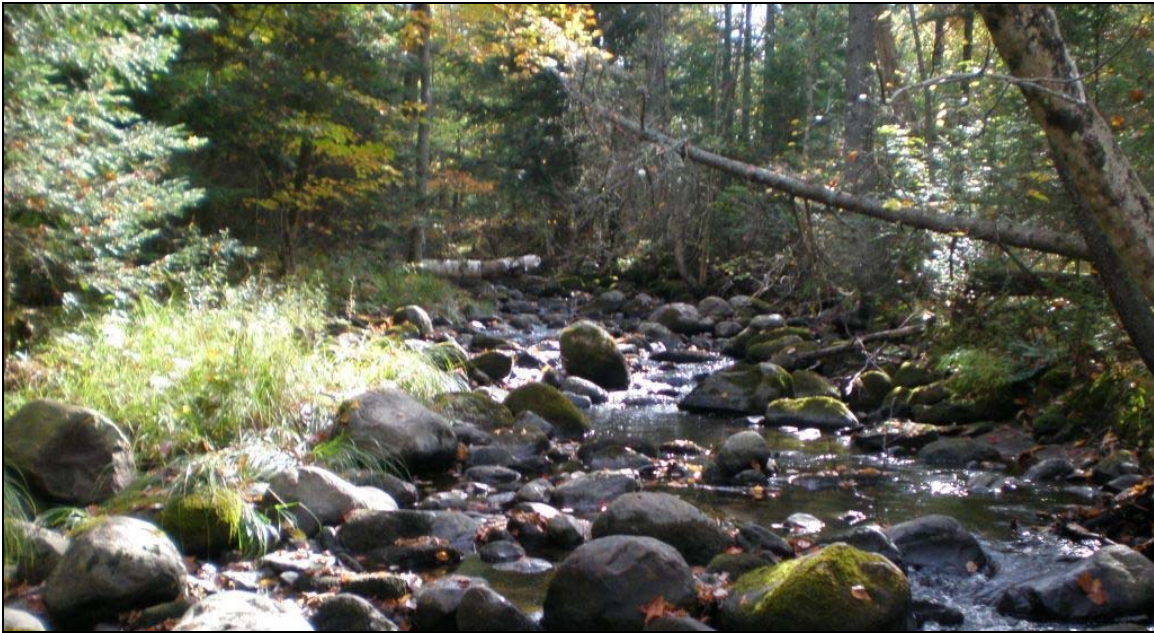
Figure 16. Cold River reach M08 is a relatively stable reach considered to be a C3 planebed system by reference. No major channel adjustments were observed to be occurring.

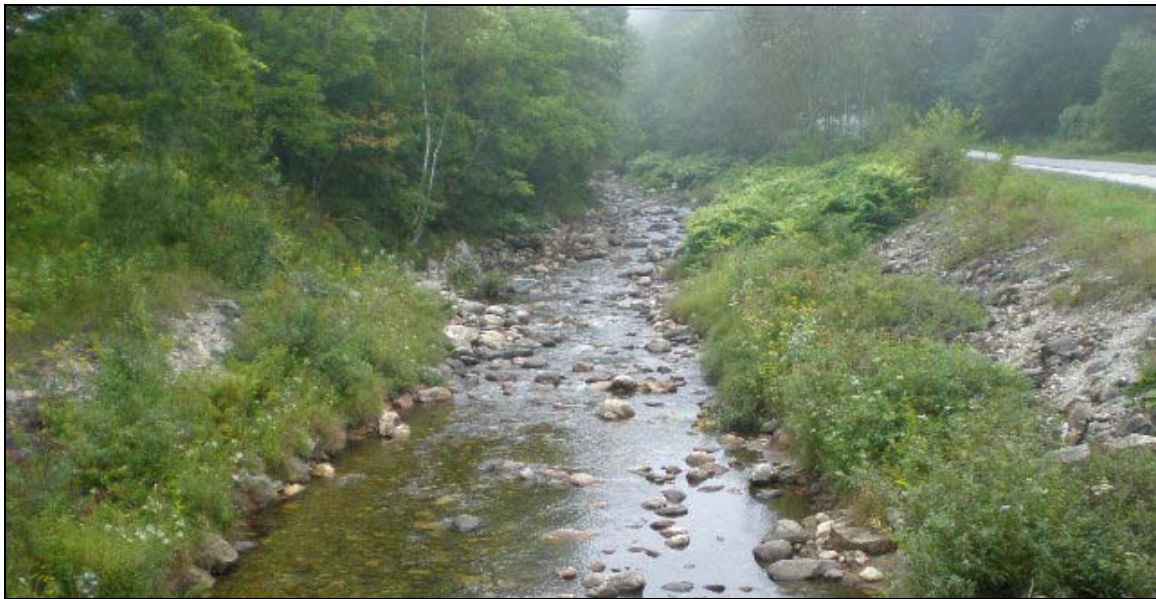
Figure 17. M07-C has been historically straightened and is now has a plane bed form.

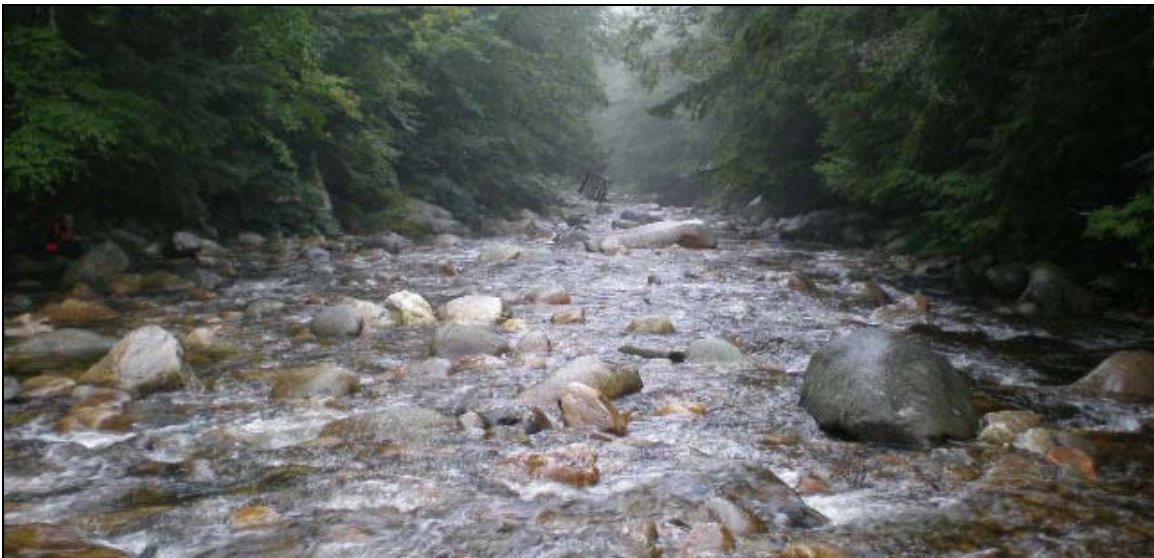
Figure 23. M04 is a B3 channel dominated by plane bed features and a healthy forested corridor.

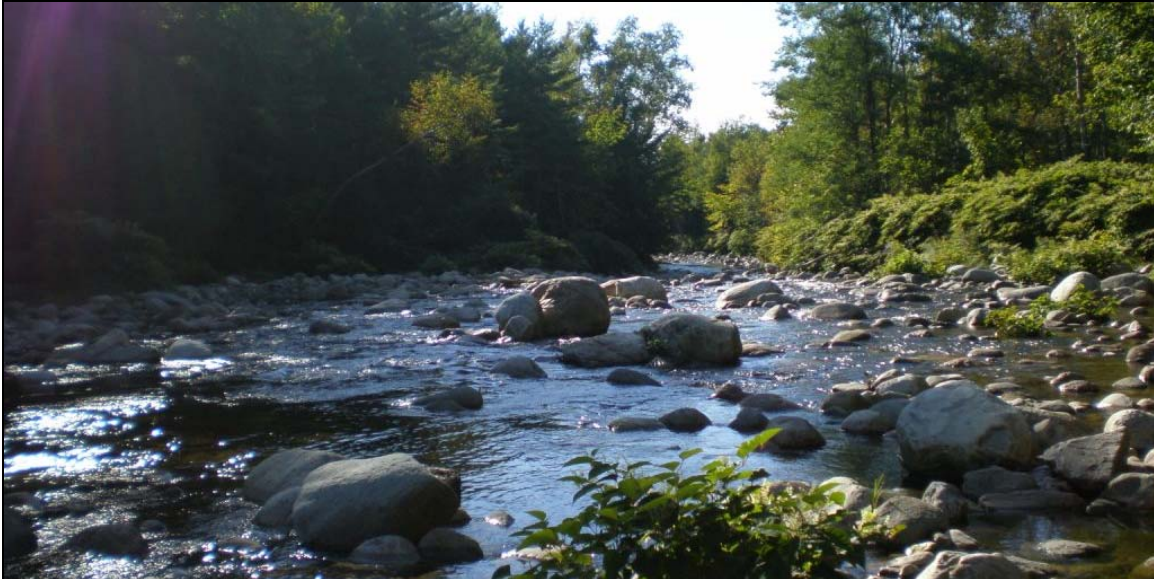
**Figure 24. M03 is a C3 system by reference, however, has incised and is currently exhibiting major widening and planform adjustment as a B3 plane bed channel.**

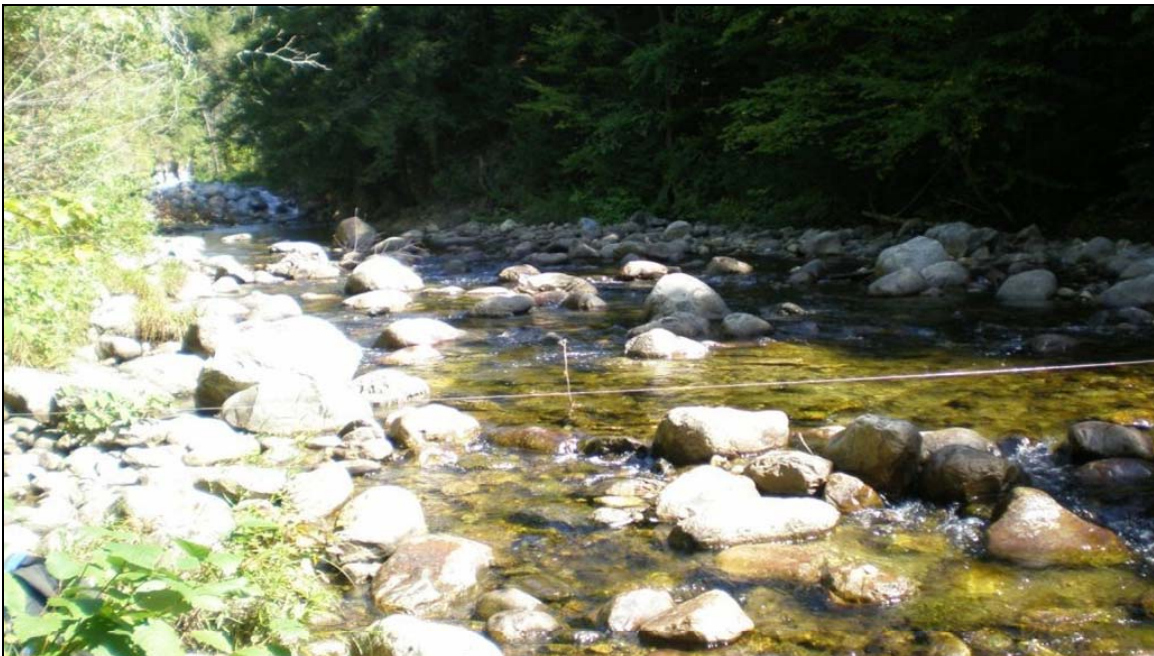
Figure 27. M01-C is a B3 plane bed segment. It connects a gorge with the alluvial valley bottom of the Otter Creek.

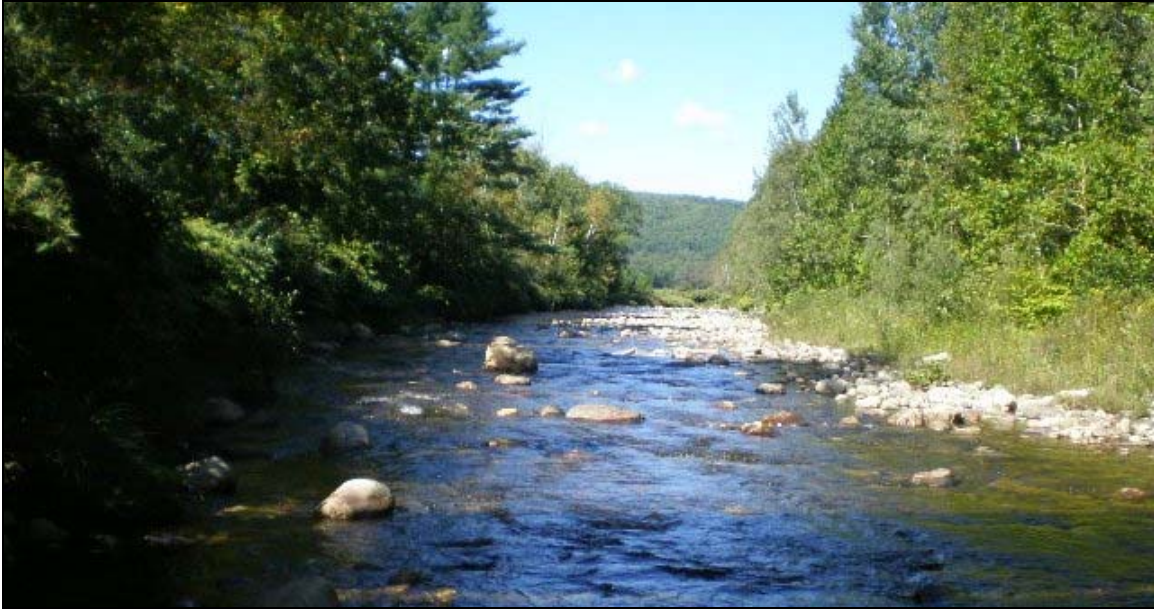
**Figure 28. M01-B has been historically straightened and dredged and is now has a plane bed system with limited floodplain access.**

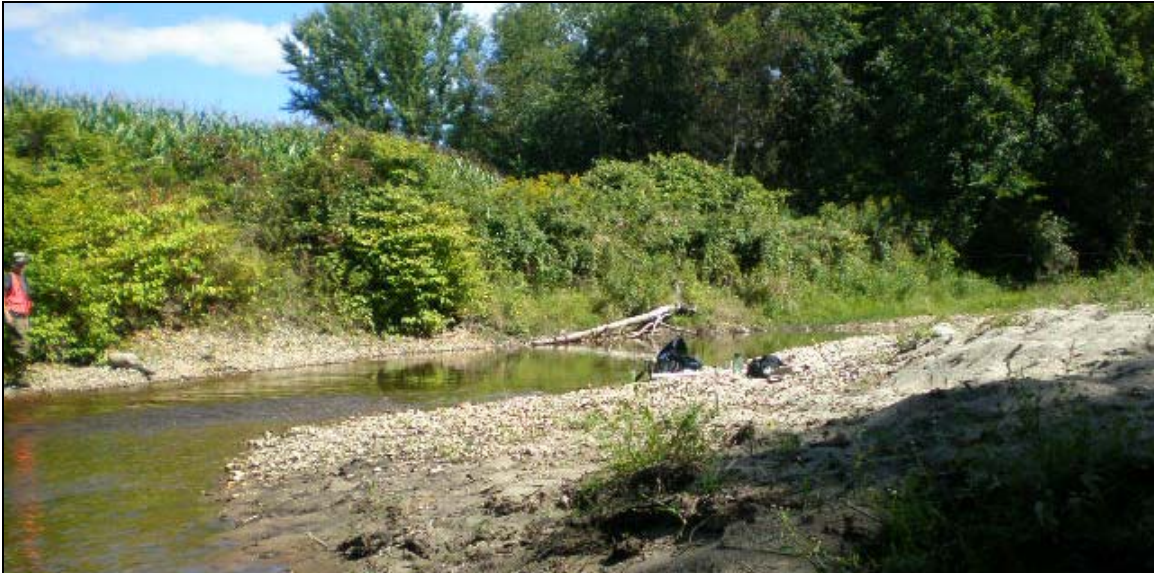
Figure 29. M01-A connects the Cold River with the Otter Creek and is an area of high natural adjustment.

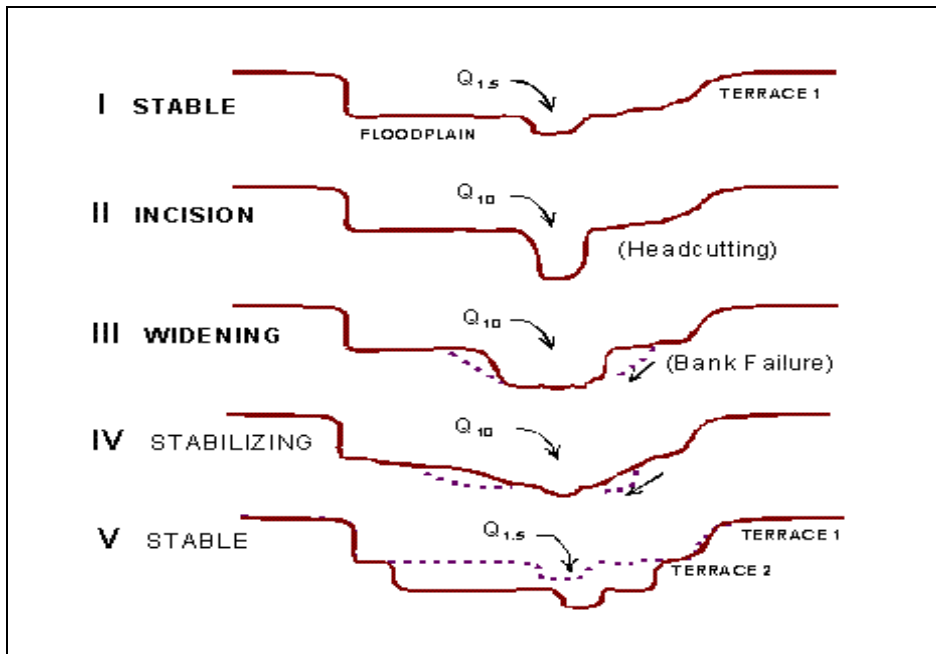
Figure 31. F-stage Channel Evolution Process (from Vermont Agency of Natural Resources, 2007b)

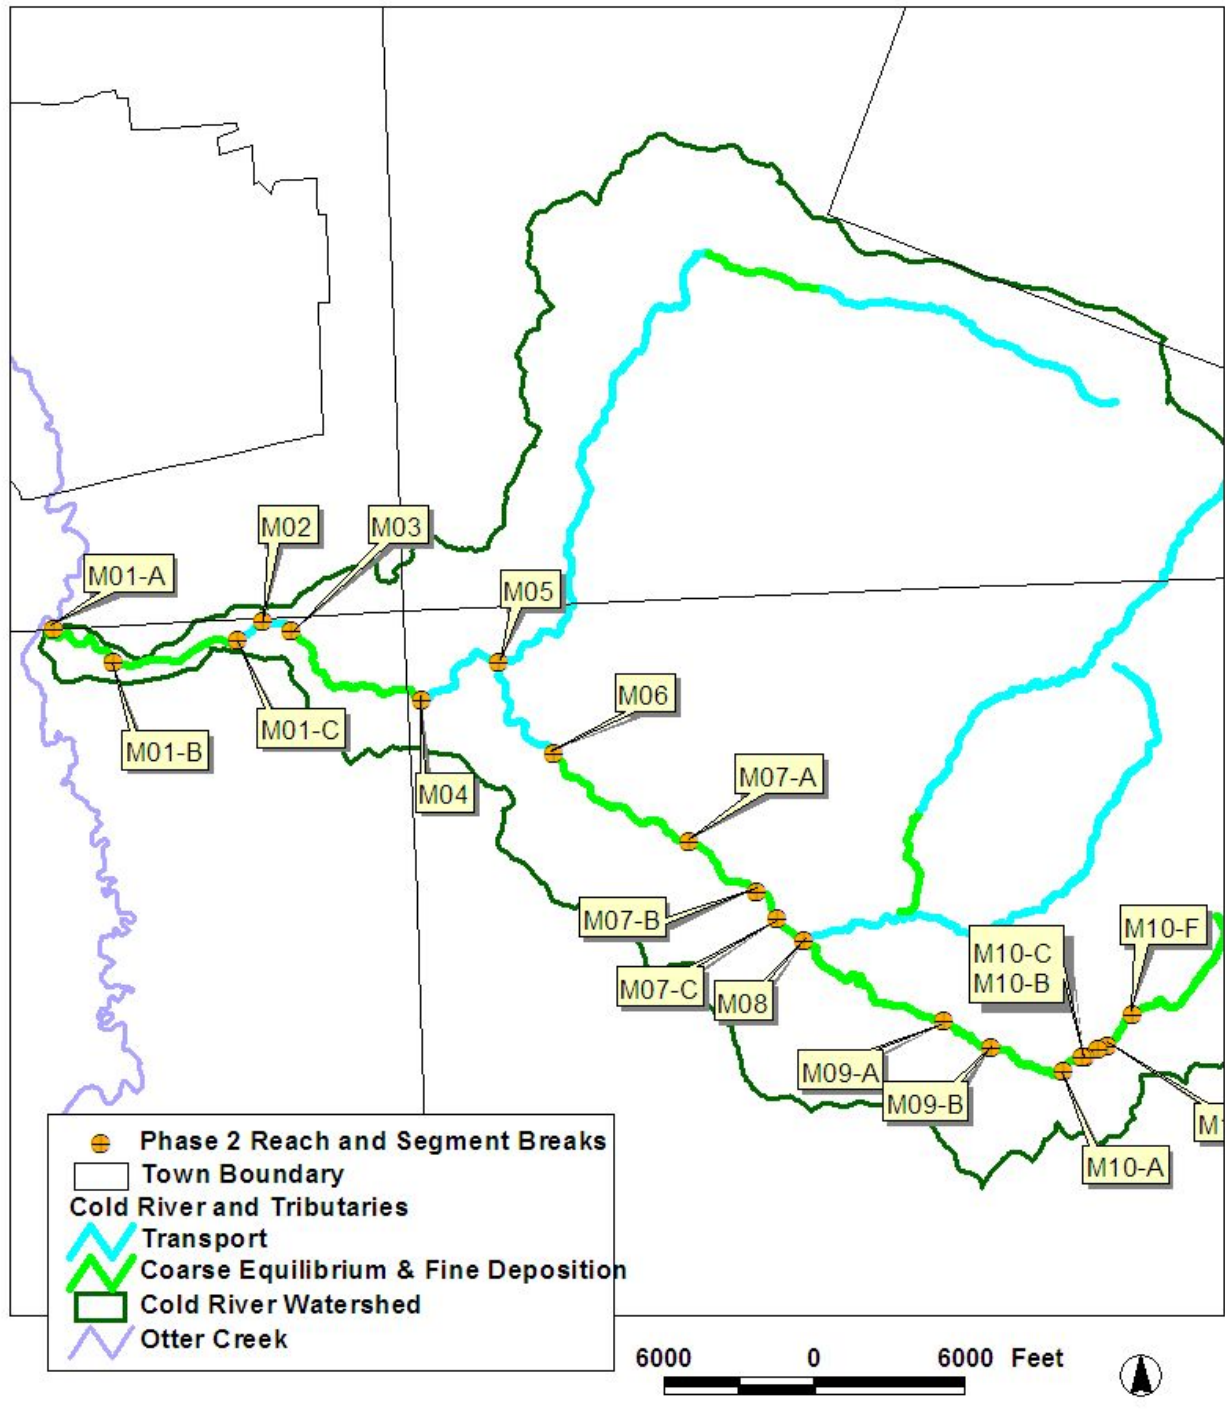
Figure 32. Sediment Transport and Attenuation under reference conditions.

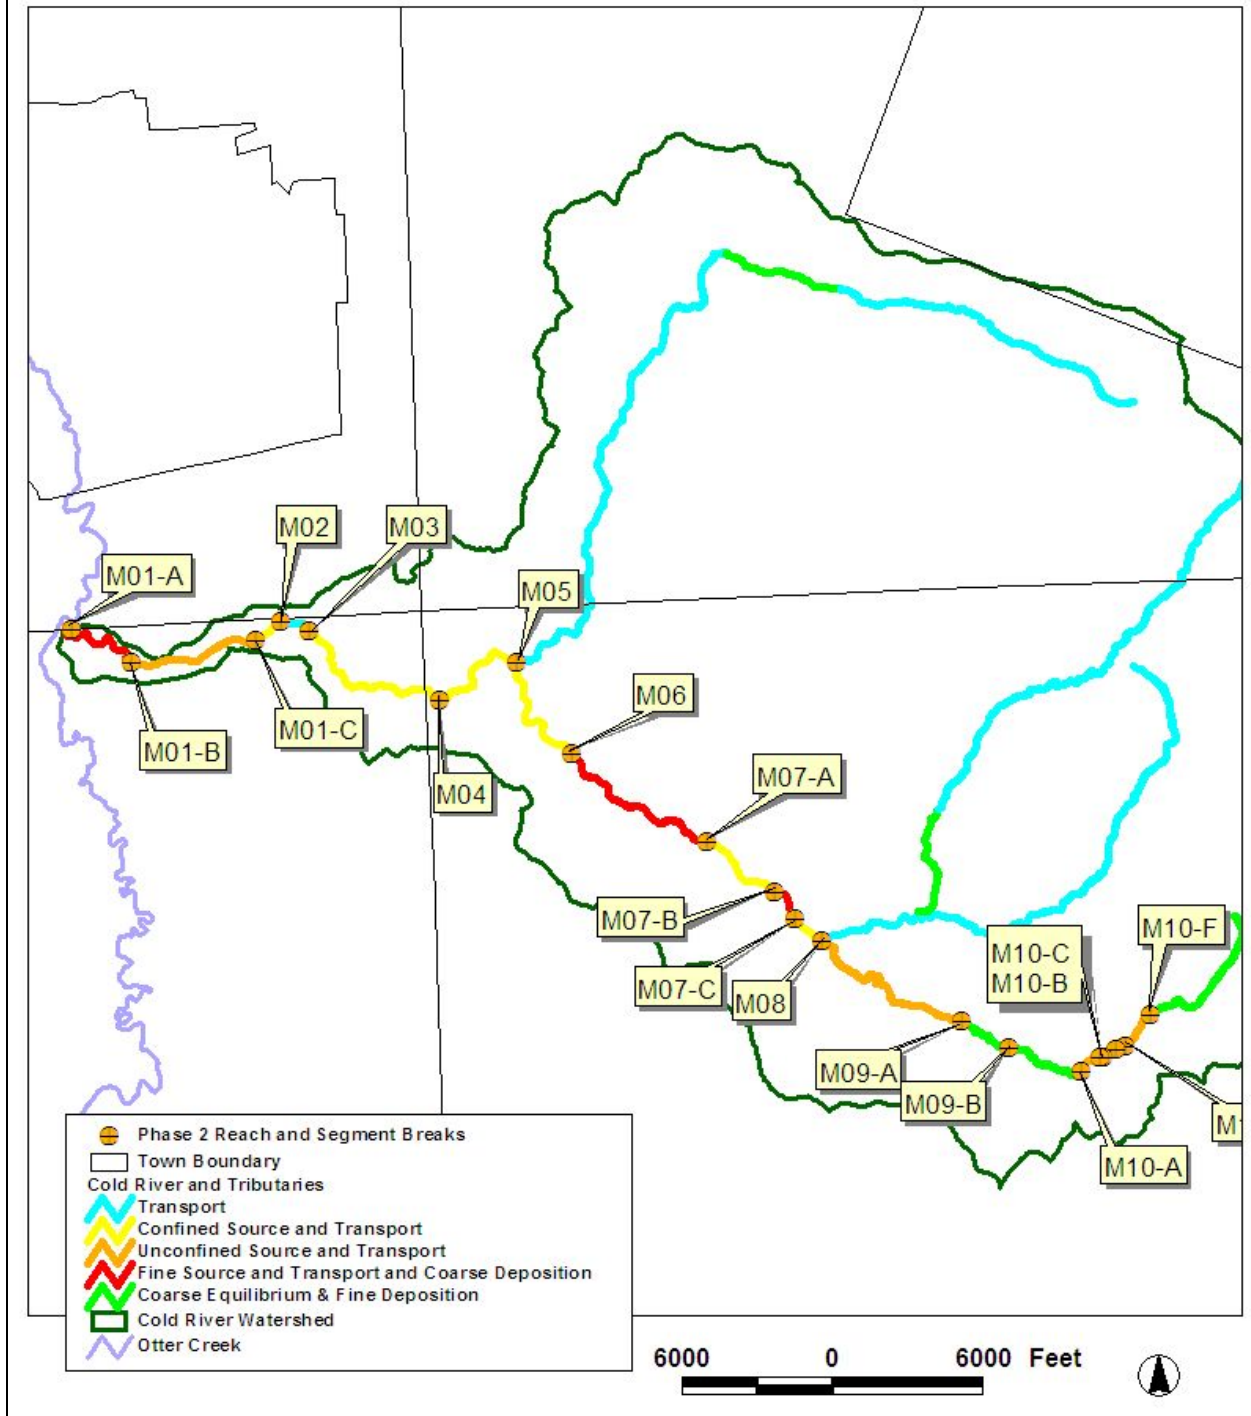
Figure 33. Sediment Transport and Attenuation, Existing Cold River conditions.

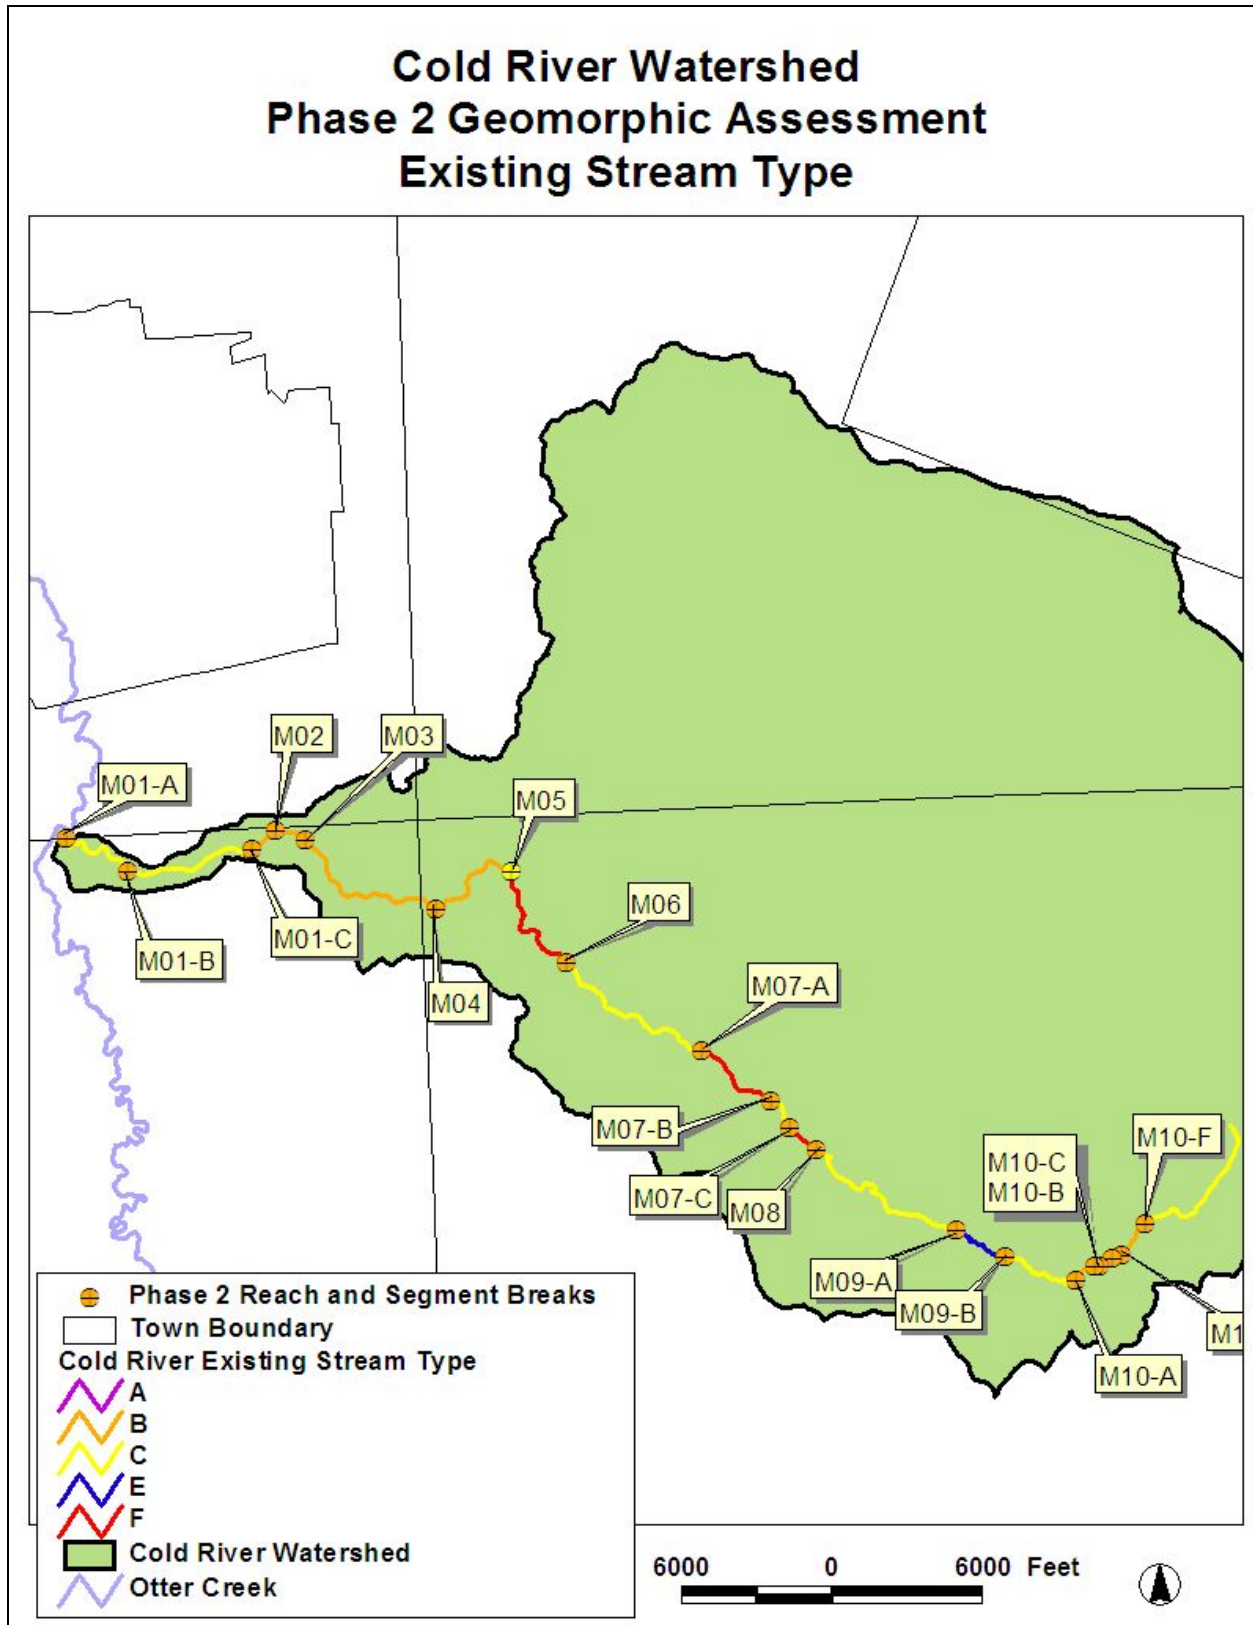
Figure 34. Phase 2 Existing Stream Types

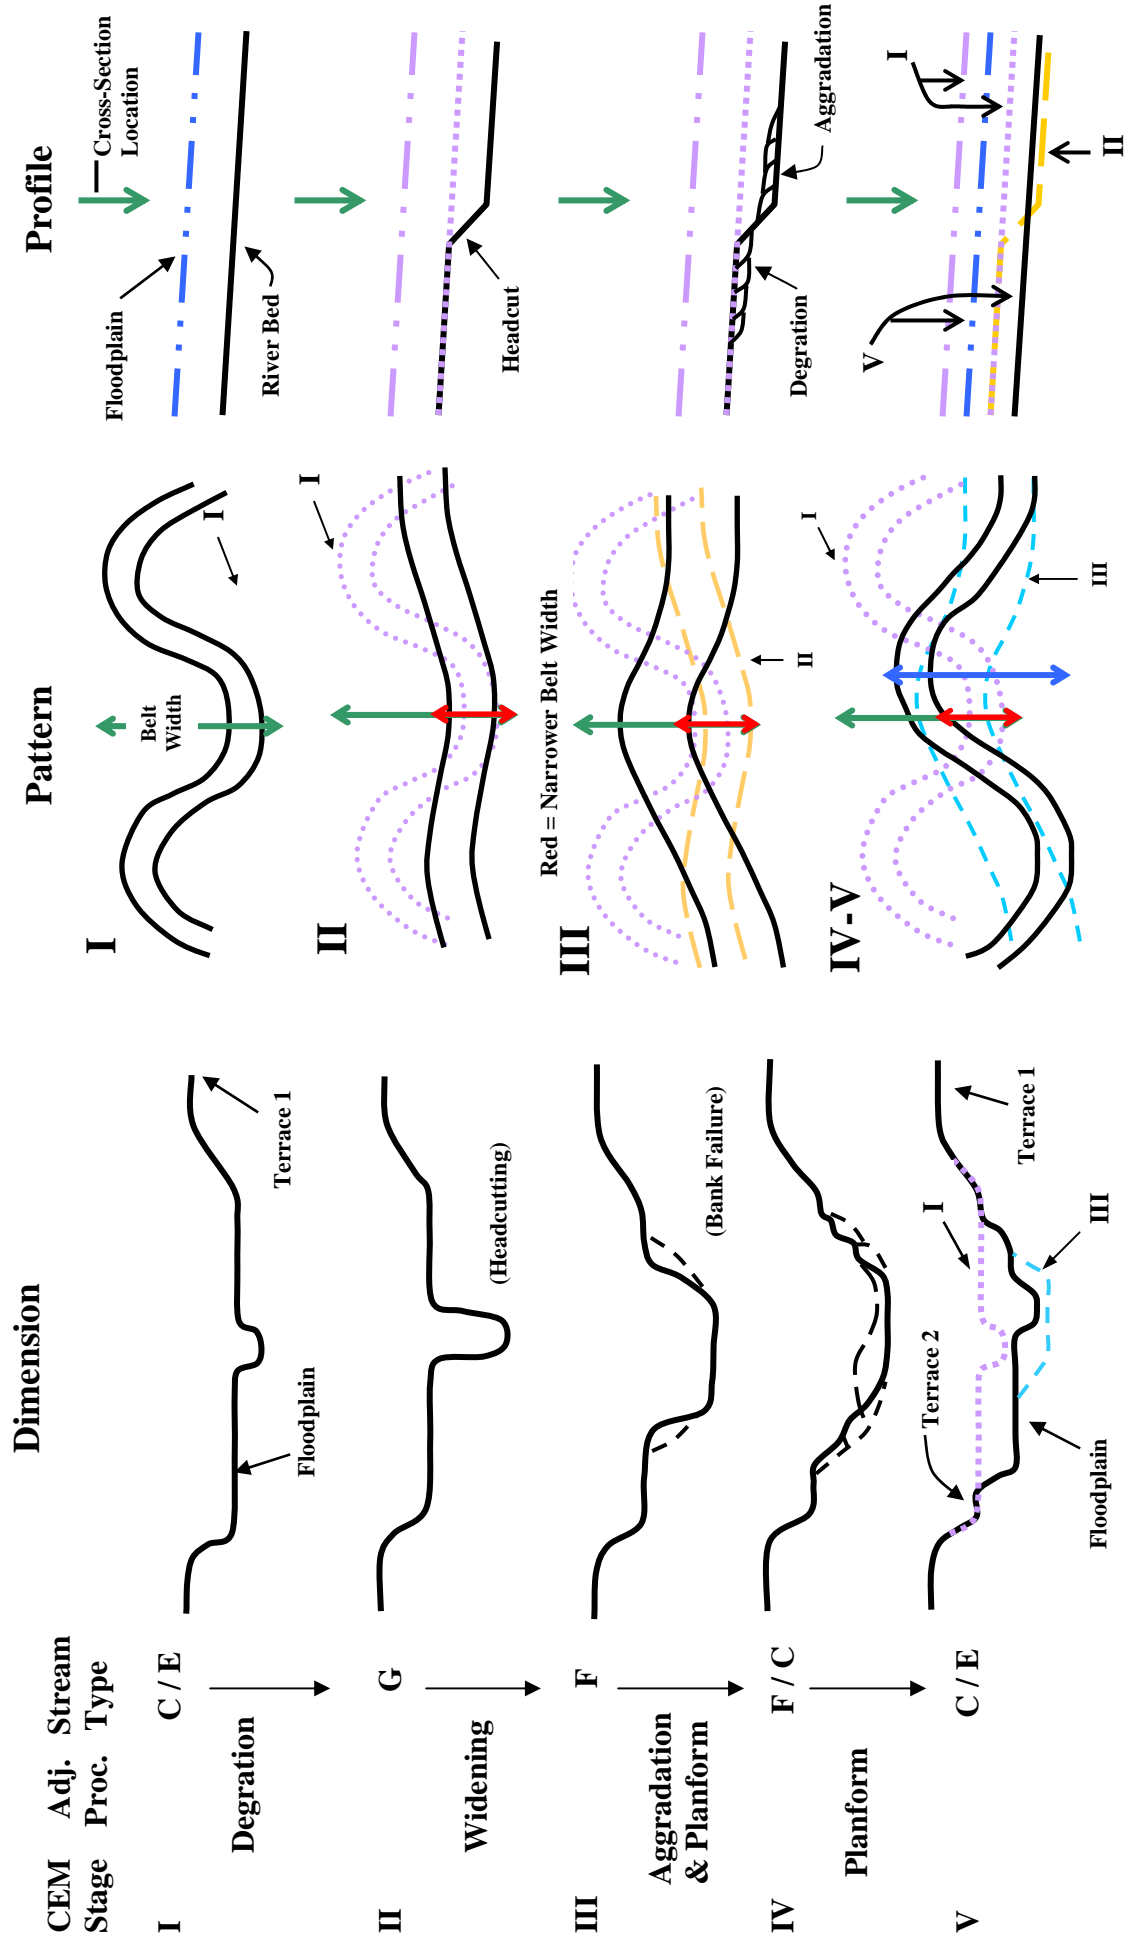
## D-stage Channel Evolution Process
