PHASE 1 STREAM GEOMORPHIC ASSESSMENT

GREEN RIVER WATERSHED

LAMOILLE COUNTY, VERMONT

Prepared by the Lamoille County Planning Commission
September 2012

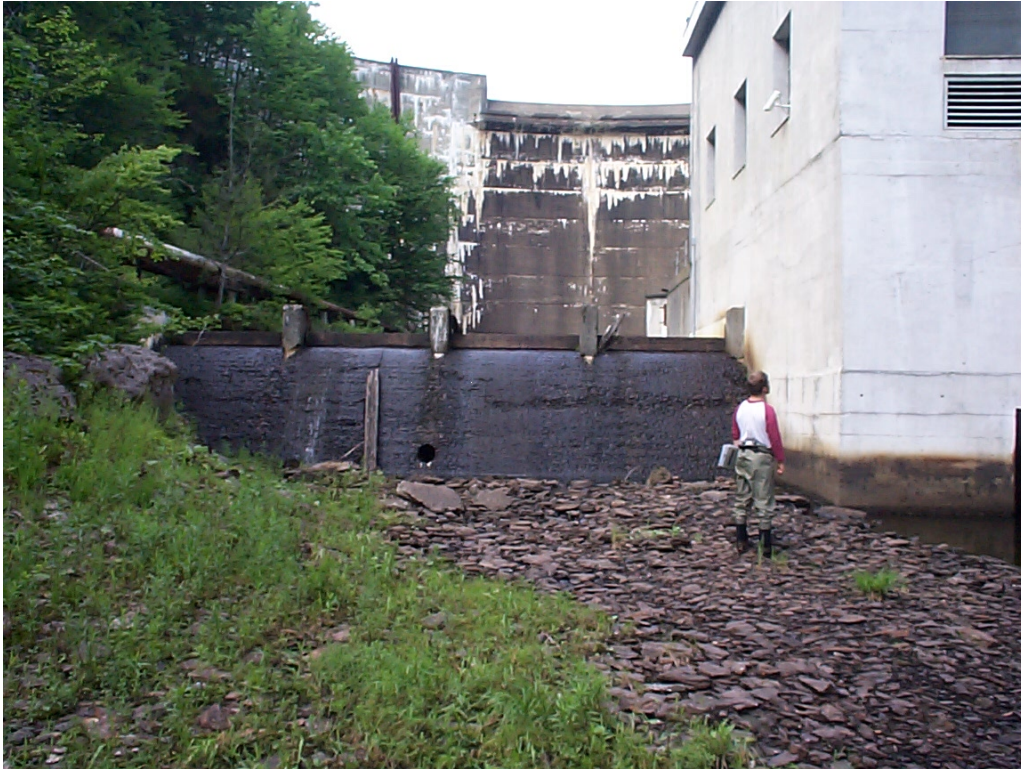
assessed in Lamoille County. The dam essentially cuts off the supply of sediment to the river downstream of the dam, thus depositional features were not as significant here as on many other rivers.

Figure 2: Reach M12 – Dam at Green River Reservoir.

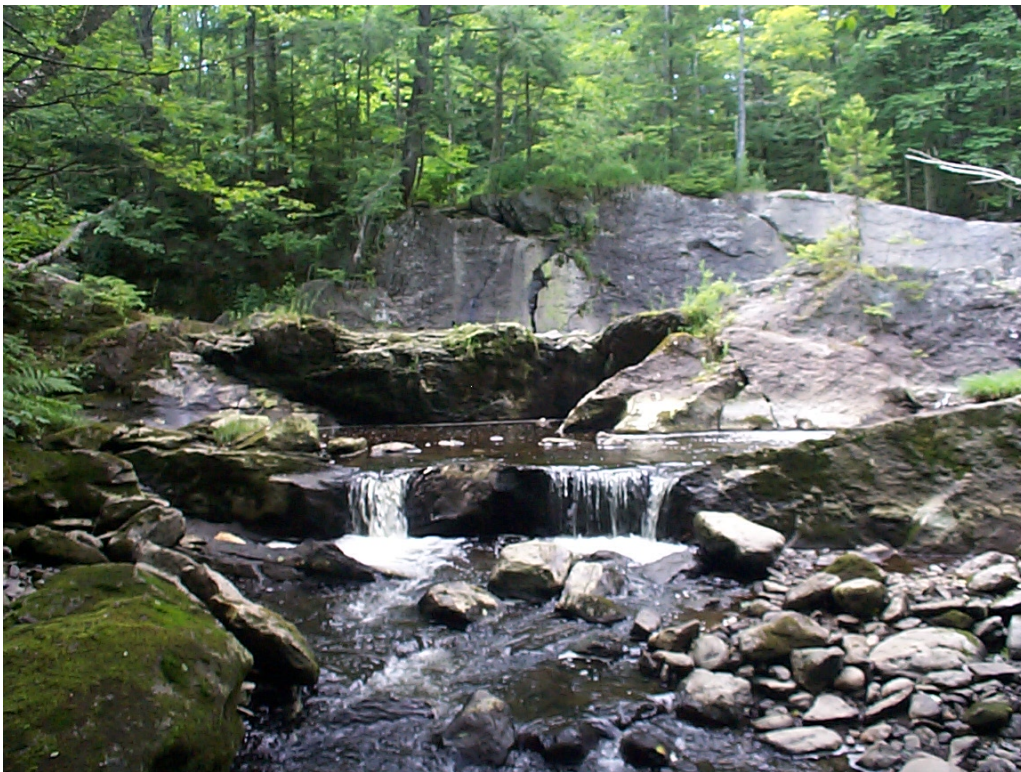
Figure 6: Reach M-08 - Natural grade control

of the assessment concluded that overall, the river is in good condition. There are sections with significant bedrock grade controls (see Figure 6), and much of the stream has an adequate riparian buffer.

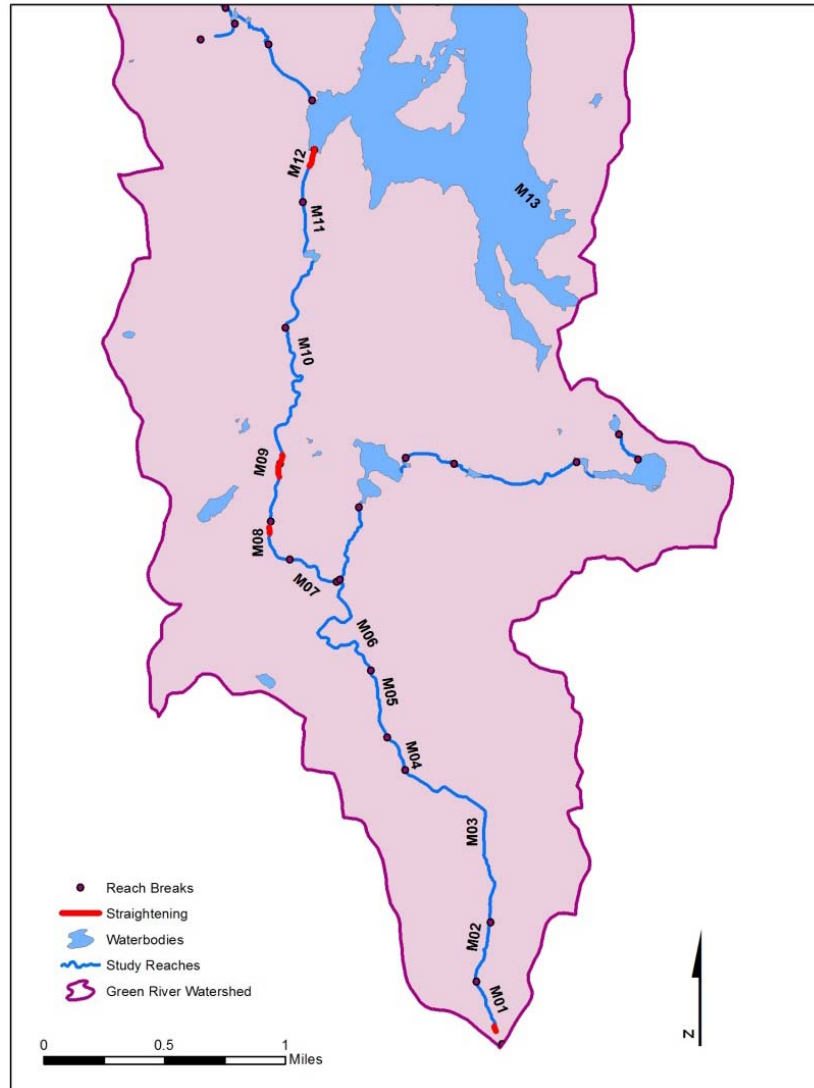
Sections of the Green River main stem impacted by straightening are shown in Figure 10. Reaches M09 and M12 resulted in high impact scores. There is evidence of channel straightening in Reaches M01 and M08, but the impacts are considered low.

Figure 10: Channel straightening in Green River watershed.

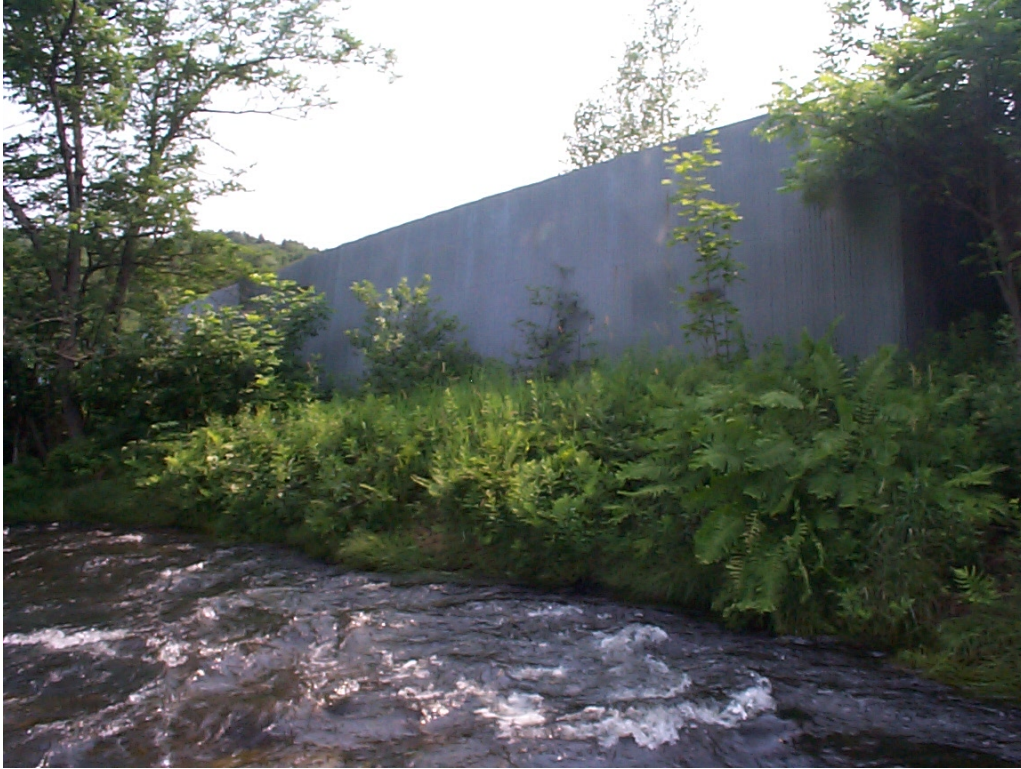
Results are presented in Appendix J (Step 6 report in the DMS). Reaches M01 and M08 each had corridor development, but the impacts were not considered significant. An encroaching junkyard in reach M01 is shown in Figure 11.

Figure 11: Reach M01 – Floodplain encroachment from junk yard behind the large fence.

Adjustment Process and Reach Condition is summarized in Appendix O. The Green River watershed and river corridor is largely undeveloped. The few exceptions are floodplain encroachments along M01 (see Figure 11) from crops and a junkyard. Reaches M08-M10 are also impacted by floodplain encroachments from a road leading to the reservoir (see Figure 12). Most of the assessed reaches include frequent bedrock outcroppings which helps stabilize the river and prevents major adjustments such as degradation. There is some significant erosion downstream and aggradation further downstream along reach M08 due to the perched culvert (see Figure 13) and sediment entering the stream from road runoff. The river would benefit from replacement of this structure with one that is not perched, as well as the installation of erosion reducing measures along the road. Slight planform adjustment was observed in reach M09, just upstream of the bedrock and culvert in reach M08. This process changes the shape and size of meander bands and the overall path the river follows.

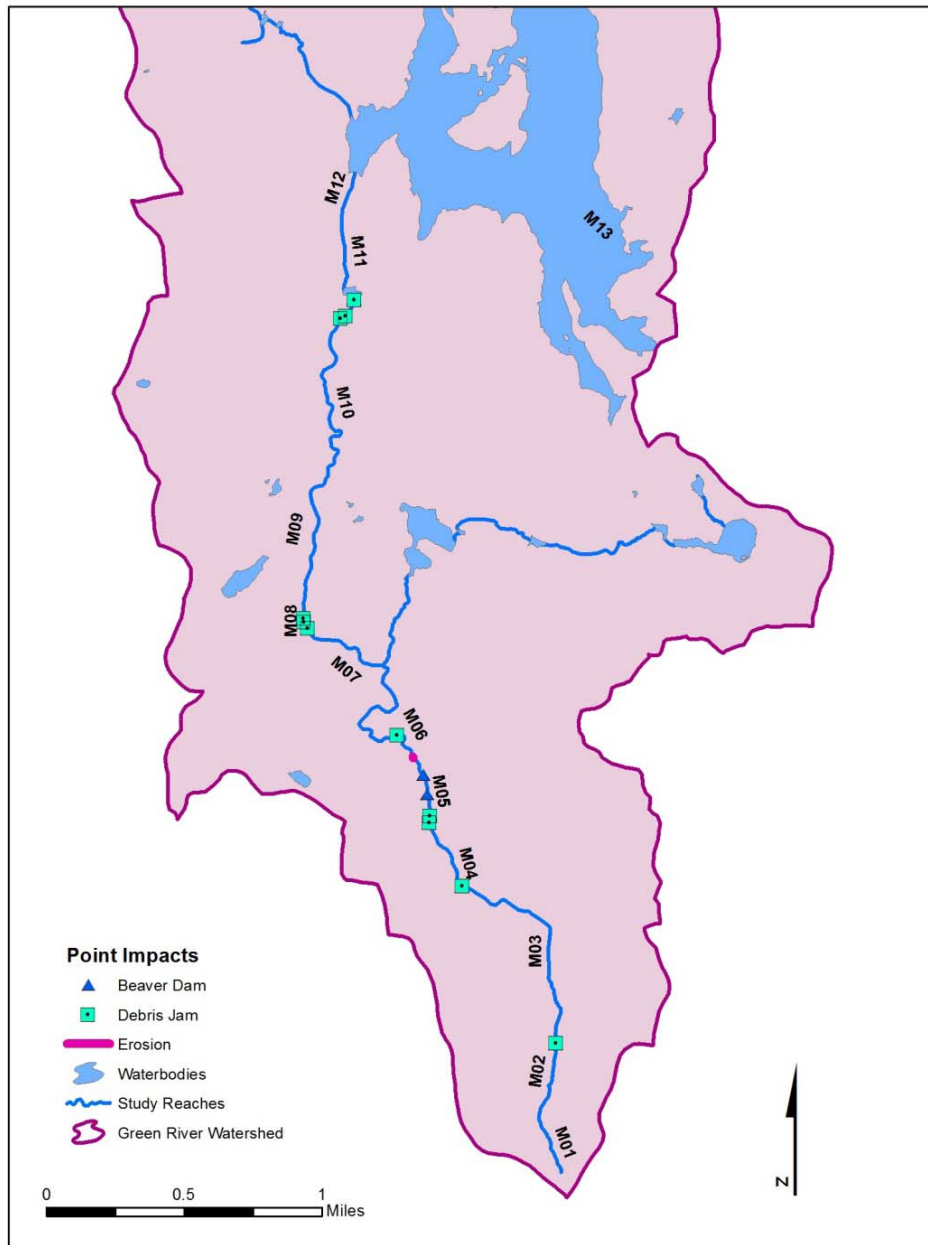
Results are presented in Appendix L (Step 7.1 report in DMS). The location of observed bank erosion is shown in Figure 13. Only one reach, M06, was documented with bank erosion and its impact was not considered significant.

Figure 13: Point impacts in the Green River watershed.
