**Foote Brook  
Johnson, Vermont**

**Phase I & II Geomorphic Assessment**

**Prepared by Bear Creek Environmental and  
the Lamoille County Planning Commission**

**September 2010  
Revised February 2018**

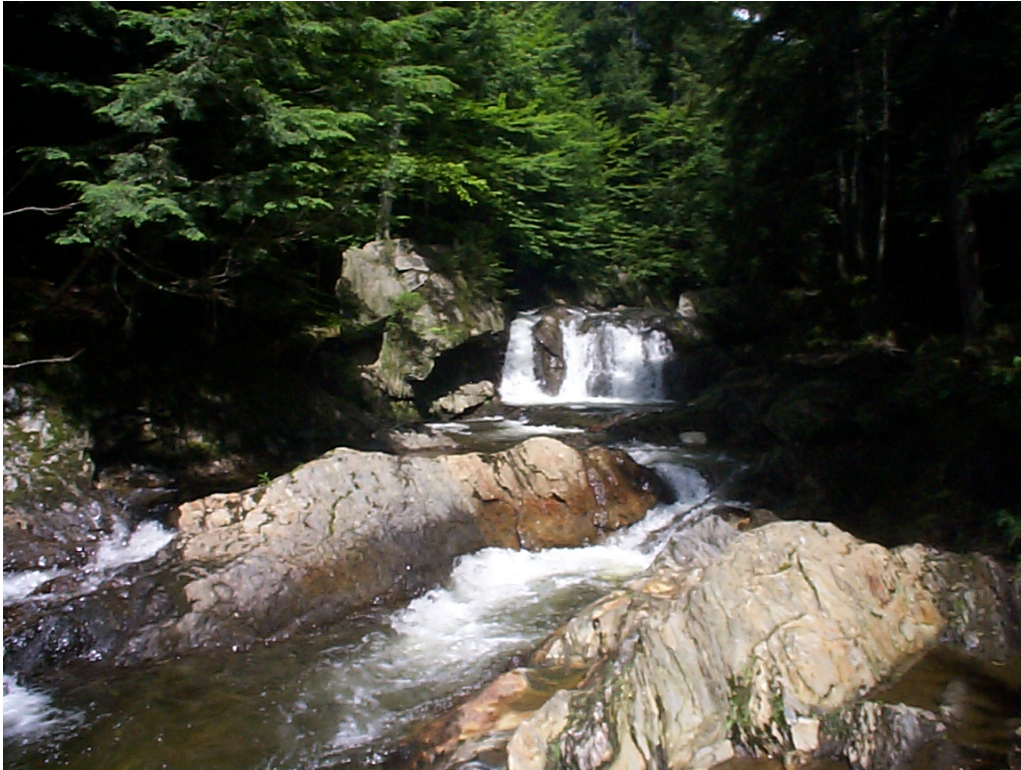
The results of the assessment concluded that overall, the river is in fair condition. There were sections with significant bedrock grade controls (see Figure 3), and much of the stream had an adequate riparian buffer. As part of this assessment, land use, encroachments, and buffer condition are analyzed within 150 feet on each side of the river. Residential and agricultural land use within the river corridor accounted for the majority of these high impact scores on Foote Brook. Of the reaches assessed on the main stem of Foote Brook, reach R13S0301 received the highest total impact score of 10 (out of a possible score of 32). Reach R13S0304 received the second highest impact score of 7 with reach R13S0302 and reach R1S0308 received an impact score of 6. These relatively high scores are due to land use within the river

Figure 3. Bedrock waterfall at “Journey’s End” swimming hole.

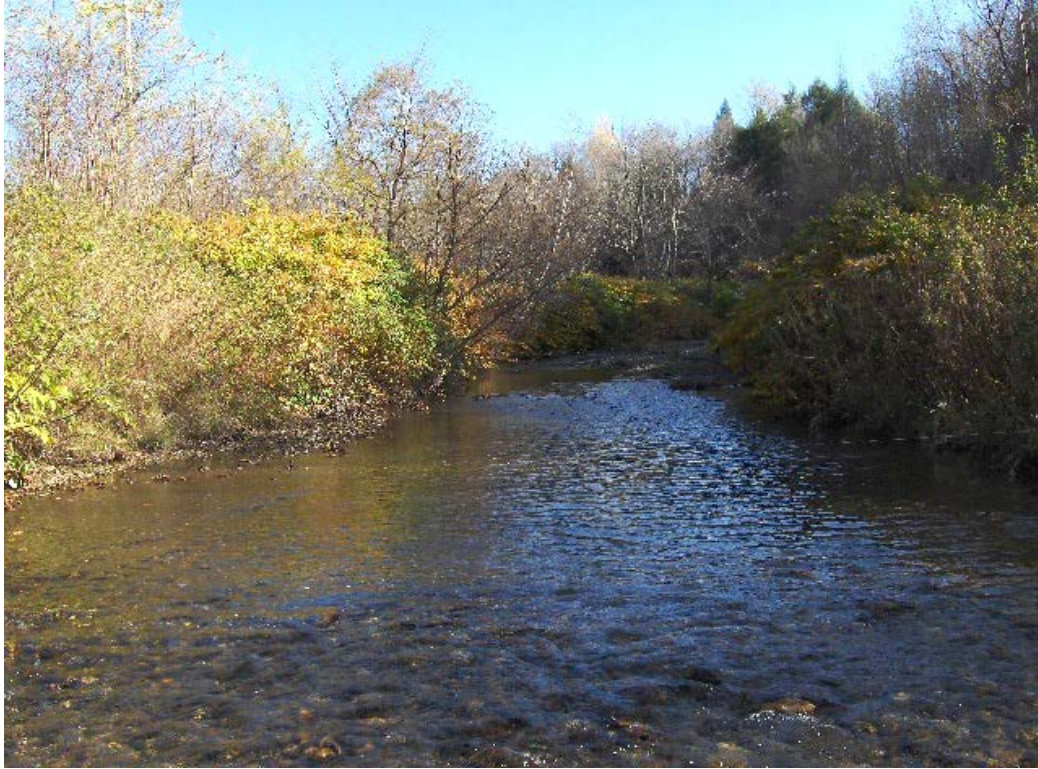
Figure 5. Typical channel in segment R13S03.01-A

The rapid geomorphic assessment (RGA) scored in the “fair” category due to major historic degradation, major aggradation and planform adjustment and minor widening. This is a “C” gravel dominated segment with a juvenile floodplain that has formed on the inside of meander bends. Riffles were classified as sedimented. Signs of planform adjustment include a channel avulsion and flood chute. The channel width is beginning to narrow through aggradation and development of bar features. The channel may continue to shift back and forth and erode terrace side slopes as the juvenile floodplain widens. It is important to allow the channel room to continue to adjust.

The rapid habitat assessment (RHA) rated in the “good” category. The RHA parameters for sediment deposition and channel flow status were rated in the fair category reflecting the major aggradation that is occurring within the reach. Very little deep water was available for fish at the time of the assessment. A corridor easement or the adoption of FEH zones are recommended to project the high quality riparian corridor in this segment. The lower end of

Foote Brook is an important attenuation asset and limiting encroachments in the corridor would allow the river to continue to adjust and reach an equilibrium condition over time.

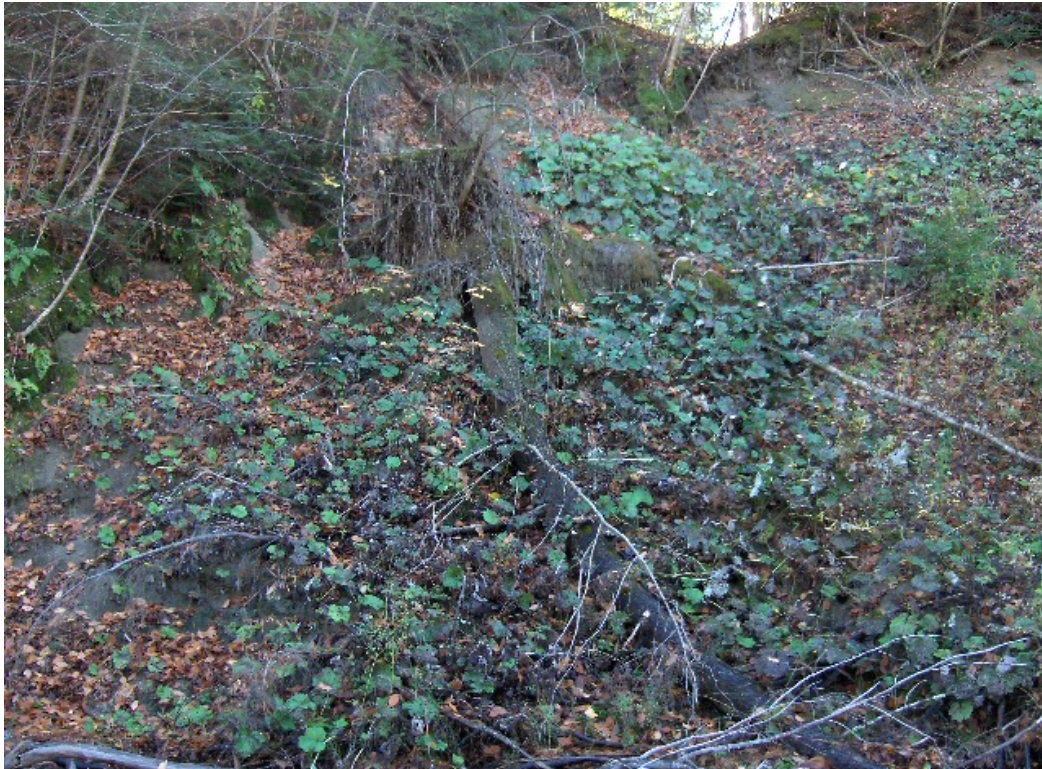
R13S03.01-B is the middle segment on the lowest reach of Foote Brook. Segment B has an existing stream type of “F” that is a departure from the reference type of “C”. The substrate is larger in segments B and C than in A, accounting for the aggradational processes that are taking place at the downstream end of the reach. A mass failure at the lower end of segment B is contributing sediment to Foote Brook (Figure 6). Similar to segment A, the dominant buffer width is greater than 100 feet on both sides on Foote Brook in segment B. There are some areas on the north bank where the buffer width is between 51 and 100 feet. Mixed trees are generally found along both banks, and there are some short sections where herbaceous vegetation is growing on the south bank in residential areas.

Figure 6. Mass Failure in segment R13S03.01-B

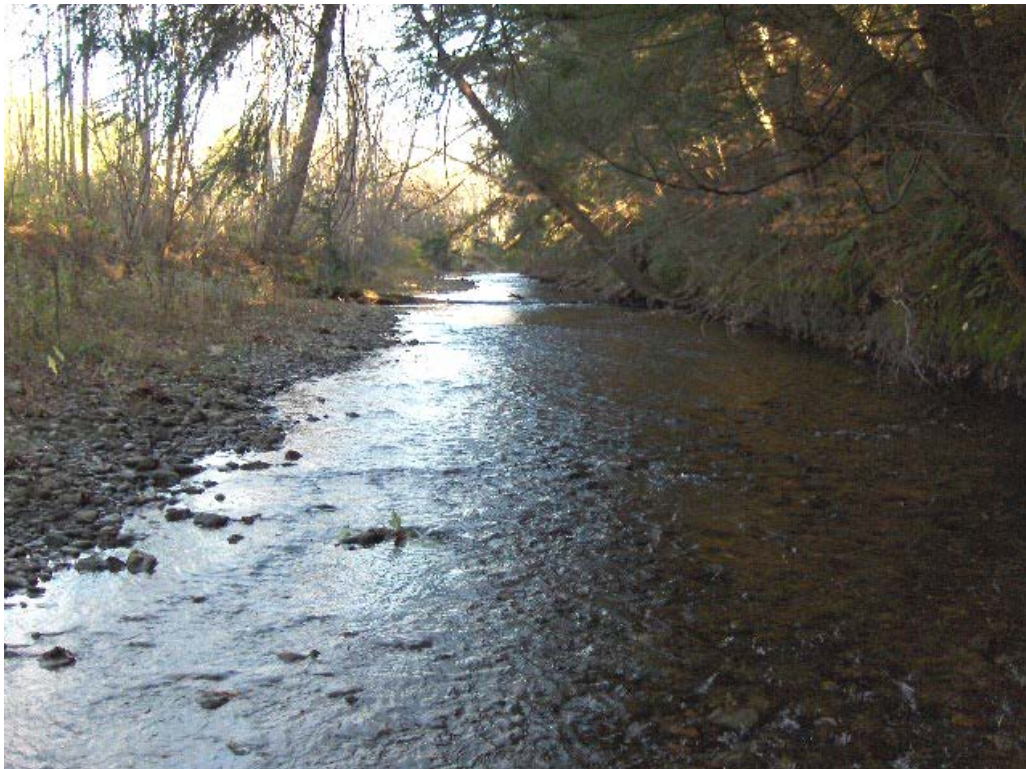
A well defined terrace about 4 feet higher than the bankfull elevation is the recently abandoned floodplain. On the cross section that was measured, this terrace extended from the north stream bank out to Route 15 (about 650 feet). The channel within segment B is incised (ratio

of 2.4), indicating there is poor floodplain access (Figure 7). This has resulted in an increase in stream power within the channel, which will eventually erode the stream banks. Bank erosion was noted to be minor; however, the erosion may have been underestimated during the Phase 2 assessment due to leaf cover. The Phase 2 assessment took place during October 2007 at the height of the foliage season. High quality native vegetation on the banks is preventing planform adjustment and widening. The channel is in Stage F-II of the channel evolution model. Extreme historic degradation is leading to minor aggradation and widening. The geomorphic condition is “fair”.

Figure 7. Incised and entrenched cross section in R13S3.01-B

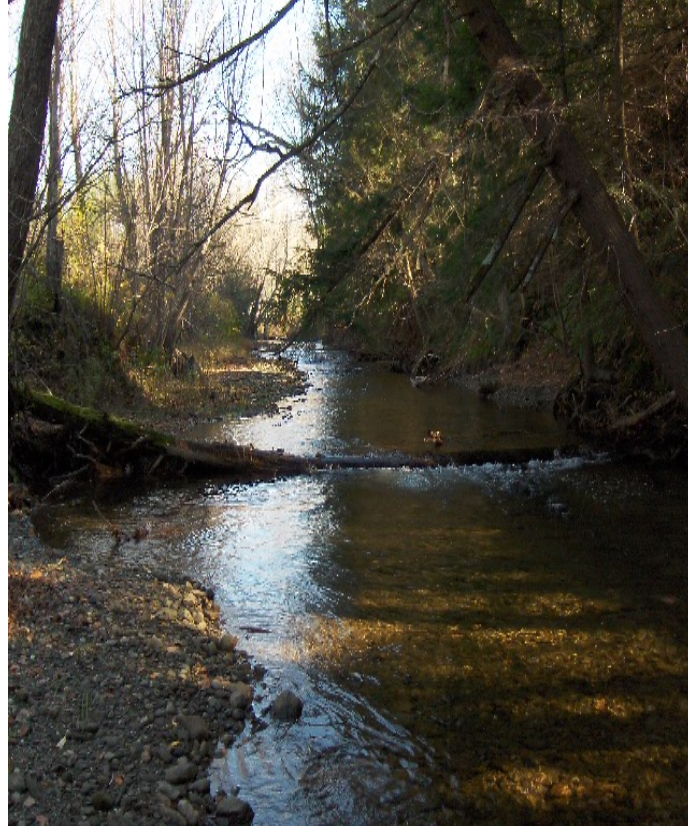
The habitat condition scored in the “good” range. All of the habitat parameters scored in the good or reference category with the exception of fish cover and channel flow status. The log in Figure 8 is creating a nice pool for resident fish.

Figure 8. Log creating a pool in R13S3.01-B

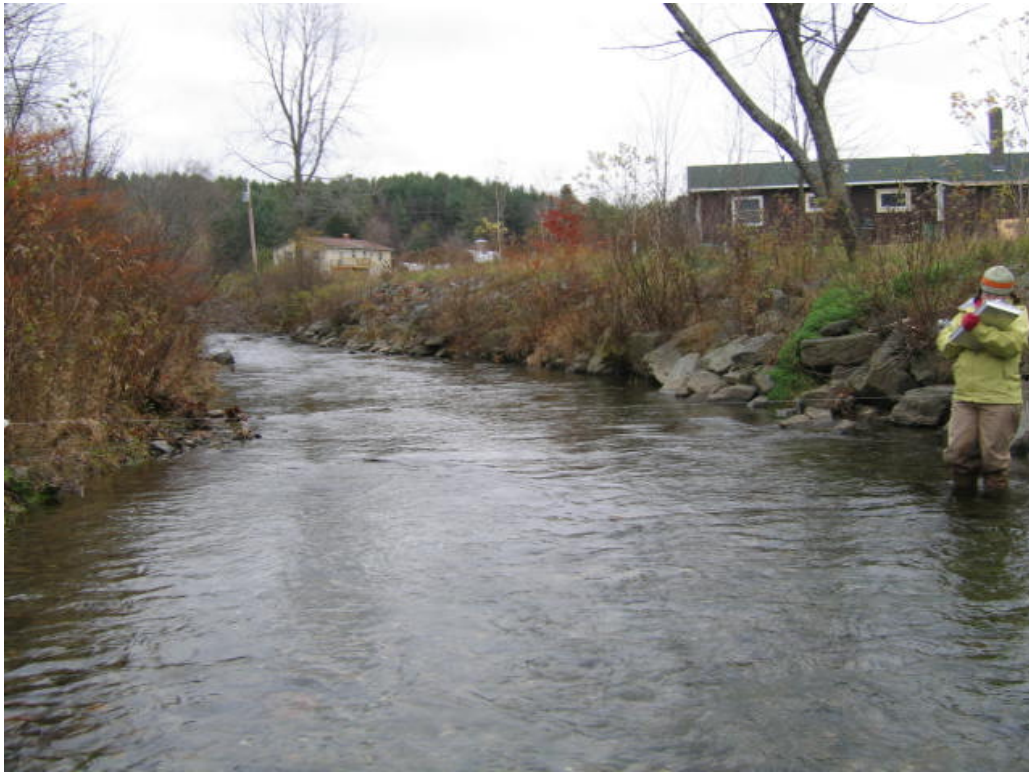
The most upstream segment, R13S3.01-C, includes the Route 15 crossing at its upper end and is extremely dynamic. The upper 550 feet of the segment has been straightened and rock riprap lines the southern bank (see Figure 9). The slope steepens significantly below a channel avulsion in the middle of the segment. An active head cut (i.e., nick point or sharp change in slope) downstream of this straightened section may have developed in response to this recent channel avulsion. The channel likely steepened in the area as a result of the channel length being shortened, and the headcut is moving upstream causing widening. The existing channel elevation is two to three feet lower than the former channel. There is a considerable amount of deposition in this area, which is immediately downstream of where the channel has been straightened. It is difficult to separate out which adjustment process, degradation or aggradation, is dominant. There are a number of large depositional features in this area, and some of the changes in slope appear to be steep riffles. One of the flood chutes was noted to have an active headcut during a visit to the site on September 19, 2010. An alternatives analysis is recommended to determine if it makes sense to try to arrest this headcut.

Figure 9. Rock riprap along southern bank in R13S3.01-C

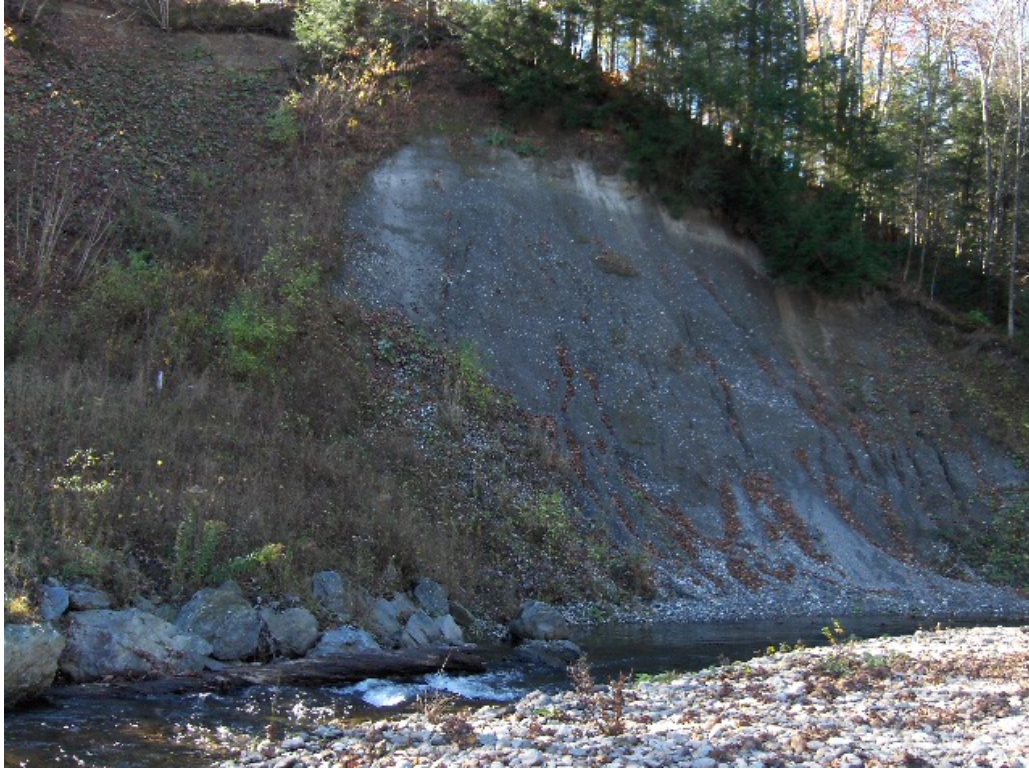
The buffers in segment C are narrow in comparison to the lower two segments of reach R13S3.01. The dominant buffer on the south bank and north bank is 26-50 feet and 51-100 feet, respectively. There are approximately 100 feet on both sides that have buffers less than 25 feet. Trees have been planted in the buffer on the south bank between a house and the mass failure near the lower end of segment C. The mass failure (see Figure 10) is 70 feet wide by 40 feet high.

Figure 10. Mass failure on south bank of R13S3.01-C

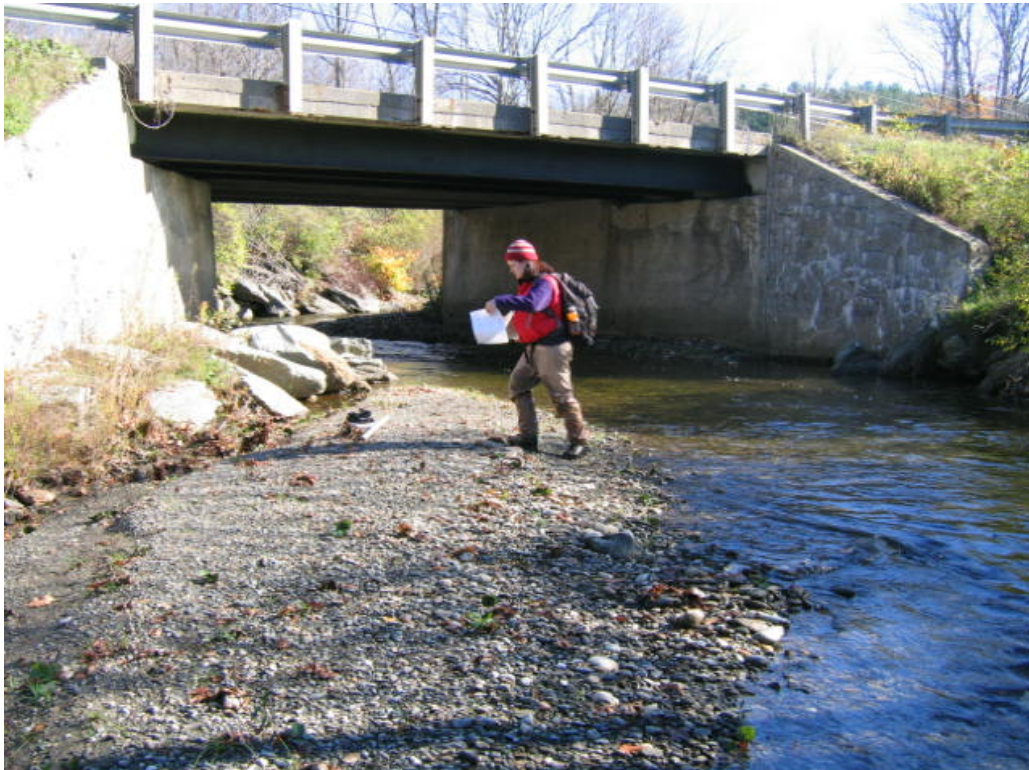
The “fair” habitat score reflects the channel alteration (almost 50 percent straightened), the narrow buffers, and the presence of Japanese knotweed (an invasive). There were no areas of deep water in the straightened section, where the bedform was planebed rather than riffle pool. In addition to the rock riprap, the bridge at the top of the reach over Route 15 is adding to the channel alteration. The span of the bridge is 24 feet and the channel width based on reference channel width is 33.4 feet. This means the bridge is undersized and is approximately 70 percent of the bankfull channel width. Deposition above and below the bridge was noted (Figure 11), as well as scour above the bridge. The angle of stream flow approach the bridge is a mild bend, which is creating a minor alignment problem. The bridge is undersized and is causing minor

geomorphic incompatibility. For this reason, the bridge is a low to moderate priority for replacement.

Figure 11. Deposition below Route 15 Bridge in R13S3.01-C

#3 Route 15 Crossing  Johnson VT  R13S03.01-C	Active Restoration	The Route 15 bridge is undersized (span is approximately 70 percent of the bankfull channel width). The bridge has poor alignment and is causing localized geomorphic instability.	Replace bridge	Low priority	Improved localize geomorphic stability	High costs for design and replacement	Unknown	VTRANS, Town of Johnson, ANR, LCPC

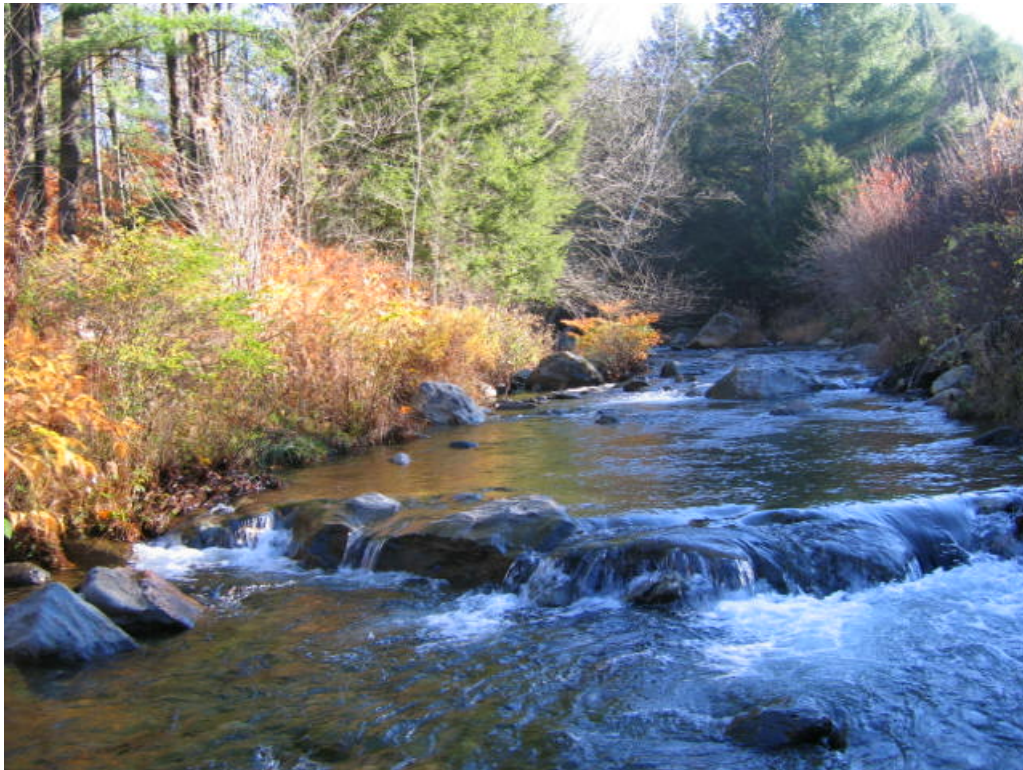
higher slope. The dominant bedform is step-pool (see Figure 12); however, there were some sections that were characterized as riffle-pool. The dominant substrate is cobble.

Figure 12. Step created by large boulders in R13S3.02

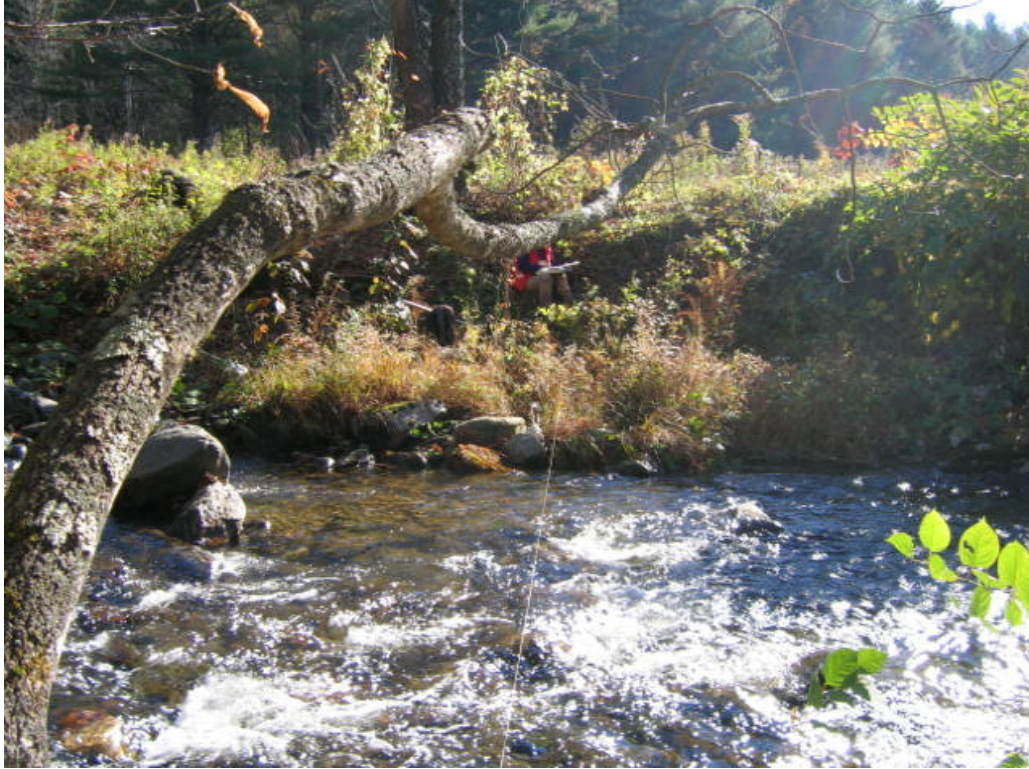
Notes taken in the field in October 2007 suggest reach 2 is stable with very little bank erosion. This appears to be contrary to the stream type departure that is noted from the cross section data. The terraces on both sides are about five feet higher than the bankfull elevation (Figure 13). It is not clear whether these adjacent terraces are a recently abandoned floodplain. There is a very narrow bankfull bench on both sides, suggesting the channel incised at one point. The combination of the large substrate, well vegetated banks, and high slope likely contribute to this being a stable section. Some minor planform adjustment was noted at the lower end of the reach where the valley widens and there is a flood chute. There is also a large side bar from aggradation that has occurred upstream of the Route 15 Bridge. The RGA scored at the lower end of the “good” range.

Figure 13. High banks on south side of channel at lower cross section (R13S3.02)

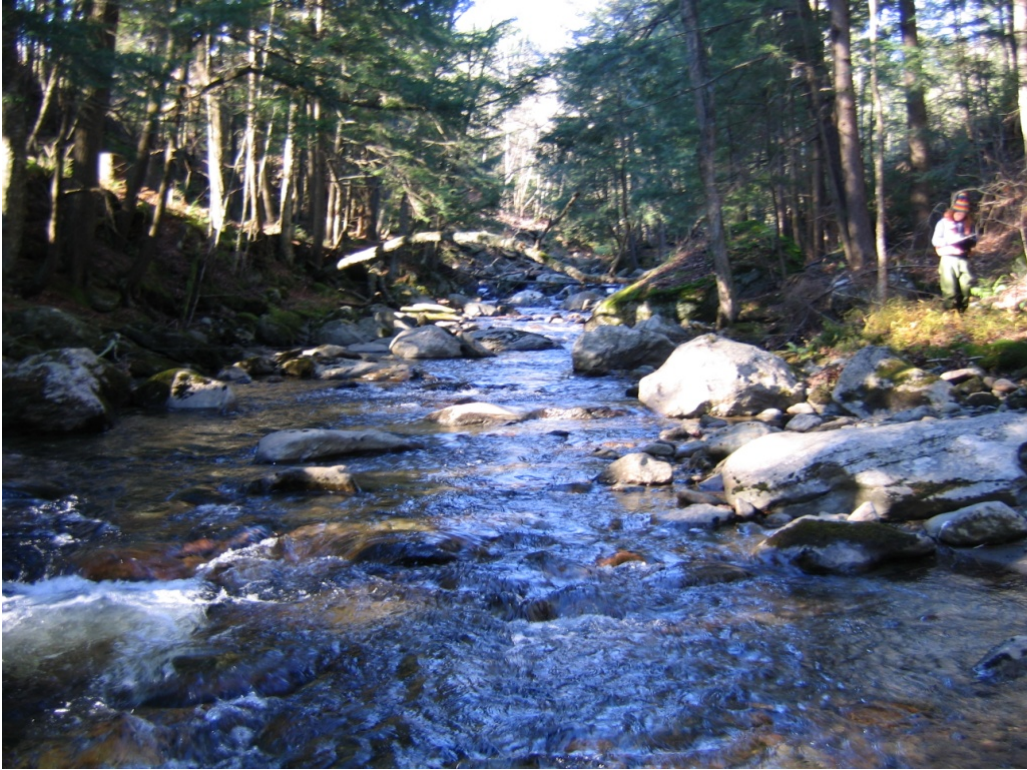
Figure 14. Step-pool bedform in reach R13S3.03

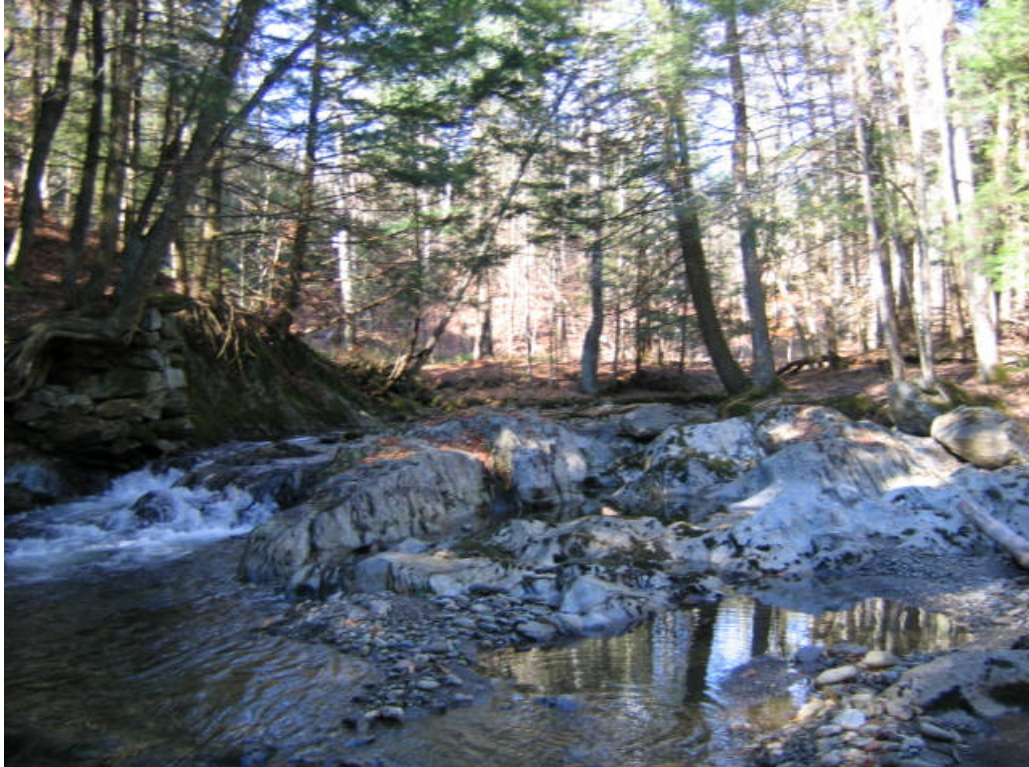
Figure 15. Bedrock grade control in middle of reach R13S3.03

Reach R13S3.03 is reference in terms of geomorphic condition and habitat. No channel adjustment processes were identified. The reach scored in the reference category for all ten habitat parameters. The riparian corridor is entirely forested with the exception of a short section of Foote Brook Road, which lies within the west corridor near the middle of the reach. Conservation of this reach is recommended.

#4 1000 to 2600 feet above Route 15 crossing  Johnson VT  R13S03.03	Active Restoration	Channel scored reference for geomorphic condition and habitat. Bedrock grade control in middle of reach where old mill site may have been located. Riparian corridor is forested with the exception of short section that on west bank that is near Foote Brook Road.	Conservation	High priority	Protect forested riparian corridor and high quality aquatic habitat.	Cost of corridor easements	No new structures within corridor and preservation of forested riparian corridor	ANR, Town of Johnson, landowners, land trust, LCPC

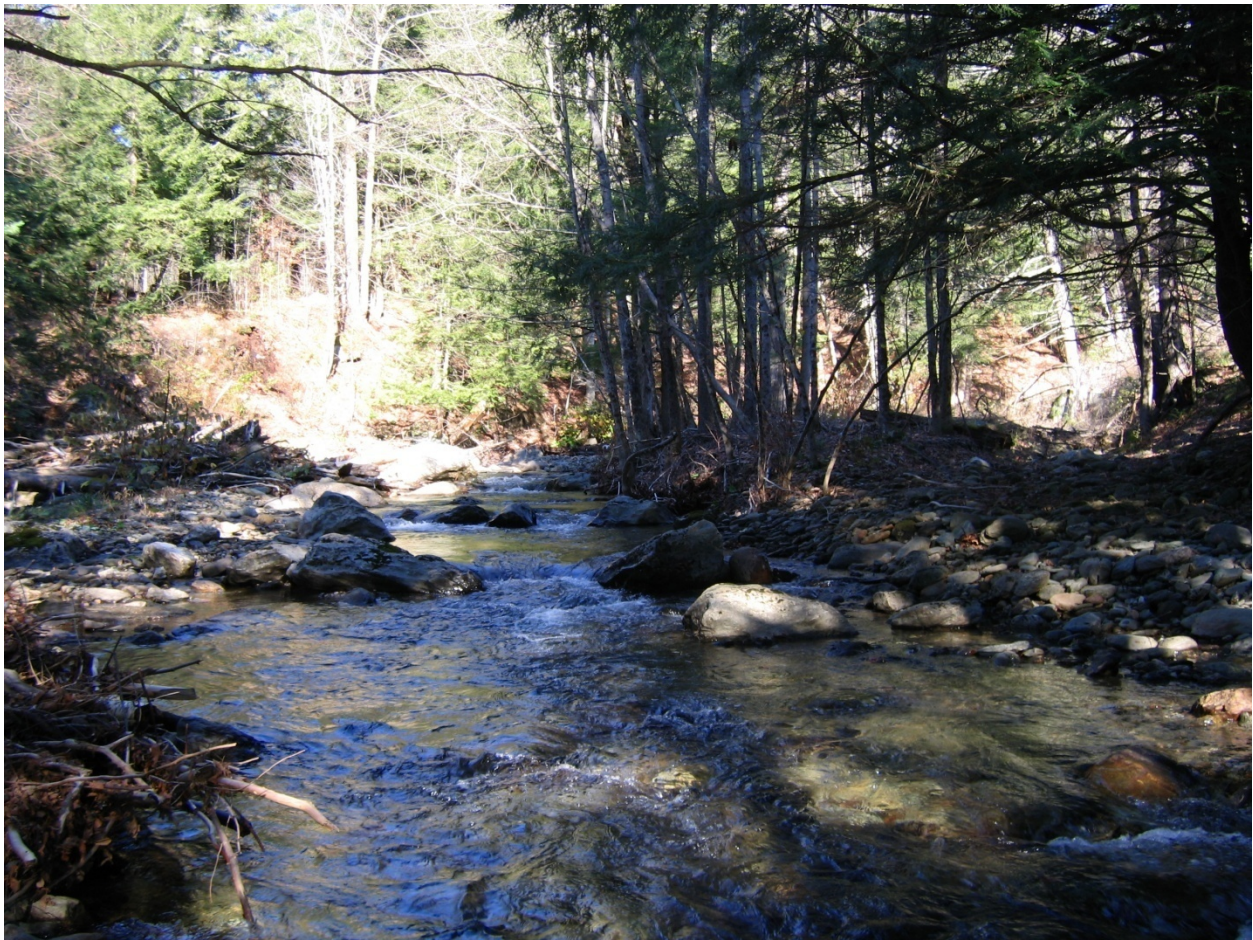
Knotweed was present on the near bank with mixed trees the dominant vegetation type on the bank and within the buffer. Buffer widths were greater than 100 feet in width on both sides. There were a number of signs of minor planform adjustment including three mid channel bars and two flood chutes. Some of this planform adjustment is attributed to large woody debris. Debris was in the channel on a bend and there is potential for planform change if the debris jam continues to build; this could result in the flood chute turning into an island (Figure 16). Overall the reach is stable and there is very little erosion. The RGA scored in the “good” range with minor historic degradation and minor aggradation and planform adjustment. The habitat scored at the low end of the “reference” range with all parameters being given a reference rating with the exception of channel flow status, sediment deposition and bank vegetative protection, which were given good ratings.

Figure 16. Flood chute and debris in reach RI3S03.04 causing minor planform adjustment
