West Branch Passumpsic River & Sutton River Corridor Plan Addendum Caledonia County, Vermont February 12, 2014

West Branch Passumpsic River & Sutton River Corridor Plan Addendum Caledonia County, Vermont

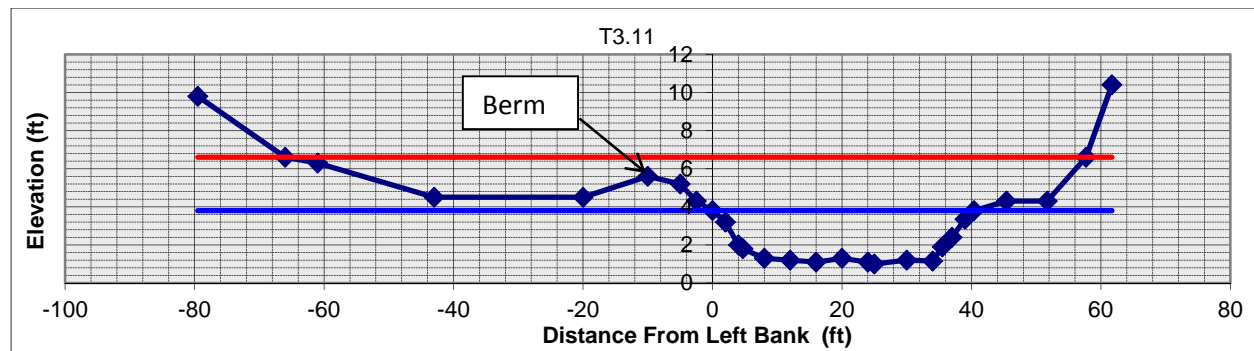
T3.11 is in **fair** geomorphic condition. This reach differs from the upstream segments in that it is rather unstable due to loss of floodplain access through berming (Figure 4.4). The major process presently occurring here is **widening**, which has followed minor downcutting of the channel bed (incision). Stormwater input from overland flow around an old sewage pipe on the western bank is causing significant erosion and sediment input (Figure 4.5). This pipe is located at the downstream end of a mass failure along the western bank contributing to sediment in the channel.

Figure 4.4. Cross section of T3.11 showing berm preventing floodplain access.

- **Passive Restoration** by planting trees within the riparian corridor in areas where buffers are less than 25 feet wide to reduce property loss from further bank erosion and enhance bank and buffer conditions. (Map 1: Project #1)
- **Passive Restoration** by allowing natural regeneration of buffer to improve buffer habitat and stream channel protection. (Map 1: Project #2)
- **Active Restoration** by conducting alternatives analysis for berm removal to open up more floodplain access for overbank streamflows and sediment storage. (Map 1: Project #3)
- **Stormwater Management** by evaluating stormwater input around old sewage pipe no longer in use and stabilizing stream bank around the pipe.(Map 1:Project #4)

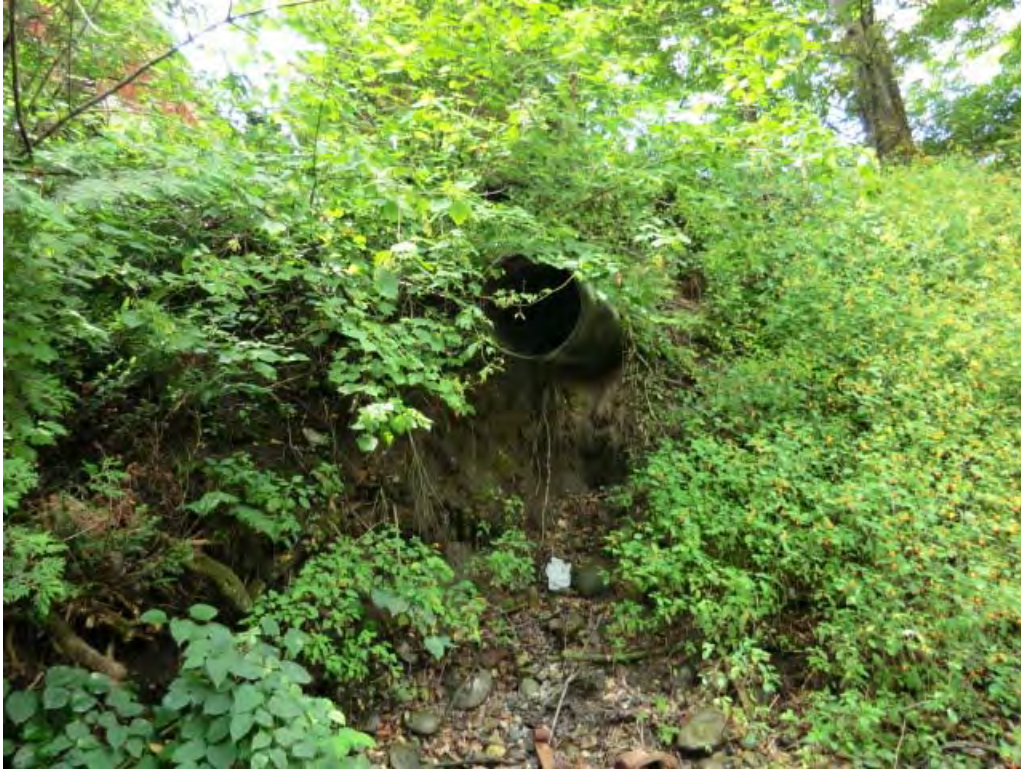
Figure 4.5. Overland flow causing erosion around old sewage pipe in T3.11.

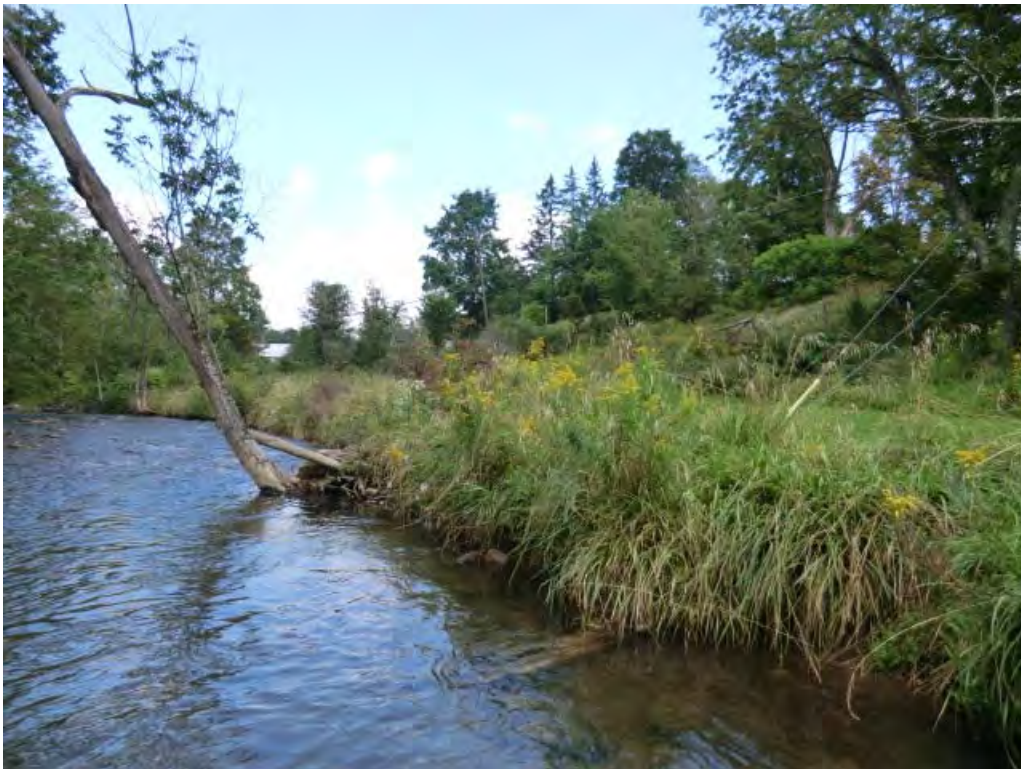
T3.11 is in **fair** habitat condition. This reach has limited pools; however, it does contain abundant large woody debris. The majority of the eastern bank has a buffer less than 25 feet and poor vegetative cover on this bank (Figure 4.6).

Figure 4.6. Widening channel and sparse buffer in T3.11.

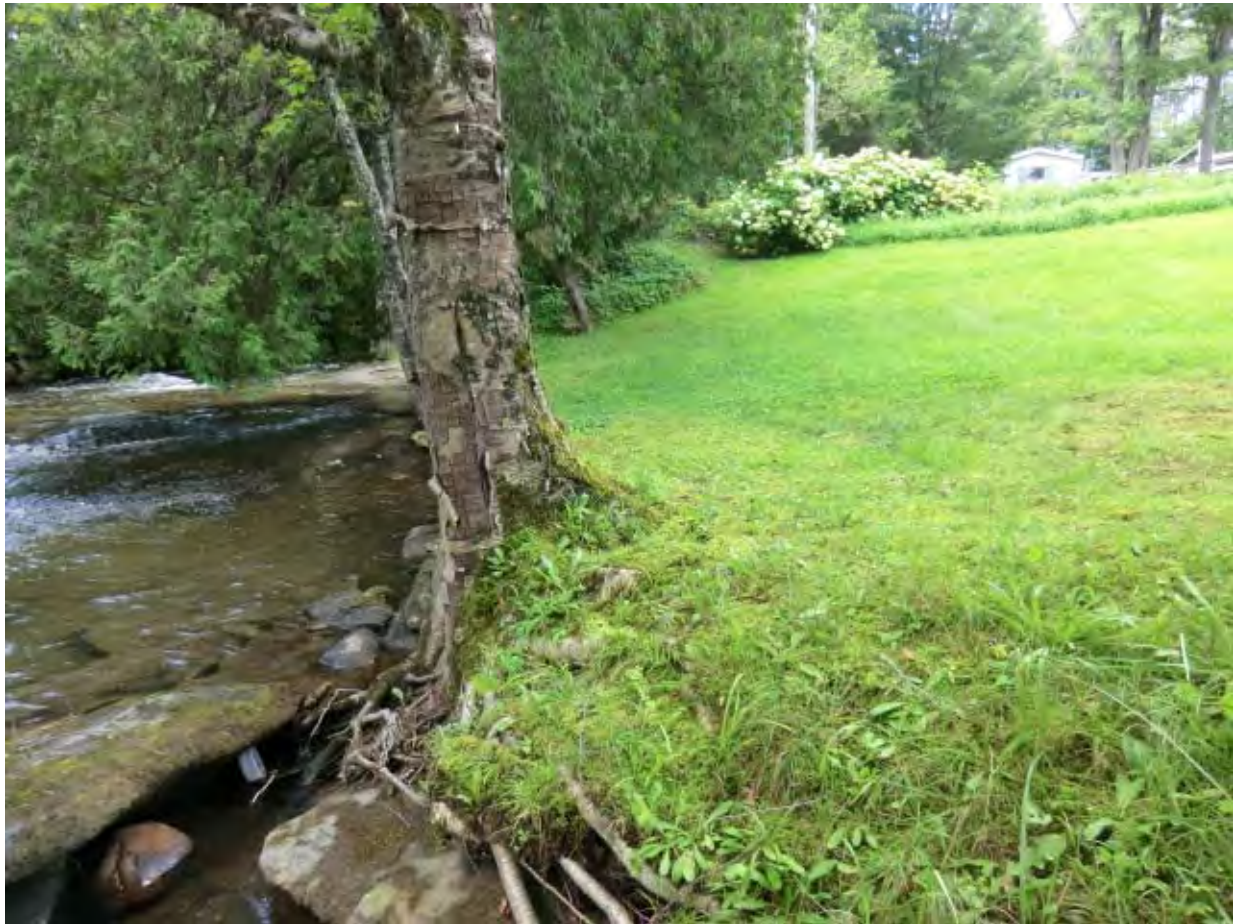
Figure 4.7. Poor riparian buffer in T3.12-A.

T3.12-A is in **good** geomorphic condition with no major process occurring. The segment has experienced minor **historic incision** and is more **aggradational** than the upstream segments, but it remains in stage F-I. Due to the presence of grade controls it is not continuing to incise into the bed. Material that is transported from bedrock controlled segments upstream is working its way through segment T3.12-A. The valley width is variable throughout the segment with an average confinement of “Narrow”. The cross section was measured in an area with a “Broad” valley. This segment is in **fair** habitat condition mainly due to its minimal large woody debris and larger pools, bank erosion and inadequate vegetation on the western bank and riparian area. Invasive species (Japanese knotweed and honeysuckle) are present along both banks.

- **Active Restoration** by removing cars from abandoned junkyard area in river corridor. (Map 2: Project #1)
- **Active Restoration and Stormwater Management** by replacing deteriorated bridge (and evaluating causes for deterioration) at Burke Hollow Road crossing to improve geomorphic stability and habitat connectivity of the stream channel; also reduce the risk of debris jams, which may increase flooding risk. (Map 2: Project #2)
- **Passive Restoration** by planting trees within the riparian corridor in areas where buffers are less than 25 feet wide to reduce further bank erosion and enhance streambank conditions. (Map 2: Project #3)
- **Active Restoration** by replacing bridge at Bridge Street crossing to reduce the risk of debris jams, which may cause increased flooding risks. (Map 2: Project #4)

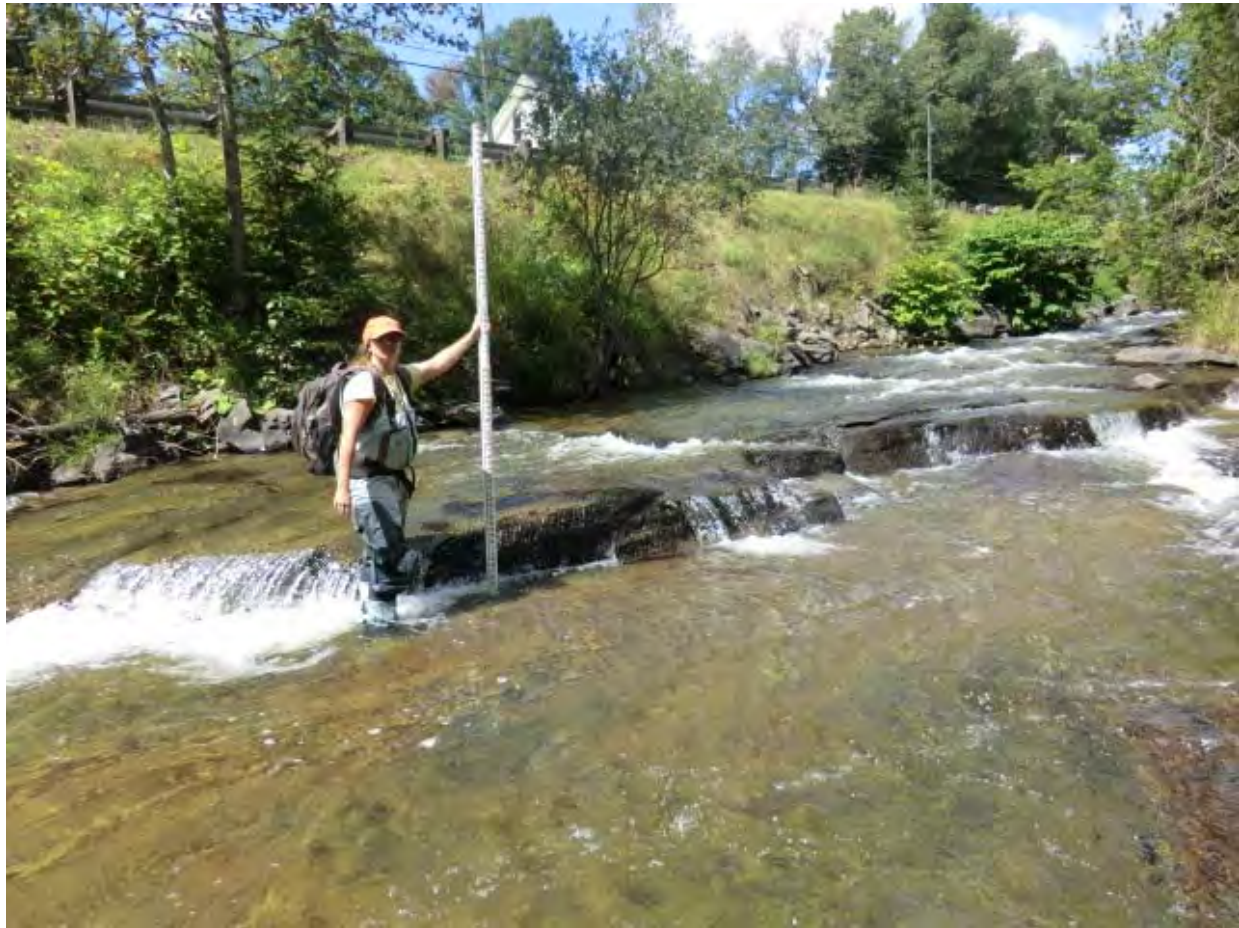
Figure 4.8. Bedrock grade control segment T3.12-B.

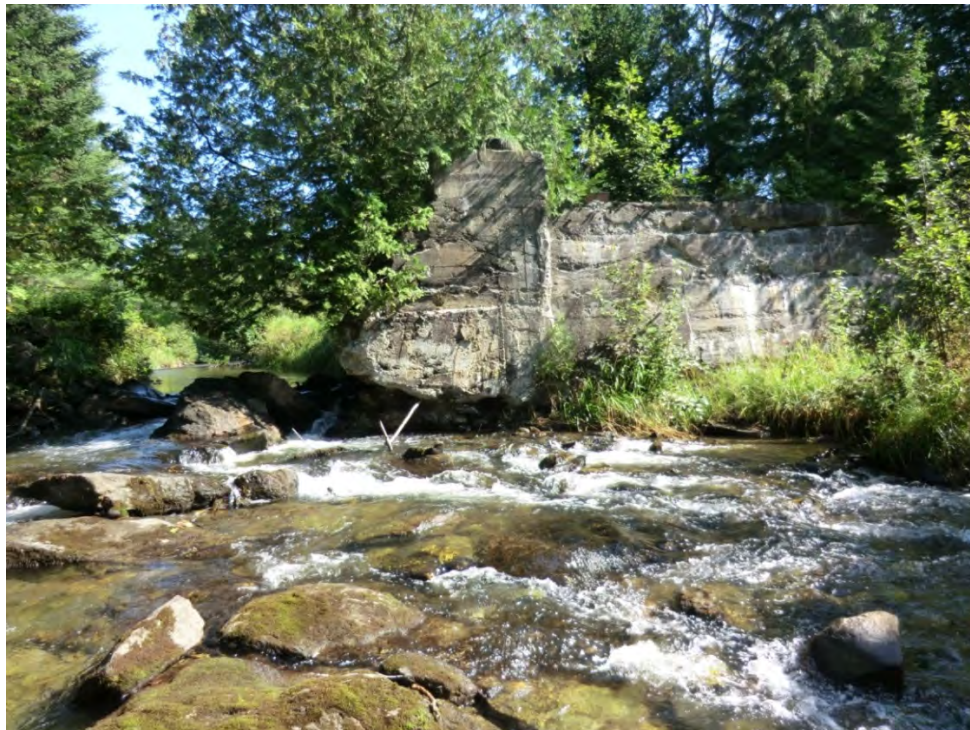
T3.12-C is in **good** geomorphic condition with major **historic incision** as the main process that has occurred most likely due to influence from the old mill dam. Abundant bedrock in the bed is preventing further incision and bedrock along the western bank and trees are preventing widening leading to its stable condition. T12-C is in **fair** habitat condition primarily due to channel morphology impacted by bed degradation, lack of connectivity from the dam, and pockets of areas with no buffer.

Figure 4.9. Old mill dam location with abutments in segment T3.12-C.

- **Active restoration** by alternatives analysis for dam removal to improve habitat connectivity and restore natural sediment transport and streamflow conditions. (Map 2: Project #5)
- **Passive restoration** by planting trees within the riparian corridor in areas where buffers are less than 25 feet wide to reduce further bank erosion and enhance streambank conditions. (Map 2: Project #6)
- **Active restoration** by alternatives analysis for old abutment removal to improve geomorphic stability and connection to the floodplain. (Map 2: Project #7)

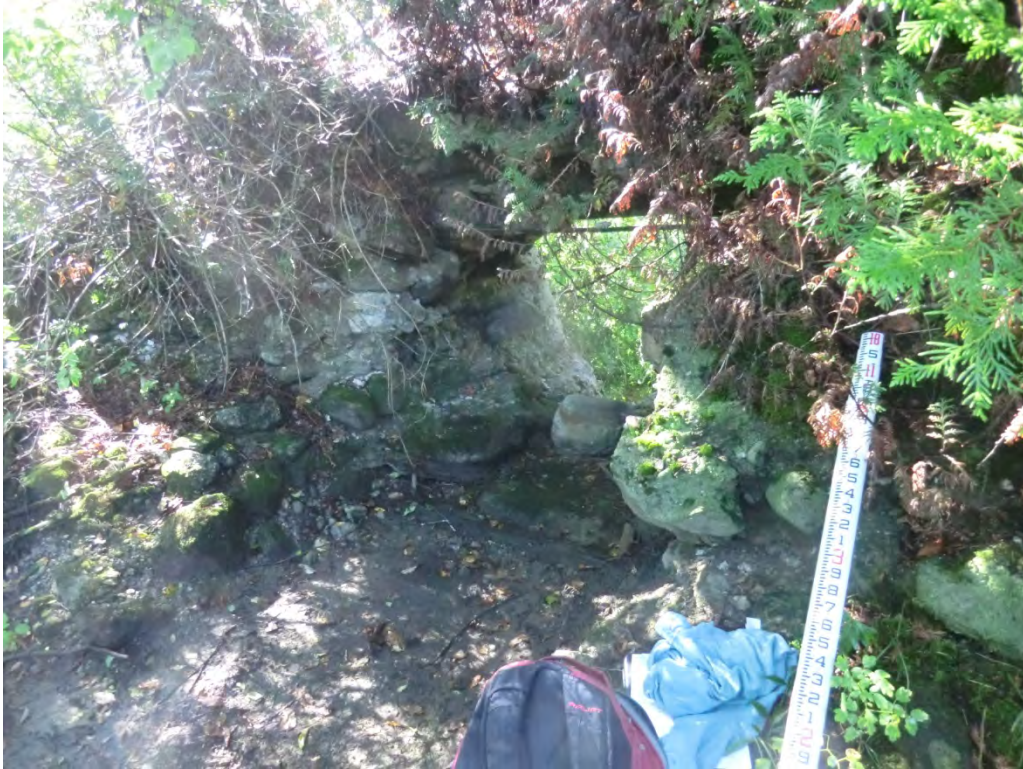
Figure 4.10. Old bypass around channel through abutment in segment T3.12-C.

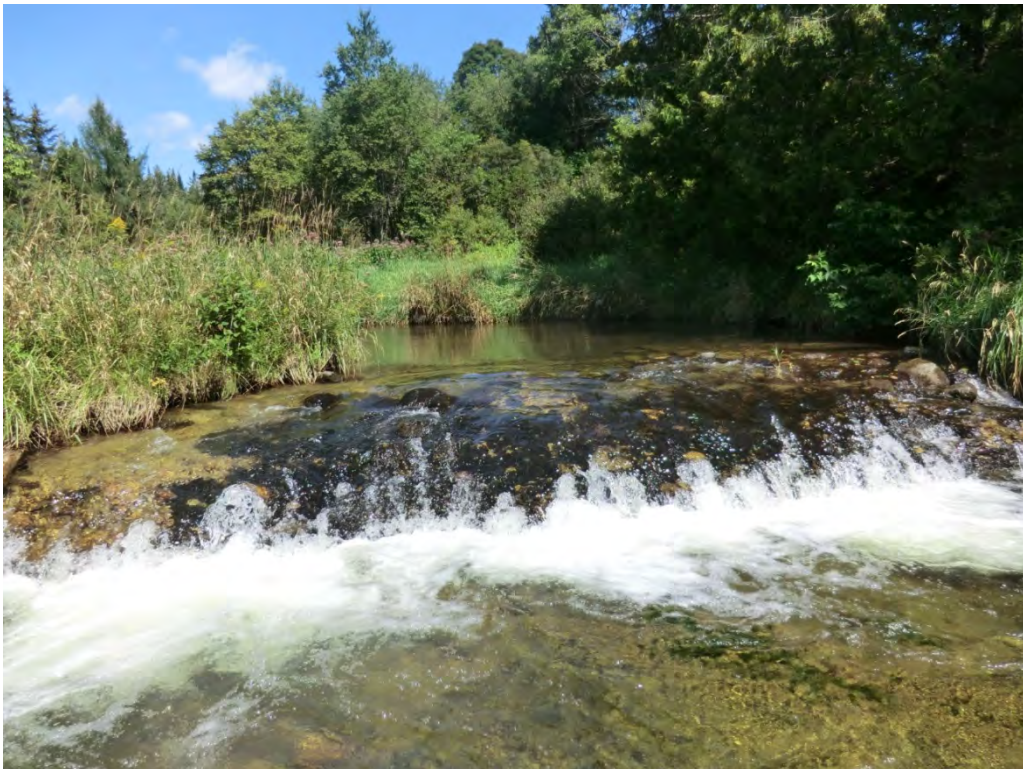
Figure 4.11. Dam in segment T3.12-C.

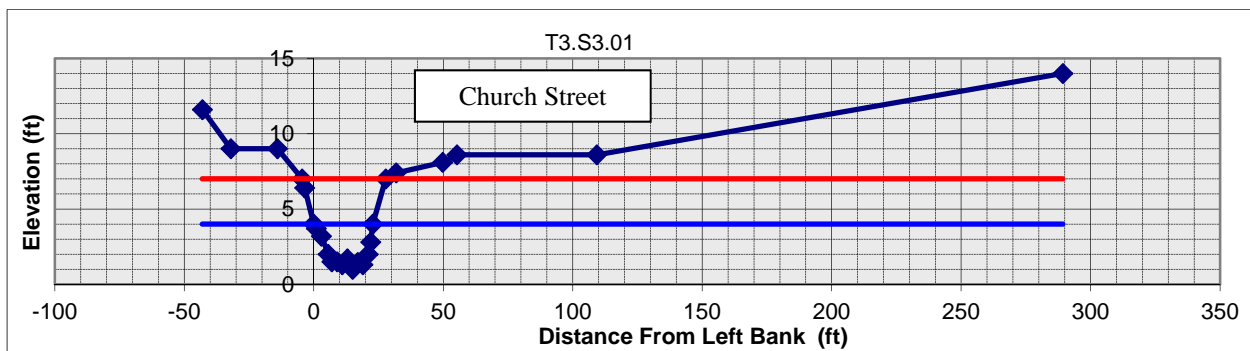
This segment is in **fair** geomorphic condition. The human caused impact to the stream has led to extreme **historic incision**. The bed has degraded so much that the channel has lost connection to its floodplain and has departed from its reference “C” stream type and is now a “B” stream (See Figures 4.12 and 4.13). Abundant rip rap along the banks is limiting widening. **Planform adjustment** is major due to the extensive channel straightening. This segment is in **fair** habitat condition because of a lack of adequate bank and buffer vegetation, extensive revetments, algal growth on the substrate, fines and embedded larger substrate, and poor channel morphology. Increased algal growth in streams is commonly associated with stormwater carrying pollutants to receiving streams. Numerous stormwater inputs were observed in this segment, which most likely have contributed to the algal growth. Some areas of the channel bed have departed from riffle-pool to plane bed from the excessive bed degradation.

Figure 4.12. Cross section in T3.S3.01-A shows the degree of incision which has caused a disconnection to the floodplain.

- **Stormwater Management** by providing improved treatment of stormwater runoff and attenuation of stormflows entering the stream. (Map 3: Project #1)
- **Passive Restoration** by planting trees within the riparian corridor in areas where buffers are less than 25 feet wide to reduce further bank erosion and enhance streambank conditions. (Map 3: Projects #2 & #3)

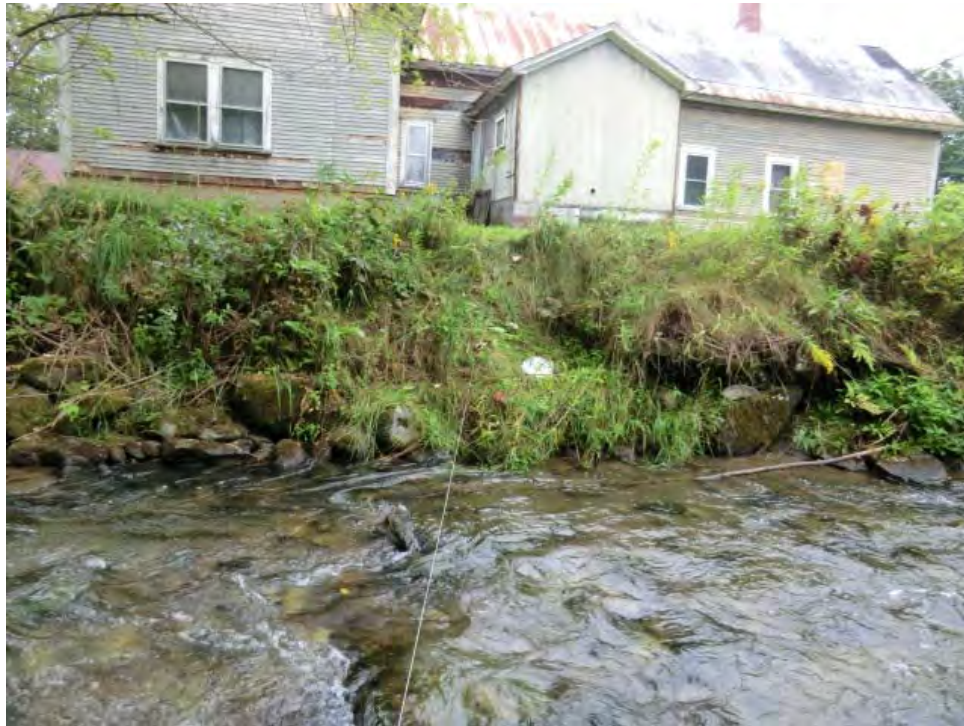
Figure 4.13. View of eastern (right) bank of cross section in T3.S3.01-A shows the degree of incision and lack of buffer.

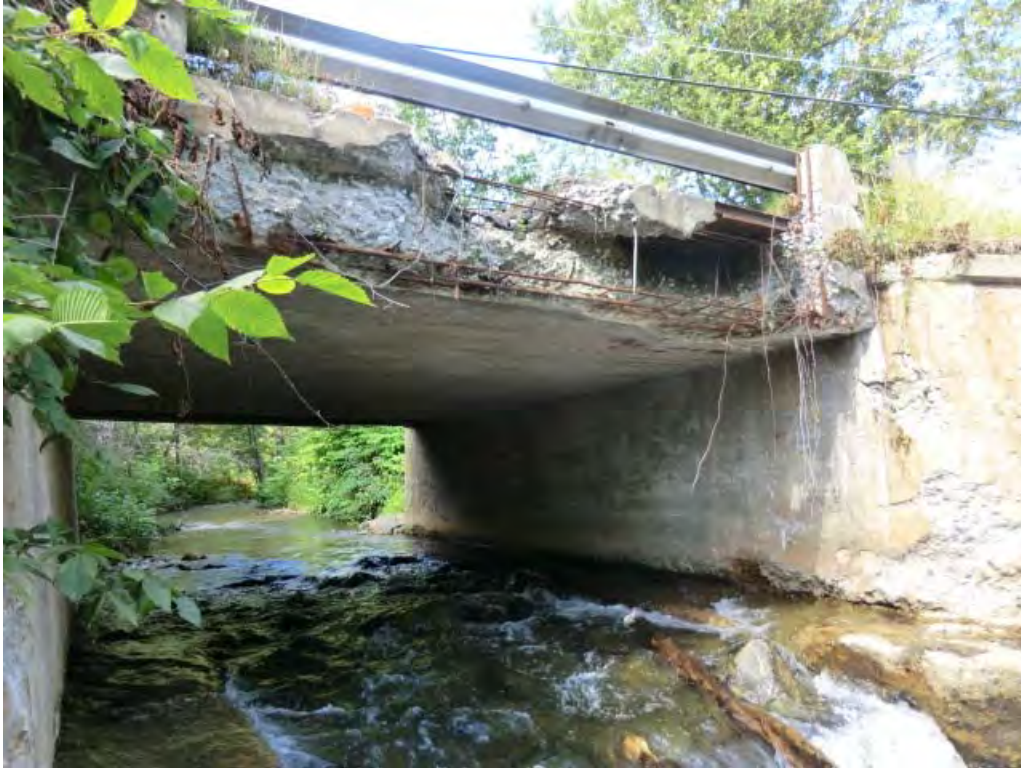
Figure 4.14. Deteriorating decking of Burke hollow Road Bridge in segment T3.12-A.

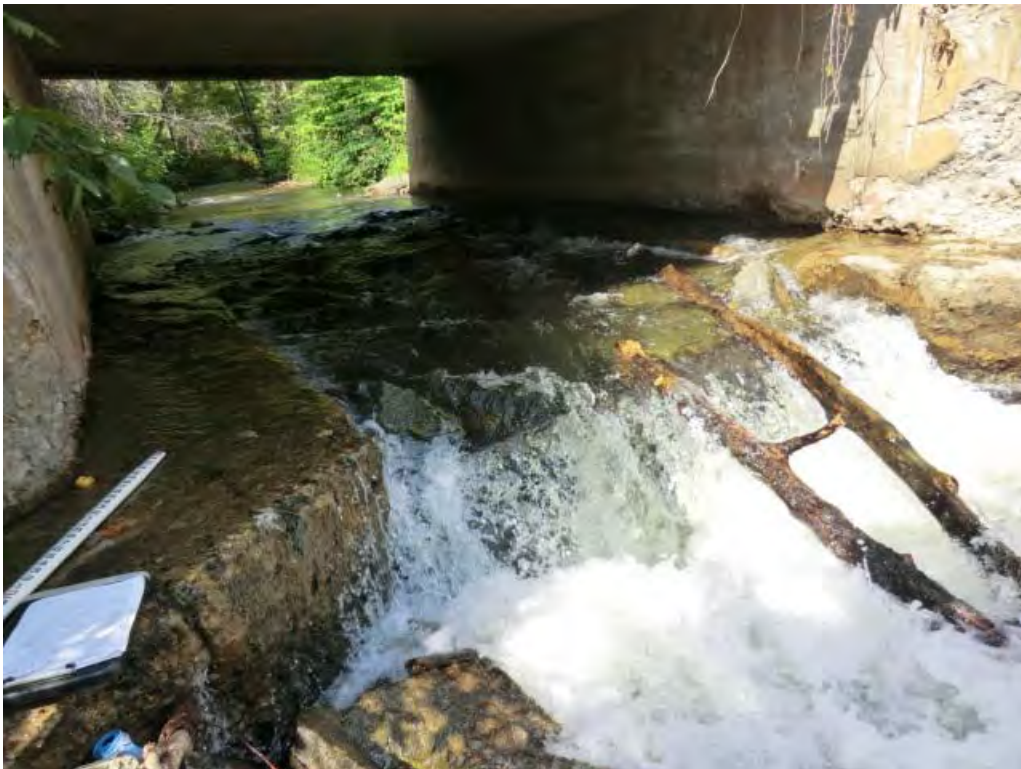
Figure 4.15 Steel bar in channel at Burke Hollow Road stream crossing potentially preventing fish passage.

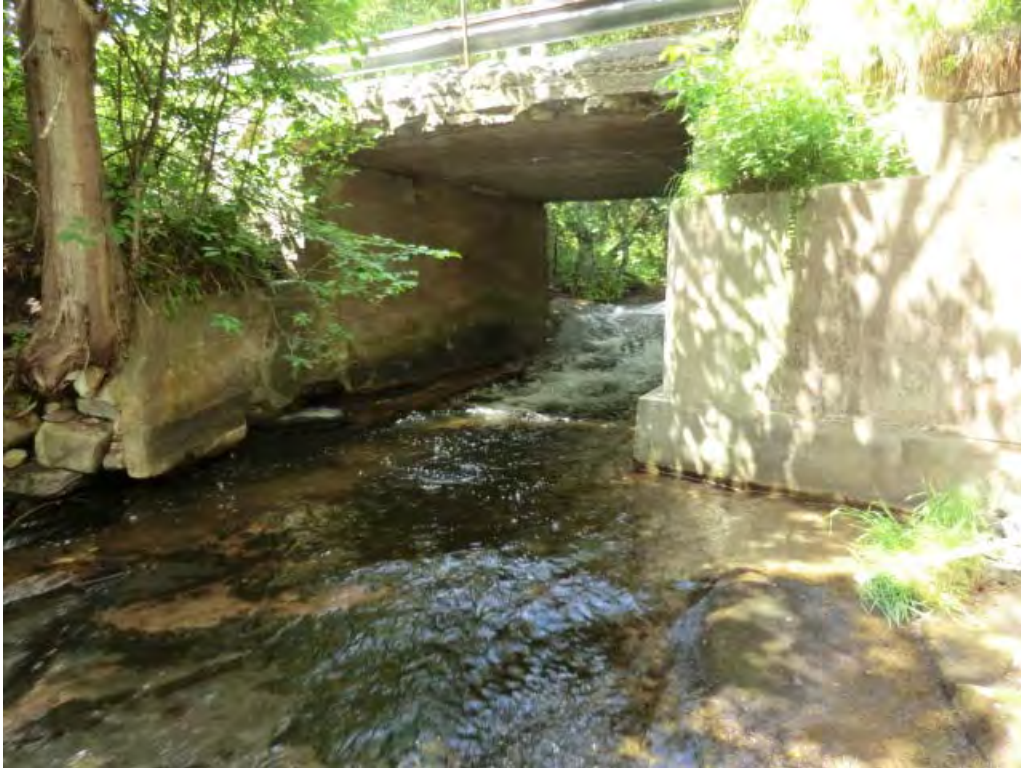
Figure 4.16. Channel constriction at Bridge Street crossing in segment T3.12-A.

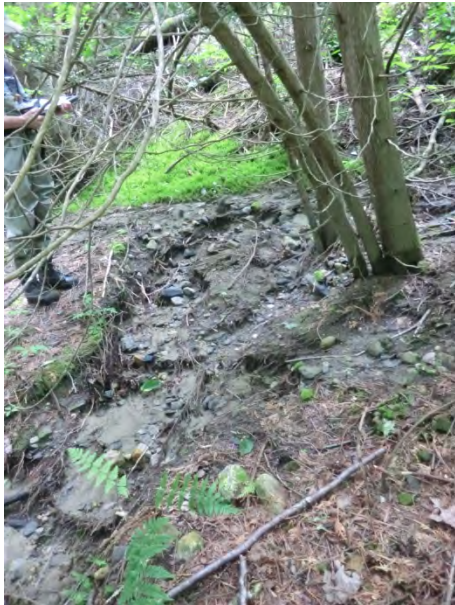
We did not see any direct ditch connections. We observed overland stormwater runoff that is making its way into the stream (see photo below). – ok, these type of sediment inputs often get missed with such a wide buffer, and no direct type of input seen; so this help demonstrate the issue ; thanks for the photos and will be helpful to highlight in the report.

Overland stormwater runoff in T1.01

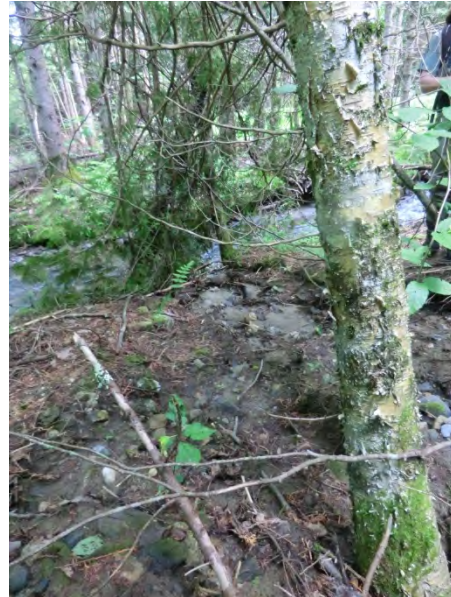
Overland stormwater runoff making its way to stream
