Phase 1 Geomorphic Assessment

Direct Drain to Lake Champlain in Shelburne and Charlotte

Prepared by Lewis Creek Association February 2008

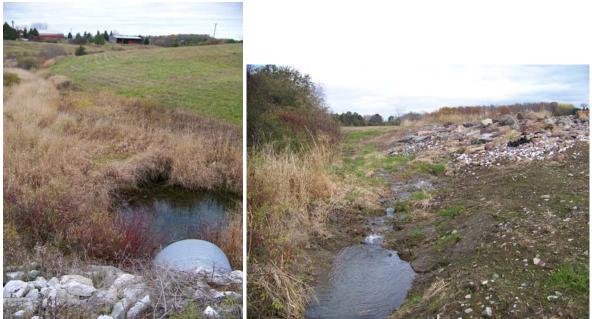
Unnamed Stream 2 (T1 S1)

Unnamed Stream 2, or the Shelburne Beach Tributary, flows north along the east side of Greenbush Road and then Beach Road and enters Lake Champlain at Shelburne Beach. This stream has a small tributary of its own (T1S1S2.02). Watershed land cover is mainly fields with some forested area and the stream corridor is field and cropland. Most areas have little to no woody riparian buffer vegetation. Total watershed area is 1.46 square miles. The lower reach (T1S1.01) has 3 dams with ponds upstream, installed in the 1930s-1940s. These ponds comprise most of the stream length and appear to have breached recently as new repairs are visible. Another dam and pond is in the upstream reach (T1S1.03). The middle reach (T1S1.02) appears entirely straightened with significant straightening in the upper reach as well. This stream flows through 5 culverts with an additional 2 culverts on a tributary. Roads and some development encroach into the corridors. Some bank erosion was visible.

View of culvert, fields and grassy stream banks (L); view of downstream end of pond/dam with recent repairs and flow emerging (R).

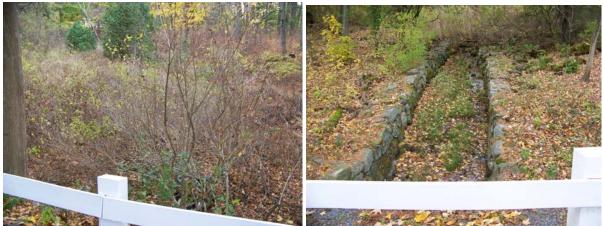
Unnamed Stream 3 (T1 S1 S1)

Unnamed Stream 3 flows north along the west side of Greenbush Road and then Beach Road and enters Lake Champlain south of Shelburne Beach. Watershed land cover is mainly fields with some forested area. Some areas have little to no woody riparian buffer vegetation. Total watershed area is 0.26 square miles. This stream flows through 5 culverts with some bank armoring visible from the windshield survey. About 18% of the channel appears to have been straightened with roads and development encroaching into the corridor.

Riparian area (L) and old riprap/channelization (R).

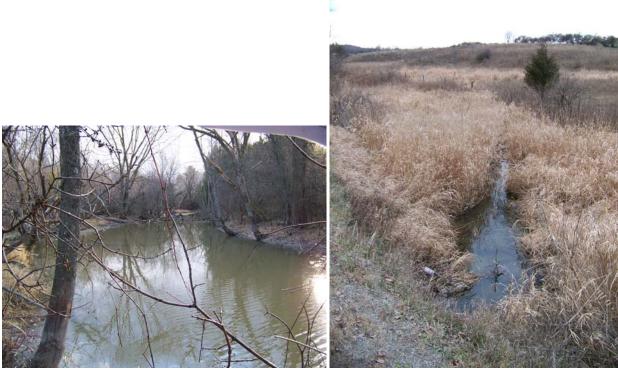
Holmes Creek (T3)

Holmes Creek begins just south of Nature Road, west of Route 7 south of the Shelburne/Charlotte boarder. It flows southwest, crossing under Greenbush Road near the intersection with the railroad track. It continues southwest until the Pringle Brook confluence, where it turns northwest and enters Lake Champlain at the Holmes Creek Covered Bridge. Dominant watershed land use is agricultural (crop and field) with some forested area, and increasing development. Many areas along upper Holmes Creek and its tributaries have little to no riparian buffer vegetation. The lower reaches of Holmes Creek appear to have good buffers. Total watershed area is 3.78 square miles. Several dams and ponds are in the upper reaches of Holmes Creek and its tributaries. The mainstem flows through 4 culverts with an additional 8 culverts on the tributaries. The upper 2 reaches of the mainstem are over 50% straightened with roads encroaching into the corridor, while the downstream reaches appear to meander freely. Some bank erosion was visible in the windshield survey.

Near the mouth of Holmes Creek (L) and upstream portion of Holmes Creek (R).

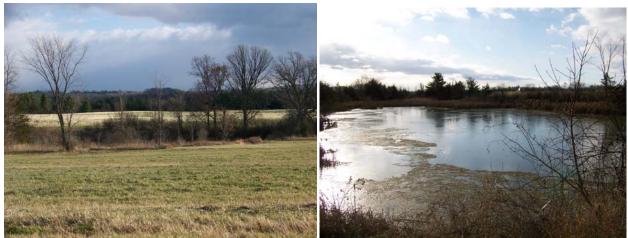
Views of Holmes Creek Tributary (T3S2) incised into the terrace (L); ponding upstream of a culvert (R).

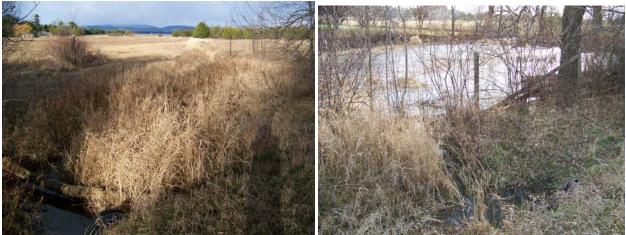
Unnamed Stream 6 flows northwest, crossing Orchard Road and enters lake Champlain north of Wings Point. Watershed land use is forest and field, with residential use dominant in the riparian corridor. Most of the stream has little to no riparian buffer. Total watershed area is 0.3 square miles. A dam with pond is in the reach along with 2 culverts. Over 70% of the reach appears

straightened with some migration evident. Few roads and development encroach into the corridor.

Channel flowing through fields to lake (L) and ponding upstream of road crossing (R).

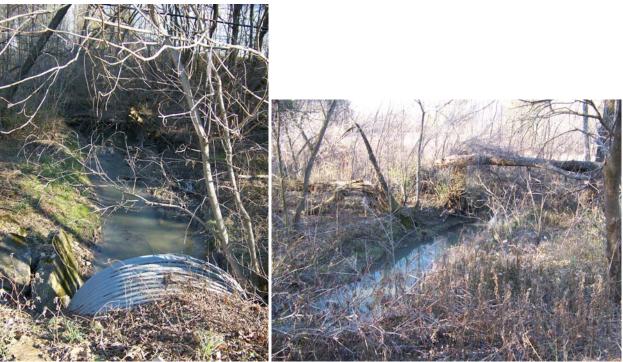
Thorp Brook (T8)

Thorp Brook and its 4 tributaries flow mainly south from the Route 7 and Hinesburg Road area across Albee Road and Greenbush Road, entering Lake Champlain in Town Farm Bay. Watershed land use is field and forest with increasing development. Many areas have little to no woody riparian buffer vegetation. Total watershed area is 3.8 square miles. Total watershed area is 3.8 square miles. One dam with pond is present along the mainstem with several more on tributaries. Relatively little straightening is evident, however the channel appears to be migrating, especially in the downstream reaches. The mainstem flows through 5 culverts with 10 more on tributaries. Relatively few roads and developments encroached into the corridor. Some bank erosion was visible in the windshield survey.

View of a culvert and bank erosion (L) and the stream channel (R).

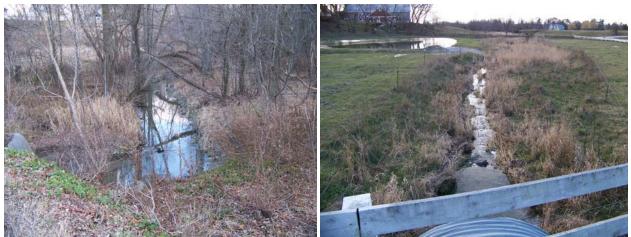
Kimball Brook (T8 S2)

Kimball Brook begins northeast of the Mt. Philo Road and One Mile Road intersection. It flows southwest crossing Route 7 and Greenbush Road before turning northwest and enters Lake Champlain at the south end of Town Farm Bay. Watershed land use is field and cropland with increasing residential development, especially in the subwatersheds near Route 7. Many areas have little to no woody riparian buffer vegetation. Total watershed area is 2.45 square miles. Almost the entire stream appears to have been straightened historically with much current channel migration evident. Kimball Brook flows through 11 culverts and has one dam and one water withdrawal evident. Some roads and development encroach into the corridor. Some bank erosion was visible in the windshield survey.

Downstream area of Kimball Brook (L) and upstream section with straightening and a pond (R).

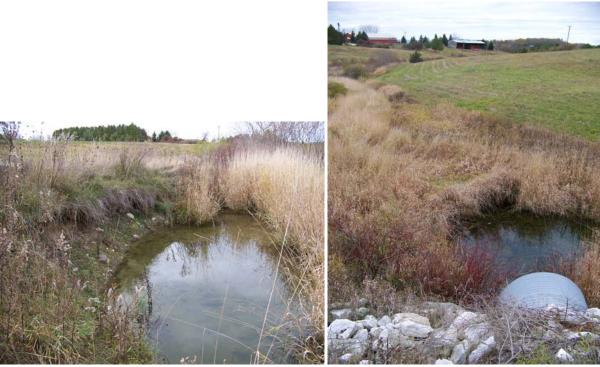
The reach begins just downstream of a large pond with a dam. The stream flows north and through a culvert under Bostwick Road where a tributary enters as well. The stream continues north and the reach break is just upstream of the first pond, where the channel begins to braid. This reach appeared to have incised, with one headcut present, so incision was still active. Some incision could be related to channel straightening or possible dredging. Almost the entire reach appeared to have been straightened historically. Some incision could also be related to increased flows out of the culvert. Overall stream channel width was 12 feet wide and the culvert width was only 5.5 feet wide, causing scour downstream. The channel did have a small floodplain area developing at the lower elevation, however the main adjustment process appeared to have experienced a stream type departure from a C (meandering) type to a B (entrenched) type.

Bank and buffer vegetation was mainly herbaceous and appeared to be cut all the way to the channel in areas. Other areas had some shrubs and saplings. Hay fields occupied the remainder of the corridor. Some bank erosion was observed. Habitat condition was "Fair" and mainly affected by a poor mix of substrate and cover types, lack of woody riparian buffer, lack of healthy pools, and bank instability.

Eroding bank at headcut with large pool (L) and channel view with herbaceous riparian vegetation and undersized culvert with scour pool downstream (R).

T1S1.02 – Protect the river corridor and plant woody buffer vegetation to eliminate vegetation cutting and potential encroachment as well as to enhance bank stability and habitat. Investigate options for restoring the channel incision downstream of Bostwick Road. Resize the Bostwick Road culvert as it is up for replacement.

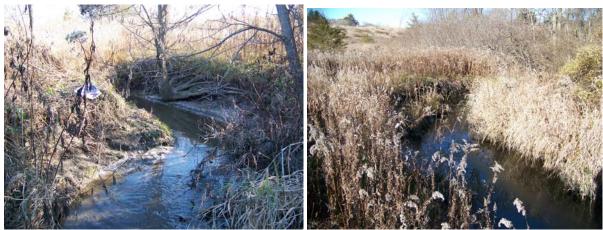
The reach begins upstream of Albee Road where a tributary enters. The stream flows southwest under Albee Road and continues south for approximately 200 feet. The area appeared heavily impacted by beavers with trees chewed and signs of water fluctuations such as flood chutes and channel migration. A neighbor noted a large beaver dam downstream of the reach, causing some water to back up into this reach. The reach was not segmented due to the presence of beaver activity throughout the reach and the fact that the dams are likely to move around over time. Overall stream condition appeared to be "Good" with only slight incision, likely masked by the aggradation. Current adjustments were aggradation and widening, but mainly planform. The beaver activity throughout the reach was also likely contributing to channel adjustments.

Overall habitat condition was "Good" with some bank instability, some areas of reduced buffer and few substrate types.

Channel views with some bank erosion/migration.

T8.03 – Protect the stream corridor to allow for continued channel migration, beaver activity, and vegetation renewal. Work with the town of Charlotte to address the issues at the Albee Road crossing, which may require resizing, realignment and replacement of the culverts. Much work has evidently been done here, so working with the town to learn what has been done and what they think could be improved is recommended. Planting buffer vegetation is not recommended due to the beaver activity.

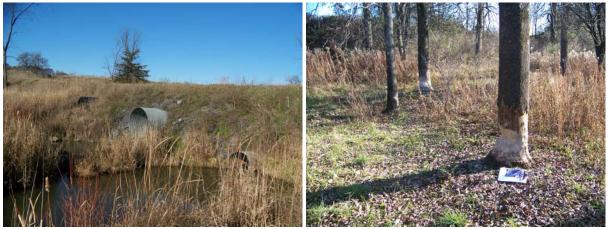
The Albee Road crossing appeared to have been a site of concern for the town as much work has been done. A total of 3 culverts were at the crossing one at low flow level, one slightly higher, and one overflow. Overall channel width was 22 feet wide with the culverts being 3 (low flow), 5 (high flow) and 3 (overflow) feet wide. The low flow culvert appeared poorly aligned with overbank flows, as it was after a bend in the stream.

Culverts with overflow pipes (L) and beaver activity (R).

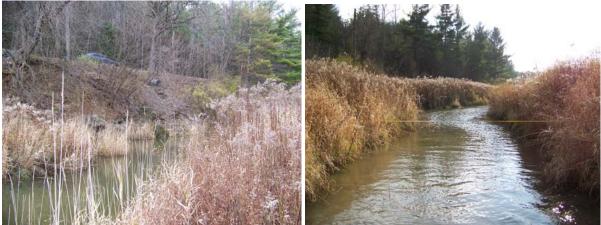
The corridor land use was wetland/grasses. The corridor area did not appear to be managed, but presumably beaver activity and flooding/ice has limited sapling growth. Habitat condition appeared to be "Fair" and mainly affected by sediment deposition, bank instability, few substrate types, and some straightening.

Channel views with Spear Street abutting the channel (L) and herbaceous vegetation (R).

T2.01 and T2.02A – Protect the river corridor and possibly restore channel incision downstream of the northern culvert and along the LaPlatte mainstem reach M08. This area is currently in crop use (corn) with some greenhouses. This project would coordinate with project recommendations for M08 on the LaPlatte. Resize the 2 culverts in T2.01 and T2.02 as they are up for replacement to eliminate the channel constriction and erosion hazards.

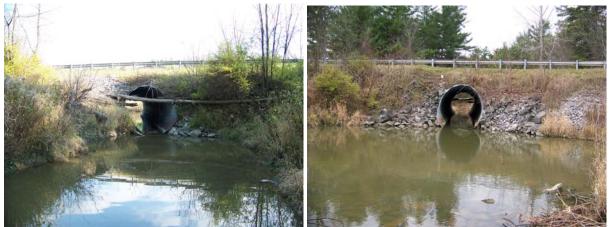
Overall channel width was 24 feet while the 2 culverts were only 14 (downstream) and 10 (upstream) feet wide. Scour was present downstream of both culverts and a beaver dam was constructed at the opening of the downstream culvert.

Upstream (L) and downstream (R) views of the southern (upstream) culvert. Note the woody debris upstream and scour downstream.

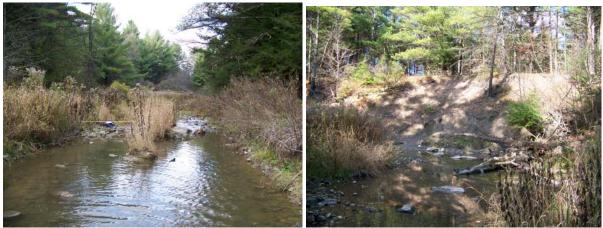
T2.02B Mud Hollow Brook

This reach flows north and northeast on the western side of Spear Street. The segment appeared to have incised historically from an upper terrace. A new terrace and floodplain are developing at bankfull elevation. The stream appeared to be in "Fair" condition with planform the dominant adjustment process. Some aggradation was present but channel widening appeared historical.

A pond was in the corridor at the upstream end of the reach. It was difficult to determine if the pond had been dug out of the floodplain or if the stream had been moved over and bermed to create the pond. An overflow pipe from the pond had evidence of scour on the terrace at the outflow.

Channel view (L) and mass failure (R).

Failing riprap and bank erosion along the pond and possible berm.
