**Phase 2 Stream Geomorphic Assessment  
Huntington River Watershed  
Town of Huntington  
Chittenden County, Vermont**

January 17, 2006

Dori Barton  
Principal/Wetlands Ecologist  
Arrowwood Environmental

Town of Huntington, and  
Vermont Agency of Natural Resources

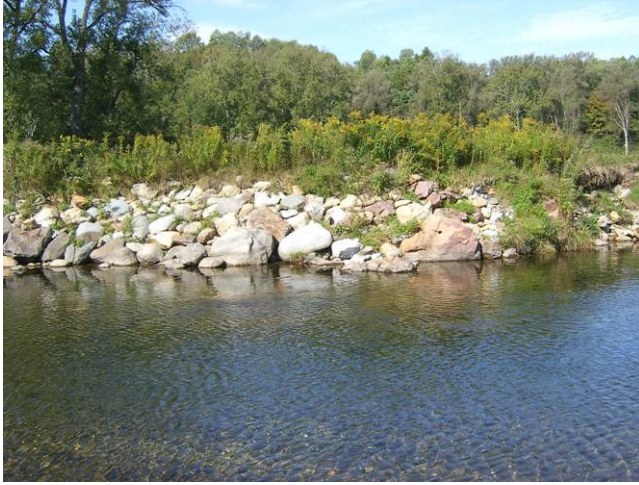
The stream channel is located close to the valley wall in the lower section of the reach. This location of the stream in relation to the valley wall, in addition to evidence of historic channel straightening and armoring, provides evidence that the channel was altered.

Figure 3: Rock revetment and lack of buffer at Reach M06's left bank

Evidence of a stabilization project was found on the lower section of the reach. A tree revetment was located on the right bank, a rock revetment on the left bank, log weirs, also on the left bank, and livestock fencing. It did not appear that the log vanes were functioning as designed, partly due to the angle of the weir, its angle of departure from the bank, and placement in relation to planform. The stream could also have migrated, since the left bank is unstable.

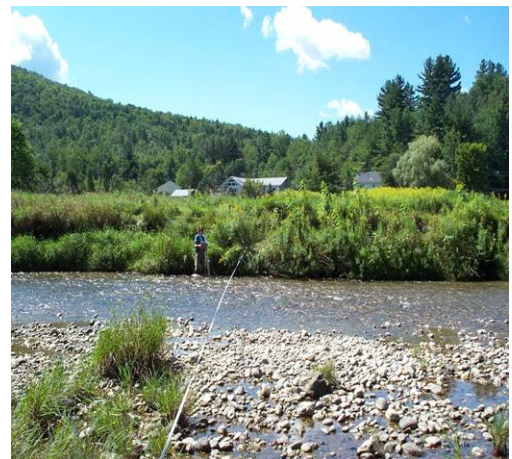
Segment M09-A's confinement is broad, due to the influence of the road on the valley width. Its incision ratio of 1.2 suggests some access to floodplain. The segment is very wide, with a width-to-depth ratio of over 40. This reach has also experienced significant historic channel straightening and gravel extraction. Bank erosion is extensive on the left bank where the stream bends.

Figure 7. Left bank at a cross-section along Reach M09

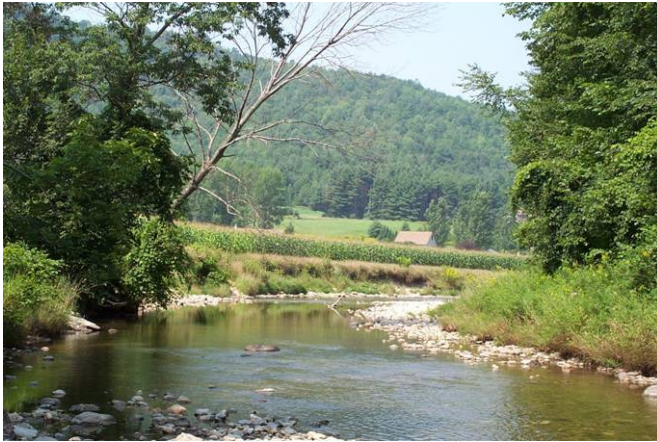
The riparian corridor is dominated by crop and hay on the left bank and residential development on the right. The buffer is poor (<25 feet), made up of predominately deciduous and herbaceous plant species. Sediment storage bars include multiple side bars and a delta bar.

Figure 12. Minimal buffer and sediment storage bars within Segment M13-B

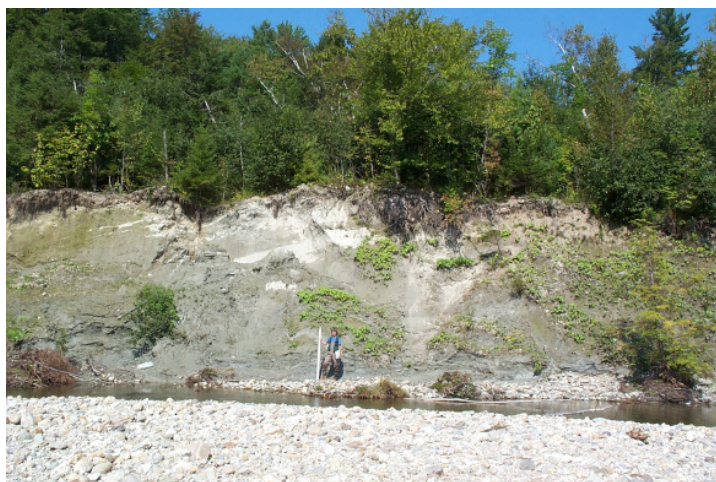
Segment M14-B's valley confinement is very broad. This segment is a Rosgen C-4 stream, denoted by a riffle-pool system with gravel substrate. The riparian corridor is dominated by crop on the right bank and forest on the left bank. The right bank buffer is poor (<25 feet), made up of predominately herbaceous plant species. A berm follows the right bank. Sediment storage bars include multiple point and side bars. The segment contains a large mass failure with an average height of 25 feet, located at a 90 degree bend of the river. It is apparent that the mass failure is caused by a combination of a berm, which forces flood flows to remain in the channel, and the highly straightened condition of M14-B and M14-C, just upstream.

Figure 14. Mass failure within Segment M14
