**Mad River Headwaters
Phase 2 Stream Geomorphic Assessments**

January 31, 2008

Samuel P. Parker, Staff Scientist, and Evan P. Fitzgerald, Principal
Fitzgerald Environmental Associates, LLC.

Friends of the Mad River
Waitsfield, Vermont

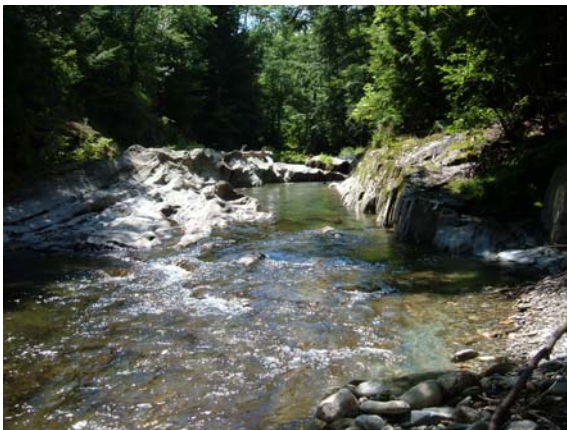
Figure 5.1 B-type geometry in Segment M20-A

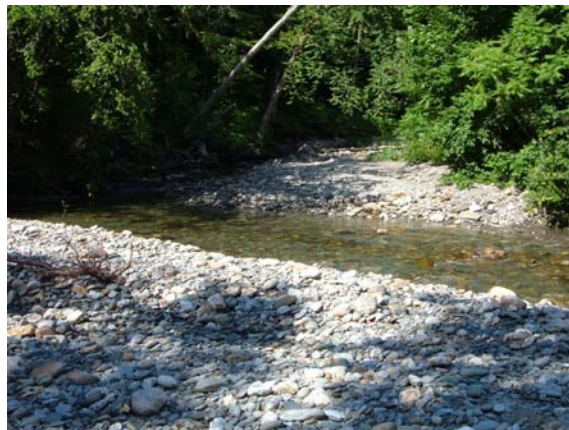
Figure 5.2 Large gravel bars in Segment M20-A

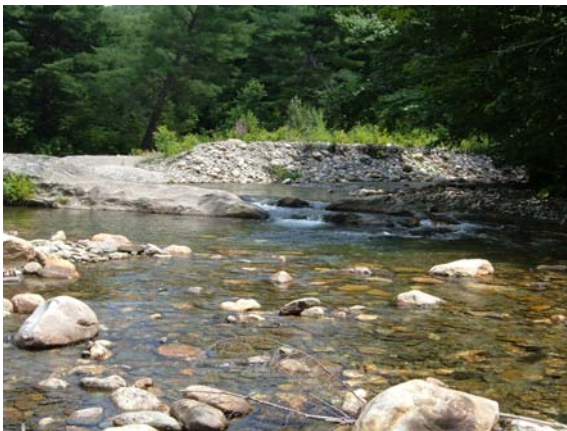
Figure 5.3 Vegetated gravel bar in M20-B

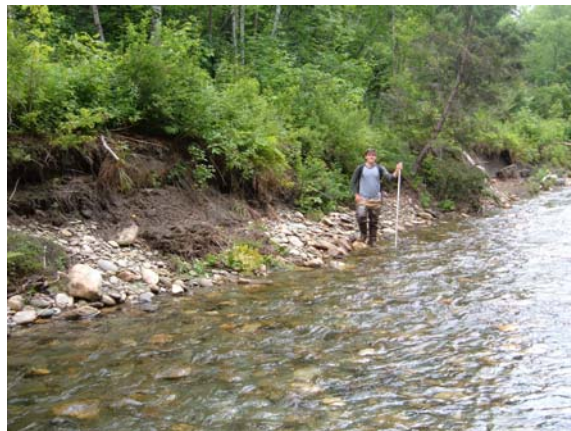
Figure 5.4 Severe bank erosion in Segment M20-B

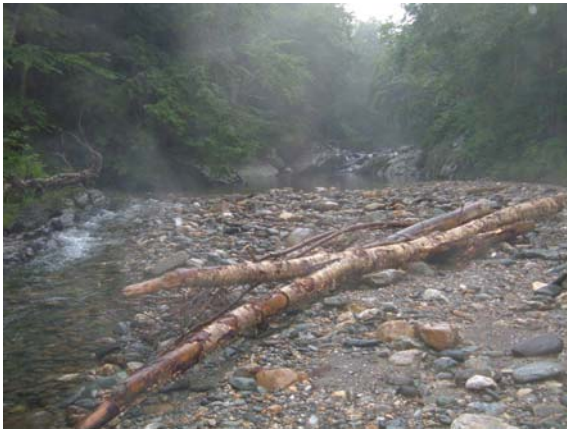
Figure 5.5 Large gravel bar and debris in M20-C

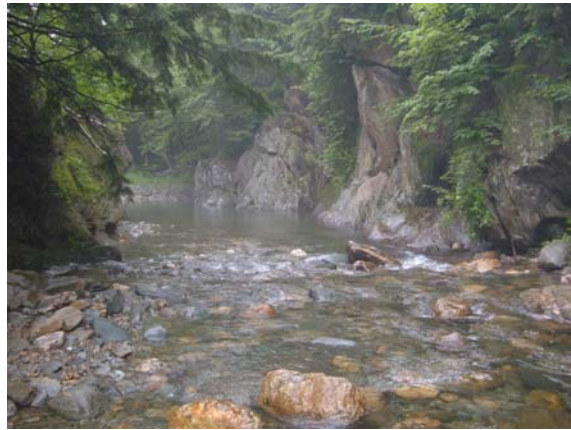
Figure 5.6 Bedrock constriction and pool in M20-C

Channel incision was noted where the cross-section was taken (incision ratio = 1.7). This incision resulted from a historic road adjacent the channel that raised the floodplain elevation above its natural location. Overall floodplain connectivity was good throughout the lower segment, and there was limited bank erosion. The bed is dominated by cobble (44%), and the plot of substrate classes indicates the bed material is very well distributed. The channel is moderately stable (RGA condition “Good”, CEM stage II), but there are areas of significant aggradation and widening associated with the channel constrictions. Alternatively, the channel constrictions create excellent habitat where the bed material is scoured and deep, well-covered pools are found (Figure 5.6). There is very good habitat

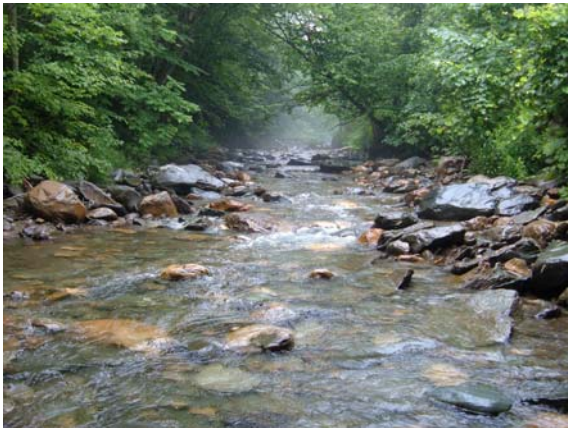
Figure 5.7 Plane bedform with limited habitat in M21

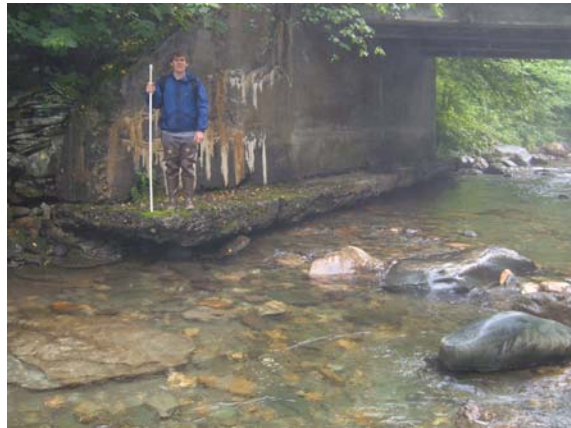
Figure 5.8 Undermined bridge abutment in M21

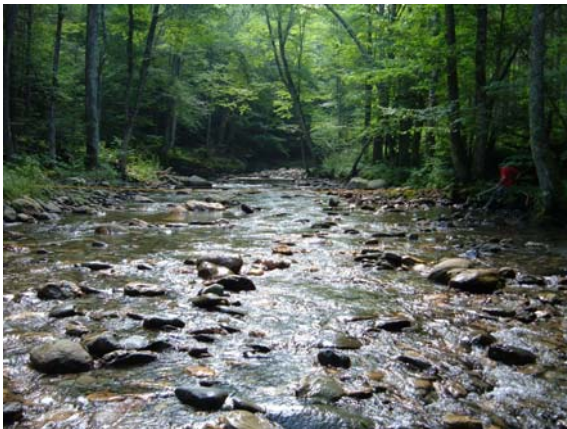
Figure 5.9 Channel cross-section in M22

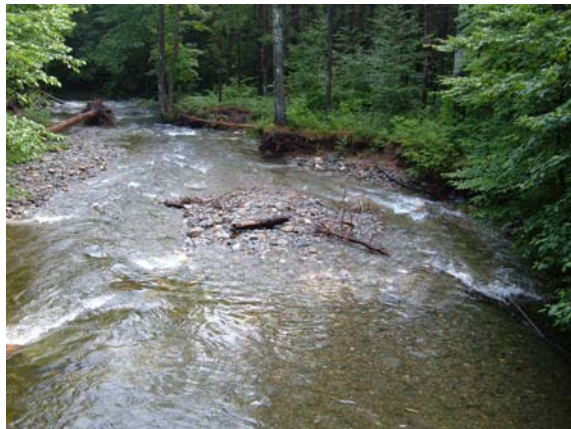
Figure 5.10 Bank erosion below Route 100 in M22

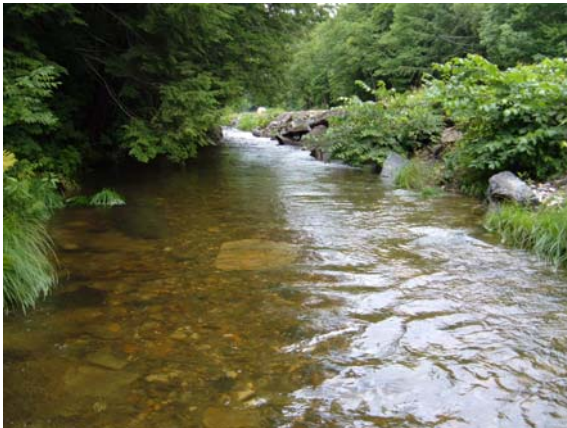
Figure 5.11 Planebed morphology in M23-A

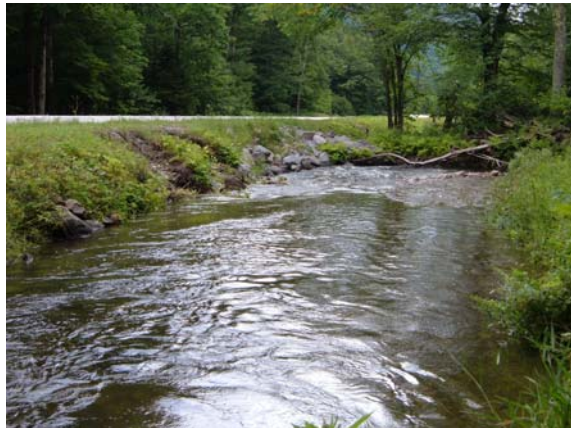
Figure 5.12 Failing rip-rap along Route 100 in M23-A

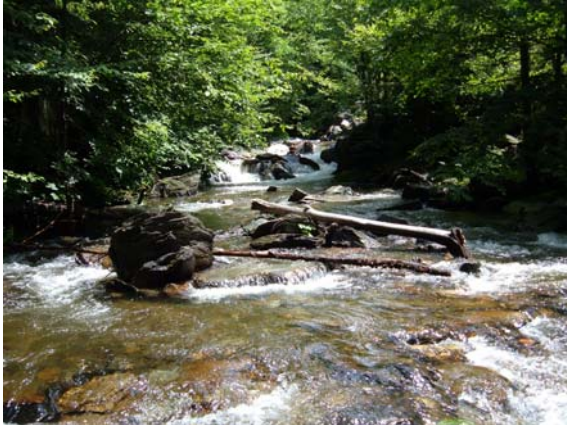
Figure 5.13 Step-pool morphology in M23-B

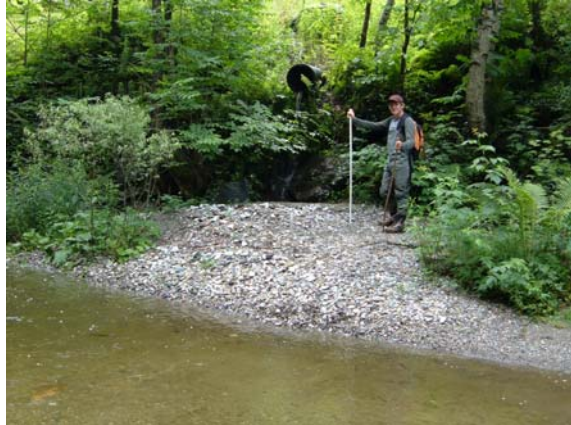
Figure 5.14 Stormwater-conveyed sediments in M23-B

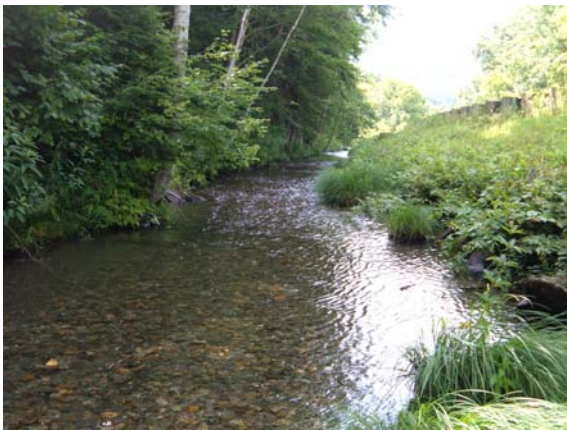
Figure 5.15 Plane bedform in lower M23-C

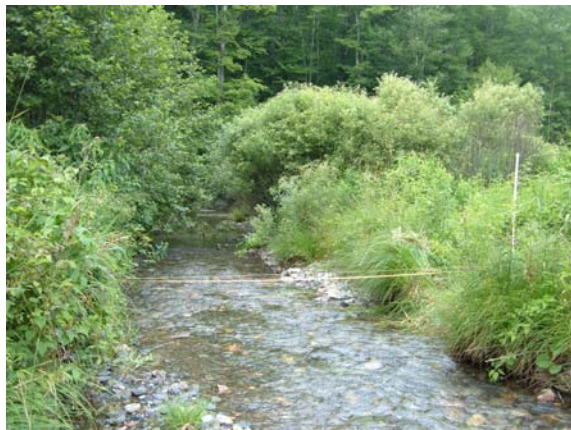
Figure 5.16 Riffle pool morphology in M23-C

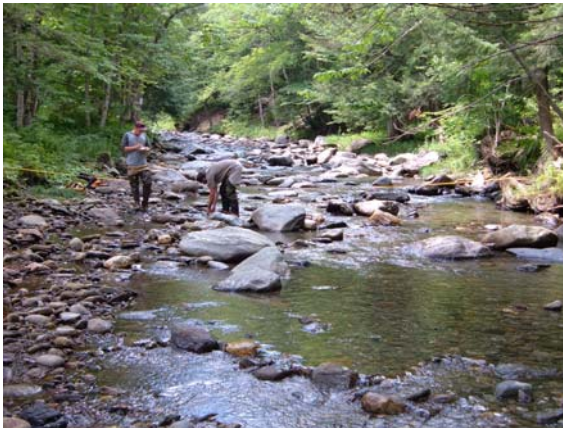
Figure 5.17 Cross section in upper T12.01

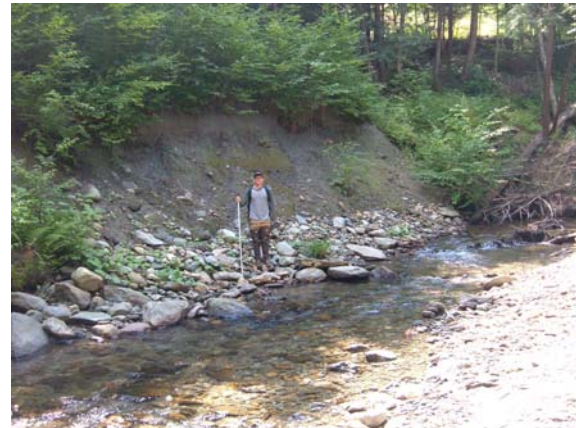
Figure 5.18 Large mass failure mid-reach T12.01

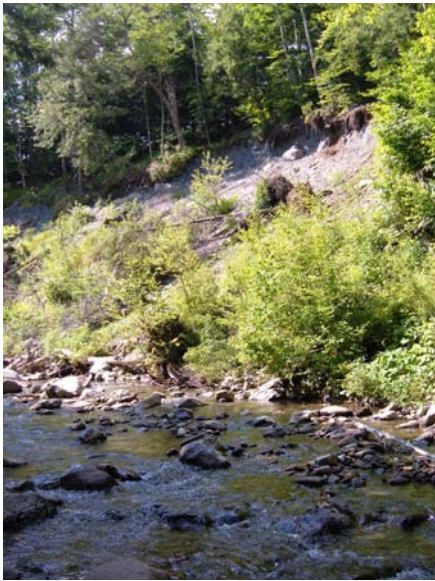
Figure 5.19 Large mass failure in T12.02-A

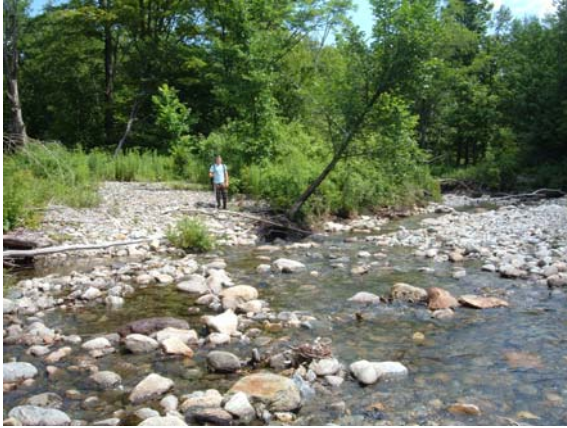
Figure 5.20 Location of 1998 channel avulsion

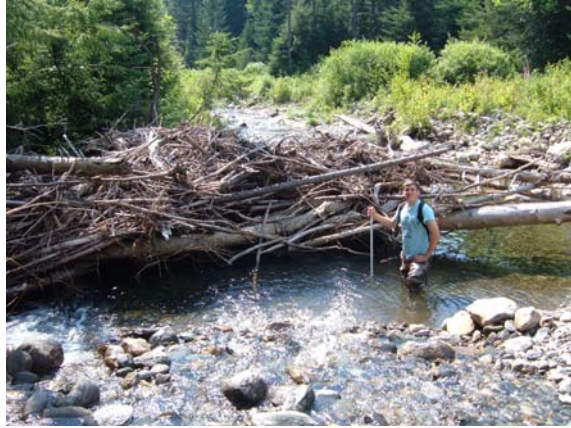
Figure 5.21 Large debris jam in lower T12.02-B

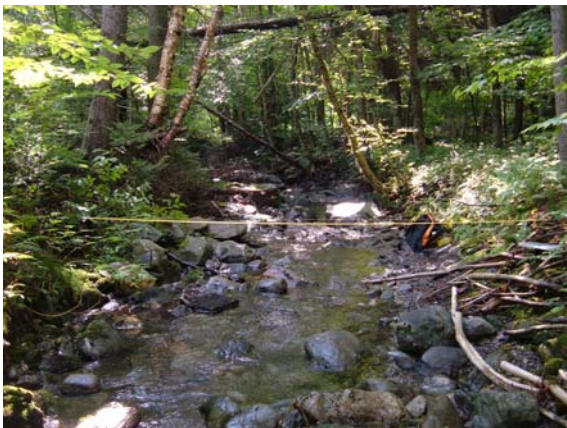
Figure 5.22 Plane bed morphology in T12.03-A

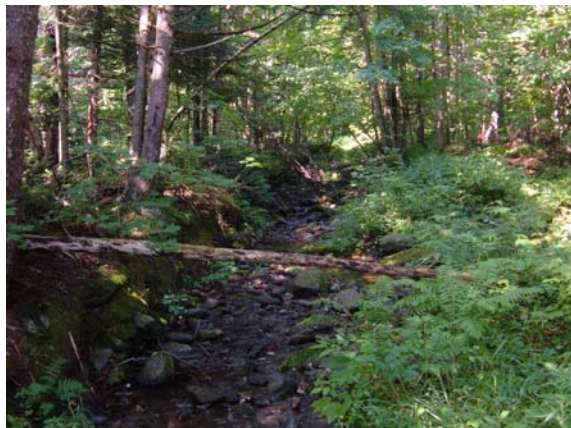
Figure 5.23 Old logging road along T12.03-A

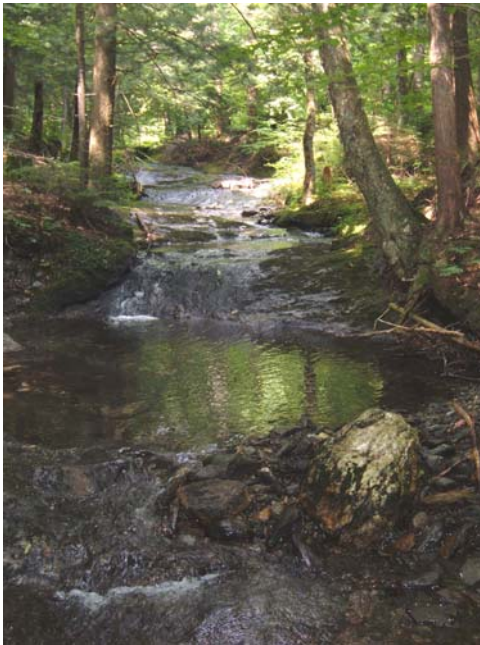
Figure 5.24 Bedrock grade controls in T12.03-B

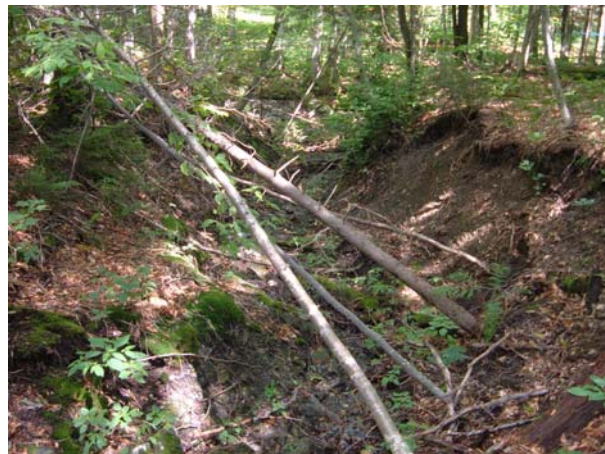
Figure 5.25 Large gully entering right bank in upper T12.03-B

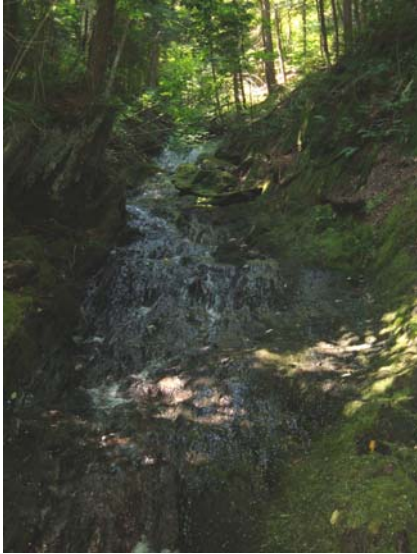
Figure 5.26 Headwaters bedrock cascade

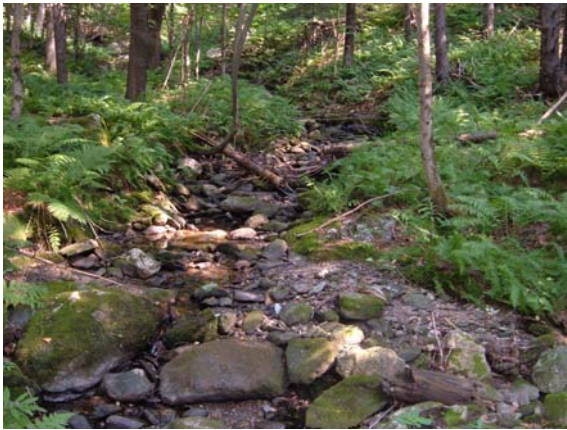
Figure 5.27 Step-pool morphology in T12.02-S2

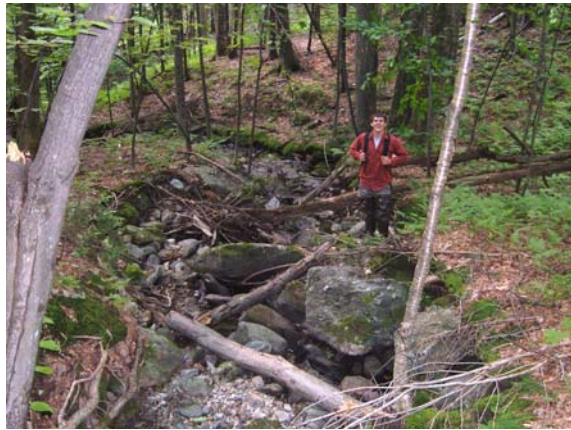
Figure 5.28 Channel incision in upper T12.02-S2

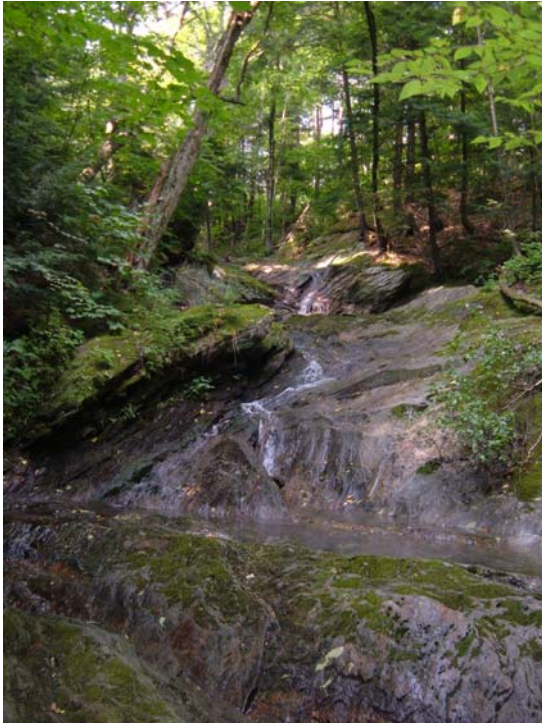
Figure 5.29 Headwaters cascade bedform

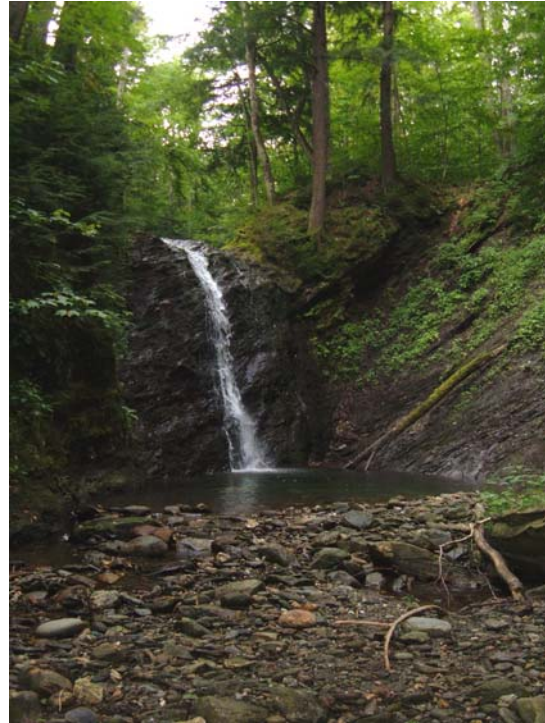
Figure 5.30 Large waterfall in T12.02.S3

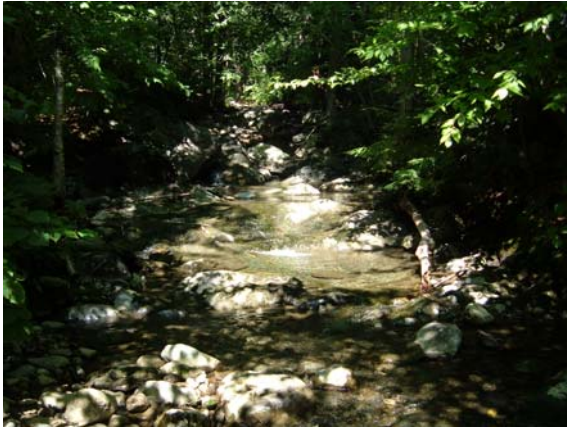
Figure 5.31 Step-pool morphology in T12.02-S4

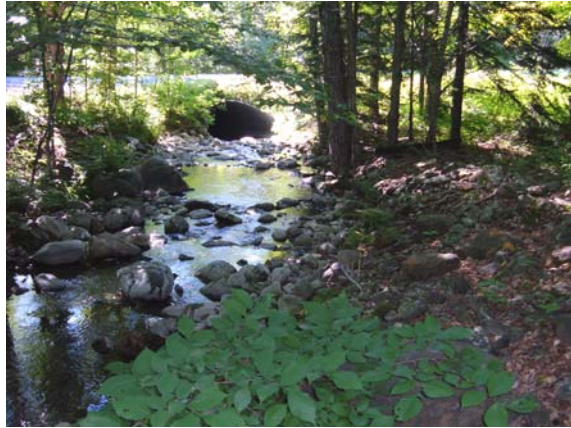
Figure 5.32 Channel widening above Lincoln Gap Rd.

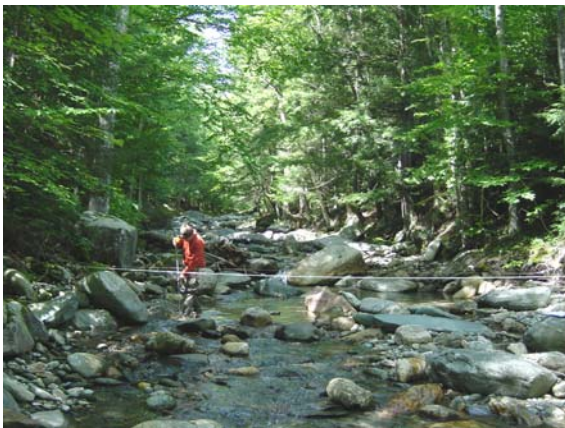
Figure 5.33 Cross section in T13.01.

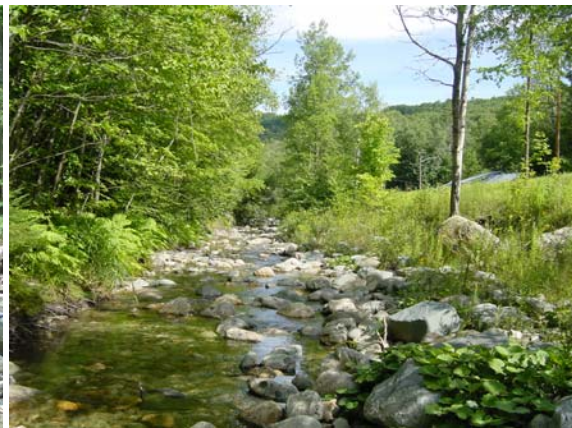
Figure 5.34 Downstream section along Route 100.

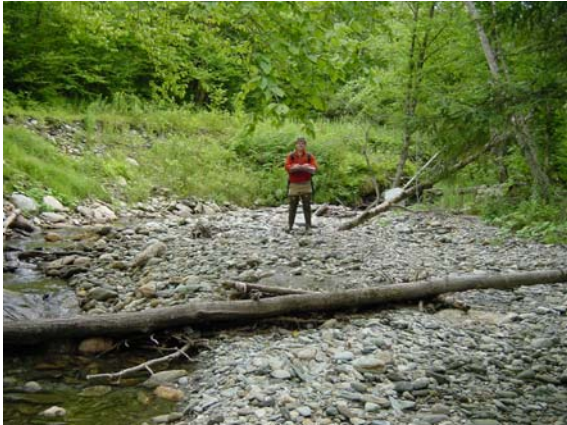
Figure 5.35 Large bar and failed road in T13.02.

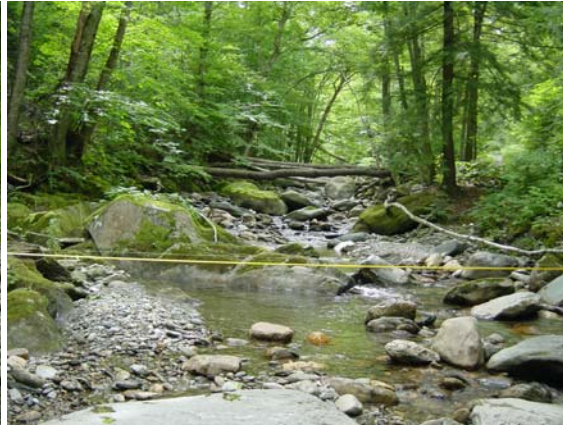
Figure 5.36 T13.02 cross section with boulders, pool.

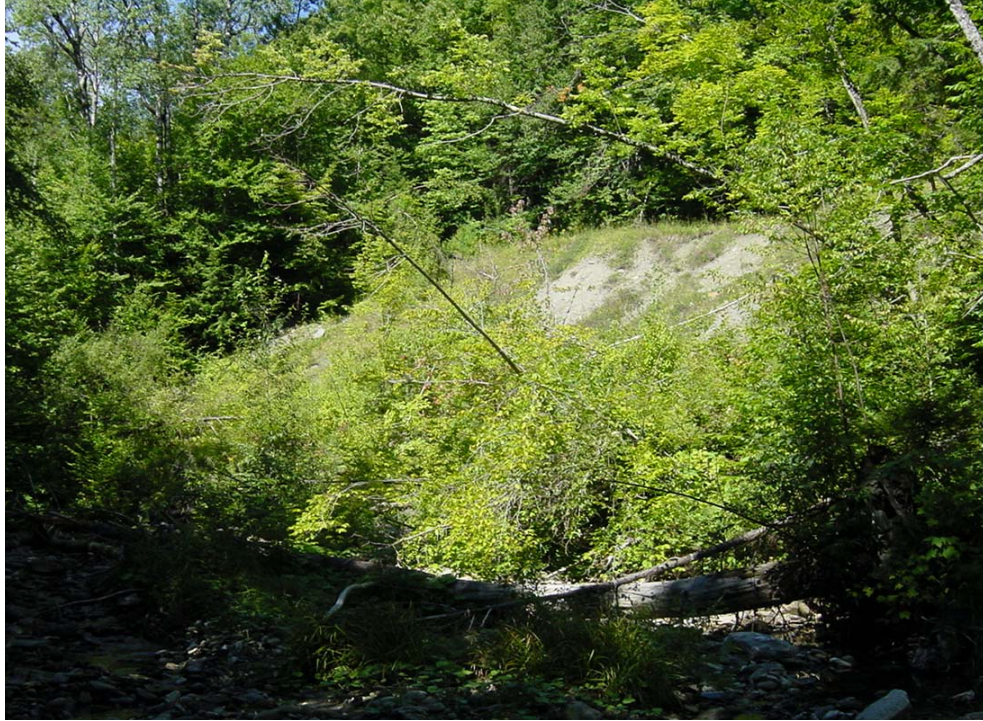
Figure 5.37 Large mass failure with exposed soil

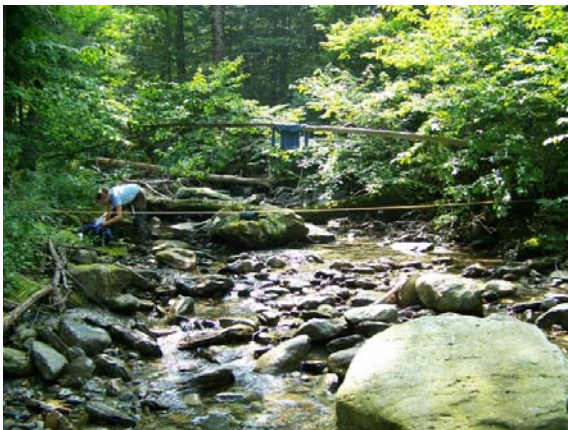
Figure 5.38 T13.04 cross-section area.

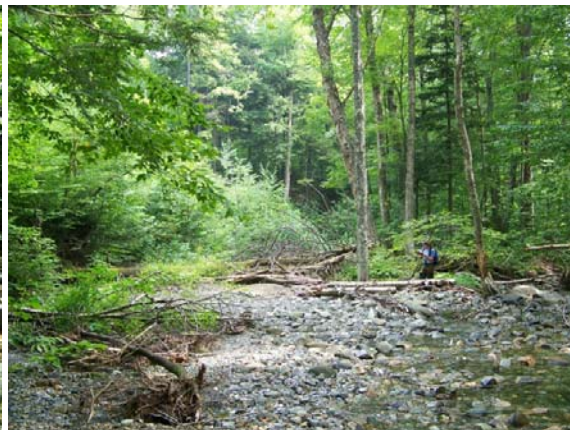
Figure 5.39 Avulsion and sediment deposition.

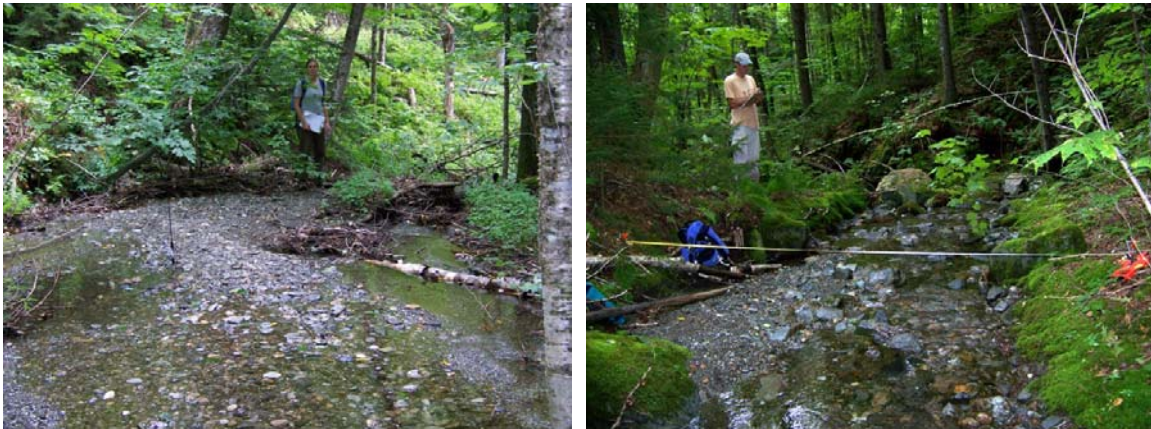
Figures 5.40 and 5.41, Sediment trapped by a debris jam (left) and cross section view (right).

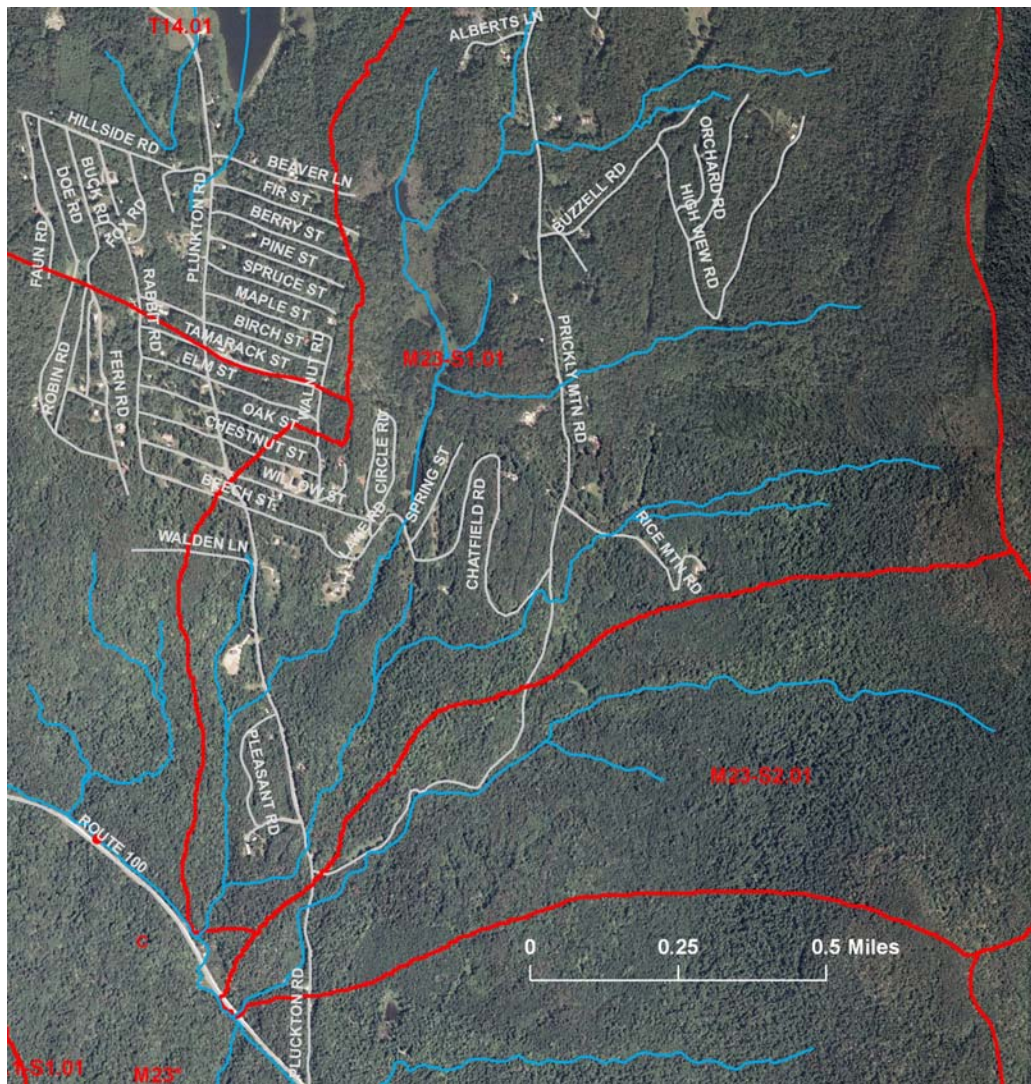
Figure 7.1 Tributaries recommended for future Phase 2 assessments.

according to the Phase 1 dataset, is 1.9 miles. However, the inclusion of additional subtributaries draining to the main channels in S1.01 would aid in future project identification efforts, and would likely result in a total of 3 to 4 stream miles for this area.
