**Bridge and Culvert Assessment  
Using Agency of Natural Resources' Protocol  
Strafford Conservation Commission  
Town of Strafford, Vermont  
West Branch of Ompompanoosuc River Watershed**

April 25, 2005

Mary Nealon  
Principal/Aquatic Biologist

Strafford Conservation Commission

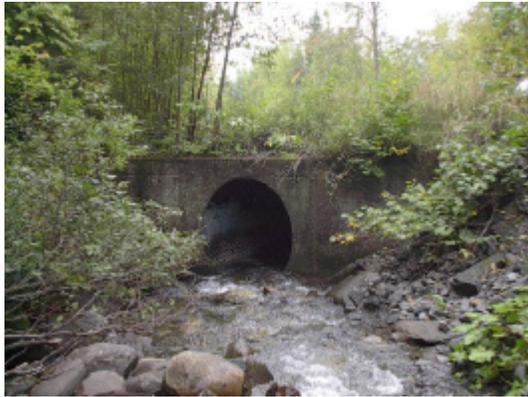
Structure # 50, 56, 31, 5, and 32 are culverts that have been included as Category I structures because they were identified as blocking aquatic organism passage under flow condition found at the time of the assessment. The following conditions must be met at the time of the assessment for a culvert to be considered to block AOP of all fish (including adult salomonids) and stream salamander:

Structure 56 (see Figures 3 and 4 below) is an example of a culvert that blocks aquatic organism passage of all fish (including adult salmonids) and stream salamanders.

Figure 3. Inlet of structure #56 on Van Dyke Road

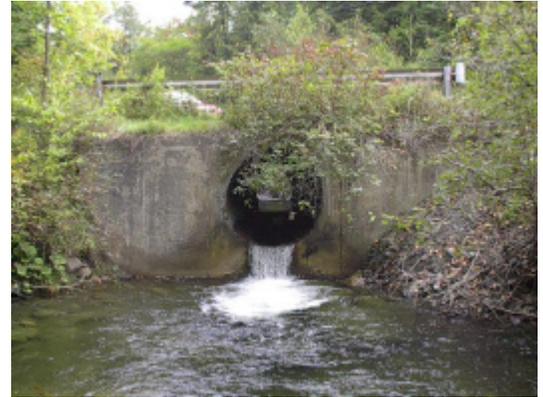
1. The culvert outlet configuration is free fall and the invert to the water surface distance is greater than or equal to 1.0 foot;

Figure 4. The invert of the culvert outlet. Outlet of structure #56 is free fall.

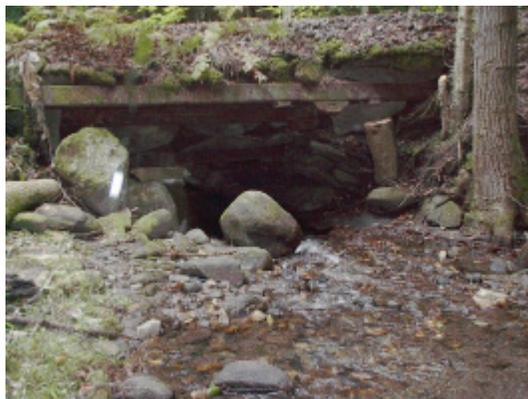
Many of the structures within the Town of Strafford were noted to be undersized. Structure #37 is an example of a bridge that has a span that is only 36 percent of the bankful width. As shown in Figure 5, Structure #37 is impeding the natural movement of sediment. The structure opening is partially obstructed with sediment that has been transported by the stream. In addition, a steep riffle is present immediately upstream of the structure. This steep riffle is indicative of a depositional process that is being caused or exacerbated by the structure. The narrow span and limited clearance of the bridge make this structure prone to ice and debris jams.

Figure 5. Inlet of structure #37

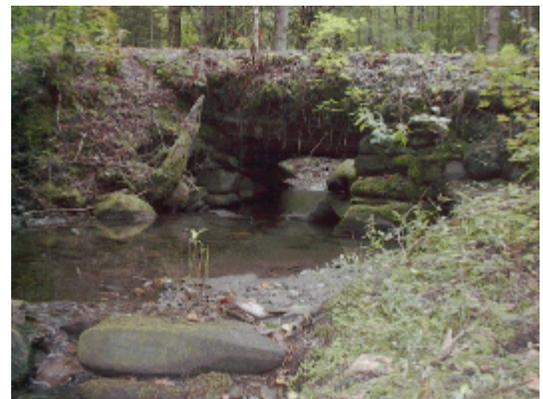
Figure 6. Outlet of structure #37
