### *Introduction:*

The following is a documentation of the key geomorphic processes and adjustments occurring in the Centennial Brook watershed at the reach scale. The intent of this documentation is twofold: 1) concisely summarize Centennial Brook watershed zones and geomorphic processes; 2) highlight for those using the data the key steps containing important or extraordinary information. When used in conjunction with the Phase I and II data in the DMS, and the SGA Watershed Maps, this documentation also provides explanation for questions that may arise concerning discrepancies in the data. At the end of each reach summary is a discussion of potential projects that could protect, sustain, or restore fluvial geomorphic equilibrium conditions, through the implementation of either passive or active stream corridor management strategies. Following the discussion text is Appendix 1, which summarizes QA/QC notes and other relevant information for the Phase I and II databases. Cross-sectional plots are included in Appendix 2. Reach summary statistics and maps are found respectively in Appendices 3 and 4.

### *Centennial Brook Summary:*

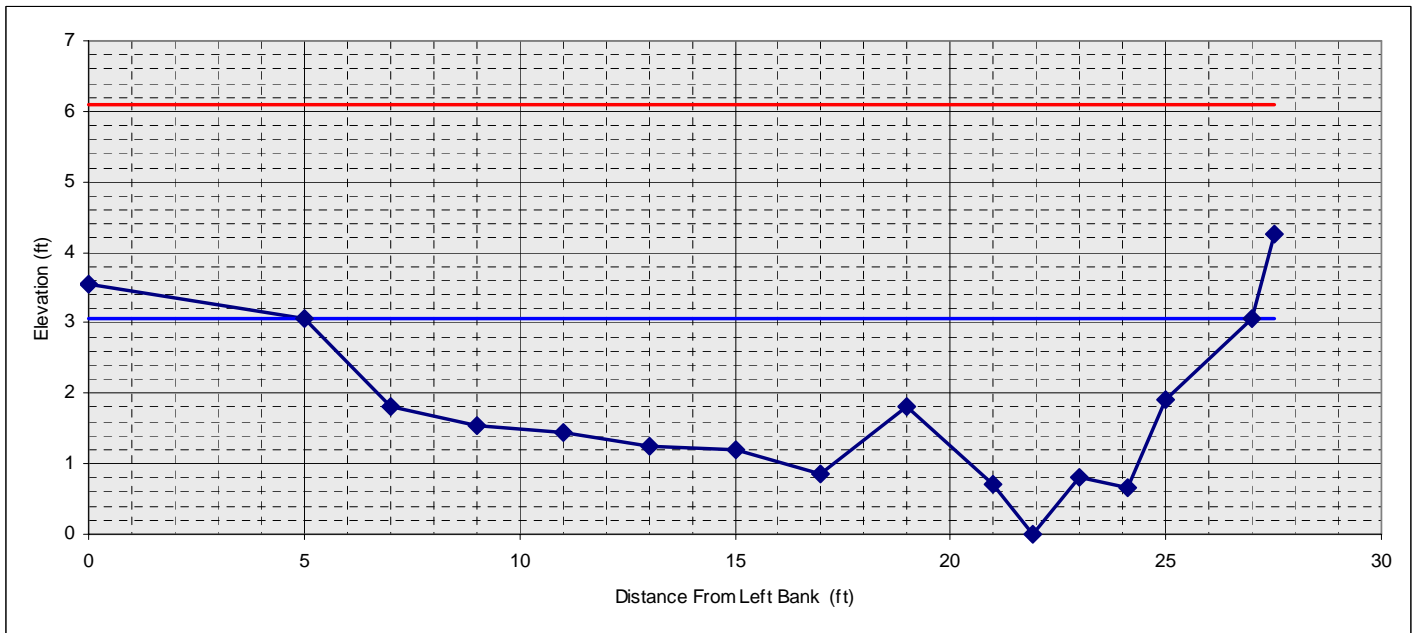
Reach M01 – X1

**M01** – The "sub-reach" section of the DMS (in step 2) has been checked to indicate that this reach was likely a cobble-bottomed step-pool channel in reference condition (even though it is not a subreach of a larger reach). There is significant incision occurring in the upper sections of the reach, however it is controlled in many areas by bedrock. Significant widening and aggradation, likely due to bank erosion from within the reach and reaches above, has filled in many of the pools resulting in more of a plane-bed system. D50 substrate is now gravel due to high percentage of fine sediments. One very large mass failure is also leading to widening and aggradation in the lower section of the reach. In addition, historic and current encroachment on the floodplain (berming) is likely contributing to increased stream power (and thus incision) during the higher streamflow events.

In **M01** in particular, historic and current encroachment has increased stream power and is resulting in extreme incision in the upper section of the reach. This incision begins just below the Grove St. culvert where the channel is constricted by both the culvert itself and the berming associated with the S.D. Ireland facility, and the adjacent parking lot associated with Schimanska Park. Ongoing encroachment in the floodplain in this section of the reach has been observed where materials continue to be dumped down the valley wall from the S.D. Ireland facility. Protecting this corridor from further encroachment should be a key, cost-effective measure taken to reduce further incision, mass wasting, and sediment conveyance to the Winooski river a short distance downstream.

**M01** – As discussed in the stream type departure section of this document, this lowest reach of Centennial Brook is experiencing extreme incision, widening, and bedform departure. Active restoration of stream channel geometry is likely not be feasible until the mitigation of the hydrologic regime of the entire watershed is addressed. This strategy, adopted by ANR, is consistent with research from other parts of the U.S. (Booth et al, 2002; Booth, 2005). Although restoration of channel geometry may not be desirable in this reach, the instability in the lower section of the reach where significant widening is occurring could be addressed with other means. First, there are large amounts of metal and concrete debris which cause debris jams and could be contributing to this widening. Manual removal of this unnatural debris out of the floodplain may reduce the severity of this widening. In addition, a mass failure on the left bank approximately half way down the reach contributes significant amounts of sediment to the channel and downstream receiving waters. Stabilization of this failure, either through re-vegetation or other non-mechanical means, could also slow the widening process in this section of the reach and could reduce fine sediment conveyance to the Winooski River and thus Lake Champlain.

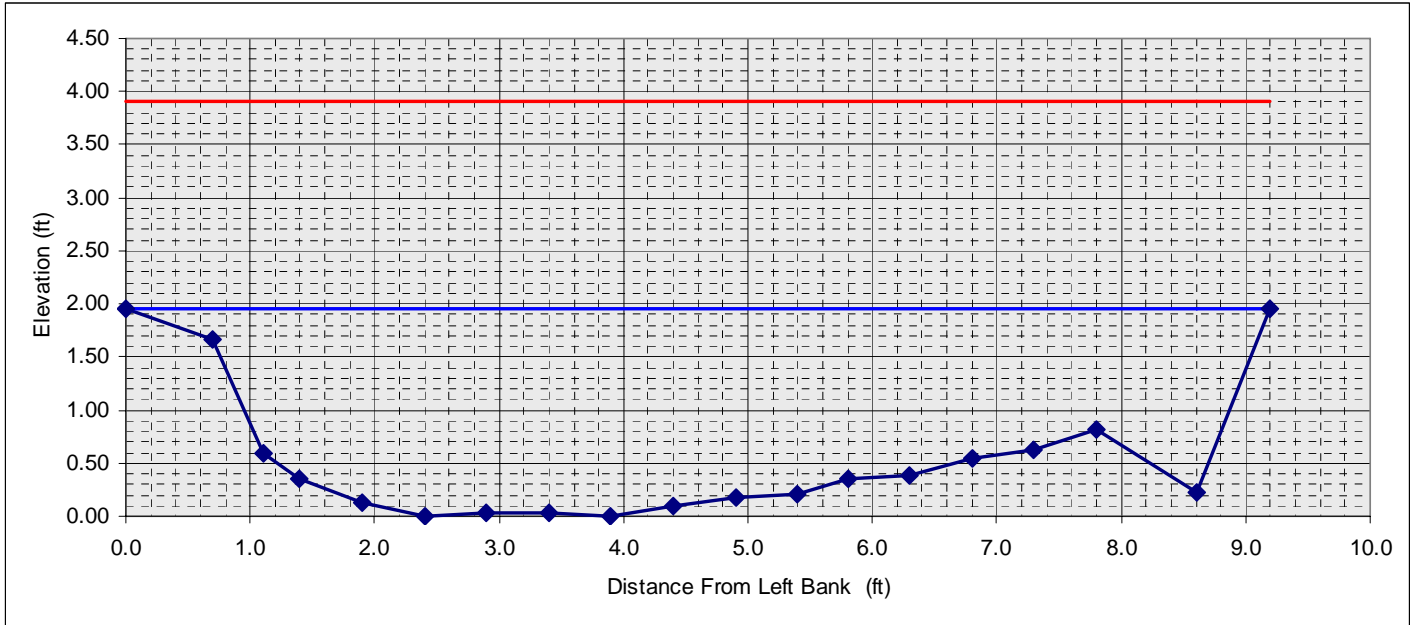
Reach M02

Throughout the Centennial Woods Natural Area, reaches M02 and M03 have very good riparian buffer and corridor conditions, allowing for extensive floodplain access for these low-gradient reaches with E-type channels. In addition, this low-gradient zone of the watershed experiences intermittent beaver activity from Grove Street up the main stem to Interstate 89. This area of beaver activity resulted in low RGA and RHA scores. Beaver ponds may actually be providing some mitigation of upstream stormflows from urban runoff. Although the effect of urban runoff in this zone of the watershed is difficult to assess, the channel incision observed in areas where there are no active beaver ponds suggests that the current flow regime may be causing degradation in areas where fine sediment had accumulated from past beaver ponding. Throughout much of reach M03, the older, undisturbed hemlock forest has many dying trees which fall directly into the stream channel. This causes many debris jams and channel widening which also makes the assessment of upstream urban impacts difficult.

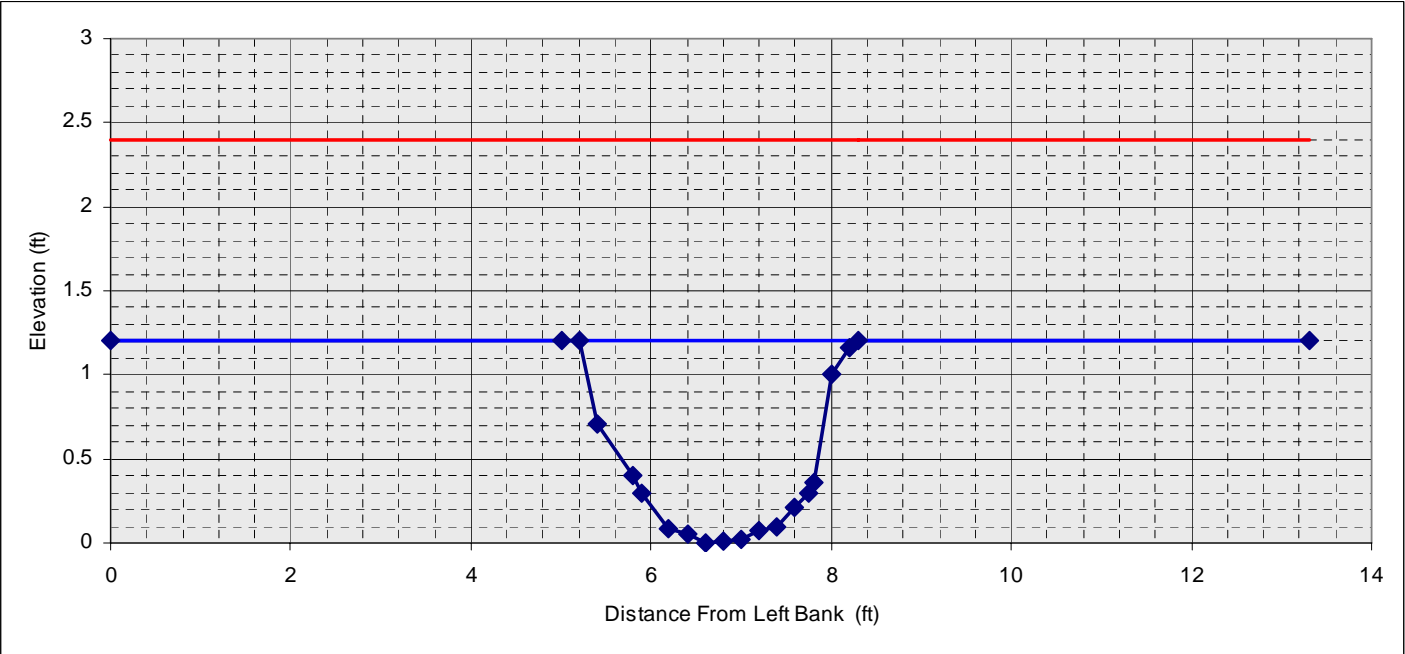
Reach M04 – X1

Above Centennial Woods and Interstate 89, the channel remains low gradient with influence from beaver ponding throughout, although not as extensive as in reaches M02 and M03. The channel chosen as the main stem for assessment is that which stems from the east, originating at the airport. However, the other tributary (T2) stemming from the southeast which originates in the Williston Road area appears to be more impacted by urban runoff from the southern section of the watershed. Although this tributary was not assessed, it may actually carry greater streamflows during stormwater runoff events, as observed by the larger channel when compared to the main stem at the confluence below Interstate 89. Unlike the Centennial Woods area, protection of the river corridor is not as permanent or extensive throughout this zone of the watershed (reaches M04 & M05). Steep valley walls and wide floodplains with abundant wetlands makes development in the corridor unlikely, but in the upland areas urban land cover dominates the watershed. Protection of this section of the stream corridor is discussed in greater detail in "projects" section. One notable channel feature found in M04 is a natural channel avulsion found in the area adjacent to the old limestone quarry (where Quarry Ridge Condominiums are located). Above and below this avulsion, the channel is a low gradient E-type channel. However, it appears that an old beaver dam forced the channel from its original location where it once cascaded down a limestone bedrock terrace through a high-gradient channel. The current location of the stream is through an underground channel which loses approximately 40 feet of elevation over a distance of about 150 feet. The current channel re-enters the abandoned channel at the valley toe just upstream from the discharge of the Quarry Ridge Condominium stormwater pond.

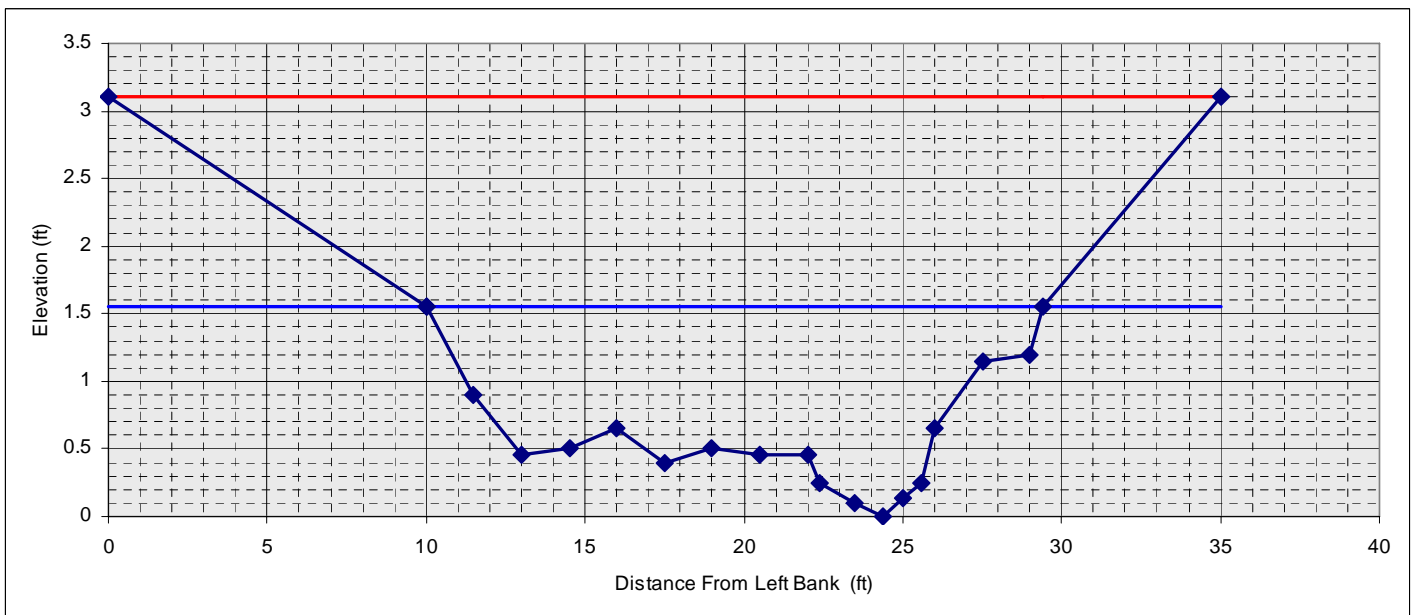
Segment T.1-A

**T1.01-A** – This segment is experiencing incision as well as aggradation due to bank erosion within the reach and in upstream segment B. Although there are sections of the reach with riffle-pool bedform, a majority of the segment has plane bedform. The segment has remained classified as a C-type channel. Relatively good connection to floodplain throughout the lower section of the segment may be ameliorating some of the impacts of frequent high flows from urban runoff in the upstream watershed.

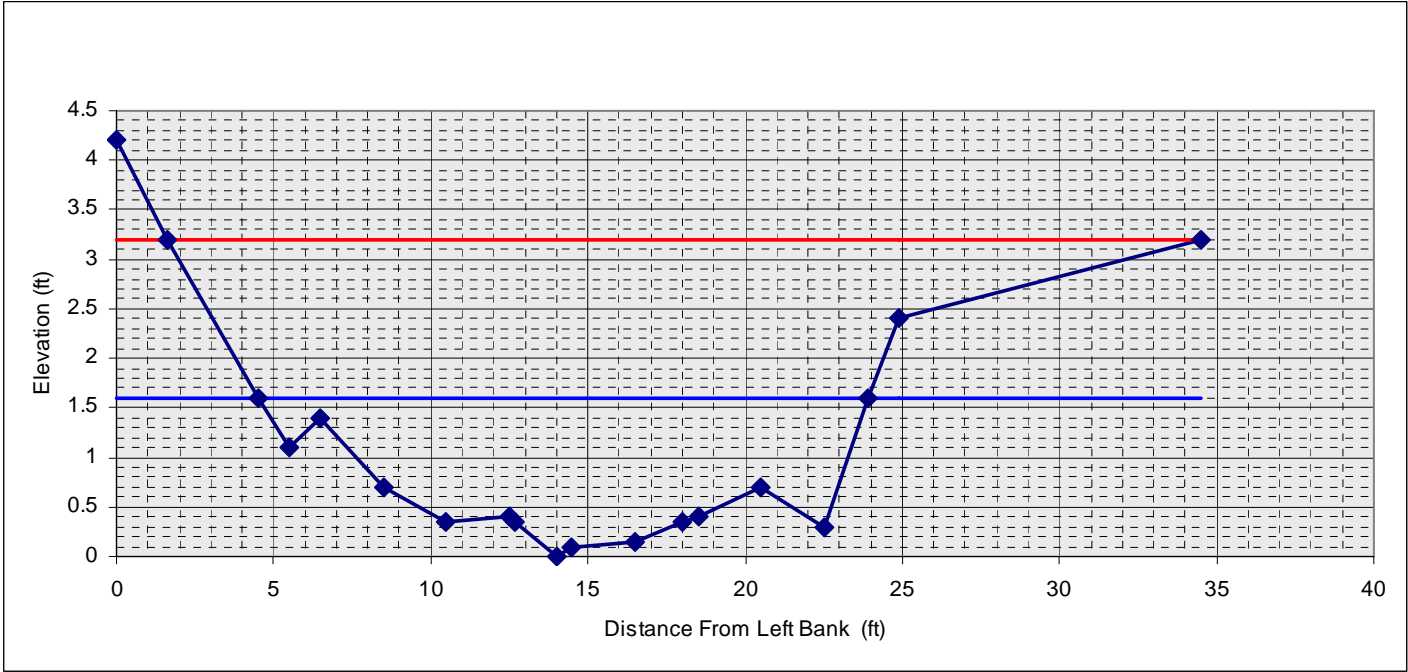
Segment T.1-B

The only tributary assessed during summer 2005 was T1, the tributary which confluent with the main stem at the M02/M03 reach break. This tributary begins to the south of Centennial Woods and receives large amounts of stormwater runoff from the Staples plaza to the south and from the UVM/Fletcher Allen campus to the west. With the exception of the buffering provided by immediate natural stream corridor around this tributary, the watershed is almost completely urbanized. This has resulted in a channel which has incised and widened, much of which is in stage III of channel evolution. The upper segment (A) of this reach is higher-gradient channel with extensive bank erosion and a significant mass failure immediately below the outlet of the stormwater pond to the south. This recently installed stormwater pond may mitigate impacts of urban runoff into the future, but adjustments in this reach will likely continue for years to come. In segment B, a change in channel bedform has been noted from riffle-pool to plane bed. Significant widening and aggradation from eroded material originating from upstream segment B has eliminated much of the pool habitat in this gravel-bottomed segment. One additional stormwater pond which collects runoff from Centennial Field and the Fletcher Allen Facility also discharges into segment A near the confluence with the main stem.
