Phase I and 2 Stream Geomorphic Assessments North Branch of Deerfield River Watershed Windham County, Vermont

Final Report
January 30, 2006

Vermont Department of Environmental Conservation
Water Quality Division
103 South Main Street
Building 10 North
Waterbury, VT 05671-0408

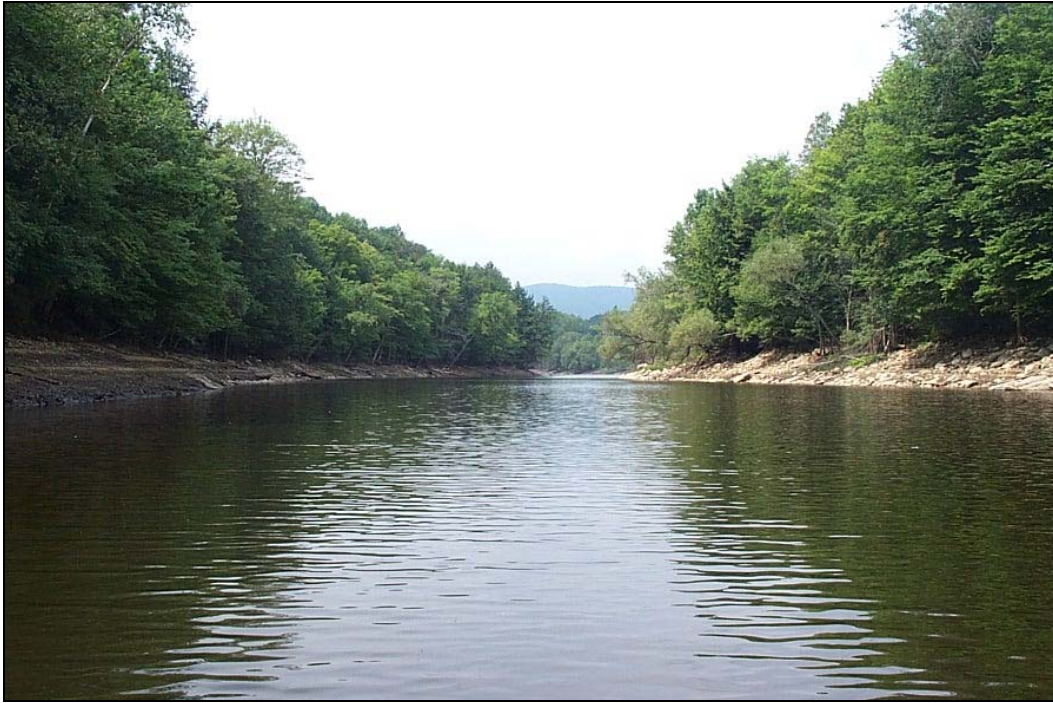
The most important influence on the geomorphic and habitat condition of this reach is the Harriman Reservoir. Store and release operations of the Harriman dam influence this reach significantly. As the lake levels rise, this reach becomes a lentic system (Figure 11). Due to the heavy influence of the damming, BCE scientists were unable to conduct a meaningful RGA and RHA assessment.

Figure 11: T2.01 is heavily influenced by the store and release damming of Harriman Reservoir. RGA and RHA data were not collected for this reach.

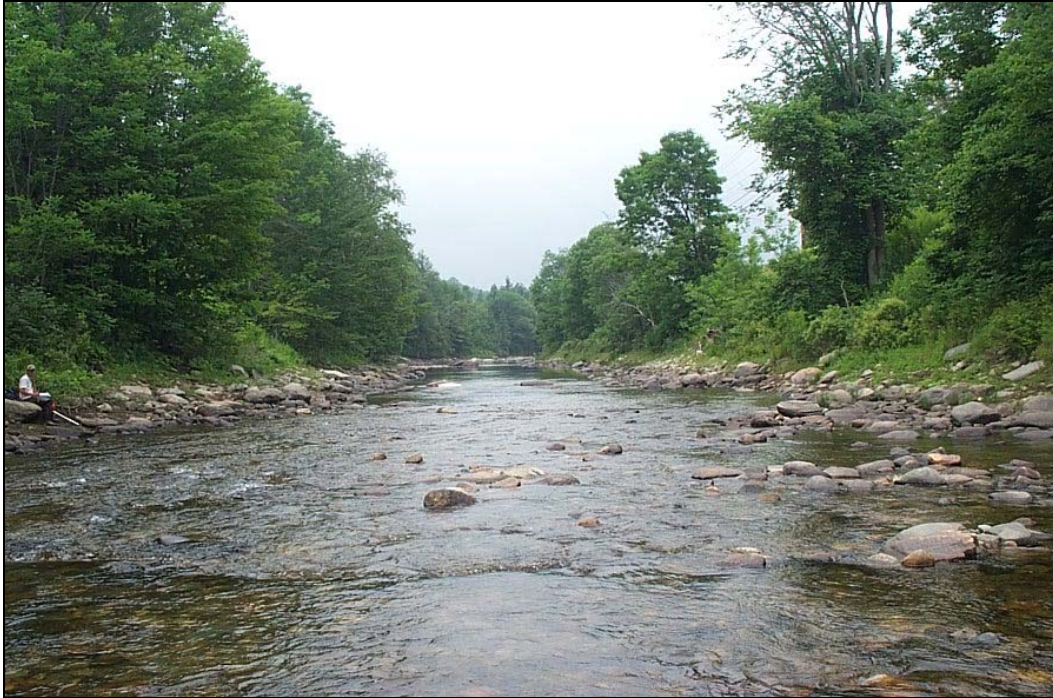
The roads and associated development have altered the channel confinement of this reach from a semi-confined to a narrowly confined channel. As a result of this change in channel confinement, the reach has historically incised and widened. The Deerfield River at this reach has departed from its reference stream type of “B” and is now classified as a “F” channel. This reach is straighter and wider than it was in its reference condition (Figure 12).

Figure 12: T2.02 has become confined by roads. It has incised and widened into an “F” type plane bed channel.

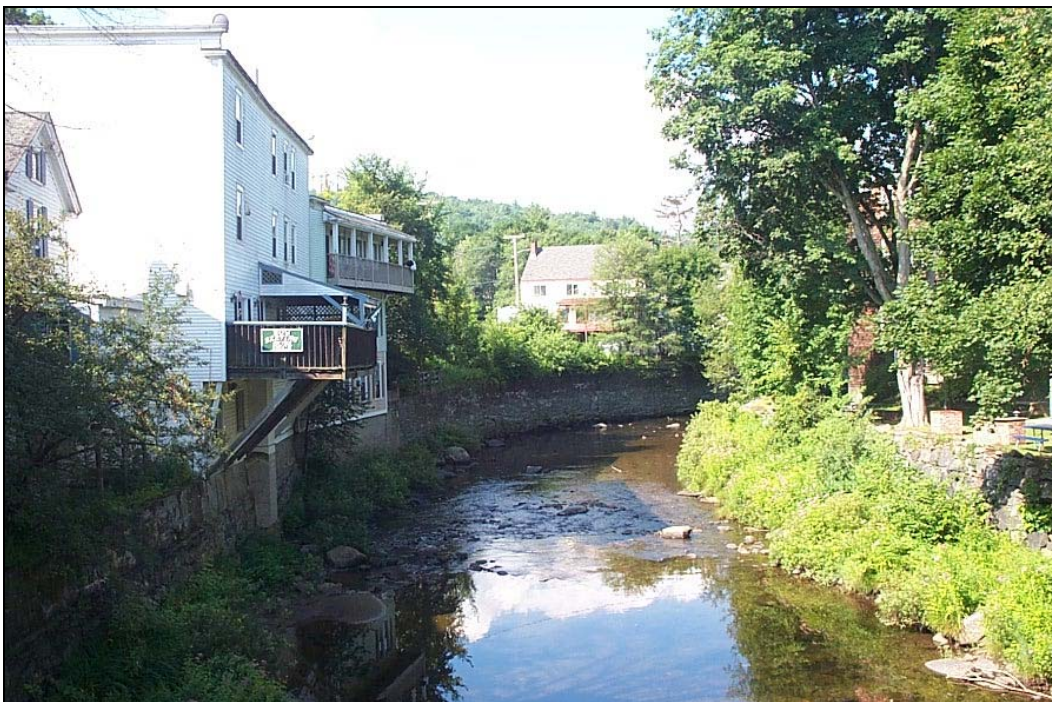
By reference, segment T2.03-A is a “B” type channel. Due to historic floodplain encroachment, either the stream has degraded or the floodplain has been filled thereby effectively increasing the amount of incision through this segment. There is currently some minor aggradation, widening, and planform adjustment occurring, however, boundary conditions of the rock walls and some bedrock ledge are preventing further channel evolution from continuing. This segment has become a “F” type channel that has been locked into stage II of the F-stage evolution model (Appendix C).

Figure 13: Segment T2.03-A has been extensively channelized through Wilmington village. Historic degradation, widening, and floodplain fill have created a “F” type channel.

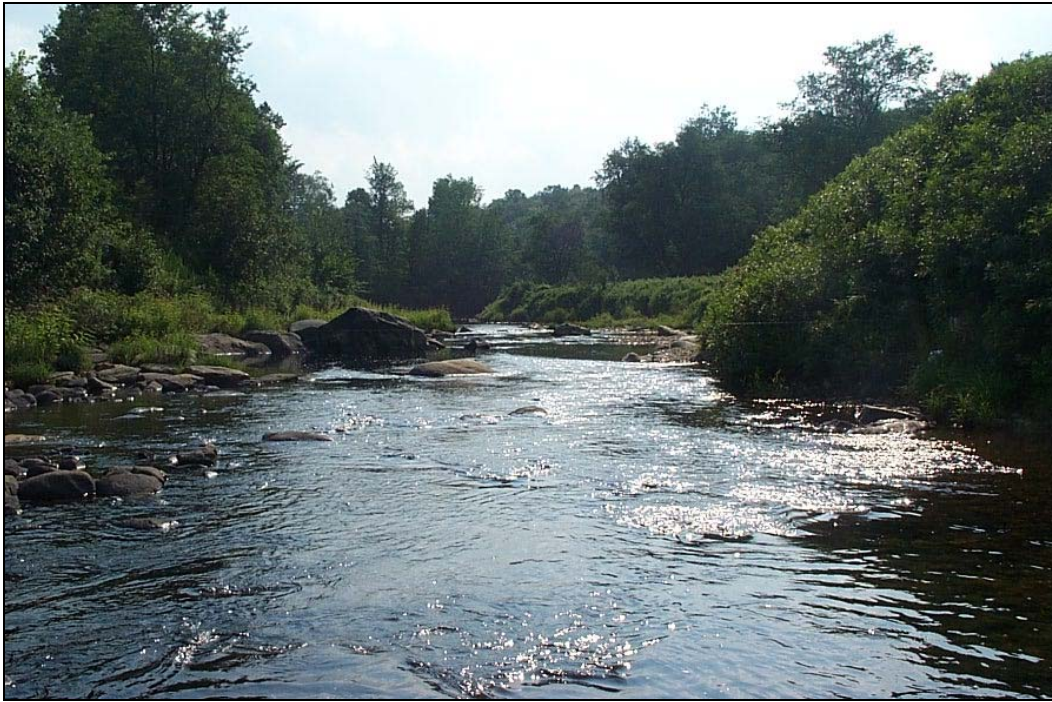
Although Vermont Route 100 runs through the entire left corridor of the stream channel, the channel is still unconfined (narrow) and has been classified as a “C” type channel dominated by gravel substrates (Figure 14). There is some evidence of incision through this reach (incision ratio is 1.35) as well as minor widening and planform adjustment. Currently, the major adjustment process occurring in this reach is aggradation.

Figure 14: Typical cross-section along segment T2.03-B with weak riffle-pool bedform. The river has shown minor degradation, widening, and planform adjustment. Currently there is major aggradation occurring within the reach.

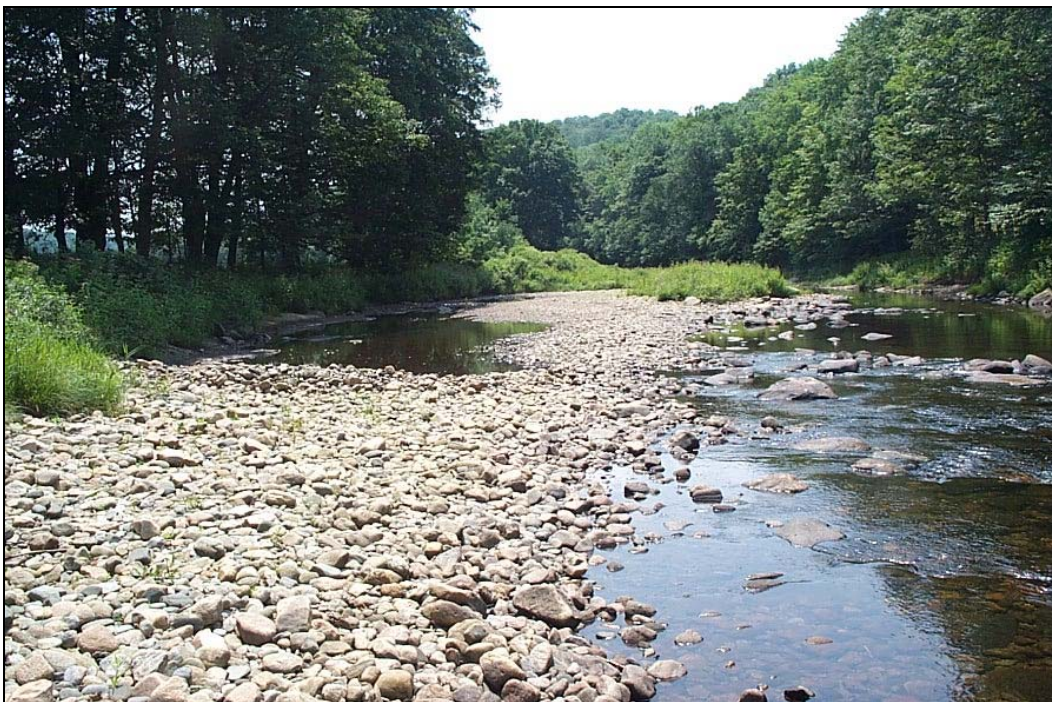
stream type. The predominant land use though the reach is agricultural. This reach has been extensively straightened and pushed up against the right valley wall. Historic straightening, and evidence of gravel extraction has led to some channel incision (incision ratio of 1.34) and widening. Currently there are signs of active channel aggradation and planform adjustment. The channel is attempting to narrow through bar development; however, some recent gravel extraction is maintaining an overwide channel as seen in Figure 15. Additionally, several active flood chutes and multiple diagonal bars indicate that the segment is attempting to regain the sinuosity that has been lost from historic straightening.

Figure 15: Bar development along T2.04-A indicates the channel is attempting to narrow and regain sinuosity. Gravel extraction, however, on this and other bars in the reach is maintaining an overwide channel.

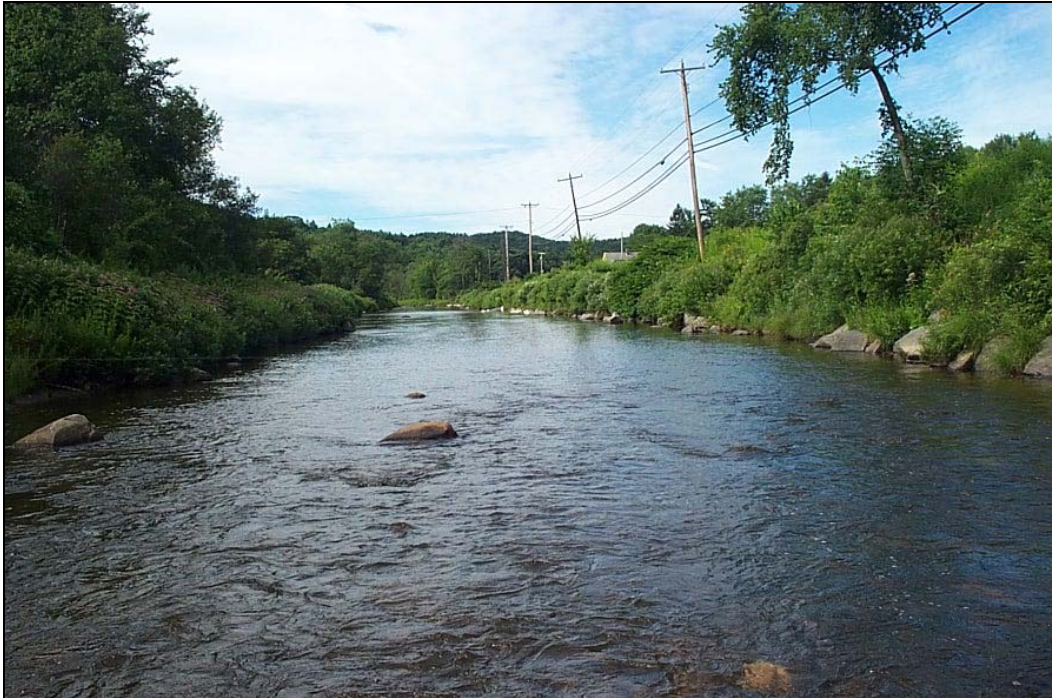
this segment, has changed the stream type from its reference “C” to a more confined “B” type channel. This extensive alteration has also affected the bedform of the stream (as well as the habitat). The bedform has likely changed from a riffle-pool to a plane bed form that now provides little depth cover for fish and aquatic organisms (Figure 16). Habitat and river health have also been affected by the removal of the riparian buffer on the right bank which now averages less than 5 feet wide from the top of the bank.

Figure 16: Segment T2.04-B has been extensively straightened and confined by Route 100. It is now a “B” type channel with a plane bed form.

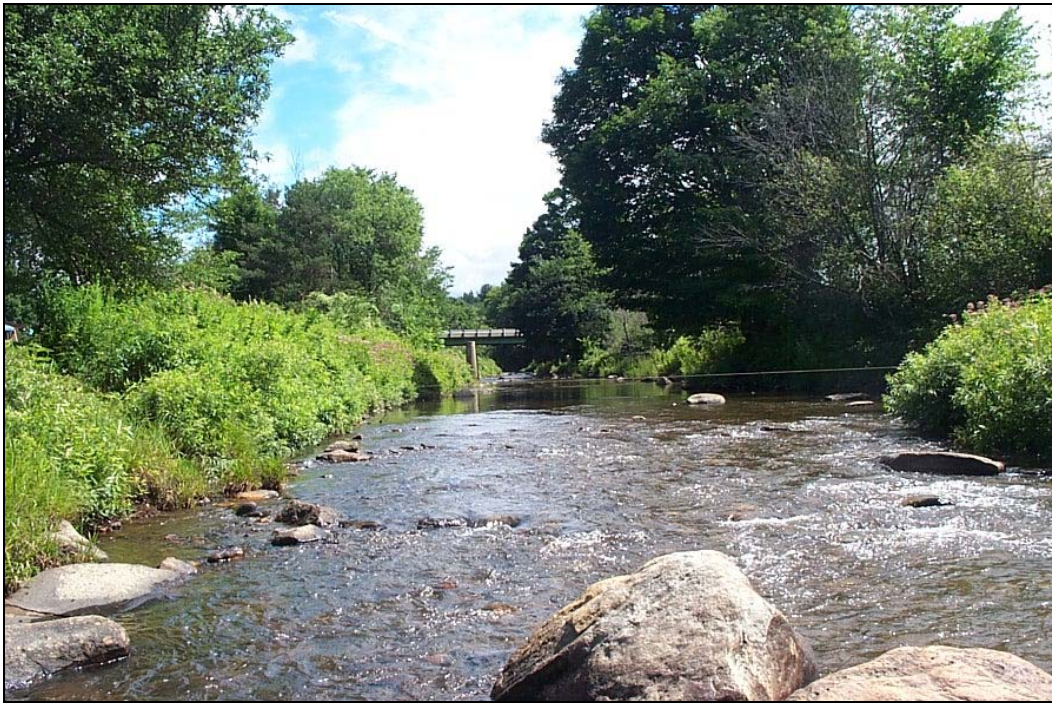
entrenchment ratio of the segment remains low and therefore it will probably continue to widen and attempt to rebuild a new floodplain. Bank erosion and riprap, which account for approximately a quarter of the total streambank surface indicate, active planform adjustment. Despite these active adjustment processes, the channel remains a “C” type (Figure 17).

Figure 17: Reach T2.05 is a predominately plane bed “C” type channel that has historically incised and is currently exhibiting major aggradation and minor widening and planform adjustment.

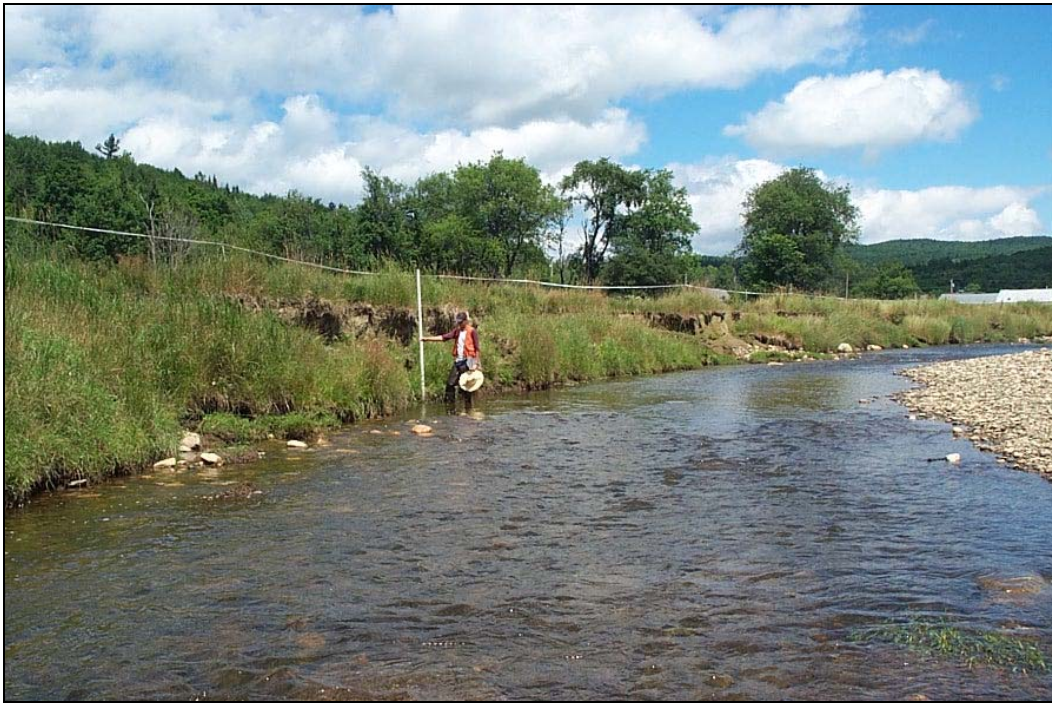
Major planform adjustments occurring within the reach are evident by a historic channel avulsion and several flood chutes mapped by BCE scientists. Currently, the channel is narrowing through aggradation. It has established a new juvenile floodplain and is once again a “C” type channel that may continue to adjust in the coming years as it works to regain a dynamic equilibrium.

Figure 18: Bank erosion along reach T2.06. The channel is attempting to narrow through major bar development along the left bank.

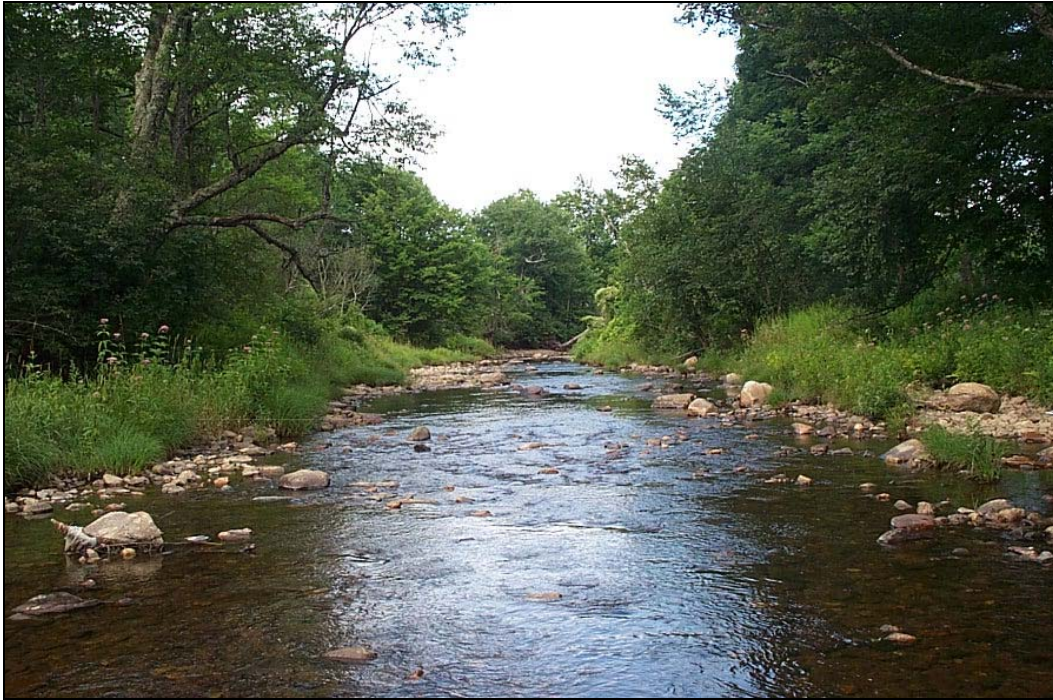
North Branch reach T2.07 begins at the confluence with Bill Brook (T2.06-S1.01) and ends 4149 feet upstream where Ellis Brook (T2.07-S1.01) joins the main channel. By reference, Phase I assessment data has indicated that this should be a “C” type channel in a very broad valley. Historic channel realignment and straightening, however, has caused major historic channel degradation. The current channel incision ratio is 2.2. Without adequate access to its floodplain, reach T2.07 is undergoing major widening, planform adjustment, and aggradation. The combination of adjustments has caused a stream type departure to an “F” channel with a weak riffle-pool structure (Figure 19).

Figure 19: Reach T2.07 has become an “F” channel with a weak riffle-pool bed form.

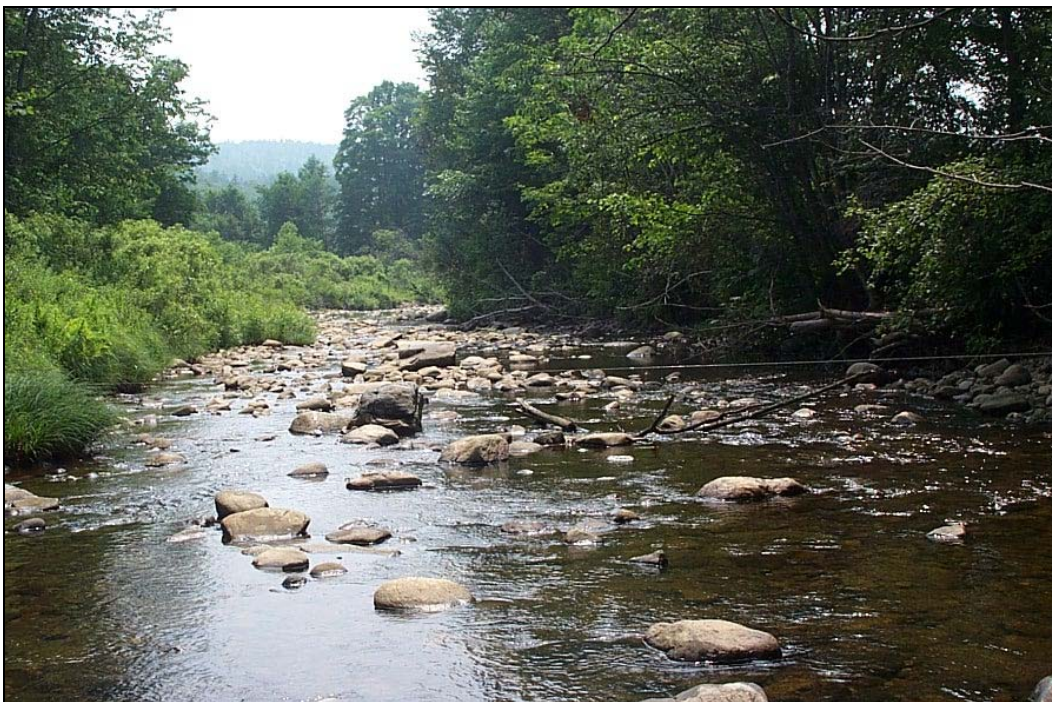
By reference, this segment is likely a riffle-pool “C” type channel. While it remains a “C” type channel, straightening and incision have caused the bedform to become a plane bed system which now lacks pool habitat (Figure 20). Continued aggradation and planform adjustment may be expected while the channel continues to redevelop.

Figure 20: Typical cross-section along the plane bed form of segment T2.08-A.

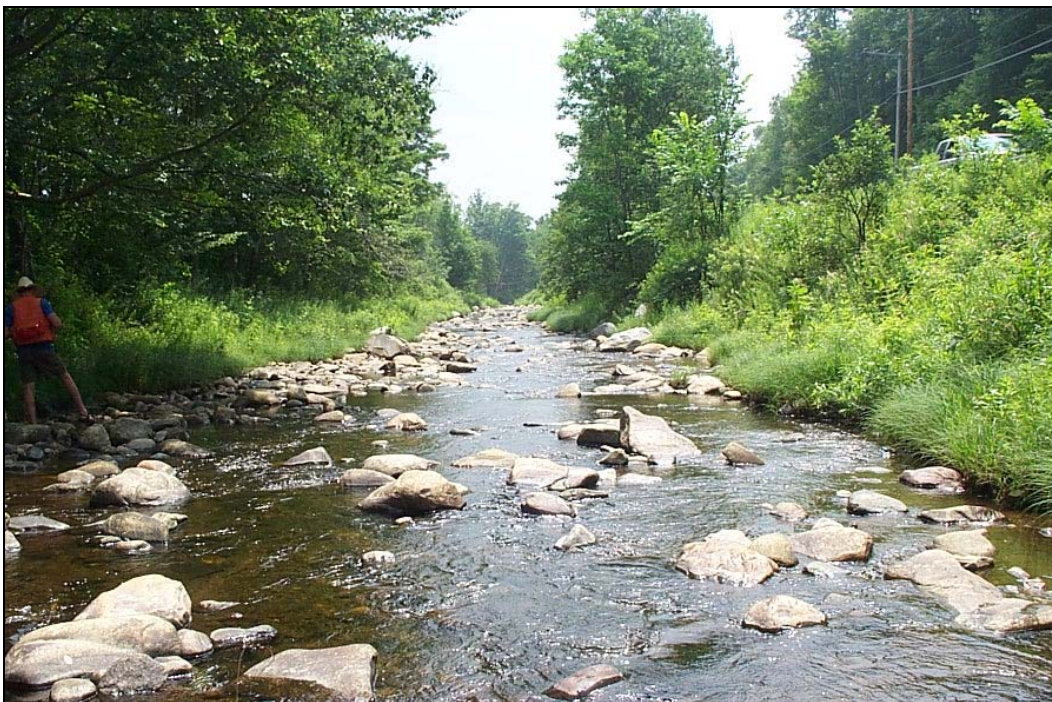
Currently the river appears to be under major adjustment from aggradation and widening, and minor planform adjustment. The reach is further impacted by riparian buffer removal which has reduced streamside vegetation to less than five feet in width from the top of each bank.

Figure 21: Typical cross-section along segment T6.08-B.

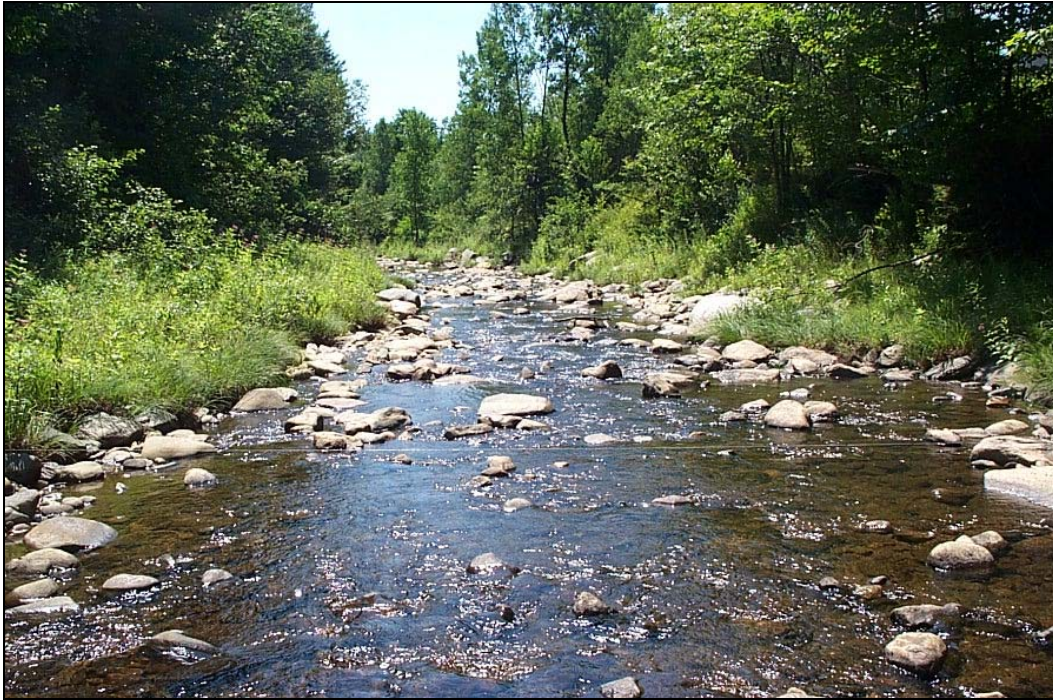
While streambank stability has been enhanced by the forested valley wall which runs along the left bank, most of the riparian buffer on the right bank has been removed to less than 5 feet of width in order to accommodate Route 100.

Figure 22: Typical cross-section along reach T2.09, a plane bed “F” type channel

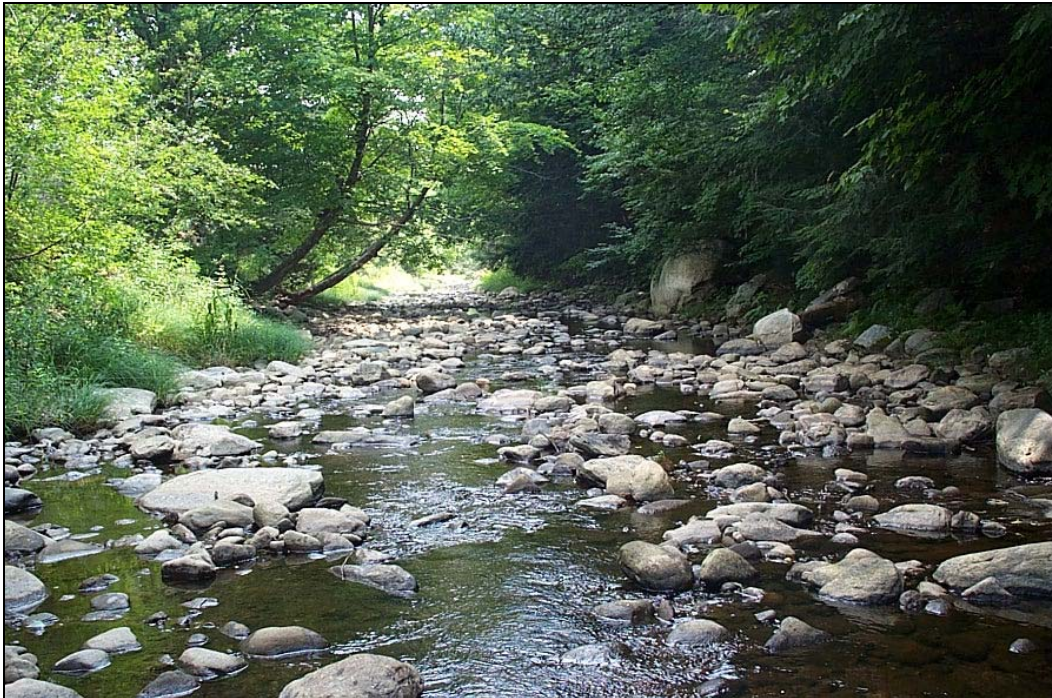
In addition to the impacts to the channel and floodplain, the encroachment of the Village has led to several other impairments. BCE scientists surveyed seven stormwater inputs during the assessment of this reach. Additionally, the riparian buffer has been reduced to less than five feet in width along most of the reach.

Figure 23: Reach T2.10 has incised and widened into an “F” plane bed stream.

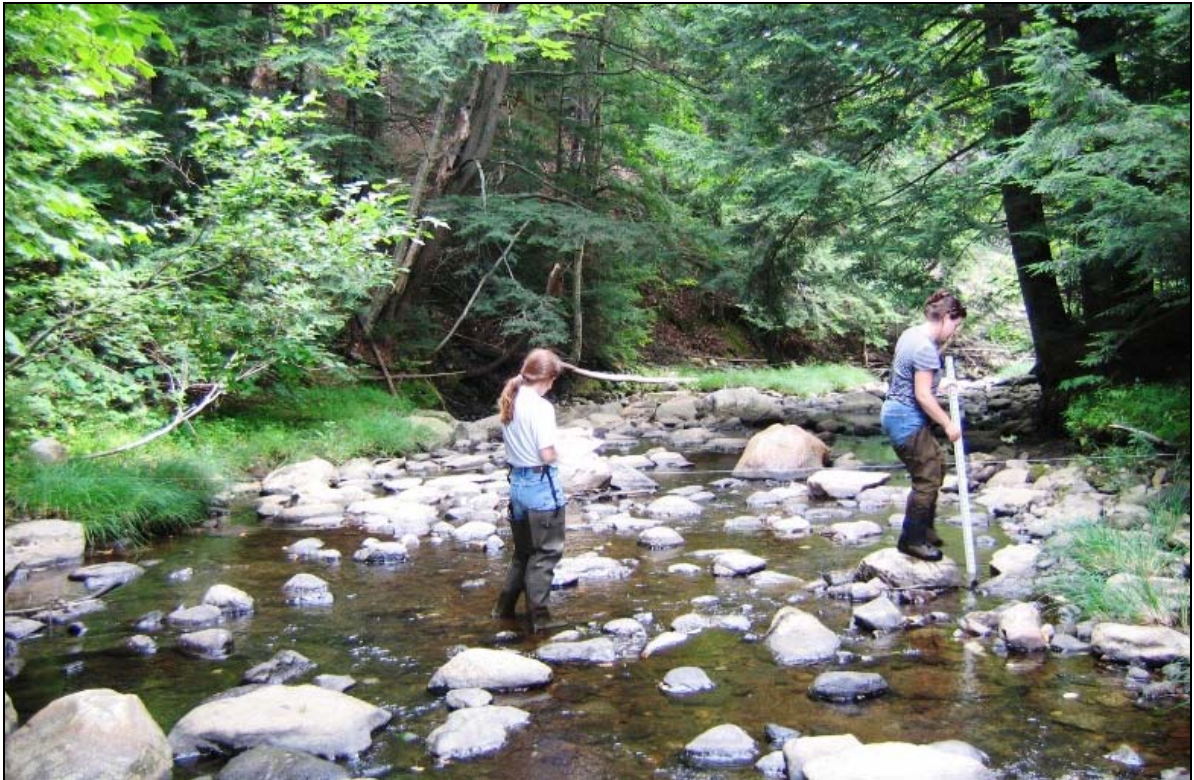
Despite these drastic changes to the channel profile planform, the riparian condition of this stream has been relatively unaltered. There exists over 100 feet of healthy mixed forest on either bank of this segment.

Figure 24: Segment T2.II-A has historically incised and widened into an “F” channel with a plane bed form.

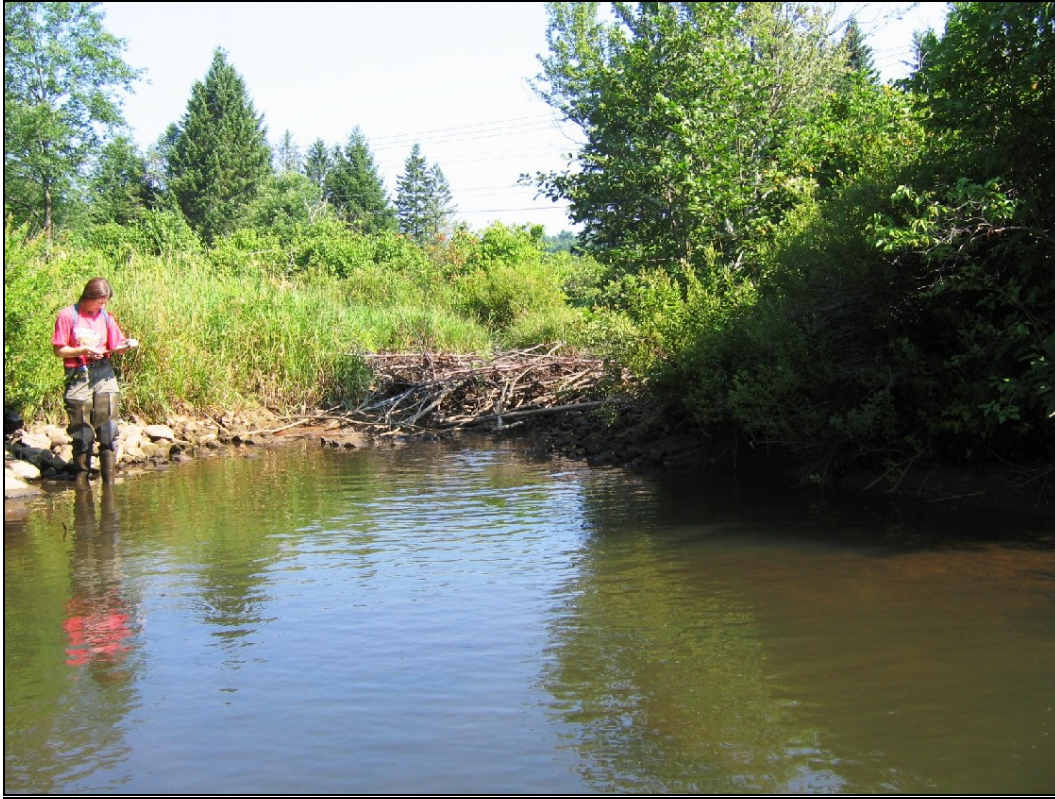
Segment T2.II-B begins at a beaver dam several hundred feet upstream of Tannery Road (Figure 25) and continues upstream to the Snow Lake Dam (T2.I2). Due to the heavy influence of the beaver dams, BCE and ANR scientists were unable to conduct a full geomorphic assessment of this segment.

Figure 25: A partial assessment of Segment T2.11-B was performed due to beaver activity which is altering the flow and sediment transport of the reach.

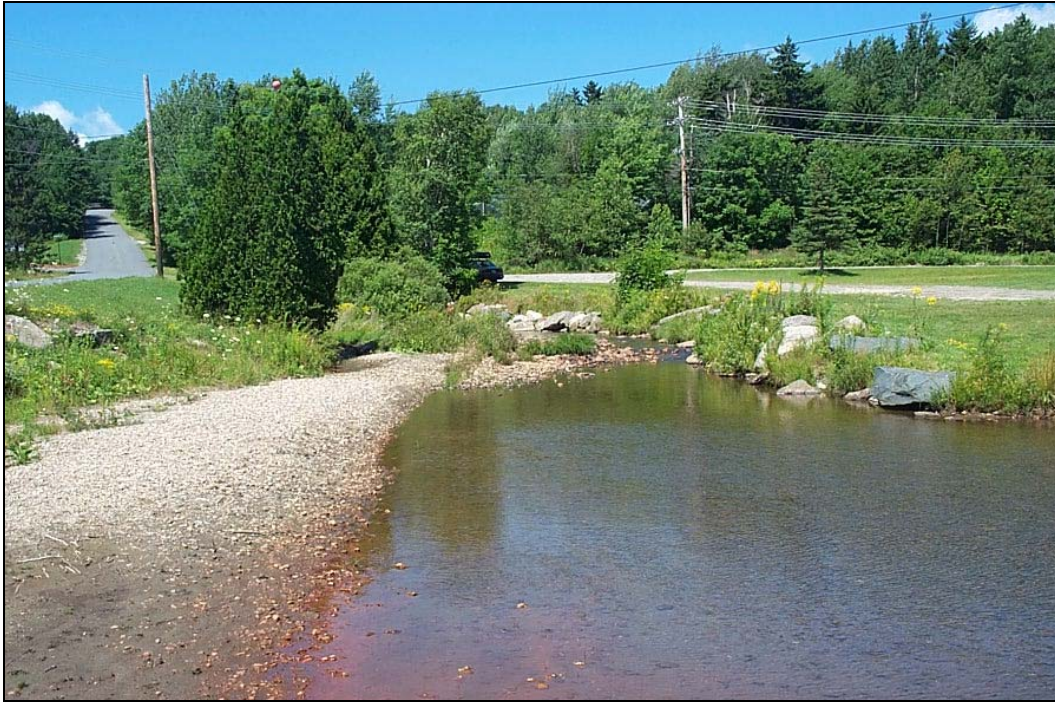
The impoundment is disrupting the natural flow of water and sediment in the North Branch system. Coarse sediments are falling out of the system and are being dredged periodically to maintain the lake. Downstream of the impoundment, the system may be impoverished of sediment and has likely reacted by degrading the streambed and eroding its banks.

Figure 26: Looking at the start of Reach T2.I3. Reach T2.I2 was not assessed due to the impoundment of Snow Lake.

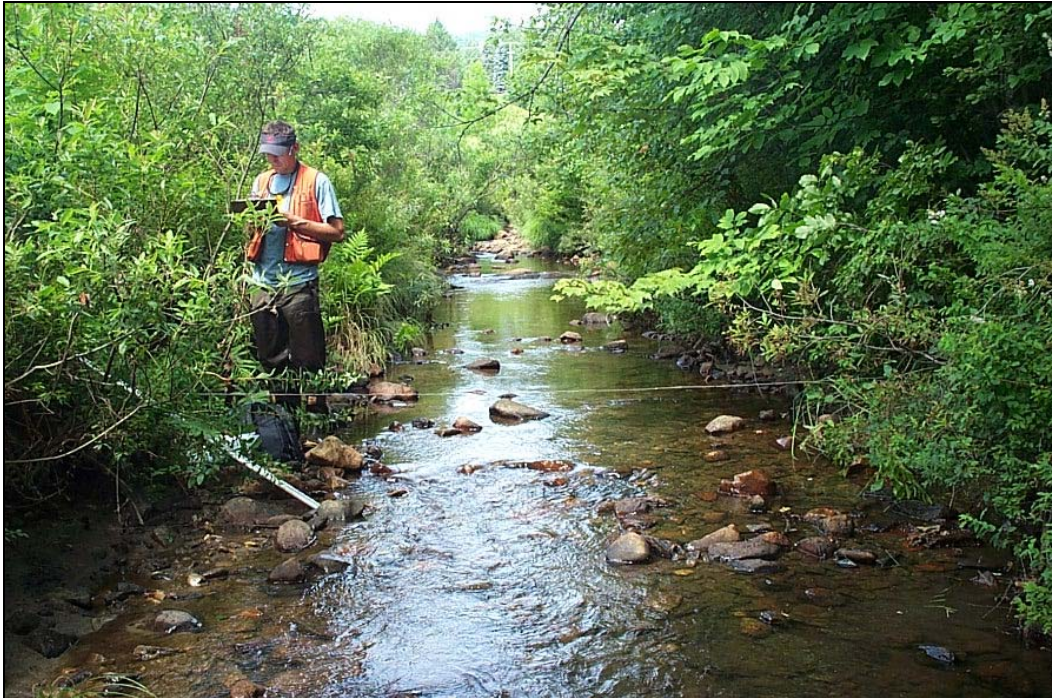
During the Phase 2 assessment BCE scientists noted evidence of minor degradation, aggradation, widening and planform adjustment. An incision ratio of 1.7 confirms historic degradation. The stream, however, has been kept from excessive widening and floodplain redevelopment through berming and armoring activities. Bank armoring on the right bank totals 480 feet while 220 feet of the left bank have been armored. The stream buffer on both sides has been removed to less than five feet.

Figure 27: Typical cross-section along reach T2.13-A.

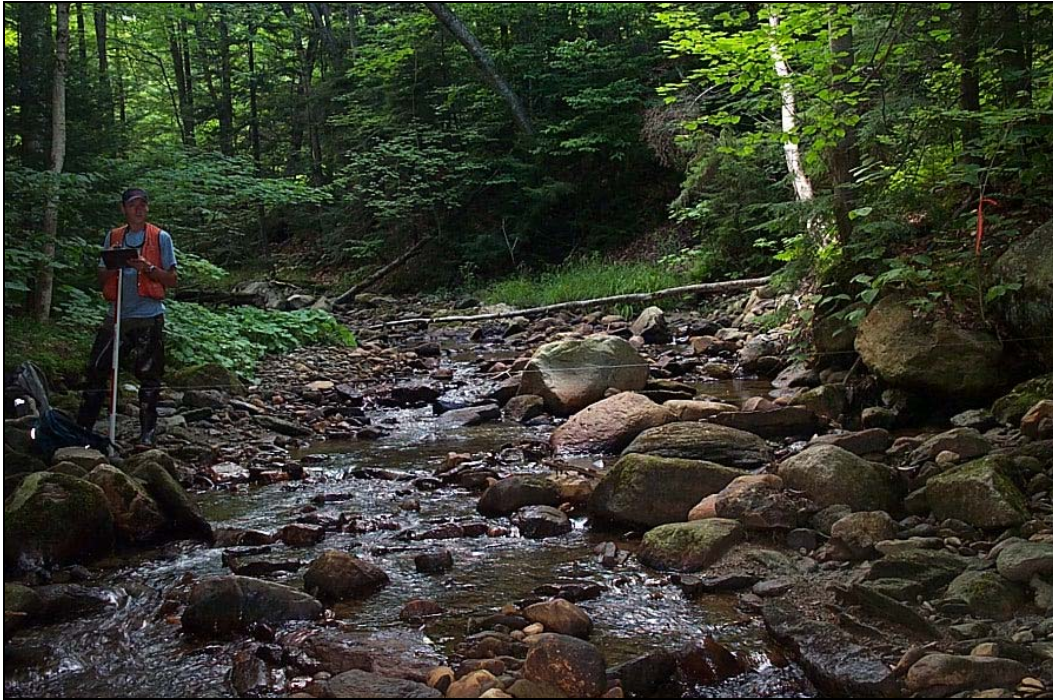
Segment T2.13-B begins at a bedrock ledge and continues upstream for 1500 feet until reaching a tributary and the start of a bedrock dominated channel. Despite development in the floodplain, this segment has retained its reference “B” stream type (Figure 28). Bedrock grade control at the upstream and downstream end has likely assisted in stream channel stability. Degradation within this reach was very minor. Additionally, only minor aggradation, widening, and planform adjustments were found to be occurring.

Figure 28: Typical cross-section along segment T2.13-B.

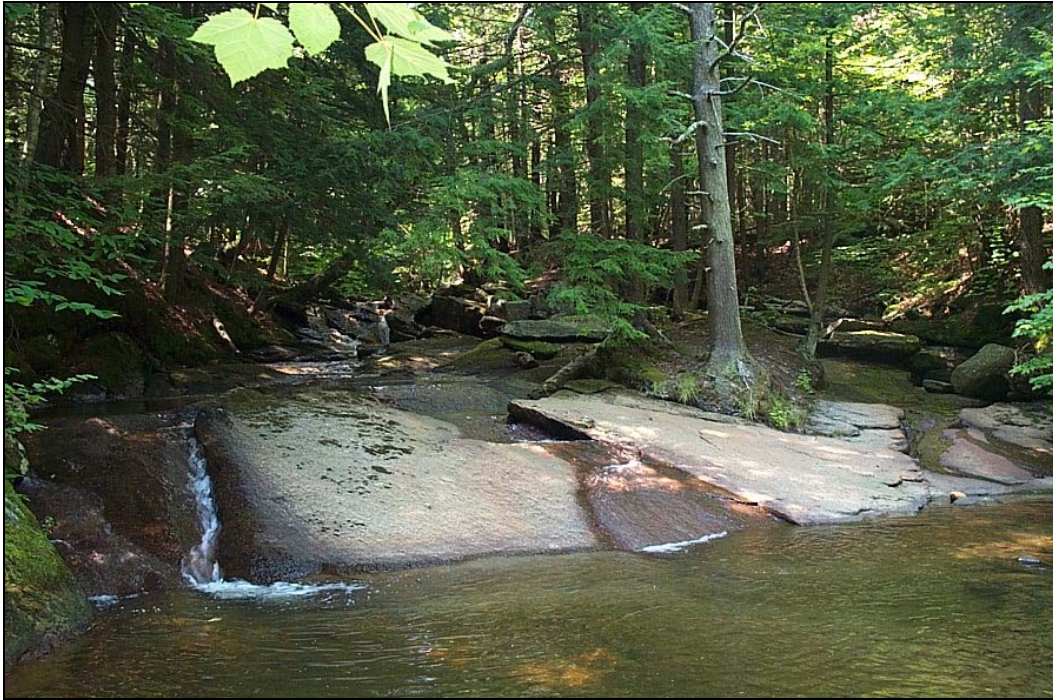
North Branch segment T2.13-C is dominated by a bedrock bottom (Figure 29). The segment is approximately 1000 feet in length and ends just downstream of the North Access Road. This reach was classified as a “B” channel dominated by bedrock substrate. Very minor corridor impacts and a relatively healthy riparian buffer (Averaging between 50 and 75 feet wide) have added to the overall stability of this segment. Excess sediment introduced into the channel via four stormwater outfalls is leading to excess sedimentation of this reach. This sediment and stormwater is filling in pools and also causing some minor widening and planform adjustments.

Figure 29: Segment T2.13-C is dominated by a bedrock bottom which creates a predominately cascade bedform.

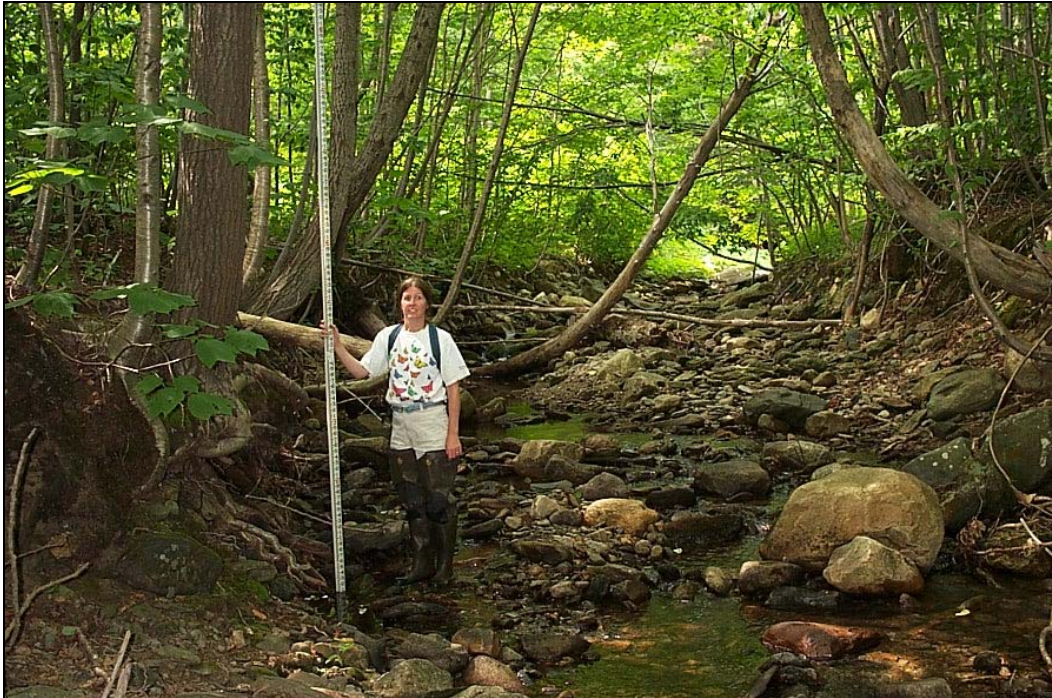
attempts to redevelop a new floodplain. Channel adjustment is causing moderate bank erosion on at least one-quarter to one-third of the segment. Many leaning trees and exposed roots confirm the widening and planform adjustment processes (Figure 30).

Figure 30: Typical cross-section along the highly incised “G” stream type of segment T2.14-A.

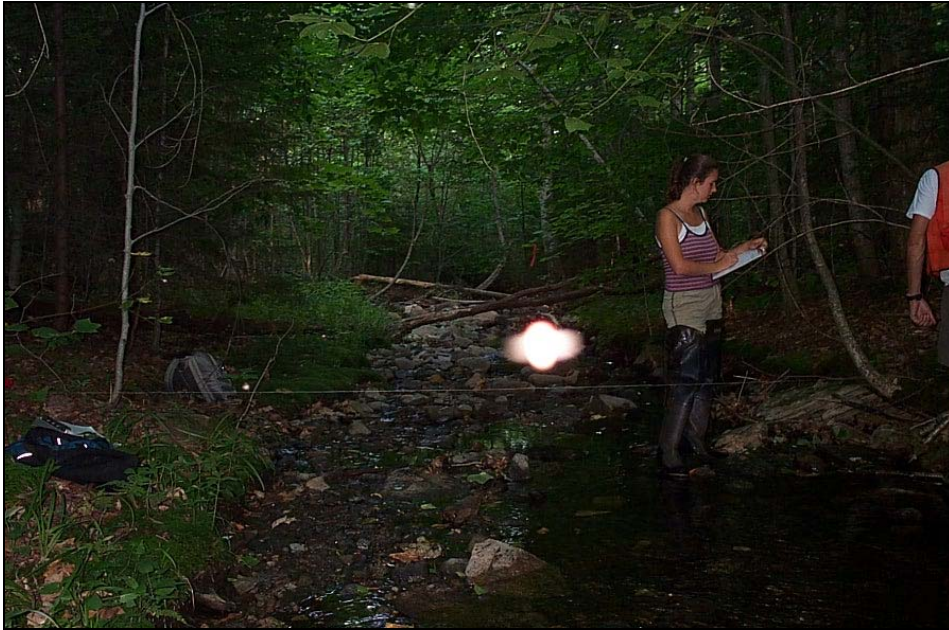
North Branch segment T2.14-B is a “C” channel with a riffle-pool bedform (except where the slope increases and a few step-pools appear). The reach begins near the most upstream residential development on the North Branch and continues upstream to a change in slope where segment T2.14-C begins. Unlike most reaches along the main stem of this watershed, segment T2.14-B has no recorded encroachments in its river corridor. As a result the stream has not undergone any major channel adjustments. The riparian buffer remains well intact and contributes to the overall stability of this reach (Figure 31). BCE scientists found no major or minor adjustment processes occurring within this segment.

Figure 31: Typical cross-section along segment T2.14-B, which is surrounded by a healthy riparian corridor and has retained access to its floodplain.

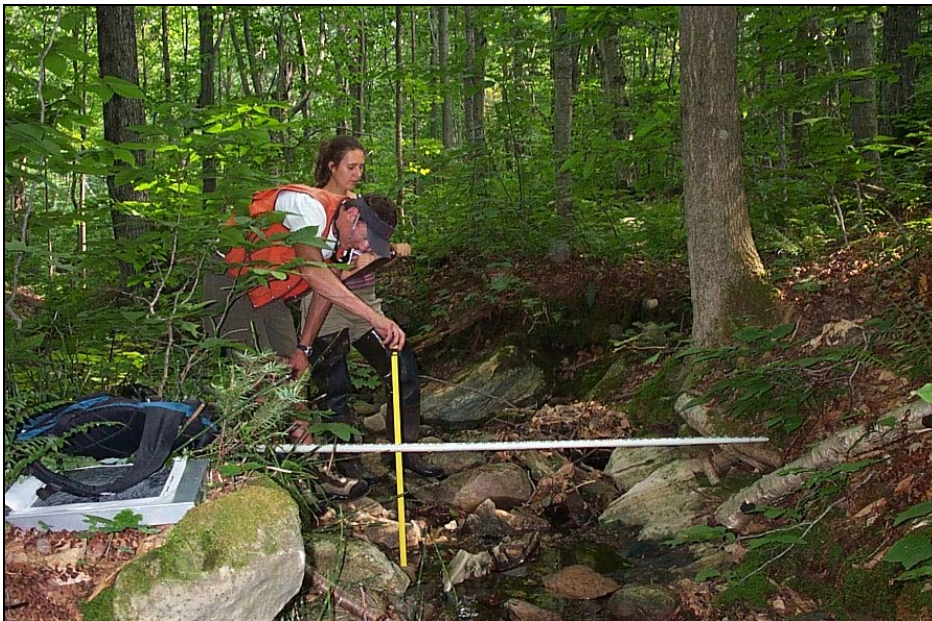
Segment T2.14-C has remained relatively undisturbed. This segment is a “B” stream type on a steep slope of 11.5% (Figure 32). The riparian buffer remains well intact and contributes to the overall stability of this reach. BCE scientists found no major or minor adjustment processes occurring within this reach.

Figure 32: Typical cross-section along segment T2.14-C

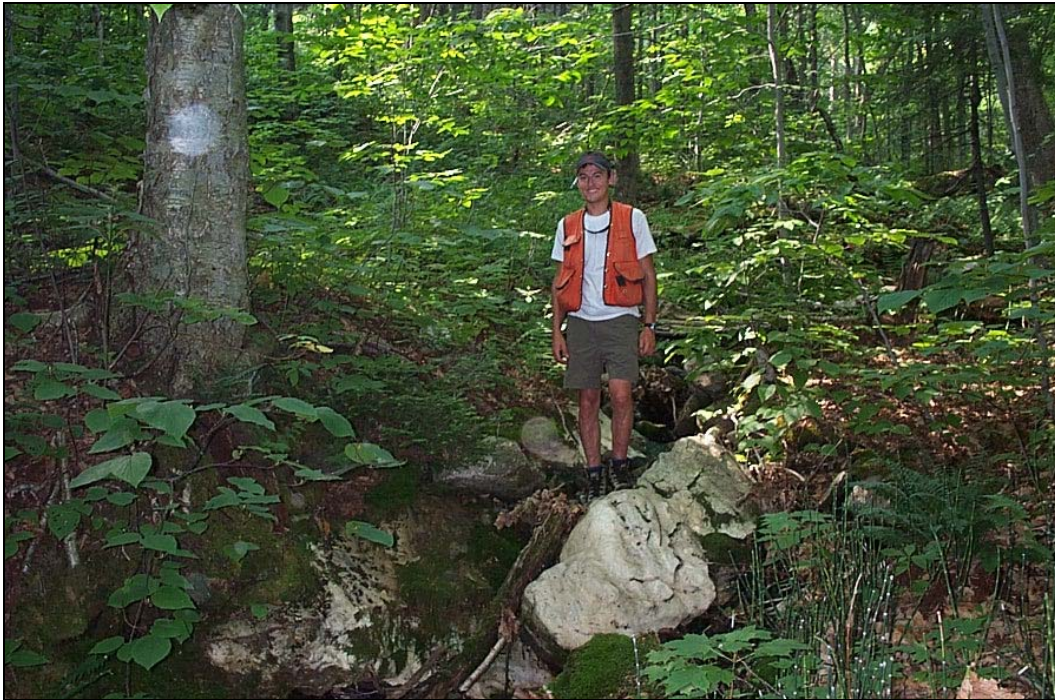
Segment T2.14-D has also remained relatively undisturbed (Figure 33). The channel was not assessed due to the remoteness of the site, difficult access, and the very small drainage area.

Figure 33: Typical cross-section along segment T2.14-D near the headwaters of the North Branch.

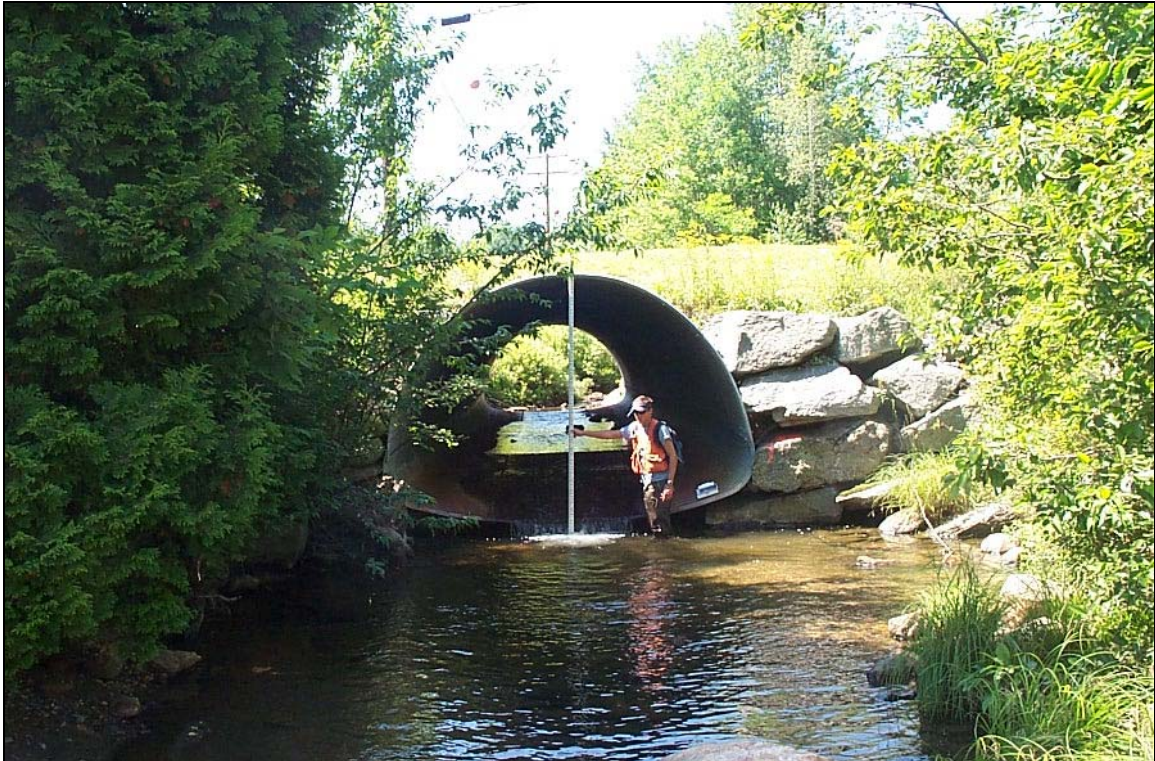
Figure 34: Undersized culverts disrupt the sediment transport capacity of the stream and may lead to both upstream and downstream destabilization. Improperly sized structures, such as this one on T2.13-A, can interfere with sediment transport and create scour below the structure.

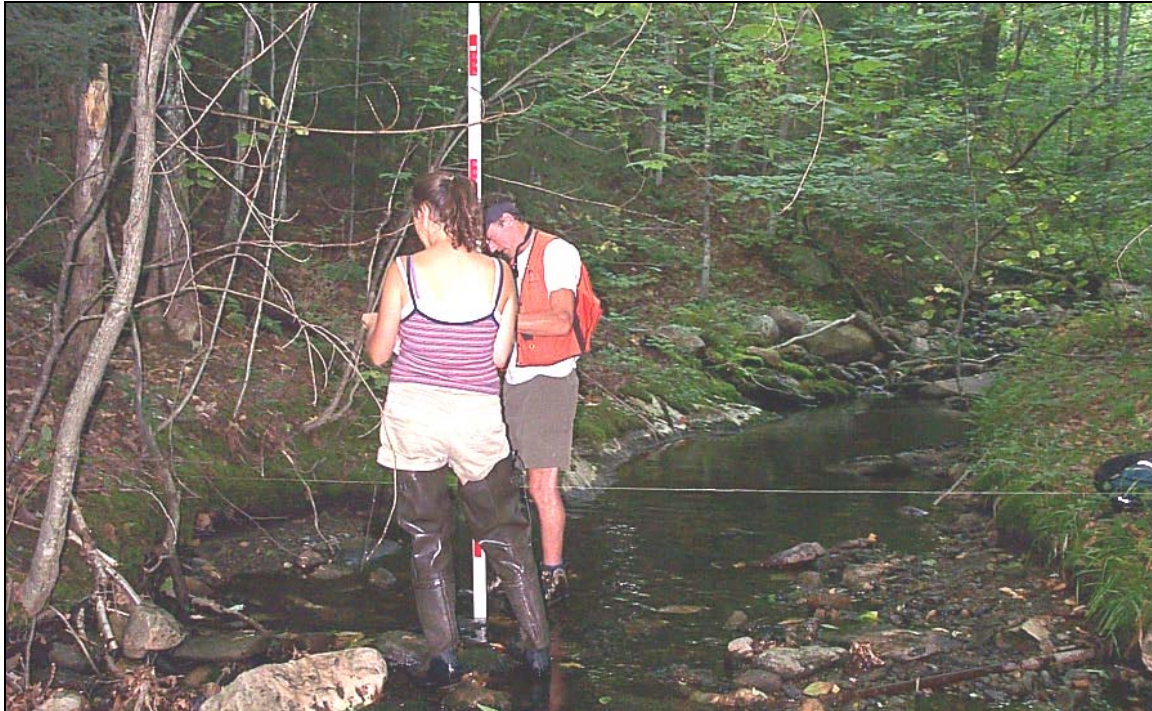
Figure 37: Reach T2.14-B rated “reference” for habitat. The reach had in-stream woody habitat, excellent riparian vegetation and riparian buffer, a diversity of substrates, and a diversity of flows including several deep pools.
