Phase I and 2 Stream Geomorphic Assessments North Branch of Deerfield River Watershed Windham County, Vermont

Final Report
January 30, 2006

Vermont Department of Environmental Conservation
Water Quality Division
103 South Main Street
Building 10 North
Waterbury, VT 05671-0408

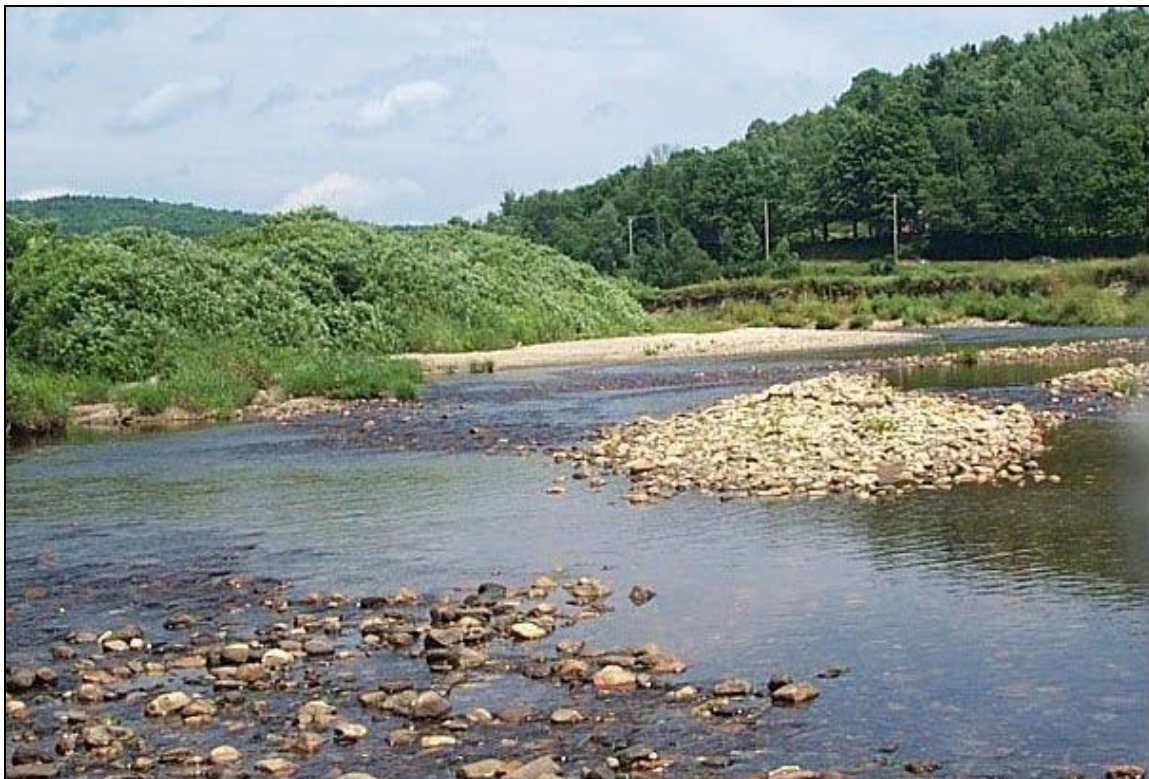
Figure 38: Reach T2.04-A rated “poor” for habitat. The reach lacked in-stream woody habitat, riparian vegetation, a riffle-pool system due to historic straightening, and was heavily embedded with fine particles of sand.
