NORTHWOODS STEWARDSHIP CENTER

Leach Stream Phase 1 Geomorphic Assessment

Essex County Natural Resources Conservation District

September 2013

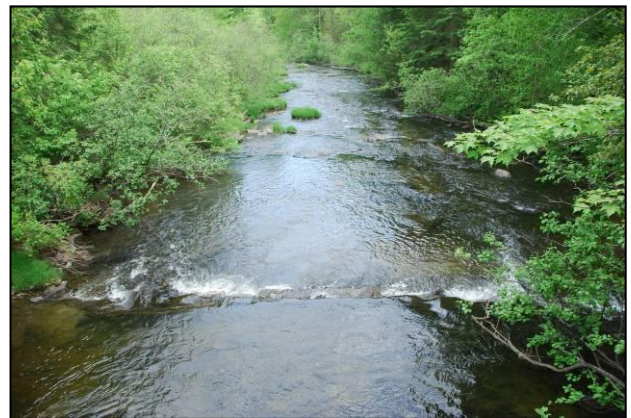
Figure 3. Natural grade control- as viewed from Jackson Lodge Road Bridge.

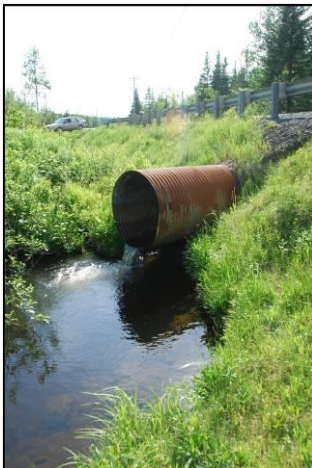
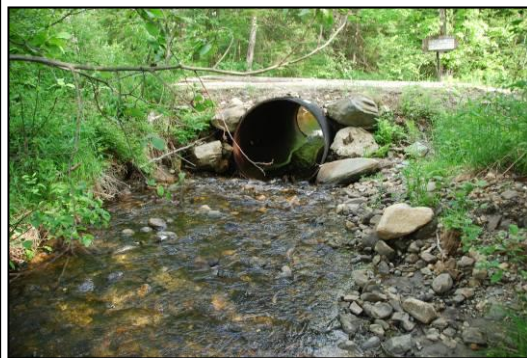
Bridges and culverts are frequently undersized and can act as channel and floodplain constrictions that have many negative impacts on streams and their surrounding areas. Undersized stream crossing structures act like dams during high flows, causing unwanted flooding and sediment deposition upstream. Sediment deposition may alter channel morphology and, in severe cases, can lead to major channel adjustments that result in loss or damage of property. By straightening and concentrating the flow of streams, culverts can also become perched, creating barriers to passage of fish and other aquatic organisms.

Figure 7. Perched and undersized culverts along reach M10S1.02 (left) and M09S1.02 (below).

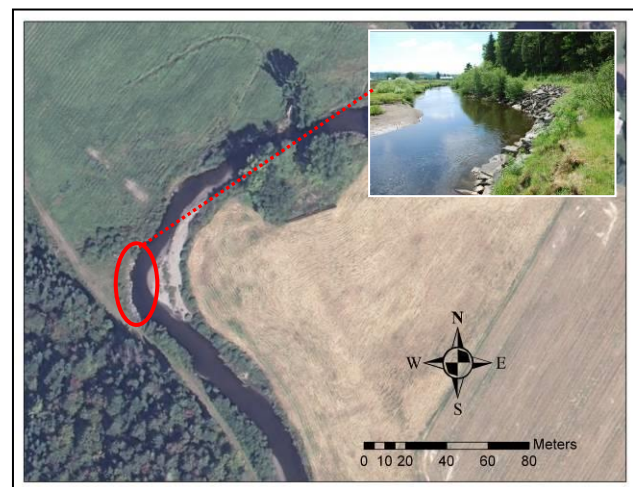
Hard materials such as rip-rap or cement are installed along stream banks in an attempt to prevent property or infrastructure loss from erosion associated with channel adjustments. Frequently, however, bank armoring only delays the channel adjustment process or diverts its effects elsewhere. Armoring can also increase stream velocity, in turn worsening bank erosion downstream. Approximately 0.43 river-miles of bank armoring were found during the Phase 1 assessments, primarily in the form of stone rip-rap in areas where the stream flows adjacent to roadways or agricultural land (Figures 9 and 10).

Figure 9. Bank armoring on reach M02.

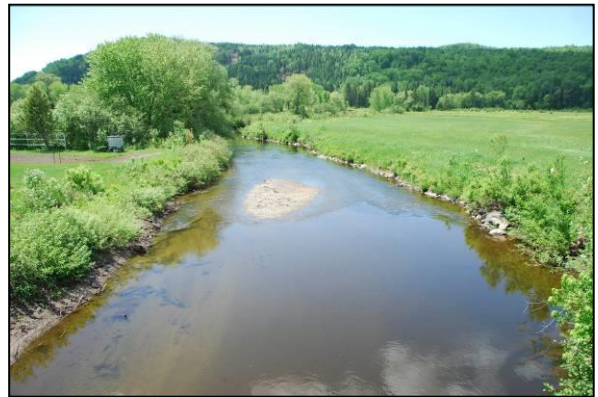
Figure 12. Mid channel bar below Route 114 bridge, leaving Canaan village (reach M02).

We found depositional features on four Phase 1 assessed reaches, with the largest concentrations occurring in reach M02, between Canaan village and the Canadian border (Figures 12 and 13). Numerous depositional features are also evident on aerial photography in reach M04, an unassessed reach in Quebec, which flows in close proximity to a gravel pit.

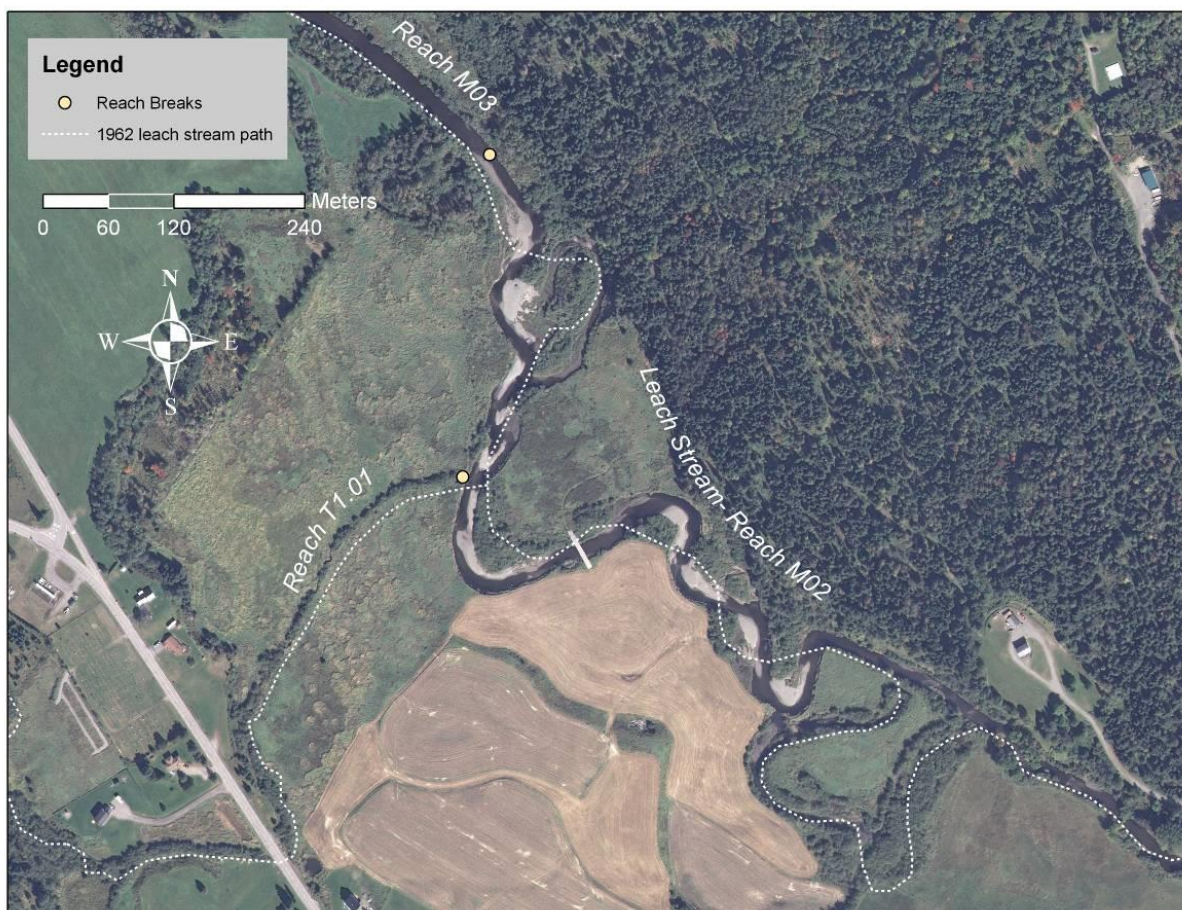
Figure 13. Upstream portion of reach M02, showing depositional features and recent channel migration downstream of straightened reach M03 (base photo 2008).

large unvegetated bars usually indicates that a stream channel is undergoing active adjustment - or that it is receiving excessive sediment inputs from upstream.
