STORMWATER MANAGEMENT PLAN FOR ALBURGH

FINAL REPORT

Stone Project ID 14-053

March 19, 2015

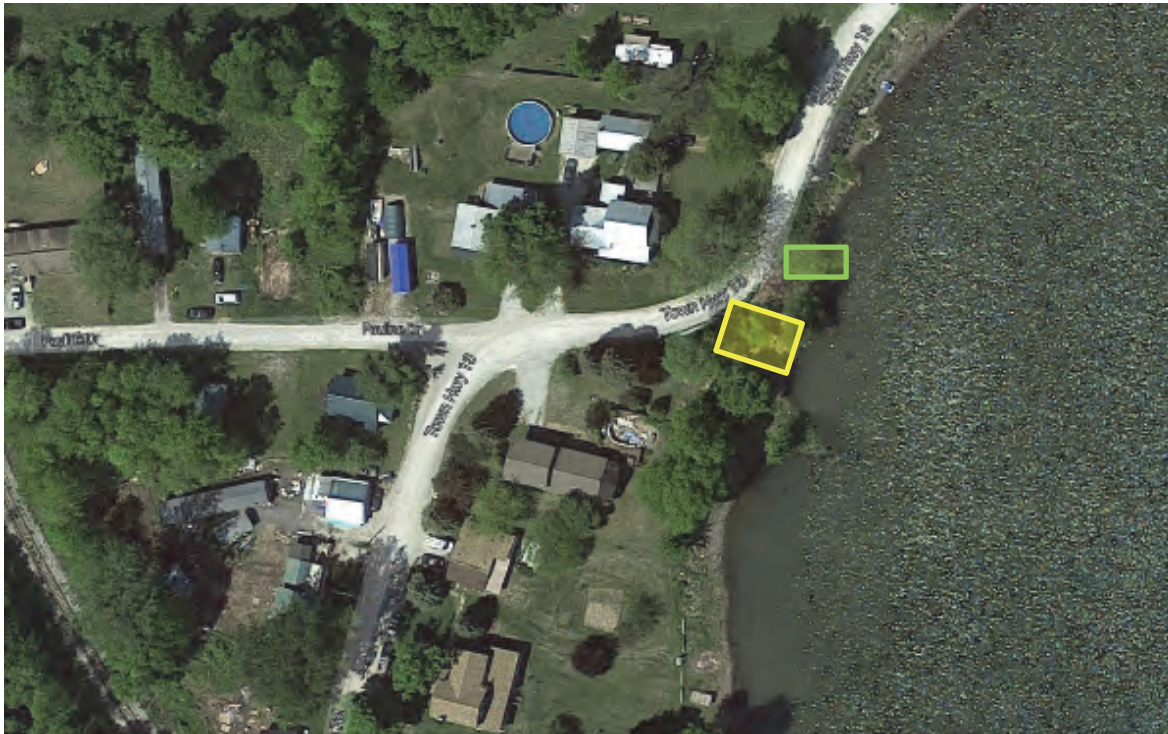
The boat launch at the intersection of Pauline Drive and East Alburgh Road is very steep (in excess of 15%) and, because of the way it is tied into the road, is serving as a direct conduit for stormwater runoff from both roads and other directly connected impervious surfaces (e.g., driveways and roofs) to Lake Champlain. There is considerable evidence that gravel from the road shoulder and road surface, as well as from the boat ramp itself, is being washed down the ramp and into Lake Champlain. The location of the boat launch is shown in Figure 1 in yellow, and a possible location for alternative conveyance in green.

Figure 1. Existing boat launch (highlighted in yellow) and possible location for alternative stormwater conveyance along East Alburgh Road (highlighted in green).

The Town has indicated improvements to East Alburgh Road will be made in 2015, including paving. This project will likely reduce the amount of gravel available to be mobilized. Further, reshaping this corner could prevent runoff from traveling along the edge of the boat ramp. Assuming stormwater will be redirected as part of this paving project, it will be important to ensure that the runoff is carefully directed to the lake and not allowed to create a concentrated, erosive flow in the shoreland area to the north of the boat launch. A step-pool conveyance or stone lined channel are two possible approaches.

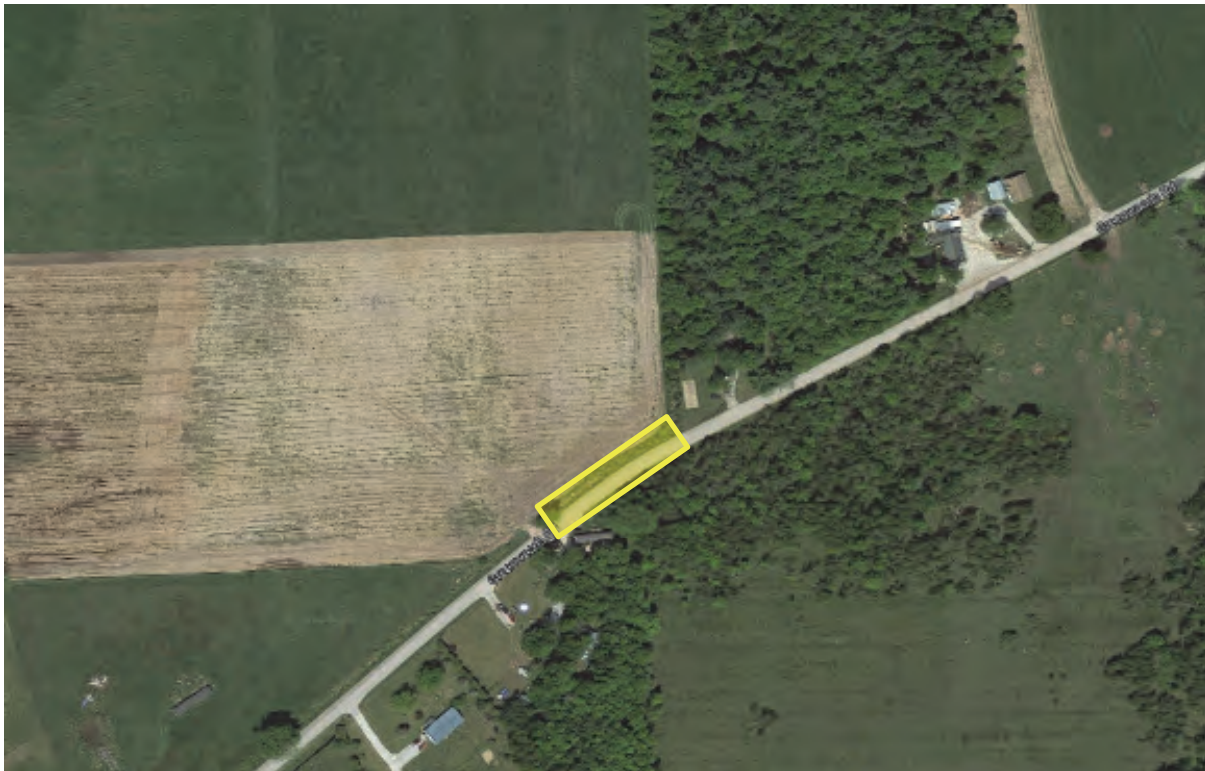
Approximately ¼ of a mile west of the intersection with Henry Road, a large agricultural drainage ditch empties into the roadside ditch (Figure 2). Both drainage features appear to have been recently maintained, but were not stabilized and there is evidence of continuing erosion. A new farm access has also been installed near the eastern end of the yellow area highlighted on Figure 2, which appears to compound some of the drainage issues. A utility pole located directly in the roadside ditch will impact options for providing adequate ditching. At a minimum, a robust vegetative cover needs to be re-established to stabilize these drainage features. It will be important to reach out to the landowner to determine if alternatives exist to routing the agricultural drainage wholly to the roadside ditch.

Figure 2. The location of potential ditch improvements on Greenwood Road is highlighted in yellow.

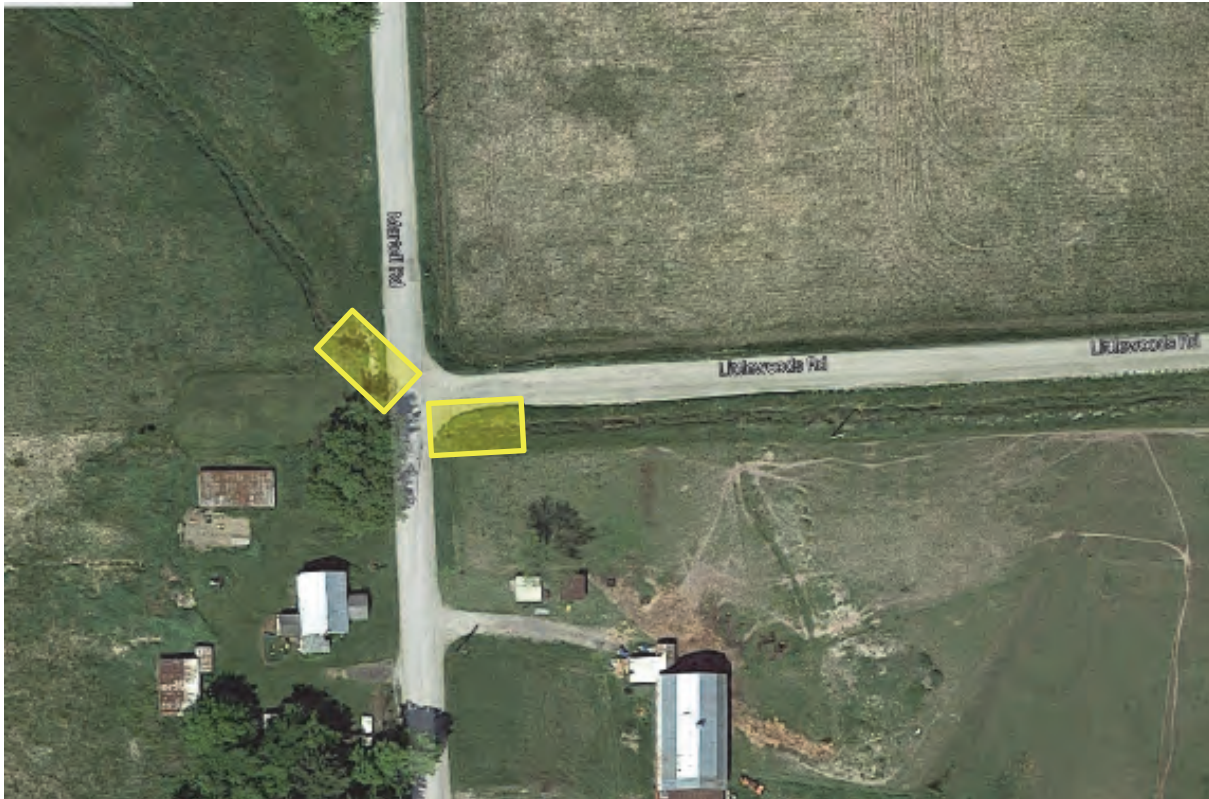
A culvert that conveys roadside and agricultural drainage from along Littlewoods Road under Martell Road and toward Mud Creek Pond appears to be undersized. As a result, a moderate scour pool has formed at the culvert inlet, creating an unstable condition. In addition, the headwall at the culvert outlet is failing and has begun to tip, causing the road shoulder along the west side Martell Road to collapse (Figure 3).

Figure 3. The location of a culvert replacement opportunity at the intersection of Littlewoods Rd and Martell Rd (highlighted in yellow).

Given the deteriorating condition of the culvert, culvert headwall, and surrounding banks, it is a good candidate for replacement. The replacement culvert should be long enough to accommodate 2:1 (H:V) slopes at the inlet. The culvert should be sized such that it matches the stream's bankfull width, and so that 1/6th of the culvert can be buried at bankfull stream width to provide a natural bottom.

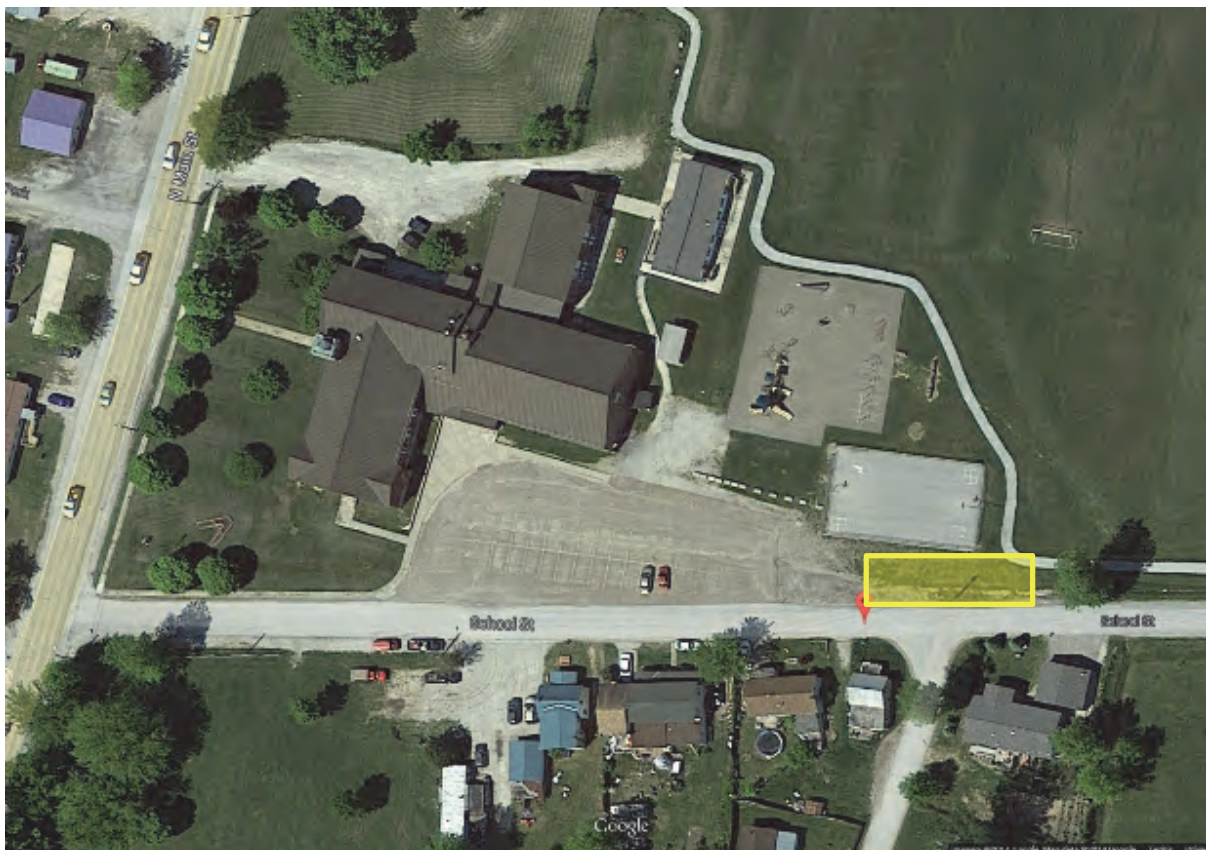
Figure 4. Aerial view of Alburgh School site which has a significant amount of unmanaged impervious cover, including the building roof and parking area. A potentially suitable area for a stormwater management practice is highlighted in yellow.

The green space between the basketball court and the road is a good candidate location for a stormwater management practice that would slow stormwater runoff from the school and allow gravel from the parking lot to settle out. Much of Alburgh is characterized by high groundwater conditions, and therefore additional site investigation would be required before a specific practice could be recommended for this site.

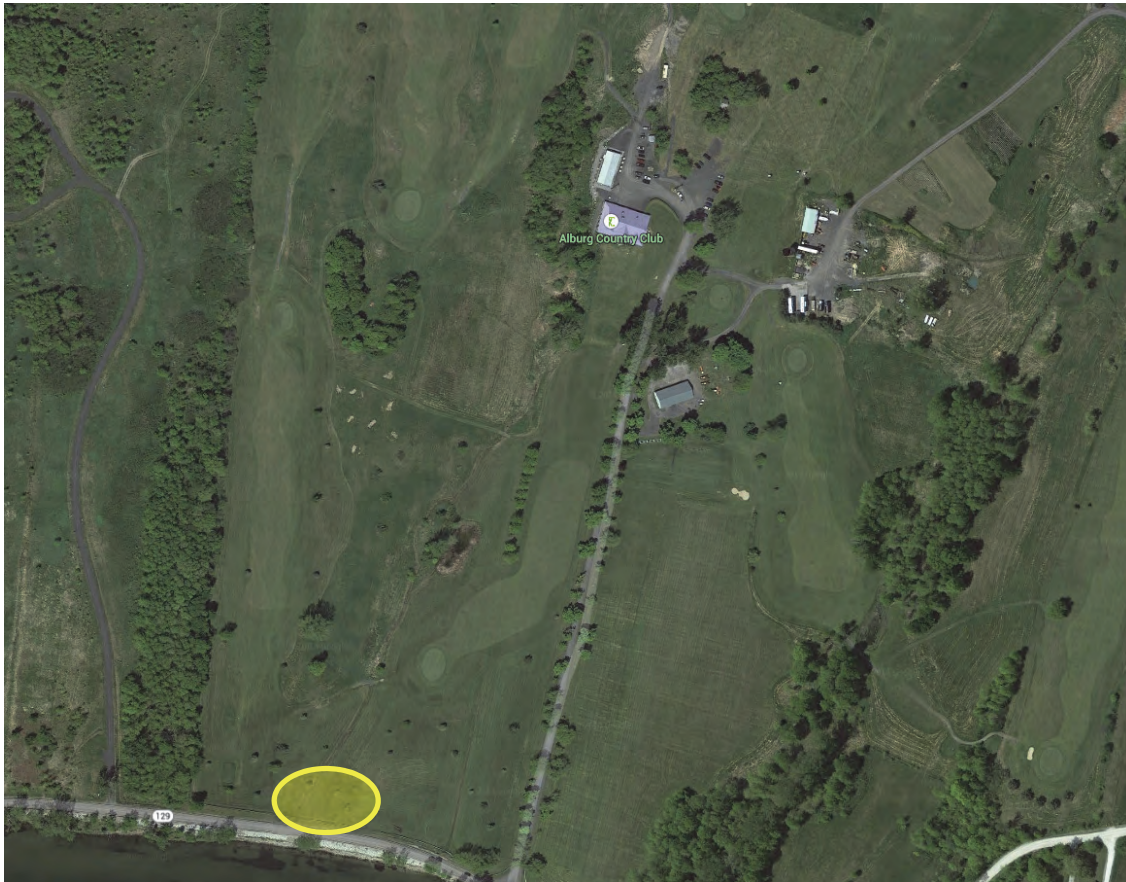
The Alburgh Country Club occupies a significant parcel of land along the western shore of Alburgh, across from the bridge to Isle La Motte. The Club property includes a drainage feature that runs from north to south approximately parallel to but 250 feet west of the access road, eventually crossing under Route 129 and discharging, untreated, to Lake Champlain. During the field work done in support of this report, sediment was observed moving in the drainage feature and erosion along the channel banks was also evident.

Figure 5. Direct drainage from the Alburgh Country Club to Lake Champlain (highlighted in yellow).

There are a number of certification programs that encourage golf courses to protect and enhance natural areas within the facility, including one run by Audubon International (<http://www.auduboninternational.org/acsp-golf-certified>). Although outside the purview of the Town, a watershed group or other interested party might wish to work with the Country Club to help them pursue such a certification.

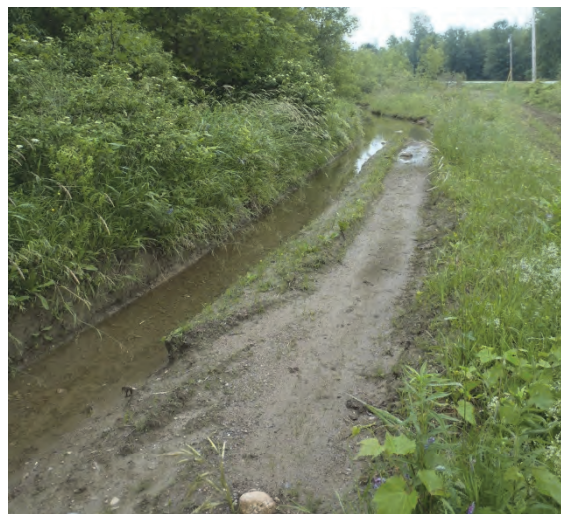
Photo 1. Flooded private access road; note 1' high bank on left side which seems to show some signs of erosion

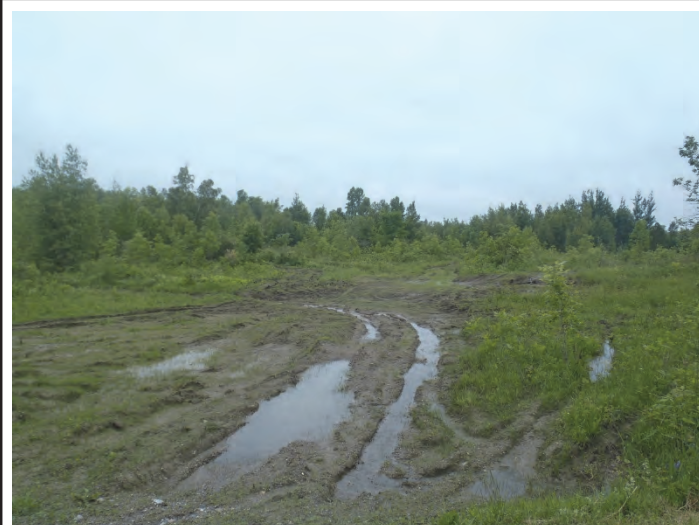
Photo 2. Area of probable ATV use

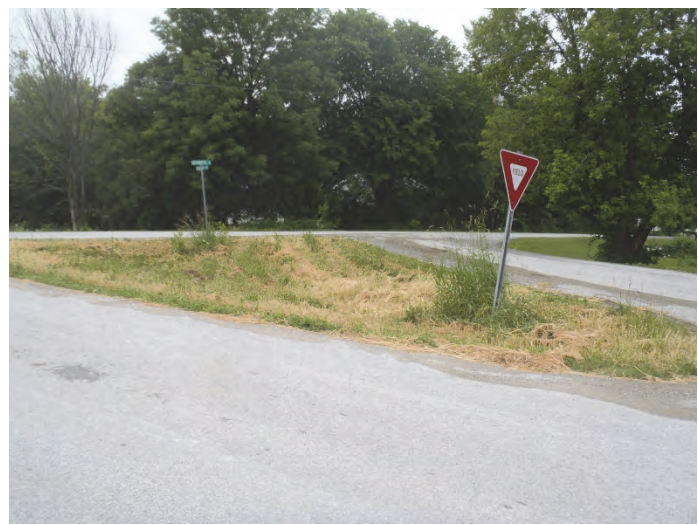
Description of Observed Conditions:
 The green space in the Y-intersection of Littlewoods Rd and Boutah Rd offers an opportunity for a stormwater retrofit that would better manage stormwater runoff from the adjoining road surfaces.

Photo 1. Green space at the intersection of Littlewoods and Boutah Rds.

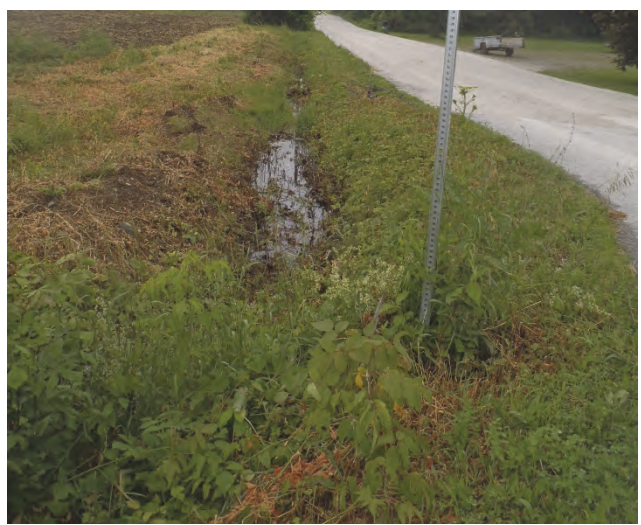
Photo 2. Existing drainage along Littlewoods Rd

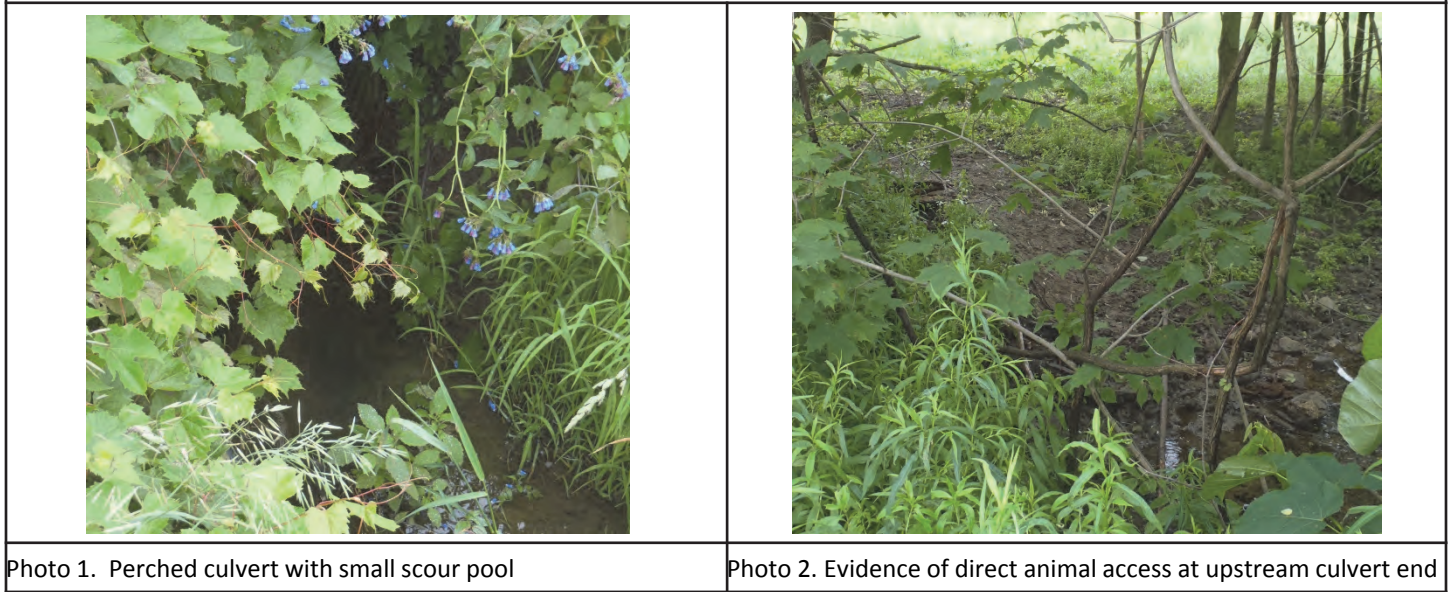
Description of Observed Conditions:
 Downstream end of culvert is perched <1' above channel; evidence of direct animal access at upstream end of culvert

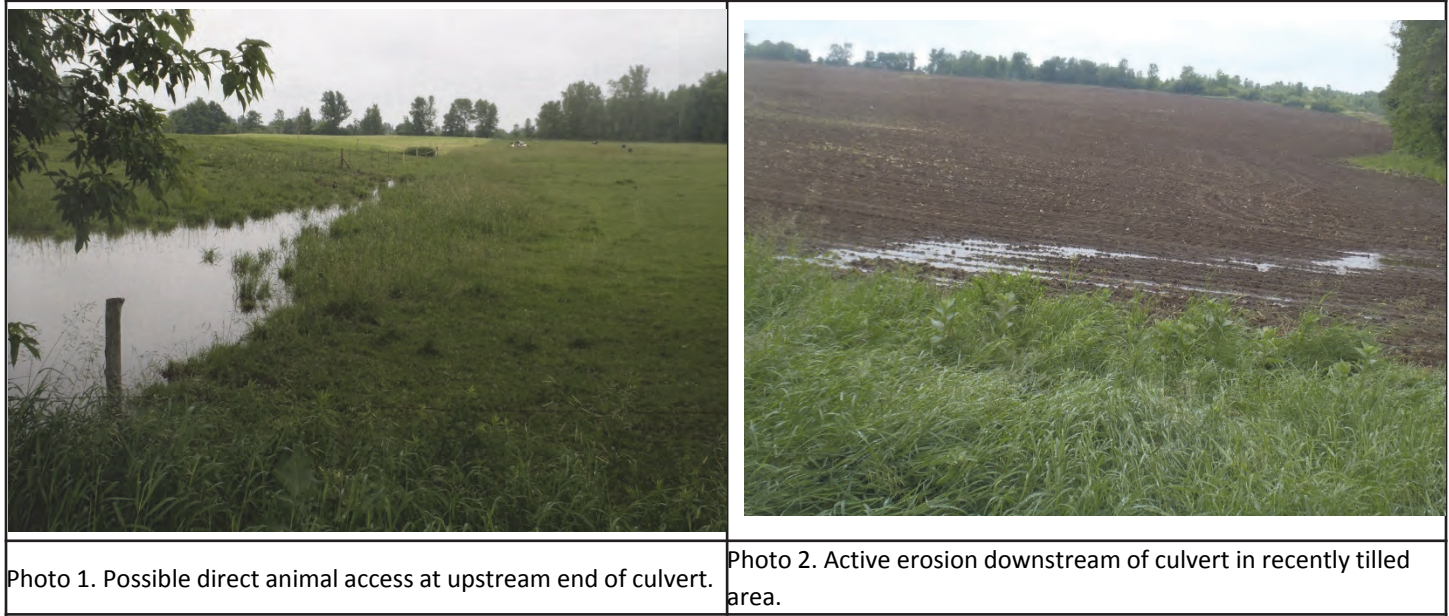
Description of Observed Conditions:
 Downstream end of cross culvert is discharging directly into recently tilled annual cropland and actively eroding; unclear if animals have direct access to upstream area. This concern has been forwarded to the Agency of Agriculture.

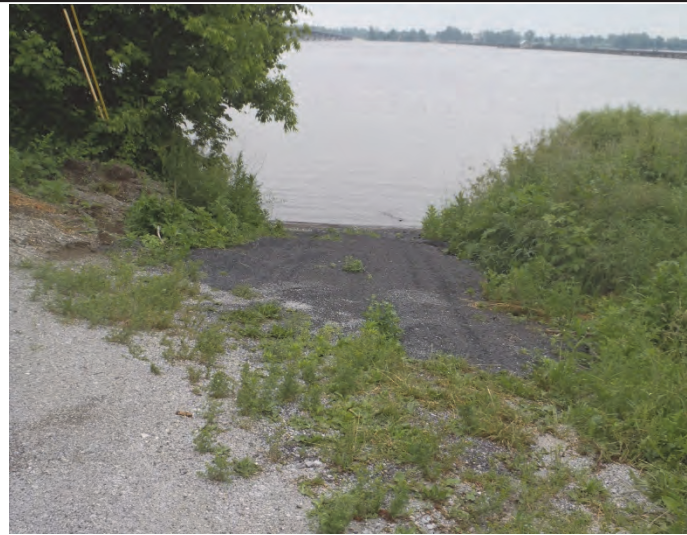
Photo 1. Some visible evidence of gravel from road washing down boat launch into lake.

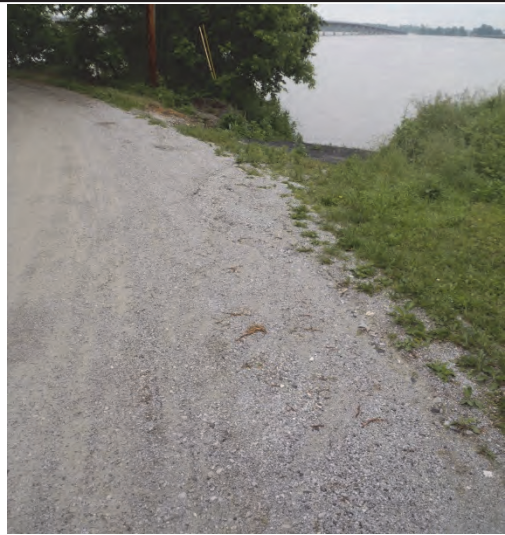
Photo 2. Perspective on steep boat launch.

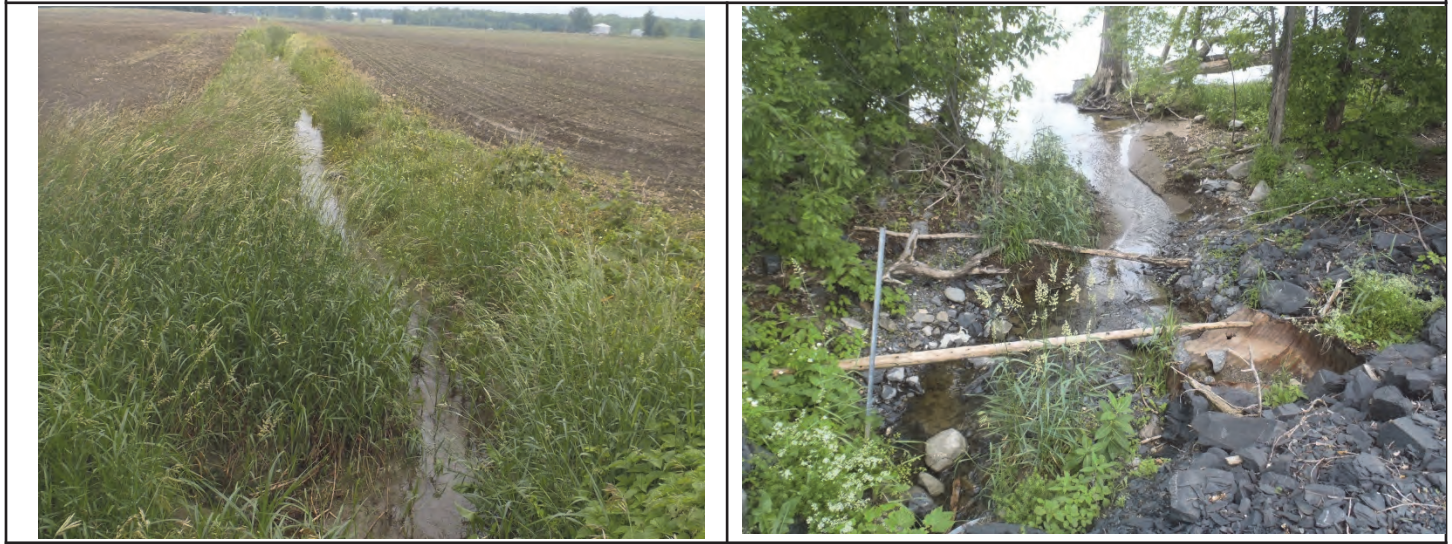
Photo 1. Narrow buffers along ditch	Photo 2. Downstream end of culvert discharging directly into Lake Champlain.
-------------------------------------	--

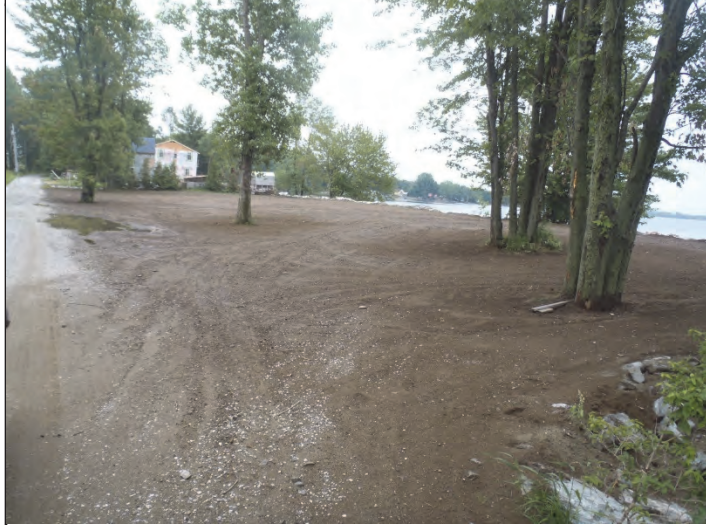
Photo 1. Significant unstabilized area.

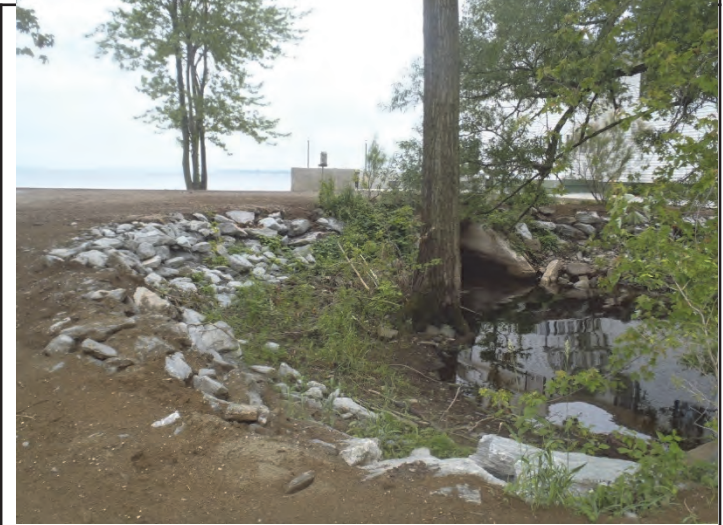
Photo 2. Evidence of sediment leaving site and being washed into Lake Champlain.

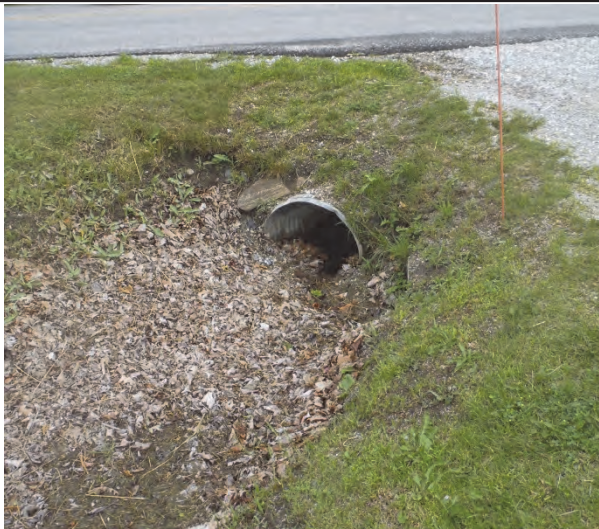
Photo 1. Upstream of culvert.

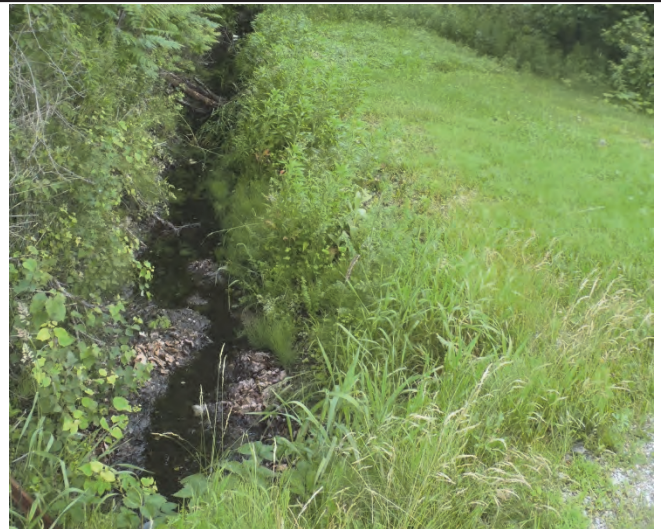
Photo 2. Downstream culvert end

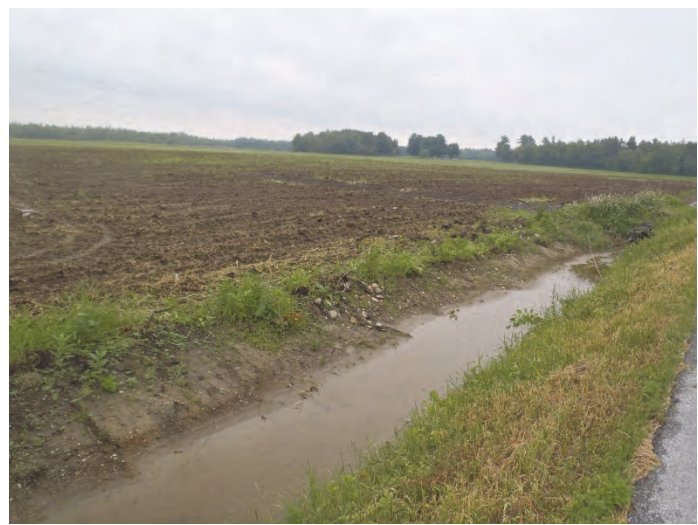
Photo 1. Raw ditch along Greenwood Rd; agricultural land plowed to edge of ditch.

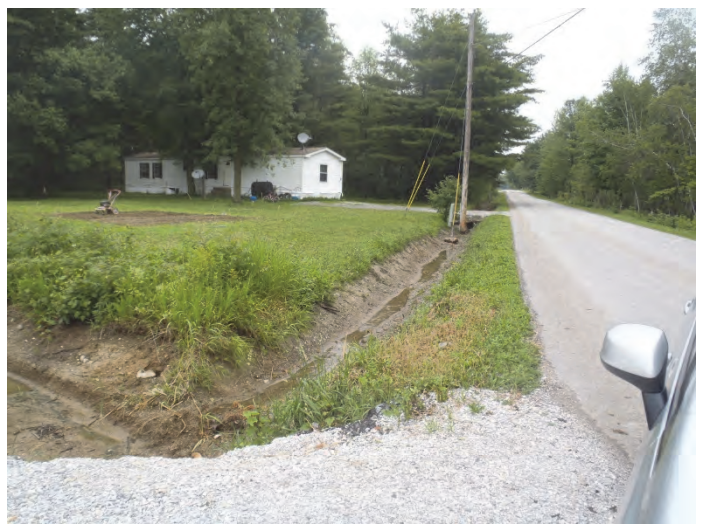
Photo 2. More raw ditch, agricultural drainage ties directly into roadside ditch at lower left corner of photo

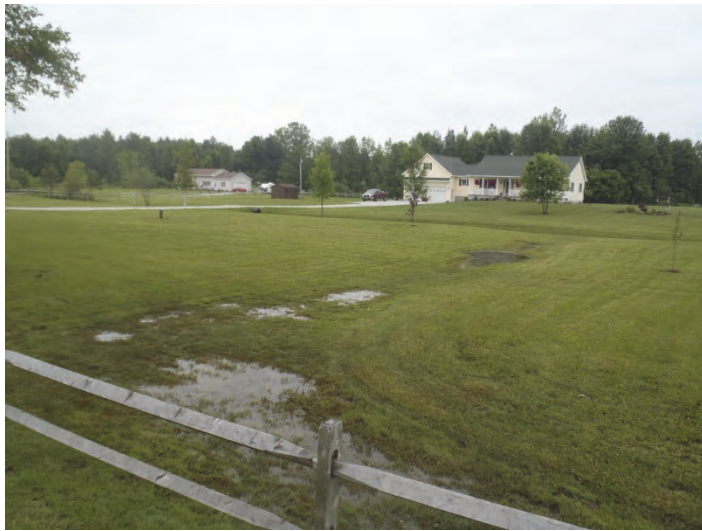
Photo 1. Evidence of pool drainage; note second drainage feature in mid-ground of photo.

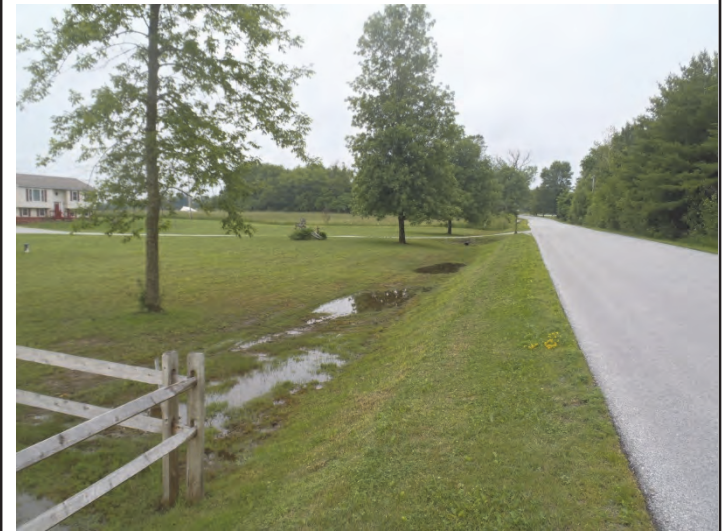
Photo 2. Poor drainage along the eastside of Greenwood Rd

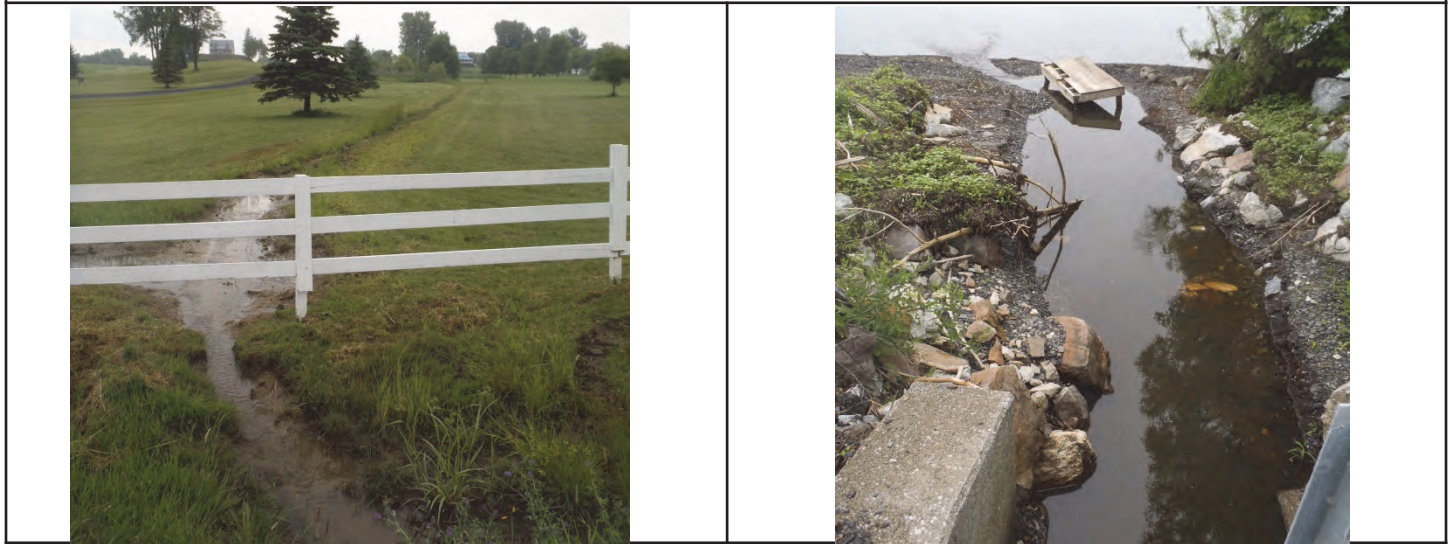
Photo 1. Active erosion above culvert.

Photo 2. Downstream of culvert.

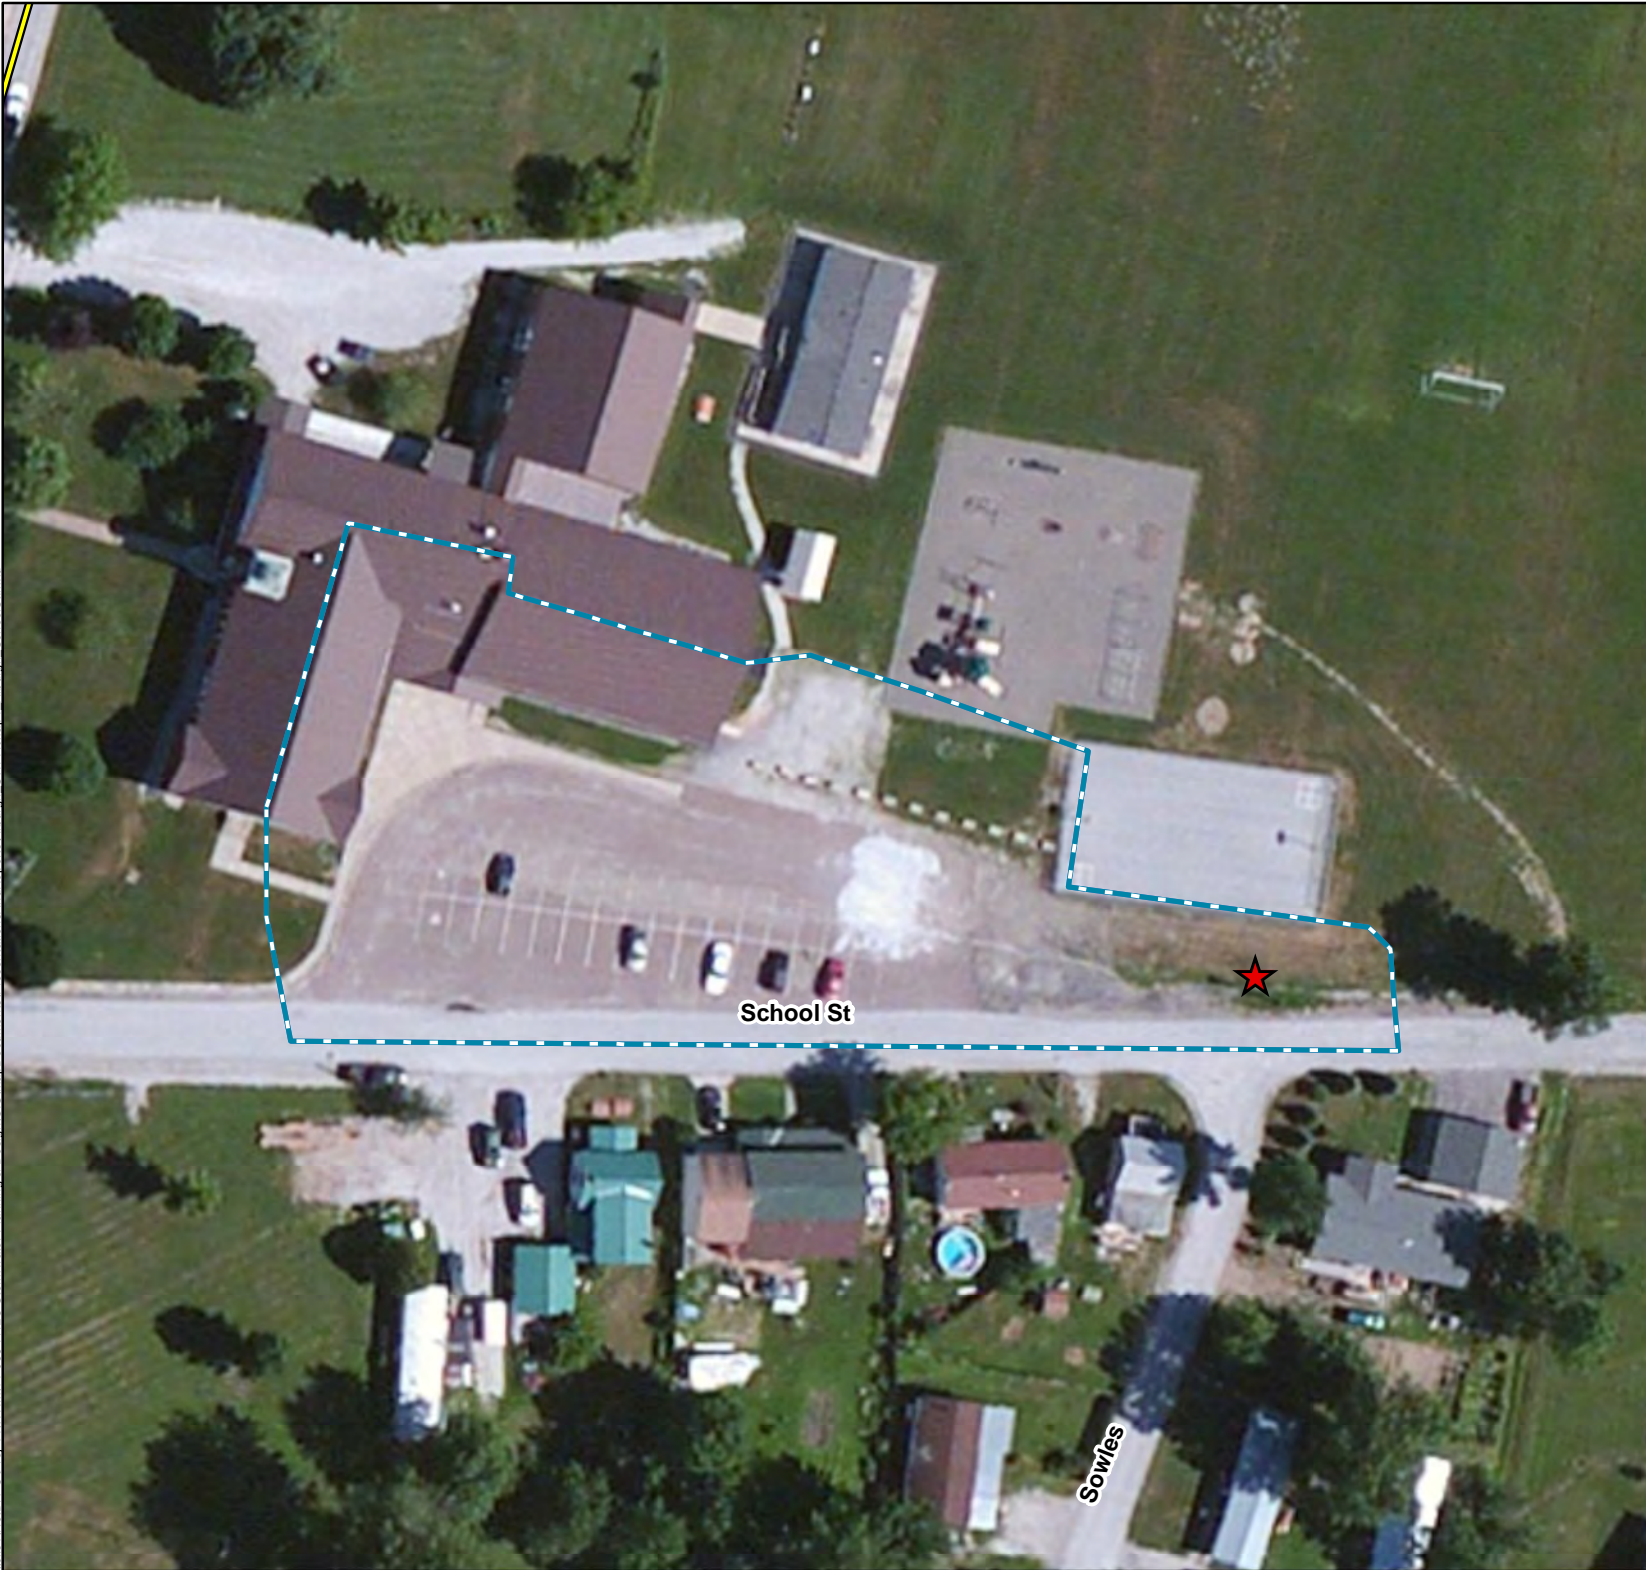
Treatment Opportunity:
 Currently stormwater runoff from nearly an acre of impervious surfaces at the Alburgh School is largely unmanaged and runs off along the shoulder on the northside of School Street. The green space between the basketball court and the road is a good candidate location for a potential stormwater retrofit.
