## **APPENDIX C**

**Problem Area Summary Sheets (8½"x11")**

**Project: SW-1** **Problem Area Summary**

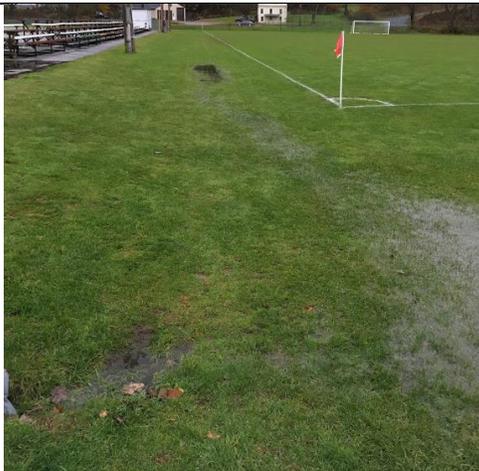
**Site Description:** Runoff from the parking lot, lawn and soccer fields causes water to pool in a shallow swale beside the field (Photo 1). Culverts to convey flow are likely undersized. Runoff does not currently receive treatment in a stormwater feature that slows/ponds the water and flows into the Batten Kill.

**Photo 1:** Pooled water beside soccer field.

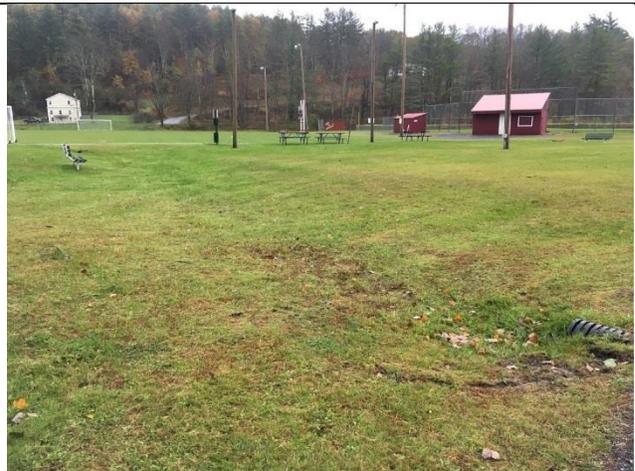
**Photo 2:** Green space on opposite side of path.

**BMP Description:** Retrofit green space near the former volleyball court to improve drainage near fields and infiltrate runoff (Photo 2). Design considerations include the locations of utilities and the future use of the area around the volleyball court, as well as the mapped FEMA floodplain. This site appears to be situated in a mapped floodway, which could make the project infeasible.

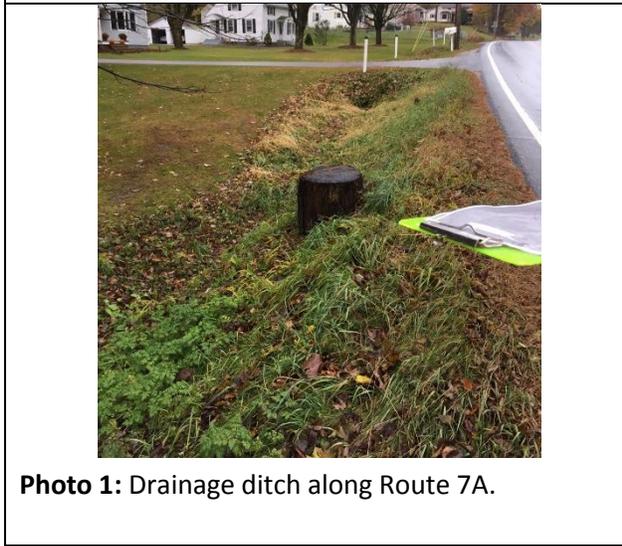
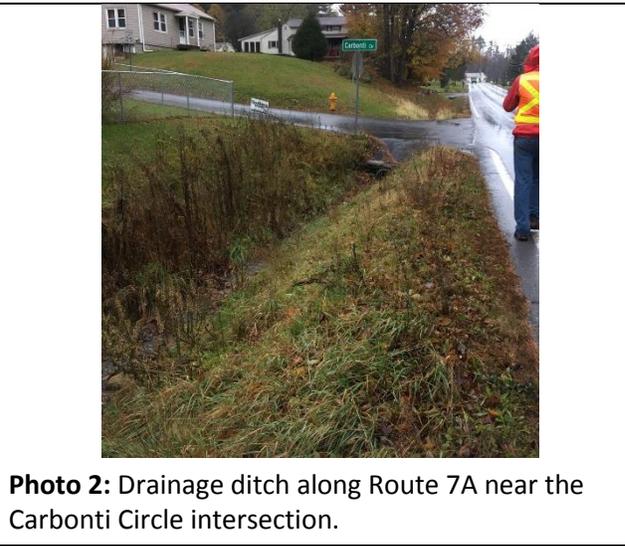
**Site Description:** Drainage ditches with runoff from Route 7A and adjacent residential areas drain north to a first-order stream (Photos 1 & 2). Significant gravel deposits settle out in the ditch just north of Carbonti Circle.

**BMP Description:** Install check dams in the swale to provide pre-treatment for sediment. Treat runoff with an infiltration basin before it enters the stream.

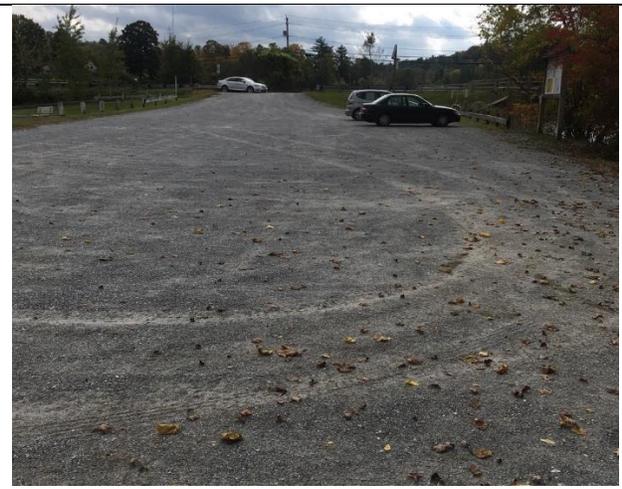
**Site Description:** Runoff from the gravel parking lot and a portion of Route 313 drains directly into the Batten Kill. Some erosion is present along the stream bank.

**Photo 1:** A gravel parking lot that is adjacent to the Batten Kill.

**BMP Description:** Corral water with a berm along the north and west end of the parking lot. Install a small infiltration basin on the north end of the parking lot in loamy soils that appear suitable for infiltration.

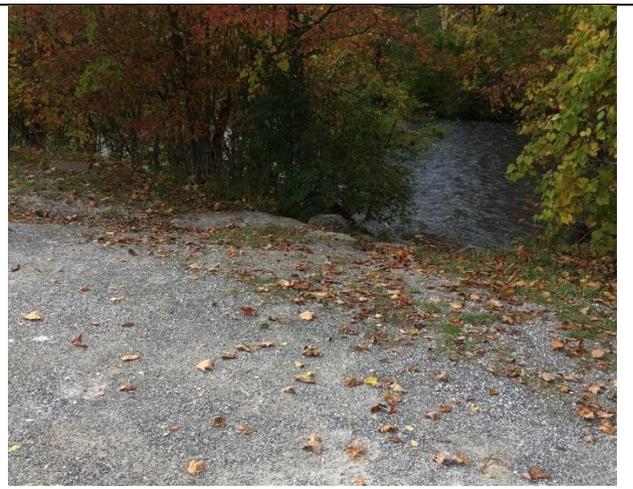
**Photo 2:** A portion of the parking lot where runoff flows directly into the Batten Kill.

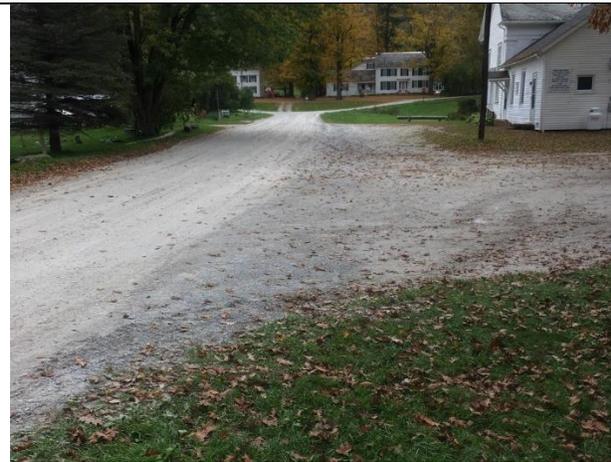
**Photo 2:** Green space near the parking lot may provide space for an infiltration basin.

**BMP Description:** Corral water with a berm along the north end of the parking lot. Install a small infiltration basin to the west near the picnic area (Photo 2).

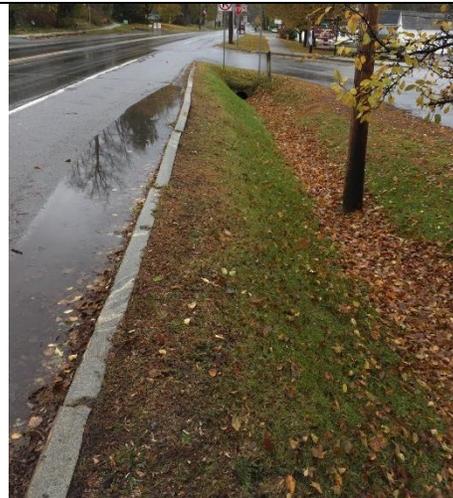
**Photo 2:** Green space near the parking lot may provide space for an infiltration basin.

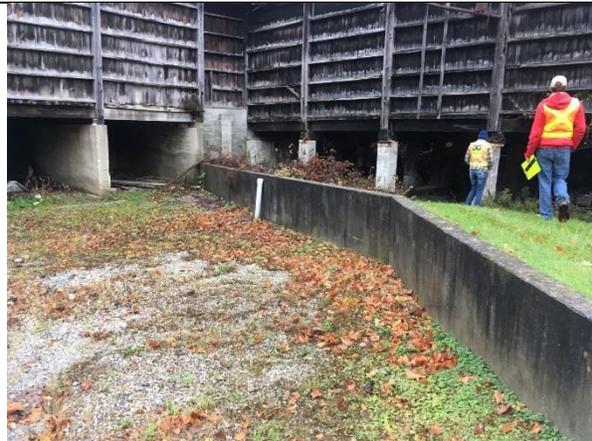
**Photo 2:** Runoff from large events infiltrates at the loading dock. Green space to the north may provide space for a BMP installation.

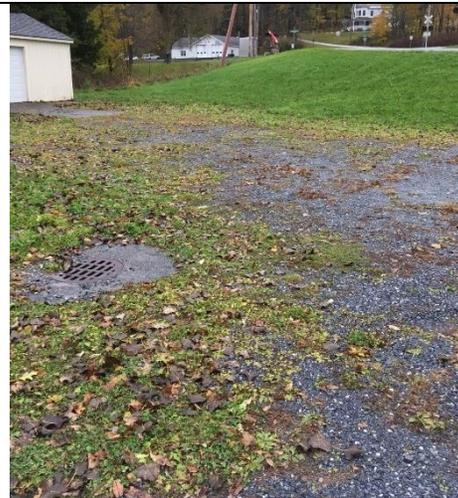
**Photo 2:** Green space in the northwest corner of the parking lot near a second catch basin may provide space for a BMP installation.

**BMP Description:** Cap the catch basin in the center of the parking lot and install a linear infiltration basin at northwest of the parking lot to treat runoff (Photo 2).

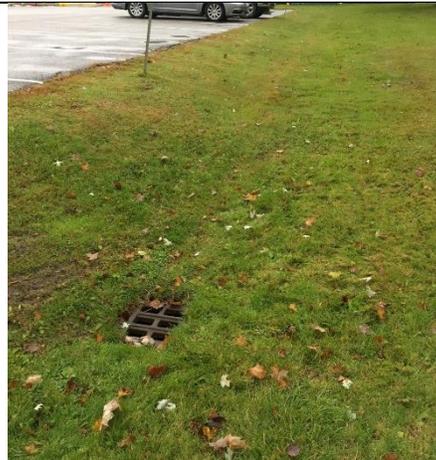
**Photo 2:** The green space and catch basin may be retrofitted to infiltrate more water.

**BMP Description:** Raise the grated inlet and grade the area to slow and infiltrate runoff (Photo 2). Size and configuration of basin will depend on the infiltration capacity of the soils, and other potential underground utility conflicts.

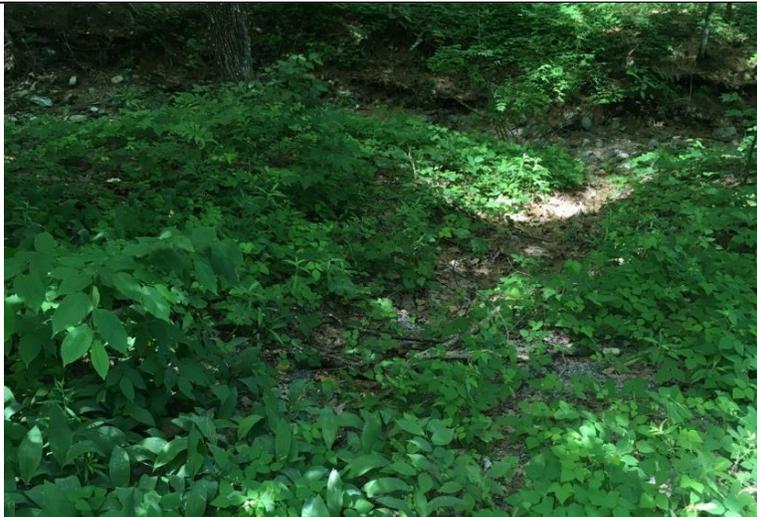
**Photo 1:** An eroded channel conveys runoff from Ball Mountain Road directly into Dry Brook.

**BMP Description:** Line the conveyance with at least 6-8" minus stone (12" minus stone recommended) to dissipate energy and prevent erosion. Consider adding a sediment trap to catch materials before they enter the stream. Follow VTANR/VTrans road stormwater management guidance to ensure consistency with MRGP design standards.

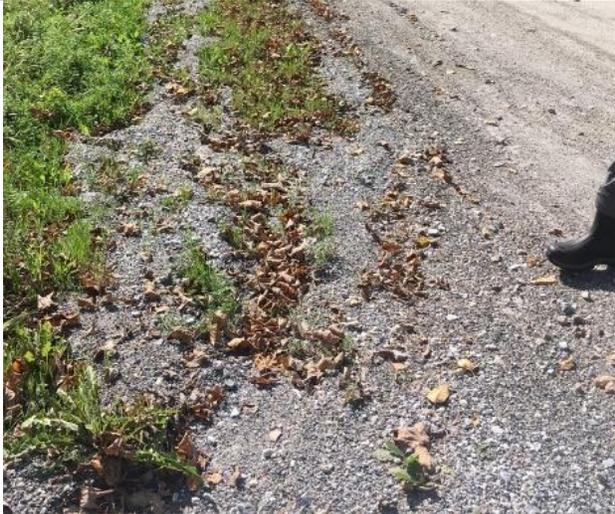
<p><b>Photo 1:</b> Rill erosion along Wilcox Road shoulder.      <b>Photo 2:</b> Rill erosion of the roadway.</p>				
<p><b>BMP Description:</b> Install 100' of ditches lined with minimum 6-8" minus stone along Mountain View Drive. Improve 300' of grass lined ditches along Wilcox Road. Remove grader berms and crown road to allow water to access ditches. Follow VTANR/VTrans road stormwater management guidance to ensure consistency with MRGP design standards.</p>

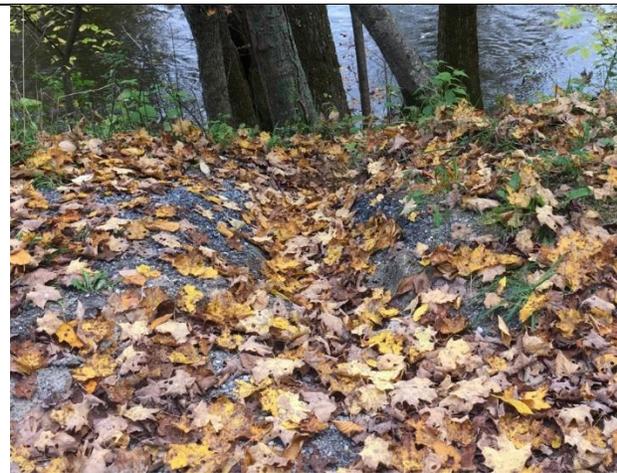
**Site Description:** 270' of road drains to an eroded conveyance draining directly to the Batten Kill. The conveyance is 1'-2' deep, 2'-4' wide, and 22' long with a slope of approximately 50% (Photos 1 & 2). This road segment ranked 35<sup>th</sup> (top 11%) in the water quality prioritization based on REI data.

**Photo 1:** Eroding conveyance to the Batten Kill.

**BMP Description:** Stabilize the conveyance and provide river access with infiltration steps. Follow VTANR/VTrans road stormwater management guidance to ensure consistency with MRGP design standards.

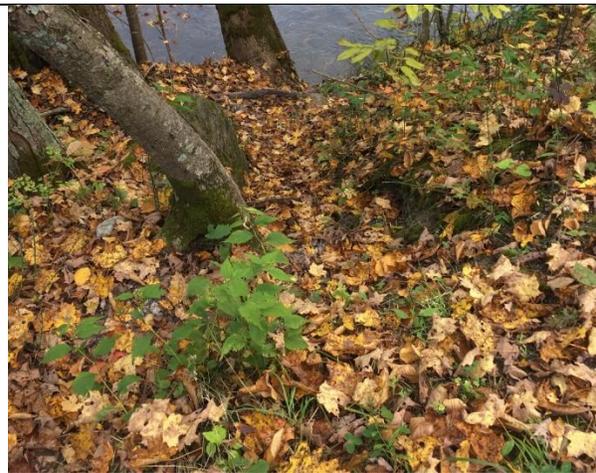
**Photo 2:** Eroding conveyance to the Batten Kill.

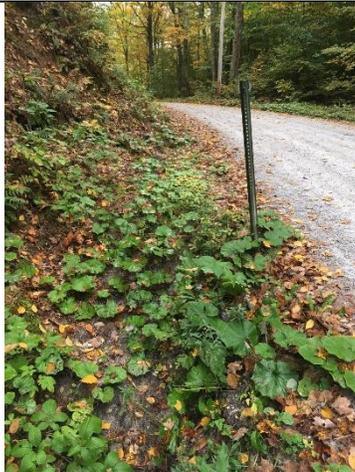
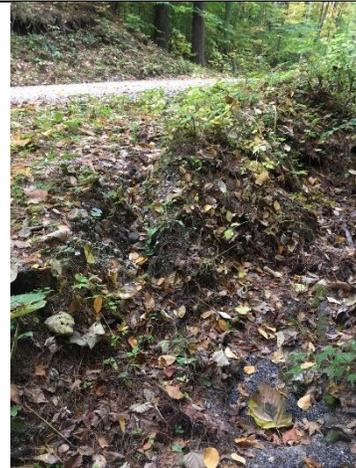
**Photo 1:** Steep sections of road lack stable ditches. **Photo 2:** Erosion of the road embankment.

**BMP Description:** Install a drainage ditch and stabilize all ditches with minimum 6-8" minus stone (12" minus stone recommended). Consider adding stone to the turnouts through the berm to prevent erosion and adding sediment traps where possible to catch road materials. Follow VTANR/VTrans road stormwater management guidance to ensure consistency with MRGP design standards.

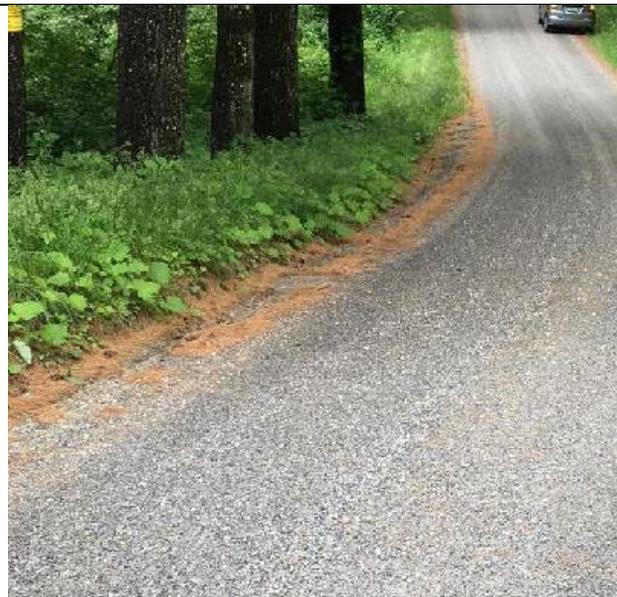
**Site Description:** Ditches are absent along both sides of a steep section of road, causing water to flow down the roadway and erode the road surface (Photos 1 & 2). This road segment ranked 36<sup>th</sup> (top 11%) in the water quality prioritization based on REI data.

**Photo 1:** Steep sections of road lack stable ditches. **Photo 2:** Road is slightly sunken and eroded where ditches are absent.

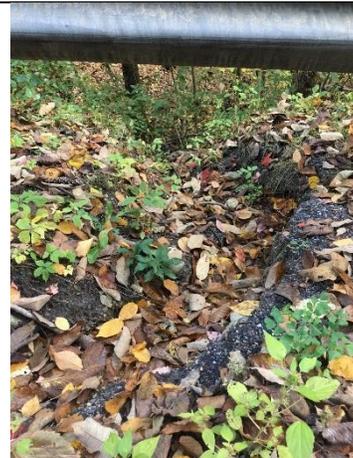
**Photo 2:** Eroded conveyance along the road embankment.

**BMP Description:** Stabilize the conveyance with minimum 6-8" minus stone (recommended 12" minus stone). Line ditches on the north side of the road with stone. Consider replacing driveway culvert with a larger diameter pipe. Follow VTANR/VTrans road stormwater management guidance to ensure consistency with MRGP design standards.

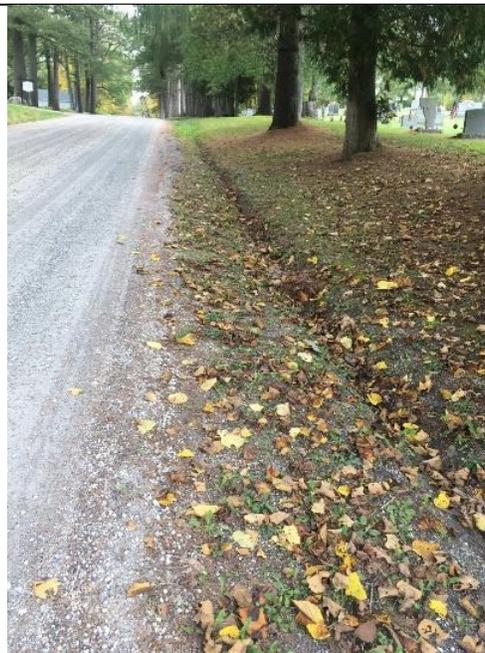
**Site Description:** Two 80' sections of ditch on the south side of the road are severely eroded (Photo 1). The eroding section of road has a slope of 8.5%. This road segment ranked 69<sup>th</sup> (top 22%) in the water quality prioritization based on REI data.

**Photo 1:** Eroded roadside ditch.

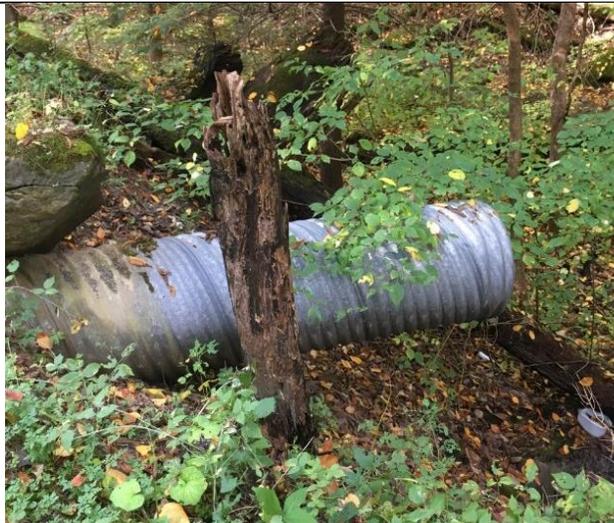
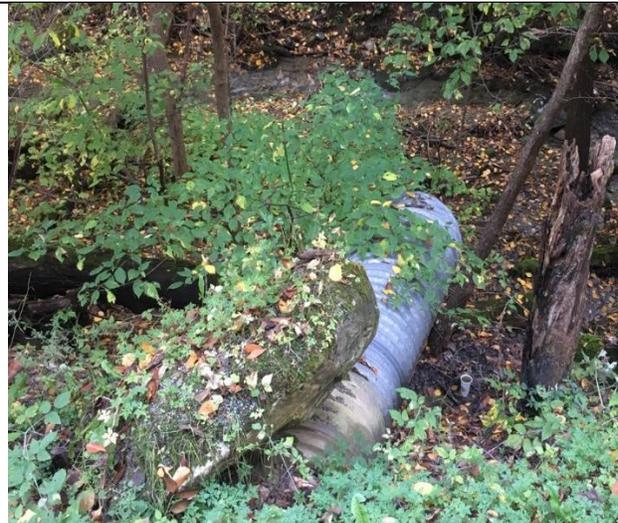
**Site Description:** Severe erosion is present at the cross culvert header and outlet, which is located 10' from Dry Brook (Photos 1 & 2). This road segment ranked 1<sup>st</sup> in the water quality prioritization based on REI data.

**Photo 1:** Erosion of the culvert header and outlet. **Photo 2:** Erosion is adjacent to Dry Brook.

**BMP Description:** Stabilize the downstream culvert header with stone and install a heavily armored splash pad at the outlet. Install a stone-lined conveyance to Dry Brook. Consider increasing the culvert slope when it is due for replacement to reduce outlet drop.

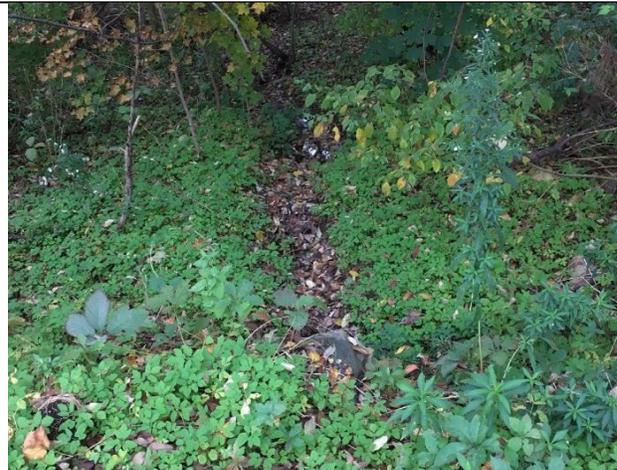
**Photo 2:** Eroding outfall channel.

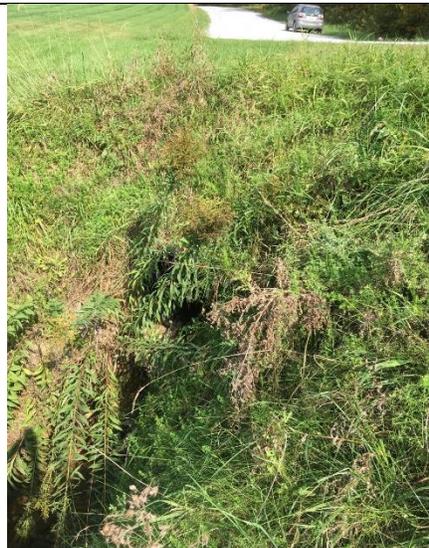
**Photo 1:** Incised outlet channel downstream of the culvert outlet.

**BMP Description:** Consider installing a larger structure sized to convey the 25-year flow. Consider installing the new culvert with higher slope and a stone apron constructed of minimum 12" minus stone to minimize scour at the outlet. The recommended culvert size for an intermittent stream crossing of comparable drainage area is 48" in diameter. Follow VTANR/VTrans road stormwater management guidance to ensure consistency with MRGP design standards.

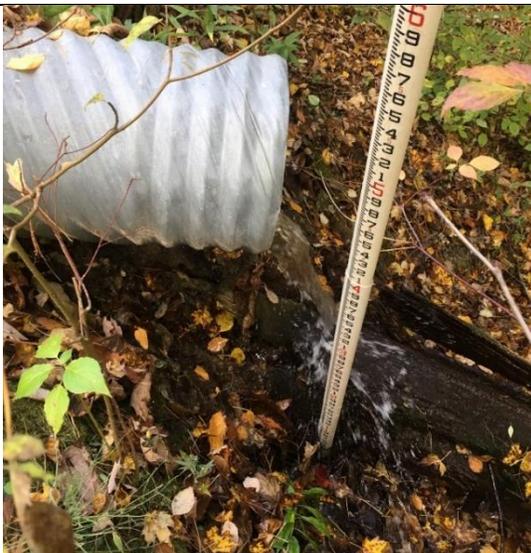
**Site Description:** The corrugated metal culvert conveys a small channel with an approximately 21-acre drainage area. The culvert capacity is estimated at 14 cfs, a flow that may be exceeded in the 50-year flood event. The culvert is perched, and the outlet is severely eroded (Photos 1 & 2).

**Photo 1:** Eroded embankment downstream of the culvert outlet.

**BMP Description:** Install a heavily armored splash pad at the culvert outlet constructed from minimum 12" minus stone to dissipate energy and halt erosion of the embankment. When the culvert is due for replacement, consider installing a larger structure. The recommended culvert size for an intermittent stream crossing of comparable drainage area is 30" in diameter.

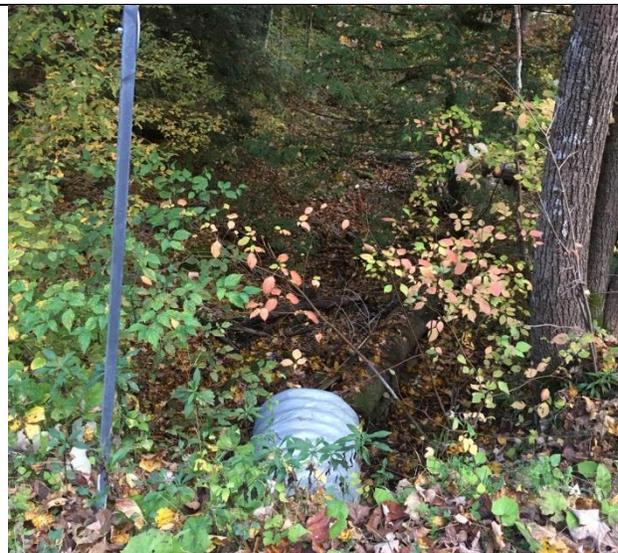
**Photo 2:** Eroded channel downstream of the culvert outlet.

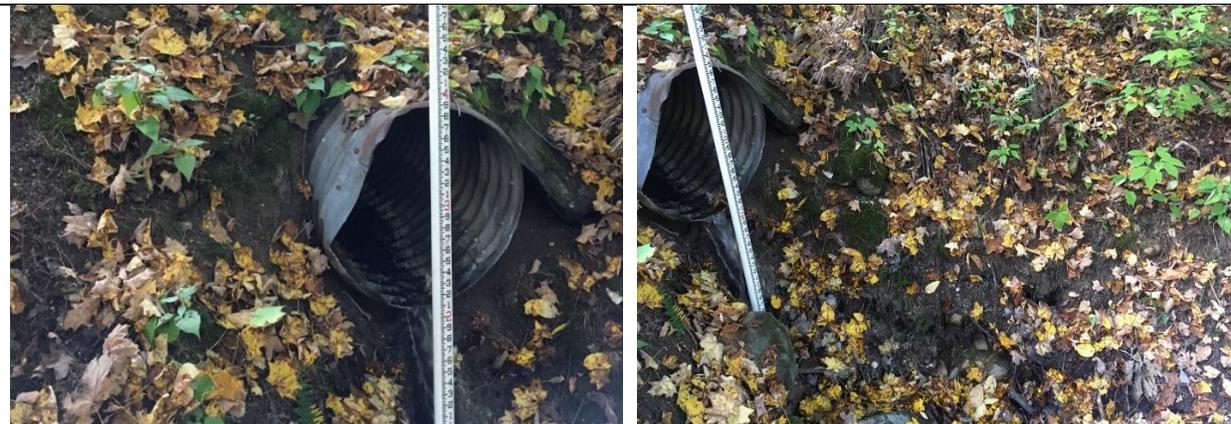
**Site Description:** The corrugated metal culvert conveys a small channel with an approximately 26-acre drainage area. The culvert capacity is estimated at 34.3 cfs, a flow that is rarely exceeded. The culvert is perched, and the outlet is severely eroded (Photos 1 & 2).

**Photo 1:** Eroded embankment downstream of the culvert outlet.

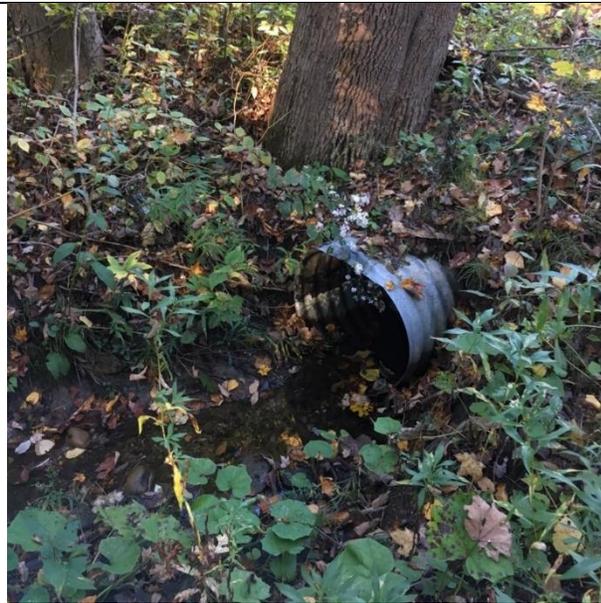
**Photo 1:** Old West Road culvert inlet.

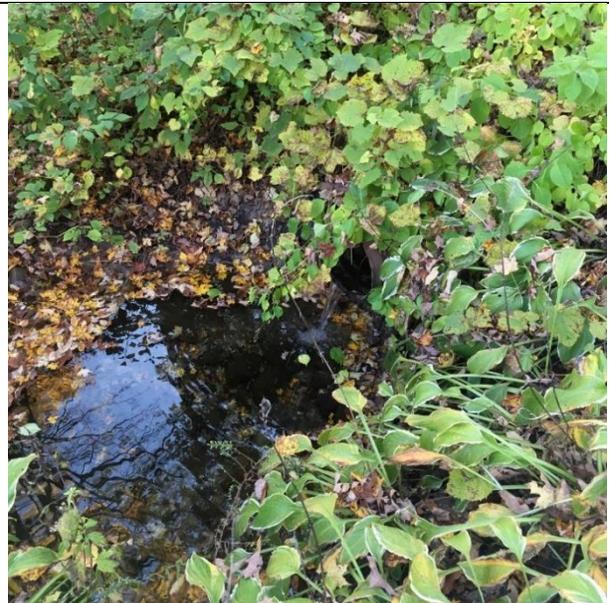
**Site Description:** The corrugated metal culvert conveys a small channel with an approximately 19.5-acre drainage area. The culvert capacity is estimated at 17.9 cfs, a flow approximately equal to the 50-year flood event. The culvert is perched, and the downstream channel is eroded (Photos 1 & 2).

**Photo 2:** Old West Road culvert outlet.

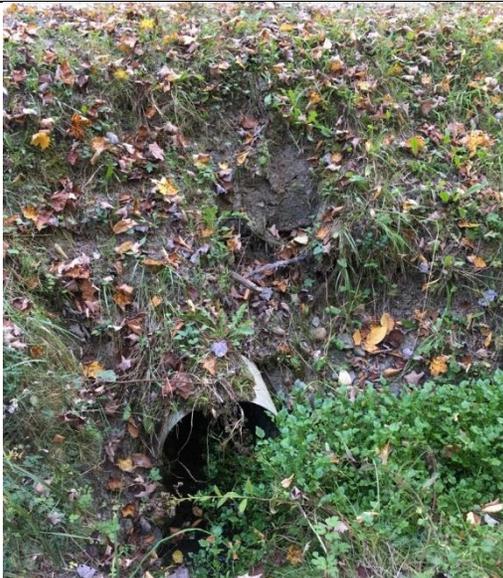
**Photo 1:** Erosion at the culvert inlet header.

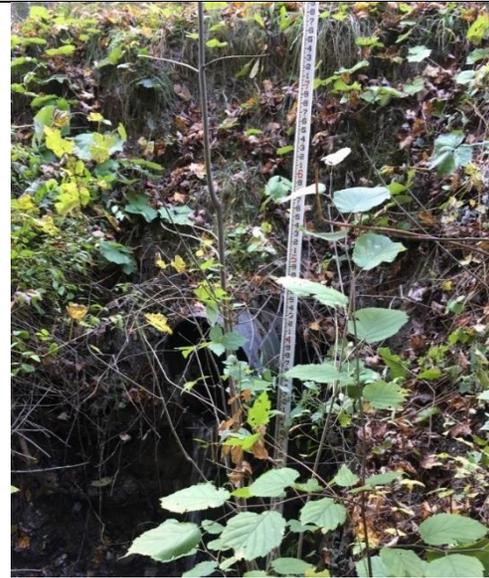
**Photo 2:** Erosion at the culvert outlet.

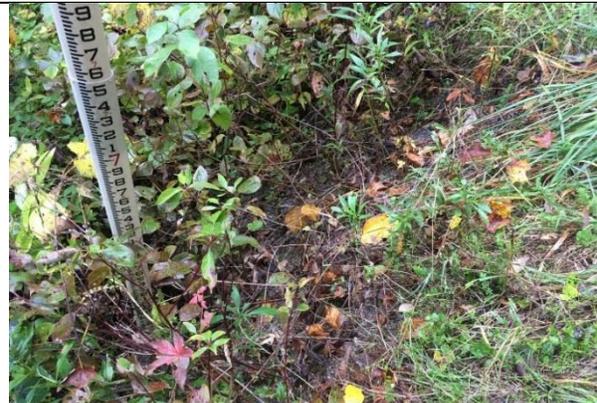
**Photo 2:** Erosion at the culvert outlet.
