STORMWATER INFRASTRUCTURE MAPPING PROJECT

BENNINGTON AREA, VERMONT

FINAL REPORT
October 8, 2015

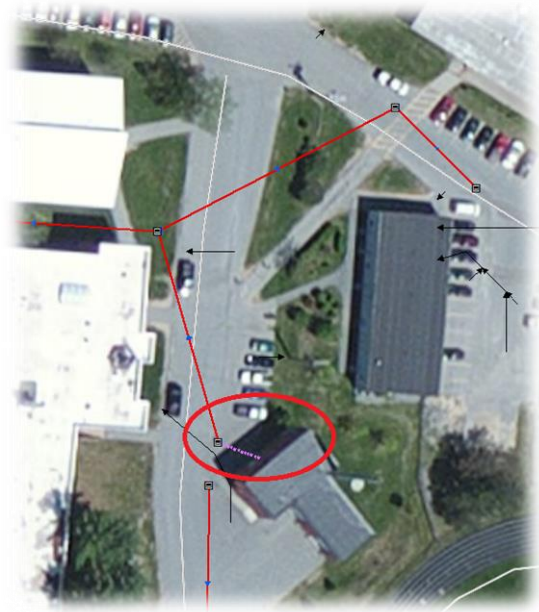
4.1 Specific Issues Noted – Mt. Anthony High School:

While mapping the stormwater infrastructure at the High School, a large regular pumped flush of water was noted in a catchbasin near the school's heating plant. A follow-up visit with the school's facilities director to confirm pipe directions and connections confirmed that that flush of water was actually just groundwater pumped from around the footing of the building and into the catchbasin. Follow-up work during the IDDE seems to confirm this.

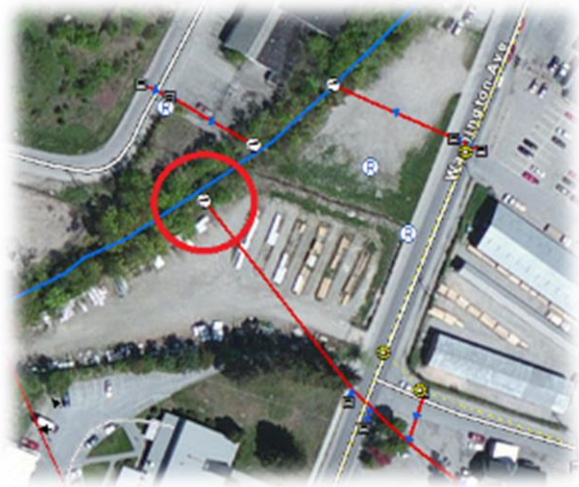
4.2 Specific Issues Noted – Outfall on Unnamed Tributary off Washington Ave

Flow was noted at this outfall during mapping in the fall of 2014 and in several of the catchbasins. It was not clear at this time whether that flow was related to a potential illicit discharge or to footing drains or underground streams. In the Bennington area, groundwater is usually near the surface, resulting in the need for footing drains for many buildings. Additionally, as Bennington has been settled for a long time, many streams have been forced underground due to development pressure. It turns out in the case of this outfall that both scenarios (footing drains and an underground stream) were causing flow in catchbasins. It was later found that there was an illicit discharge farther up this line, but not one that would have resulted in the flows observed during mapping.

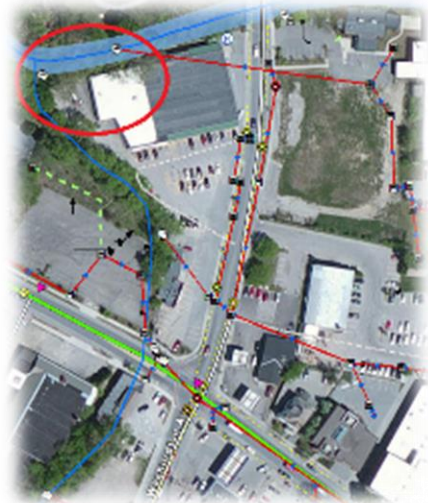
4.3 Specific Issues Noted – Outfall on Walloomsac River behind VT DMV

A similar situation to the one described above was found at this large outfall on the Walloomsac River. However, in this area it turns out that the 'outfall' was actually the outlet of a large box culvert carrying an unnamed tributary of the Walloomsac River. There are several drainage networks that outlet to this box culvert – however none have been found so far to have any illicit discharges.

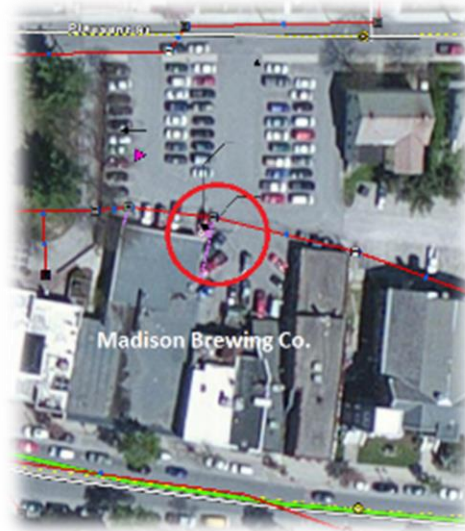
4.4 Specific Issues Noted – Catchbasin in parking lot behind Madison Brewing Company

An intermittent flow, originating in a catchbasin, was noted during mapping. However this issue is still ongoing – preliminary testing during illicit discharge work has not revealed any factors that clearly point to this as an illicit discharge. Investigation is ongoing.
