Upper Winooski

Class Three and Four Road Erosion Assessment

March 24, 2014

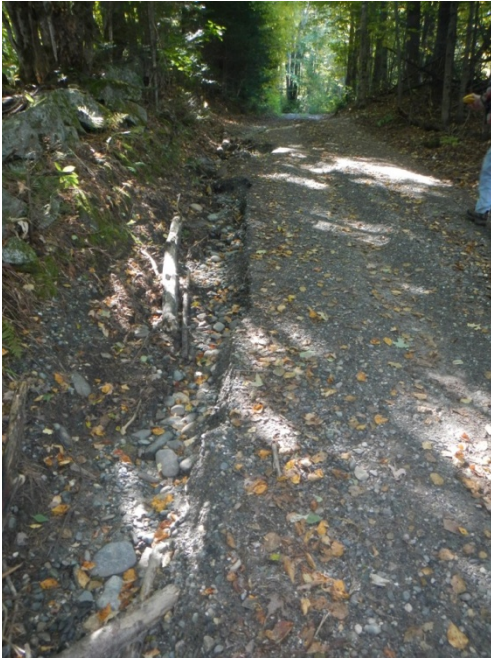
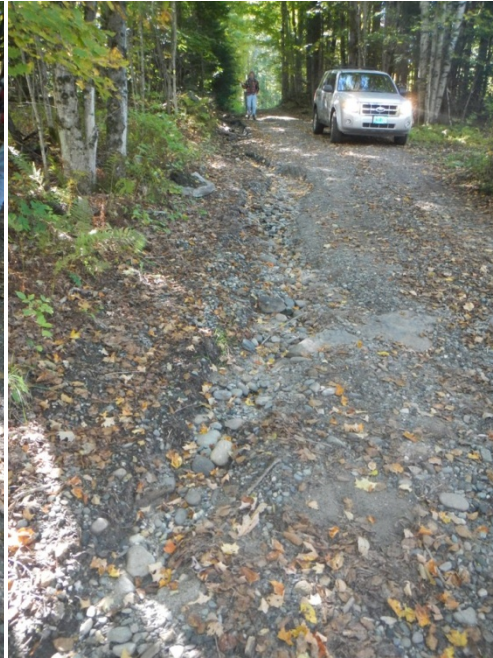
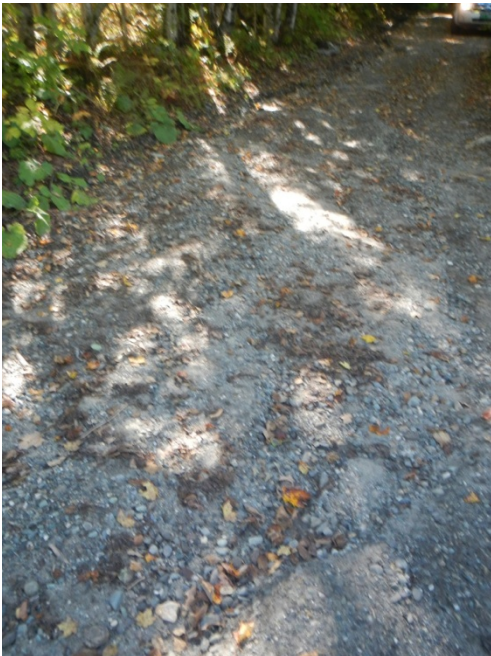
Location – 125 feet of road shoulder erosion where Blodgett Rd intersects with E Hill Rd in Woodbury and Cabot, VT. This is a class 4 road.

Location of Erosion	Water Volume	Steepness of Site	Soil Cover	Deposition to Stream	Type of Erosion	Total Score
ROADWAY SHOULDER	HIGH	STEEP >15	BARE	HIGH	GULLY	13.0

- Improve road shoulder by ditching and stone lining ditch for length of erosion 125 ft
- Work with town of Woodbury to create stone line turn out at intersection of E Hill Rd.

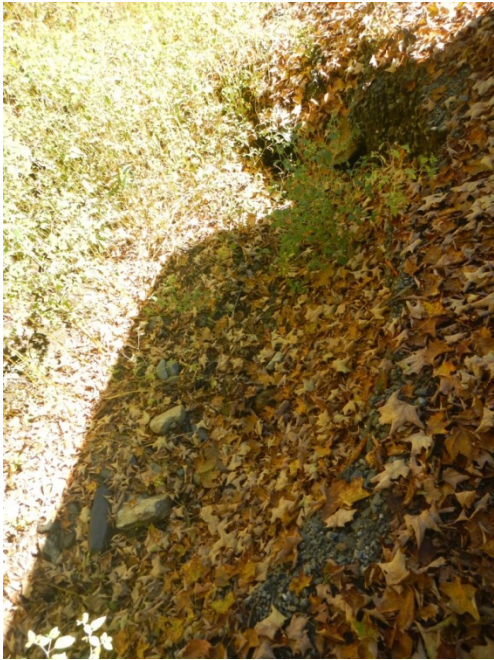
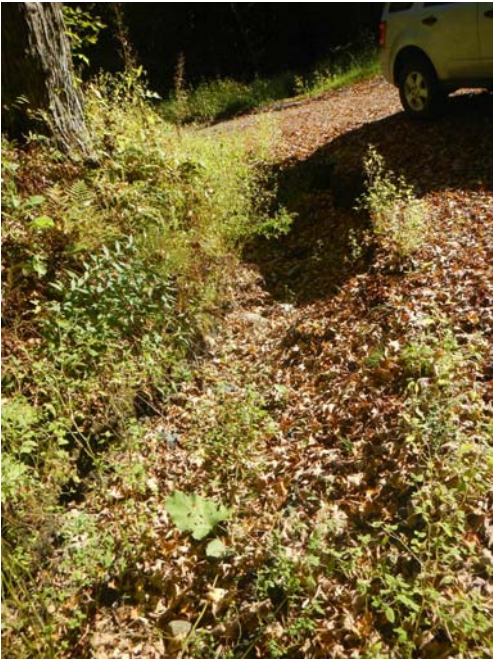
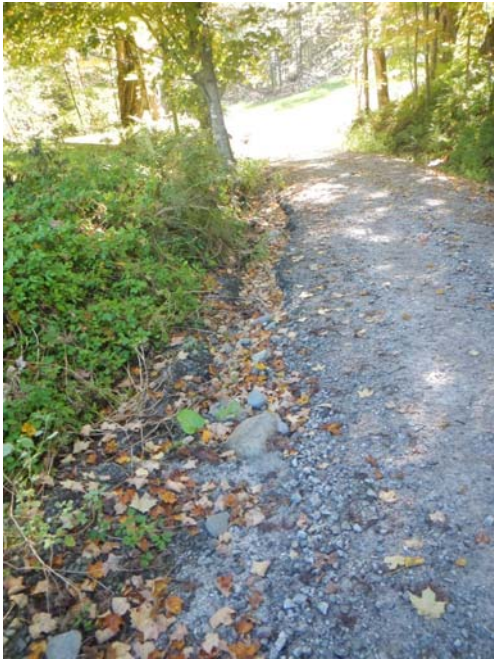
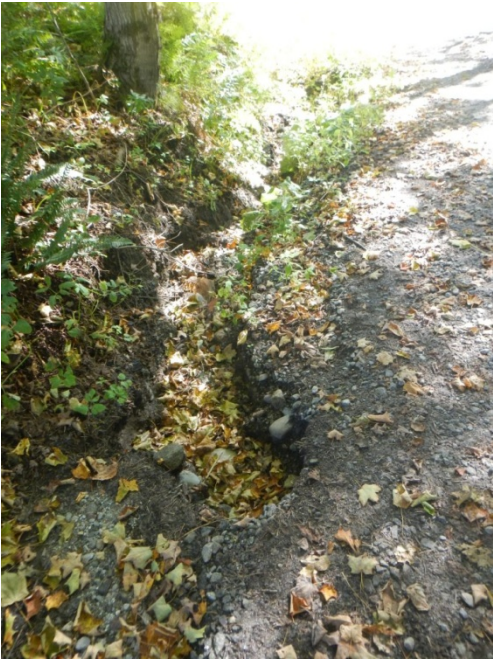
Location – 129 feet of ditch erosion along Blodgett Rd 0.36 miles west of W Hill Pond Rd in Cabot, VT. This is a class 4 road.

Location of Erosion	Water Volume	Steepness of Site	Soil Cover	Deposition to Stream	Type of Erosion	Total Score
DITCH	HIGH	MOD 5-15	BARE	HIGH	GULLY	11.7

- Add stone aprons at outlets of existing culvert
- Install headers and footers on all existing culvert
- Improve ditch by stone line for length of erosion about 129 ft
- Replace existing culvert if undersized for location.

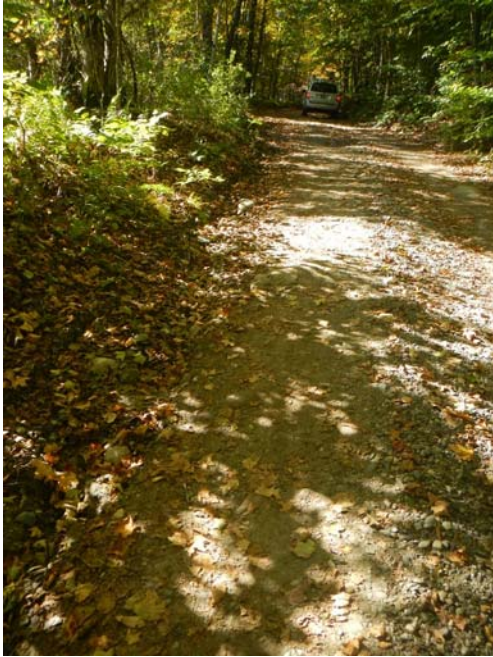
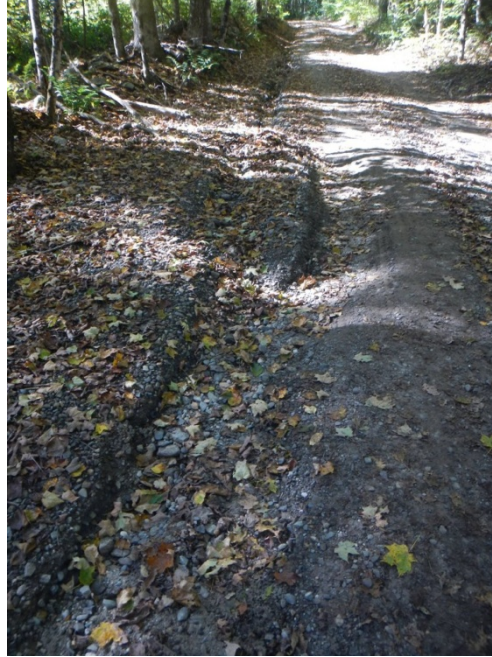
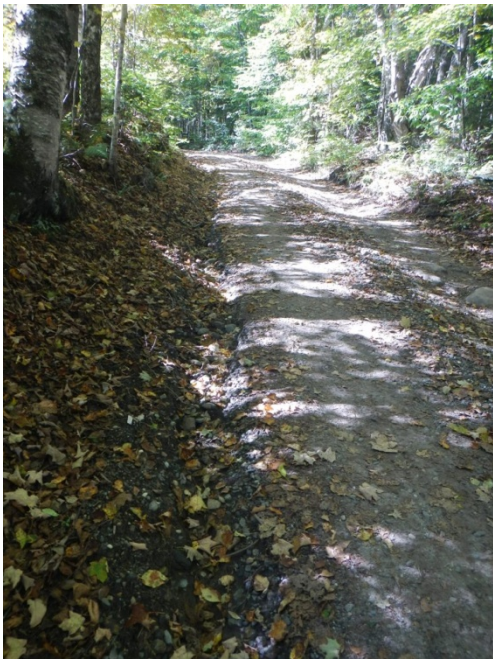
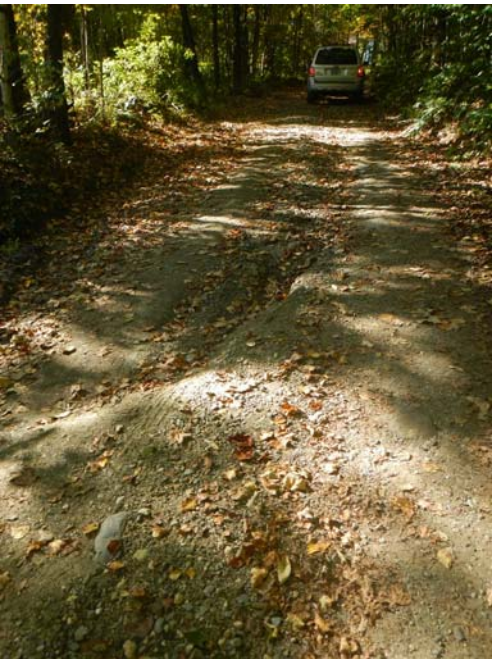
Location – 163 feet of road shoulder erosion along Blodgett Rd 0.27 miles west of W Hill Pond Rd in Cabot, VT. This is a class 4 road.

Location of Erosion	Water Volume	Steepness of Site	Soil Cover	Deposition to Stream	Type of Erosion	Total Score
ROADWAY SHOULDER	HIGH	STEEP >15	BARE	LOW	GULLY	11.0

- Improve road shoulder by ditching and stone line for length of erosion about 163 ft

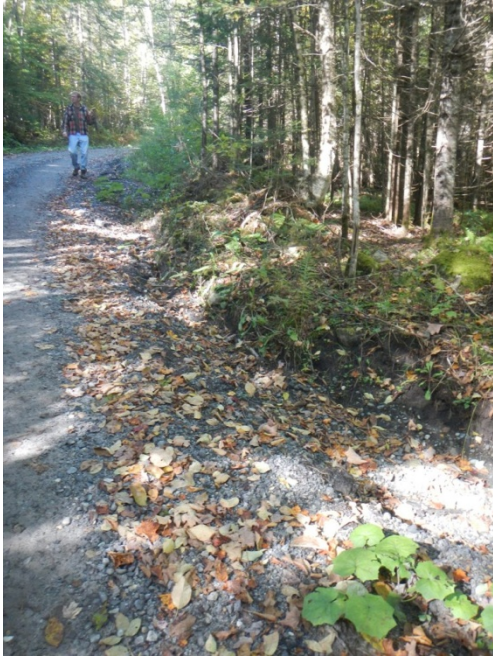
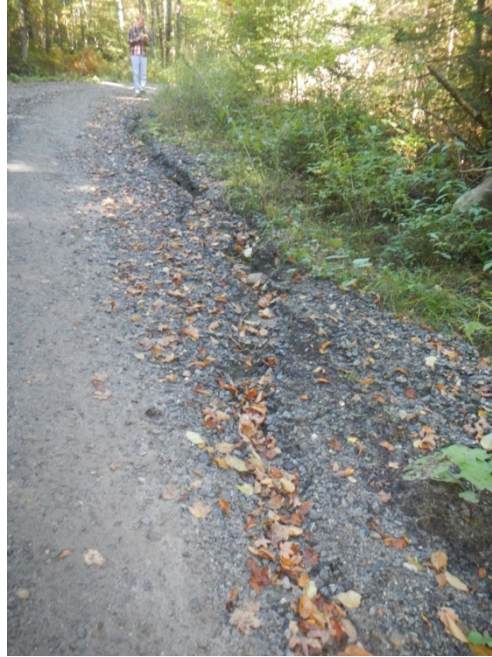
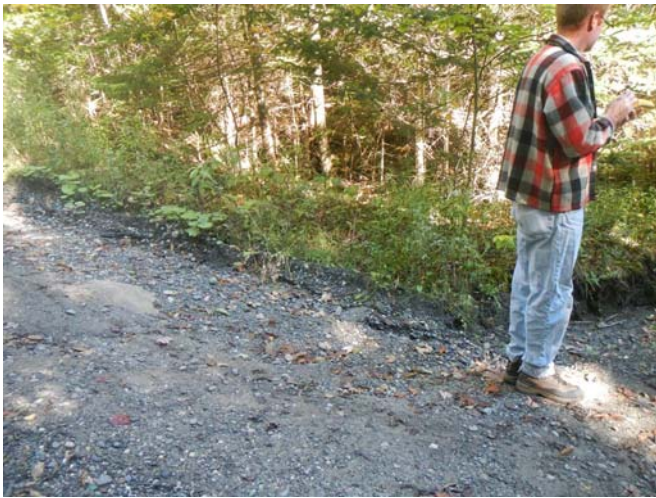
Location – 139 feet of road shoulder erosion along Blodgett Rd 0.18 miles west of W Hill Pond Rd in Cabot, VT. This is a class 4 road.

Location of Erosion	Water Volume	Steepness of Site	Soil Cover	Deposition to Stream	Type of Erosion	Total Score
ROADWAY SHOULDER	MEDIUM	STEEP > 15	BARE	HIGH	GULLY	10.4

- Add stone lined turn out at end of erosion
- Improve road shoulder by ditching and stone line for length of erosion about 139 ft

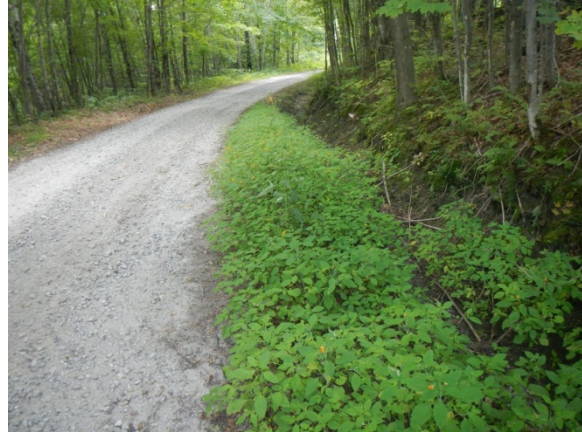
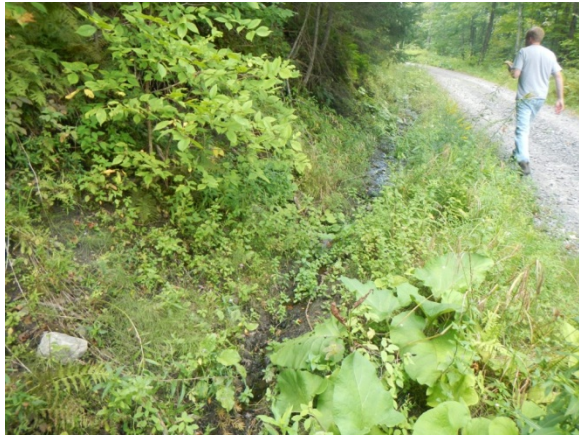
Location – 432 feet of Ditch erosion along Last Rd 0.36 miles south Danville Hill Rd in Cabot, VT.

Location of Erosion	Water Volume	Steepness of Site	Soil Cover	Deposition to Stream	Type of Erosion	Total Score
DITCH	HIGH	MOD 5-15	MINIMAL VEGITATION	HIGH	GULLY	10.4

- Add 1-2 new cross culverts along ditch
- Add stone aprons at outlets of new culverts
- Install headers and footers on all new culverts
- Improve ditch by stone lining for length of erosion about 432 ft

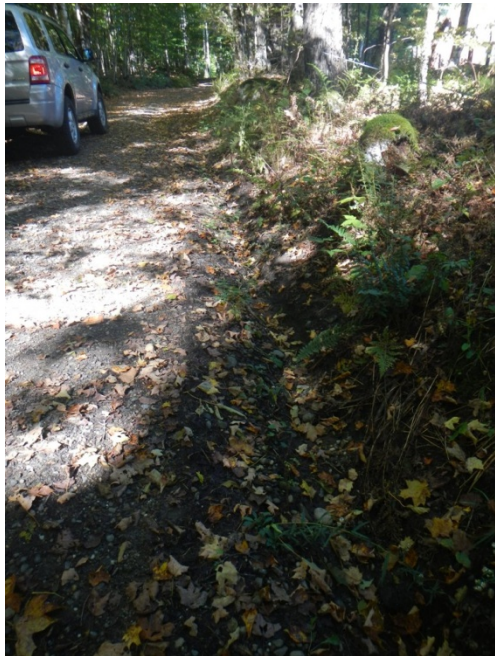
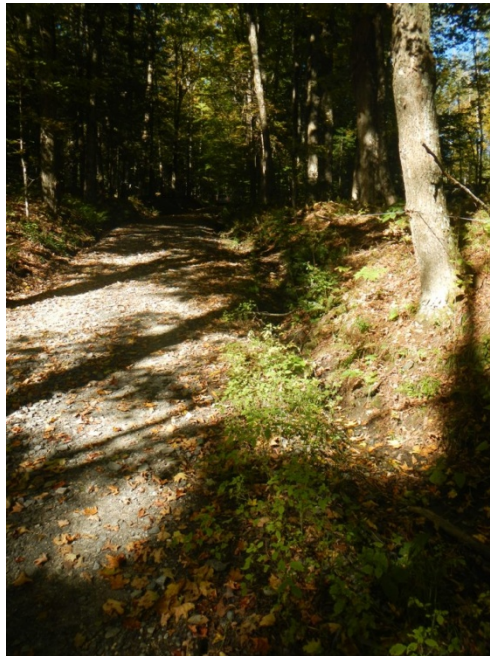
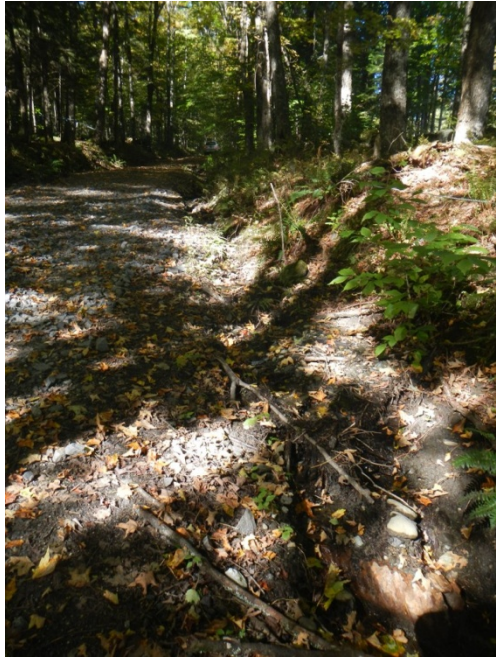
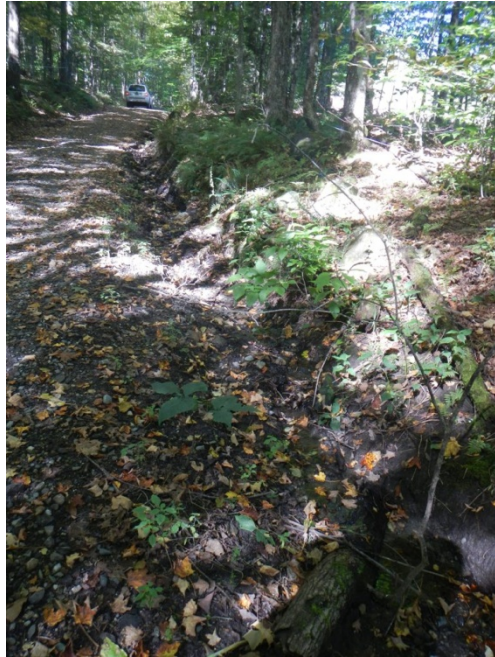
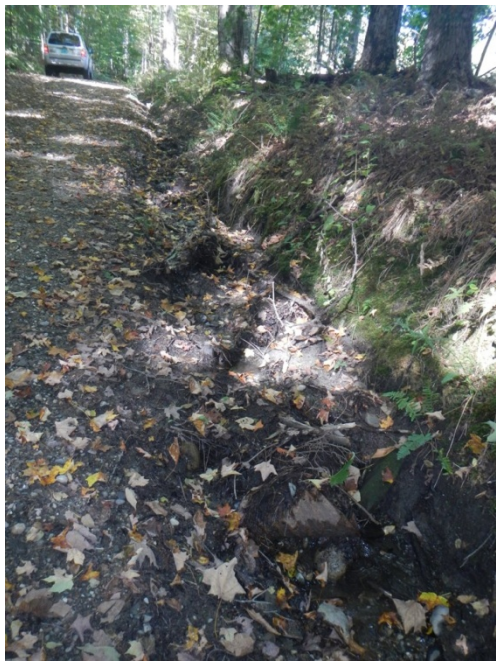
Location – 258 feet of road shoulder and ditch erosion along Blodgett Rd 0.5 miles west of W Hill Pond Rd in Cabot, VT. This is a class 4 road.

Location of Erosion	Water Volume	Steepness of Site	Soil Cover	Deposition to Stream	Type of Erosion	Total Score
DITCH	HIGH	MOD 5-15	BARE	LOW	GULLY	9.9

- Improve ditch by stone line for length of erosion about 258 ft
- Add stone lined turn out at end of erosion

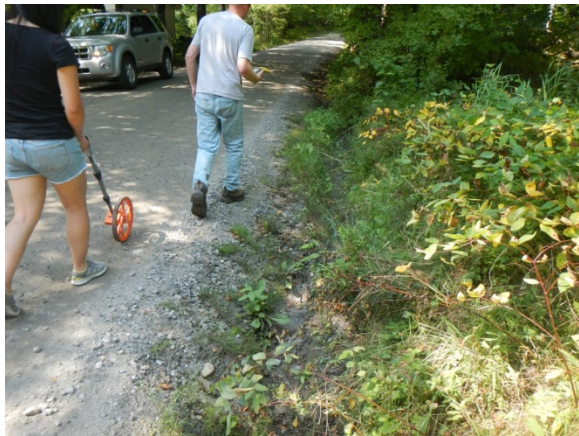
Location – 200 feet of ditch erosion along Thistle Hill Rd 1 mile west of Route 2 in Cabot, VT.

Location of Erosion	Water Volume	Steepness of Site	Soil Cover	Deposition to Stream	Type of Erosion	Total Score
DITCH	HIGH	LOW < 5	MINIMAL VEGETATION	HIGH	GULLY	9.7

- Improve ditch by stone line for length of erosion about 200 ft
- Replace existing culvert if undersized for location.

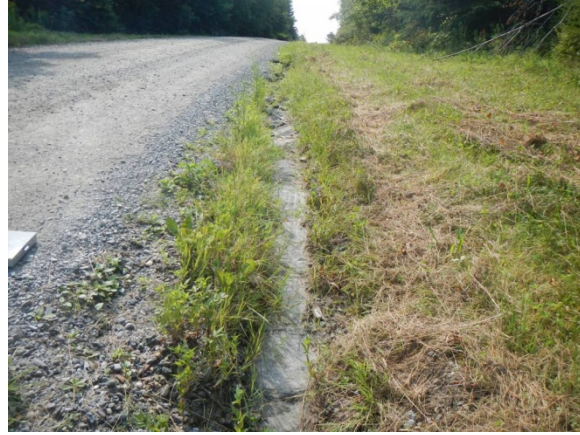
Photo 2

Location – 315 feet of road shoulder and ditch erosion along Thistle Hill Rd 0.18 miles south of Wheeler Rd in Cabot, VT.

Location of Erosion	Water Volume	Steepness of Site	Soil Cover	Deposition to Stream	Type of Erosion	Total Score
DITCH	HIGH	MOD 5-15	MINIMAL VEGITATION	LOW	GULLY	8.8

- Improve road shoulder by ditching and stone line for length of erosion about 315 ft
- Stone line turn out at end of erosion

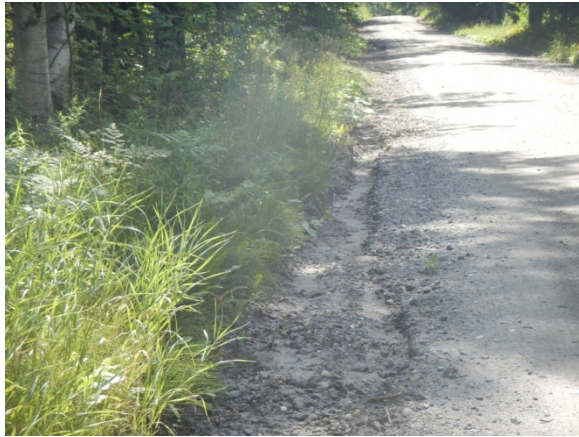
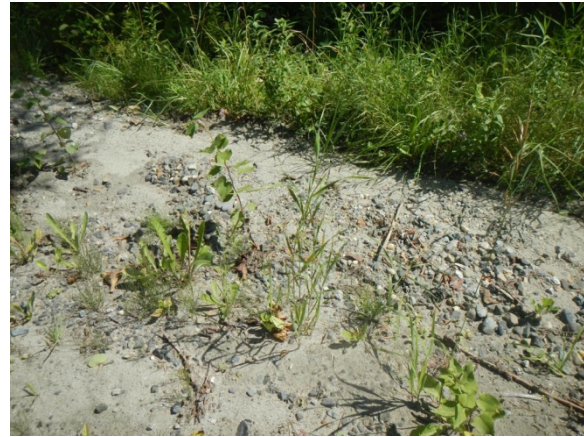
Location – 546 feet of road shoulder erosion along Hollister Hill Rd at the intersection of Sadie Foss Rd in Marshfield, VT.

Location of Erosion	Water Volume	Steepness of Site	Soil Cover	Deposition to Stream	Type of Erosion	Total Score
ROADWAY SHOULDER	MEDIUM	MOD 5-15	BARE	LOW	GULLY	7.7

- Add 1-2 new cross culverts along erosion
- Add stone aprons at outlets of new culverts and existing culvert
- Install headers and footers on all new culverts and existing culvert
- Improve ditch by stone lining for length of erosion about 546 ft

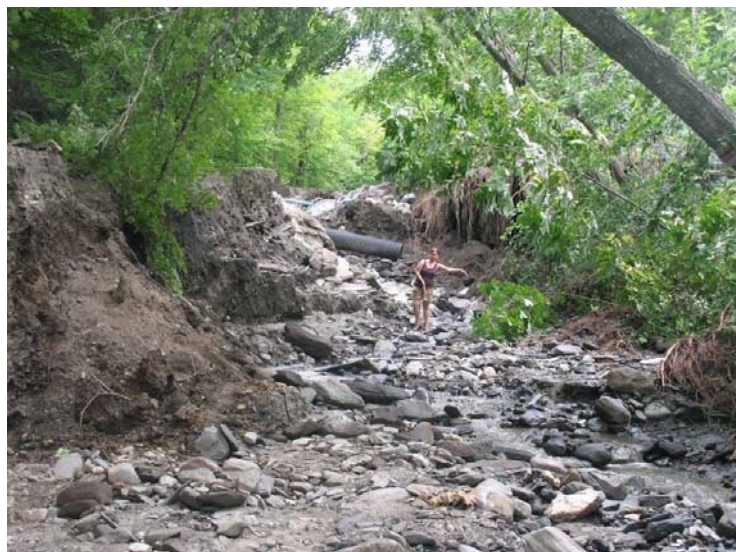
Figure 2. This gully formed in a microburst storm when a small stream jumped its banks at a plugged culvert at the top of a hill in 2007. The woman at center of the photo is spanning the post-storm width of the stream with her arms. Adequately sized and well-designed culvert installs benefit both roads and streams.
