TOWN OF GEORGIA

STORMWATER MANAGEMENT PLAN

FINAL REPORT

Stone Project ID 112475-W
February 20, 2013

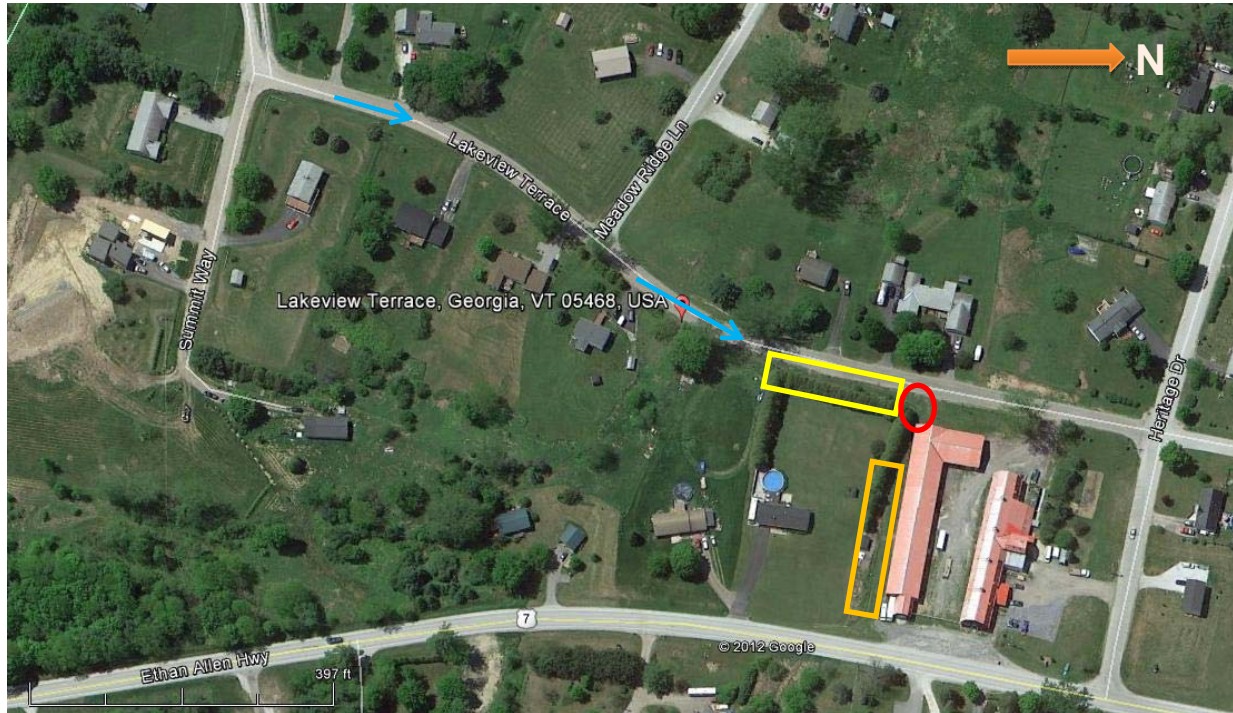
Figure 5. Red Barn property and surrounding neighborhood. Location of existing scour hole shown in red. Potential STP locations shown in yellow and orange.

- Repair and reinforcement of the scoured channel would reduce sediment loads downstream. Installation of a STP such as a bioretention basin, in the existing roadside ditch along the hedge row (upstream of the scour hole) would improve water quality and also prevent future erosion or scouring of the channel.
- An alternative or addition to a solution along Lakeview Terrace is to locate a treatment practice encouraging infiltration along the southern border of the Red Barn Storage property. Locating the treatment practice here would increase the land area potentially available for infiltration.

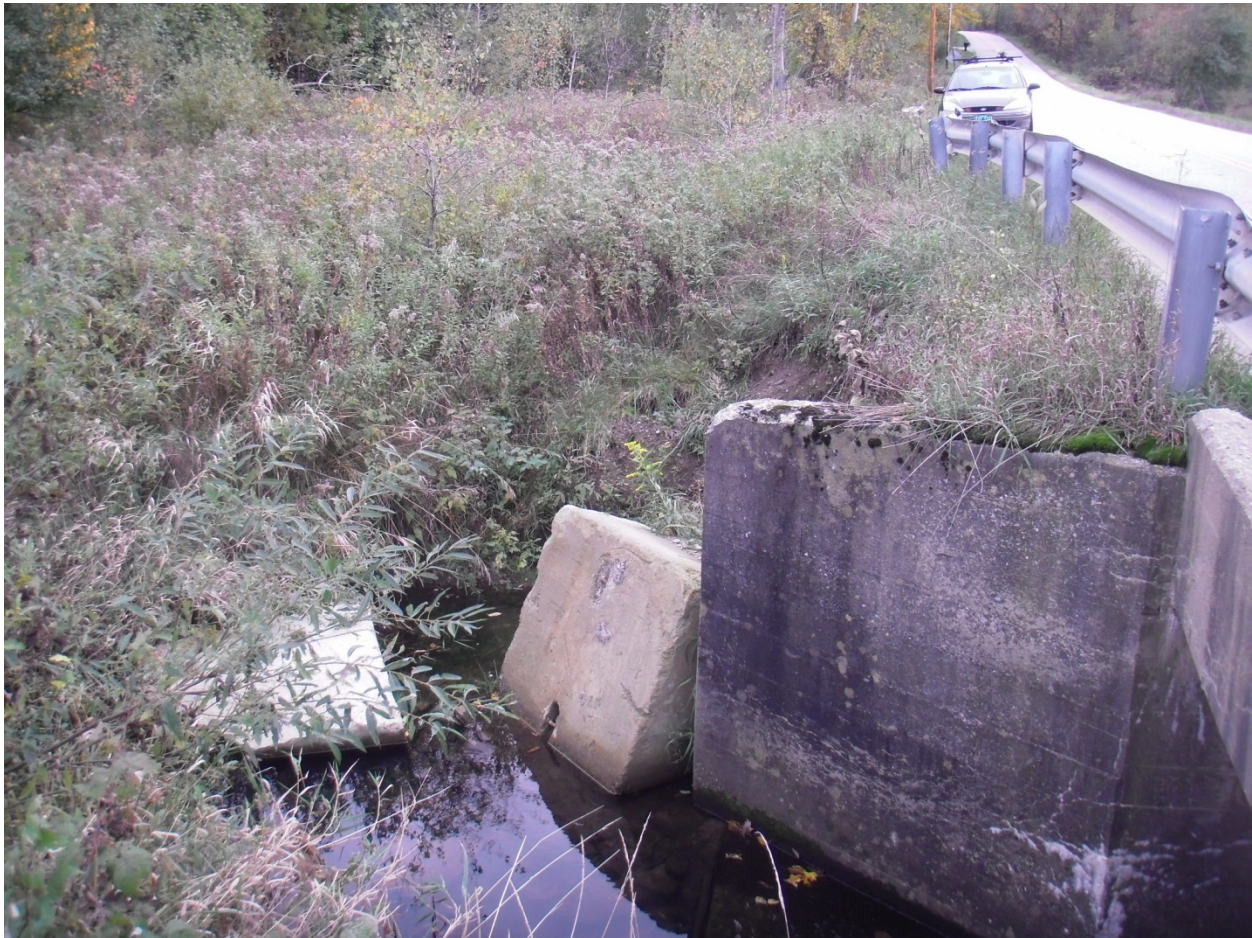
Significant streambank erosion is occurring at the Oakland Station Road- Mill River crossing. Mill River crosses under Oakland Station Road via a concrete box culvert just south of Conger and Loomis Roads. Unmanaged road runoff is causing erosion behind the southeast wingwall (Figure 6), and past stabilization attempts appear to be failing. Erosion from this source could be minimized with improved management of road runoff coupled with bank stabilization that includes properly sized riprap keyed-in below the scour depth of the stream bed.

The outlet of the box culvert drops steeply to a scour pool. This appears to be a barrier to aquatic organism passage. If this blockage is truly blocking the passage of fish and other aquatic organisms, retrofit options should be considered to improve the connectivity of the stream by lessening or removing the drop between the box culvert and the scour pool below. A tail-water control structure, such as a rock weir at the end of the scour pool, can raise the pool surface to create better passage conditions.

Figure 6. Failing slope near inlet to box culvert over Mill River on Oakland Station Rd.

This structure appears to be in serviceable condition. However, when this box culvert reaches the end of its service life, it should be replaced with a structure that meets current State of Vermont design standards. This will help ensure sediment transport equilibrium, reduce erosion hazards, and maximize the ecological integrity of this road-stream crossing.

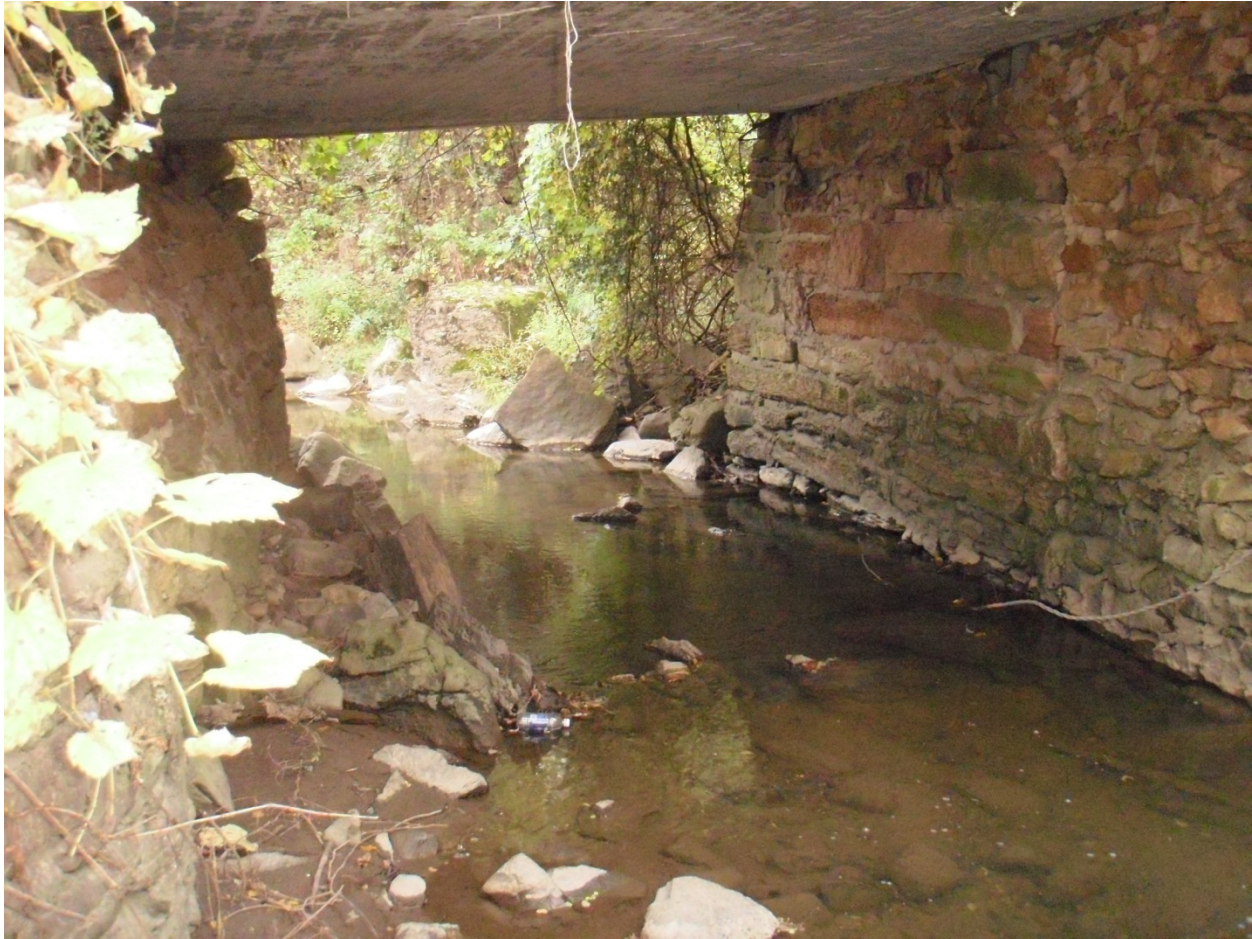
The Rugg Brook-Mill River Road bridge, just east of Bronson Road, consists of a concrete slab resting on two stone-masonry abutments (Figure 7). The span between abutments is narrower than the bankfull width of the stream. At elevated flow rates, this causes increased velocities, leading to erosion of the stream bed and banks, as evidenced by a large scour pool that has formed downstream of the structure. The existing structure appears to be approaching the end of the service life, with undercutting apparent beneath the abutments and deterioration of the stone masonry. When the structure is replaced, the new structure should be constructed with sufficient length to allow unimpeded flow of the stream at bankfull conditions. Designing the bridge with adequate length ensures sediment-transport continuity and maximizes ecological integrity of the road-stream crossing, while creating a flood resistant structure that requires reduced maintenance over its service life.

Figure 7. Deteriorating stone abutments of Mill River Rd. bridge over Rugg Brook.

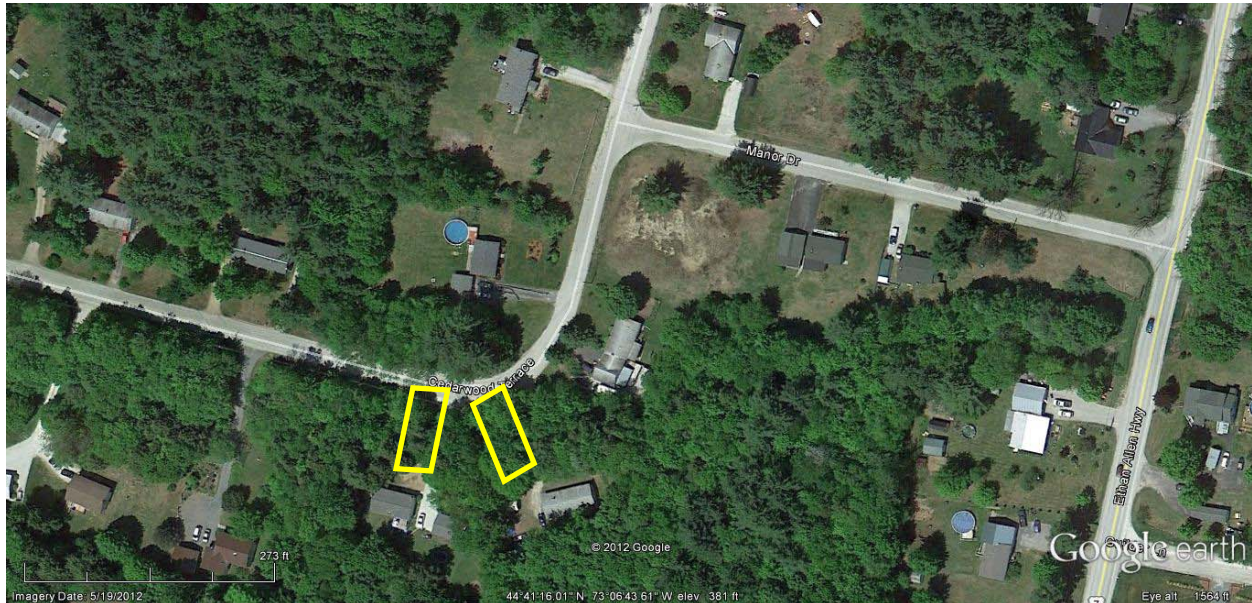
Stormwater-related issues reported during the March 7 kick-off meeting were investigated in the area of Cedarwood Terrace (Figure 9). While on site, one local land owner cited significant erosion of the road shoulder, claiming there was once enough room to park a vehicle where there is now only a few feet of space between the road and channel side-slope. Two compromised culverts were found under driveways providing access to two abutting private residences; there is some evidence of on-going erosion around the culverts.

The root cause of stormwater issues in this neighborhood is increased volume and flow attributable to increased impervious surfaces associated with development. Opportunities for stormwater treatment practices on public land or rights-of-way in the Cedarwood Terrace and Manor Drive neighborhoods are limited. Participation from private homeowners through implementing practices such as rain gardens or pervious pavement would help reduce stormwater impacts and improve water quality.

Figure 9. Compromised culverts conveying stormwater under private drives on Cedarwood Terrace, highlighted in yellow

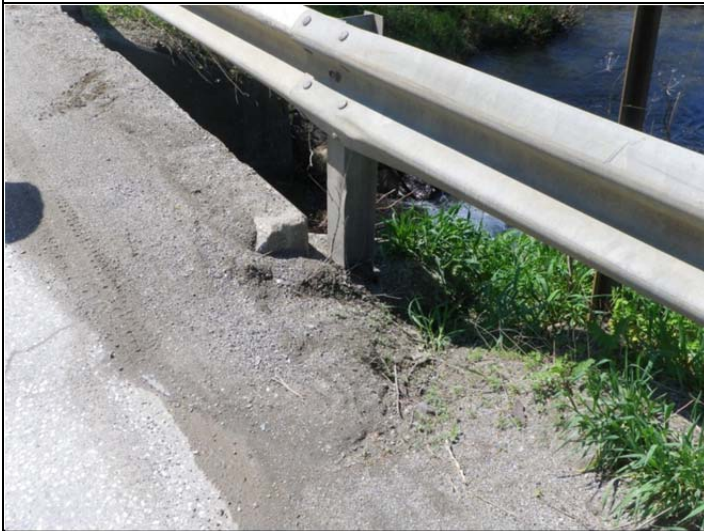
Photo 1. Road runoff

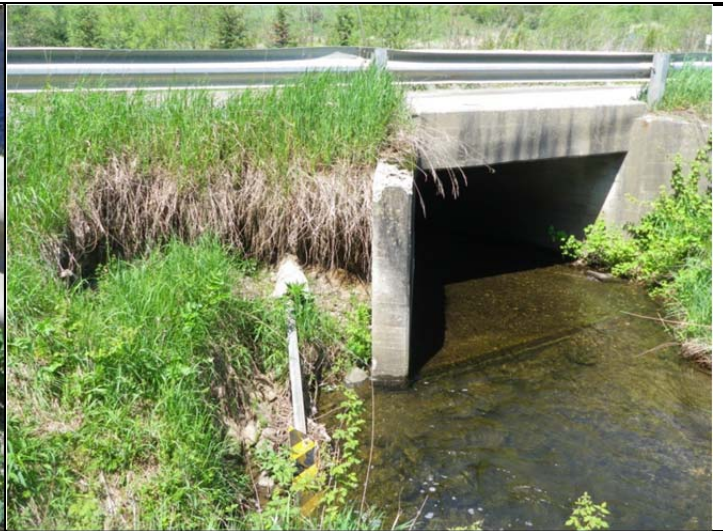
Photo 2. Looking downstream at bank erosion

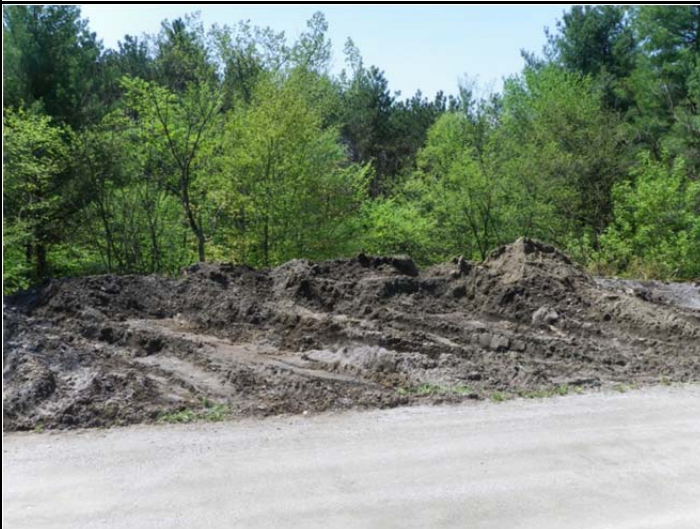
Photo 1. Fill on south-side of Decker Rd

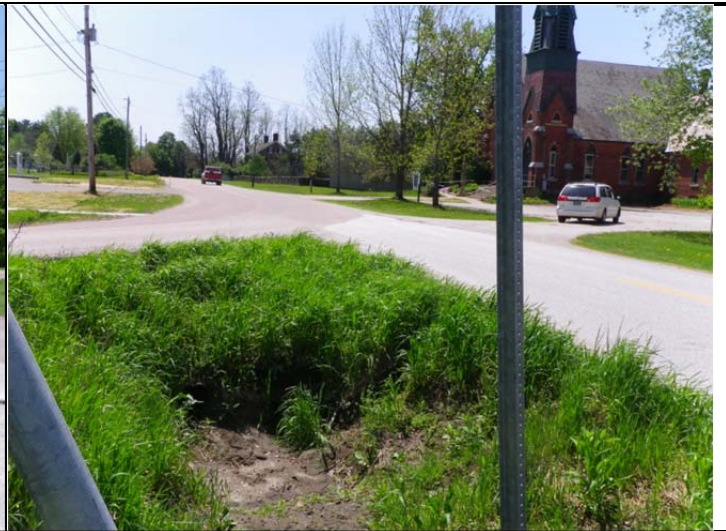
Photo 2. Sediment build up in the "Y" median

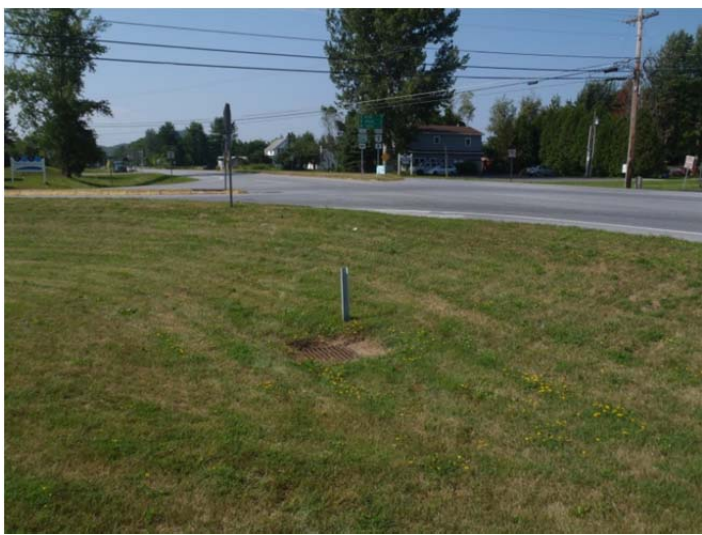
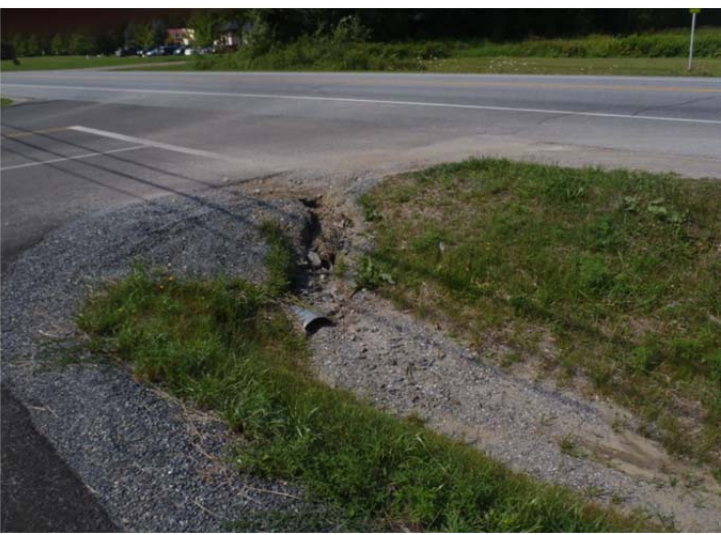
Photo 1. Catchbasin in 104A/Rt 7 triangle median	Photo 2. Plugged culvert at Georgia Market driveway

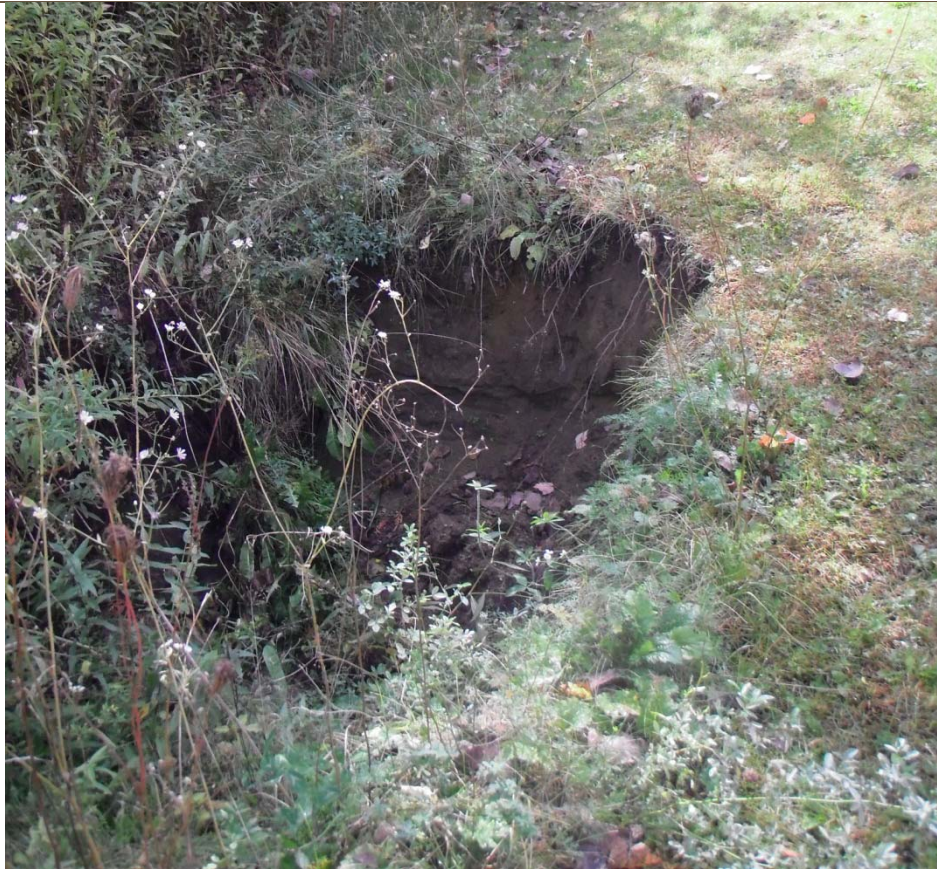
Figure 16. Headcut in road side ditch at the bottom of Lakeview Terrace.

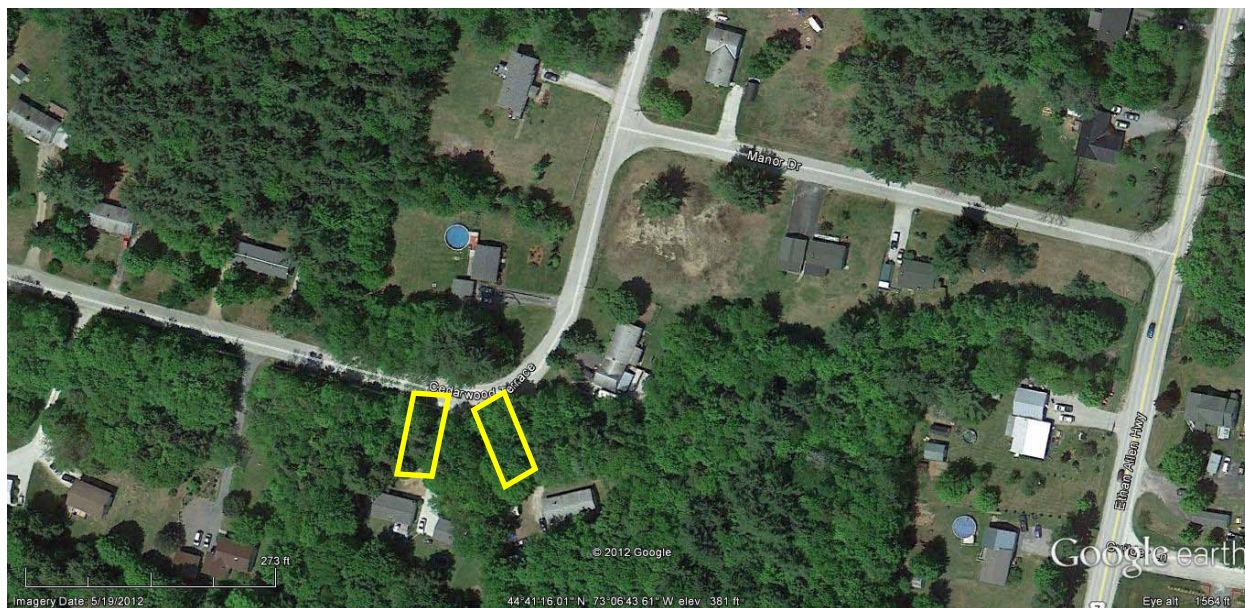
Figure 19. Two compromised culverts conveying stormwater under private drives on Cedarwood Terrace (highlighted in yellow).

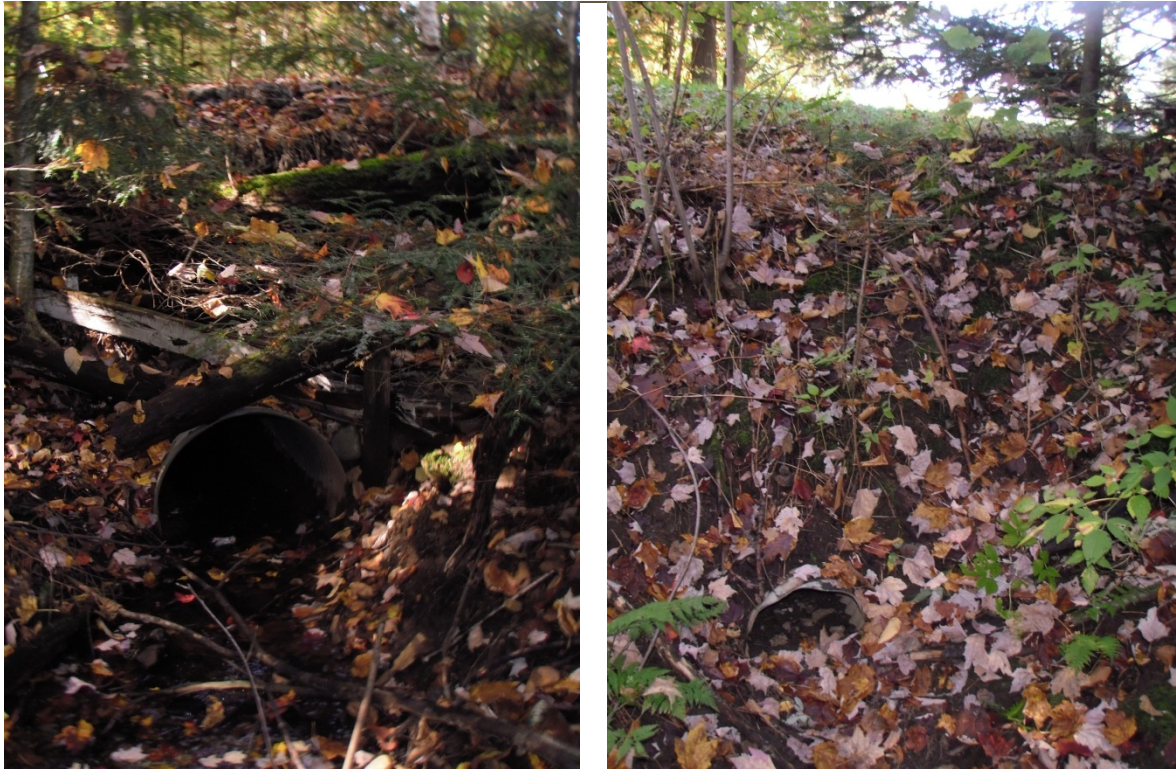
Figure 20. Partially clogged culverts with unstable cover slopes.

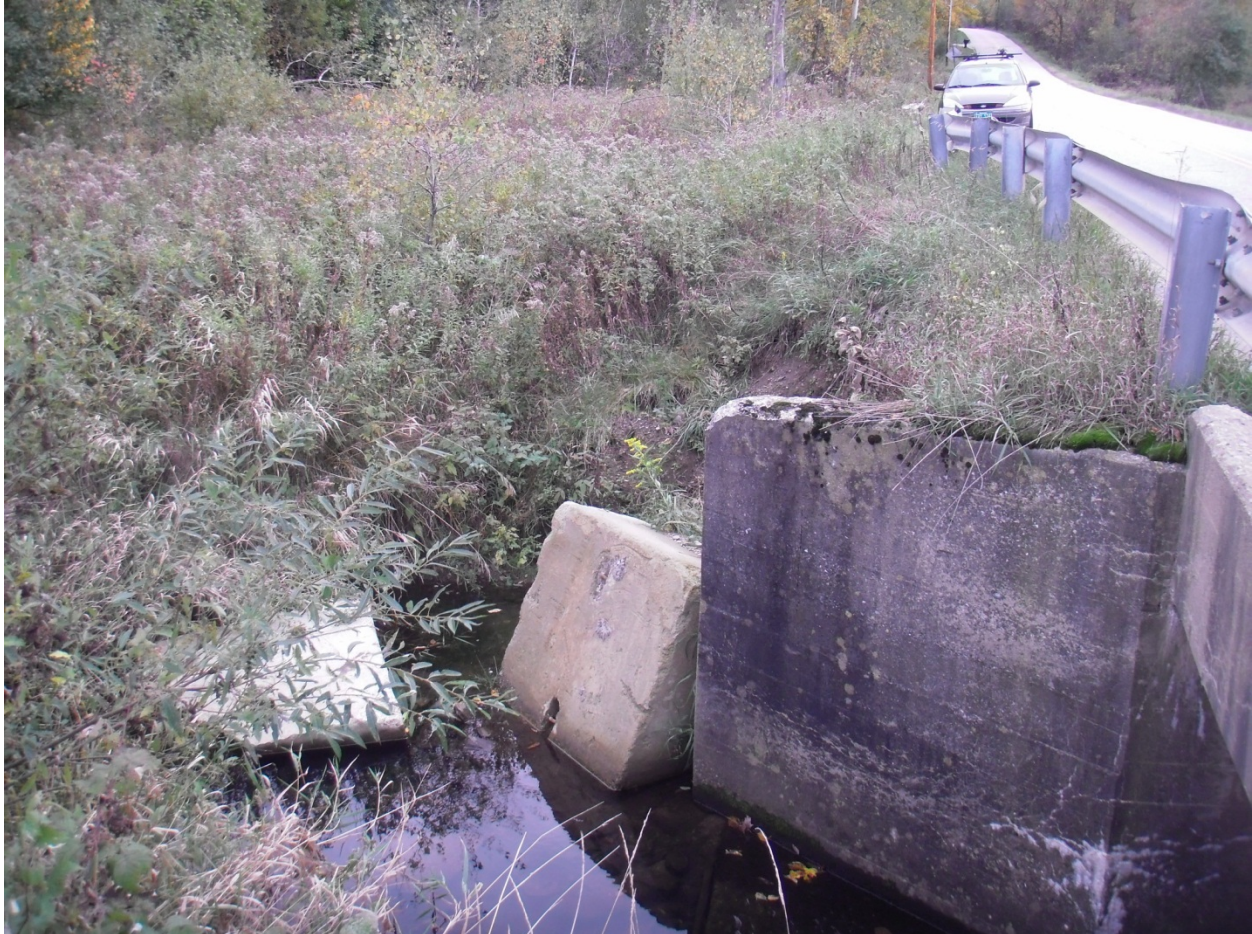
Figure 21. Failing slope near inlet to box culvert over Mill River on Oakland Station Rd.

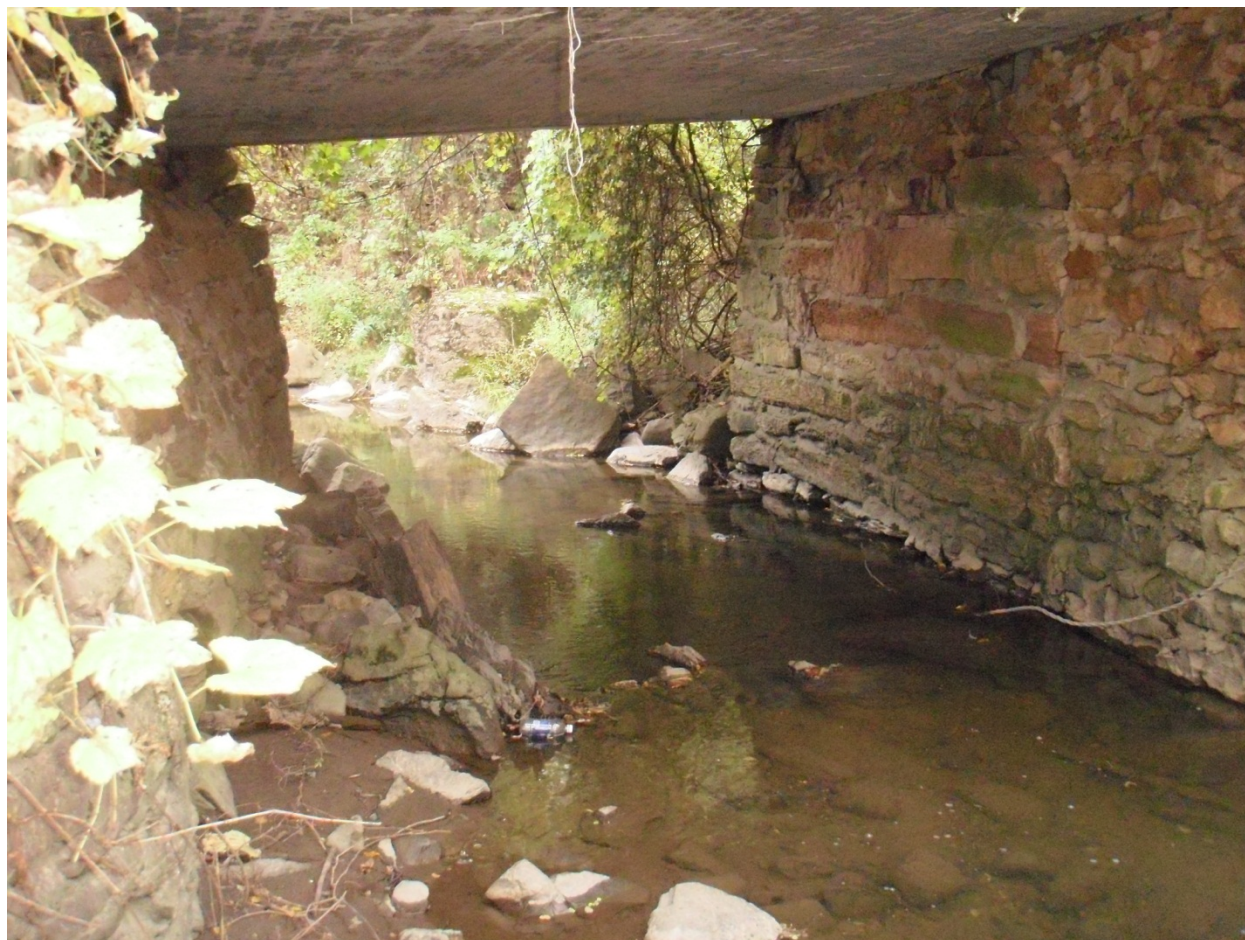
Figure 22. Deteriorating stone abutments of Mill River Rd. bridge over Rugg Brook.
