STORMWATER MANAGEMENT PLAN FOR HIGHGATE

FINAL REPORT

Stone Project ID 112475-W

March 1, 2013

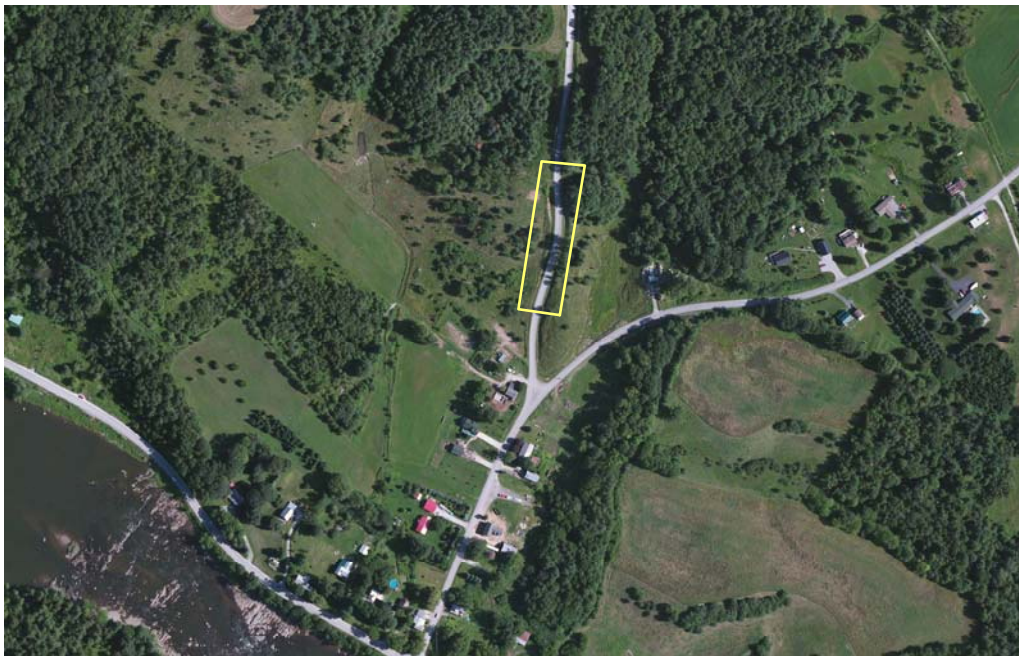
Recent roadway improvement work along Durkee Road in Highgate Center has resulted in over-steepened banks, causing erosion of sections of the ditch backslopes along both sides of the road. The section of road affected is fairly steep, and is located only about a third of a mile from the Missisquoi River. Approximately 300 feet of road side ditch is affected, with the backslope reaching a maximum approximate height of 10 feet. Appropriate grading of ditch side slopes and re-seeding to establish a stable channel are recommended practices. If a stable grade cannot be achieved, armoring the ditches would also help to stop the erosion.

Figure 1. An area of eroding slopes along Durkee Road is highlighted in yellow.

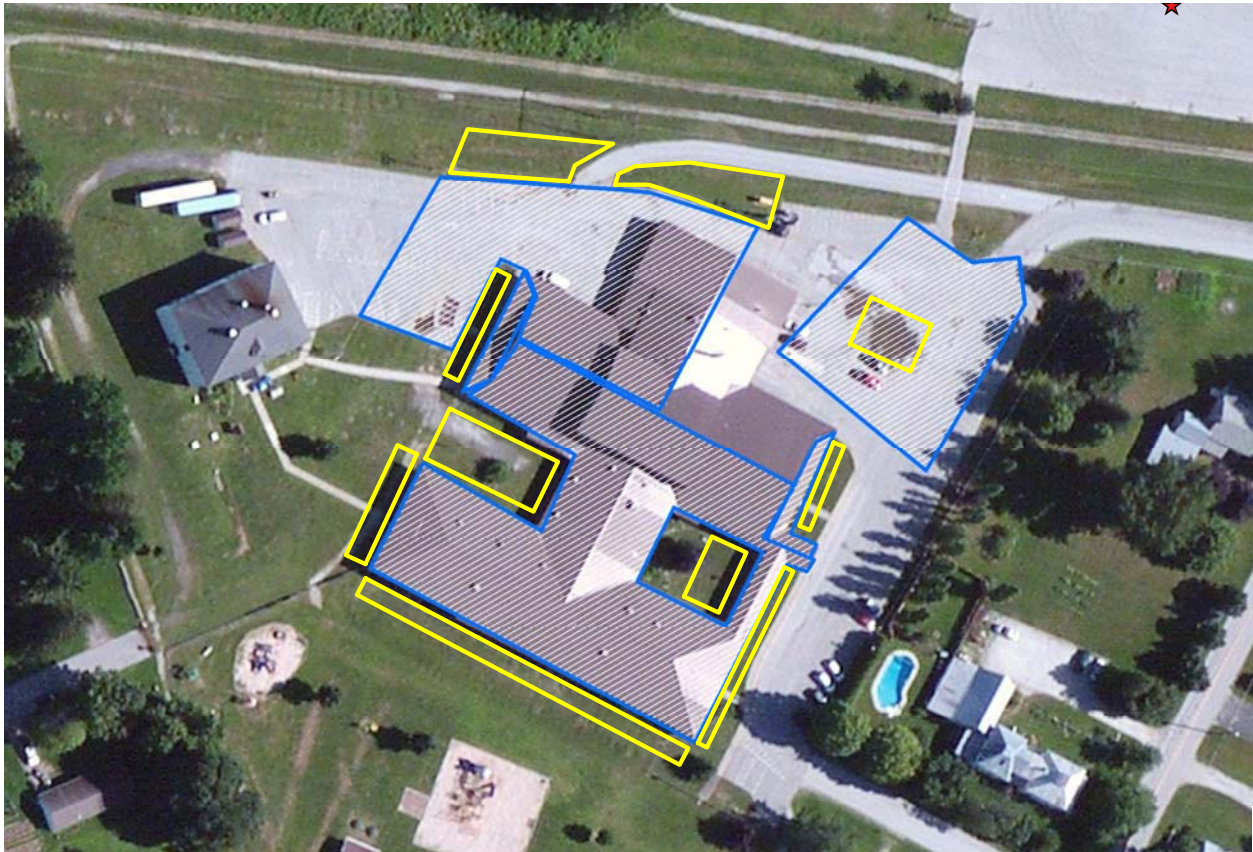
Figure 2. Highgate Elementary School. Treatable impervious surface is highlighted in blue, and potential treatment practice locations are shown in yellow.

There is no closed drainage storm sewer infrastructure on or near the property, and little change in grade to accommodate underdrain outlets to the ground surface. Thus, any STPs constructed at this site would rely on the natural capacity of the underlying soils to infiltrate stormwater. Careful analysis of infiltration rates at proposed STP locations would be essential to insure the development of a properly functioning design.

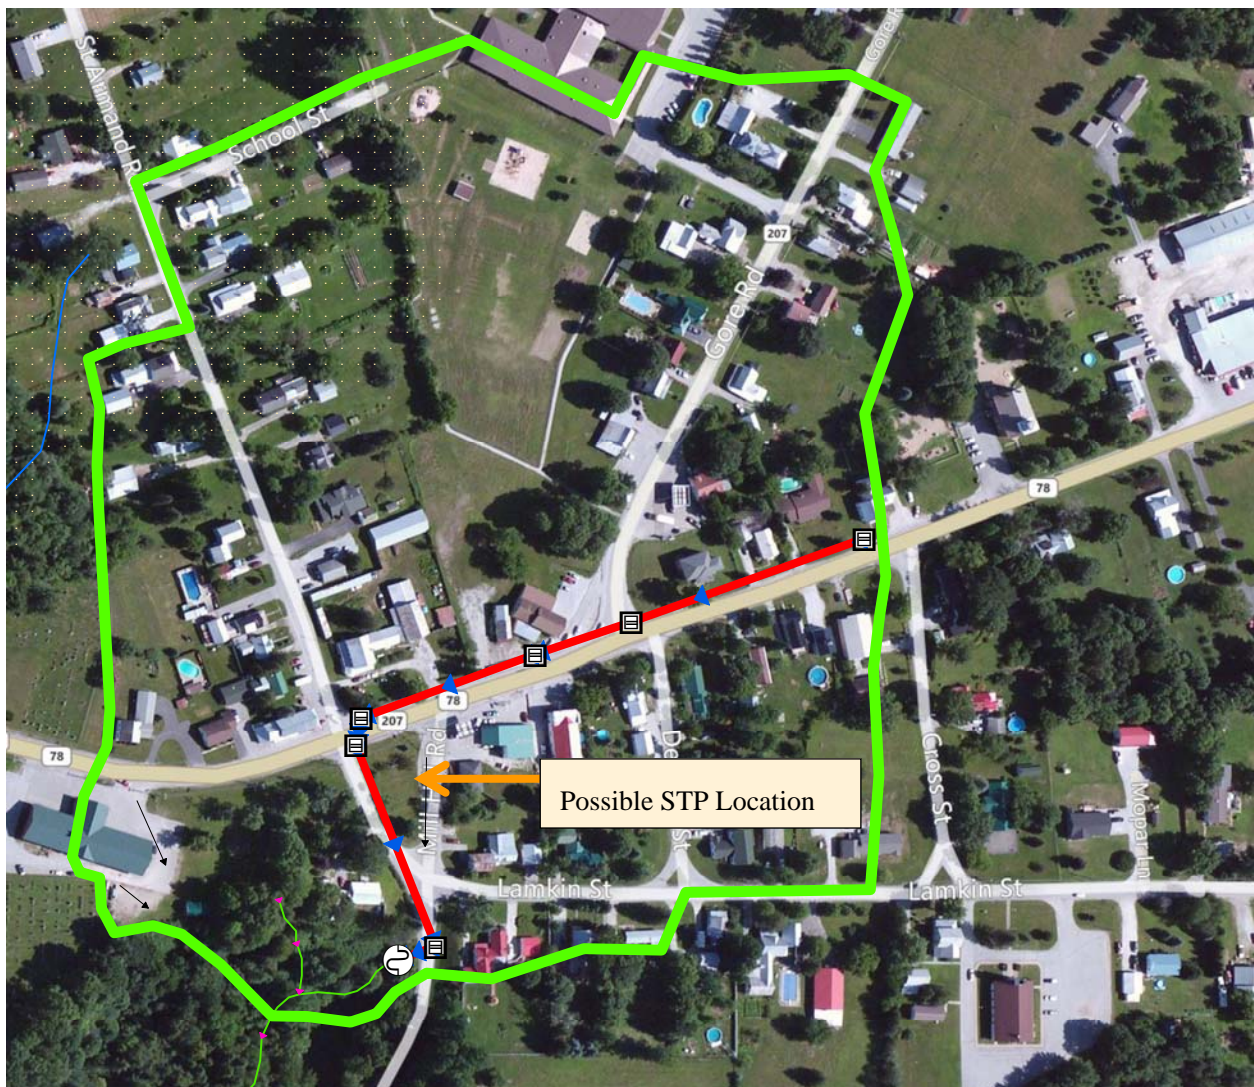
Nearly all of the village area of Highgate, a 32 acre catchment, drains south to a swale located along Mill Hill Road. A closed drainage system that collects stormwater along a section Vermont Route 78 discharges directly to this swale (Figure 3). Direct drainage from the street surfaces and this storm sewer are causing localized erosion at the outfall. Armoring this outfall with riprap is recommended—and to achieve more substantial improvements, source control is recommended to reduce the volume of runoff reaching the outfall. A “green street” approach could be employed, to turn out stormwater runoff from the road (particularly along St. Armand Road) into a series of small soak-away areas. Another treatment practice option could include a more centralized STP in the triangle median at the intersection of St. Armand Road, Vermont Routes 207 and 78, and Mill Hill Road. Much of this catchment area is underlain by well-drained Windsor loamy fine sand (HSG A), meaning the soils have a high infiltrative capacity and few seasonal high groundwater or shallow bedrock limitations.

Figure 2. The downtown area of Highgate is shown in this figure. Storm sewer is shown flowing from east to west, then to an outfall south of town on Mill Hill Rd. The contributing watershed is shown in green.

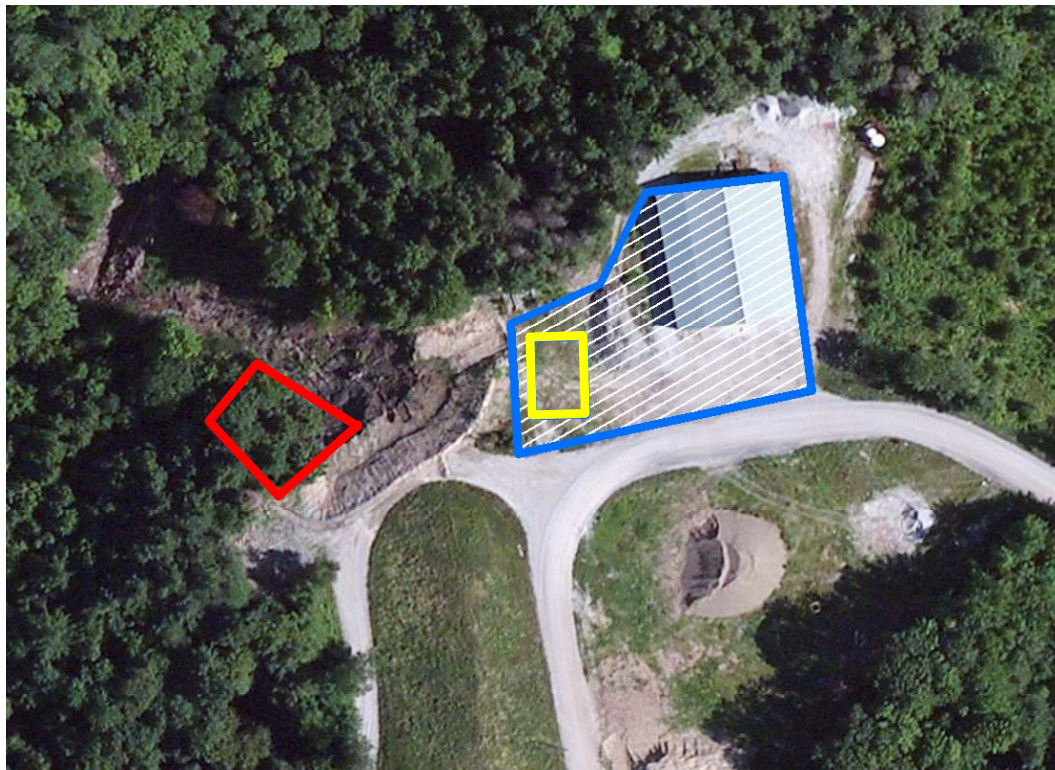
The Town of Highgate’s sand shed property (Figure 4), located on Transfer Station Road, is a potential source of sediment to an unnamed tributary of the Missisquoi River. This property was the site of a slope failure that occurred in the spring of 2011; the orthophoto below shows the slope failure clearly. The failed slope was repaired and stabilized, but stormwater is concentrating and leaving the site west of the repaired slope, and a gully is evident at this location (outlined in red). Stabilization measures should be considered to prevent propagation of the gully. In addition, during a December 2012 inspection, a catch basin (located near the western edge of the proposed STP, outlined in yellow) was found to be filled with sediment to the point where it did not function. It was not clear whether this catch basin drained to a dry well or to a conventional outlet.

Figure 4. Highgate town sand shed property. 0.65 acres of treatable impervious area is shown in blue, proposed STP location in yellow, and erosion gully shown in red. Note: slope damage shown in photo has been repaired.

Soils at the site appear to be well-drained Windsor loamy fine sand (HSG A), with a seasonal water table more than five feet below ground surface. Infiltration-based STPs will be effective if the native soils have not been overly compacted by grading or heavy equipment movement over the site. An infiltration-based STP could be constructed that used the existing catch basin as a high-flow outlet. The STP would keep sediment on-site, reduce impacts to water quality, and reduce the need to frequently clean out the catch basin.

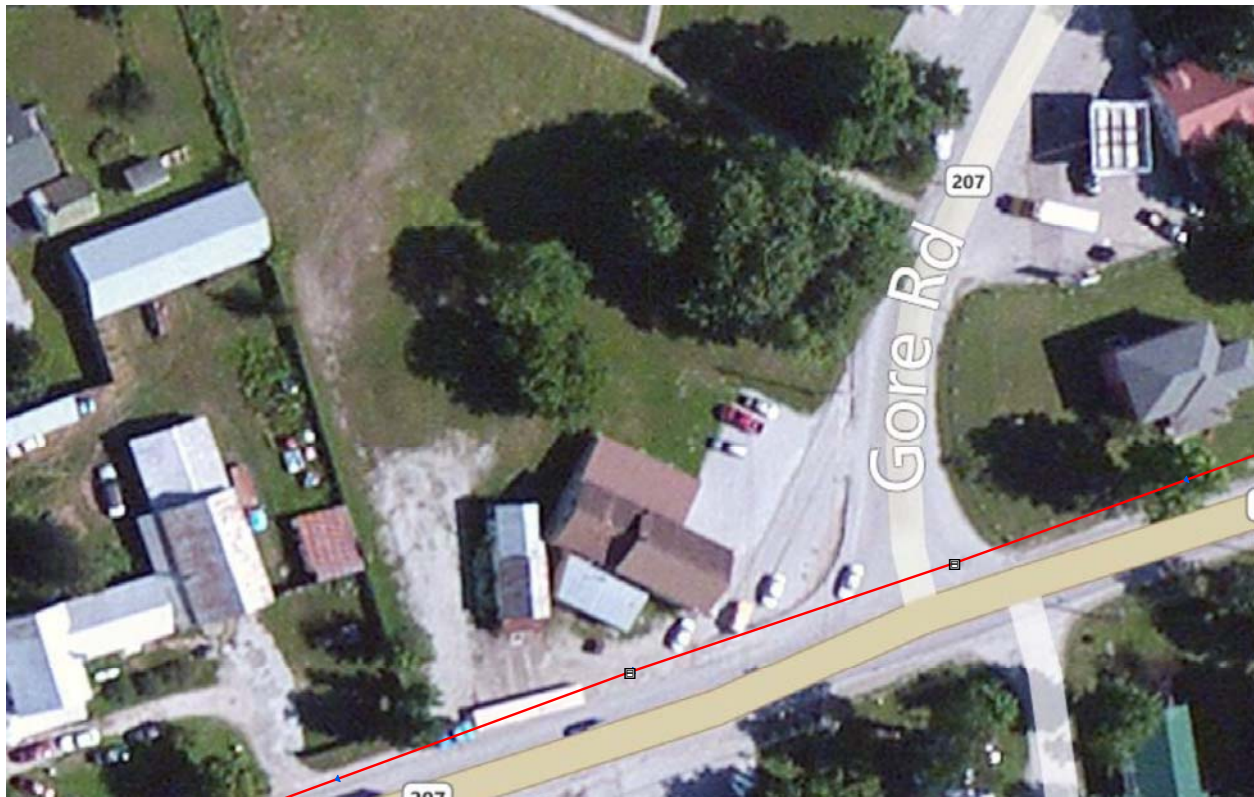
Figure 5. The Highgate Municipal Town Plan proposes the construction of a Park-and-Ride facility at the corner of Vermont Routes 207 and 78. Soil conditions favor infiltration-based practices, such as porous pavement, at this site.

Soils in at this location appear to be well-drained Windsor loamy fine sands, with a seasonal high water table more than five feet below ground surface. These soil conditions, coupled with the site’s flat topography, make infiltration-based practices an effective STP option. As plans develop, low-impact design practices such as porous pavement and infiltration features should be strongly promoted. Alternatively, if plans for a Park-and-Ride facility at this location have been abandoned, the existing impervious pavement could be removed and natural site hydrology restored.

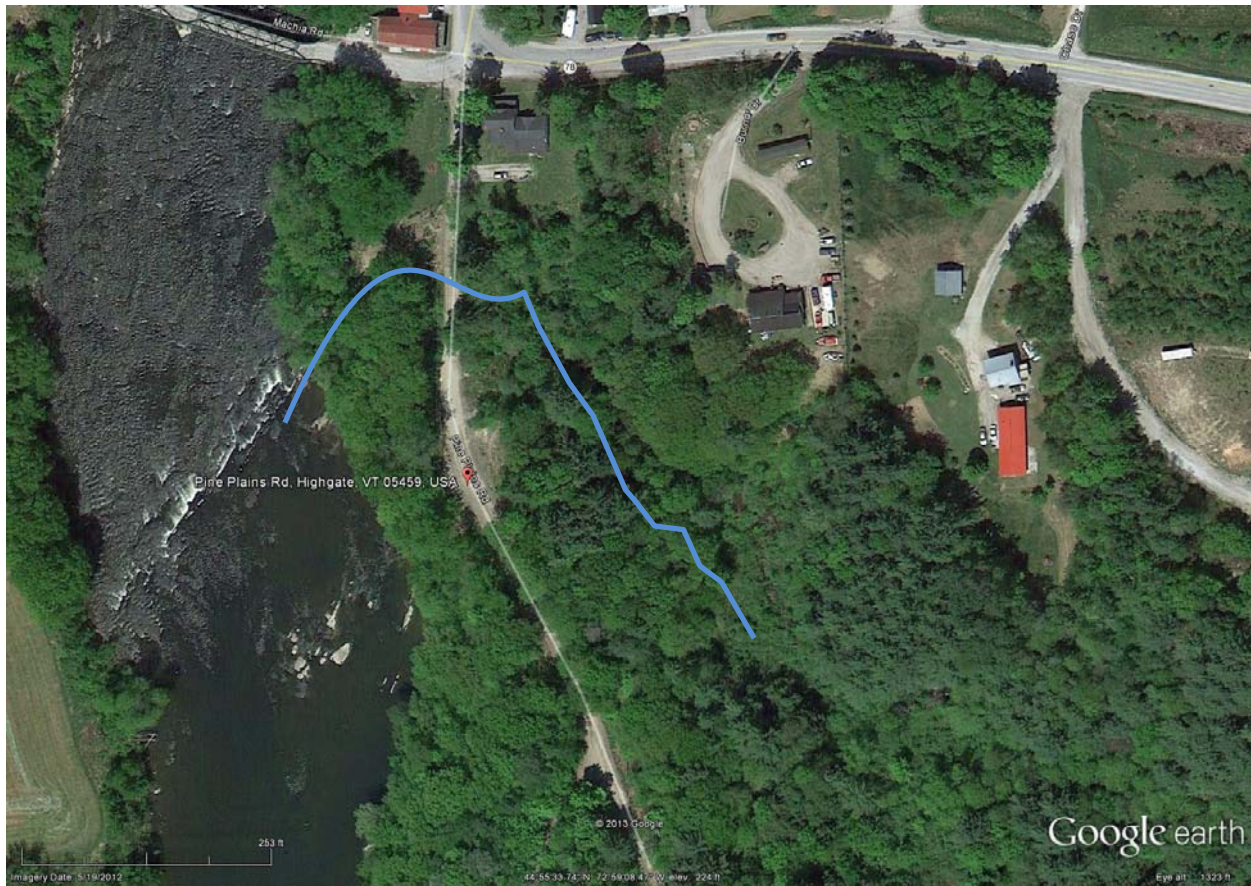
Pine Plains Road was found to be in poorly maintained condition (Figure 6). Only a short section of the road is maintained by the Town of Highgate, with the steepest sections maintained by private interests. Roadside ditches are in need of maintenance or do not exist. The lack of maintenance of the private section of the road is impacting the town-operated section. Poor ditch condition, coupled with poor grading, has resulted in substantial erosion of the road surface, which is turned out into the adjacent woodland and eventually deposited in a small tributary stream just upstream of its confluence with the Missisquoi River (Figure 6).

Figure 6. Pine Plains Rd. (south of Vermont Route 78) is poorly maintained. Eroding sediment from the road is impacting an unnamed stream near its confluence with the Missisquoi River.

The problems associated with Pine Plains Road could be remedied by excavating roadside ditches and properly grading the road. In steeper sections, road grade dips may be required to direct water off of the road surface. Roadside ditches in steeply sloping locations may need to be rock-lined. Ultimately, however, it is unclear what authority the Town has to require correction of drainage issues located on the privately-maintained section of Pine Plains Road.

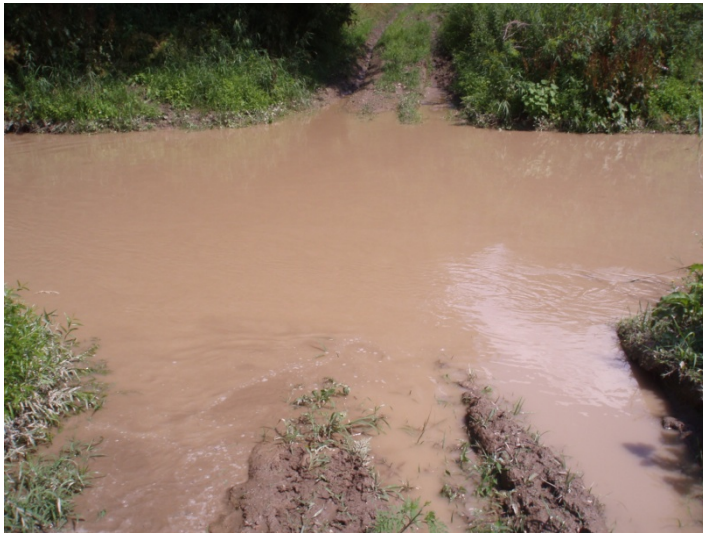
Unimproved or poorly constructed farm road stream crossings are a significant source of sediment to the Rock River and its tributaries in the Town of Highgate. During this project, landowners granted access to and provided Project Team staff the opportunity to observe four specific crossings; an example of the conditions observed is provided in Figure 7 below. While these crossings are on private land and thus are not directly within the purview of the Town, they have a significant and on-going impact on stream water quality. Implementation of best management practices for agricultural road crossings will also improve property owners' ability to access their land. State and federal programs may be available to aid with implementing these improvements.

Figure 7. Unimproved farm road crossing, shown during high flow conditions. Significant ruts suggest the landowner is often challenged to ford the river.

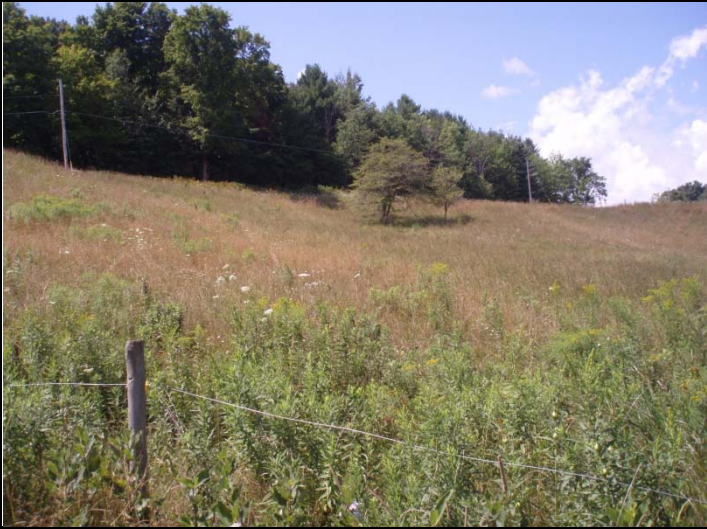
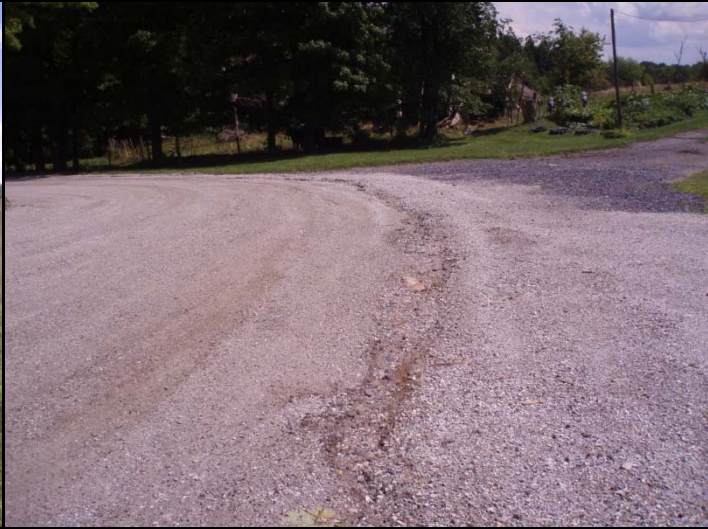
Photo 1. Pasture on Rollo Rd. sloping to Rock River	Photo 2. Erosion on Rollo Rd

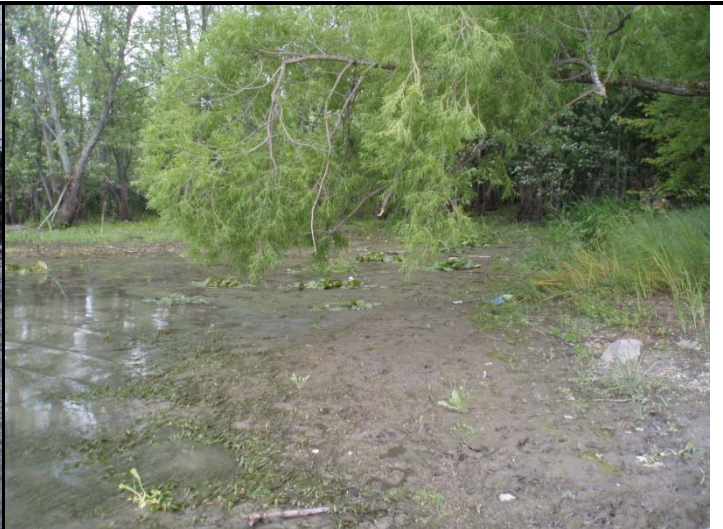
Photo 2. Evidence of flooding upstream of bridge

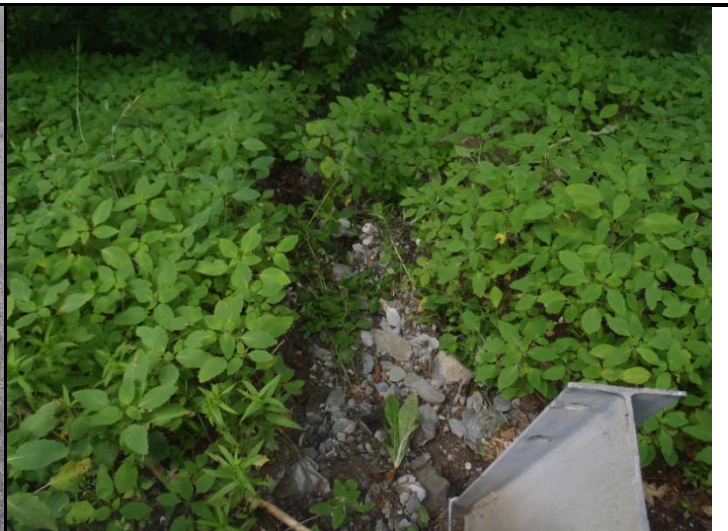
Photo 2. Blowout at the end of guardrail

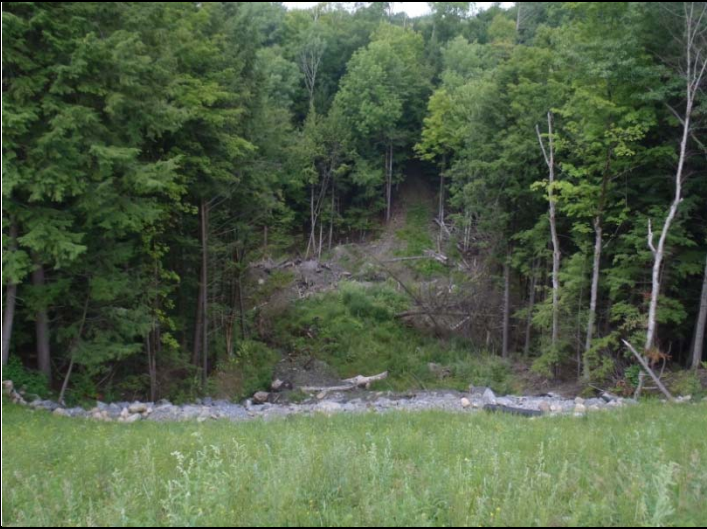
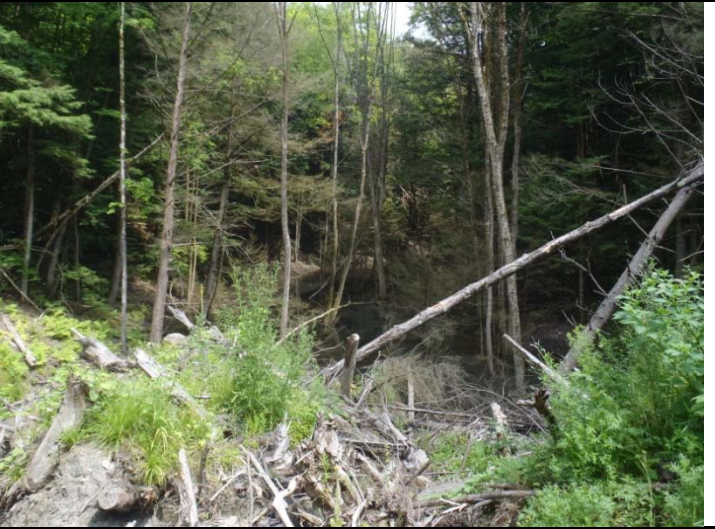
Photo 1. Looking down landslide from town shed	Photo 2. Debris obstructing waterflow at bottom

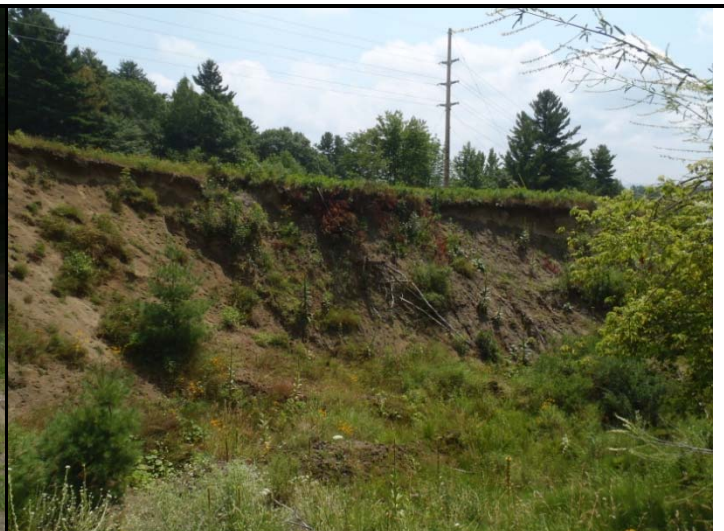
Photo 2. Eroded bank

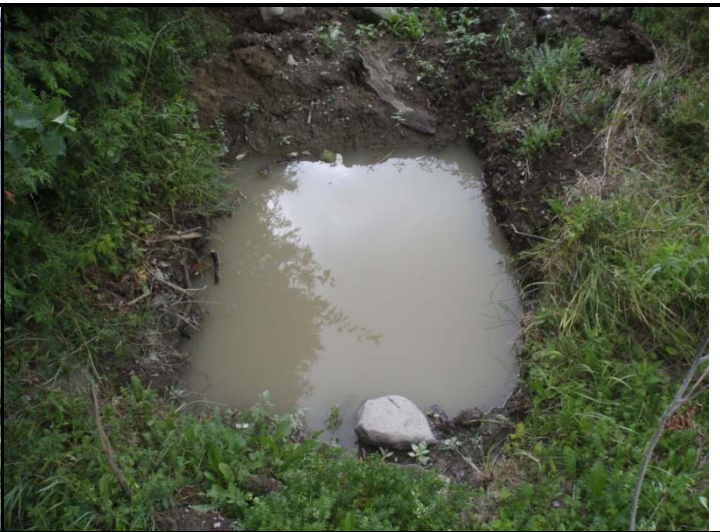
Photo 2. Close-up of submerged outfall

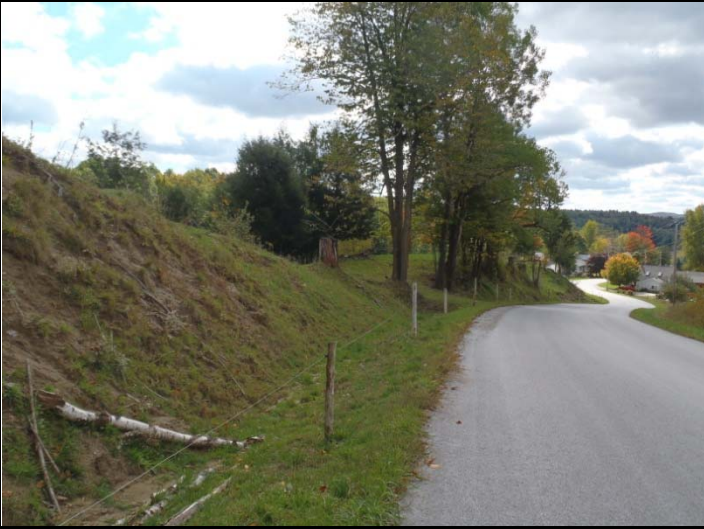
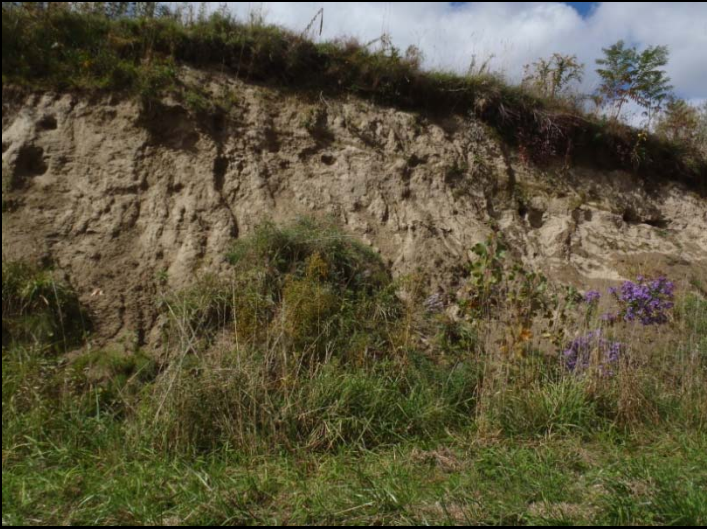
Photo 1. Ditching on East side of Durkee Rd	Photo 2. Erosion on West side of Durkee Rd

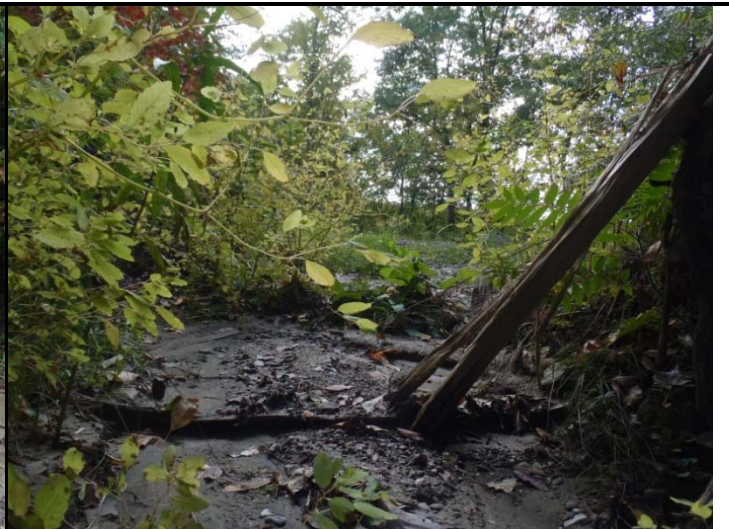
Photo 2. Separate instance of overland flow

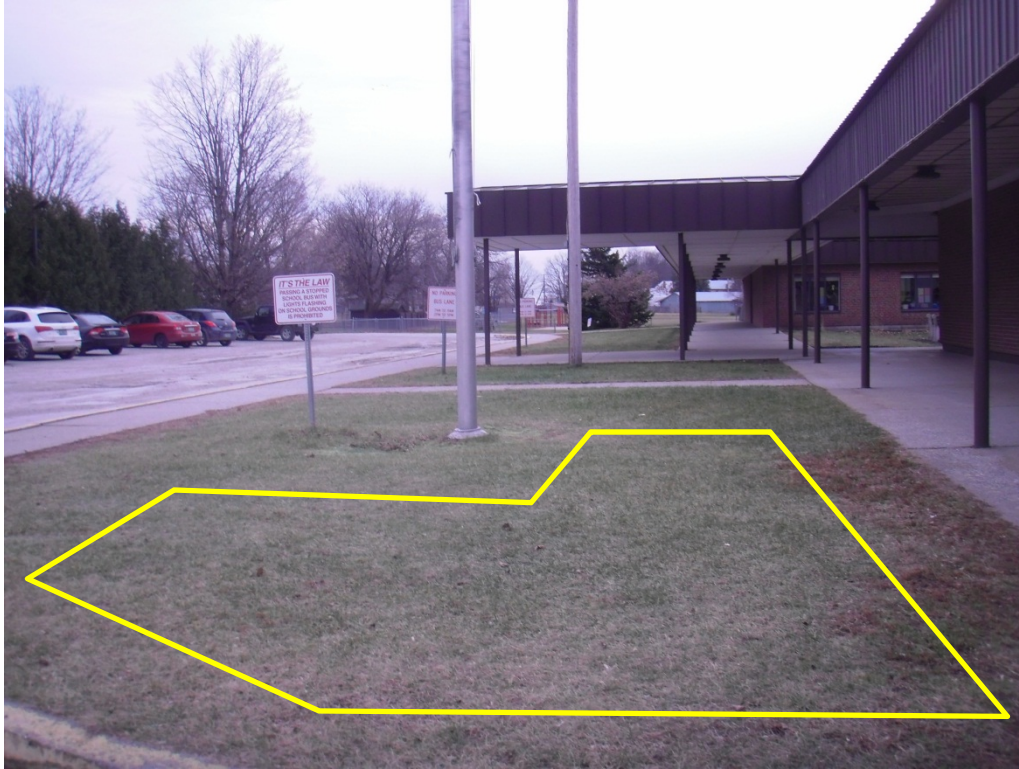
Figure 5. Bioretention areas located under the drip edge of the roof could collect and infiltrate runoff near the front entrance to the school.

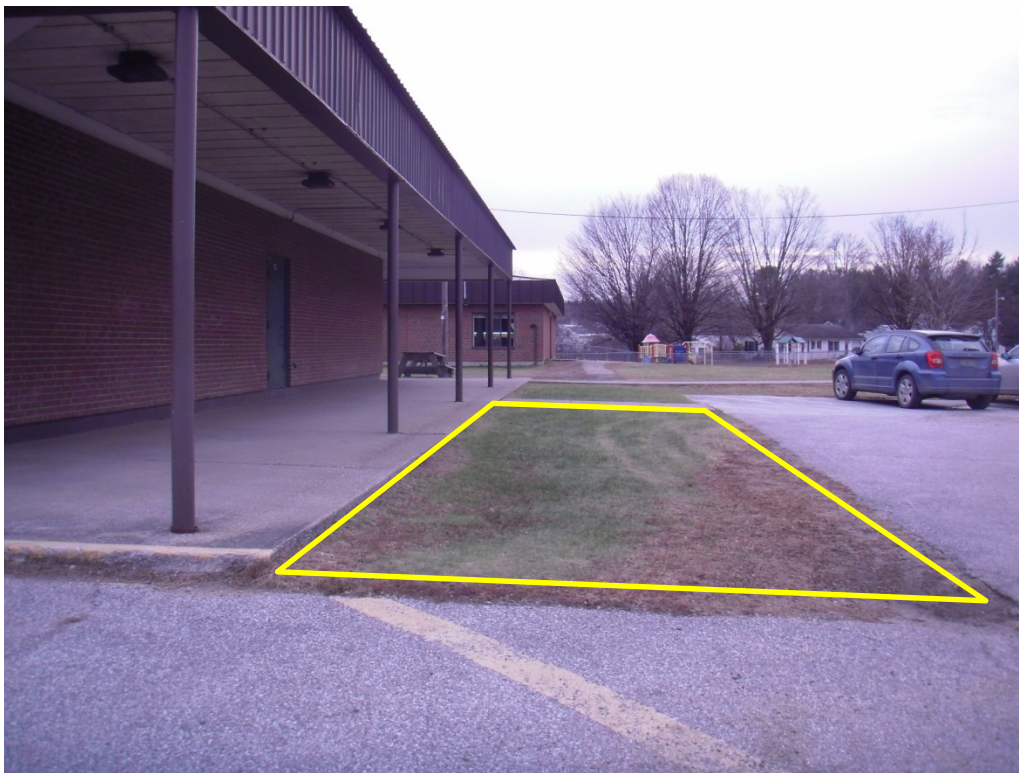
Figure 6. Infiltration area opportunity in the back of the school.

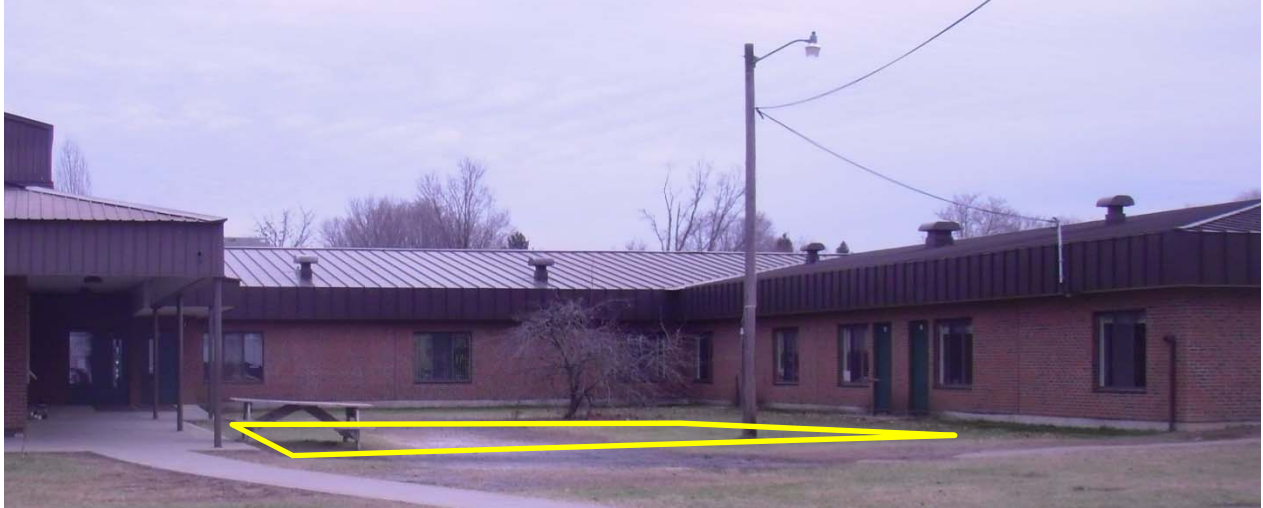
Figure 7. A large rain garden or bioretention area could be installed in the rear courtyard of the school where green space is not currently utilized.

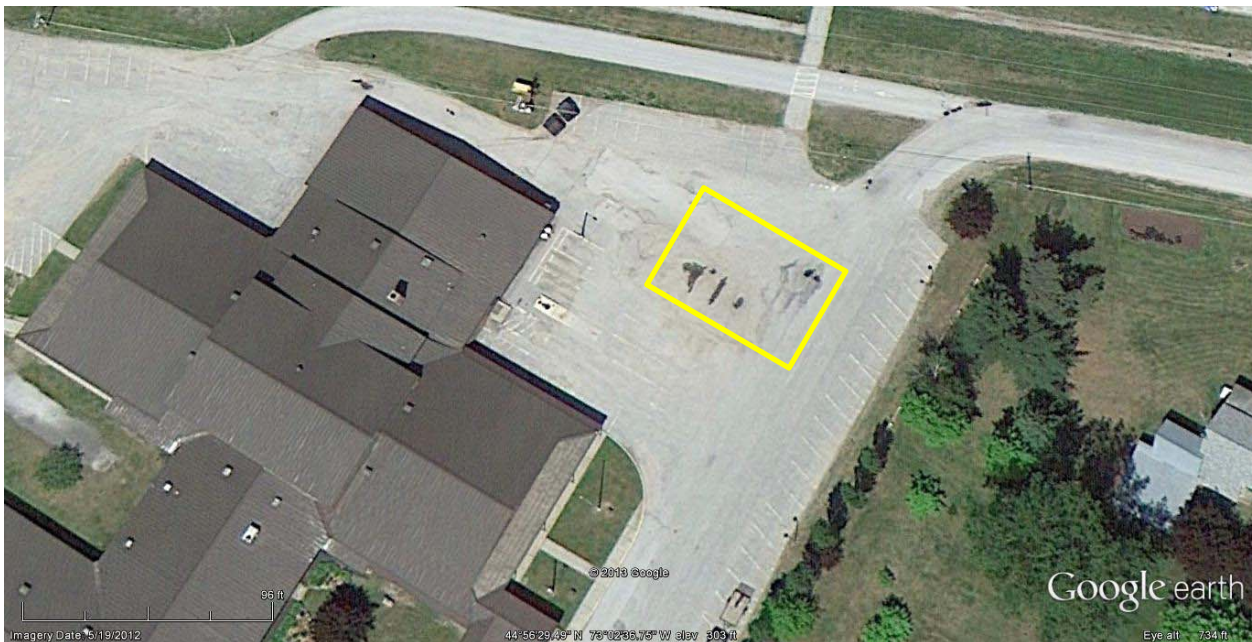
Figure 8. Low area in parking lot (shown in yellow) could be converted to stormwater treatment practice.

Parking lot runoff could be treated in STPs located around the perimeter as shown in Figure 4, or in the middle of the lot as shown in Figure 8. The area highlighted in yellow is a low point that currently collects a section of parking could be converted to act as an infiltration area—a parking island designed to collect and infiltrate stormwater. This STP would look similar to a typical parking lot island, only rather than being raised above the pavement, the island would sit slightly below the surrounding pavement. Stormwater would flow into the island where it would infiltrate. An example of this infiltration practice is shown in Figure 9.

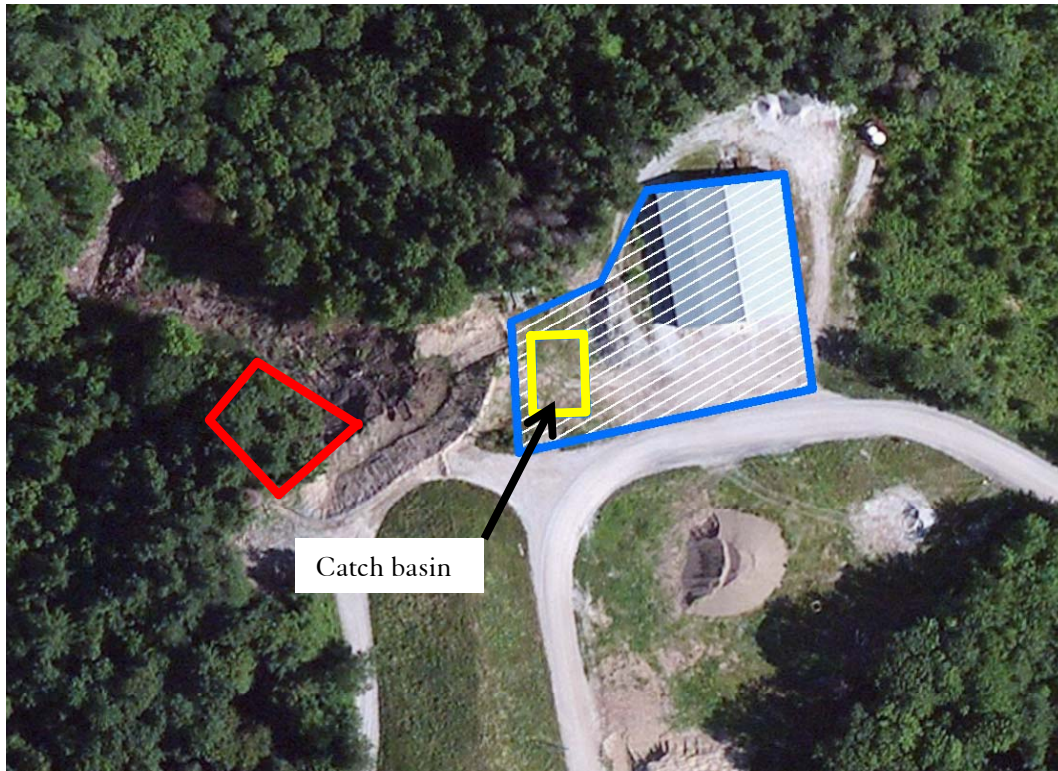
Figure 10. Highgate town sand shed property. 0.65 acres of treatable impervious area is shown in blue, proposed STP location in yellow, and erosion gully shown in red. Note: slope damage shown in photo has been repaired.

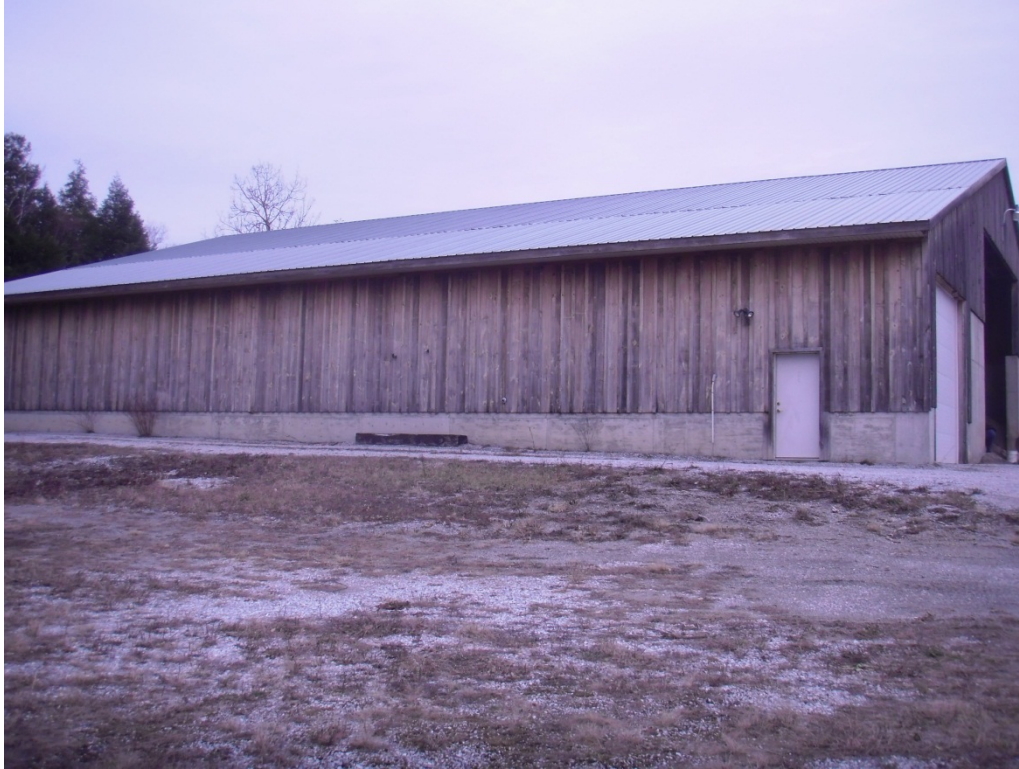
The Highgate town sand shed property (Figure 11), located on Transfer Station Road, is a potential source of sediment to a tributary of the Missisquoi River. This property was the site of a slope failure that occurred in spring of 2011 (visible in Figure 10). The failed slope has since been repaired and stabilized but some lingering issues remain. A catch basin was found to be completely filled with sediment during a December 2012 inspection (see Figure 12). It was not apparent whether this catch basin drained to a dry well or to a conventional outlet. Regardless, the catch basin is filled to a point where it does not function. Stormwater is also concentrating and leaving the site west of the repaired slope. A gully is evident at this location. Stabilization measures should be considered to prevent propagation of the gully.

Figure 11. Town sand shed and adjacent gravel lot includes more than 0.5 acres of potentially treatable impervious surface.

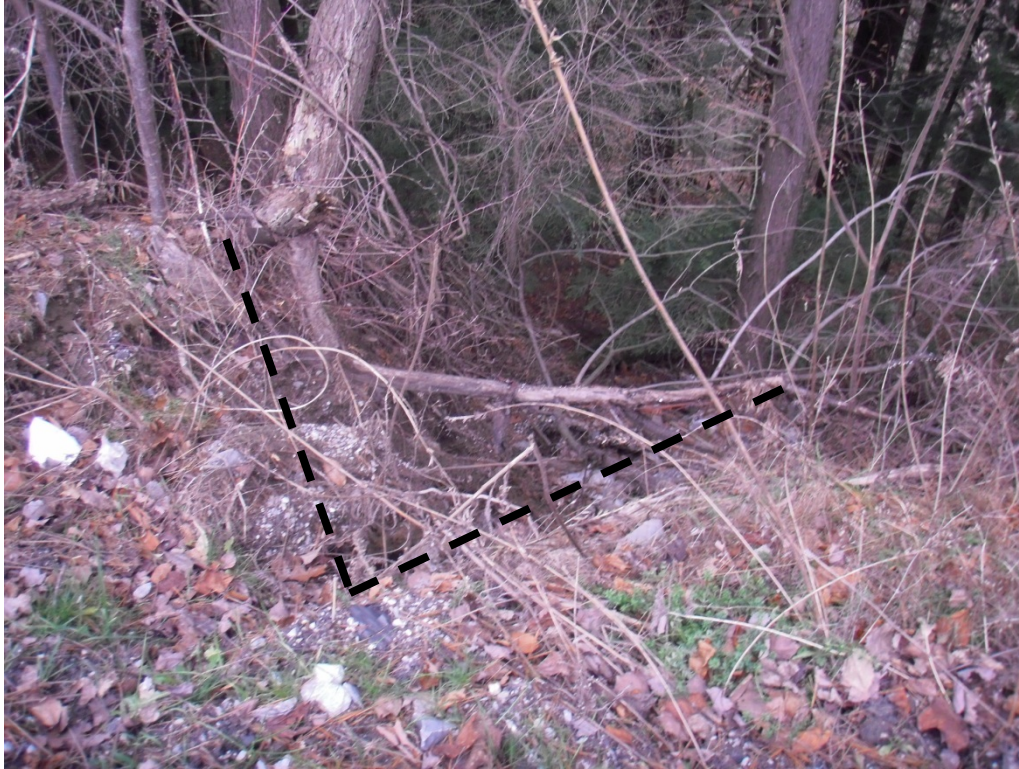
Figure 13. Erosion gully forming near repaired landslide at Highgate town sand shed.

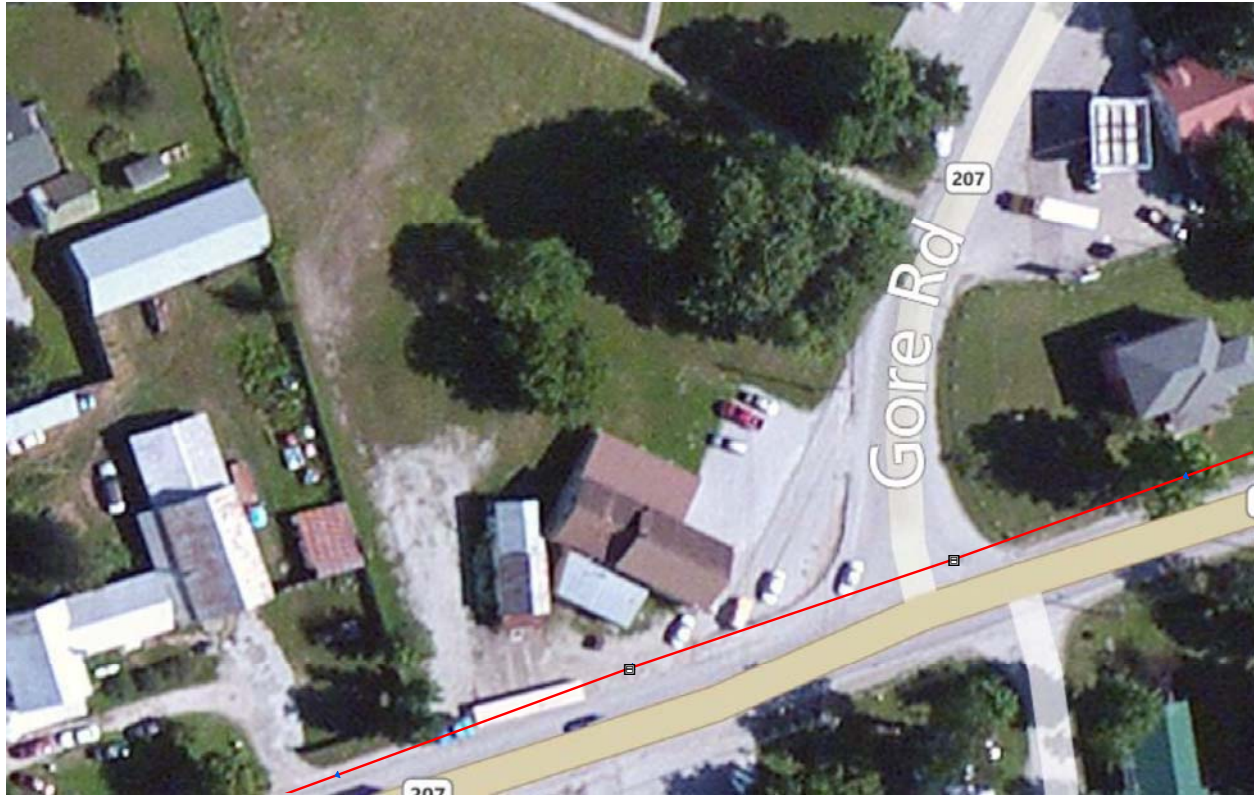
Figure 14. The Highgate Municipal Town Plan proposes the construction of a Park-and-Ride facility at the corner of VT-207 and VT-78. Soil conditions favor infiltration practices such as porous pavement at this site.

Soils in at this location are reported by the NRCS as Windsor loamy, fine, sand with a deep water table (over 200 cm). These soil conditions and flat topography make infiltration practices an effective option. As plans develop, low-impact design practices such as porous pavement and infiltration features should be strongly promoted. Alternatively, if plans for the Park-and-Ride facility at this location are abandoned, the existing pavement could be removed and natural site hydrology restored.

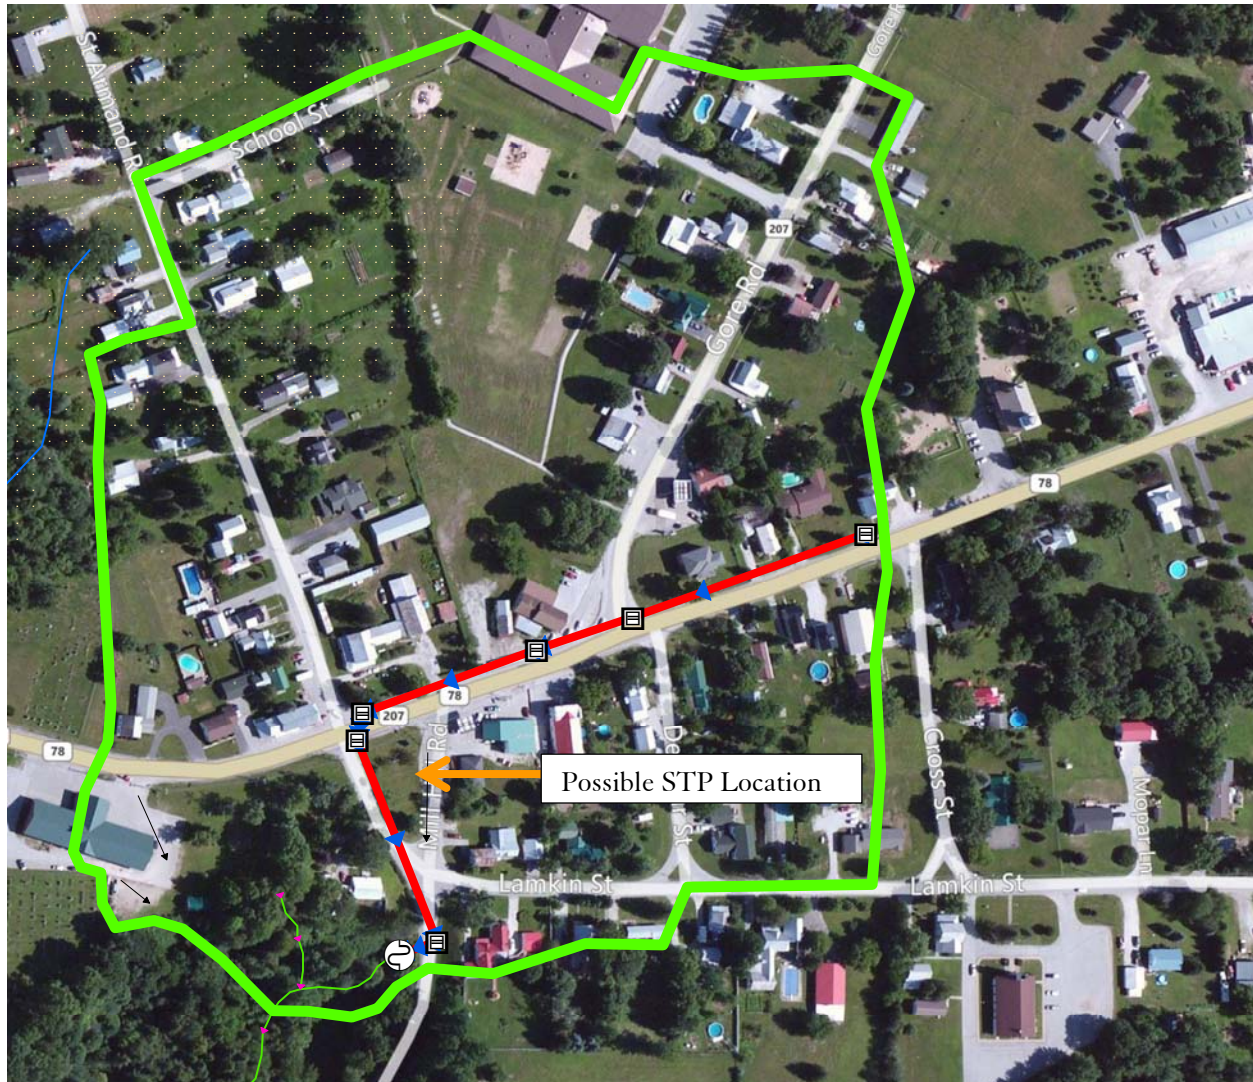
Figure 15. The downtown area of Highgate is shown in this figure. Storm sewer is shown flowing from east to west, then to an outfall south of town on Mill Hill Rd. The contributing watershed is shown in green.

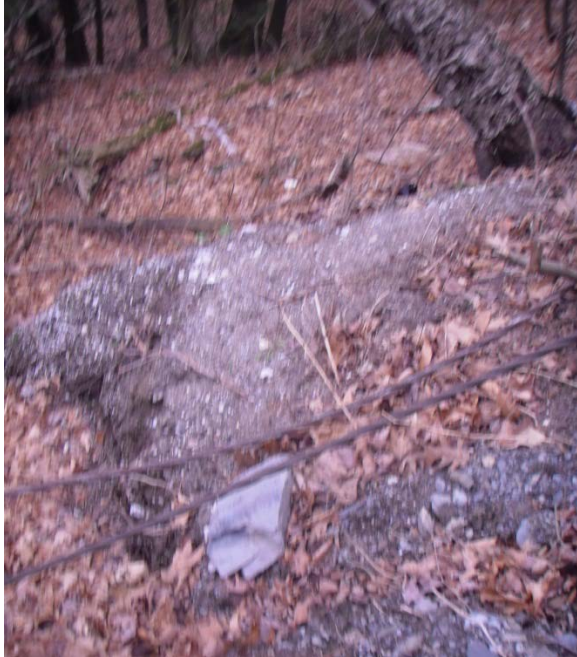
Figure 16. Erosion at the Mill Hill Rd. storm sewer outfall.

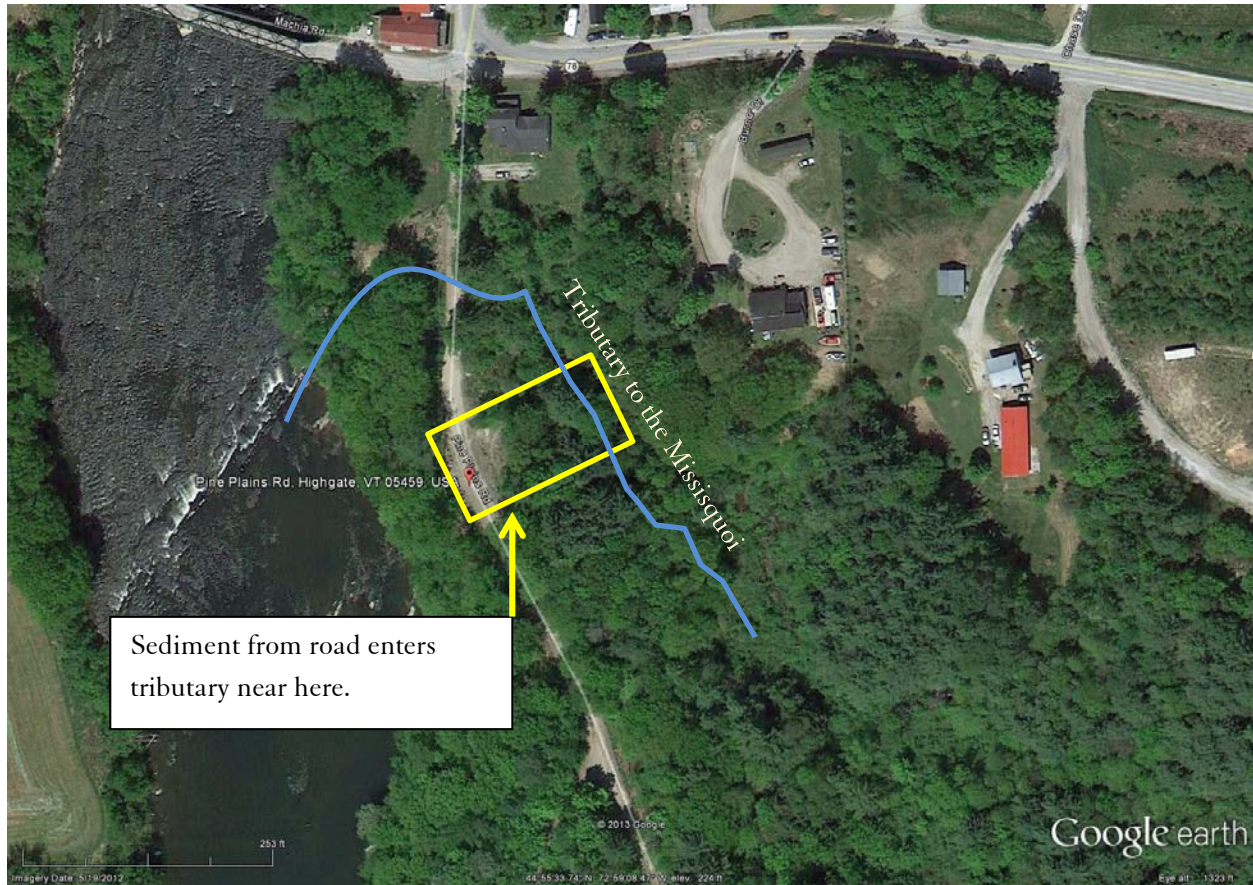
Figure 17. Pine Plains Rd. (south of VT-78) is poorly maintained. Eroding sediment from the road is impacting a tributary near the confluence with the Missisquoi River.
