STORMWATER MANAGEMENT PLAN FOR HIGHGATE

FINAL REPORT

Stone Project ID 112475-W

March 1, 2013

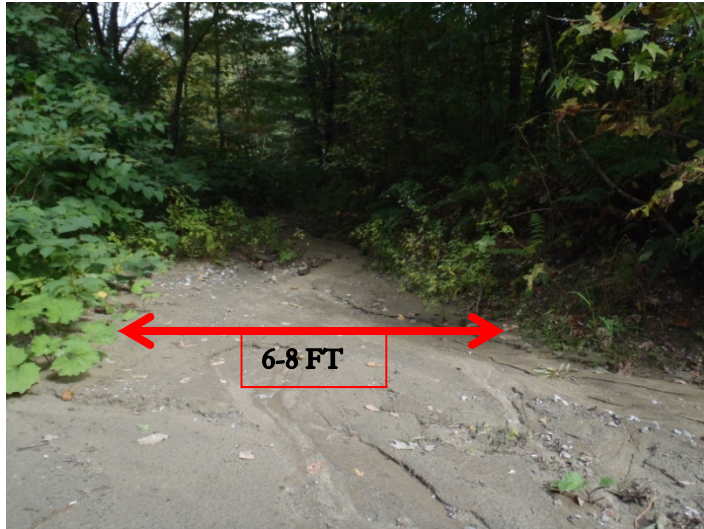
Figure 18. Eroding sediment from the road entering tributary to Missisquoi River.

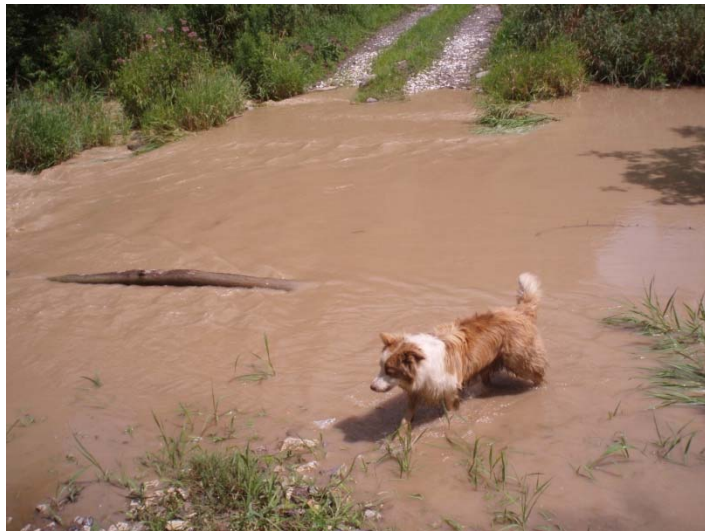
Figure 25. Unimproved farm road crossing, shown during high flow conditions. Bank erosion evident on both sides of the stream.

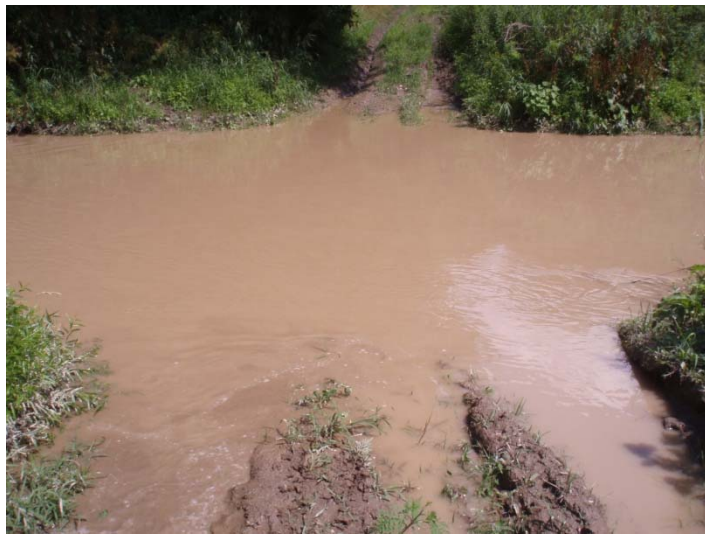
Figure 25. Unimproved farm road crossing, shown during high flow conditions. Significant ruts suggest landowner challenged to ford river during certain flow regimes.
