# Centerville Brook Corridor Plan

Hyde Park, Vermont

February 10, 2010

# Centerville Brook Corridor Plan Hyde Park, Vermont

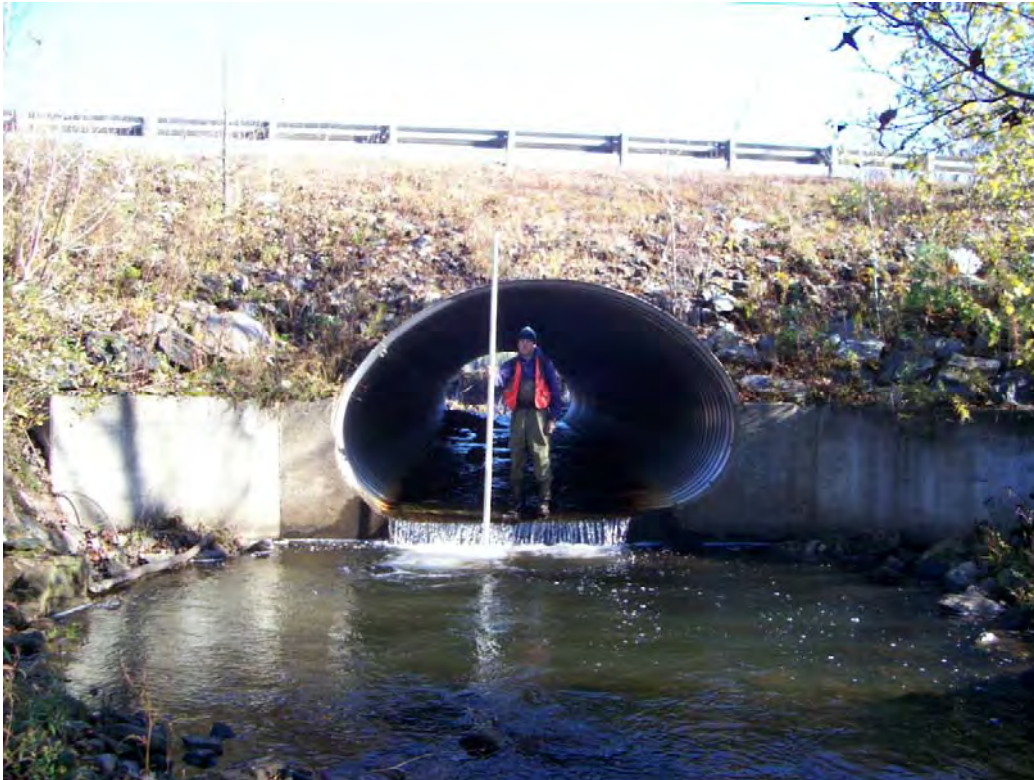
None of the culverts had sediment throughout the structure and were flagged as having reduced aquatic organism passage. The culvert crossing at Centerville Road in reach R1507-B is freefall with an outlet drop of 1 foot (see Figure 10). Using the VT Organism Passage Coarse Screen (Milone and MacBroom 2008) this culvert was flagged as no AOP for all aquatic organisms including adult salmonids. This structure is a high priority for replacement or retrofit.

**Figure 10. Culvert at Centerville Road in reach R15.07-B was flagged as “No Aquatic Organism Passage” using the Vermont Culvert Aquatic Organism Passage Screening Tool (Milone and MacBroom, Inc, 2008)**

R1505-D	Frost Road, Hyde Park	Bridge	Sharp bend	56% <sup>2</sup>	NA	Partially compatible	Moderate to high
R1507-B	Centerville Road, Hyde Park	Culvert	Free fall	57% <sup>3</sup>	No AOP <sup>6</sup>	Mostly compatible	High

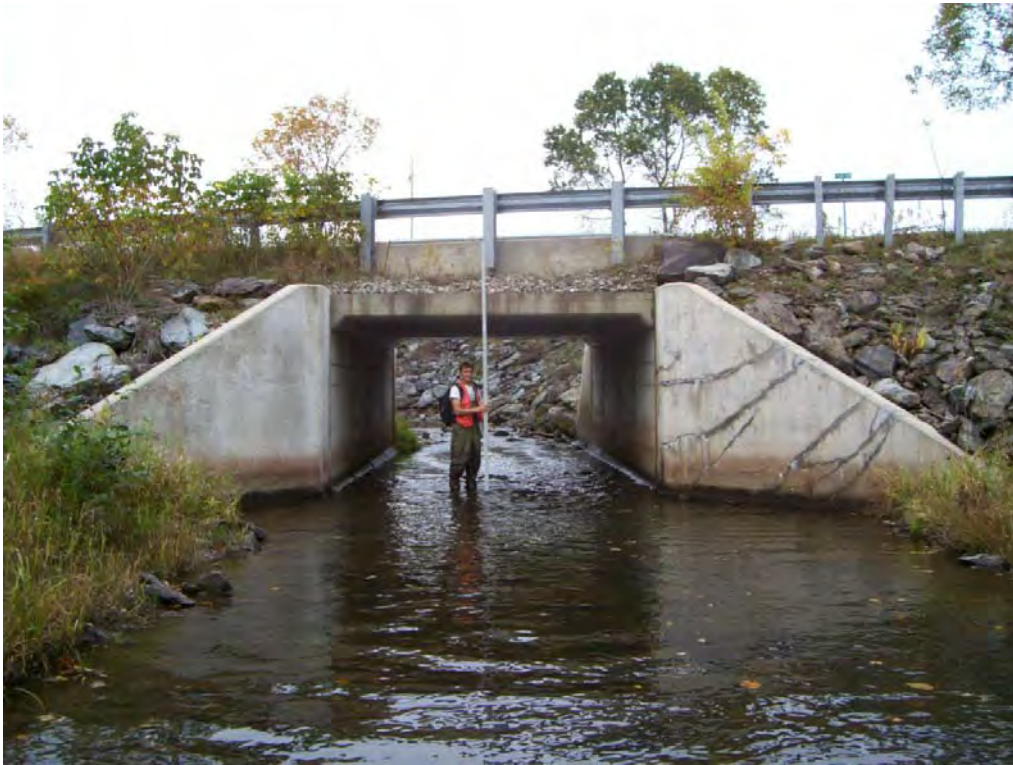
Seven of the eight structures in Table 5 were found to be fully or mostly compatible using the geomorphic screening tool. The bridge on Frost Road in Hyde Park (Figure 11) was found to be partially compatible using the Vermont Geomorphic Screening Tool (Milone & MacBroom, Inc., 2008). This structure is rated as moderate to high priority for replacement due to the sharp bend and scour above and below the structure. The alignment of this crossing should be reconsidered if the structure is replaced at some point in the future.

**Figure 11. Bridge crossing at Frost Road within segment R15.05D. Centerville Brook approaches this structure at a sharp bend.**

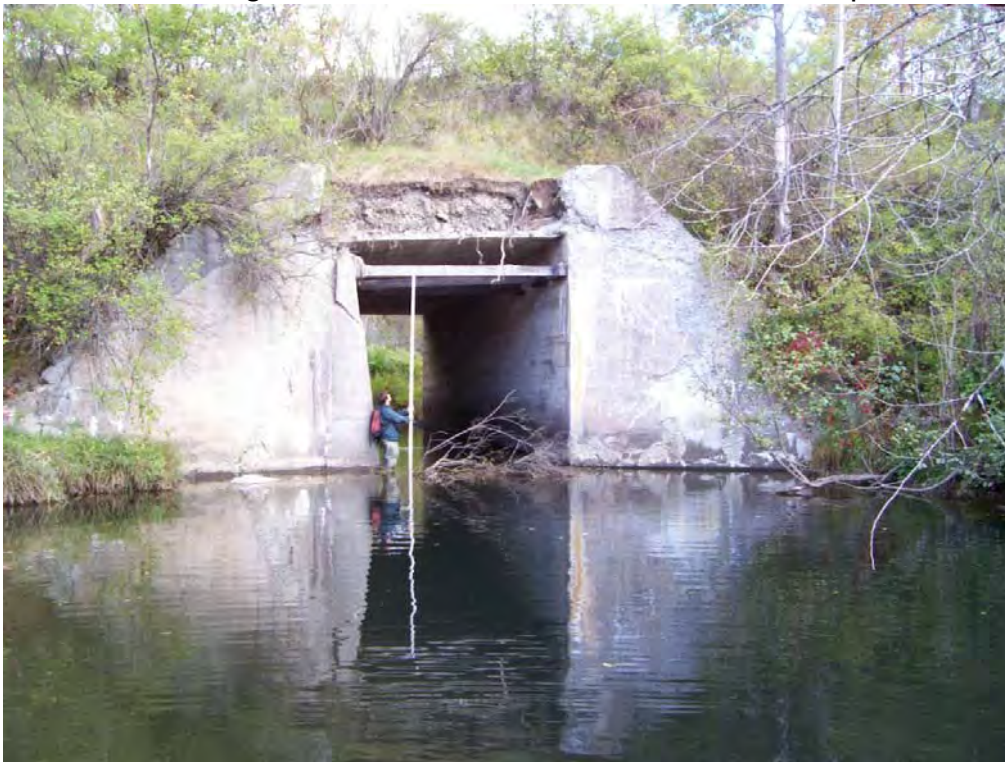
The bridge in reach R15.02, which crosses the Rail to Trail network, is undersized relative to the bankfull width and was noted to cause localized geomorphic instability due to sediment transport and alignment. As shown in Figure 12, the bank above the outlet of this structure is eroding. It is recommended that this structure be replaced.

**Figure 12. Rail to trail crossing in reach R15.02 has bank erosion above the outlet. This structure is undersized relative to the bankfull channel width and is recommended for replacement.**

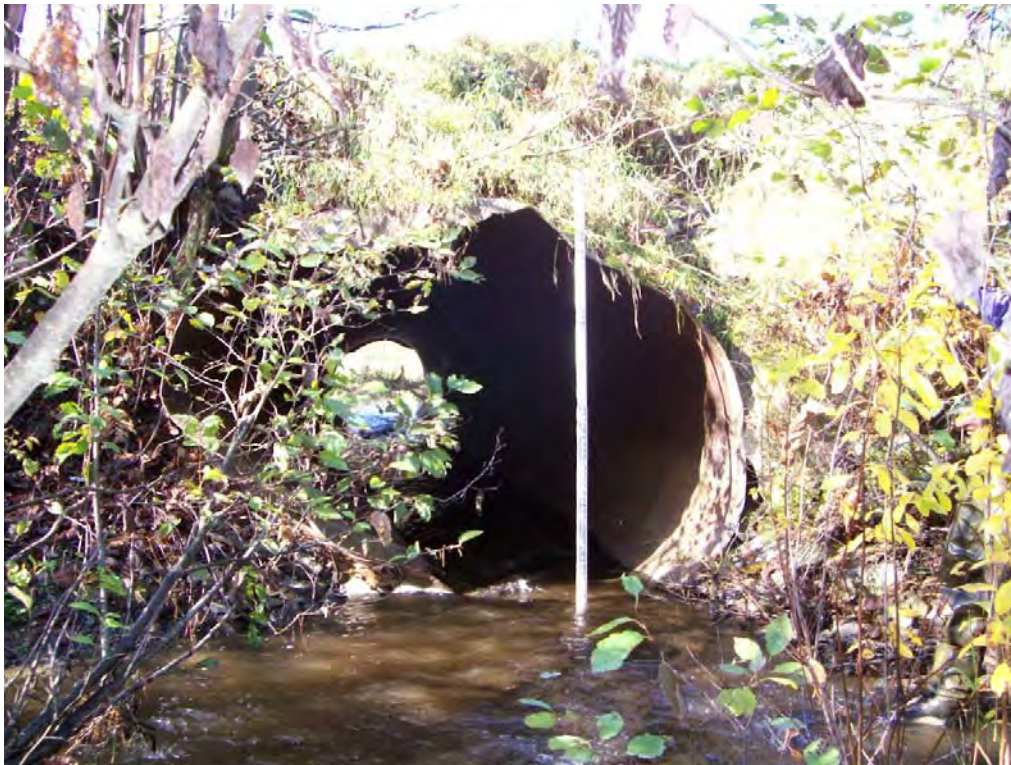
The farm crossing in reach R1506-A is also undersized, but is rated low priority for replacement at this time. The structure is located in a wetland and floodwaters have access to the floodplain. The culvert crossing at Brook Road (Figure 13) is undersized and was given a moderate to high priority to replacement due to sediment transport problems; reduced AOP and the poor condition of the culvert.

**Figure 13. Brook Road culvert crossing in reach R15.07-A is undersized and impeding sediment transport. The culvert is in poor condition and has the potential to reduce AOP.**

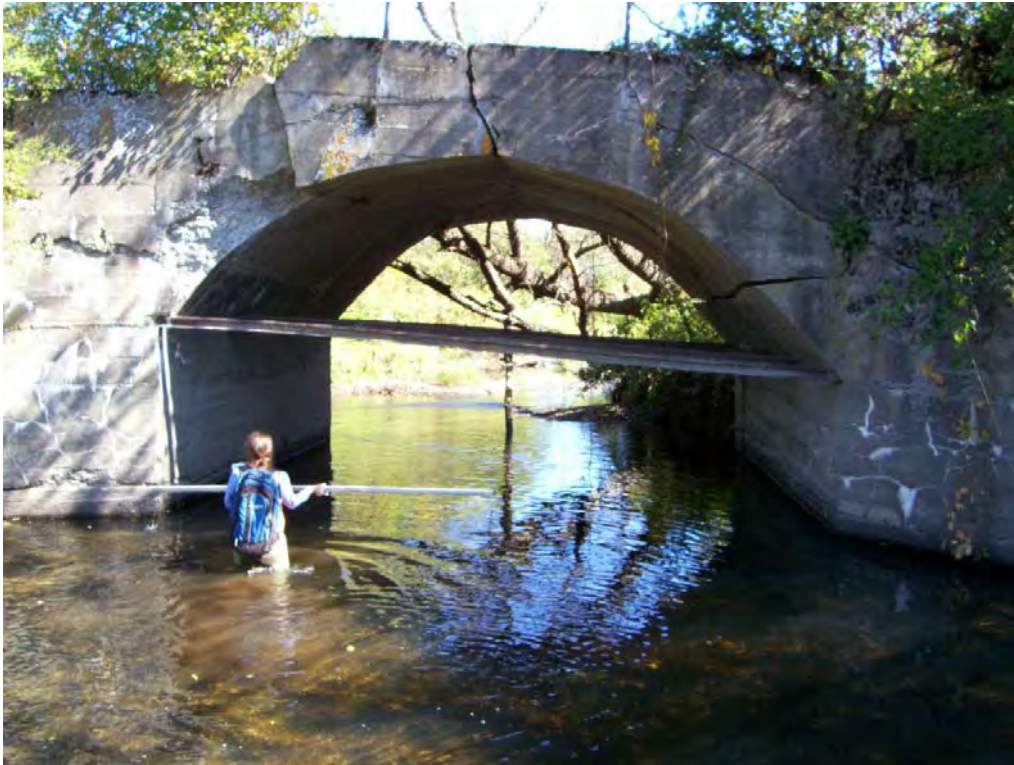
The farm bridge in reach R1501-A does not have a span which is less than 50% of the bankfull width, but was nonetheless rated as moderate to high priority for replacement. This span of this structure is 50% of the bankfull width and was noted to be causing sediment transport problems (deposition above, deposition below, score above, scour below) and was poorly aligned. The structure is in poor condition as shown in Figure 14.

**Figure 14. Farm bridge in reach R15.01-A that is structurally unsound and is causing localized geomorphic instability.**

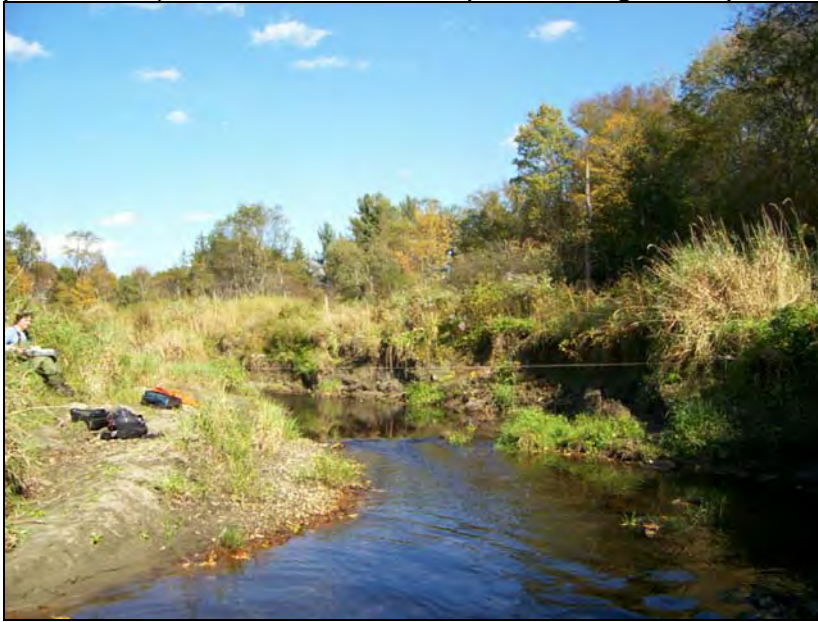
reach. The reference stream type is an “E” channel; however, due to major adjustment the channel is a “C” riffle-pool bedform undergoing major widening and extreme planform adjustment as a new floodplain is being developed.

**Centerville Brook segment R15.01-A is an “E” type channel that has undergone a stream type departure and major existing channel adjustment.**

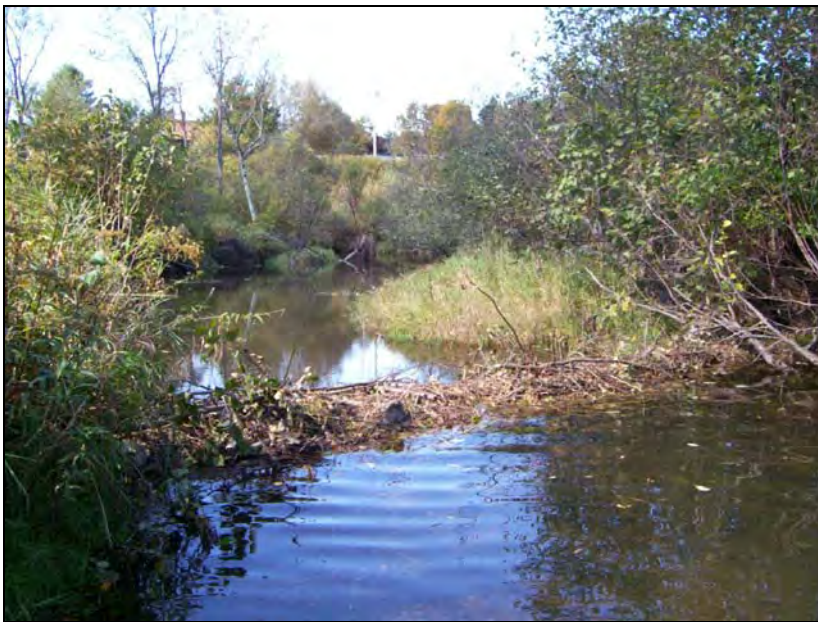
Centerville Brook segment R15.01-B flows through abandoned agricultural lands east of Hyde Park village. The stream in this reach has been impounded by several beaver dams. A complete geomorphic assessment was not conducted in this segment due to the influence of these dams.

**Centerville Brook R15.01-B has been dammed by beavers in numerous locations.**

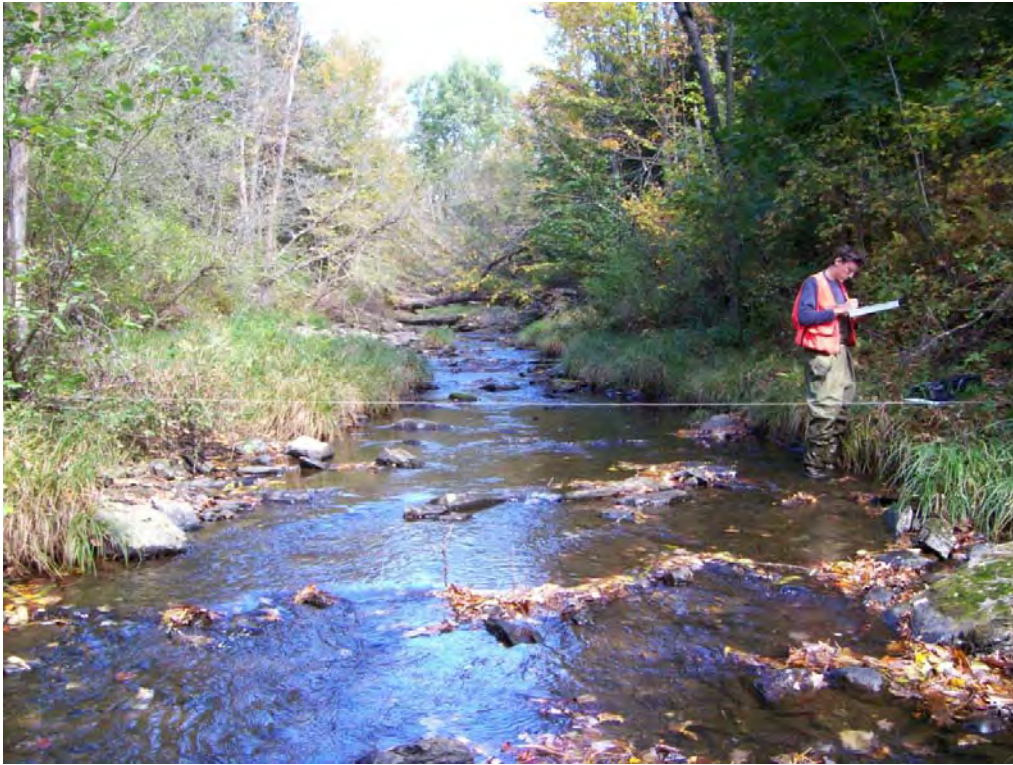
Centerville Brook reach R15.02 begins at the Main Street culvert and flows downstream for several hundred feet to the crossing of the old railway. The stream in this segment has some bedrock grade control. The lower two-thirds of the reach has enough floodplain access to make it a “C” type riffle-pool channel. The railroad crossing at the lower end of the stream reach is particularly narrow. The bridge on the rail to trail path is undersized and creating localized geomorphic instability.

**Centerville R15.02 is a “C” type channel.**

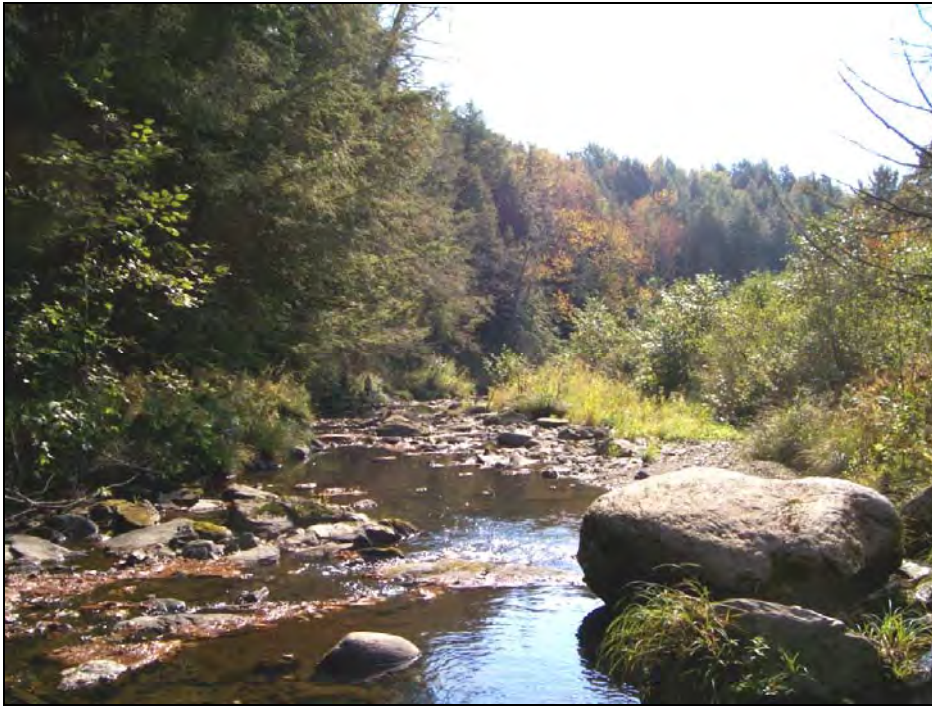
Centerville Brook segment R15.04-B is located in between two bedrock dominated segments. The valley walls in this segment broaden allowing for the deposition of sediments and a more active stream channel. Evidence of beaver damming was found near the downstream end. This damming in addition to the natural bedrock constriction found at the downstream end may account for some of the extensive sediment storage, incision, and planform adjustment that was observed in this reach. The stream is a “C” channel with a riffle-pool bedform through this segment.

**Centerville Brook segment R15.04-B appears to have historically incised.**

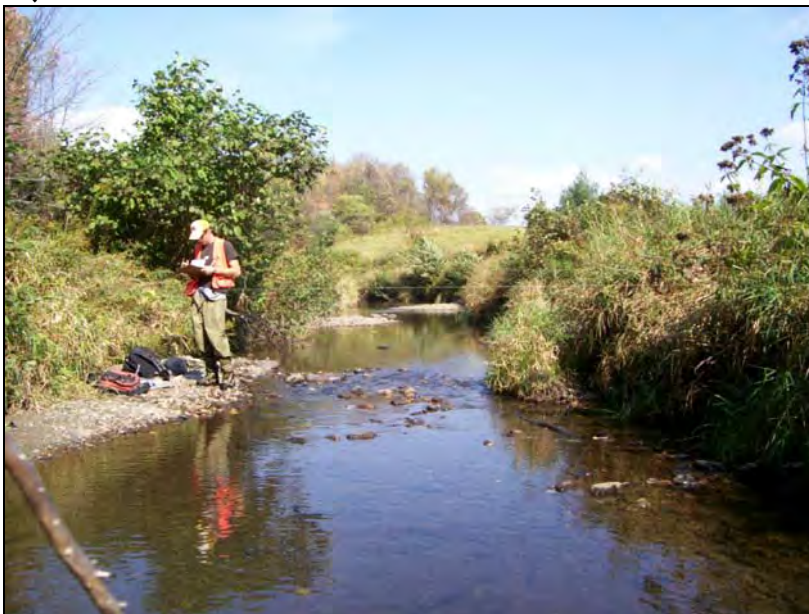
Centerville Brook R15.04-D is a short segment (850 ft.) which flows between two sections of bedrock gorge. The valley in this segment widens considerably and the streambed turns into an “E” stream type with a gravel riffle-pool bedform. The stream through this section appears to have been historically straightened and the buffer on the west bank seems to have been greatly altered. In response to these alterations, the channel was found to be undergoing minor aggradation, widening and planform adjustments.

**Centerville Brook segment R15.04-D is an “E” channel that has been historically straightened.**

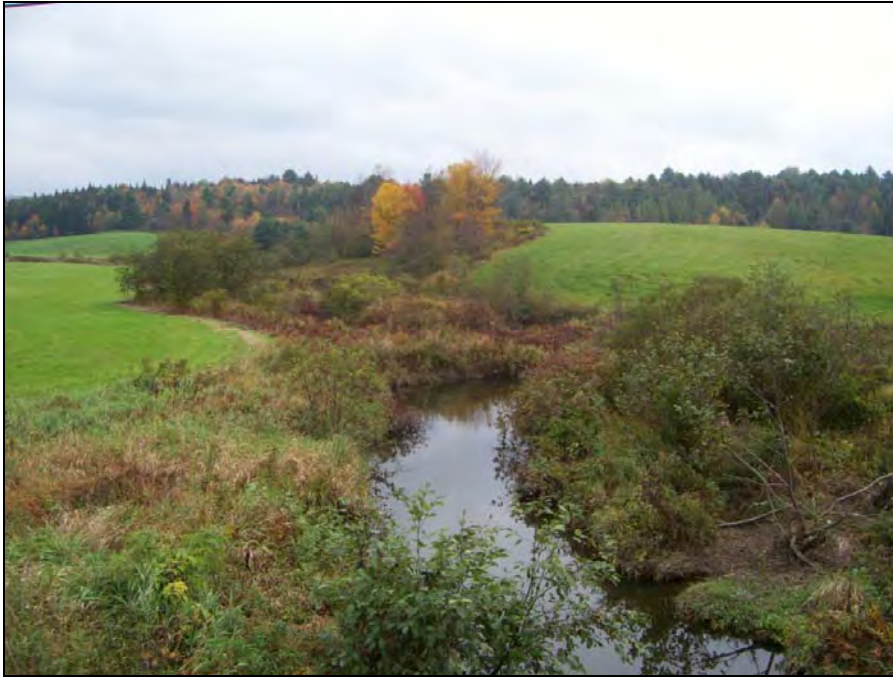
Centerville Brook segment R15.05-B begins above Slobada Road and continues downstream for over a mile crossing under Cleveland Corners and Silver Ridge roads. The stream corridor through this long reach is surrounded by hay fields; however, due to the wetland-type nature of the stream channel, agriculture has generally remained out of the immediate floodplain. Instead, a healthy riparian corridor lines both banks through almost the entire segment. This riparian vegetation is providing food and habitat for beavers that are actively damming the channel throughout this segment.

Centerville Brook segment R15.05-B has good floodplain access and numerous active beaver dams.

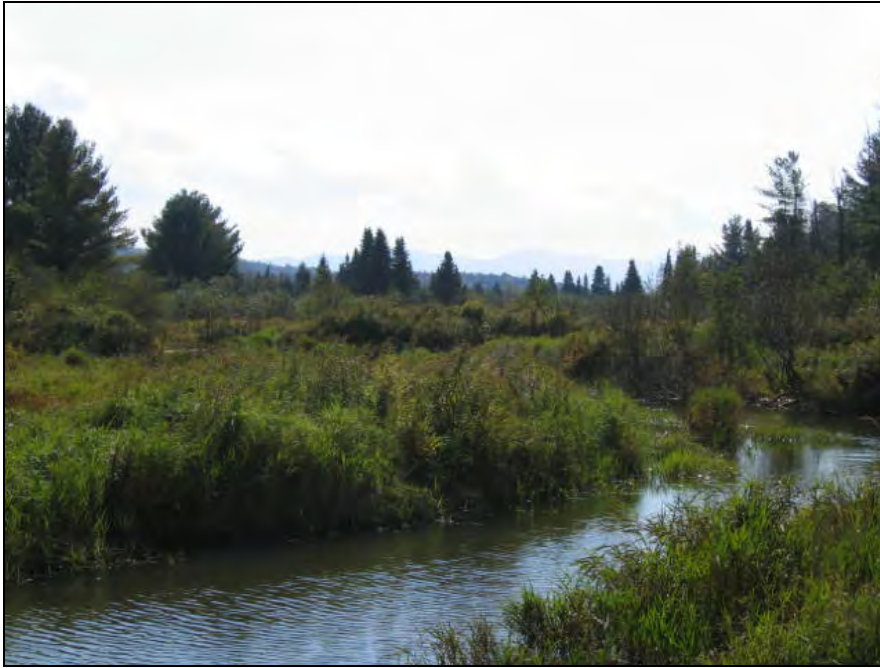
Centerville Brook segment R15.06-B has been impounded by a large beaver dam. Due to this impoundment this segment did not receive a full geomorphic and habitat assessment.

**Segment R15.06-A is a wetland system due to a beaver dam.**

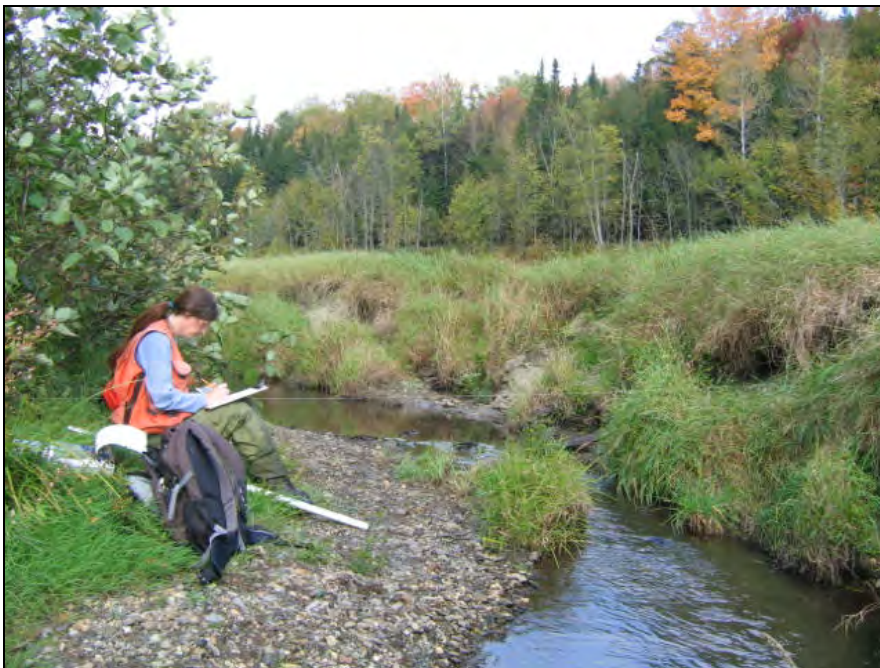
**R15.06-B is a C channel that is widening and adjusting planform.**

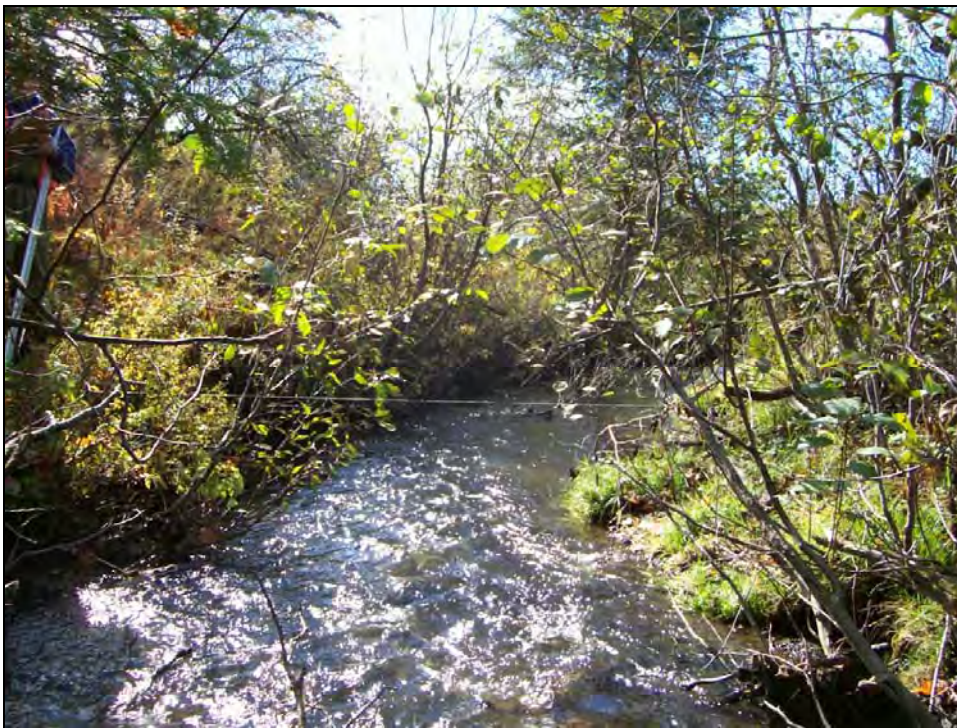
Centerville Brook segment R15.07-A is drastically different from its upstream segment. The segment begins at a small waterfall where the valley walls broaden and the slope of the channel decreases. This upper most area was historically an alder swamp until a landslide during the summer of 2006 occurred. Following the slide the material was allowed to be graded out at the site and the stream was locked into place with stone rip-rap for one hundred feet. There was excessive erosion, an active headcut, and very soft sediments in this upper portion of the reach. These sediments were found to be transporting downstream to a culvert under Brook Road. On the other side of the culvert the land use changes to pasture, however, the stream remains an “E” type channel with alder lining the banks except where cows have trampled the banks and vegetation for access to the stream. With the exception of the uppermost area where a small headcut is active, the channel does not appear to have incised recently, however there is evidence of minor widening, aggradation, and planform adjustment in response to changes in boundary conditions, heavy pasturing in the floodplain, a culvert, and the mass failure.

**R15.07-A is an “E” channel with alder vegetation and active pasture on both banks.**

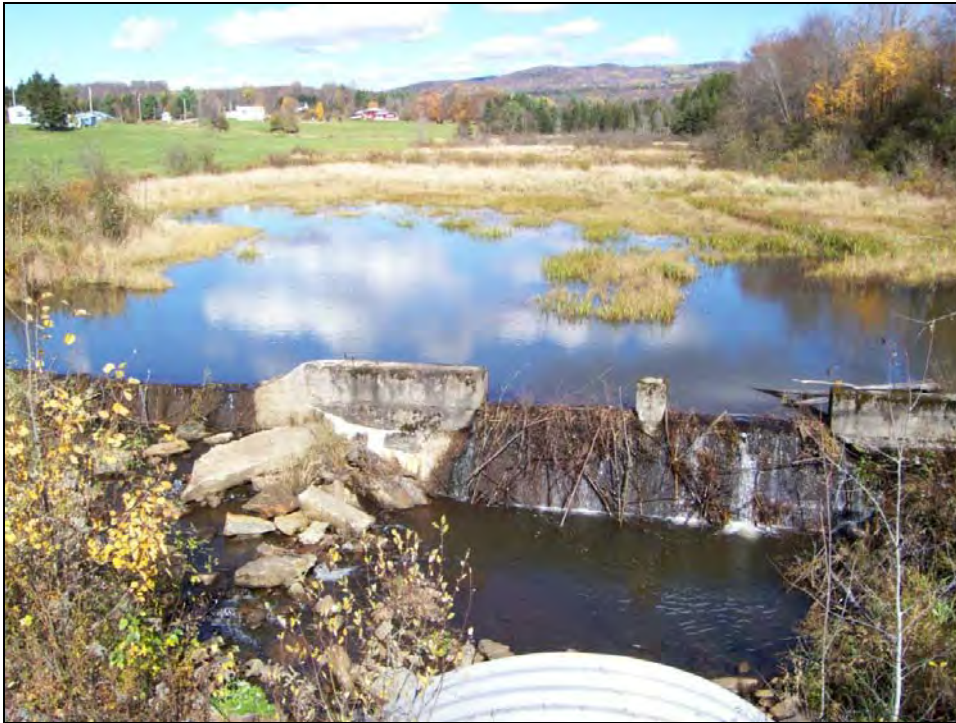
Centerville Brook reach R15.08 begins at a human-made dam just upstream from the crossing of Centerville Road. This dam, along with several beaver dams, creates a series of wetlands through most of this reach. Due to the impoundments a complete geomorphic assessment of the reach was not possible; however, field scientists walked the majority of the reach in order to evaluate some of the Phase 2 parameters. The dominant impact to this reach is the lack of a wide riparian buffer or filter strip along an active cow pasture.

**Reach R15.08 is a wetland system due to a human-made dam and several beaver dams.**

#15 Upstream of Centerville Road Crossing  R1508	Active Restoration	Wetland channel due to concrete dam, which is 7.5 feet high.	Alternatives analysis for dam removal	High priority for dam removal	Restore aquatic organism passage and riverine habitat.	Very high construction and permitting costs for structure removal and channel restoration	Wetland to riverine habitat	ANR, LCPC, landowners
