# **Gihon River Corridor Plan**

**Johnson, Hyde Park, & Eden, Vermont**  
**October 30, 2009**

# **Gihon River Corridor Plan Johnson, Hyde Park, and Eden, Vermont**

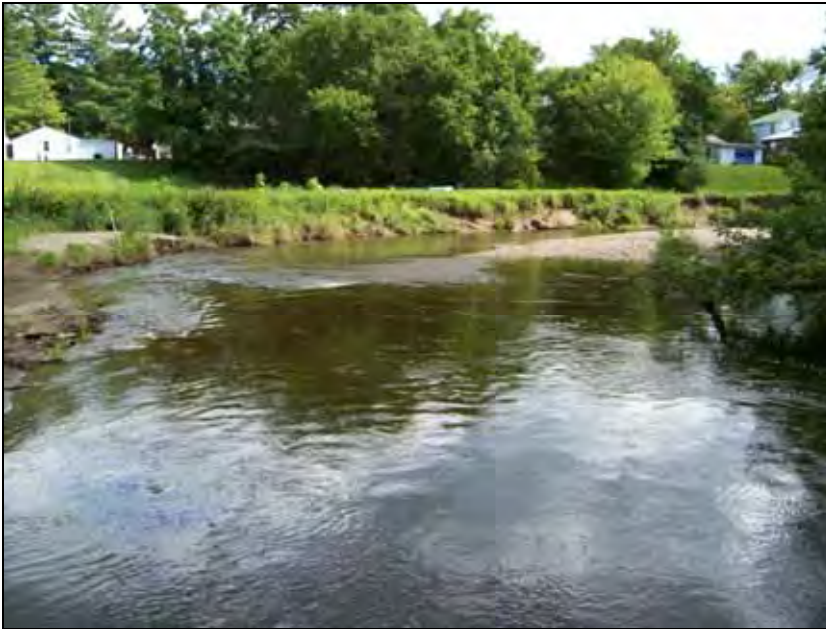
The active adjustments recently observed include major aggradation and planform adjustment as well as minor widening. These adjustments are a result of the river working to create a new floodplain due to historic degradation which has caused the stream to incise.

**Reach M01-A is undergoing major planform adjustment, aggradation, and minor widening.**

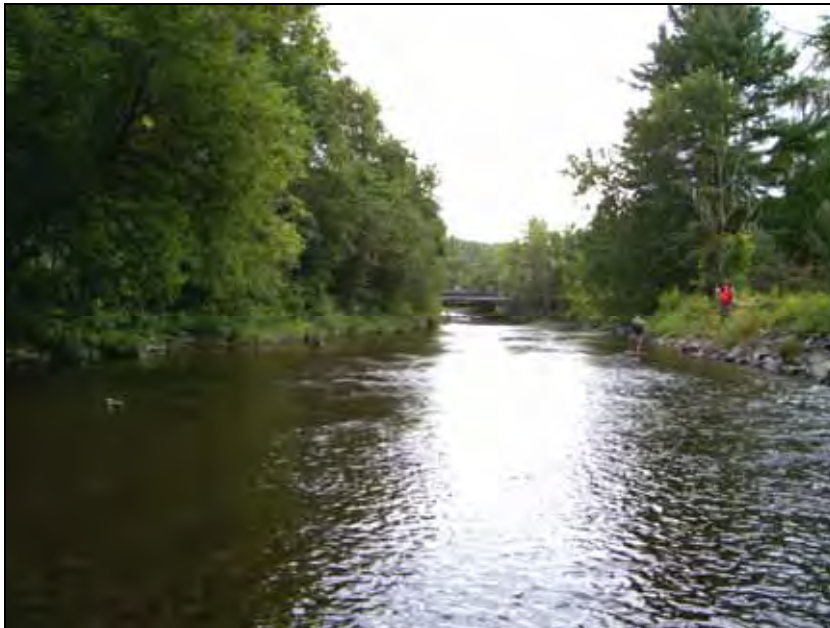
**Reach M01-B is a plane bed stream due to historic channel straightening through the village of Johnson. Bank armoring has limited widening and planform adjustment**

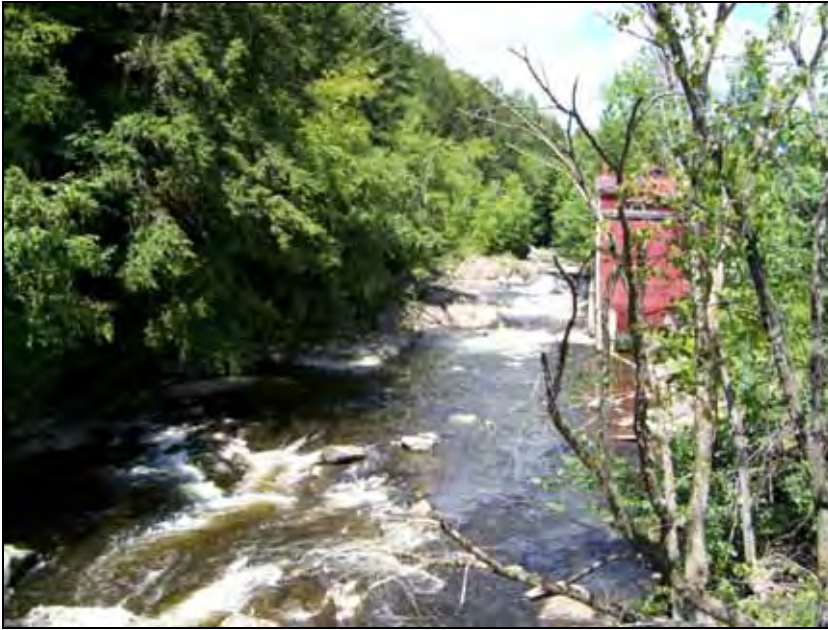
**M02 is a bedrock controlled channel and the site of a former dam**

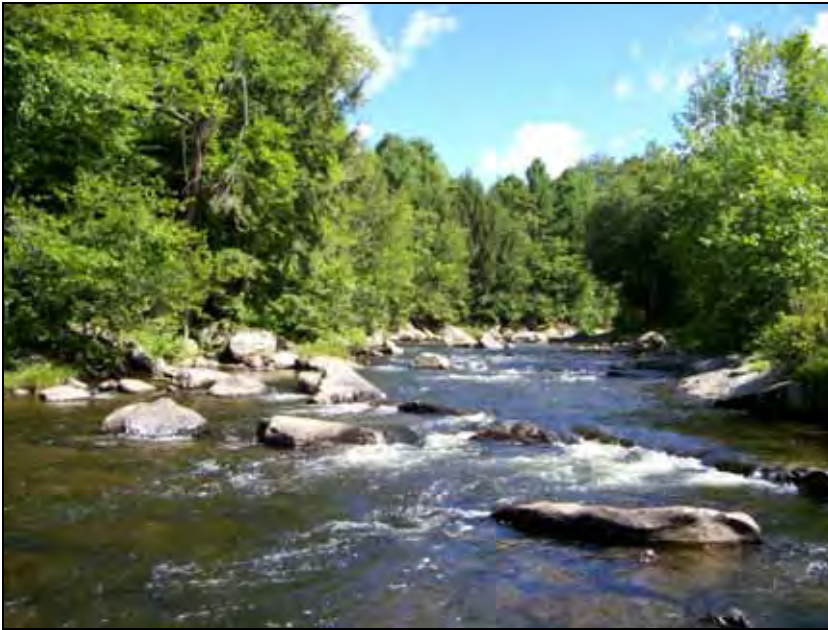
The reach appeared to be undergoing some major widening and is receiving sediment from upstream. Naturally occurring bedrock and large material in the stream channel have likely assisted in the overall stream stability of the reach.

**M03 has large material and bedrock in the channel which has helped reduce instability**

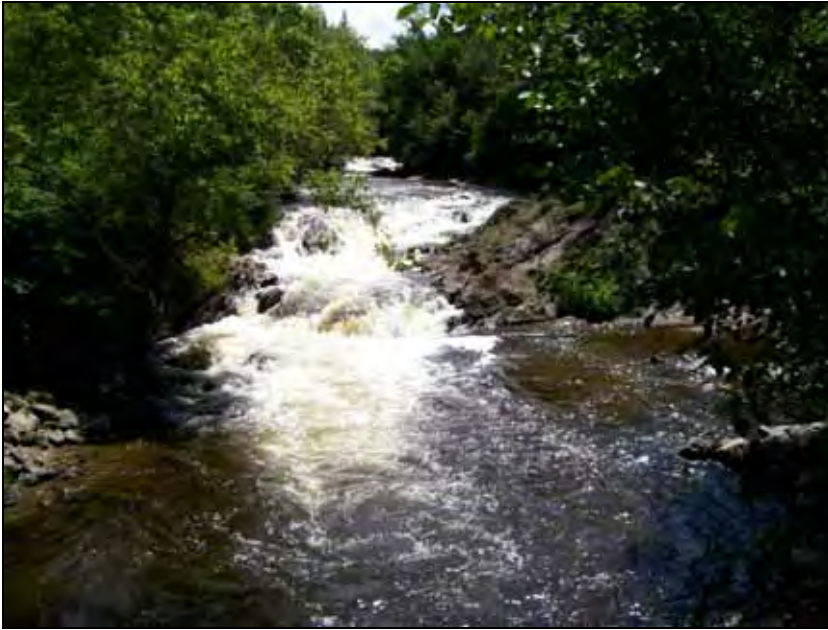
**M04-A is a bedrock controlled segment**

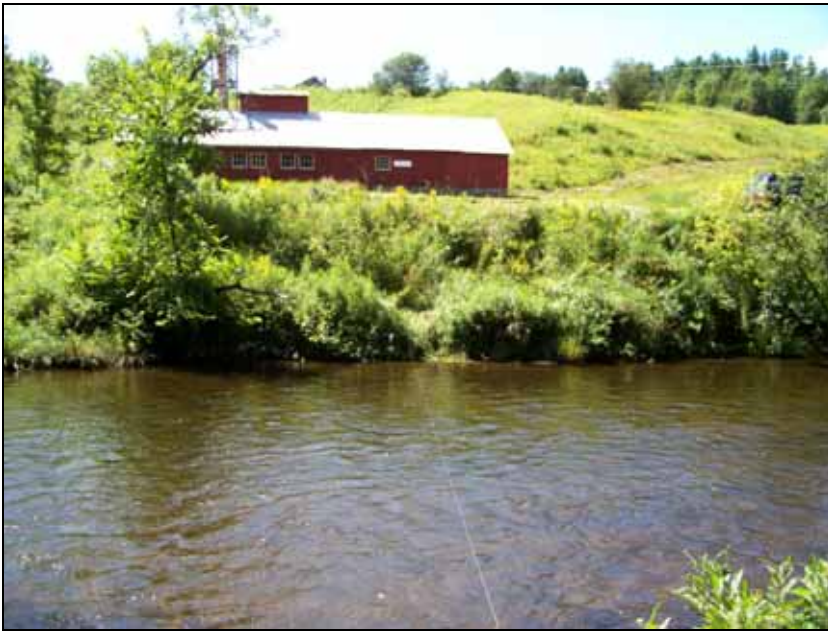
**M04-B is a transitional segment between a very broad and semi-confined valley (B type channel)**

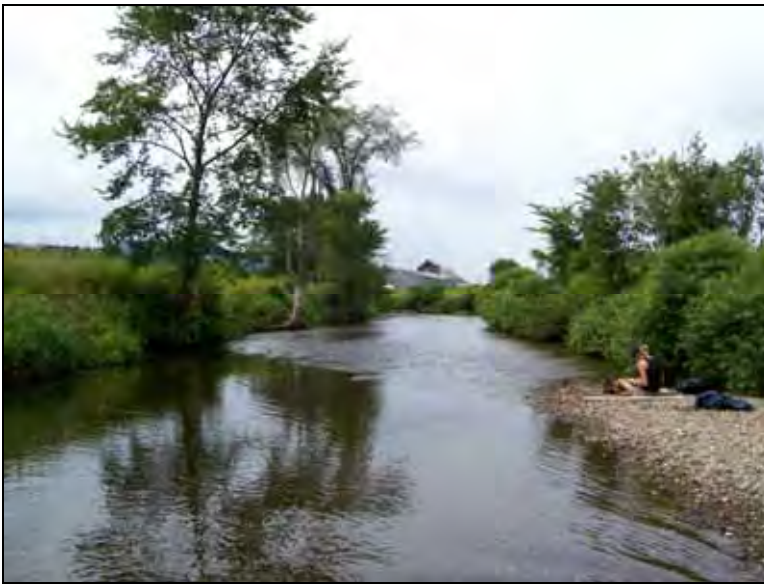
**M06 has historically degraded and is currently undergoing major planform and minor widening adjustment**

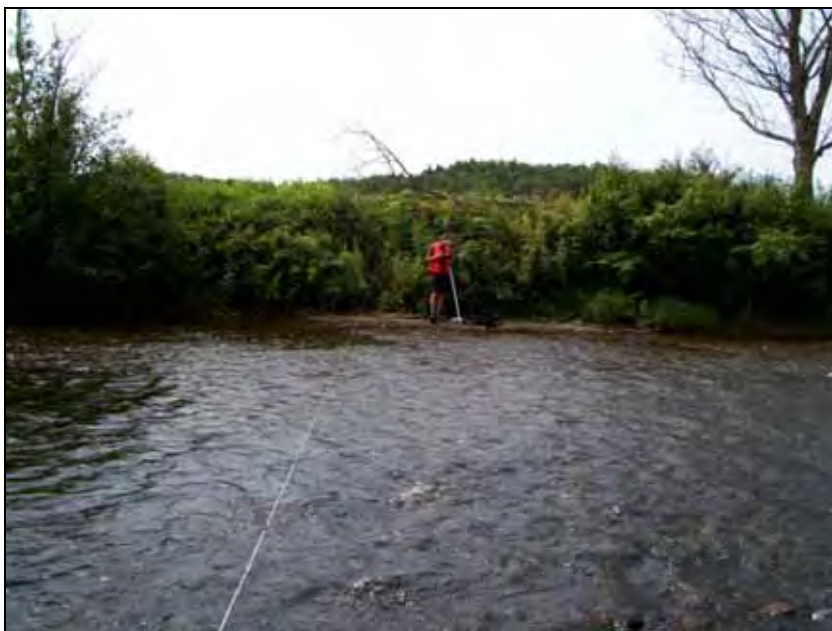
**M07 has historically incised, as depicted in this photograph**

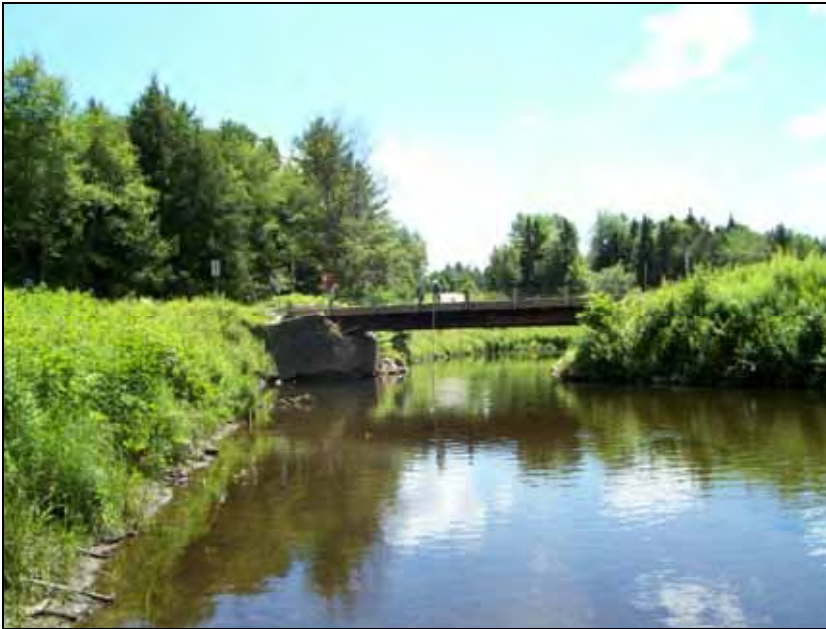
**Segment M09-A is impacted by a dam at the downstream end of the reach. It was excluded from a full geomorphic assessment due to the backwater effect of the dam**

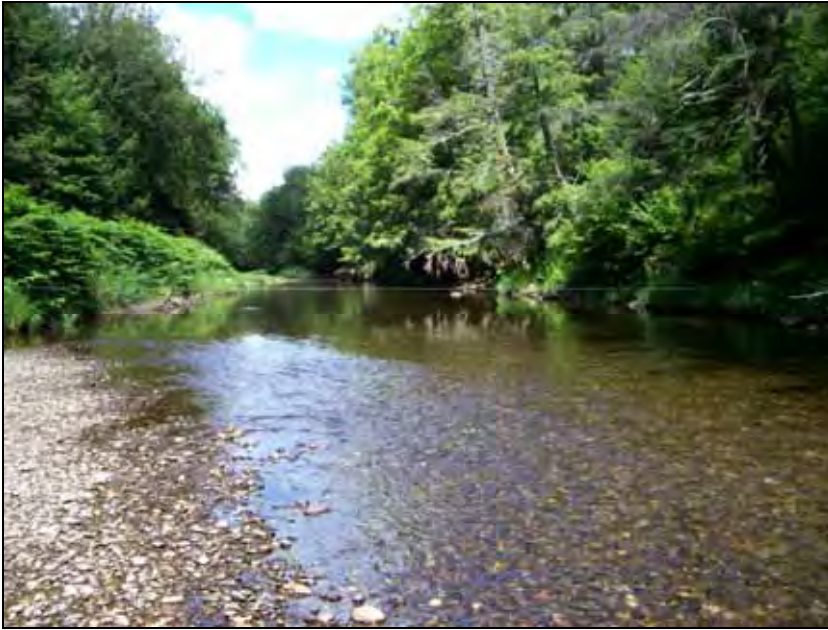
**Segment M09-B is a naturally occurring B channel in a confined valley that has bedrock outcrops and a healthy riparian buffer on both banks.**

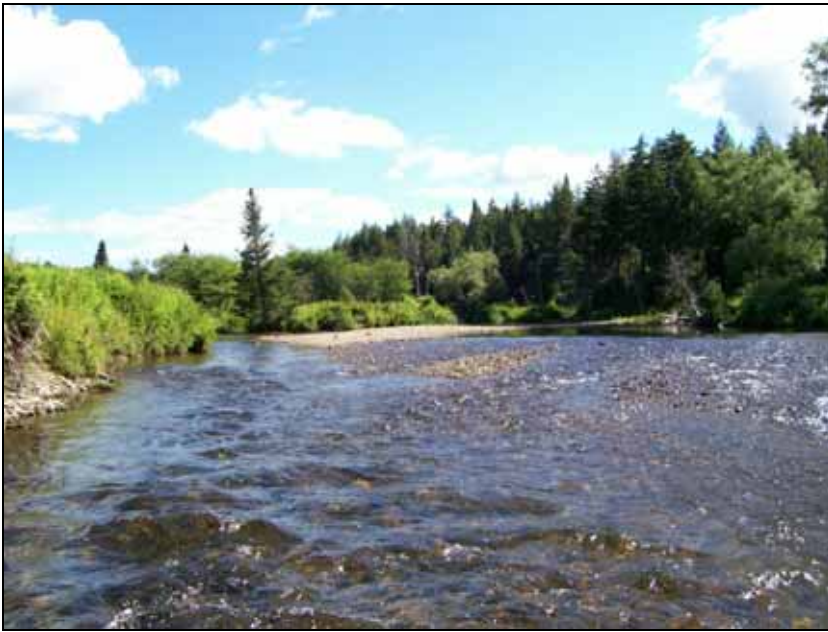
**M10 is undergoing extreme planform adjustment along with major widening and aggradation**

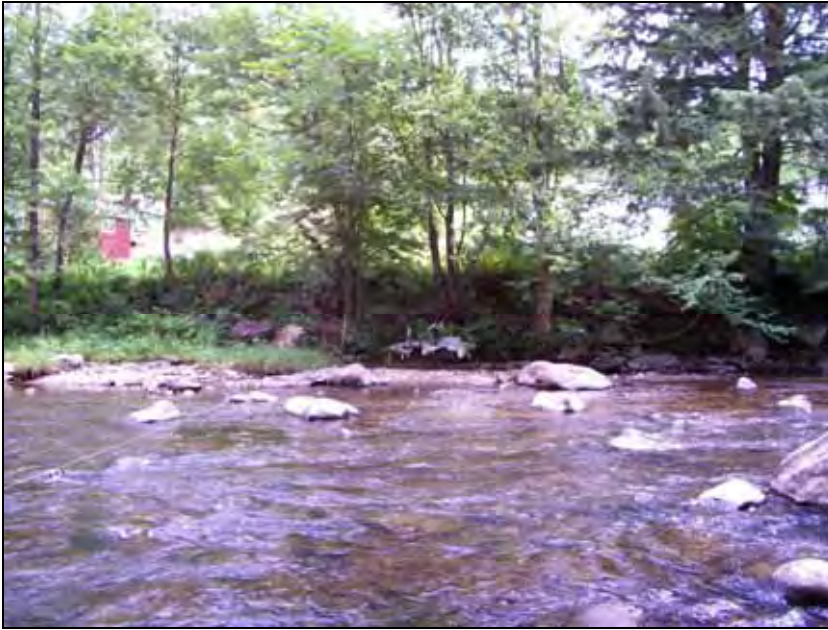
Channel armoring on both banks was present and the riparian buffer on the east bank has been reduced to less than five feet in width. Major channel widening was recorded as the dominant current channel adjustment process within this segment.

**MI I-A is widening as a result of historic channel incision**

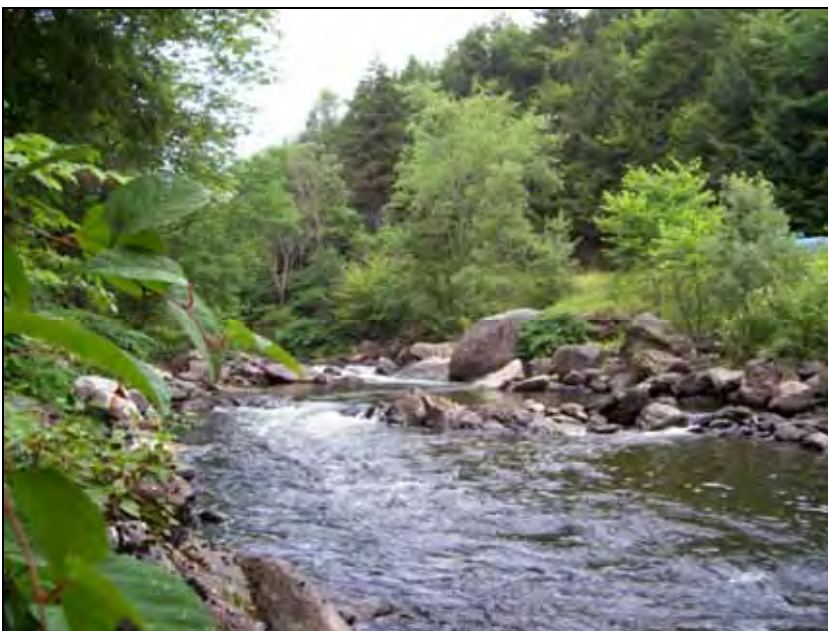
**MI I-B is a bedrock dominated channel intersected by Wilson Road**

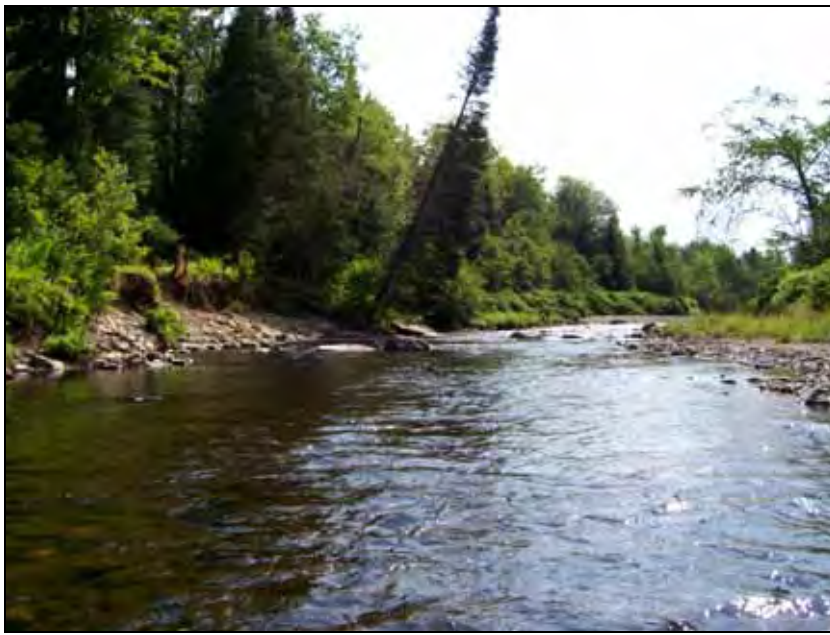
**M12 is undergoing extreme planform adjustment**

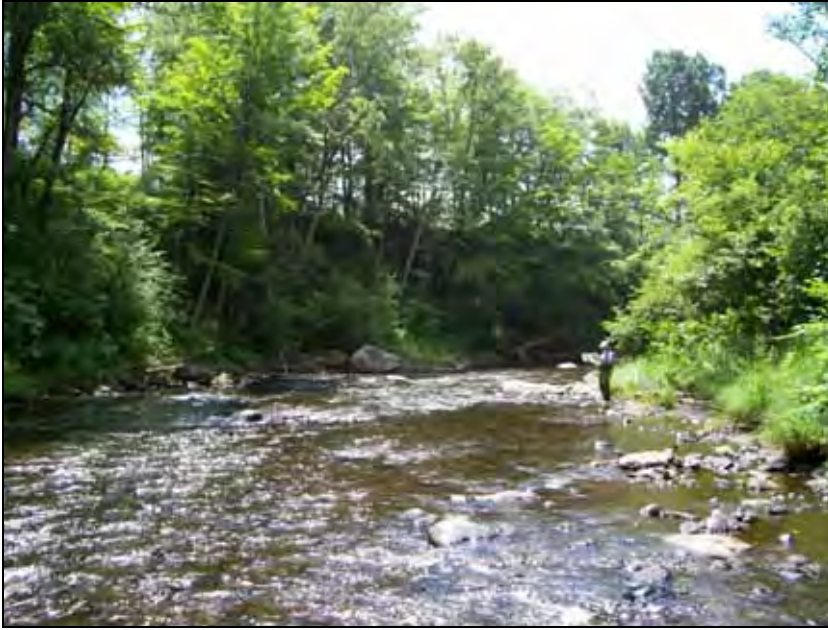
**M13-A is undergoing major planform adjustment as a result of historic streambed incision**

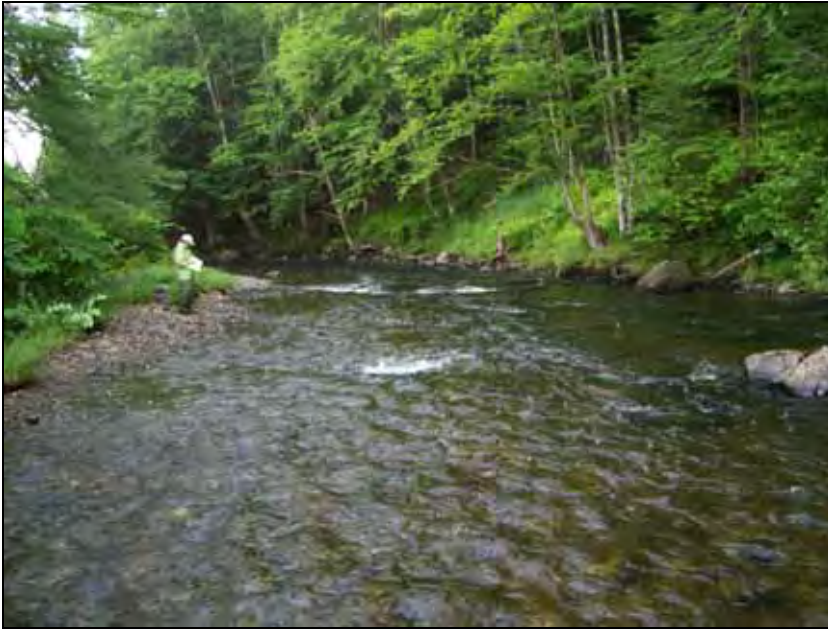
**M13-B is adjusting its planform as a result of historic channel incision**

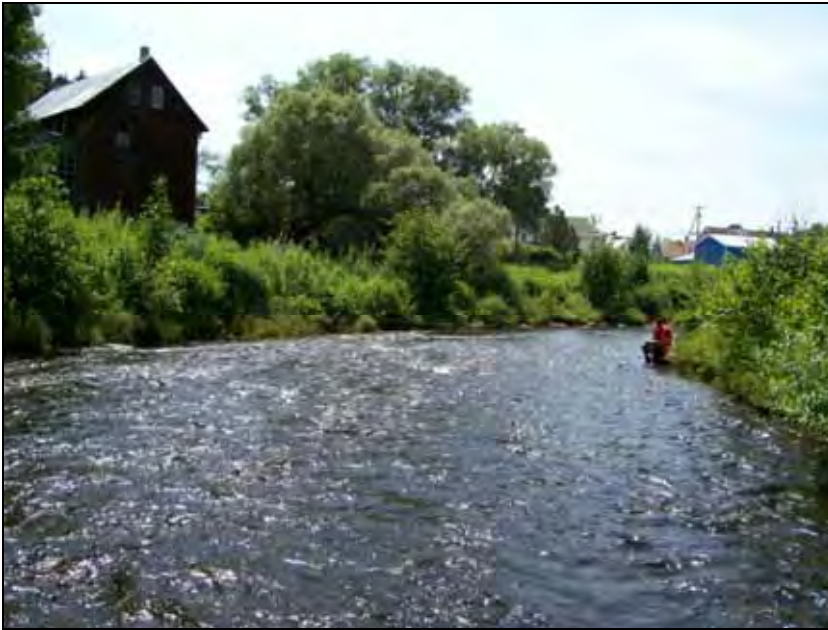
**M14-A has minor widening and planform adjustment**

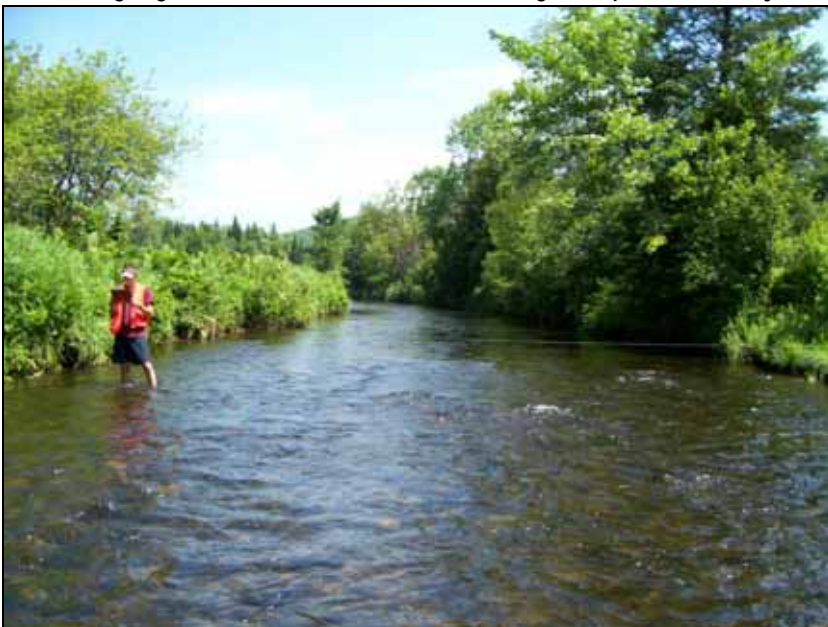
**M14-B is widening in response to historic channel straightening and incision. The riparian buffer on both banks has been greatly impacted by agriculture and residential land use**

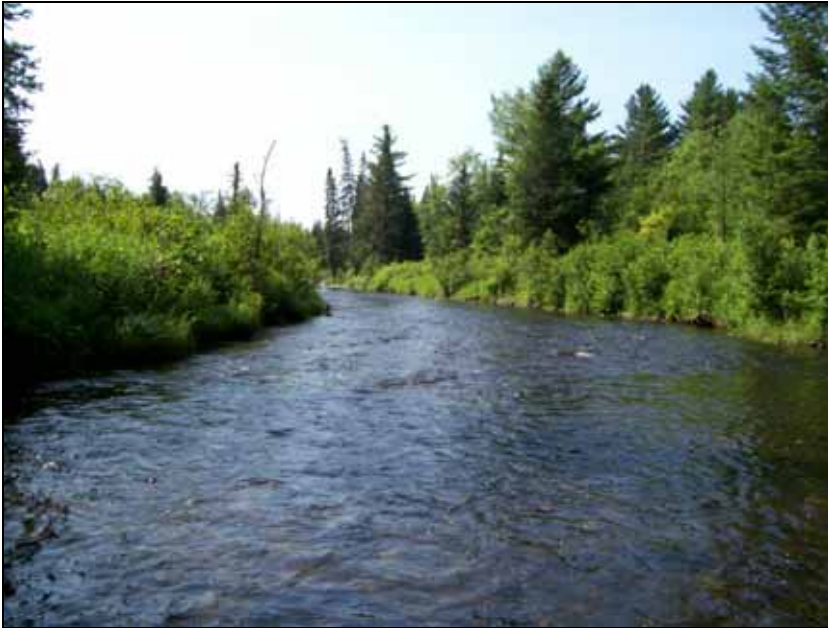
**M14-C is somewhat incised with only minor channel widening, planform, and aggradation**

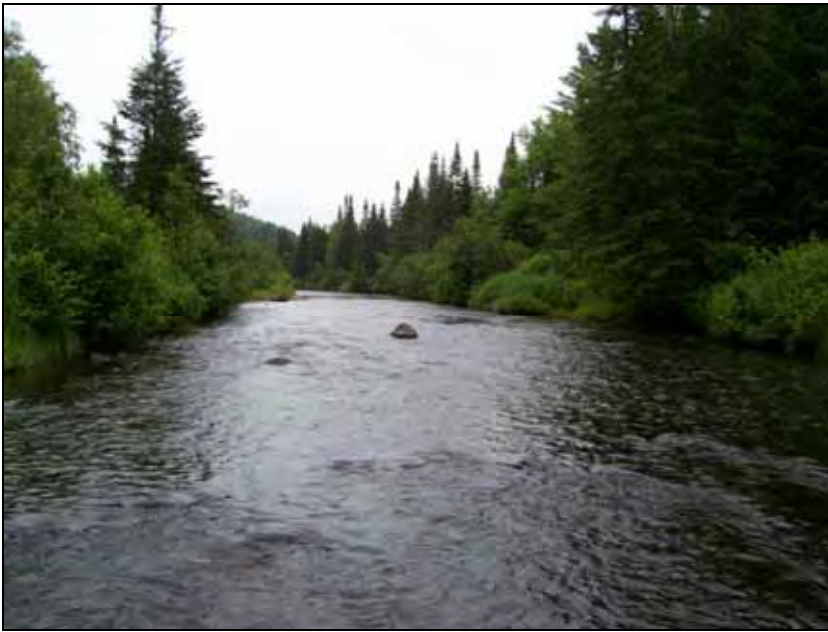
**M15 flows through a heavily forested corridor and has good geomorphic stability**

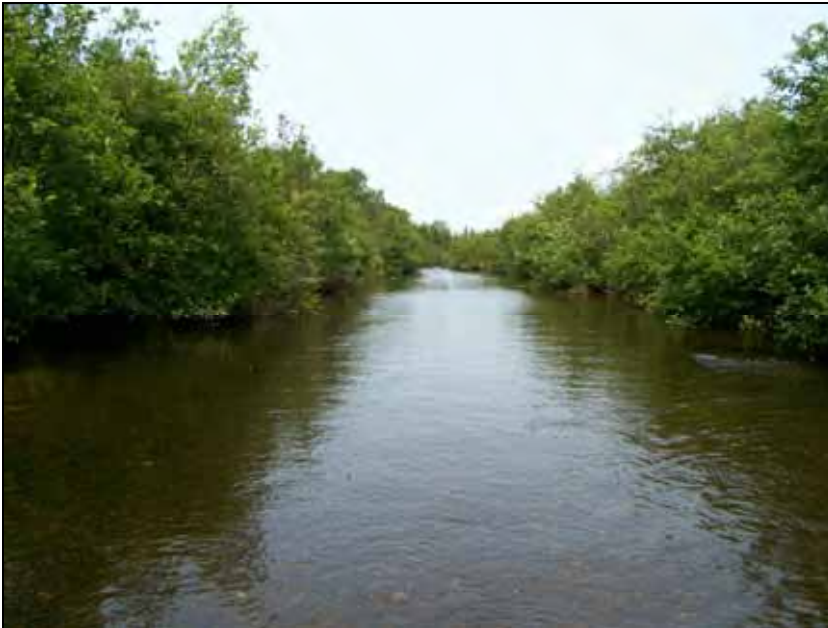
**M16-A is a C channel with very densely vegetated banks that have likely assisted in keeping the channel stable**

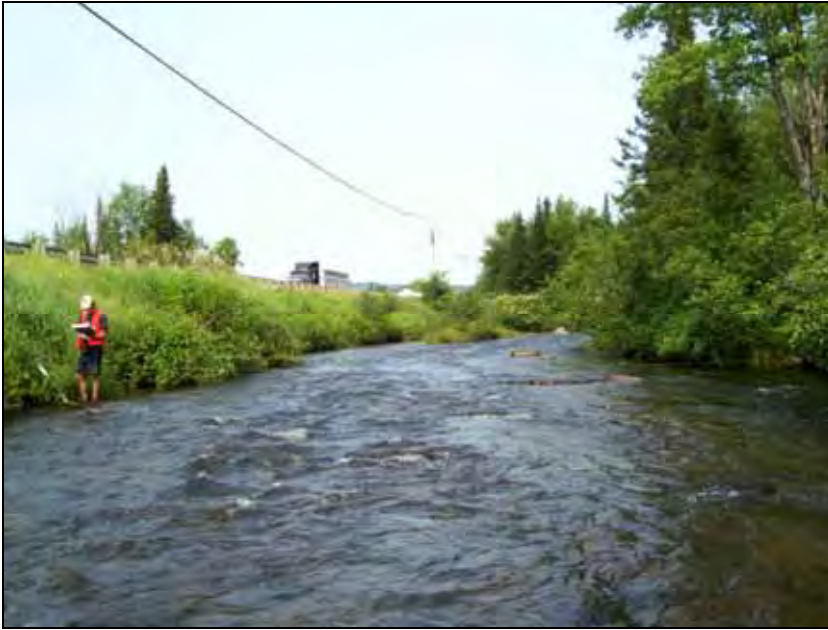
**Route 100 has changed the planform and channel confinement of M16-B**

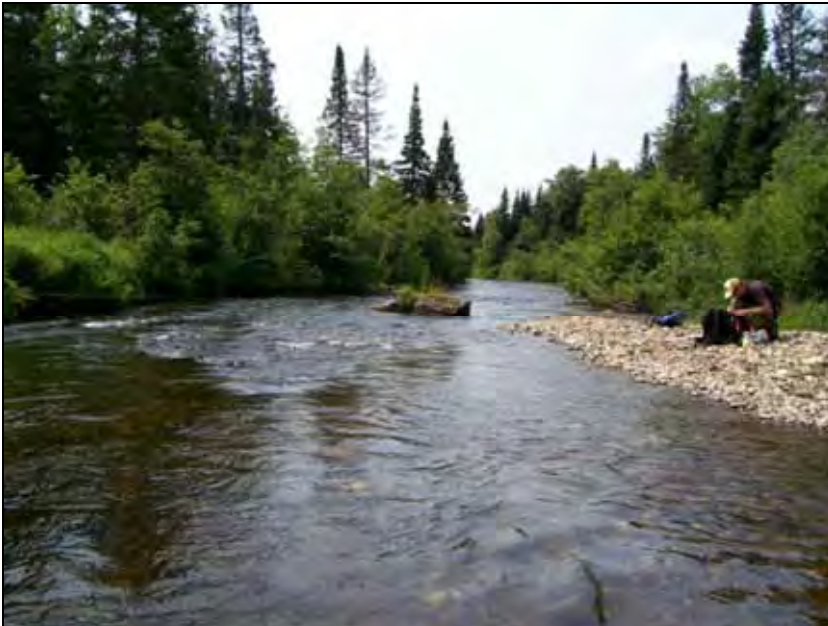
**M16-C is a C channel that is widening and adjusting planform**

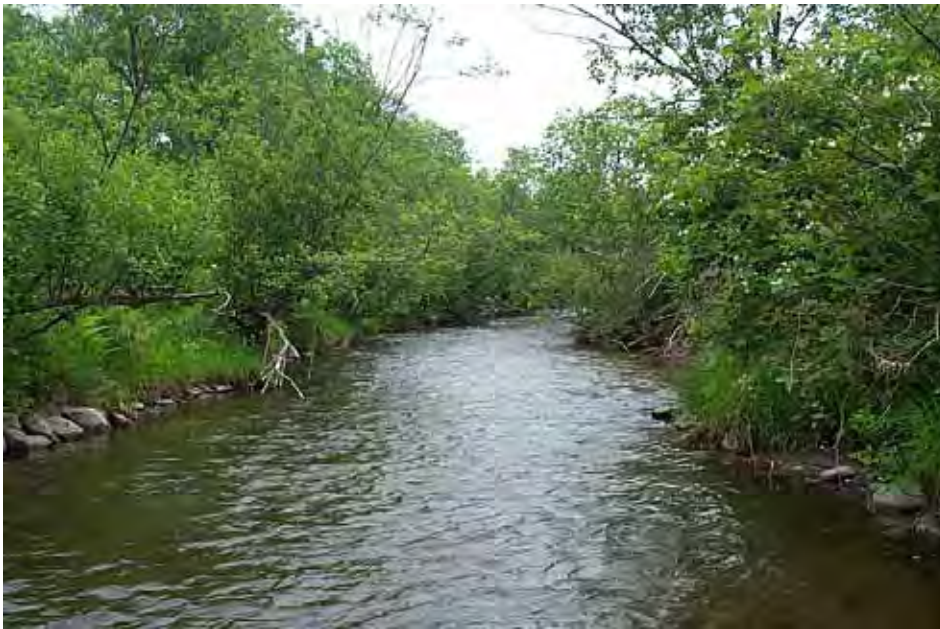
**M17-A has been historically straightened and is now has a plane bed form**

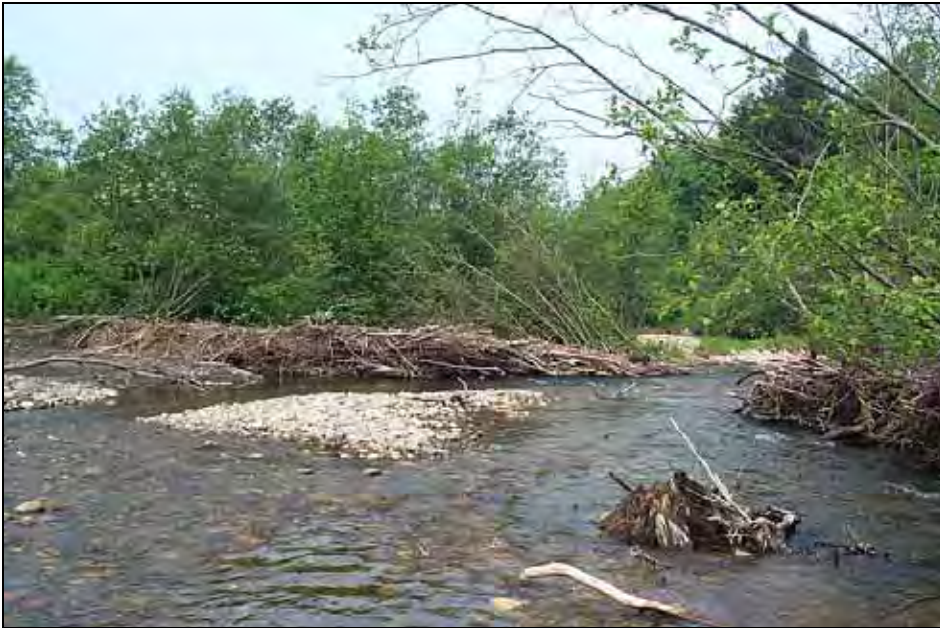
**Gihon segment M17-B is heavily influenced by beavers which have created excellent habitat, despite a geomorphically active channel**

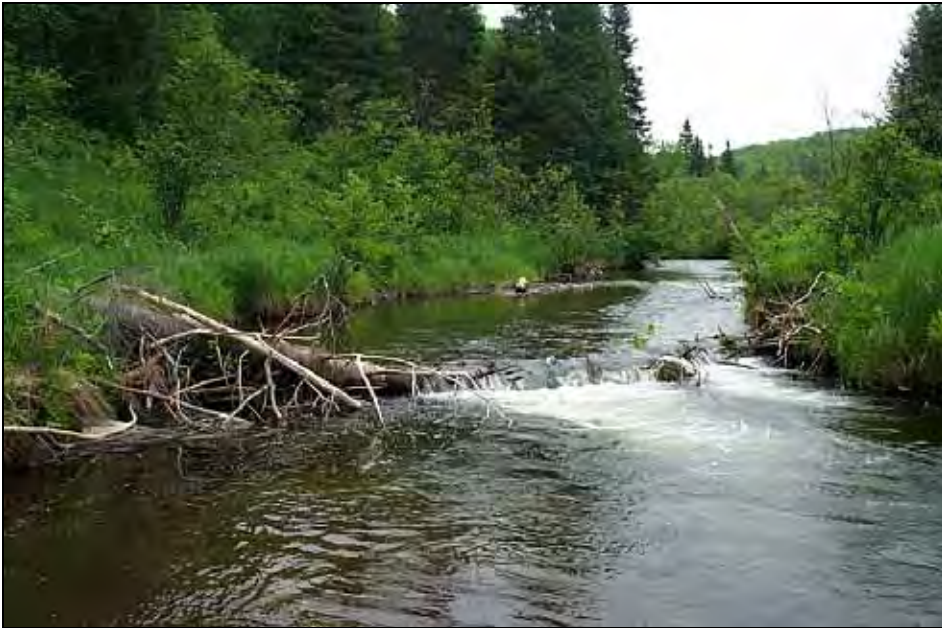
**M18-A is in very good geomorphic condition. In-stream woody vegetation in this segment offers good instream habitat**

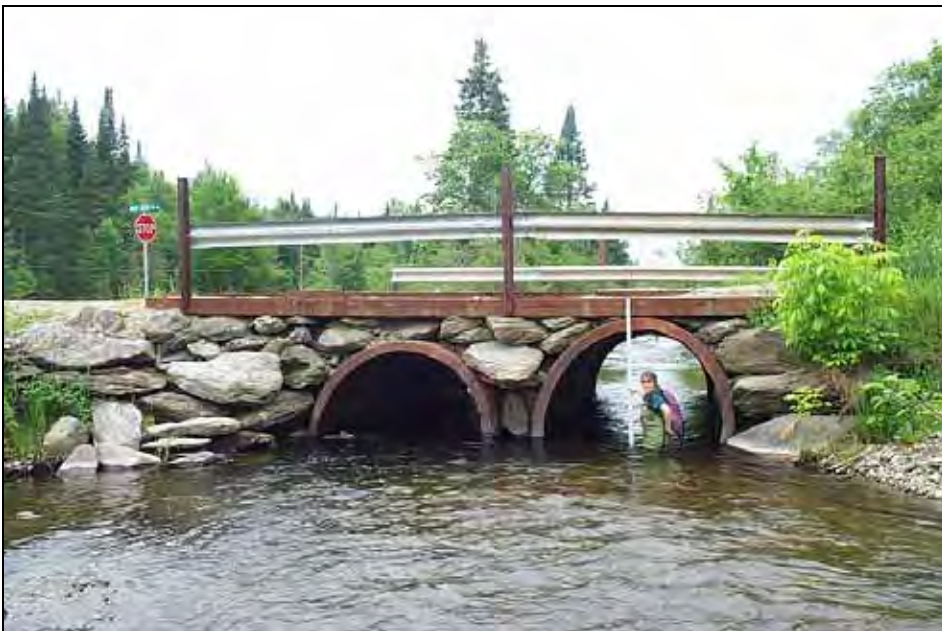
**Twin culverts in M18-A high priority for replacement**

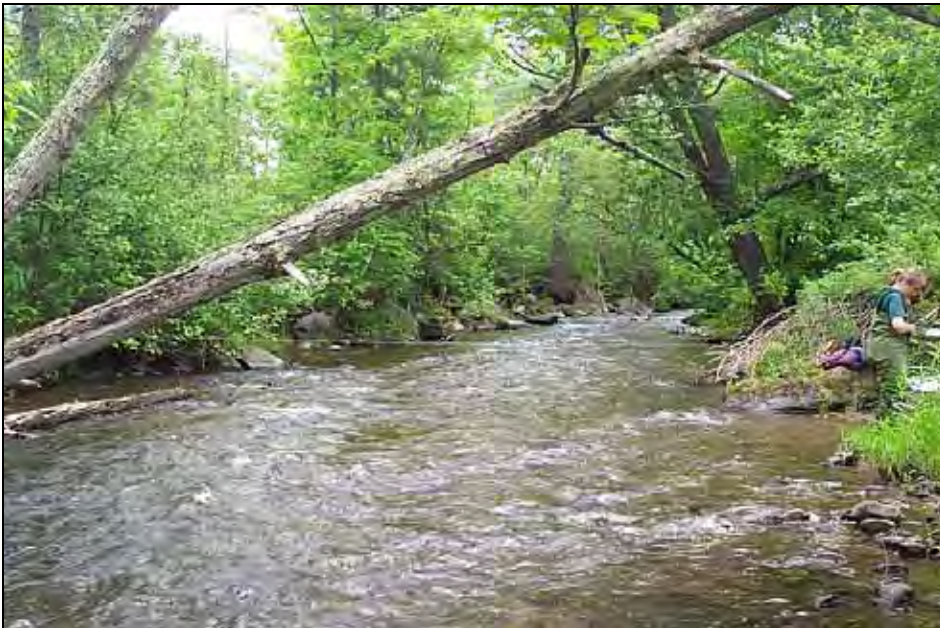
**Segment M18-B has been historically straightened. It is an incised channel that is currently undergoing minor channel widening, aggradation, and planform adjustment**

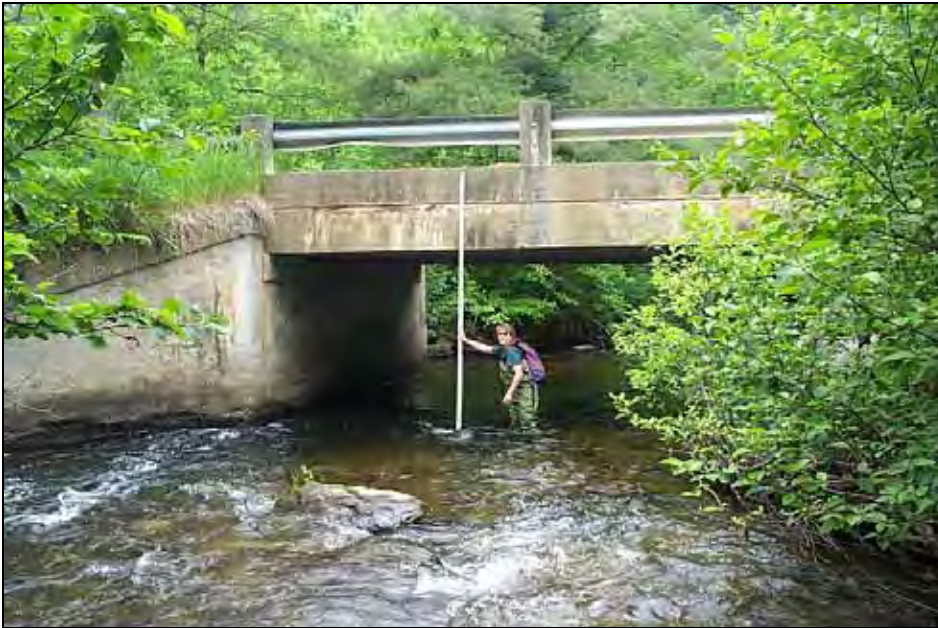
**Undersized bridge in M18-B identified as a priority for replacement**
