Lamoille County Road Erosion Assessment

A project funded by the Vermont Watershed Grants Program and conducted by the Lamoille County Planning Commission with assistance from Watershed Consulting Associates, LLC.

February 2014

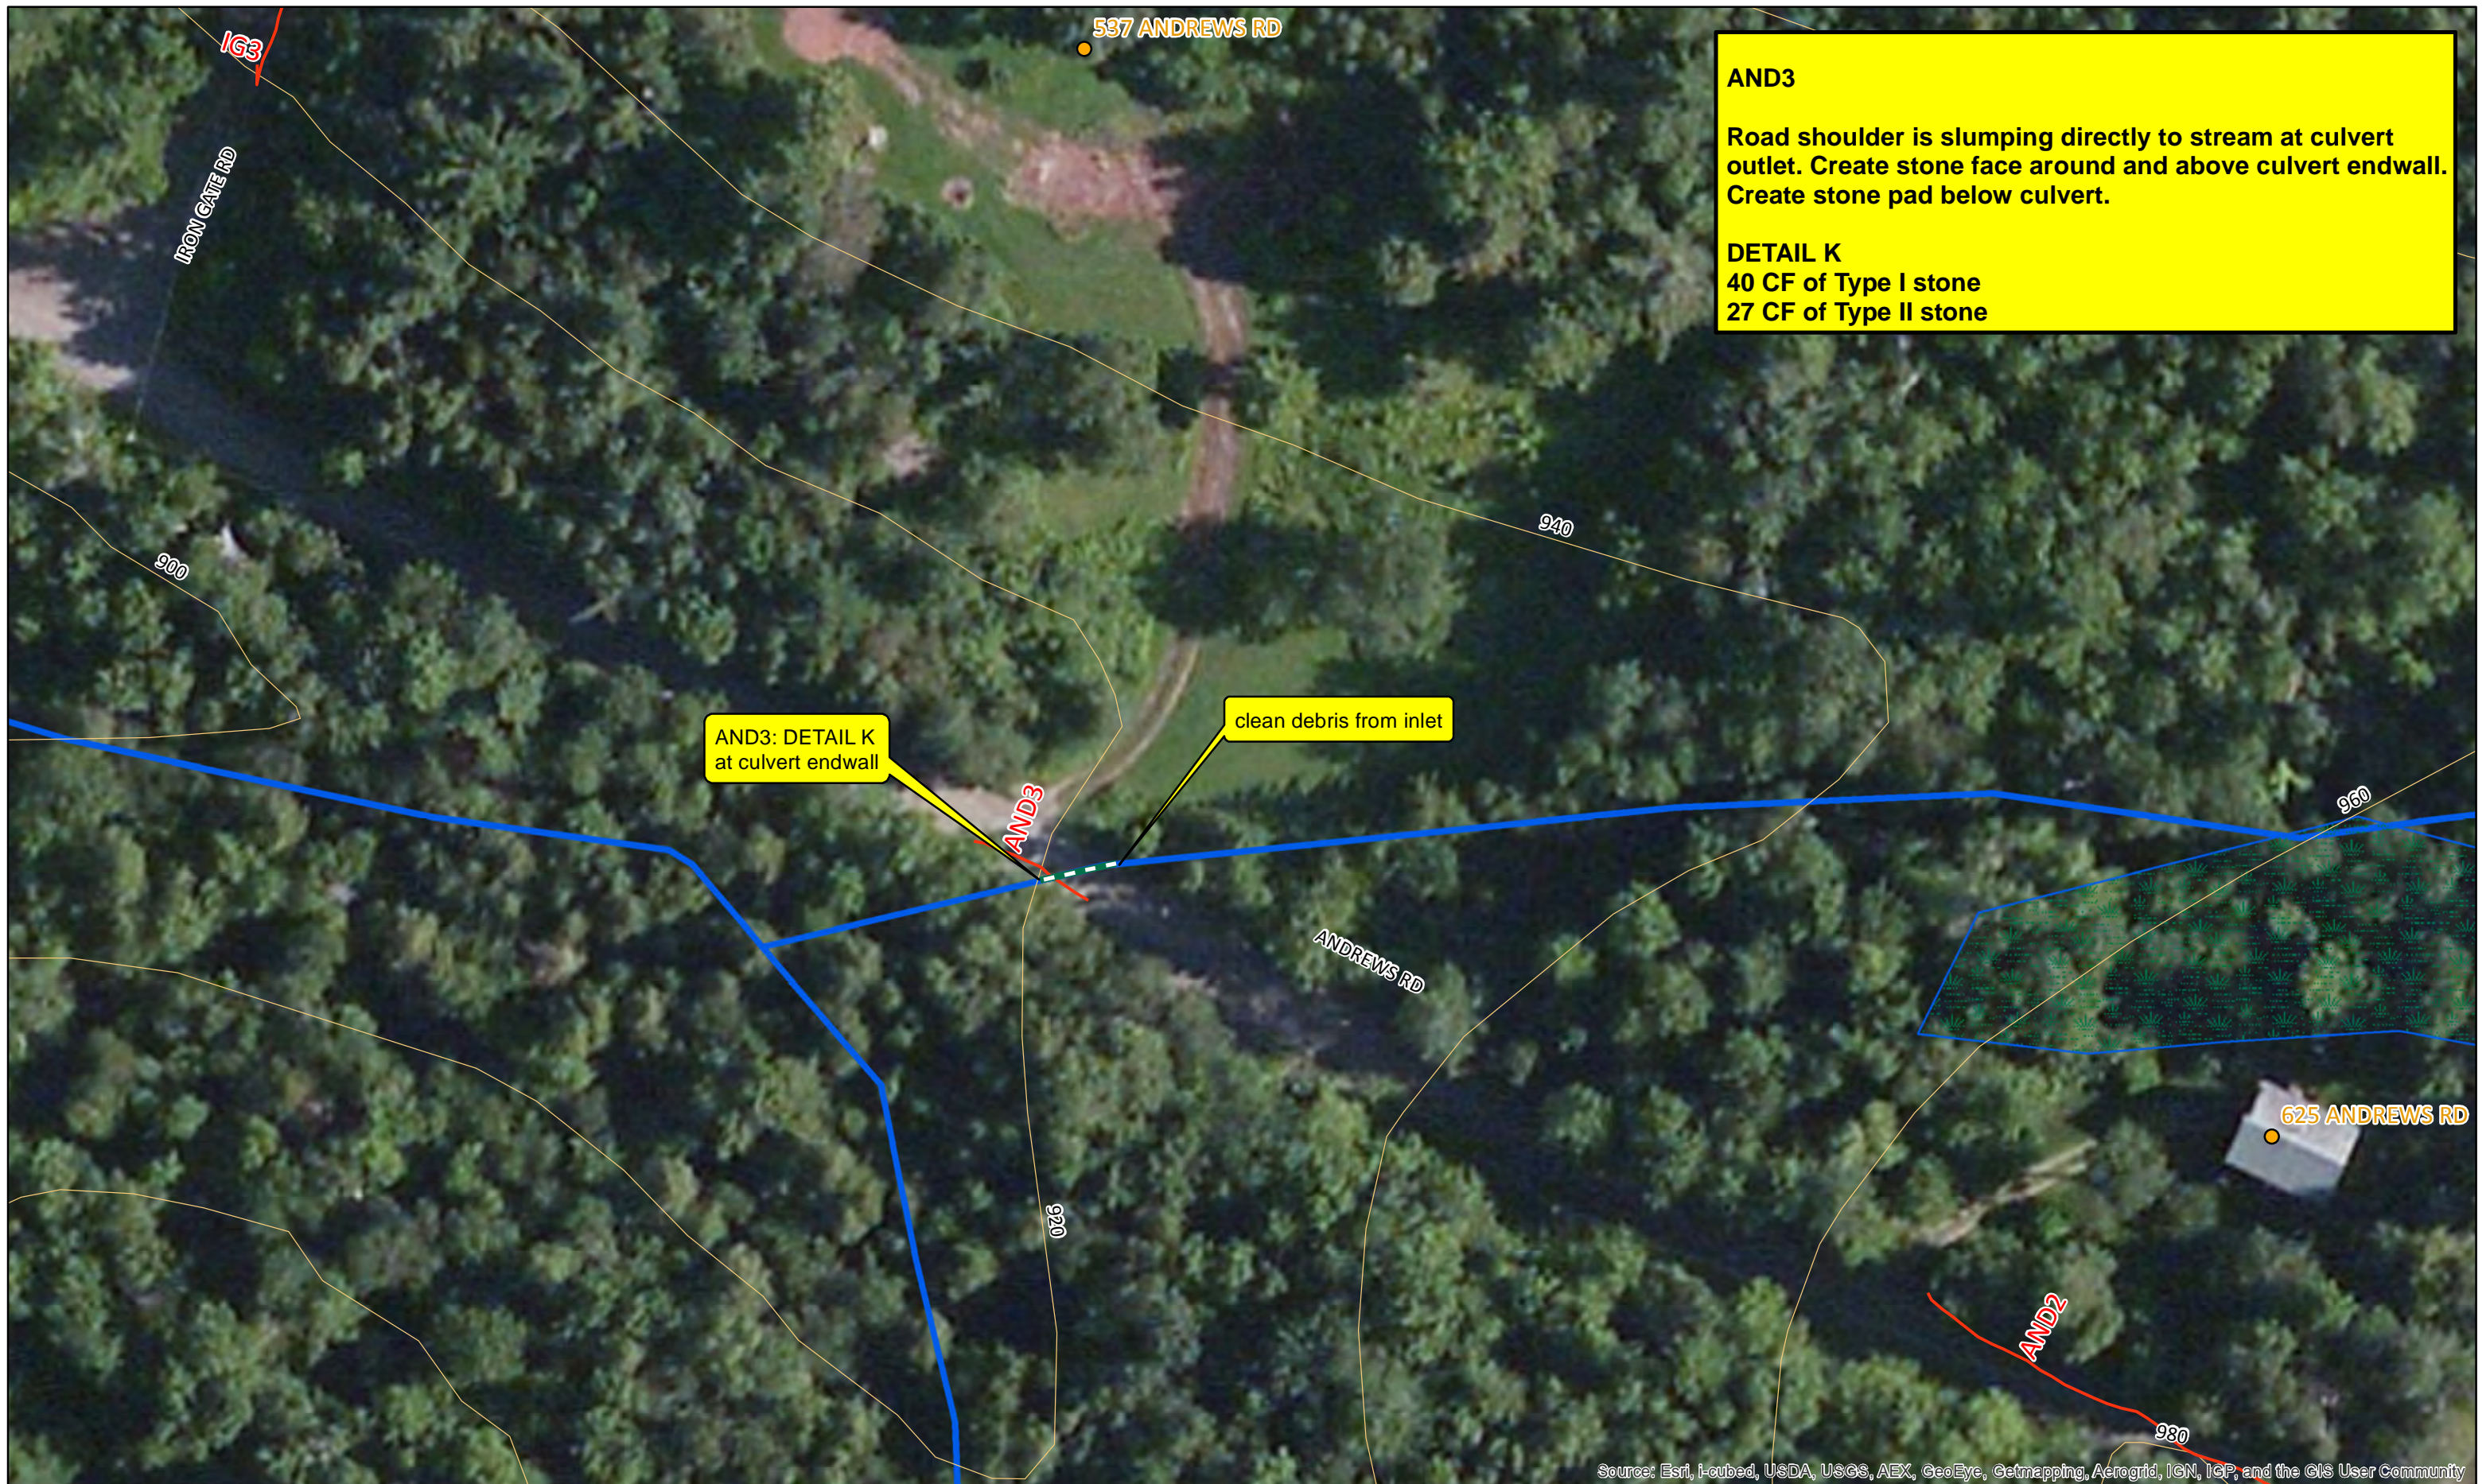
AND3

Road shoulder is slumping directly to stream at culvert outlet. Create stone face around and above culvert endwall. Create stone pad below culvert.

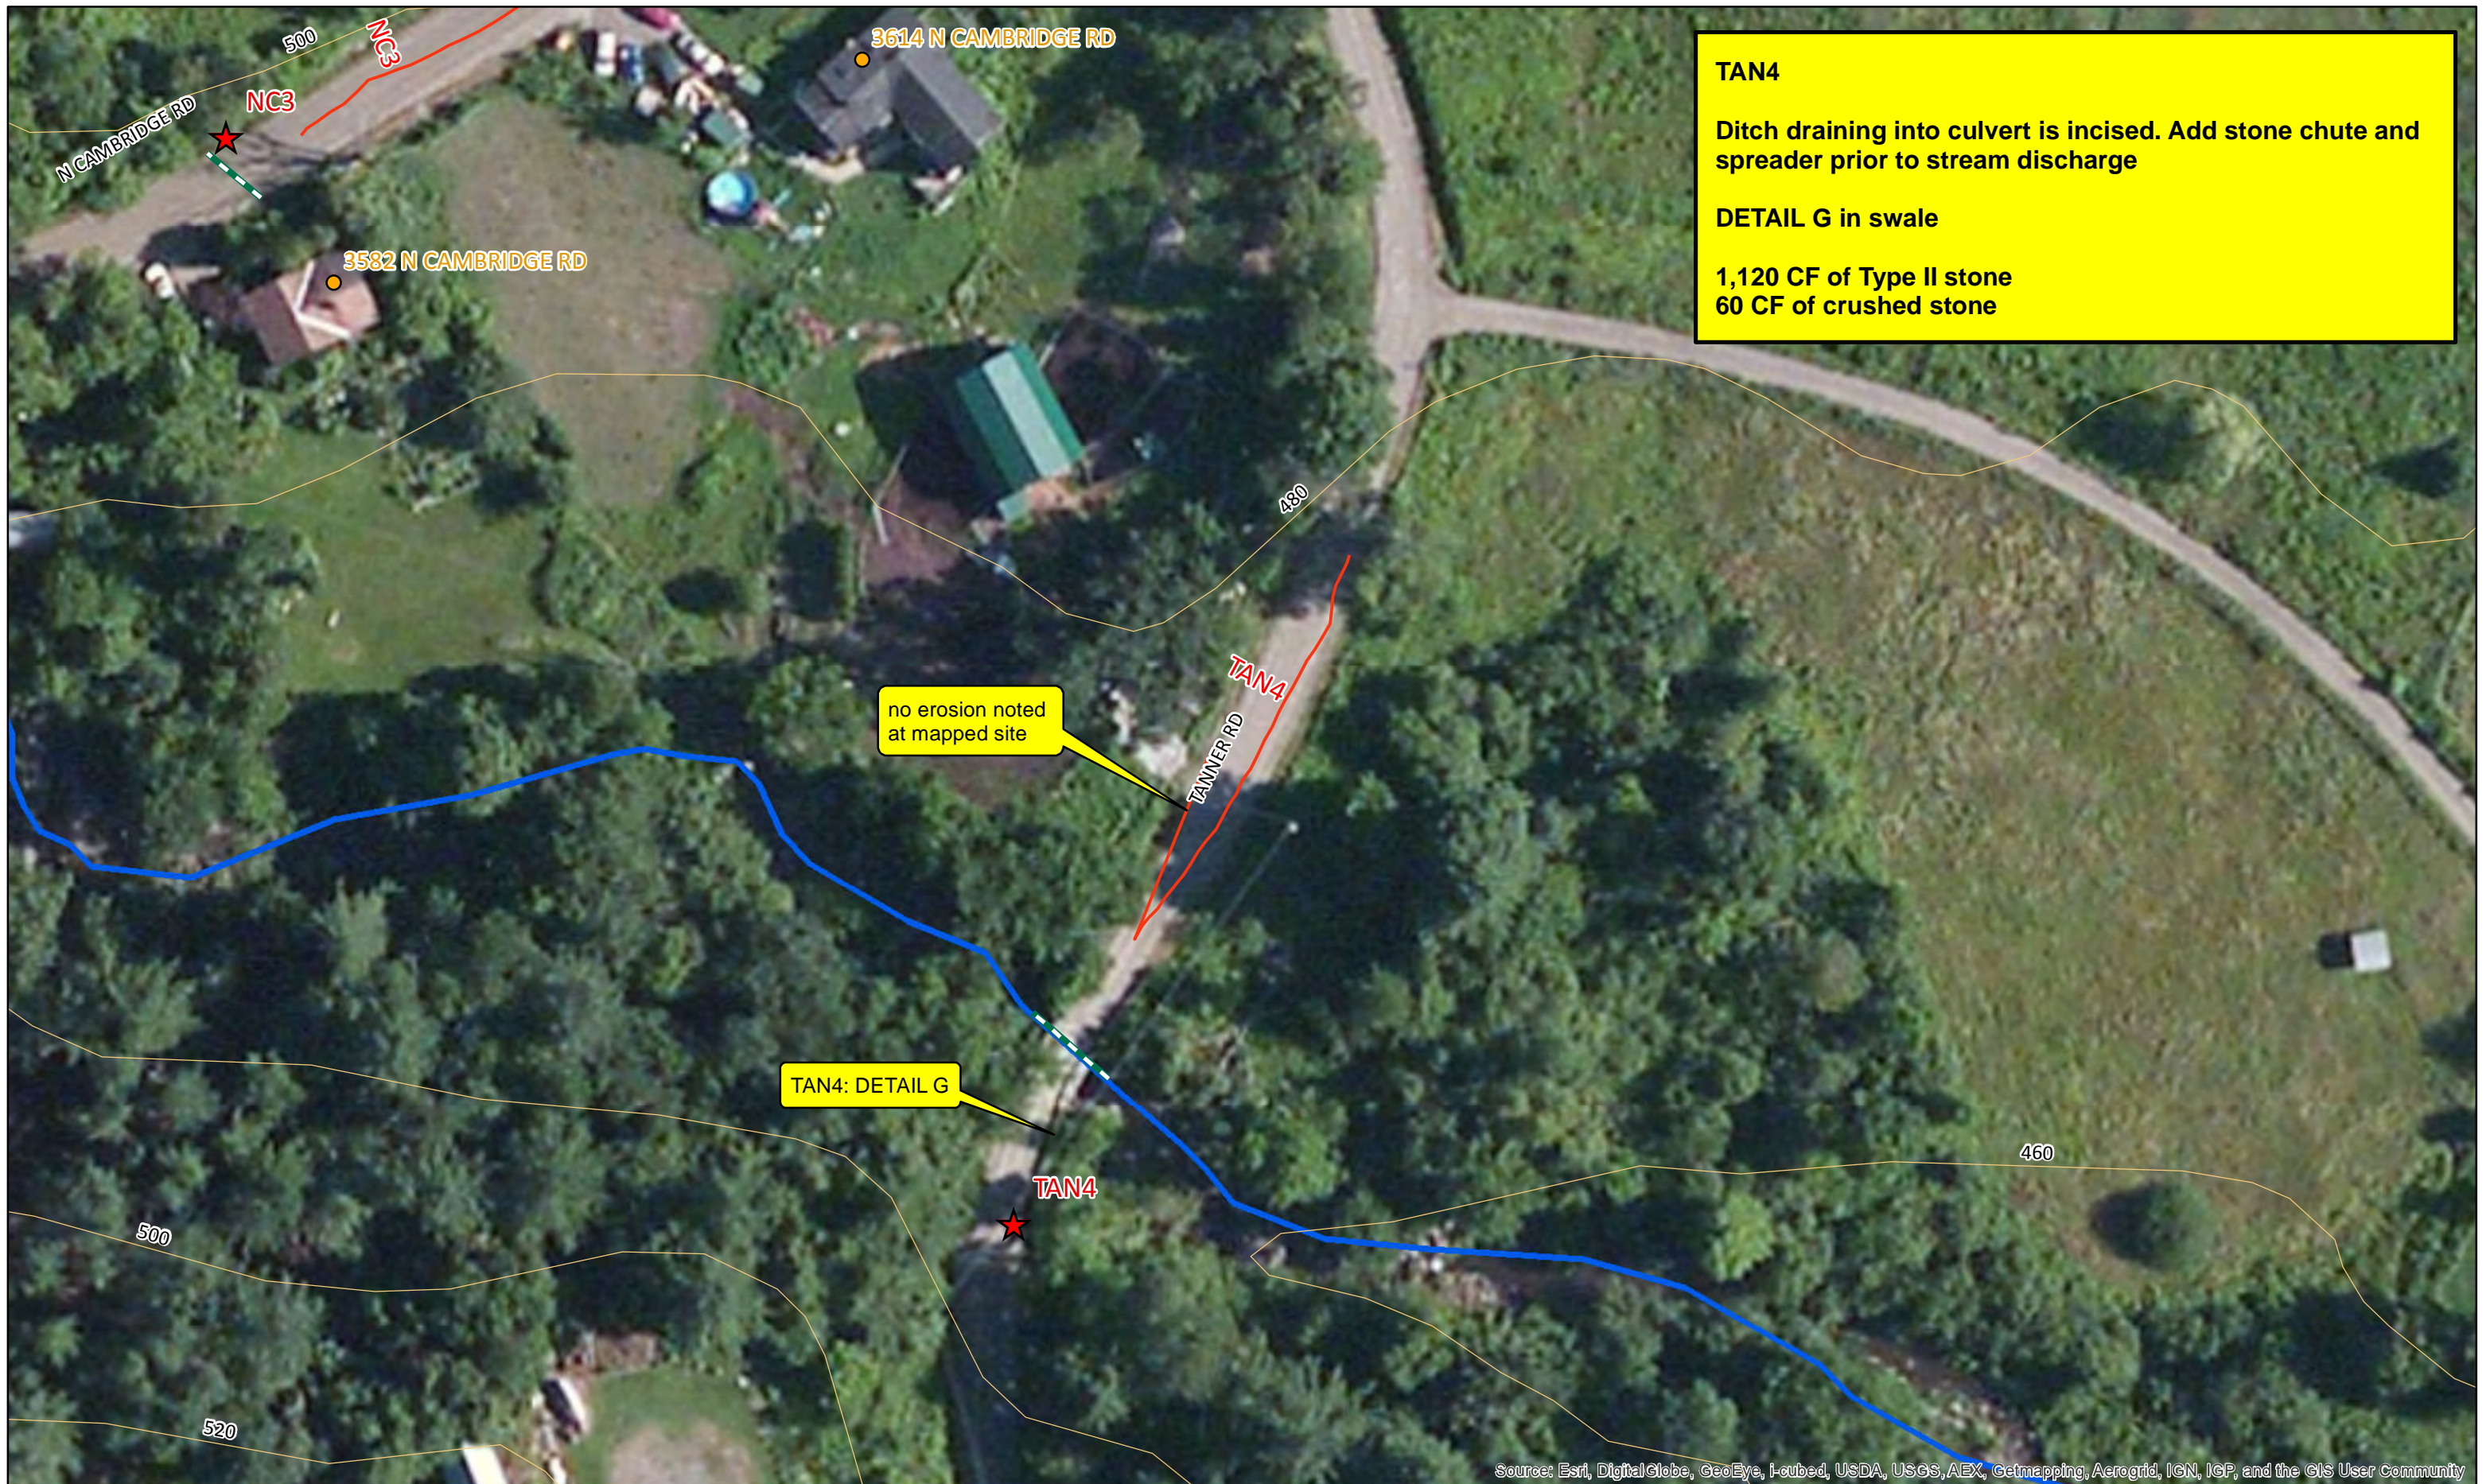
TAN4

Ditch draining into culvert is incised. Add stone chute and spreader prior to stream discharge

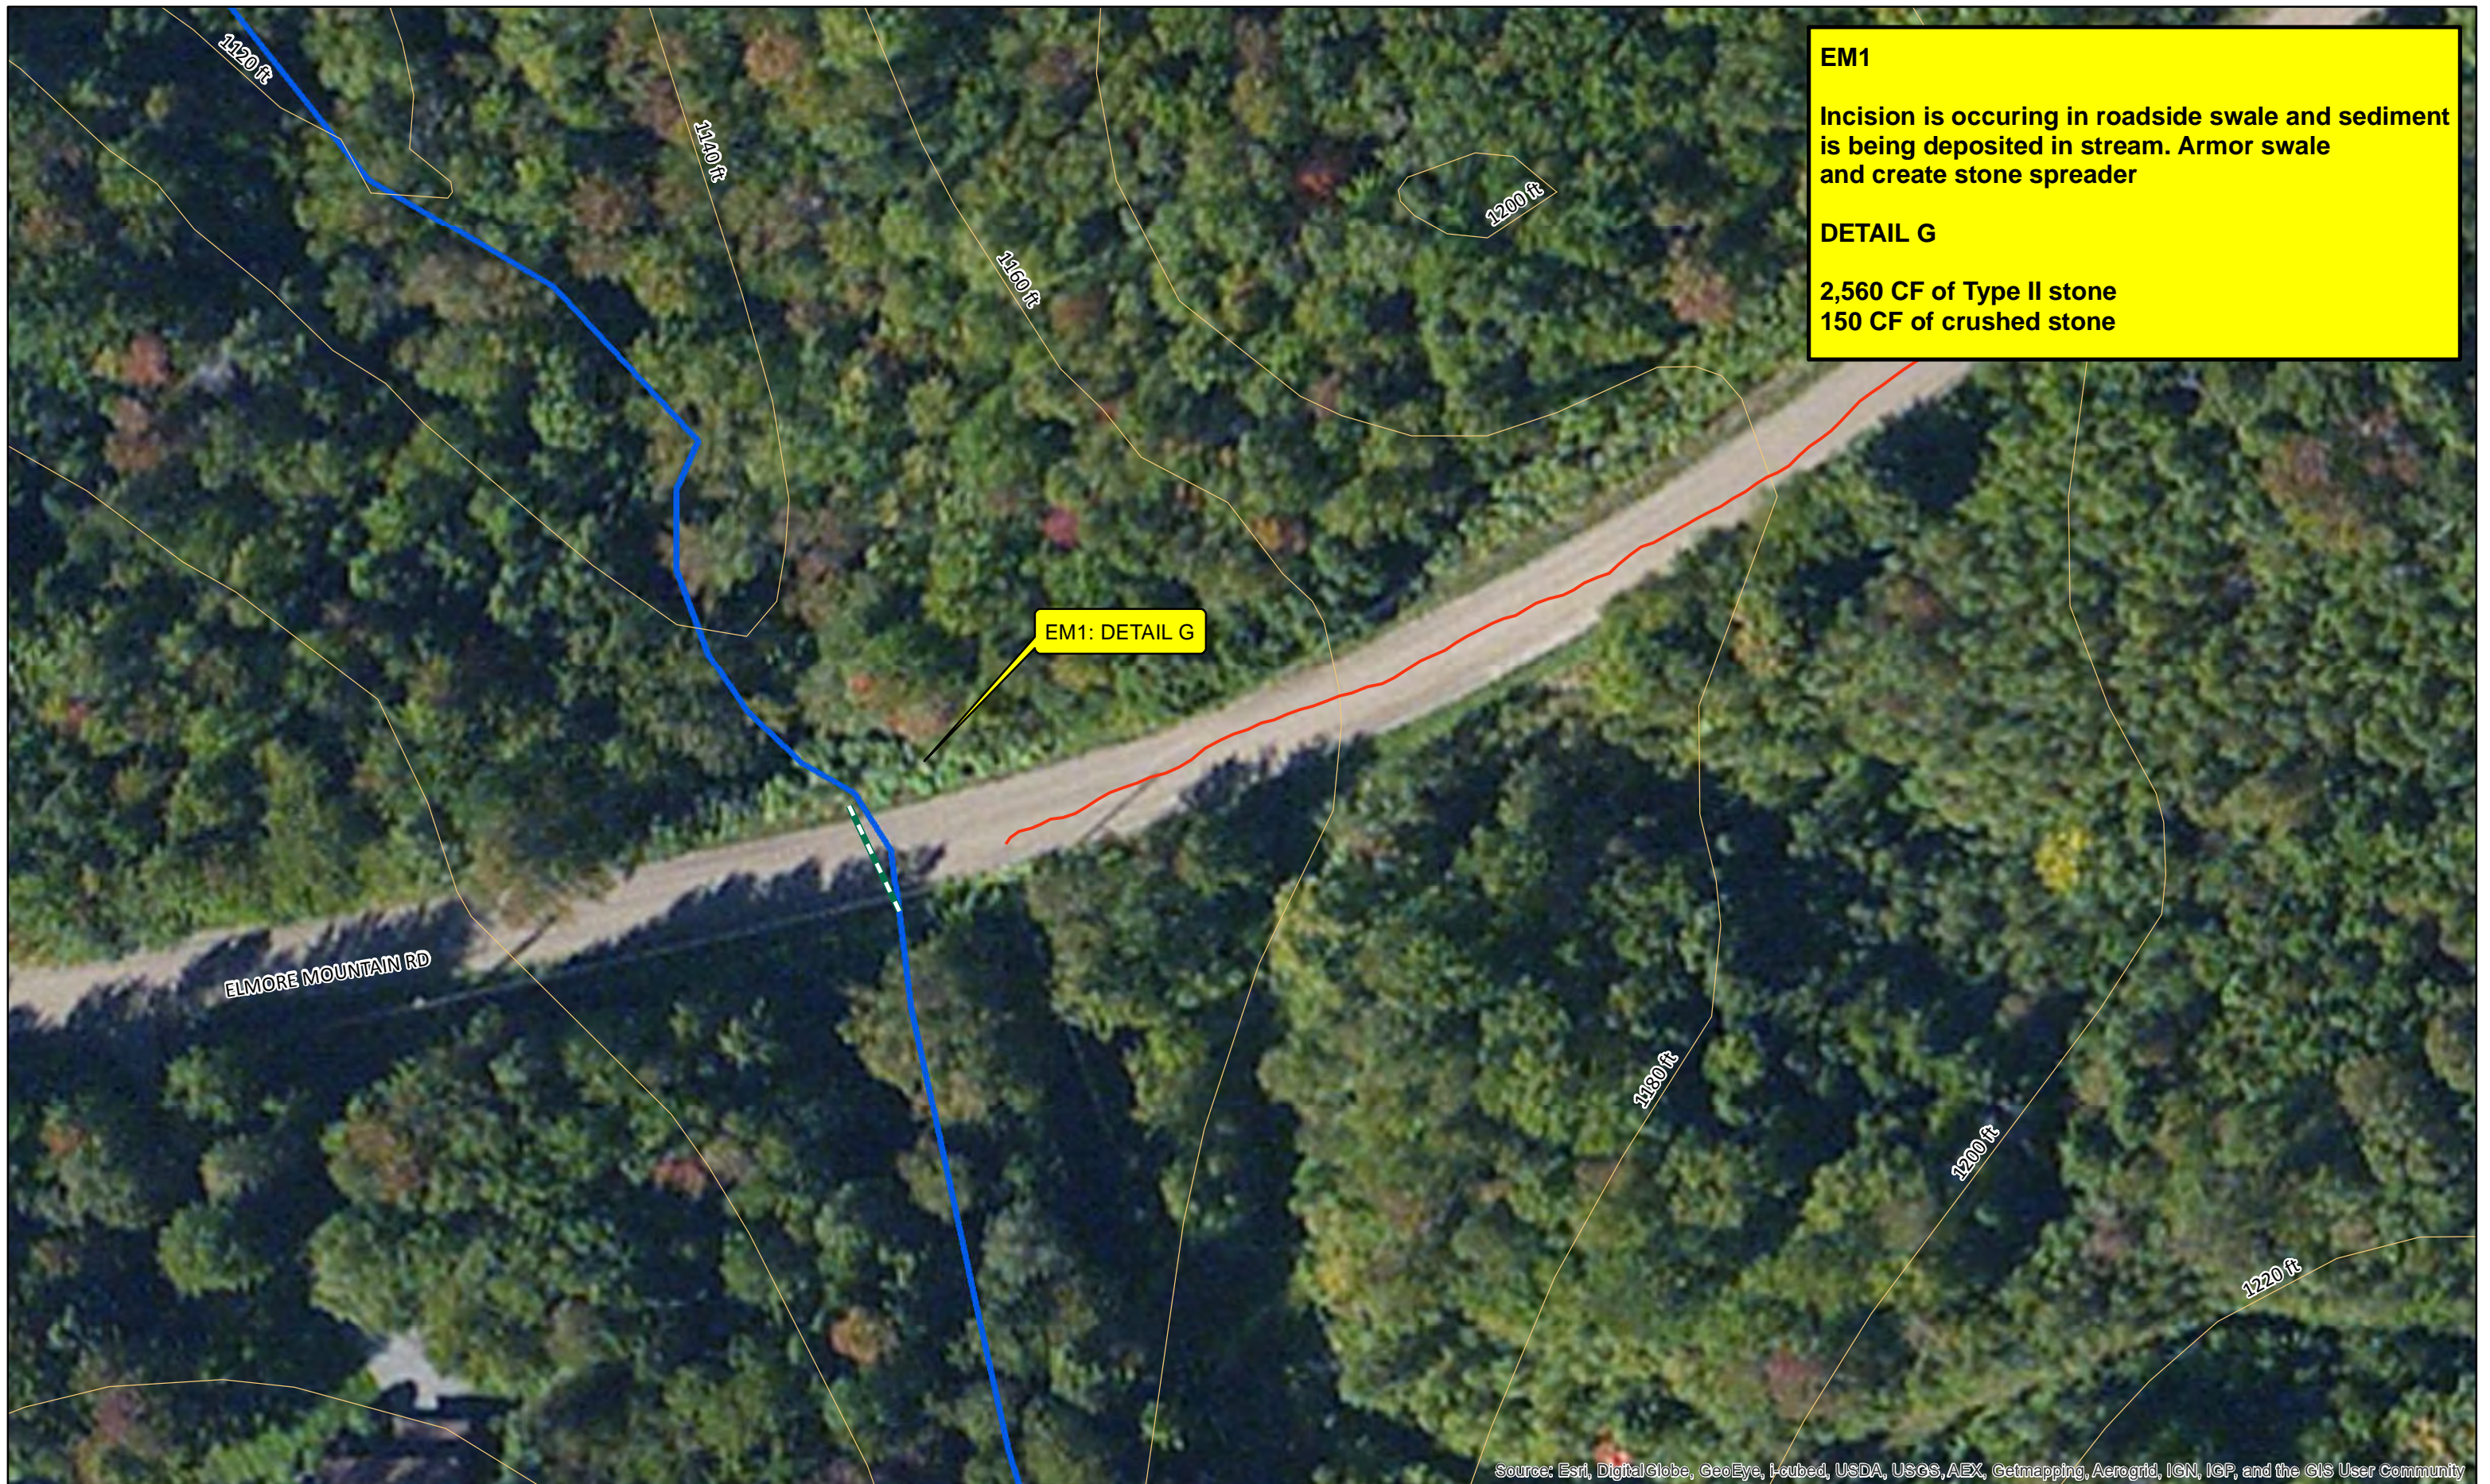
EM1

Incision is occurring in roadside swale and sediment is being deposited in stream. Armor swale and create stone spreader

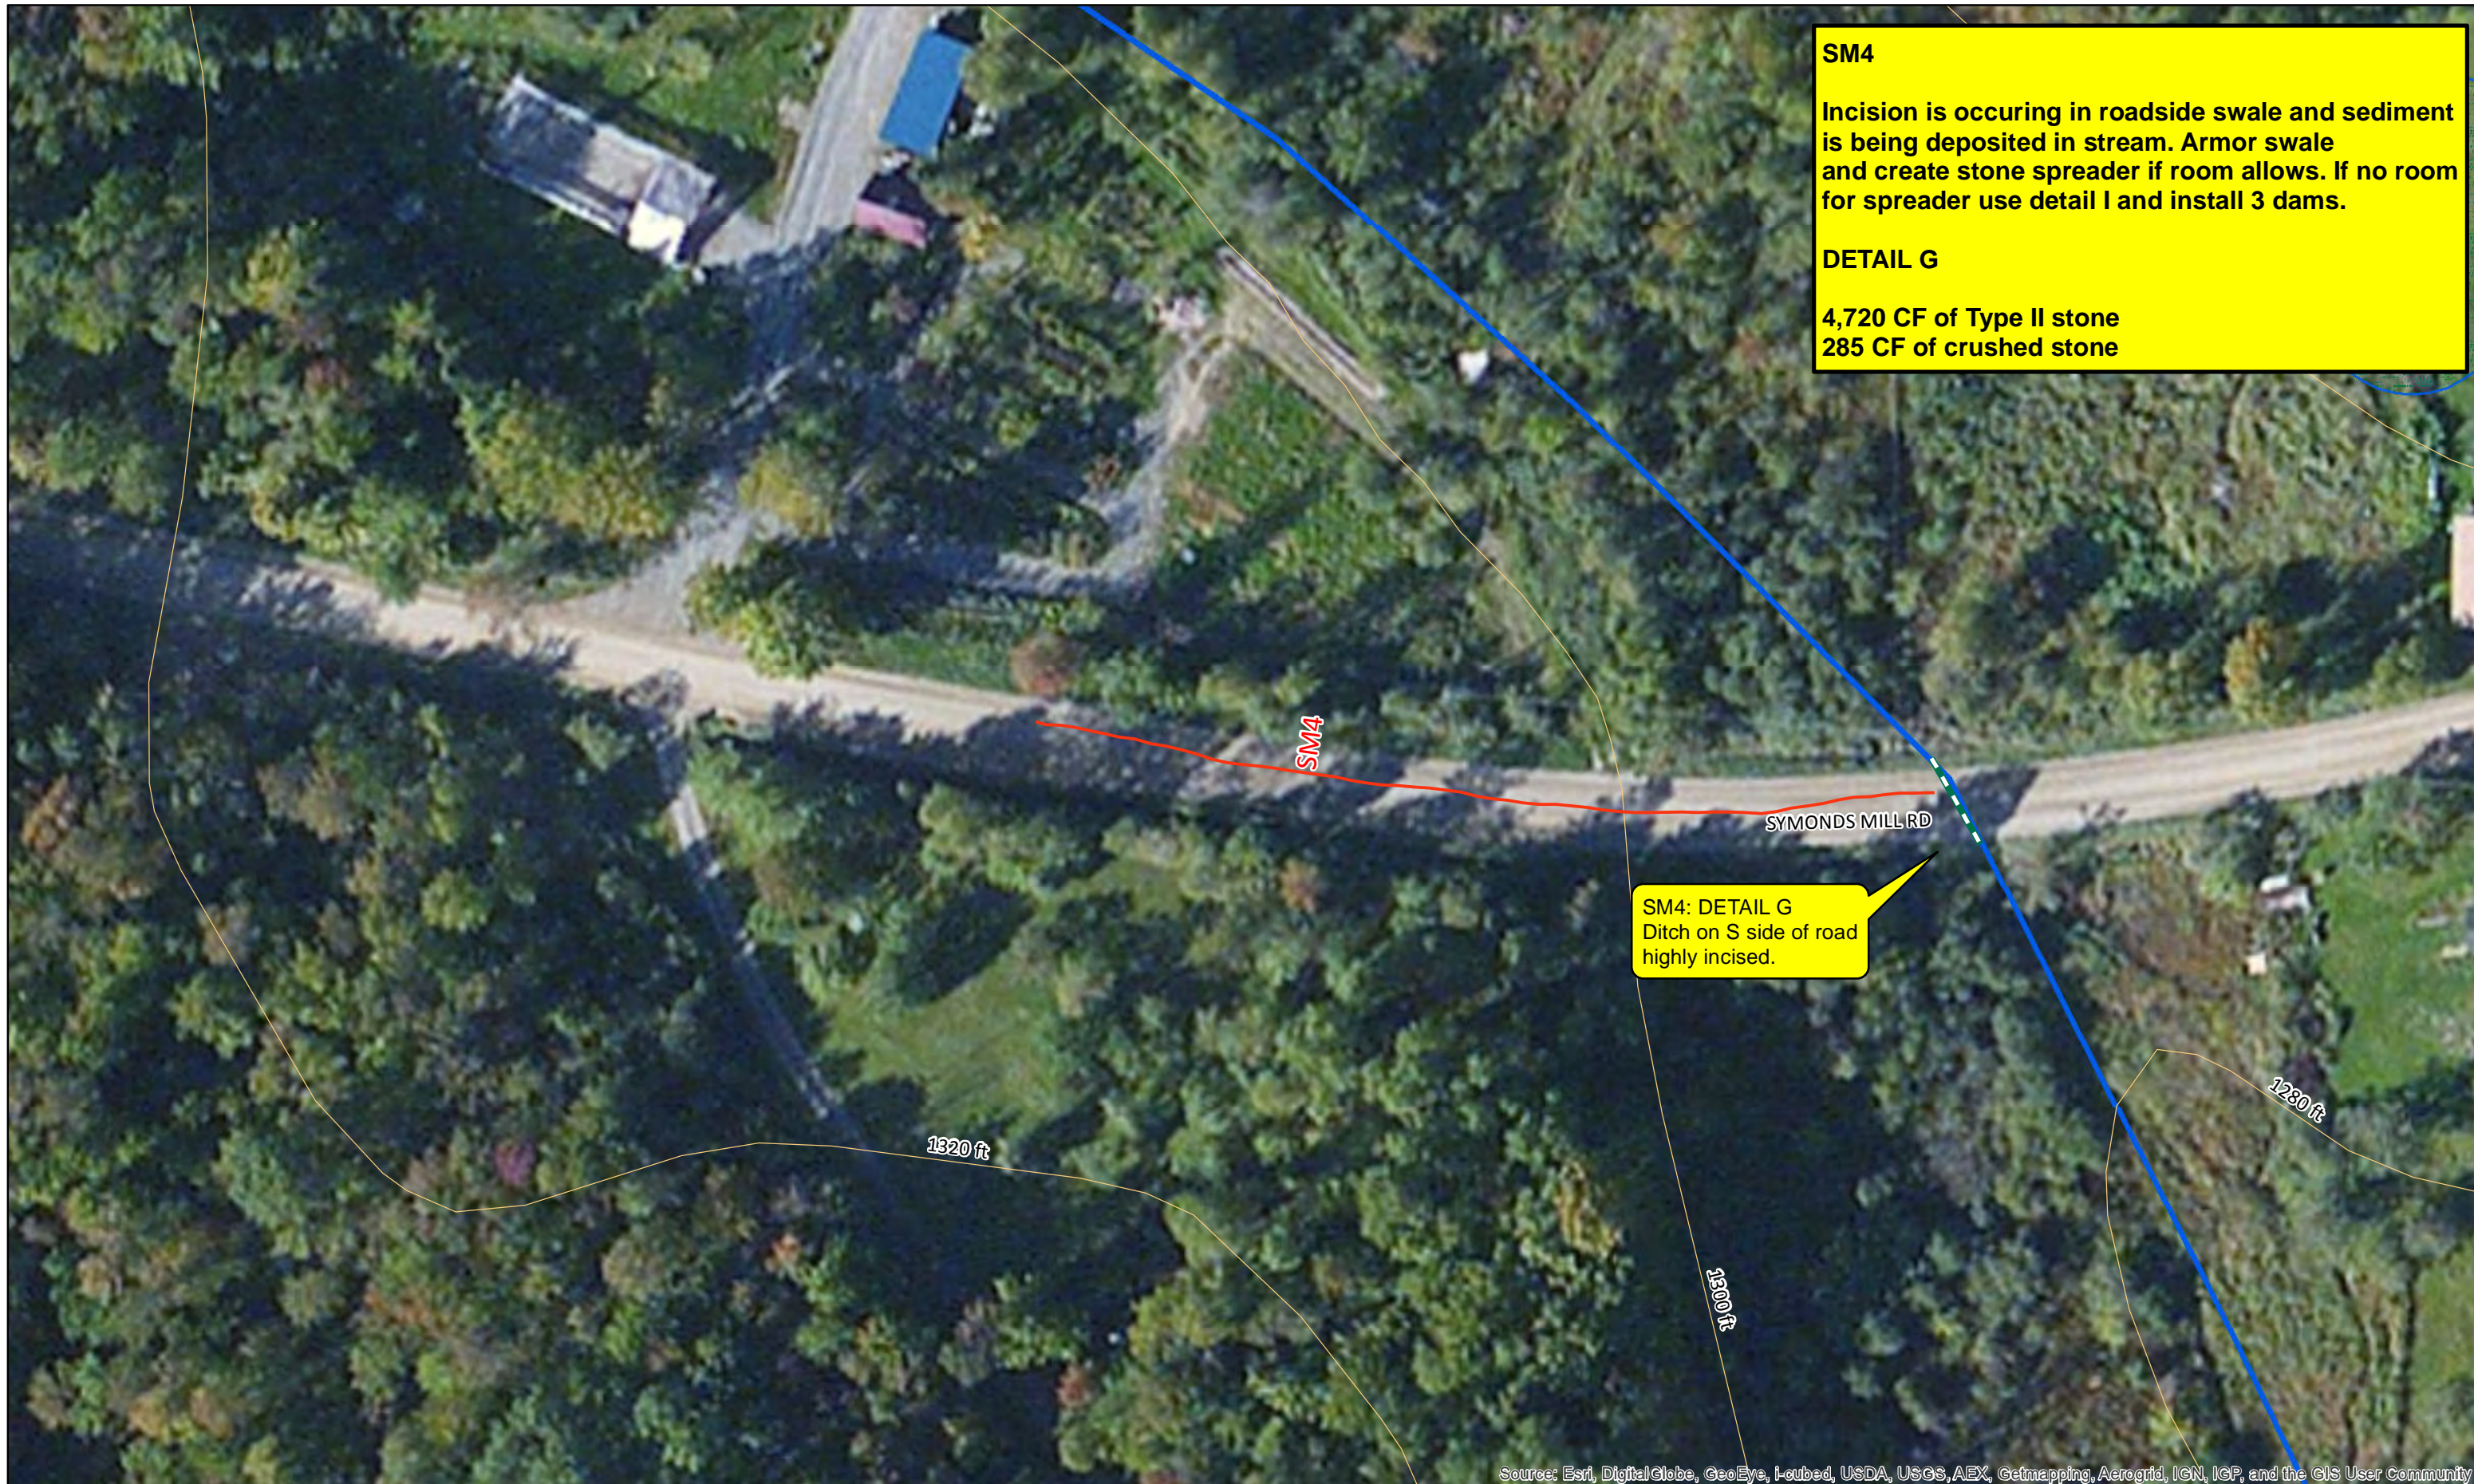
SM4

Incision is occurring in roadside swale and sediment is being deposited in stream. Armor swale and create stone spreader if room allows. If no room for spreader use detail I and install 3 dams.

SM4: DETAIL G
Ditch on S side of road
highly incised.

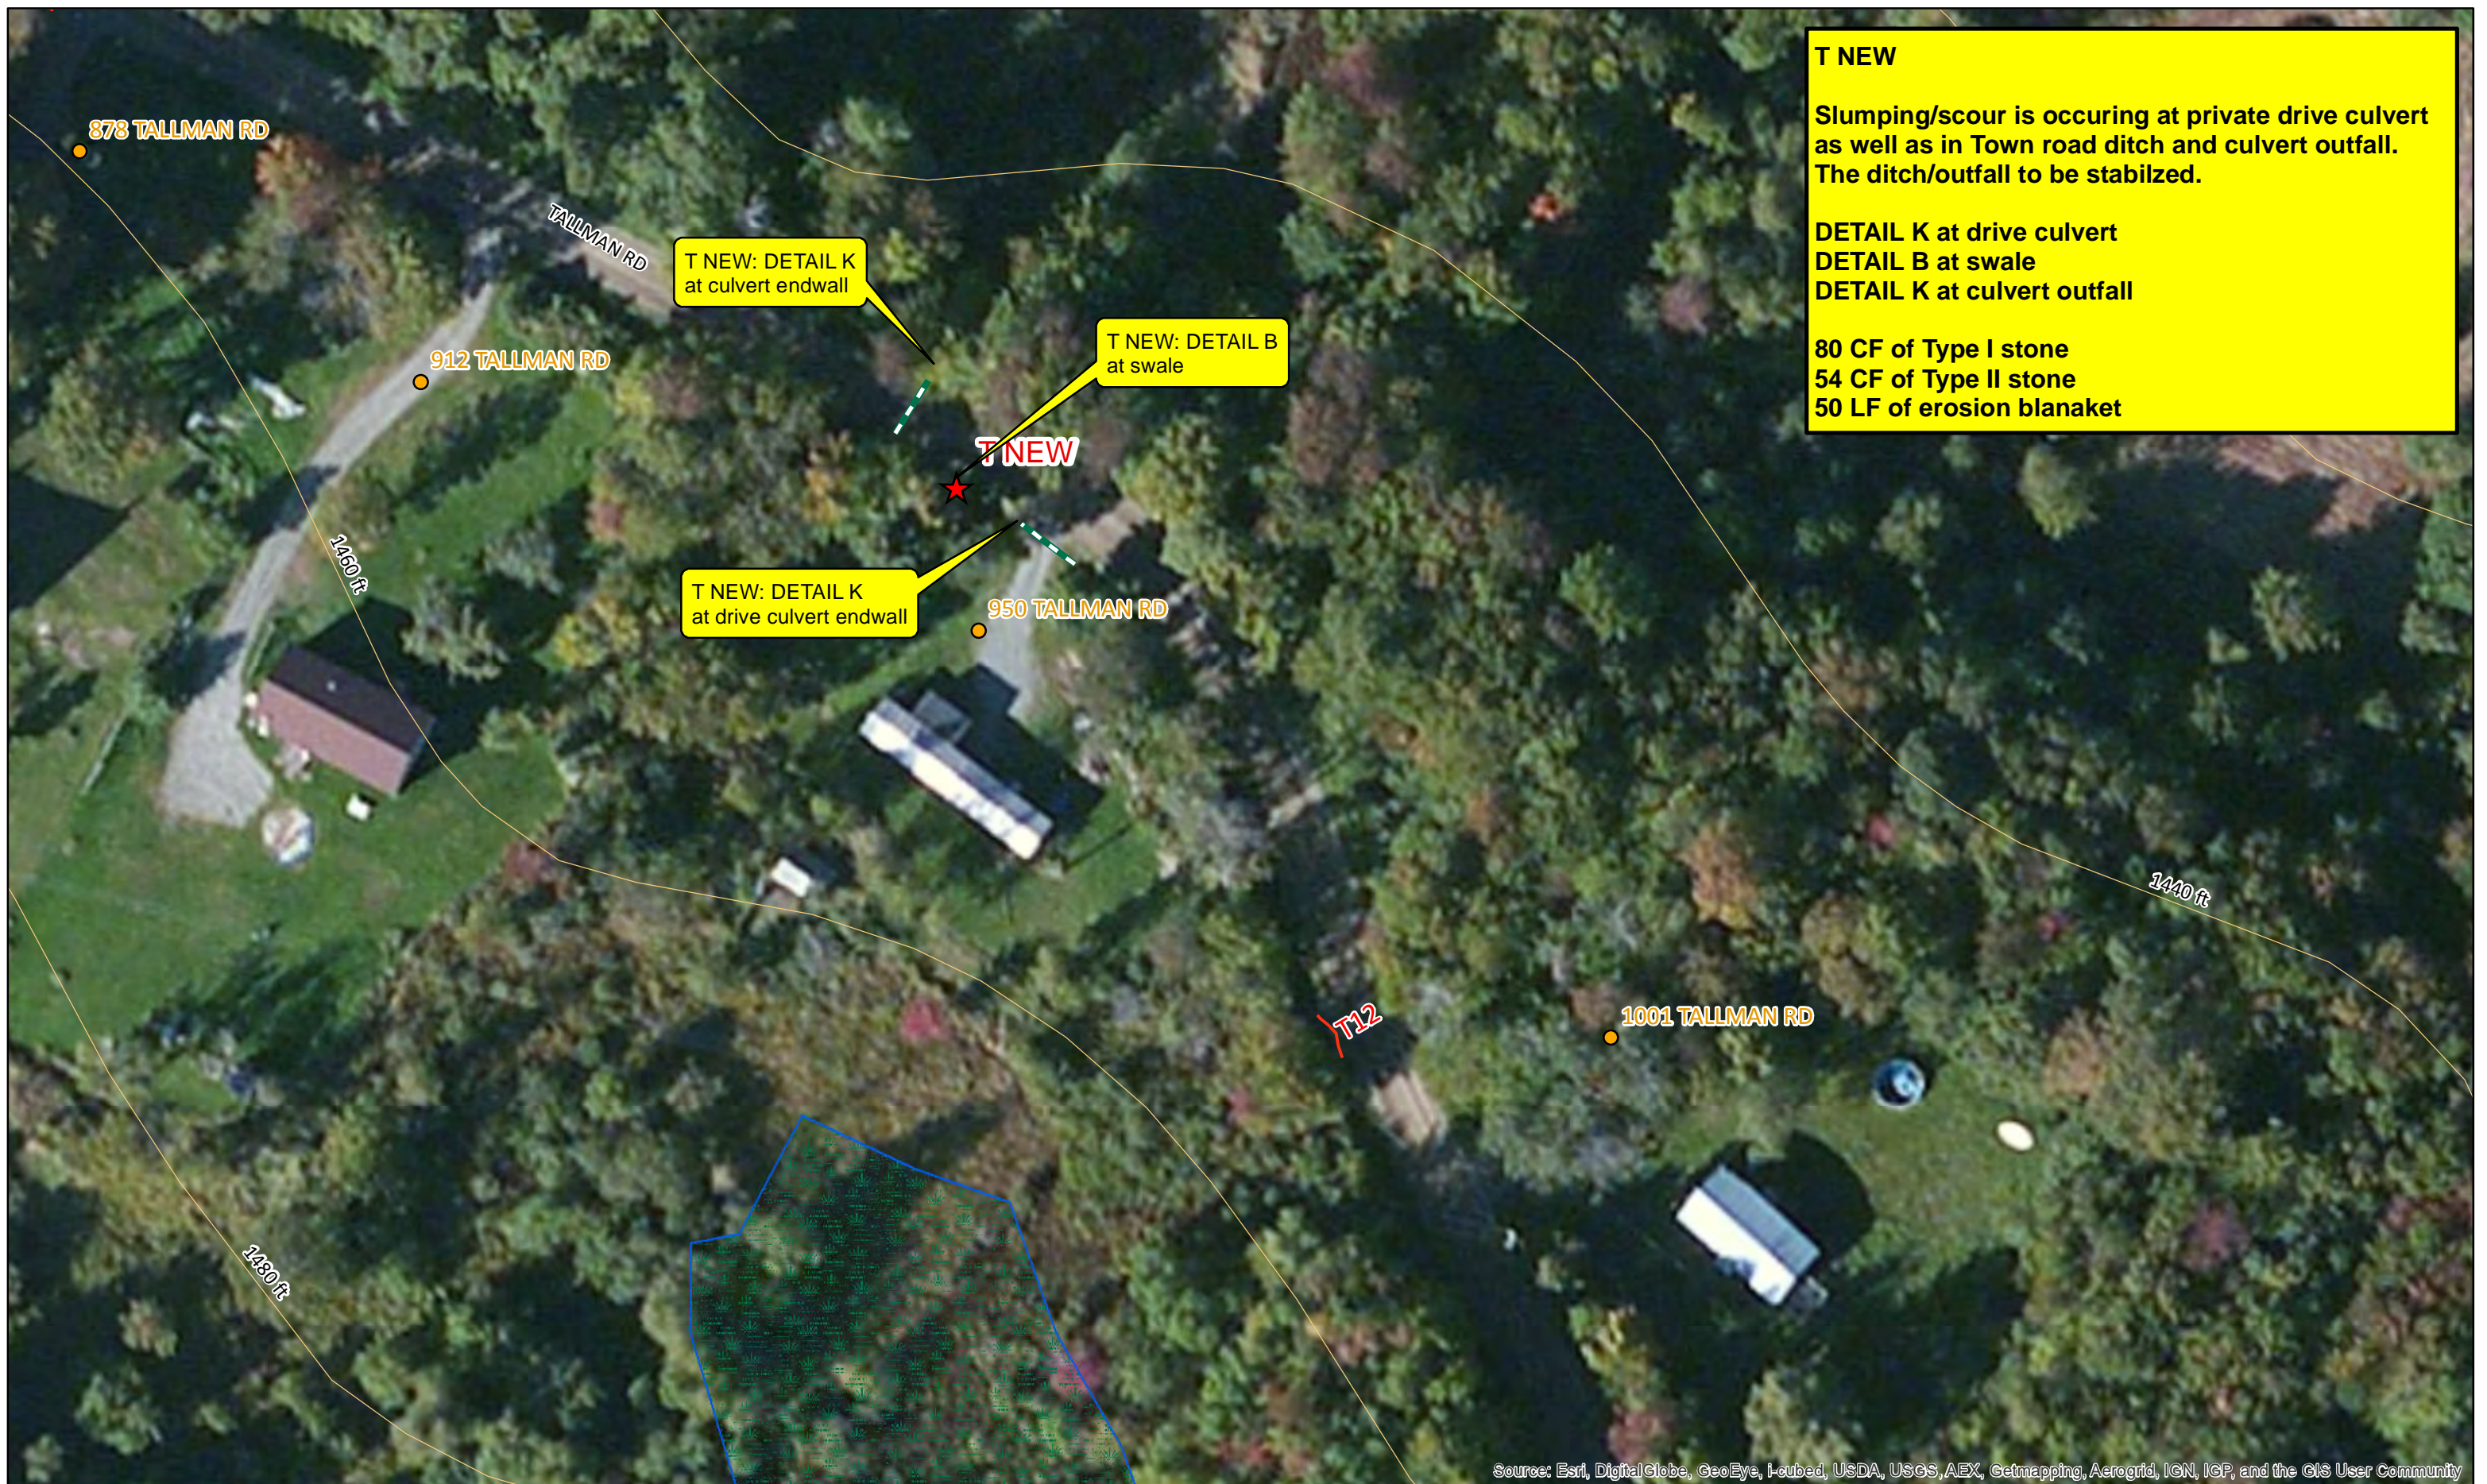
T NEW

Slumping/scour is occurring at private drive culvert as well as in Town road ditch and culvert outfall. The ditch/outfall to be stabilized.

DETAIL K at drive culvert
DETAIL B at swale
DETAIL K at culvert outfall

80 CF of Type I stone
54 CF of Type II stone
50 LF of erosion blanket

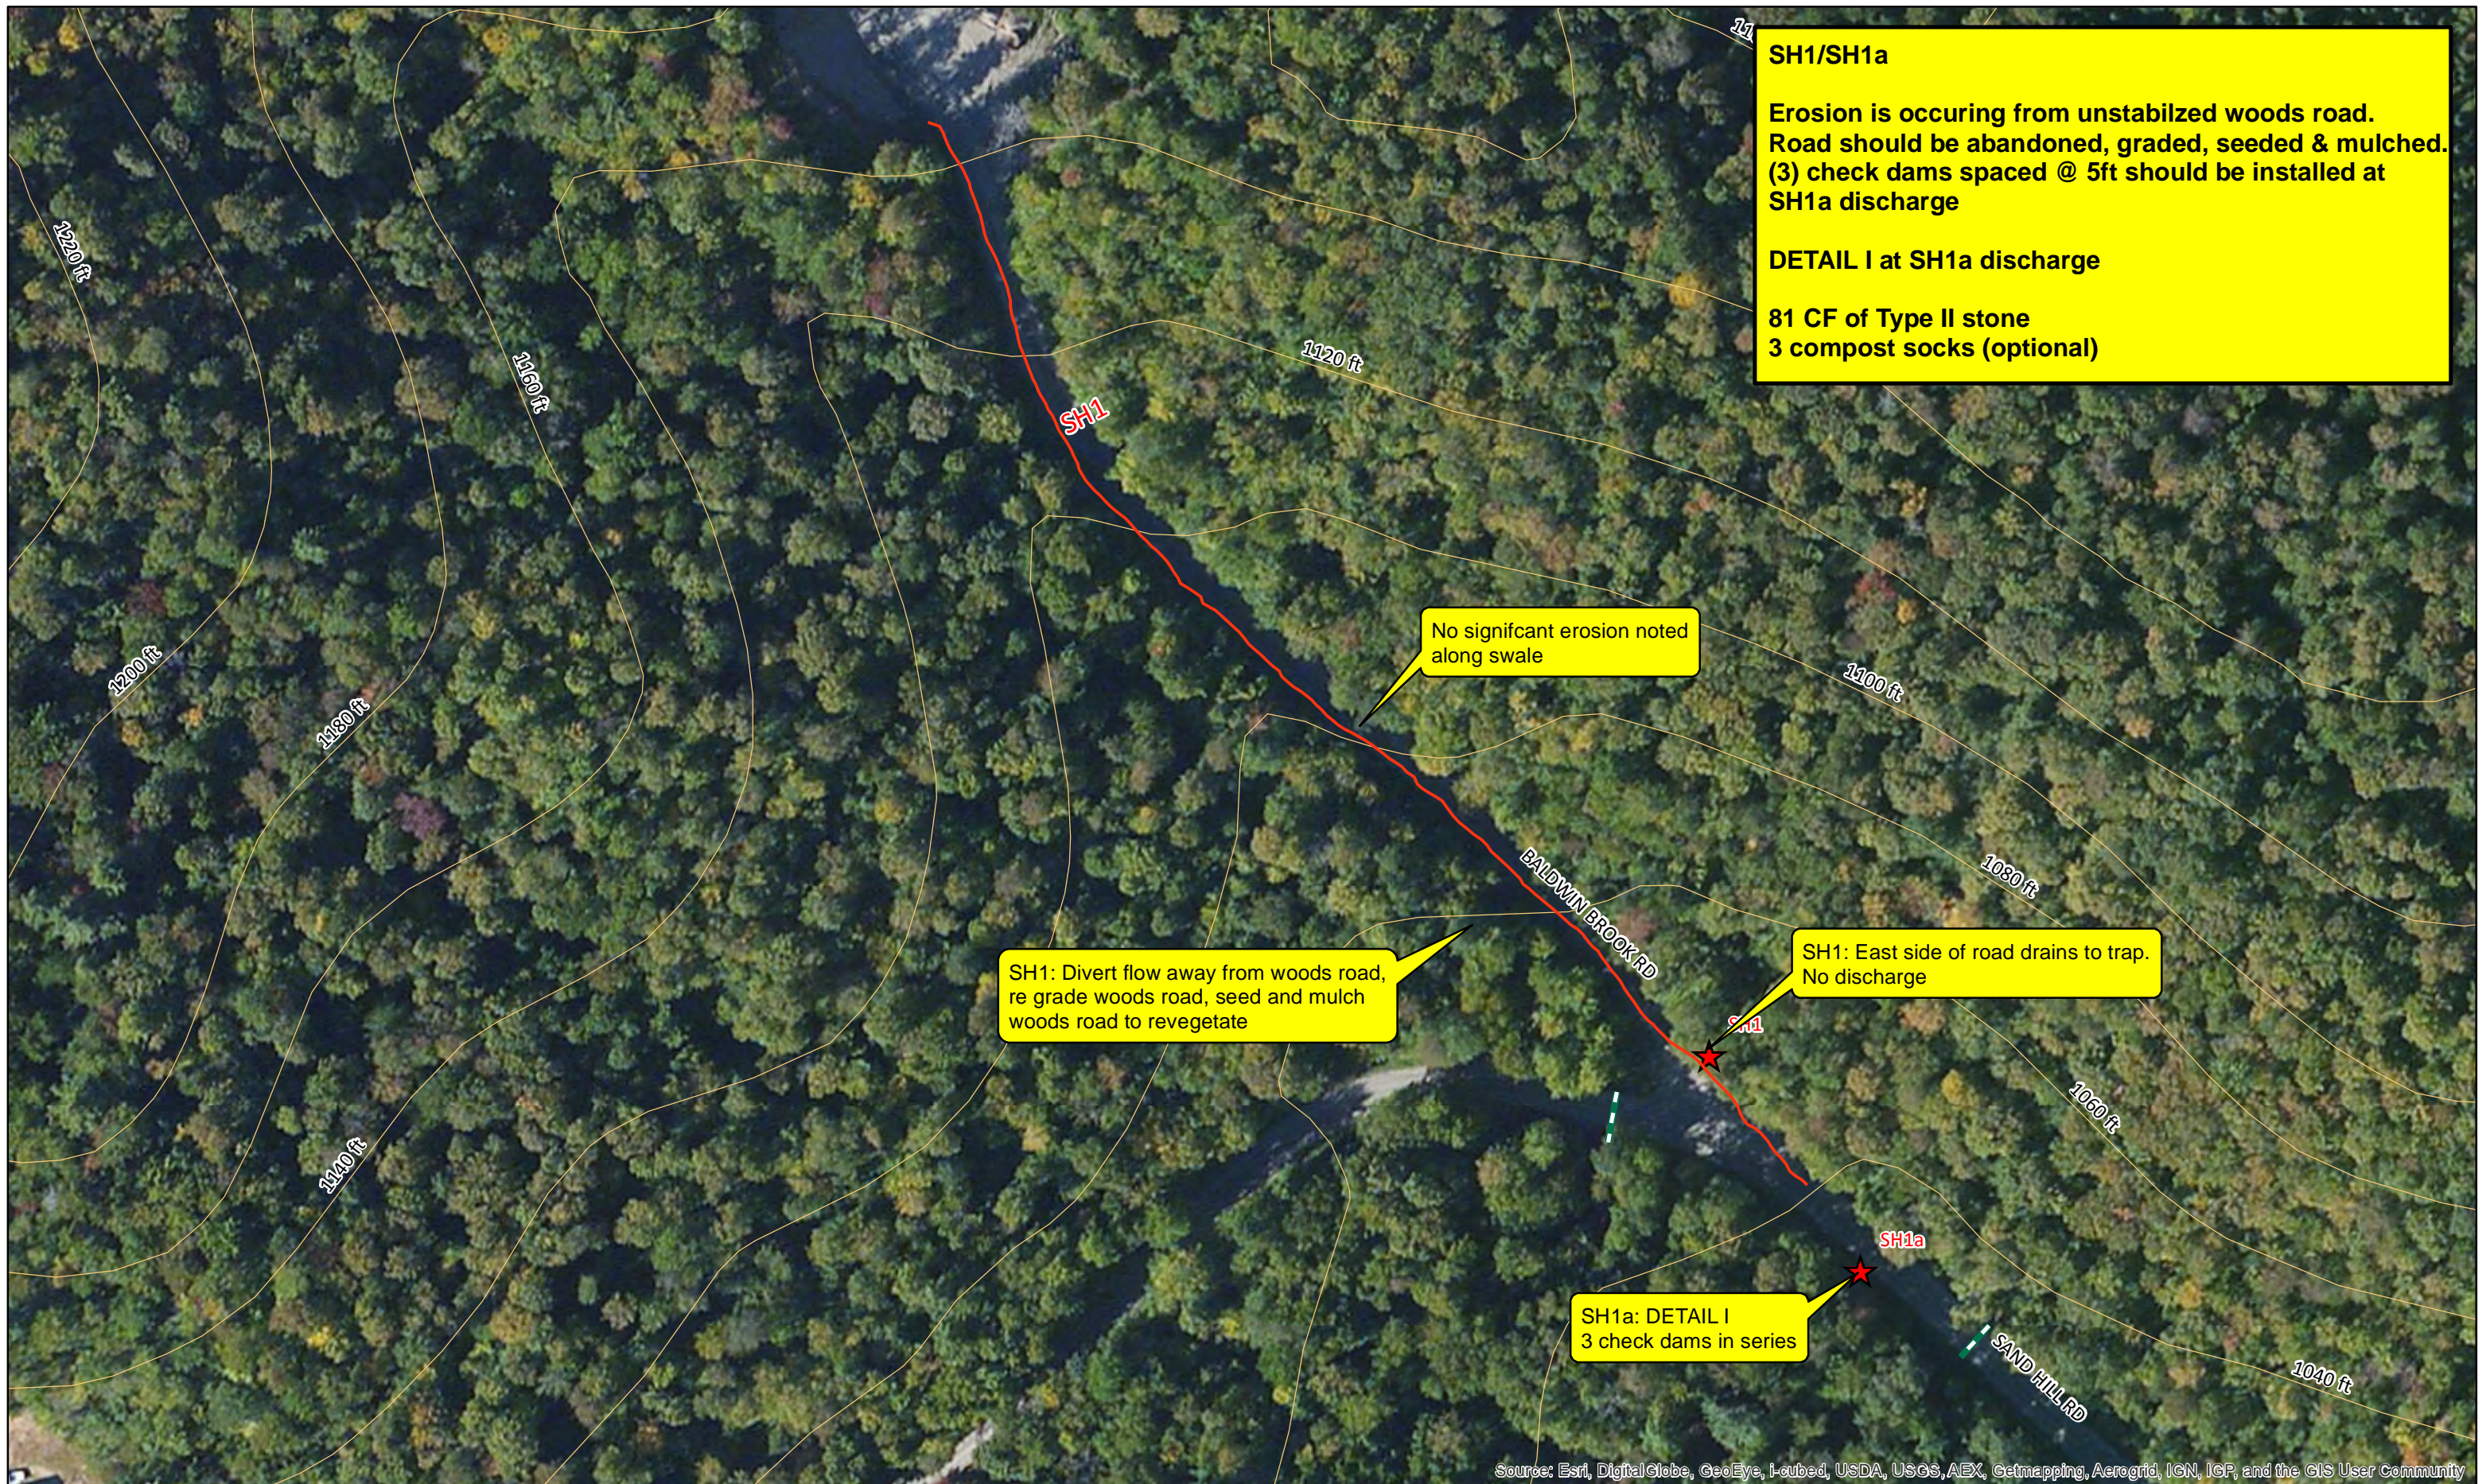
SH1/SH1a

Erosion is occurring from unstabilized woods road.
Road should be abandoned, graded, seeded & mulched.
(3) check dams spaced @ 5ft should be installed at
SH1a discharge
