Lamoille County Road Erosion Assessment

A project funded by the Vermont Watershed Grants Program and conducted by the Lamoille County Planning Commission with assistance from Watershed Consulting Associates, LLC.

February 2014

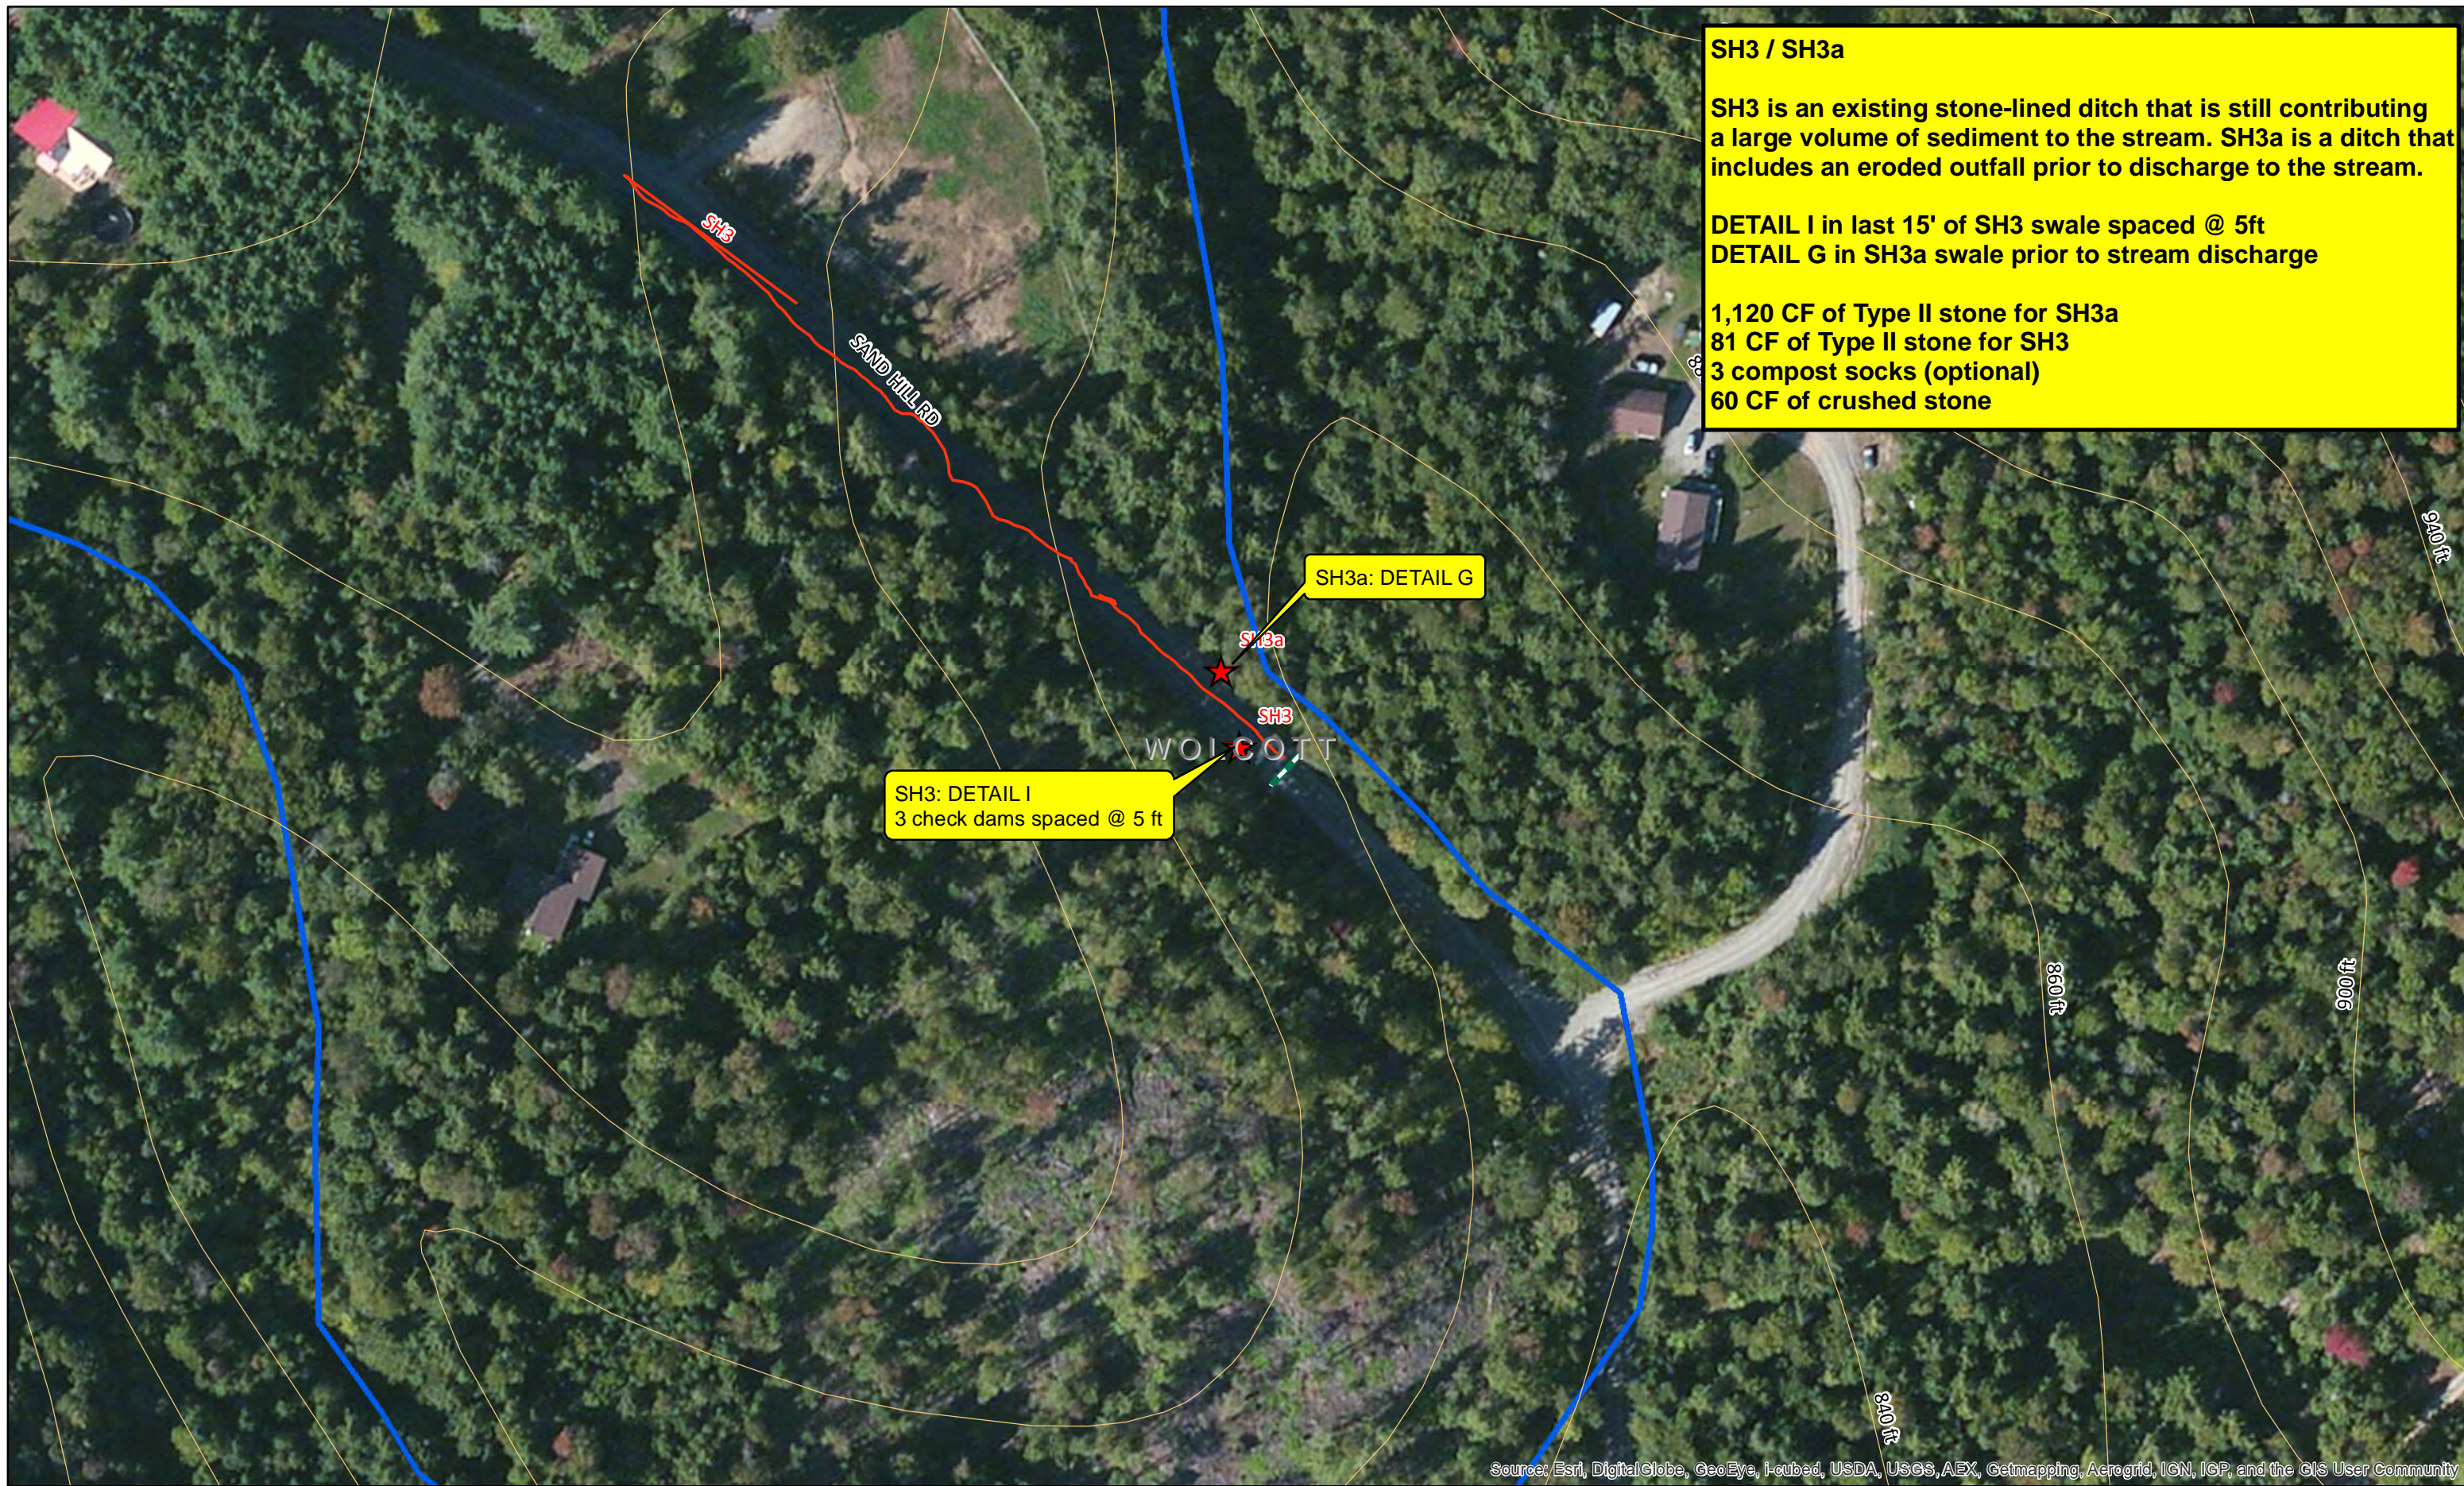
SH3 / SH3a

SH3 is an existing stone-lined ditch that is still contributing a large volume of sediment to the stream. SH3a is a ditch that includes an eroded outfall prior to discharge to the stream.

SH3a: DETAIL G
