Detecting and Eliminating Illicit Discharges to Improve Water Quality in the Lamoille River Basin

Final Report

Issued: January 31, 2014

Revised: July 11, 2014

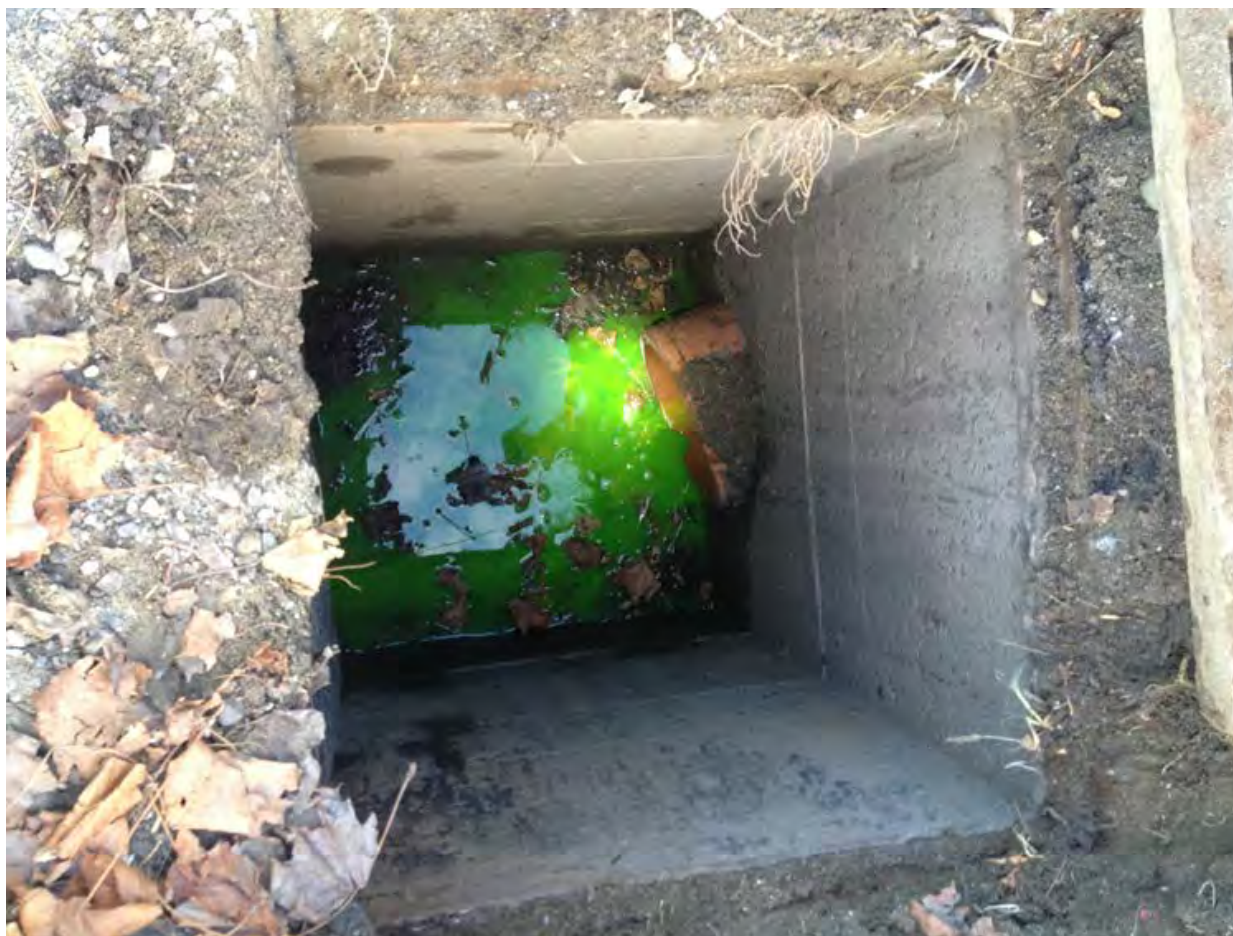
Dye flushed down a toilet in the Hardwick Elementary School appeared in this catchbasin on South Main Street, confirming a sanitary wastewater connection to the stormwater drainage system

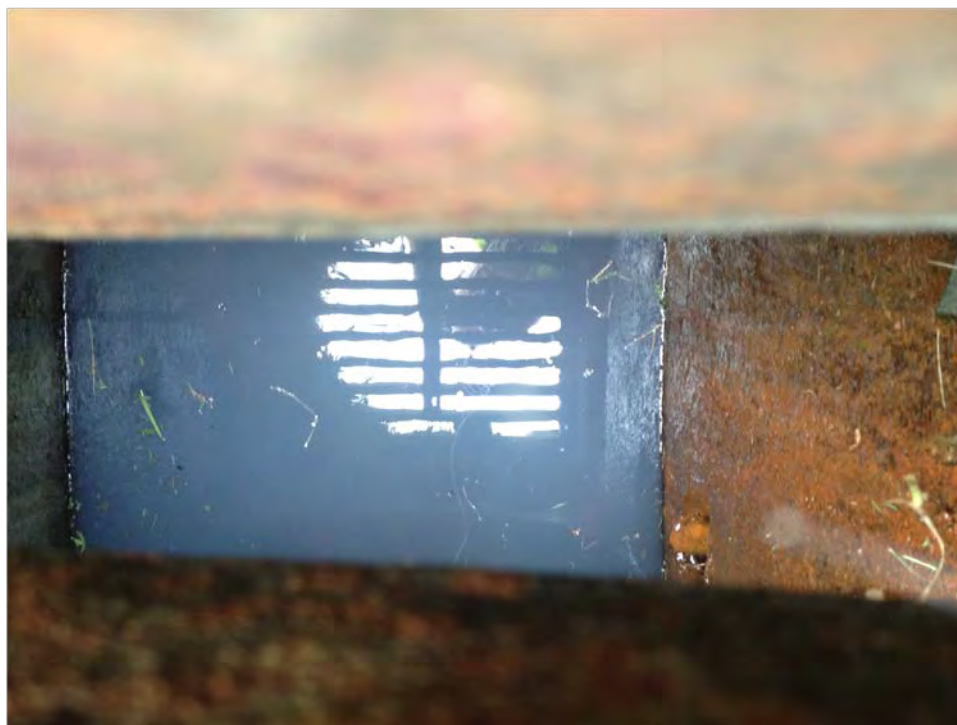
Figure 2. Laundry wastewater present in CB-B in system GA070

service station. A distinct laundry odor was observed in the first three catchbasins up-pipe from the outfall. The odor was strongest in the second catchbasin up-pipe from the outfall, CB-B. Water in the sump of CB-B was opaque and blue-gray in color (Figure 2). Ammonia and MBAS detergents were detected at low concentrations at the outfall and optical brightener was detected at the outfall and in the first three up-pipe catchbasins.

strongly suggested a laundry/graywater discharge to this system.

Optical brightener monitoring pads were placed in catchbasins CB-A, CB-B, and CB-C on August 13, 2013 to confirm the presence of laundry detergent. A marked laundry detergent odor was observed in catchbasins CB-B and CB-C when the pads were deployed and again when they were retrieved on

August 23, 2013. Pads placed in CB-A, CB-B, and CB-C showed strong optical brightener fluorescence. Because no pipes enter CB-B and CB-C, we suspect the source of the laundry detergent is infiltration from the onsite wastewater treatment system at the tan ranch house located on Route 7 in front of the bike shop and kitchen store. A second possible source is infiltration from the newly constructed (2011) mound system at the Franklin West Supervisory Union building at 4497 Highbridge Road.

Given the presence of laundry detergent and the location of the tan house relative to the storm drain, we suspect that the onsite wastewater treatment system serving this property is not providing adequate wastewater treatment. The question becomes: what level of treatment constitutes failure? *E. coli* levels measured at the outfall were low; therefore the system may provide adequate pathogen removal. The phosphorus concentration was also low, suggesting that phosphorus removal in the leachfield soils may be adequate. We expect mobile constituents such as nitrogen, chloride, and optical brighteners to pass from onsite wastewater treatment systems to groundwater. This is not necessarily a problem. In our view, the strongest basis for finding that the system was not providing adequate wastewater treatment was the bluish-gray color observed in catchbasin CB-B on July 27, 2012 and the laundry odor repeatedly observed in CB-B and CB-C.

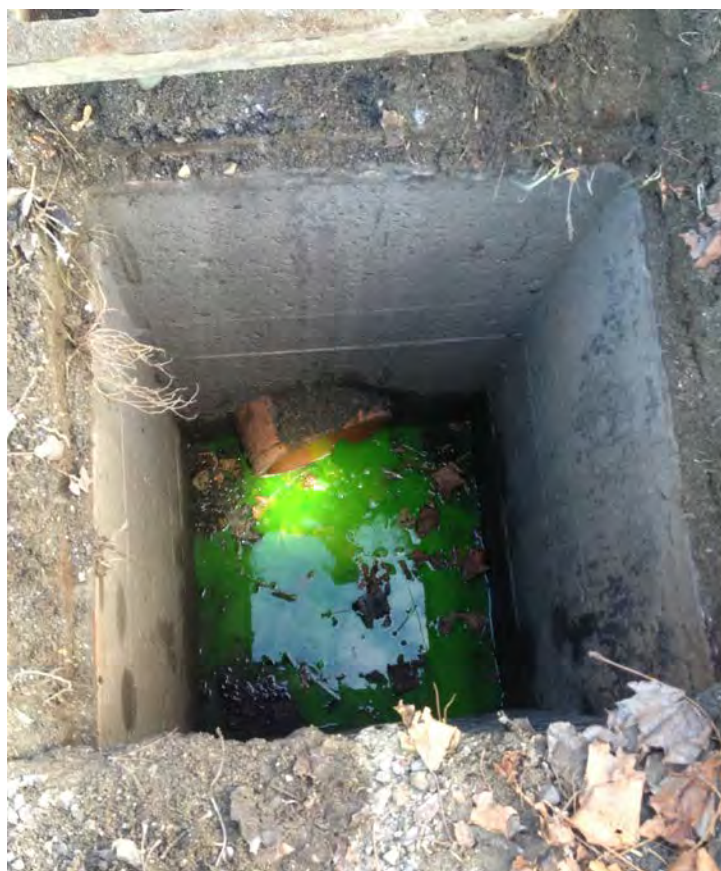
Figure 3. Dye flushed down a toilet at the elementary school appeared in catchbasin CB-C

On November 5, 2013, a meeting was held with the Town Manager, Jon Jewett, to discuss IDDE findings in Hardwick. With assistance from public works staff, all the kitchen drains in the elementary school were dye tested; none were found to be connected with the HA070 system. Investigations were started

in the kitchen due to the repeated observations of fish odors. A push camera was then deployed in catchbasin CB-C. Approximately 50 feet into the pipe a large diameter pipe intersected the line from the direction of the elementary school. Through sound checks, we confirmed the opposite end of the pipe, a ductile iron pipe that protruded through the basement wall and was sealed with a threaded cap. No visible building plumbing was connected to this pipe. Finally, toilets were dye tested in different areas of the elementary school building and a wing of the school with four bathrooms was determined to be connected to the HA070 system (Figure 3). The exact connection is unclear, but we suspect that the sanitary line from this wing of the building is plumbed to a roof downspout which intersects the ductile iron pipe just outside the basement wall.

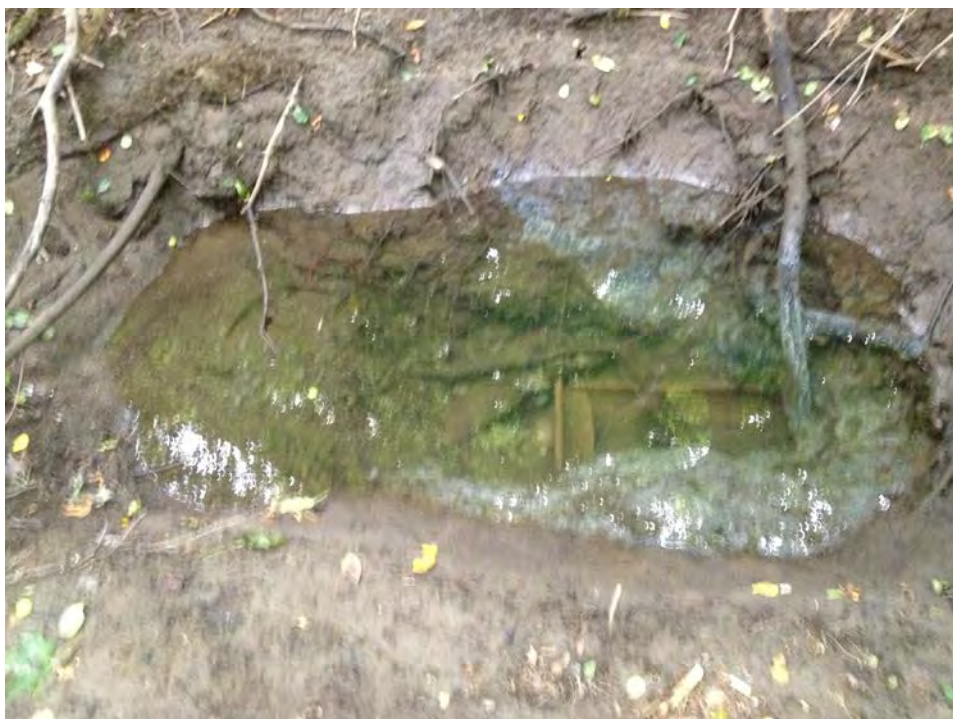
Figure 4. Sinkhole with gray film suggesting wastewater contamination

On November 13, 2012, we attempted to follow the path of the buried stormline up from the outfall. The vitrified clay line is broken in places, creating two sinkholes. The sinkhole pictured in Figure 4 had a wastewater odor and condoms were visible, indicating a wastewater source. Optical brightener monitoring pads were placed at the outfall, the sinkhole, CB-D, and MH-I. Optical brightener was

detected at the outfall, the sinkhole, and MH-I. Although the mapping of this system contained inaccuracies which confused interpretation of the data, the results indicated a direct sanitary wastewater connection somewhere within the system.

On October 31, 2013 excavation at the sinkholes quickly revealed that they were holes over breaks in the former combined sewer main. In the previously sampled sinkhole (closer to Johnson Street Extension), both ends of the broken vitrified clay line were exposed. Because the line was the main and not a broken lateral, attention shifted to finding the source of the contamination within the downtown area. All residences located on Main Street between Church Street and Johnson Street Extension were dye tested on October 31, 2013 and over the following weekend. In every case, dye was seen in the sanitary system and not the stormwater system (at MH-I).

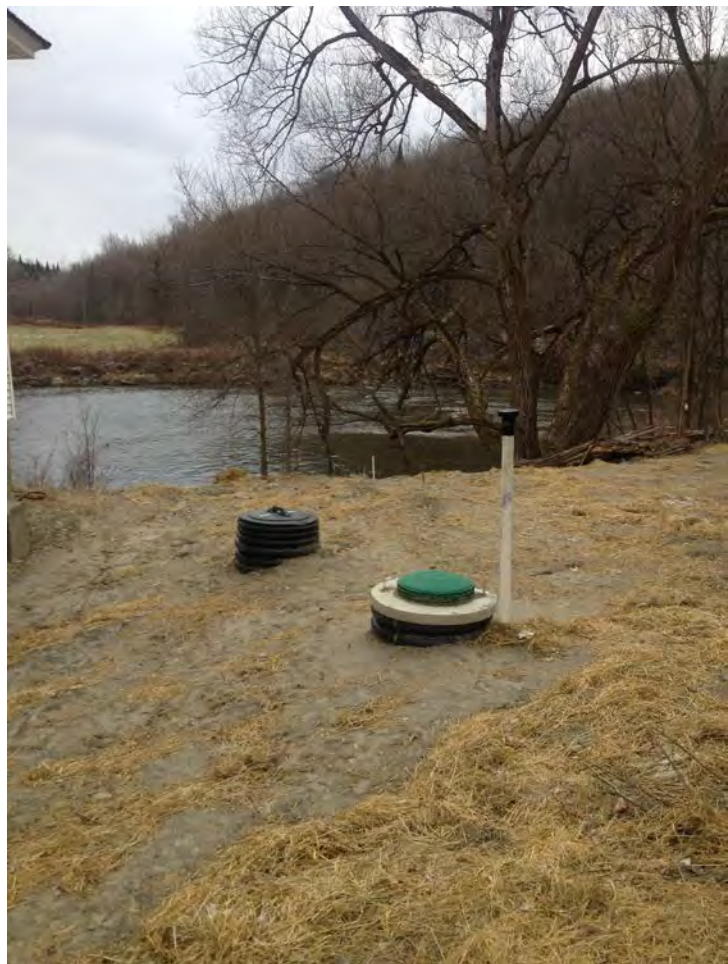
**Figure 5. Replacement septic system at the Wolcott Town Hall**

A meeting to discuss the IDDE results was held on September 12, 2013 with Wolcott Town officials (Linda Martin, Town Clerk and Belinda Clegg, Assistant Town Clerk and Select Board Chair) and Jim Ryan, the Lamoille River Basin Planner. Following the meeting, the Town Health Officer, Bernard Earle, determined that the septic system serving the Town Hall building was malfunctioning and was therefore a likely source of *E. coli* at the outfall. The Town constructed a new leach field and installed a pump vault to route septic tank effluent to the new leach field (Figure 5). The PVC pipe discharging at WO050 was routed around the septic system and the outfall was extended to the top of the river bank. When outfall WO050 was resampled on January 21, 2014, the *E. coli* concentration was low, 95 MPN/ 100 mL. This result suggests that replacement of the leach field may have reduced wastewater infiltration to the system.

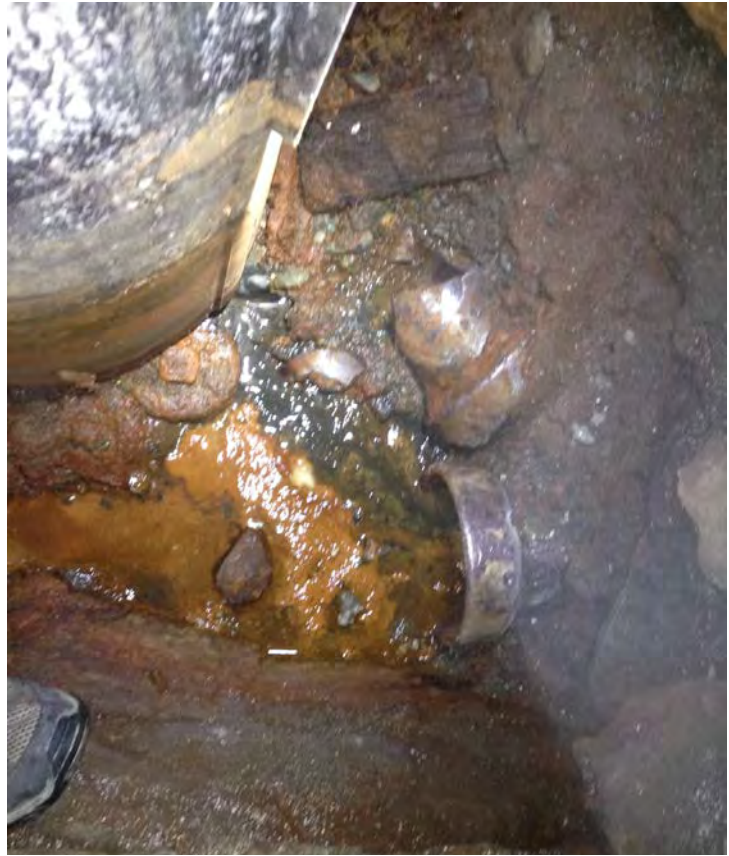
Figure 6. Leaking wastewater pump chamber next to perimeter drain

On November 19, 2013, an attempt was made to determine the source of the flow at the WO050 outfall. In the basement of the Buck's Furniture showroom, a shallow trench dug along the perimeter of the basement wall conveys groundwater from the basement to a gravity drain in the southwest corner of the basement. This groundwater is believed to be the primary source of dry weather flow at the WO050 outfall. A wastewater pump chamber is located within two feet of this drain. While inspecting this interior drain a leak was noted in the corroded steel pump chamber, causing

wastewater to leak into the perimeter ditch and into the drain (Figure 6). According to our contact at Buck's Furniture, Ricky Fichtner, the owner indicated he would replace the leaking pump chamber expeditiously. However, six months after we notified the business this work still had not been performed. DEC is now pursuing its options to resolve the problem.
