Blanchard Brook, Montpelier, Vermont

Blanchard Brook in Montpelier has been found to be impaired by stormwater runoff quality as measured by the biology of the stream and is on the state's 303d list of impaired waterways. There are at least 12 significant discharges to the stream from the developed lands of Montpelier. The largest discharge to the stream is drainage area #127 which drains a large section of the central watershed. The recommended course of action for stormwater impacted streams is to install a treatment structure that controls both the water quality volume and the channel protection volume from these discharges near the outfall. A map showing the location of the discharges and a possible retrofit location is provided. A cost estimate (excluding land costs) is provided. Since this is a developed area modifying the existing wet ponds to manage these two volumes would be the least disruptive to the landowners. The landowners in drainage areas #121-122 will have to upgrade their discharges to the stream to meet 50% of the water quality volume from the properties although most of the runoff can be treated for sediment removal with drainage areas #3000b. This report also

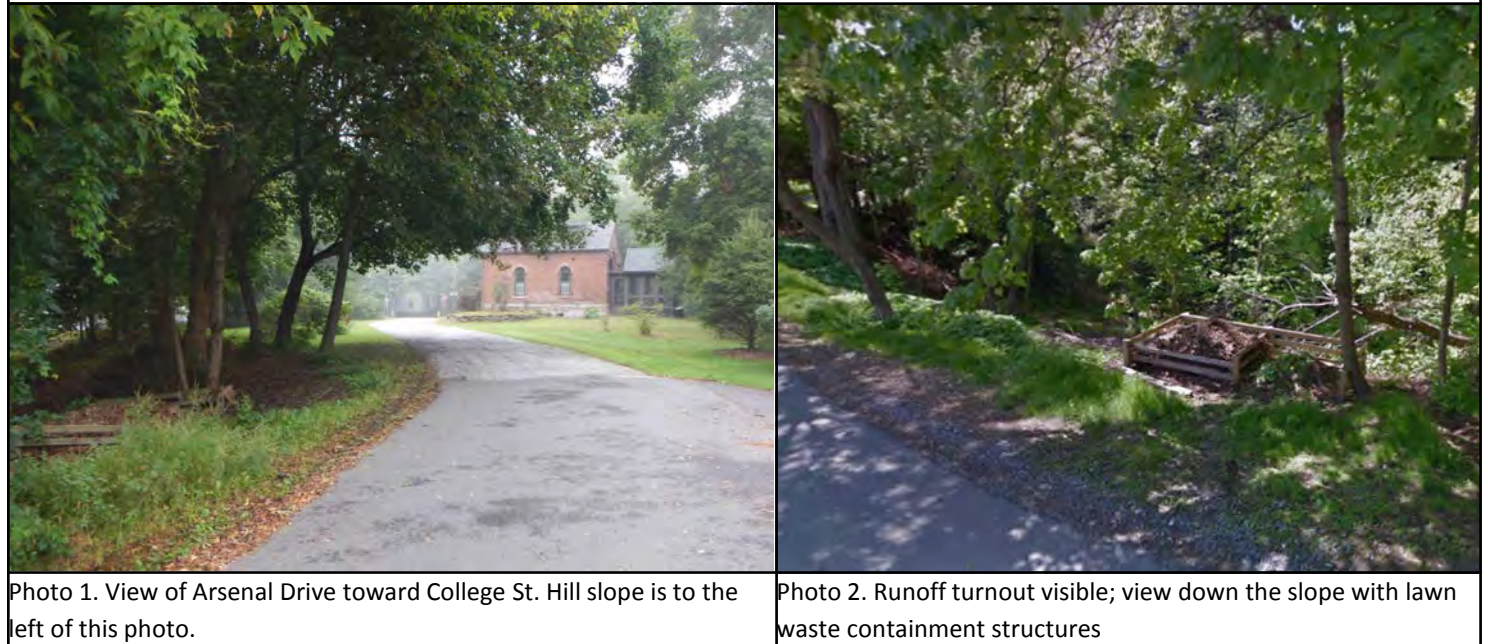
| Problem Area ID: BB-01 | Latitude: 44.256666 | Longitude: -72.563895 |

Description of Observed Conditions:
 Stormwater runoff from approximately 150' immediately east of College St. is turned out over a steep hillside and through an area where lawn waste is being composted. "Green Street" retrofitting could be used to better manage road runoff.

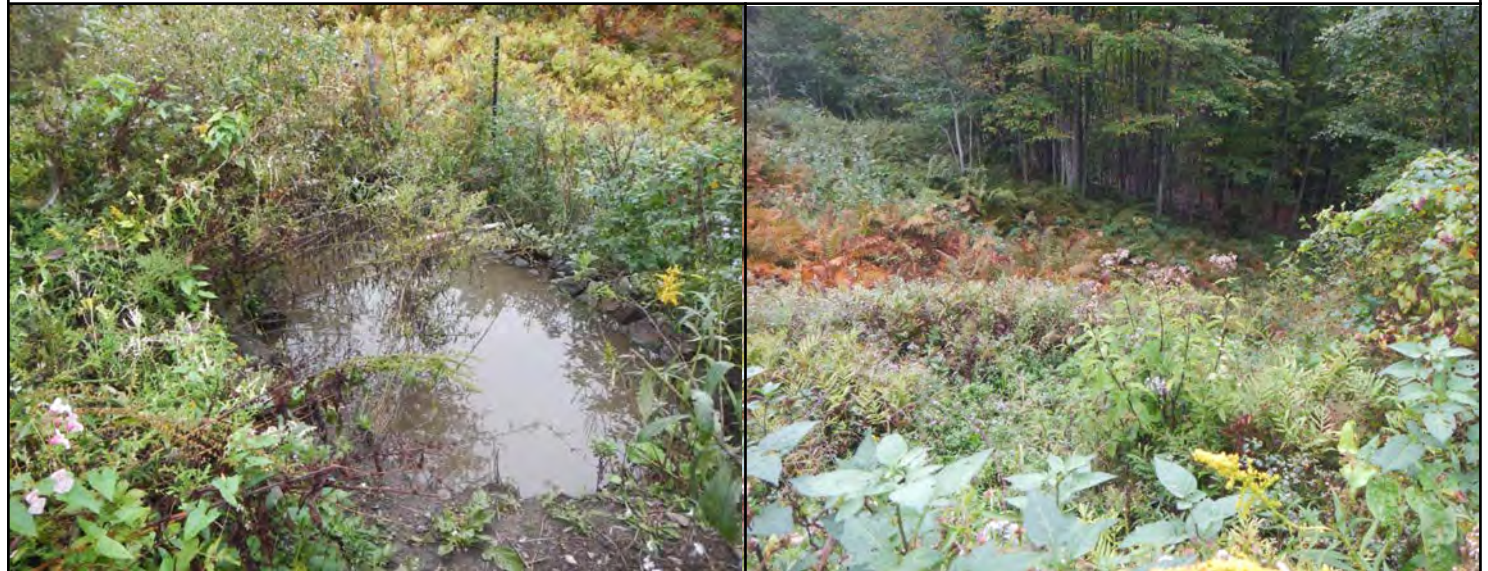
| Problem Area ID: BB-02 | Latitude: 44.256503 | Longitude: -72.561980 |

Description of Observed Conditions:
 City constructed a small splash pad/energy dissipation area approximately ¼ of the way down the slope in the backyard of #8 McKinley St as part of a CSO separation project. Homeowner indicated a willingness to consider improvements to the pond. Some erosion was visible below this structure.

Photo 1. Pool about ¼ of the way down the slope in the back yard. Photo 2. View down the slope from the pond.

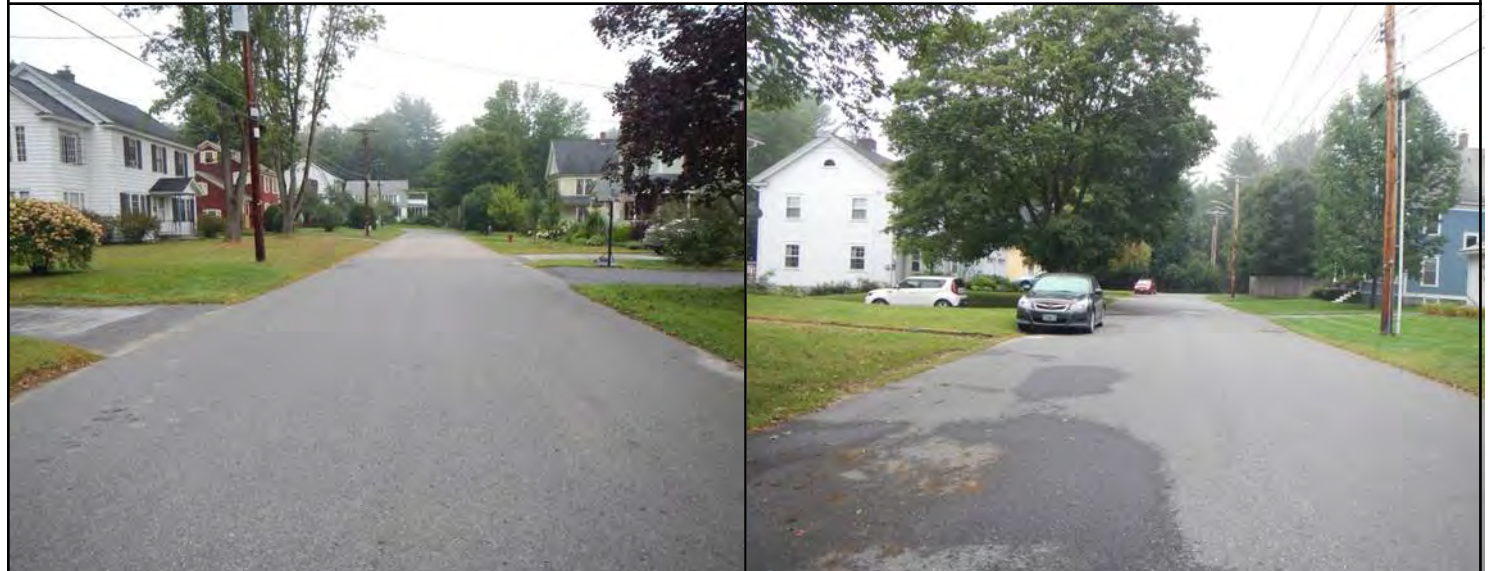
| Problem Area ID: BB-03 | Latitude: 44.257311 | Longitude: -72.561528 |

Description of Observed Conditions:
 Hinkley Street is wide, with no curbs separating the road edge from the adjoining green space. "Green Street" retrofit could be used to capture/treat runoff and add the benefit of traffic calming.

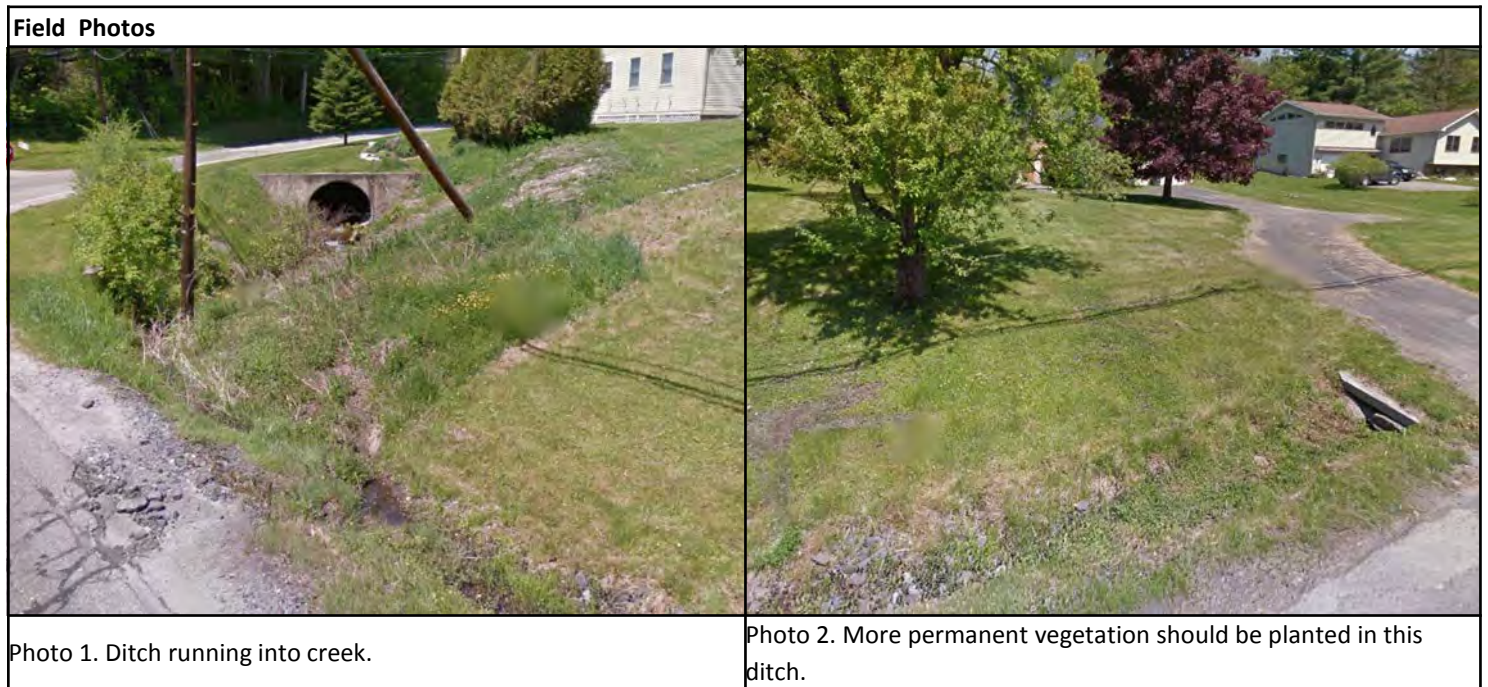
| Problem Area ID: BB-04 | Latitude: 44.262094 | Longitude: -72.558453 |

Description of Observed Conditions:
 Roadside drainage at the intersection of Towne Hill Rd and Main St is eroding. Drainage could be reshaped and stabilized to both reduce erosion and improve treatment.

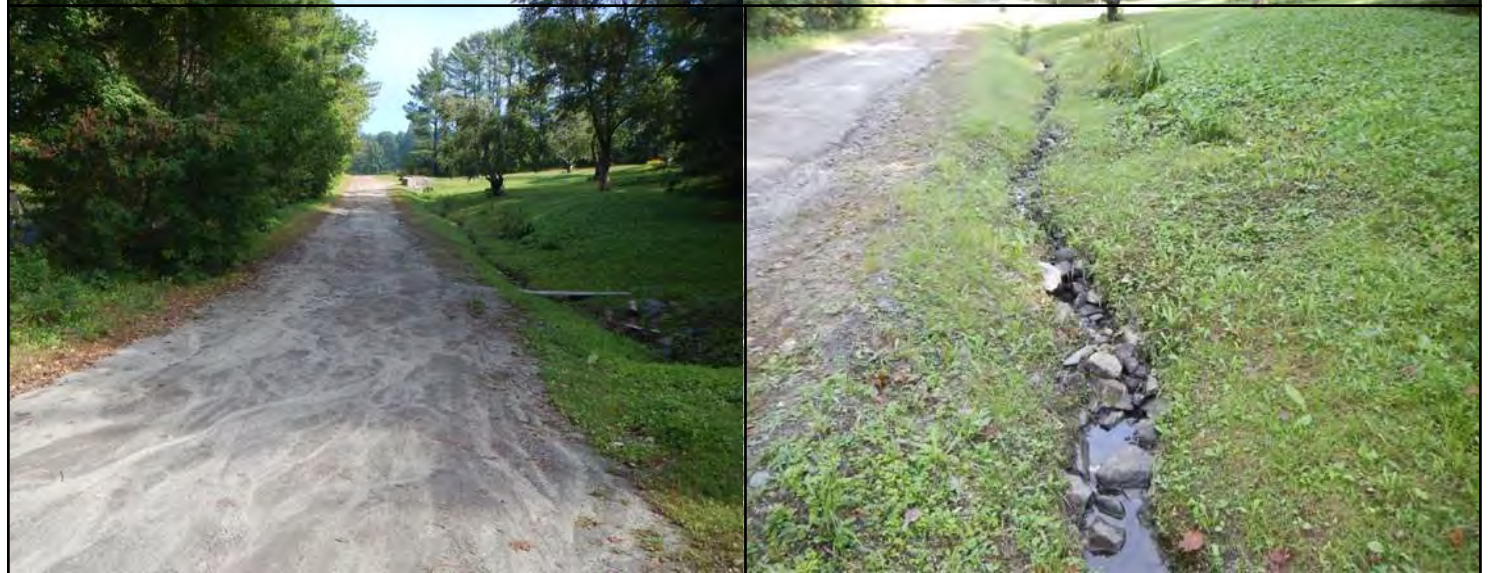
| Problem Area ID: BB-05 | Latitude: 44.261693 | Longitude: -72.557134 |

Description of Observed Conditions:
 Significant erosion of both the road surface and in the adjacent ditch was observed (Photo 1). A storm water treatment practice at the corner of Easy St and Towne Hill Rd could be effective in slowing and treating flow. The ditch itself should also be appropriately shaped and stabilized, and the road should be crowned.

Photo 1. Easy Street and roadside ditch to the right. Photo 2. Ditch in need of repair.

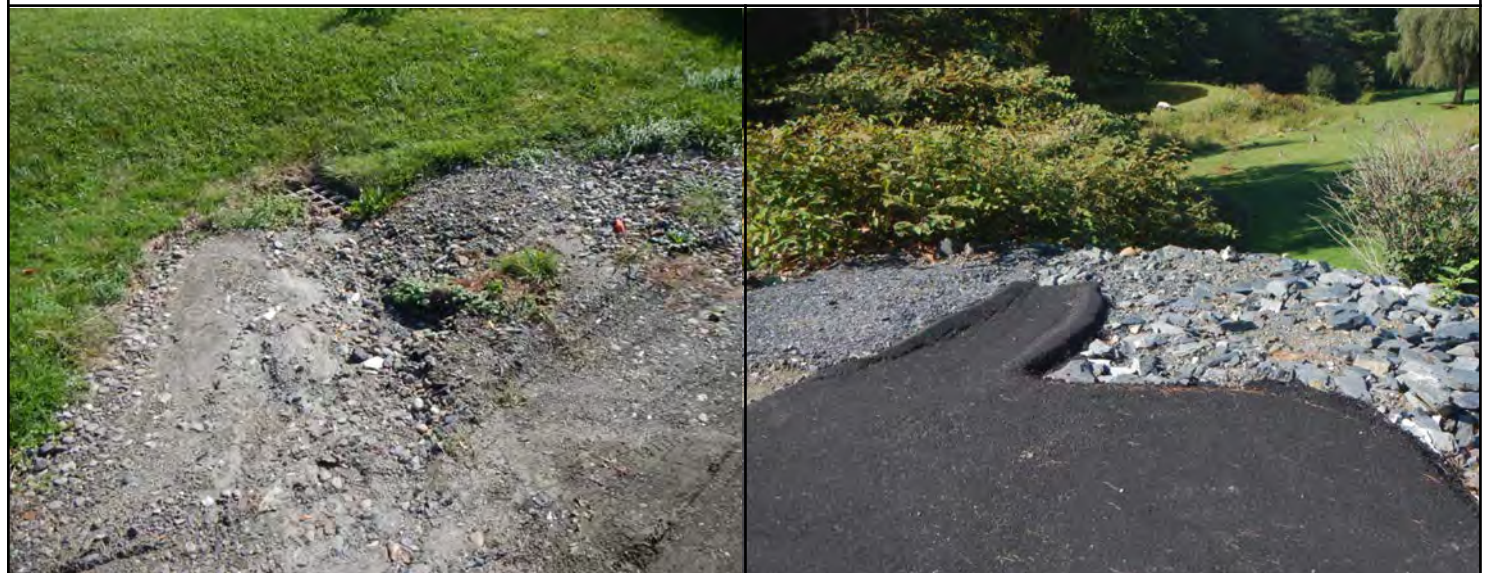
| Problem Area ID: BB-07 | Latitude: 44.258303 | Longitude: -72.554199 |

Description of Observed Conditions:
 Grandview Terrace was resurfaced during the summer of 2015. Concentrated flow along the edge of the shoulder has already started to erode the gravel and it is accumulating around the catch basins at the bottom of Grandview Terrace. The paved turnout was installed too high, making it ineffective for directing storm water. The shoulder at ~140 Grandview Terrace is in poor shape as well, and requires maintenance.

Photo 1. Erosion at catch basin Photo 2. Ineffective turnout structure.

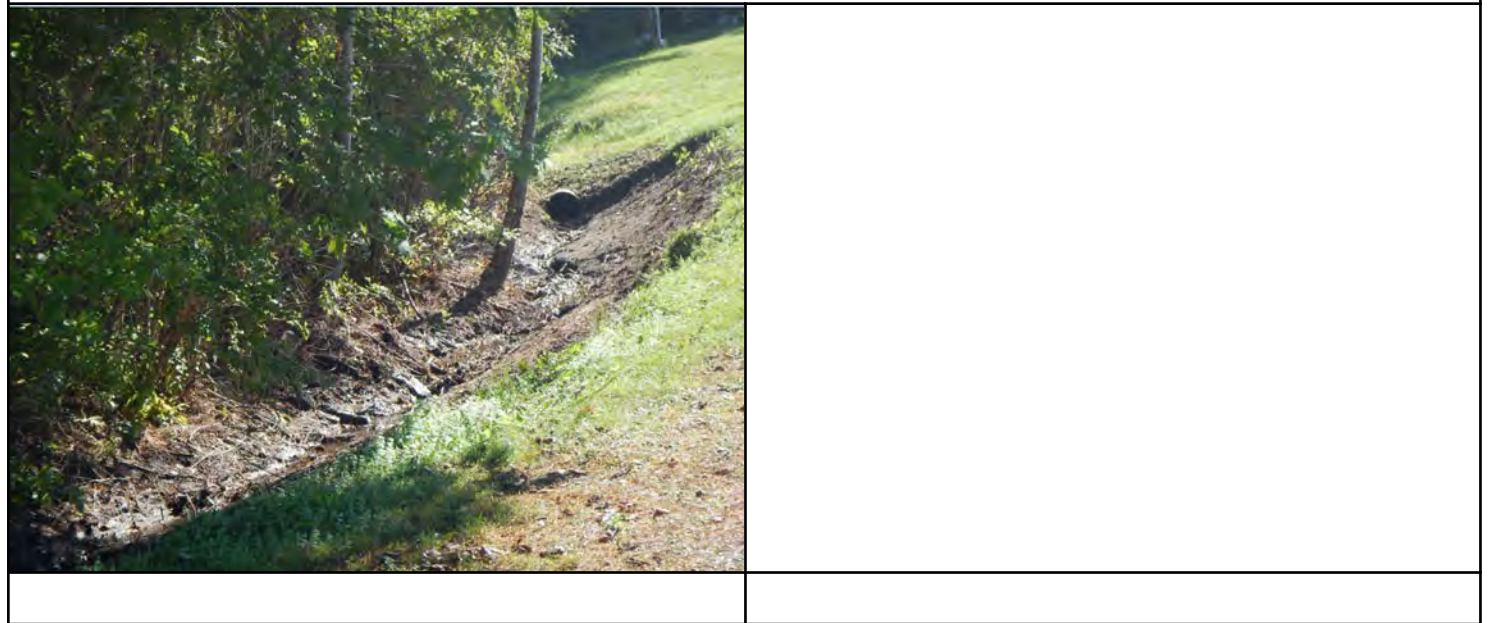
| Problem Area ID: BB-08 | Latitude: 44.257749 | Longitude: -72.553852 |

Description of Observed Conditions:
 Drainage at 28 Spring Hollow Road has recently been maintained, but was not stabilized. The V-shape and oversteepened banks of the drainage ditch will also need to be addressed.

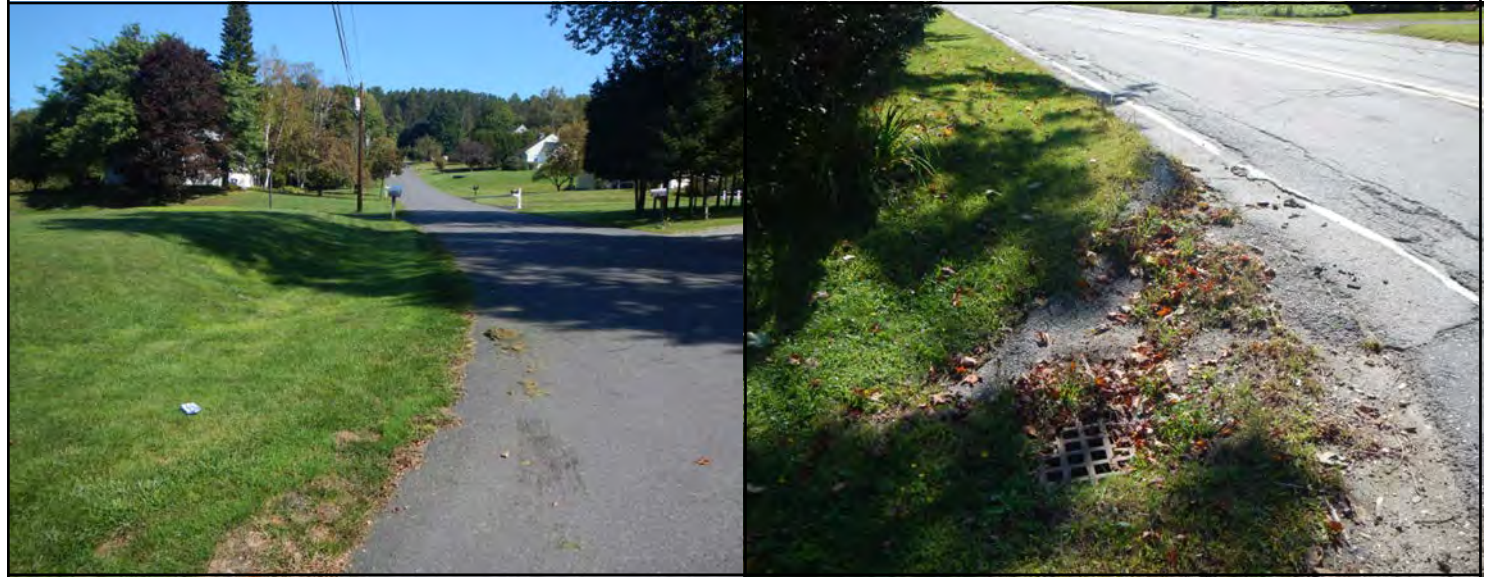
| Problem Area ID: BB-09 | Latitude: 44.259568 | Longitude: -72.551785 |

Description of Observed Conditions:
 “Green Street” or other retrofit within the ROW on Woodcrest Rd could be used to capture/treat runoff and add the benefit of traffic calming (Photo 1). On the opposite side of Woodcrest Rd a riser could be added to the catch basin to more effectively manage storm flows (Photo 2).

Photo 1. Potential rain garden site at the corner of Woodcrest and Towne Hill Rds.

Photo 2. Catch basin that needs to be fitted with a riser.

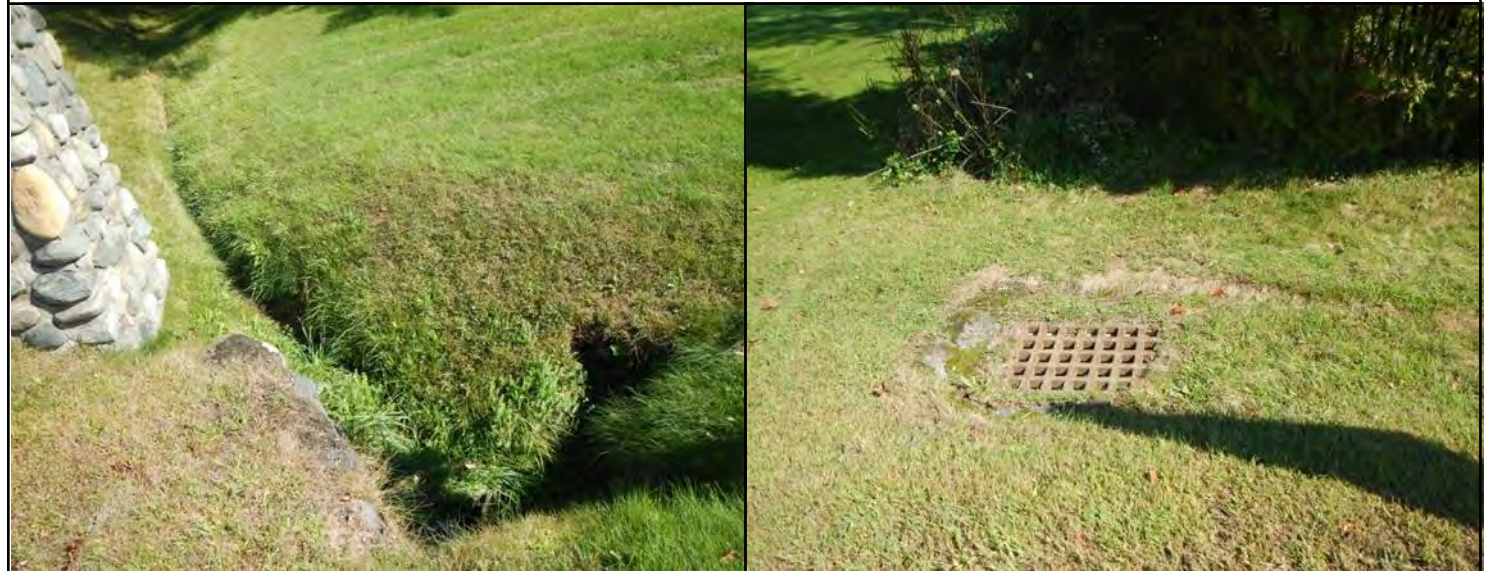
| Problem Area ID: BB-10 | Latitude: 44.259040 | Longitude: -72.550512 |

Description of Observed Conditions:
 The narrow ditch on the east side of the road needs to be reshaped and stabilized. Catch basin immediately to the west also shows signs of erosion.

Photo 1. Narrow ditch that needs to be expanded. Photo 2. Erosion around catch basin.

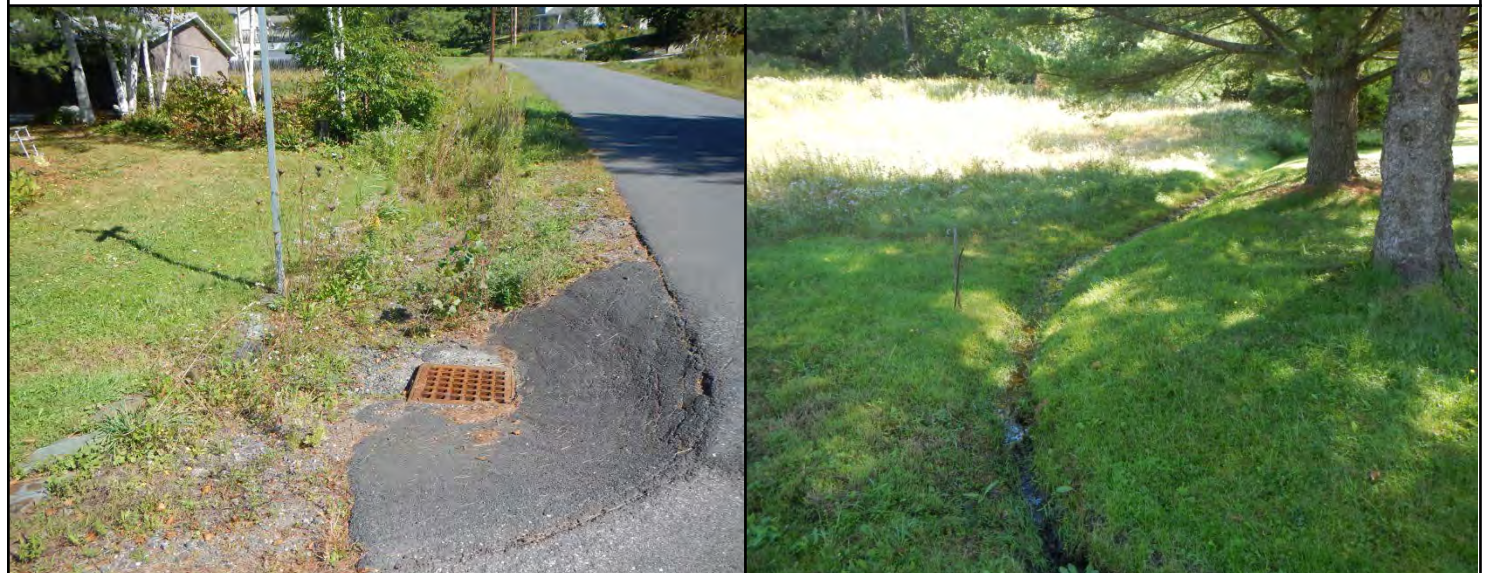
| Problem Area ID: BB-11 | Latitude: 44.260909 | Longitude: -72.552409 |

Description of Observed Conditions:
 The catch basin at the corner of Dover and Phillips could be raised. Stormwater storage/treatment could be provided in the green space as well (Photo 1). The ditch on the property across Dover Rd. could be reshaped and stabilized to reduce erosion (Photo 2).

Photo 1. Catch basin and potential treatment area. Photo 2. Narrow ditch that could be reshaped.

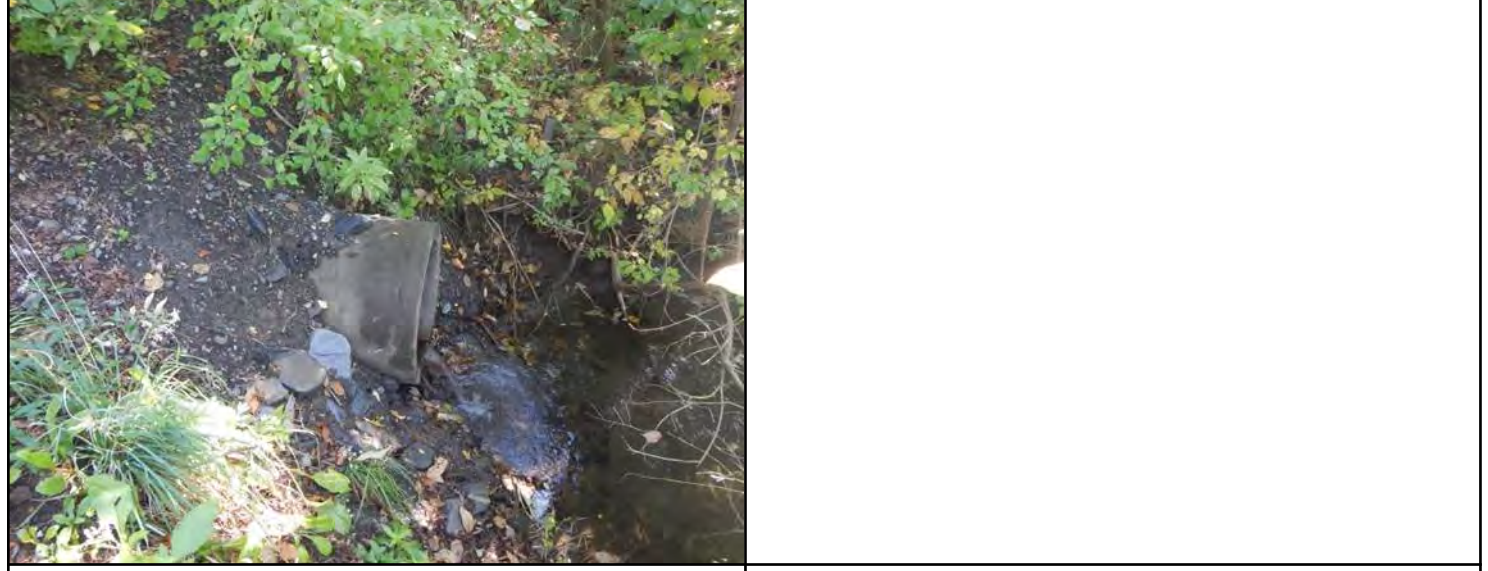
| Problem Area ID: BB-12 | Latitude: 44.262527 | Longitude: -72.553891 |

Description of Observed Conditions:
 The old concrete culvert to the east of 60 Chestnut Hill Road appears to be undersized and should eventually be replaced. For now, a splash pad beneath the outfall would help reduce localized erosion.

Photo 1. A splash pad at the outfall could reduce localized erosion.

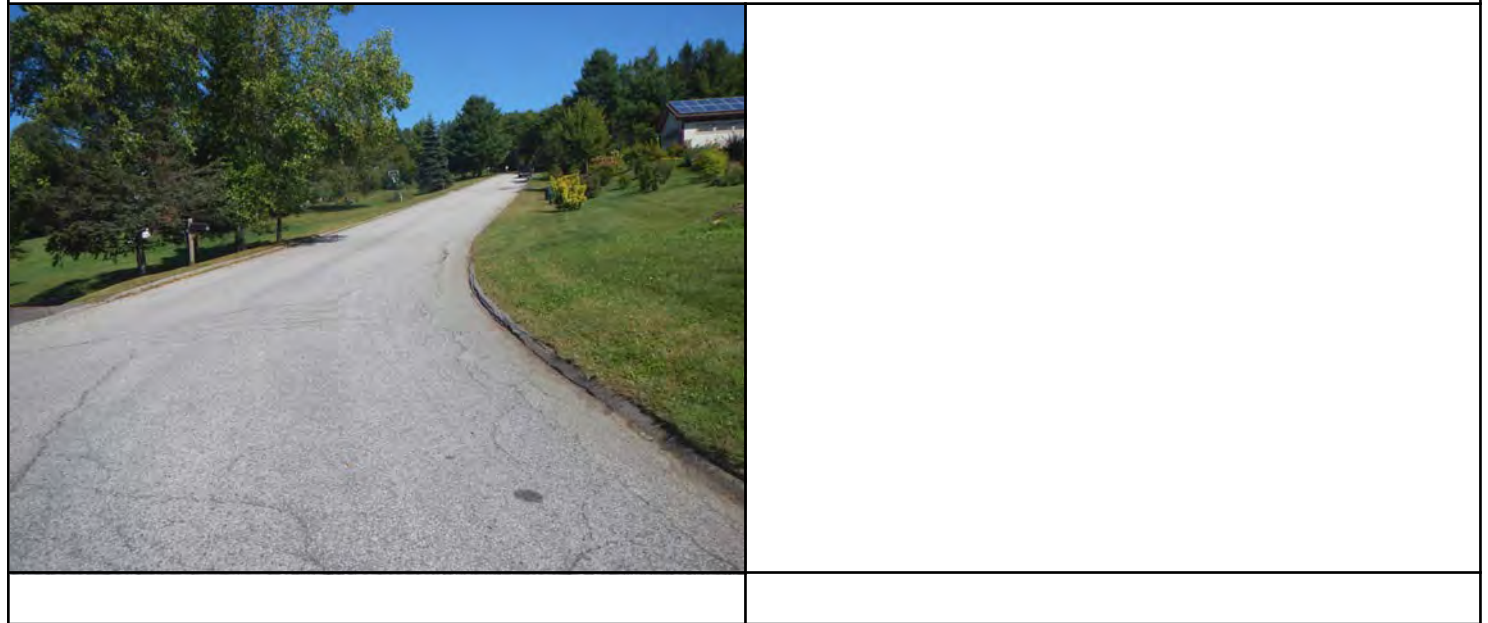
| Problem Area ID: BB-13 | Latitude: 44.262167 | Longitude: -72.553011 |

Description of Observed Conditions:
 Stream channel is currently unraveling below the road; this channel was partially stabilized following a 2008 storm event. Removing the curb on the east side of the street below 135 Phillips Road would allow for a grassed swale to manage stormwater runoff.
