# Ayers Brook Watershed Stormwater Management Plan

Towns of Randolph, Braintree, Brookfield

Completed by Two Rivers-Ottawaquechee Regional Commission

February 2016

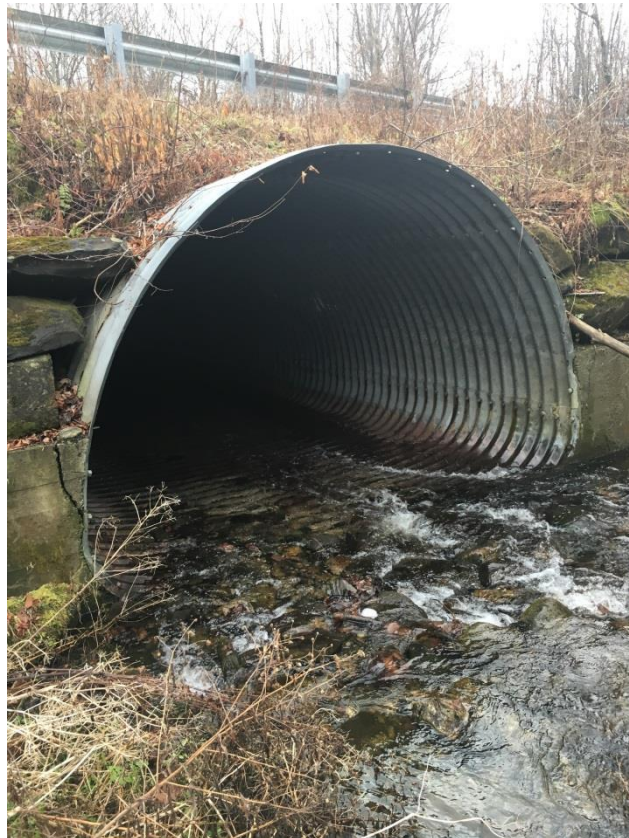
Culvert at Junction of Peth and Labounty Roads: Inlet

**Location and Description:** There is an undersized culvert at the junction of Peth Road and Labounty Road. The culvert is 9 feet high, 9 feet wide, and 52 feet long. The existing squashed culvert cannot appropriately handle the level of water that it currently experiences. It should be replaced with a bridge or arch to handle the hydraulic capacity of Spear Brook, a third order stream in the Ayers Brook Watershed. The outlet of this culvert is also perched, which prevents aquatic organism passage and leads to streambank and streambed scouring downstream.

**Recommended Treatment:** Upgrade this culvert to a bridge or arch. The width or span of this structure should be close to 22.16 feet according to bankfull width. Specific hydrologic studies may indicate that structure width may be bigger or smaller.

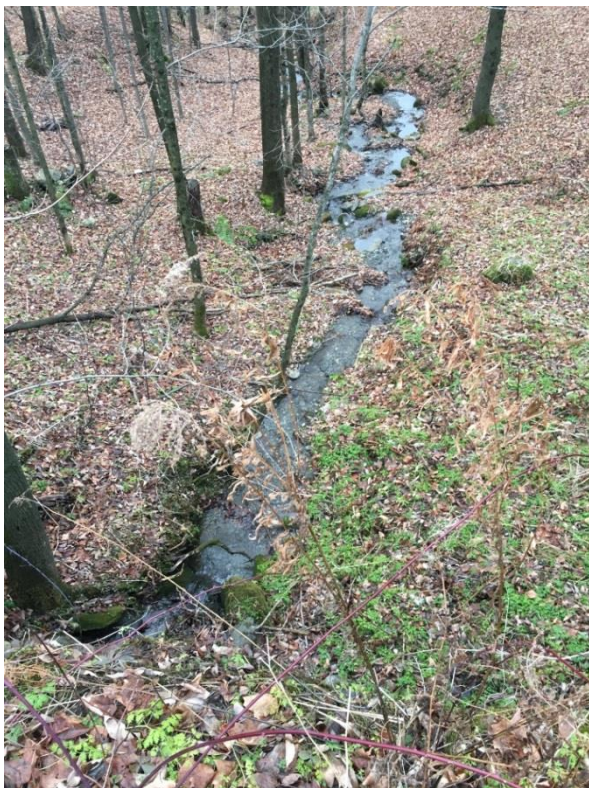
Peth Road: Culvert Outlet Stream

**Location and Description:** The 15 inch high, 15 inch wide, and 40 foot long culvert at this location is significantly undersized for the amount of water it witnesses. A rock wall at the outlet of this culvert poses a structural threat to the road if it were to collapse or fail. Sediment has accumulated at the inlet of this culvert. The outlet of this culvert is also perched, which prevents aquatic organism passage and leads to streambank and streambed scouring downstream.

**Recommended Treatment:** Upsize the culvert and stone-line the inlet and outlet ditches. The width or span of this structure should be close to 3.56 feet according to bankfull width. Specific hydrologic studies may indicate that structure width may be bigger or smaller.

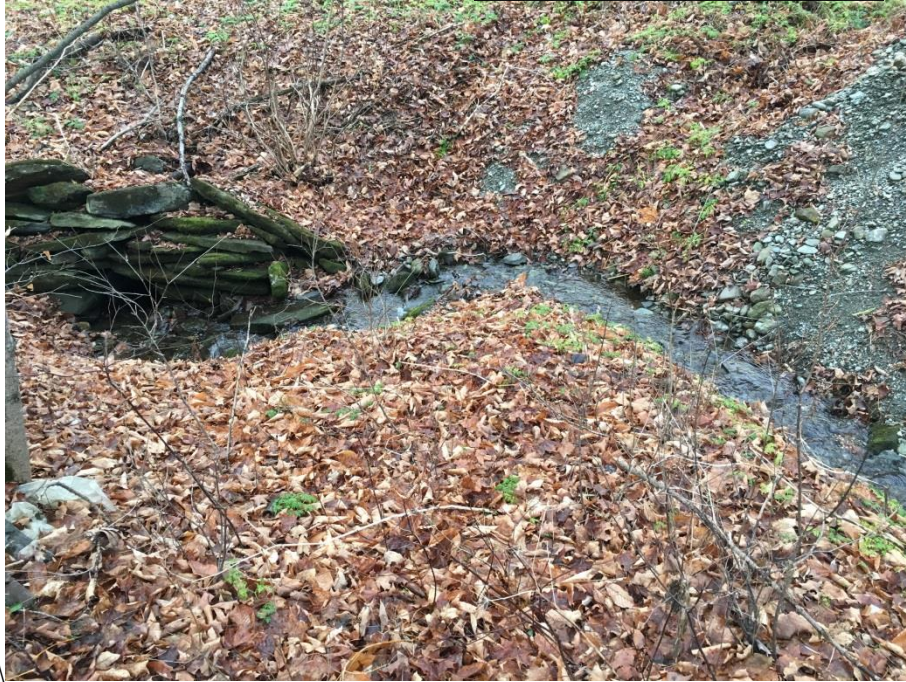
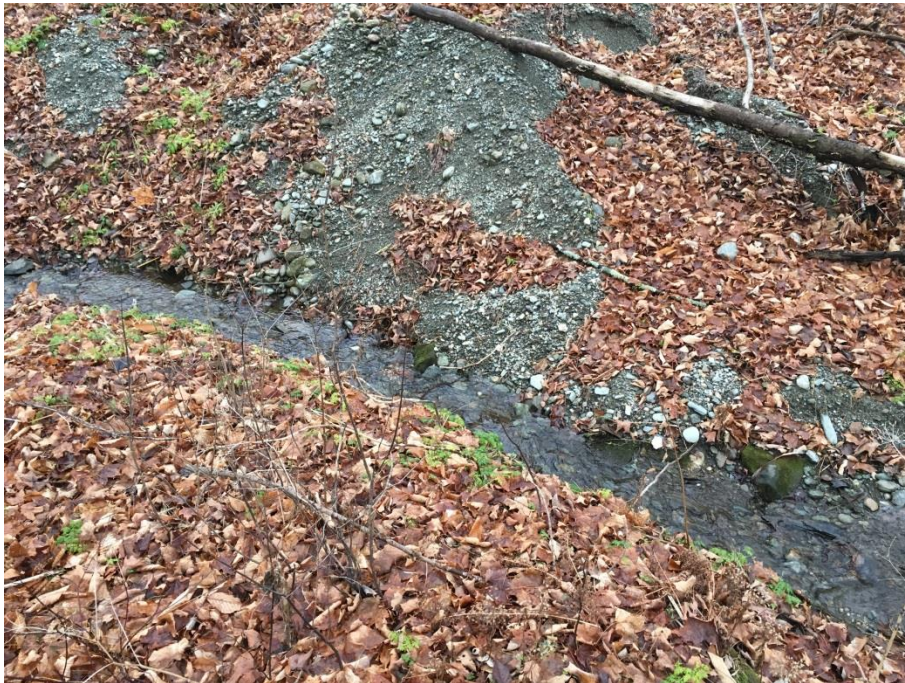
Peth Road: Sediment Buildup at Inlet

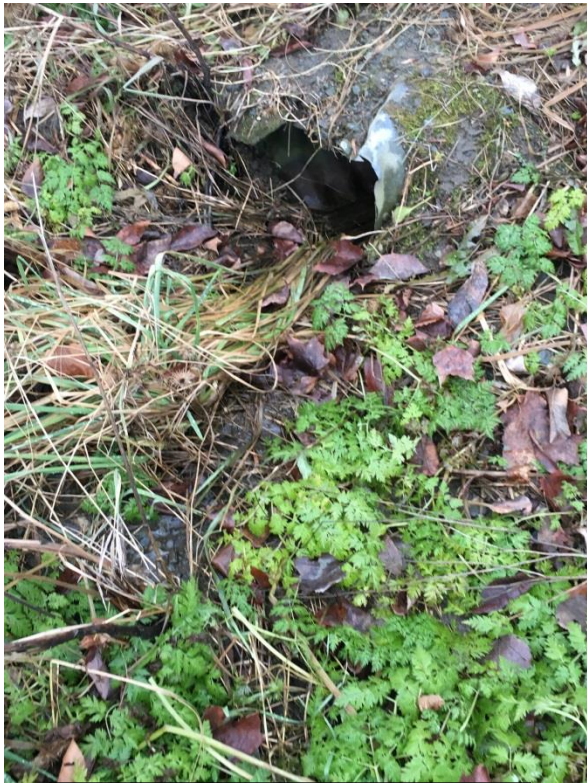
Peth Road: Culvert Inlet

**Location and Description:** This 15 inch high, 15 inch wide, and 30 foot long steel culvert on Peth Road is in significant disrepair. The inlet has been damaged and is not properly ditched. The perched outlet has led to a severely eroded gully. Perched outlets also impede aquatic organism passage.

**Recommended Treatment:** Stone-line the ditch inlet and outlet. Upsize the culvert to appropriately handle current levels of water. Repair eroded gully by fixing outlet bed with placed rock material.

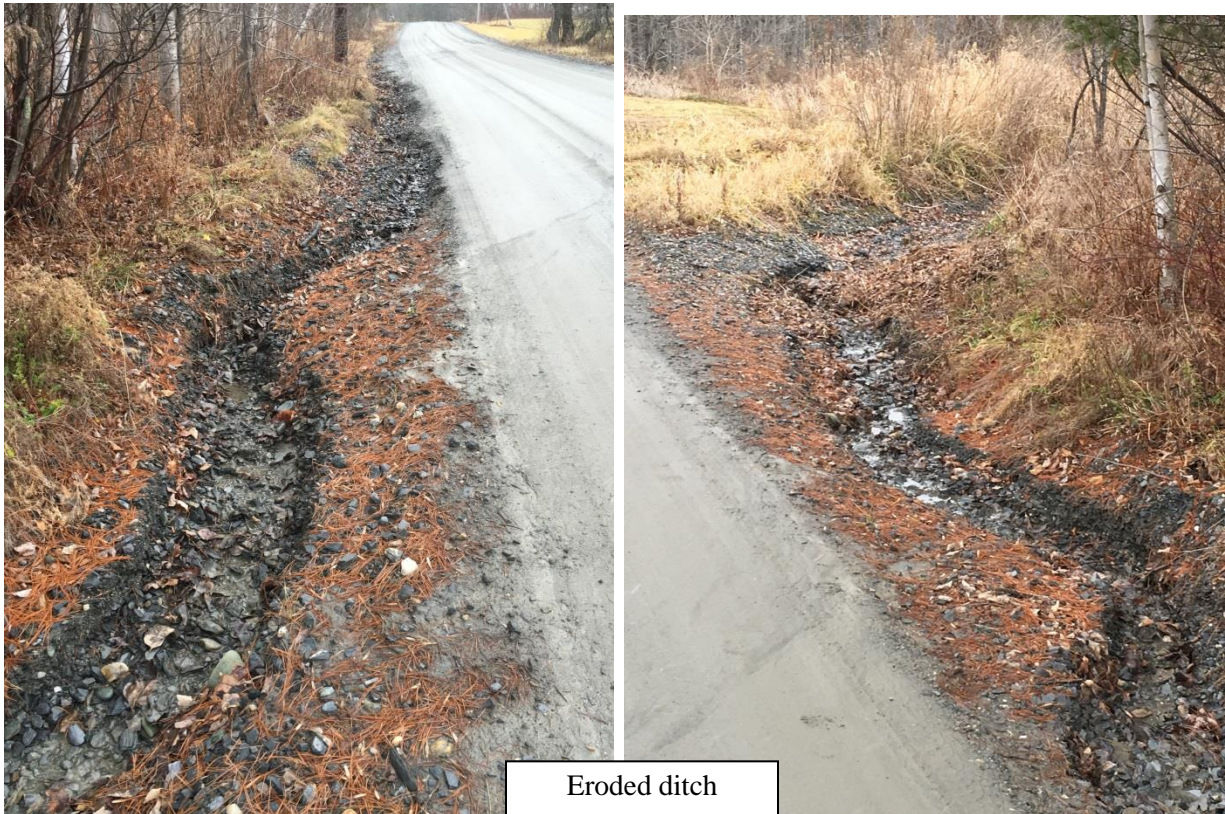
Eroded ditch

**Recommended Treatment:** Stone line ditch terminus and install check dams

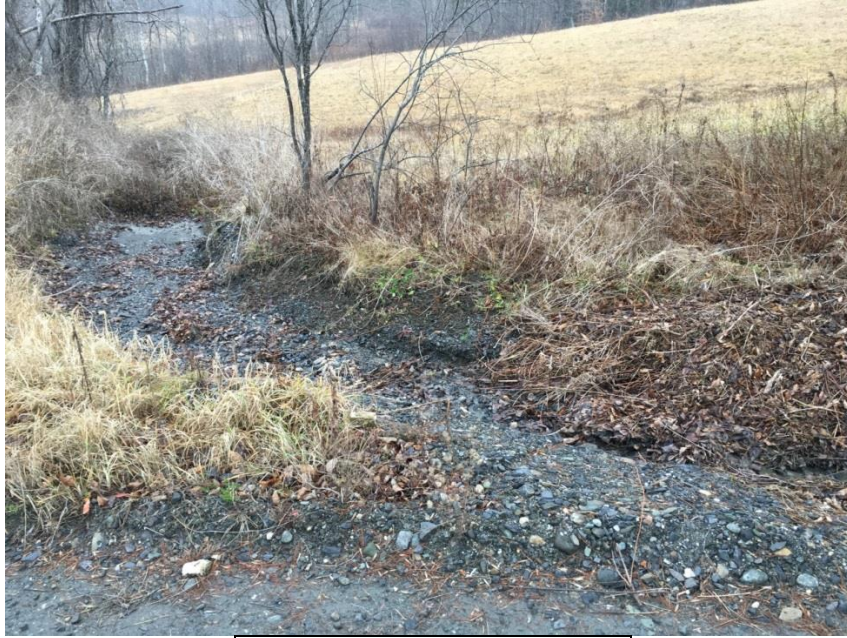
Road Washout from  
Stormwater Runoff

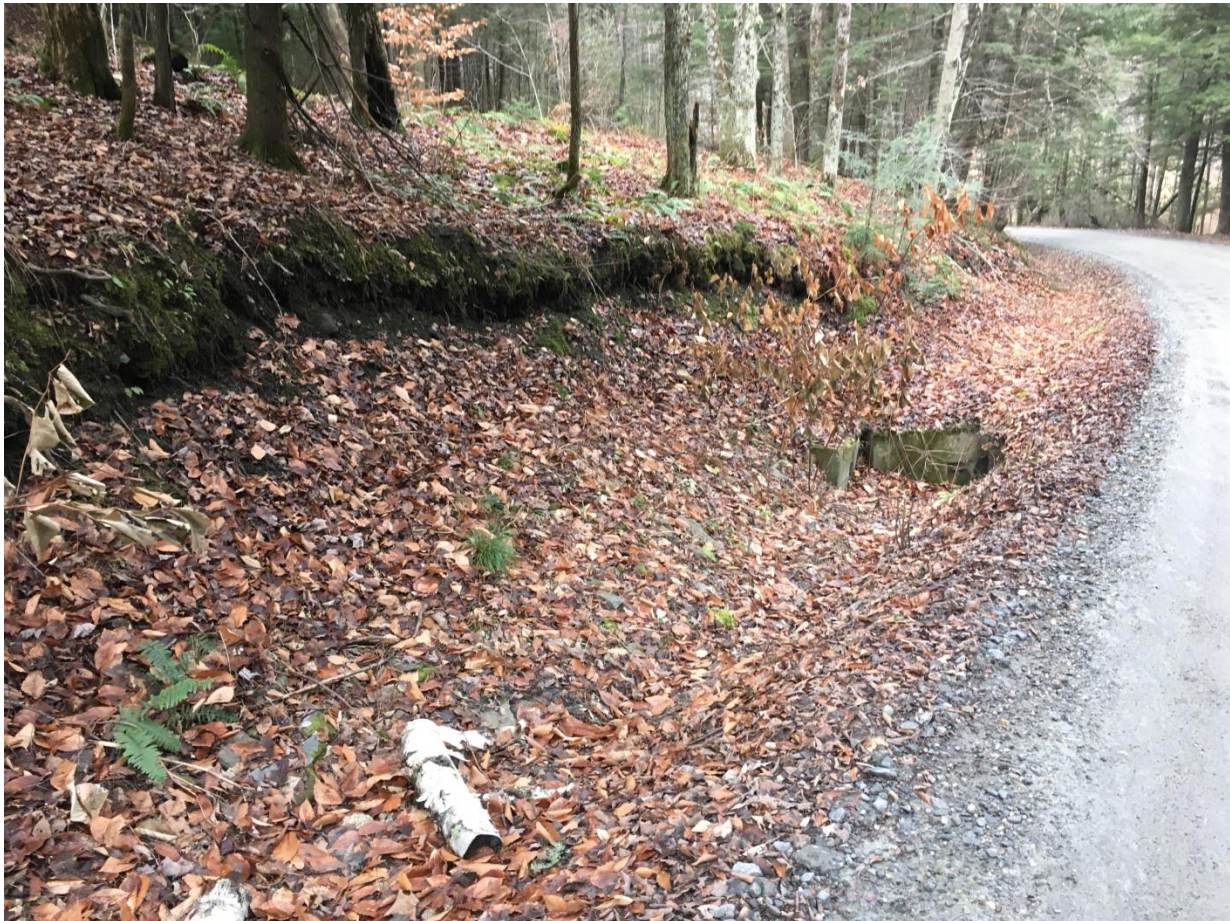
Erosion at inlet

**Recommended Treatment:** Stone-line ditches along the inlet and outlet to prevent further erosion. Install check dams. Upsize culvert to appropriately handle current water levels. Stabilize the eroded banks with mulching.

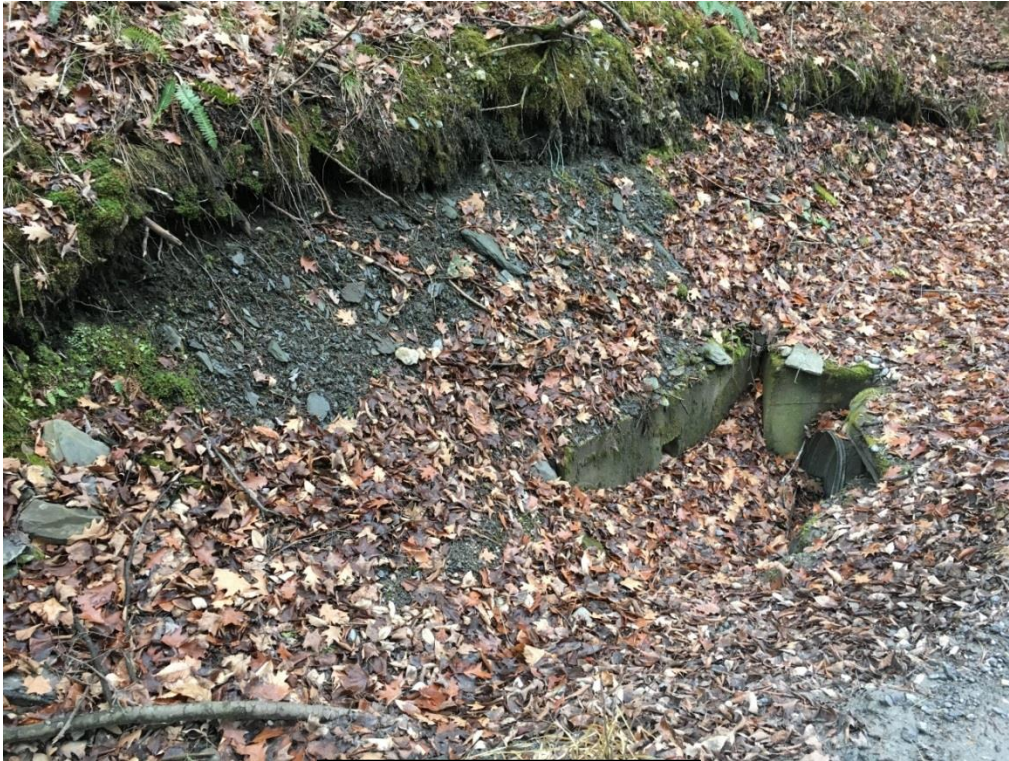
Erosion at culvert inlet

**Recommended Treatment:** Stone-line ditches along the inlet and outlet to prevent further erosion. Install check dams. Stabilize the eroded banks with mulching. Upsize culvert to appropriately handle current and future water levels.

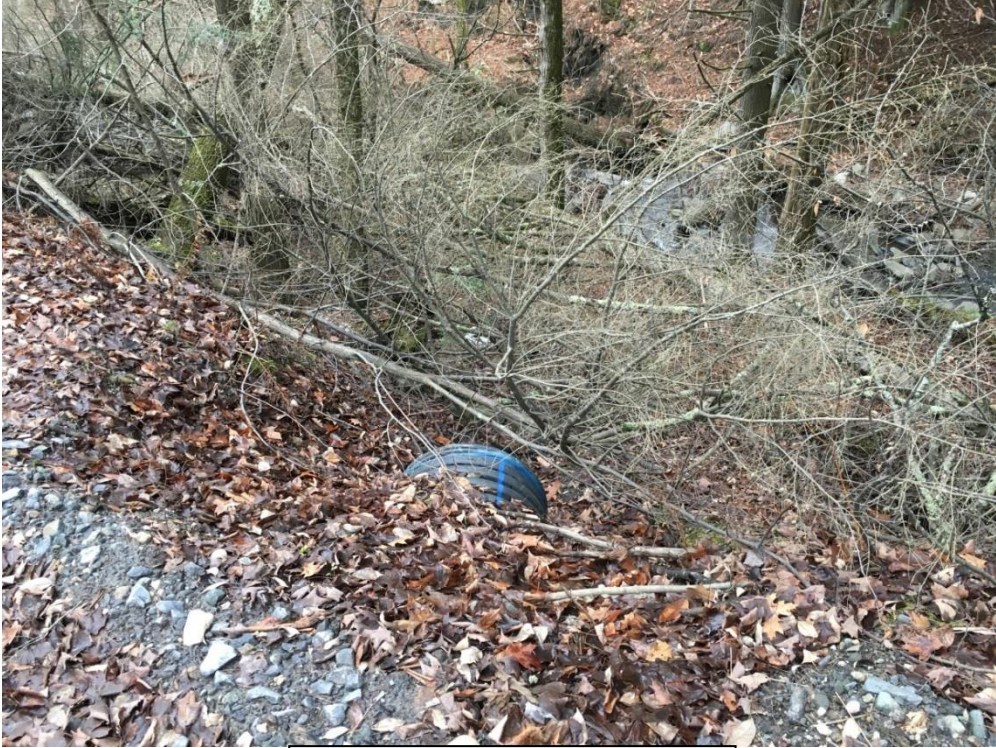
Outlet discharge to surface waters

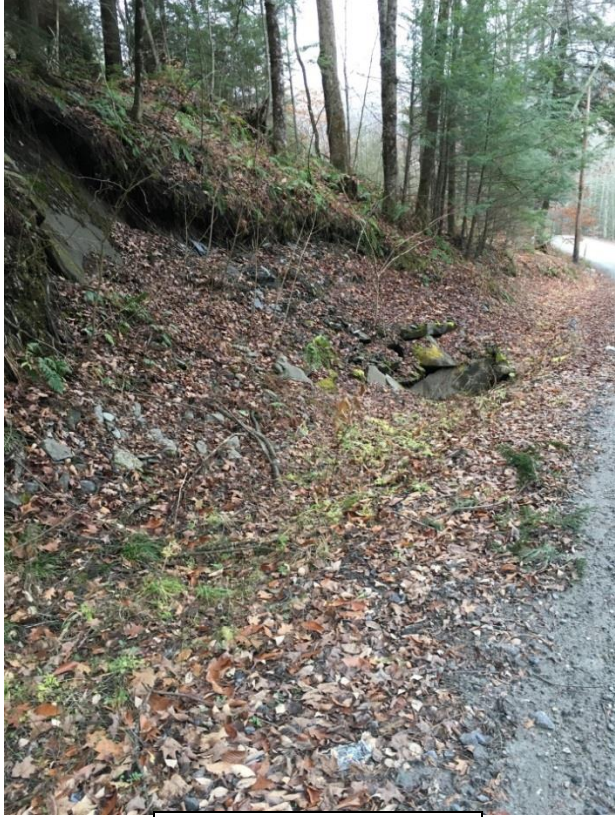
Erosion at culvert inlet

**Recommended Treatment:** Stone-line ditches along the inlet and outlet to prevent further erosion. Stabilize the eroded banks with mulching. Upsize culvert to appropriately handle the current level of water.

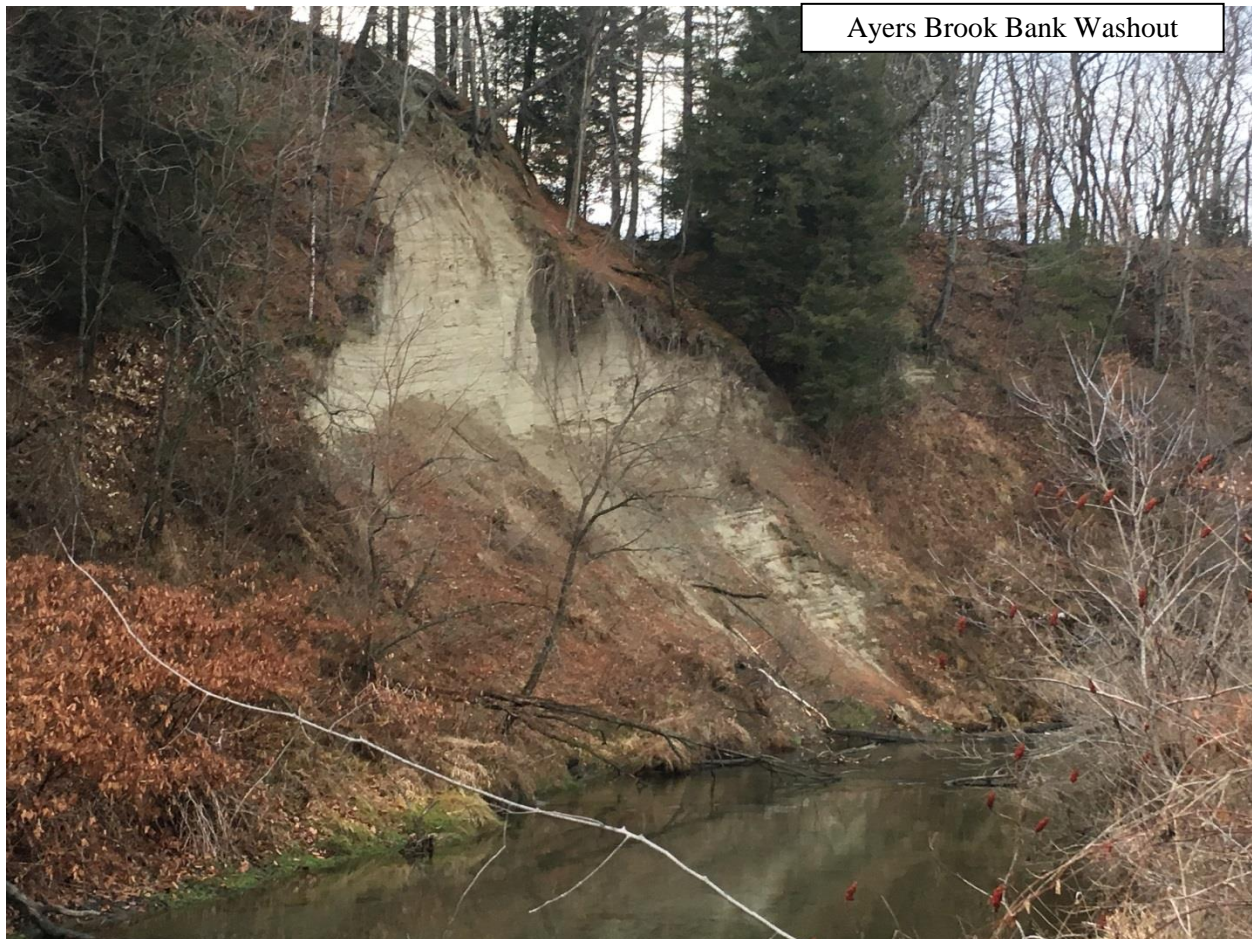
**Location and Description:** West of Vermont Route 12 and south of Sugar Plum Court, a private road, there is a large washout on the western bank of Ayers Brook that will likely result in widespread bank failure. Some of the houses on the south side of Sugar Plum Court are jeopardized by this unstable bank. This river reach is the site of a USGS stream gauge. East of Route 12, the White River Partnership led a Trees for Streams riparian planting in 2008; however the 410 planted trees and willow stakes did not survive.

**Recommended Treatment:** Monitor top of streambank for fissures. The base of bank provides the potential for a root wad soft-armoring project.

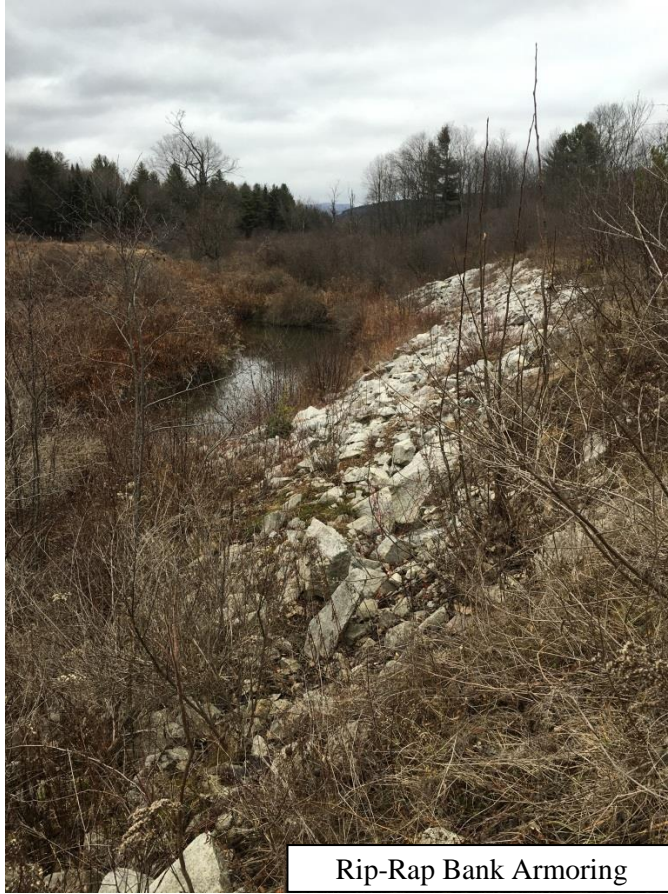
Farther north along Ayers Brook, north of Scenic Road on Route 12, is another section of extremely eroded and exposed streambank that is undergoing channel adjustment. A section of rip-rapped bank armament near this bank failure has pushed the erosive energy of Ayers Brook farther along in its stream channel path. Future encroachment of the river's flood hazard area should be avoided in order to allow the brook to meander and reestablish its flood storage capacity.

Rip-Rap Bank Armoring

**Recommended Treatment:** Plant riparian buffers to help stabilize the bank. Plantings should occur away from the near bank and outside bends where future erosion from lateral movement from Ayers Brook will continue. The Ayers Brook River Corridor Management Plan also identifies this area for a river corridor protection under CREP (Conservation Reserve Enhancement Program) or a similar conservation strategy.

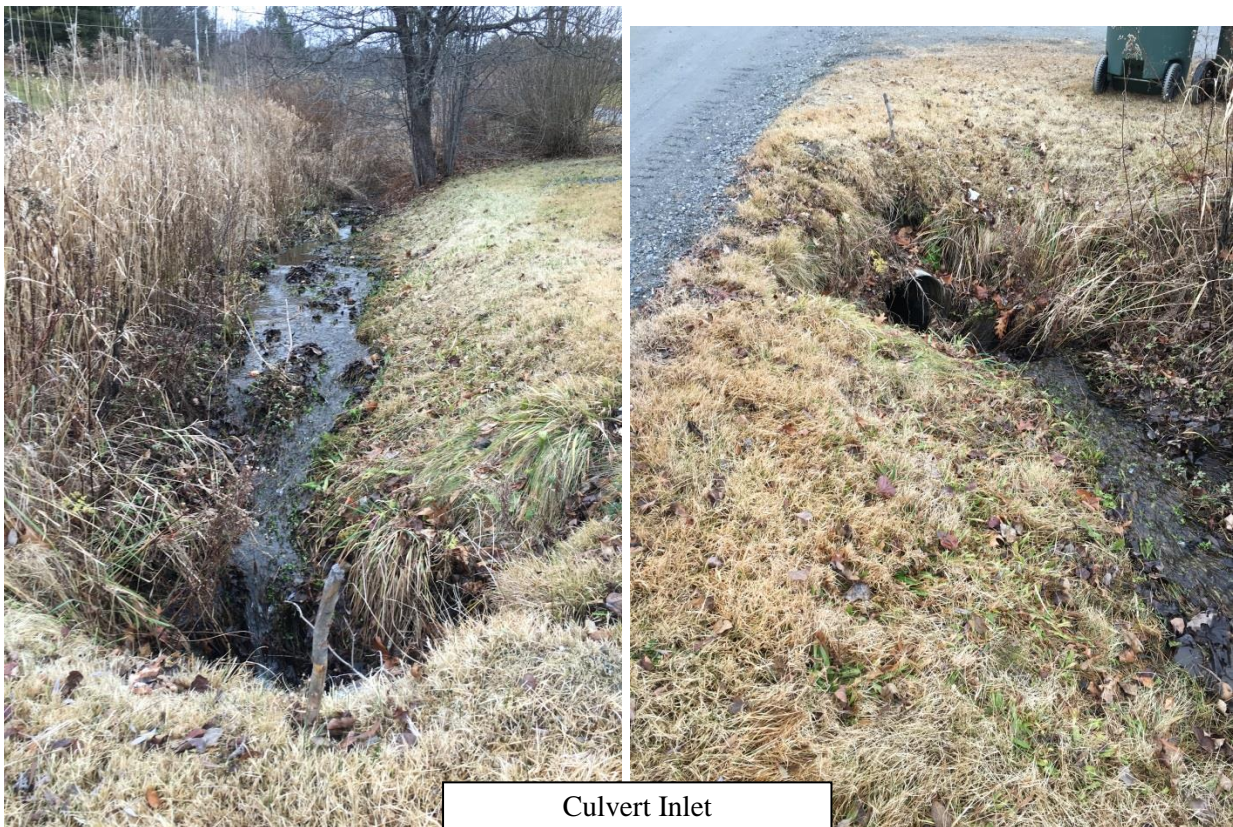
A 24 inch high, 24 inch wide, and 40 foot long steel culvert on Radio Drive receives high volumes of water. The culvert is currently in fair condition. A secondary small plastic driveway culvert is contributing water to the outflow of this culvert.

**Recommended Treatment:** Stone-line inlet and outlet ditches. Upsize culvert to appropriately handle current water levels. The width or span of this upsized culvert should be close to 3.32 feet according to bankfull width. Specific hydrologic studies may indicate that structure width may be bigger or smaller.

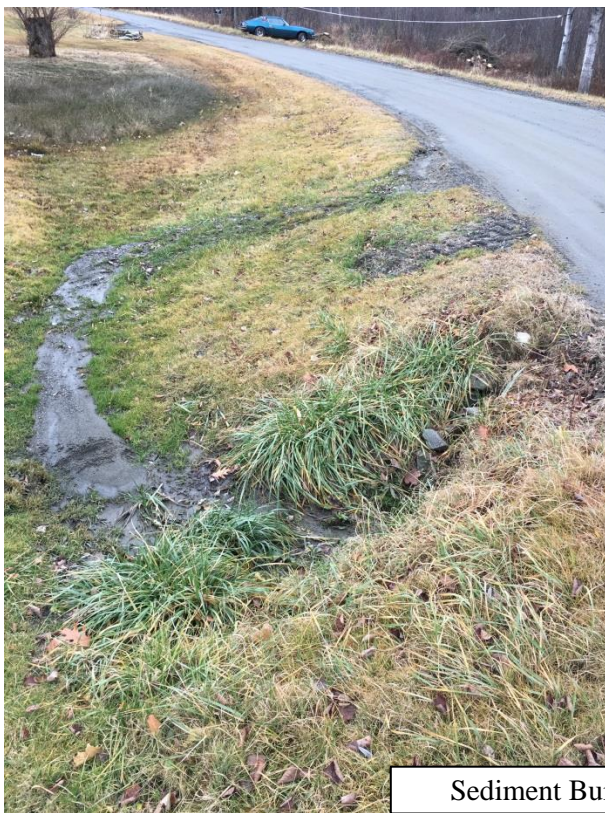
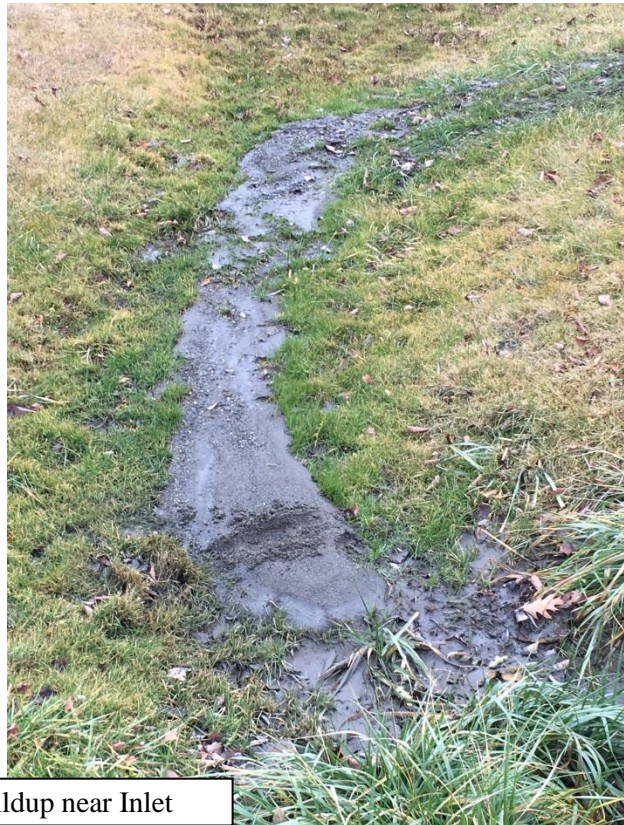
The second culvert is a 15 inch high, 15 inch wide, and 40 foot long steel culvert. Sediment is currently accumulating near the culvert inlet due to improper ditching.

Sediment Buildup near Inlet

**Recommended Treatment:** Properly ditch leading to the inlet of this culver, and stone-line the inlet ditch.

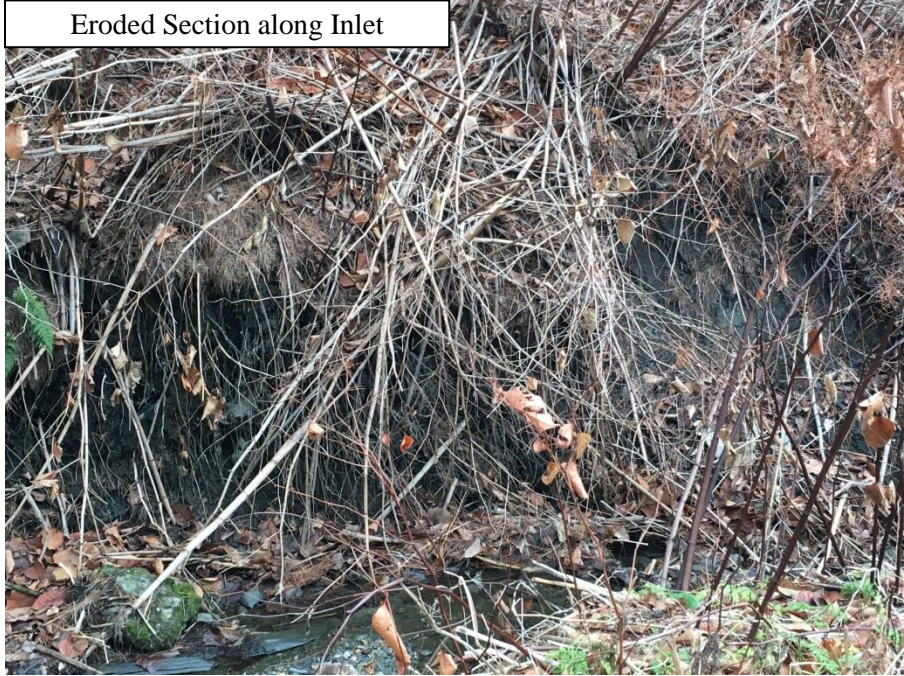
The plastic culvert at this location is 36 inches high, 36 inches wide, and 65 feet long. This site contains significant trash debris, including multiple tires in gullies along the side of the road. Significant water has caused a high level of erosion at the inlet, which has been increased by small drainage pipes contributing water at eroded sections. There is significant pooling of water at this culvert's outlet.

Eroded Section along Inlet

**Recommended Treatment:** Stone-line inlet and outlet ditches. Install check dams. Remove trash from inlet and outlet ditches.

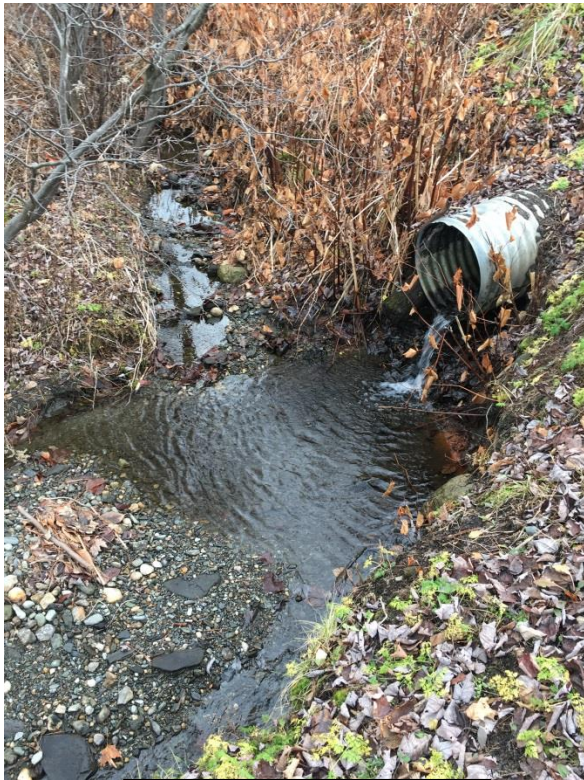
This 24 inch high, 24 inch wide, and 35 foot long steel culvert requires upgrading to appropriately handle the amount of water flow that it currently experiences. A high volume of water has pooled at the outlet. The top part outlet of the culvert is damaged, and the culvert outlet is perched, which prevents aquatic organism passage.

Perched Culvert Outlet

**Recommended Treatment:** Upsize culvert, including repairing broken portion of outlet. Stone-line outlet ditch. The width or span of this upsized culvert should be close to 3.82 feet according to bankfull width. Specific hydrologic studies may indicate that structure width may be bigger or smaller.

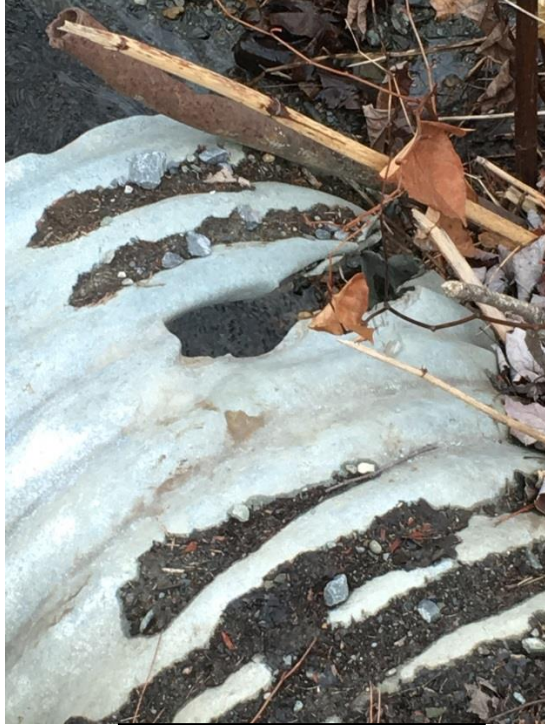
Broken Part of Outlet

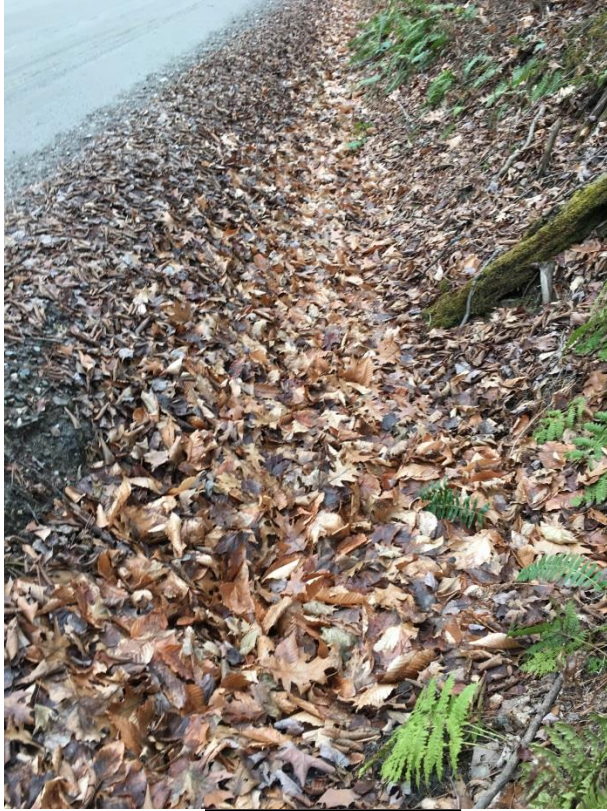
Ditch at Inlet

**Recommended Treatment:** Upsize culvert. Stone-line inlet and outlet ditches. Repair eroded gully by fixing outlet bed with placed rock material.
