APPENDIX D

Problem Area Summary Sheets (8½"x11")

Project: SW-1 **Problem Area Summary**

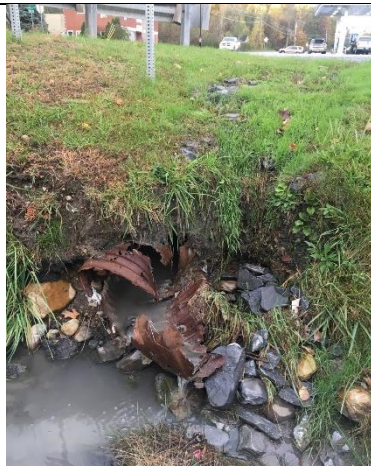
Site Description: Stormwater infrastructure from Route 7A, Green Mountain Power infrastructure, and the Paulin Inc. gas station parking lot drain to the adjacent wetland/stream drainage. The outfall pipe is corroded and collapsing.

Photo 1: Collapsed stormwater infrastructure outfall with silty runoff from connected impervious.

BMP Description: Repair the existing outfall pipe. Evaluate SHGWT and consider installing an underground sand filter with a capacity of 75% of WQv to treat runoff. Special considerations may be needed for hydrocarbons associated with the gas station runoff.

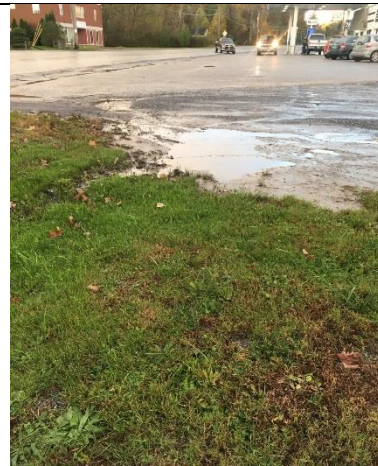
Photo 2: Impervious areas draining to the outfall and open space where a BMP could be installed.

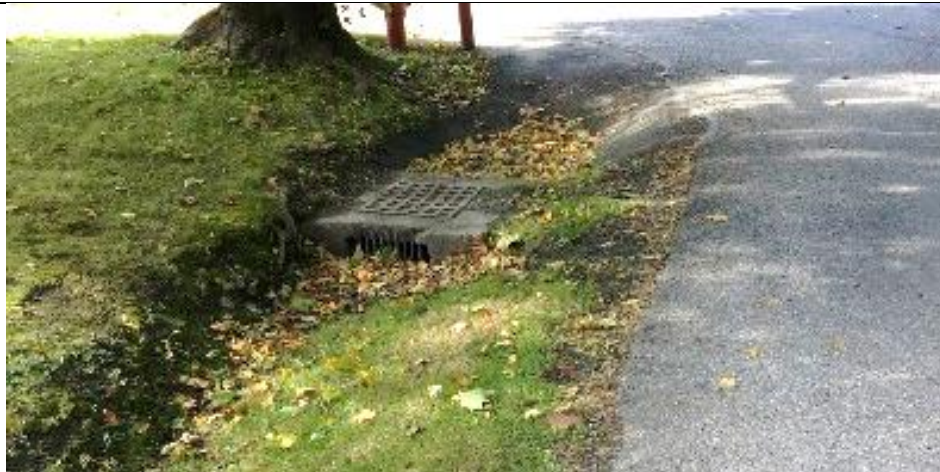
Site Description: Runoff from the southwest portion of Hawks Avenue neighborhood and approximately 225 feet of Bank Street enters a catch basin on the south side of the road near the intersection with bank street. The storm drain network continues down northwest along Bank Street, with approximately 4 more catch basins receiving runoff.

Photo 1: Beginning of the storm drain network at the intersection of Hawks Avenue and Bank Street

BMP Description: Evaluate SHGWT and infiltration rates. Soils mapping suggests the soils are very suitable for infiltration treatment (Hydrologic Soil Group A). Consider installing off-line underground infiltration features alongside each catch basin in the storm drain network (approximately 5) with appropriate pretreatment.

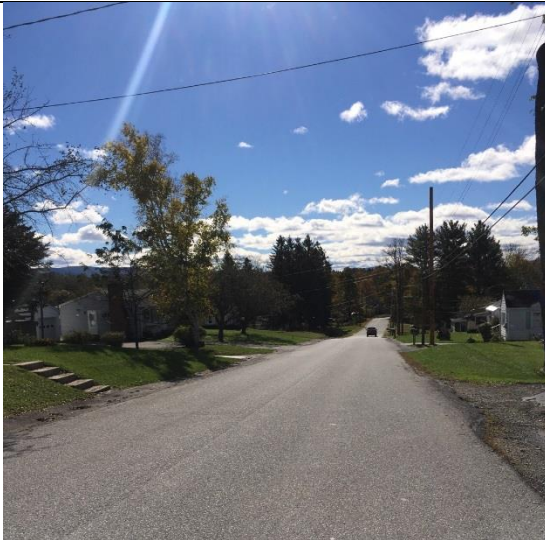
Site Description: A steep section of the Twitchell Hill Road neighborhood drains via a paved ditch to a grass-lined swale. Runoff drains to a stream channel approximately 300 feet to the east.

Photo 1: Twitchell Hill Road, with paved ditches draining the left side of the road.

BMP Description: Widen the swale and install outlet control, such as a concrete riser. Install check dams in the swale to slow and infiltrate water.

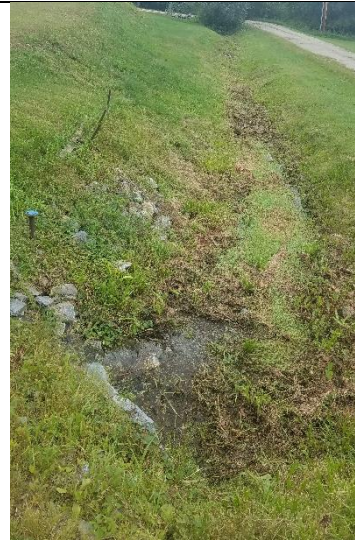
Photo 2: Existing swale along the driveway of 116 Twitchell Hill Road.

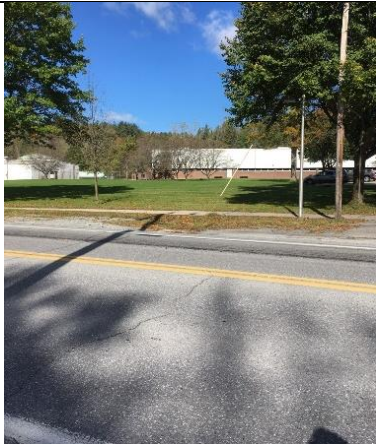
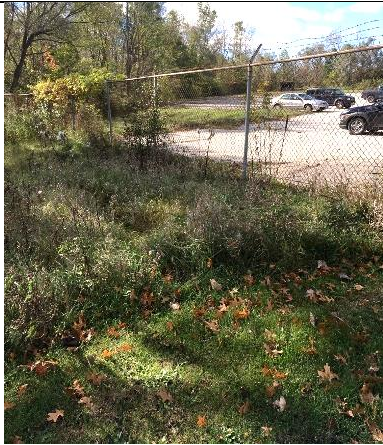
<p>Photo 1: Route 67 and some of the impervious associated with the TFB Realty LLC property. The green space north of Route 67 may serve as an alternate location for a treatment feature.</p>		<p>Photo 2: Parking lot and a portion of the green space where a treatment feature could be installed.</p>		
<p>BMP Description: Install a treatment feature, such as an infiltration basin or gravel wetland, in green space east of the parking lot or north of 67. Evaluate soils and SHGWT to determine whether an infiltration feature is possible. Consider diverting stormwater from the storm drains to treat runoff before reaching the stream channel.</p>

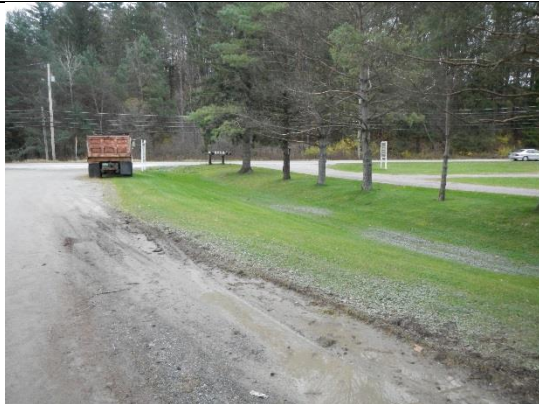
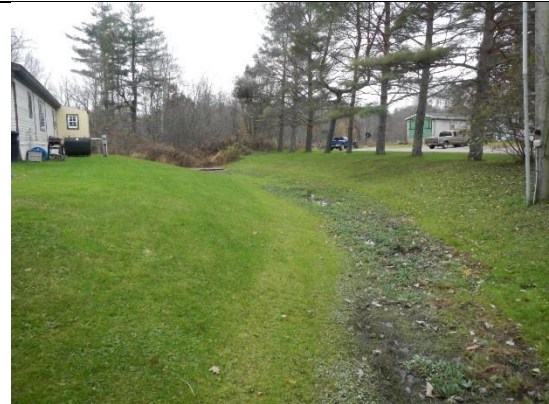
Site Description: The existing swale receives runoff from Route 7A, Trailer Park Road, and the Phil Harrington Construction Co. This is the location of a priority drainage area retrofit identified by VTDEC in the 2018 Shaftsbury Stormwater Report, draining Subwatershed 18 (Action List # 1).

Photo 1: Trailer Park Road/Harrington Construction Company parking lot and existing swale. **Photo 2:** The existing swale viewed from Route 7A.

BMP Description: There is approximately 2 feet of relief between the swale inlet and the downstream wetland, and hydric soils were observed starting at the approximate midpoint of the feature. Therefore, depth to season high water table is likely not appropriate for an infiltration treatment practice. Due to the large drainage area of this project (approximately 46 acres with 10% impervious), a first-flush treatment feature could be designed to treat a portion of the WQv while fitting in the available space. An interim option may be to install check dams in the swale to slow and infiltrate water. Reduce mowing frequency in the swale and level the construction company parking lot to reduce concentrated flow to the swale.

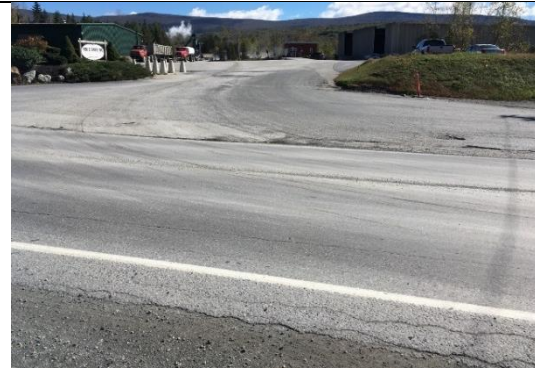
Photo 2: Route 7A and WM. E. Dailey entrance. The eastern portion of this currently drains south to stormwater infrastructure but may be rerouted.

BMP Description: Explore this project in conjunction with SW-1. A portion of the drainage area from VT 7A and the WM. E. Dailey parking lot that enters stormwater infrastructure to the south, may be rerouted by installing a deep sump catch basin and underground infiltration or detention under the east shoulder, with an outlet to the wetland across the street. Stormwater treatment on the west side of the road may be improved through installation of a treatment feature, such as a gravel wetland.

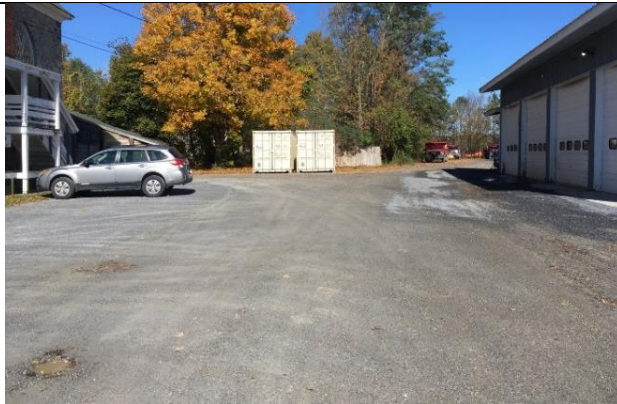
Site Description: A dry well receives a large portion of runoff from the existing Town Garage and Town Office properties. Both properties have gravel driveways and parking areas and the runoff flows to the dry well with no pretreatment, increasing the risk it will clog over time. The remaining runoff runs west along Buck Hill Road toward Route 7A drainage infrastructure.

Photo 1: Runoff from rooftops and the gravel drive flows to a dry well along Buck Hill Road.

BMP Description: Explore potential for a pretreatment feature in the green space in front of the Town Office to treat runoff from the rooftops and gravel parking lots. An aesthetically appealing vegetated pretreatment feature may be possible in this high visibility area, but a deep sump catch basin is also an option if space and utilities require a lower profile feature. Pipe pretreated runoff to existing dry well.

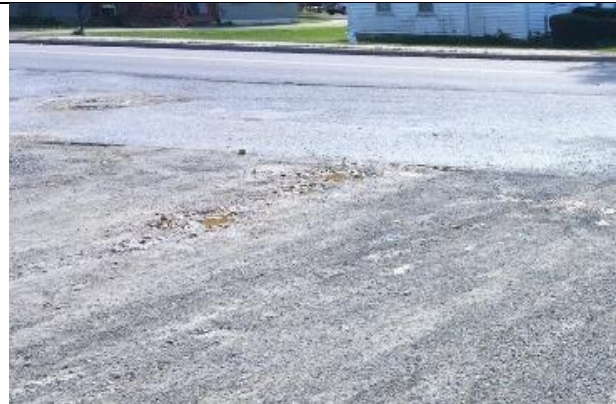
Photo 2: Particulates from the gravel drive flowing to the dry well (top left) may reduce its function.

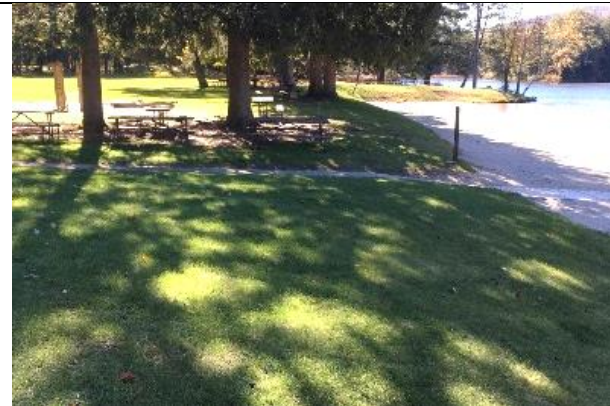
Site Description: Runoff from lawn, rooftops, and paved paths east of the lake drain to the shoreline. Runoff from the gravel parking lot east of the lawn also drains toward the lake.

Photo 1: A paved path and grassed picnic area at the State Park.

BMP Description: Adopt lakeshore BMPs. Install treatment feature for parking lot runoff such as a rain garden or bioretention basin in the green space west of the lake. Consider installing pervious pavement where possible. Replace paved paths to the lake with infiltration step paths.

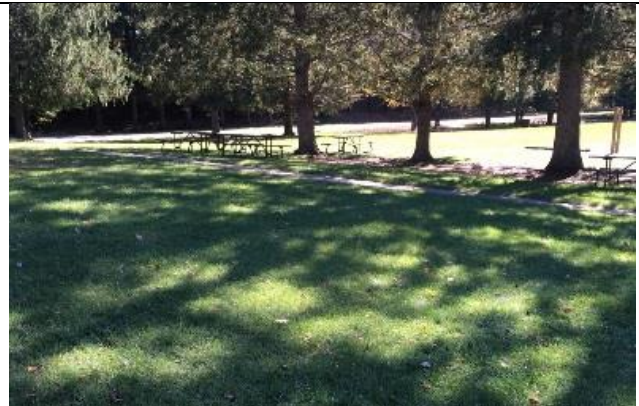
Photo 2: Lakeside picnic area with the State Park parking area in the background.

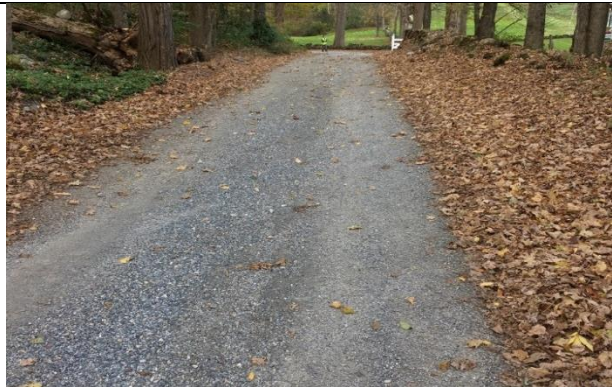
Site Description: Approximately 250 feet of road lacks ditches on both sides, causing erosion of the roadway. Gravel is deposited at the drop-inlet to a driveway culvert at #209 Jack Cross Road, which frequently clogs the culvert. The clogged culvert causes runoff to travel down the driveway toward the house. Stone walls on either side of the road may make it difficult to install ditches in some areas. This road segment ranked 13th (top 2%) in the water quality prioritization based on REI data.

Photo 1: A stretch of Jack Cross Road with no ditches.

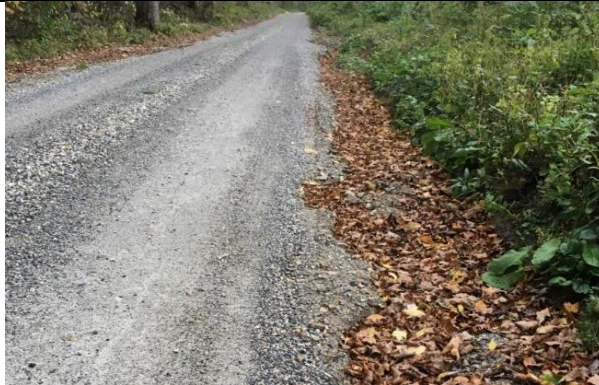
Site Description: Approximately 300 feet of road lacks ditches on both sides, causing severe erosion of the roadway that drains directly to a stream. Resizing and stabilization recommendations for the culvert are described in the C-4 problem area summary sheet. This area includes road segments ranked 2nd (top 1%) and 21st (top 4%) in the water quality prioritization based on REI data.

Photo 1: Runoff flowing down Potter Montgomery Road is causing severe erosion of the roadway.

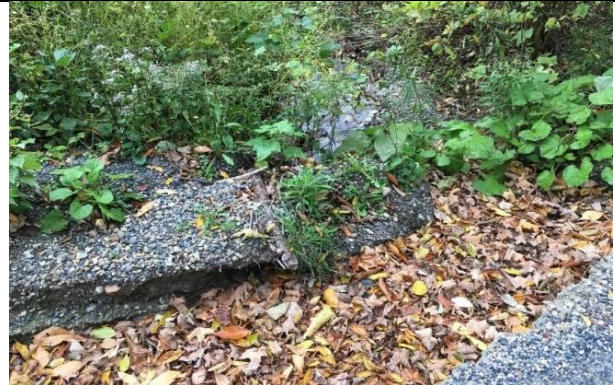
Photo 2: The runoff is eroding a conveyance to the adjacent stream.

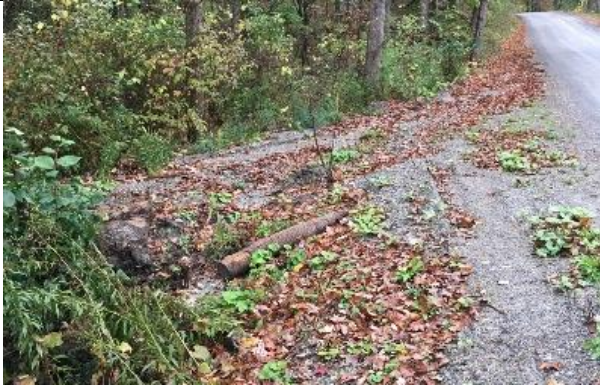
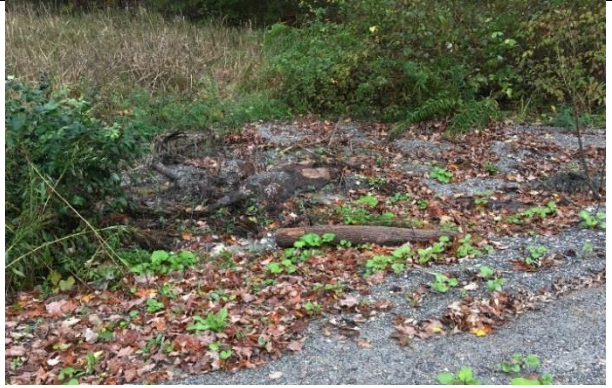
Location:	North Road			
Latitude:	42.9657 N			
Longitude:	-73.2063 W			
Land Ownership:	Town			
<p>Site Description: Unstable drainage ditches are eroding, depositing large quantities of road material in a wetland on the north side of North Road. This road segment ranked 8th (top 1%) in the water quality prioritization based on REI data.</p>

<p>Photo 1: Water flowing over the roadway is eroding road materials into the wetland.</p>		<p>Photo 2: Road gravel in the wetland adjacent to North Road.</p>		
<p>BMP Description: Deepen approximately 300' of ditch and stabilize with stone. Install a sediment trap on the north side of the road, east of the wetland to prevent road materials from entering wetland.</p>				
WQ Benefits	Landowner Support and O&M	Cost and Constructability	Additional Benefits	Total Score (Priority)

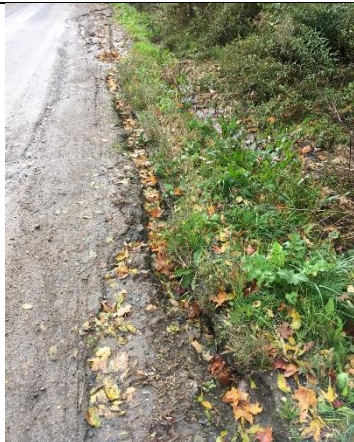
Site Description: Approximately 3,000 feet of road has drainage issues, including a severely eroded stretch of road and ditch approximately 800 feet long that drains directly to a stream. The ditches west of the stream receive runoff from tile drains in the farm field to the north, which contributes to wet road conditions. This area includes two Very High Priority REI segments ranked 92nd (top 17%) in the water quality prioritization based on REI data.

Photo 1: Formation of a secondary ditch due to a grader berm on the north side of the road.

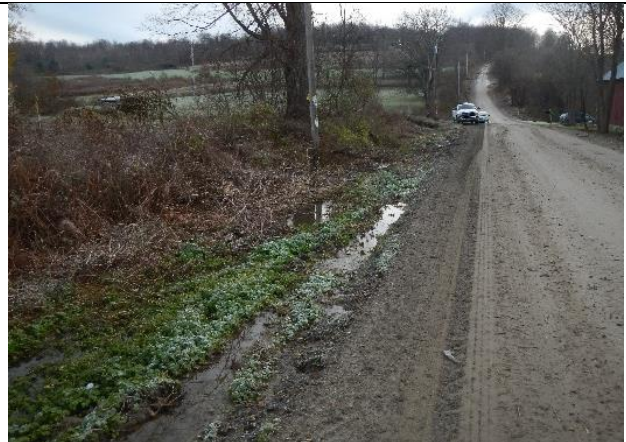
Photo 2: Water pools on the roadway, partially due to runoff from tile drains that are piped into the ditch.

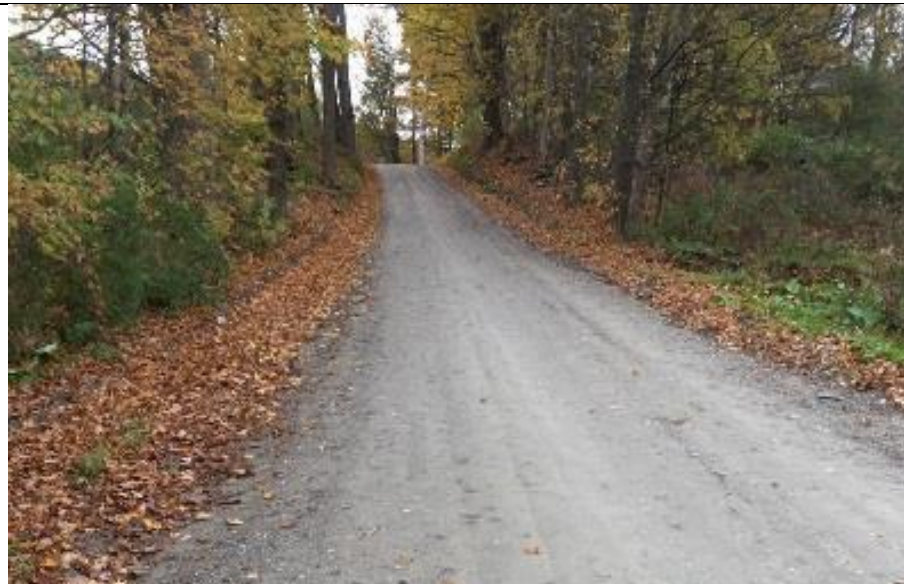
Site Description: Approximately 240 feet of road has unstable drainage ditches on both sides. These extend directly into the downslope stream, which crosses the road to the east of the ditch. This area includes a road segment ranked 123rd (top 23%) in the water quality prioritization based on REI data.

Photo 1: Unstable ditches along Cold Spring Road west of the stream crossing.

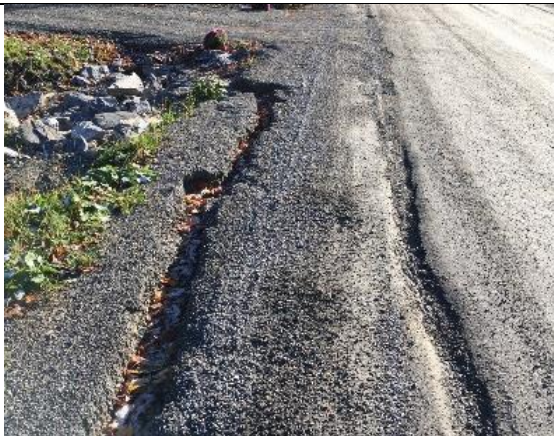
Site Description: Approximately 200 feet of ditch on the north side of the road is unstable. The unstable ditch extends east where it enters a stream via poor eroding conveyance. This Very High Priority REI segment ranked 1st in the water quality prioritization based on REI data.

Photo 1: Rilling along road edge.

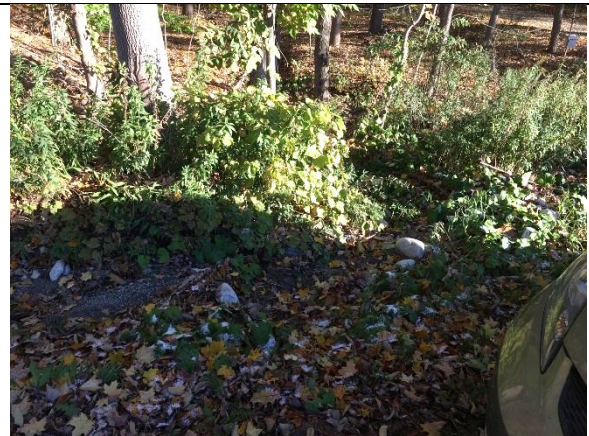
Photo 2: Eroded channel down to stream.

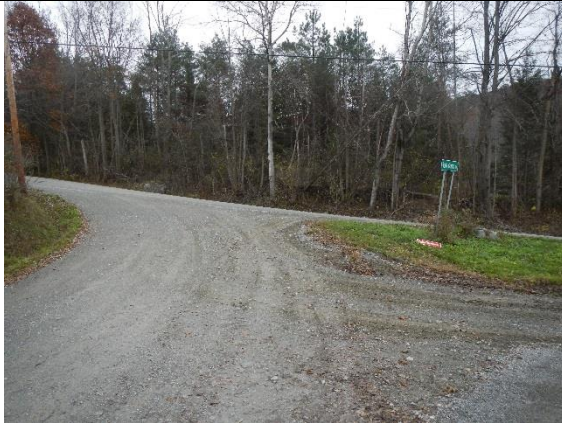
Site Description: The two-entrance intersection at Sally Gannon Road and approximately 800 feet of Murphy Hill Road to the north have inadequate road drainage, causing water to pool on the roadway and erosion of the roadside ditch. Ditches on Murphy Hill road are somewhat undersized and unstable. The northern extent of the project area includes ditch work on a Murphy Hill Road segment ranked 7th (top 1%) in the water quality prioritization based on REI data.

Photo 1: Intersection with Murphy Hill Road, viewed from Sally Gannon Road.

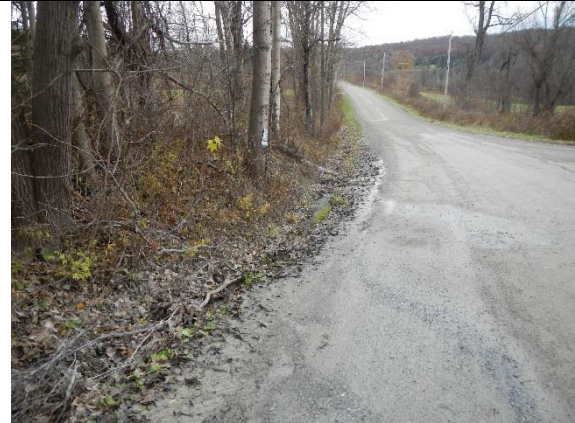
Photo 2: Unstable ditches along Murphy Hill Road.

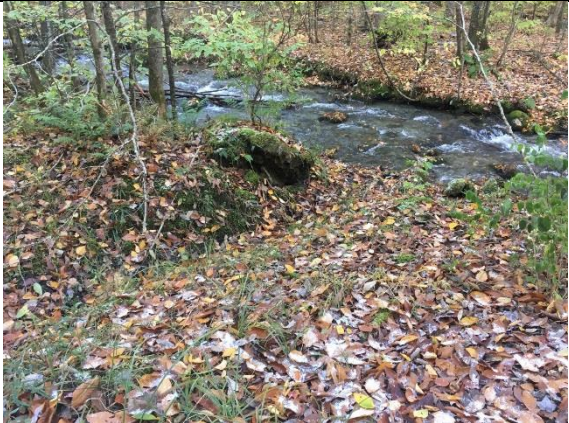
<p>Photo 1: Road runoff is contributing to erosion of the tributary culvert header.</p>		<p>Photo 2: Eroded conveyance to Little White Creek near the transition between Class 3 and Class 4 road on Shaftsbury Hollow Road.</p>

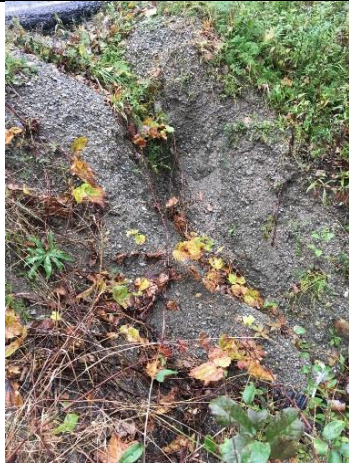
Site Description: The culvert outlet header is severely eroded. The erosion may cause undermining of the paved roadway and clogging of the drainage culvert. This road segment ranked 240th (top 45%) in the water quality prioritization based on REI data.

Photo 1: Eroded road embankment.

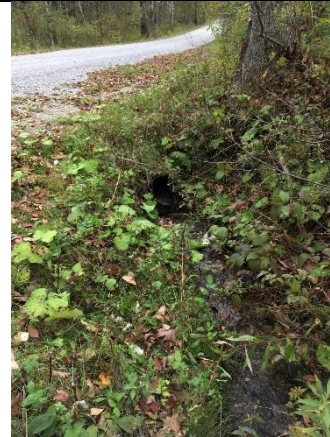
Site Description: The smooth HDPE culvert conveys a small channel with an approximately 16.5-acre drainage area. The capacity of the 18” culvert is estimated at 13 cfs, a flow that may be exceeded in the 10-year flood event. The culvert headers are eroding, with severe erosion of the road embankment around the culvert outlet.

Photo 2: Harrison Road culvert inlet.

BMP Description: Install a larger structure with stone headers. The recommended culvert size for an intermittent stream crossing of comparable drainage area is 24” in diameter. Based on HY-8 modeling, a 24” structure will pass the 25-year flood if the road elevation is raised 1 foot at the crossing. A 30” structure will pass the 25-year flood with no change in road elevation.

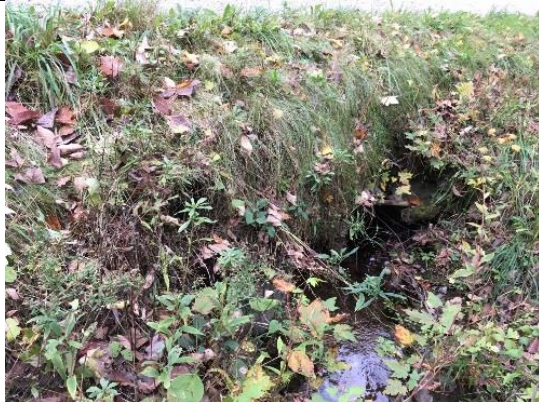
Site Description: The CMP conveys a small channel with an approximately 71-acre drainage area. The capacity of the 2.2' culvert is estimated at 38 cfs, a flow that may be exceeded in the 25-year flood event. The culvert is in poor condition with a collapsing inlet and the upstream header is eroding.

Photo 1: Erosion at the upstream culvert header.

BMP Description: Install a larger structure with stone headers. The recommended culvert size for an intermittent stream crossing of comparable drainage area is 42" in diameter. Based on HY-8 modeling, a 36" structure will pass the 25-year flood and a 42" structure will pass the 100-year flood.

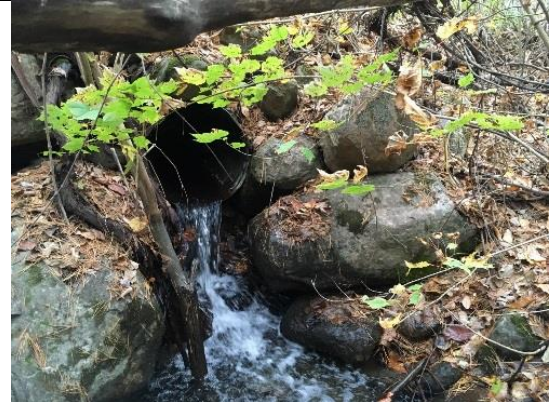
Photo 2: Perched culvert outlet.

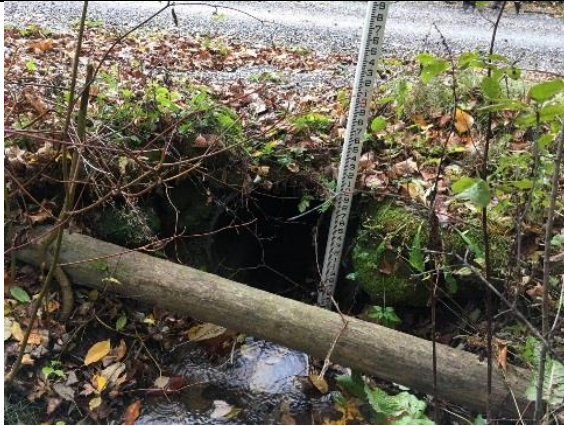
Site Description: The CMP conveys a small channel with an approximately 37-acre drainage area. The capacity of the 24" culvert is estimated at 20 cfs, a flow that may be exceeded in the 10-year flood event. The culvert headers are eroding, with severe erosion of the road embankment around the culvert. See RD-3 problem area sheet for more information on road erosion problems upslope of the culvert.

Photo 1: Potter Montgomery Road culvert outlet.

BMP Description: Install a larger structure with stone headers. The recommended culvert size for an intermittent stream crossing of comparable drainage area is 36" in diameter. Based on HY-8 modeling, a 36" structure will pass the 100-year flood. Additional cover is needed to protect the structural integrity of the culvert. Some gravel may be sourced from excavation associated with RD-3.

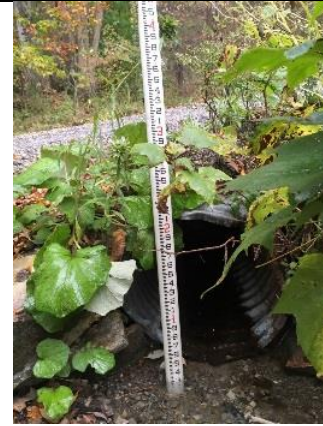
Photo 2: Potter Montgomery Road culvert inlet.

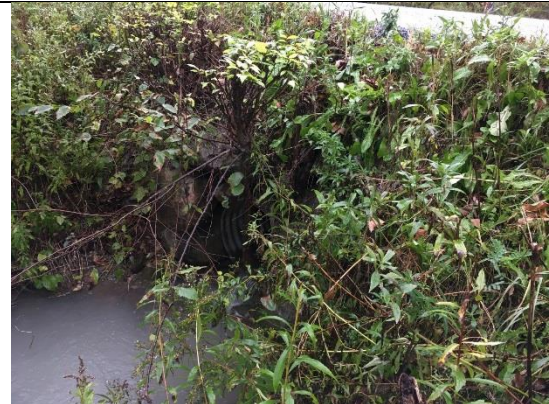
Site Description: The CMP conveys a small channel with an approximately 121-acre drainage area. The capacity of the 24” culvert is estimated at 31 cfs, a flow that may be exceeded in the 10-year flood event. The culvert headers are eroded as well as the channel downstream of the culvert.

Photo 2: East Road culvert outlet.

BMP Description: Install a larger structure with stone headers. The recommended culvert size for an intermittent stream crossing of comparable drainage area is 60” in diameter. Based on HY-8 modeling, a 60” structure will pass the 100-year flood.

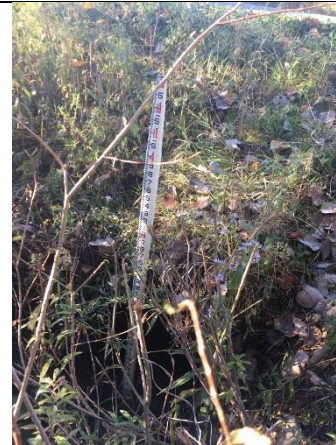
Site Description: The CMP conveys a small channel with an approximately 100-acre drainage area. The capacity of the 30" culvert is estimated at 47 cfs, a flow that may be exceeded in the 10-year flood event. The culvert headers are eroded as well as the road embankment and channel downstream of the culvert.

Photo 2: Murphy Hill Road culvert inlet.

BMP Description: Install a larger structure with stone headers. The recommended culvert size for an intermittent stream crossing of comparable drainage area is 48-60" in diameter. Based on HY-8 modeling, a 48" structure will pass the 25-year flood.

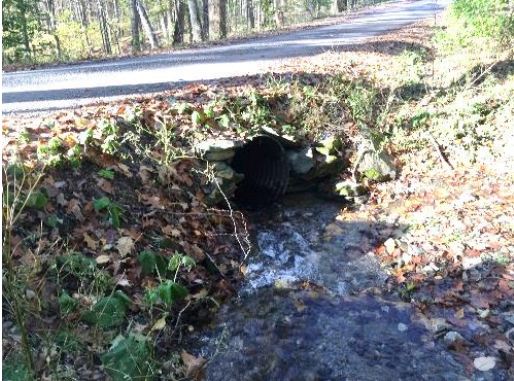
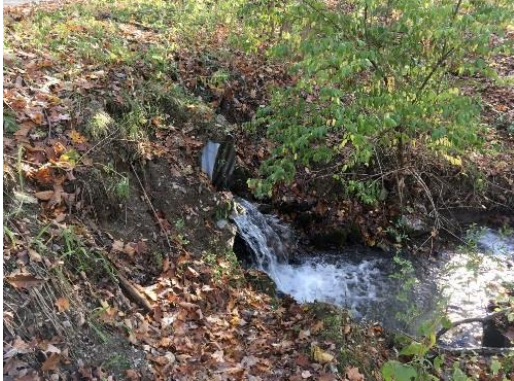
Location:	Granger Hollow Road			
Latitude:	43.0166 N			
Longitude:	-73.2644 W			
Land Ownership:	Town			
<p>Site Description: The CMP conveys a channel with an approximately 280-acre drainage area. The capacity of the 30" culvert is estimated at 33 cfs, a flow that may be exceeded in the 10-year flood event. The culvert headers are eroding, with severe erosion of the road embankment and downstream channel at the culvert outlet.</p>

Photo 1: Granger Hollow Road inlet.		Photo 2: Granger Hollow Road outlet.		
<p>BMP Description: Install a larger structure with stone headers. The recommended culvert size for a stream crossing of comparable drainage area is over 66" in diameter. Based on HY-8 modeling, a 72" round or a 95" by 67" elliptical structure will pass the 25-year flood.</p>				
WQ Benefits	Landowner Support and O&M	Cost and Constructability	Additional Benefits	Total Score (Priority)

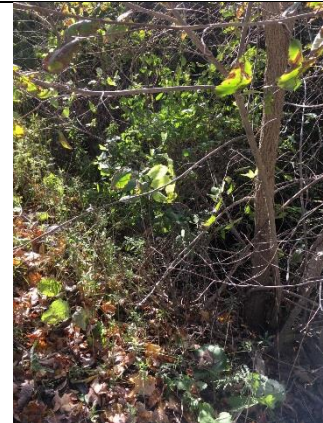
Photo 2: Murphy Hill Road culvert outlet.

BMP Description: Install a larger structure with stone headers. The recommended culvert size for an intermittent stream crossing of comparable drainage area is 42-48" in diameter. Based on HY-8 modeling, a 42" structure will pass the 25-year flood.

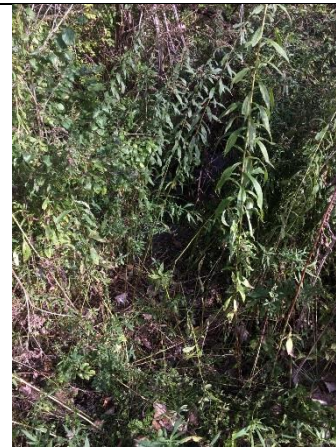
Photo 2:

Site Description: The CMP conveys a channel with an approximately 179-acre drainage area. The capacity of the 36" culvert is estimated at 30 cfs, a flow that may be exceeded in the 10-year flood event. There is some erosion of the road embankment at the inlet and outlet.

BMP Description: Install a larger structure with stone headers. The recommended culvert size for a stream crossing of comparable drainage area is over 66" in diameter. Based on HY-8 modeling, a 72" round or 84" by 60" elliptical structure will pass the 25-year flood.
